Midtemperature Solar Systems Test Facility Test Results: Effects of Severe Hailstorm on August 9, 1978

Thomas D. Harrison

Thomas D. Harrison
Experimental Systems Operation Division 4721
Sandia Laboratories
Albuquerque, NM 87185

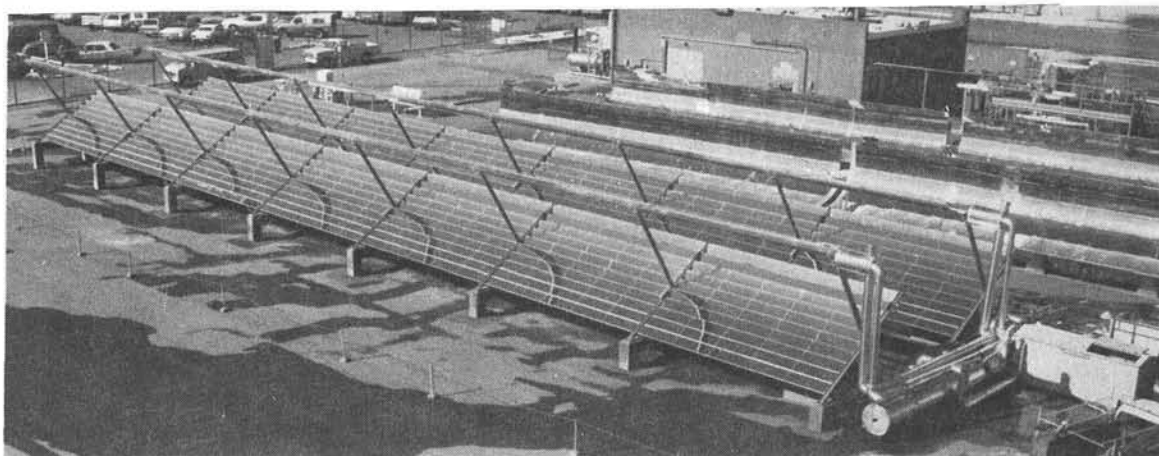
Figure 4. Solar Kinetics Parabolic Trough

Solar Kinetic Parabolic Trough -- One row of the Solar Kinetics parabolic trough (Figure 4) remained installed after testing was completed. It is an aluminum monocoque with 18-gauge heat-treated aluminum-sheet skin front and back. The aperture is 1 x 12.2 m. The reflective surface is FEK 244 acrylic film. It was stowed facing south with the plane of the aperture down at an angle of about 20° to the vertical. When the wind was from the south, the angle of fall of the hail was estimated to be 20 to 30° from the vertical.

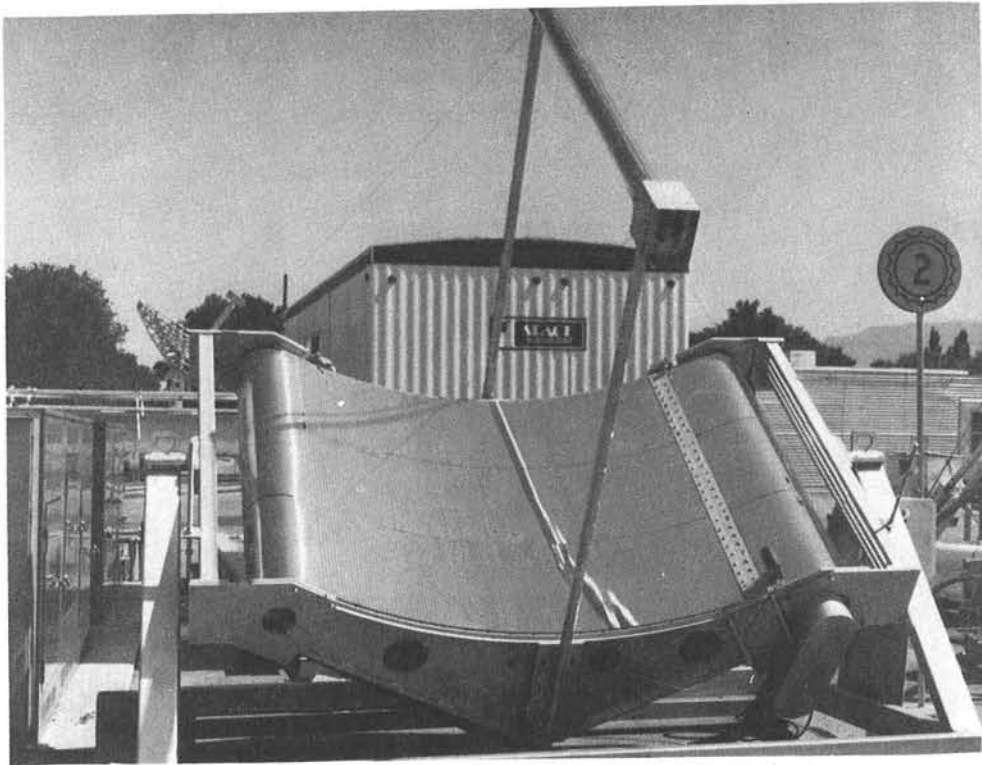
Figure 8. FMC Fresnel Belt

FMC Fresnel Belt -- This fixed-receiver module (Figure 8) has 12-mm-wide, 1.5-mm-thick, front surface, silvered glass facets bonded with a pliable adhesive to a stainless-steel belt 0.8 mm thick backed by a rigid surface. The 4-m² aperture was tilted south at an angle of ~75° from vertical. Approximately 18 of the 552 mirror facets were broken or cracked by the hail.

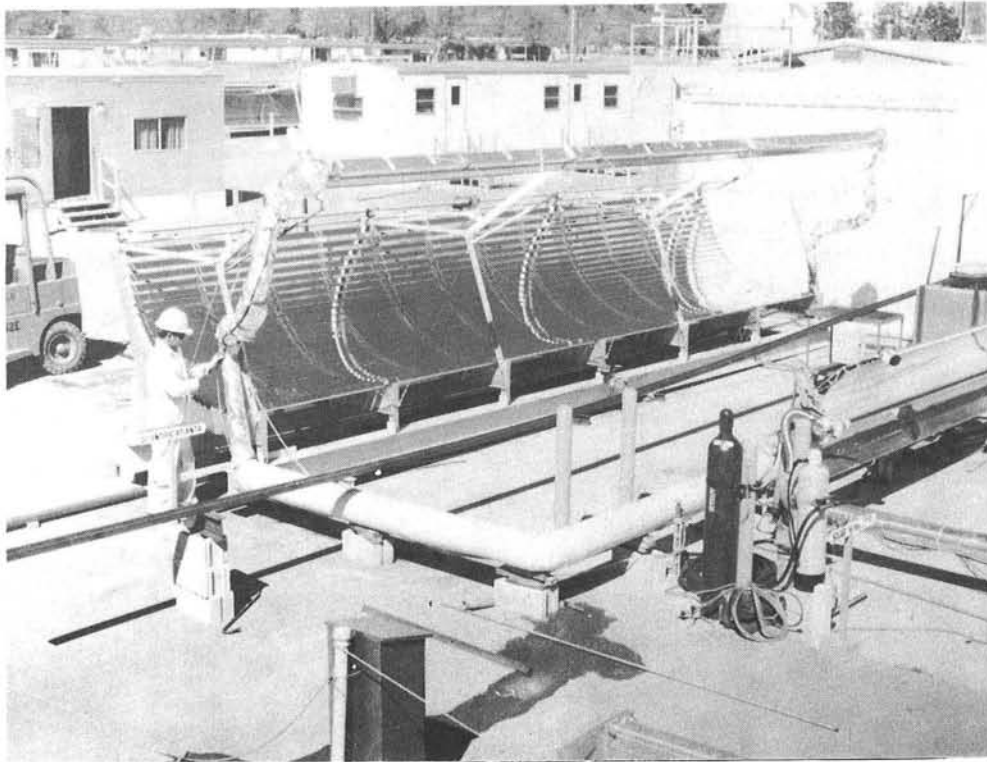
Figure 9. Scientific Atlanta FFMC

Scientific Atlanta FFMC -- This collector (Figure 9) was stored in a display area facing south. The 2.5-mm-thick, 76-mm-wide, 1.5-mm-thick mirrors were loosely supported along their long edges only. Approximately 30 of the 327 mirror strips were broken by the hail.

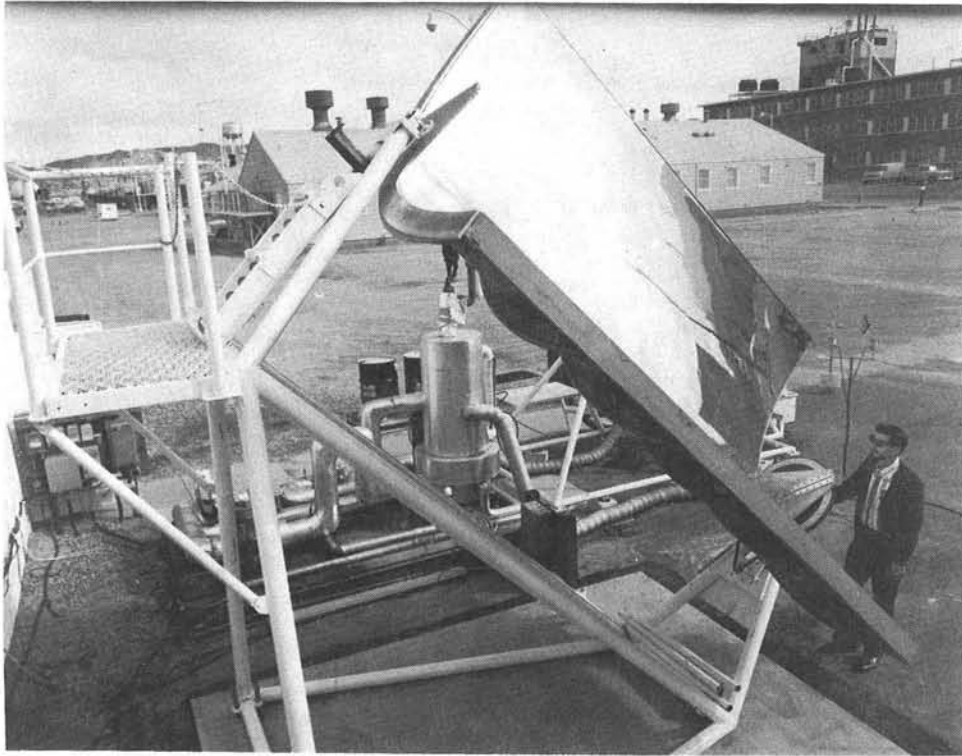
Figure 10. Sandia Prototype Parabolic Trough

Sandia Prototype Parabolic Trough -- This 2.7 x 3.6-m trough (Figure 10) is oriented N-S and tilted south about 45° to the vertical. The trough is formed by 19-mm plywood and the lower half has two reflective surfaces, an 0.6-mm ALZAK[®] reflector and two sections of 3.2-mm sagged glass. There was moderate dimpling of the ALZAK[®]. The adjacent two sections of 3.2-mm sagged glass were not damaged.

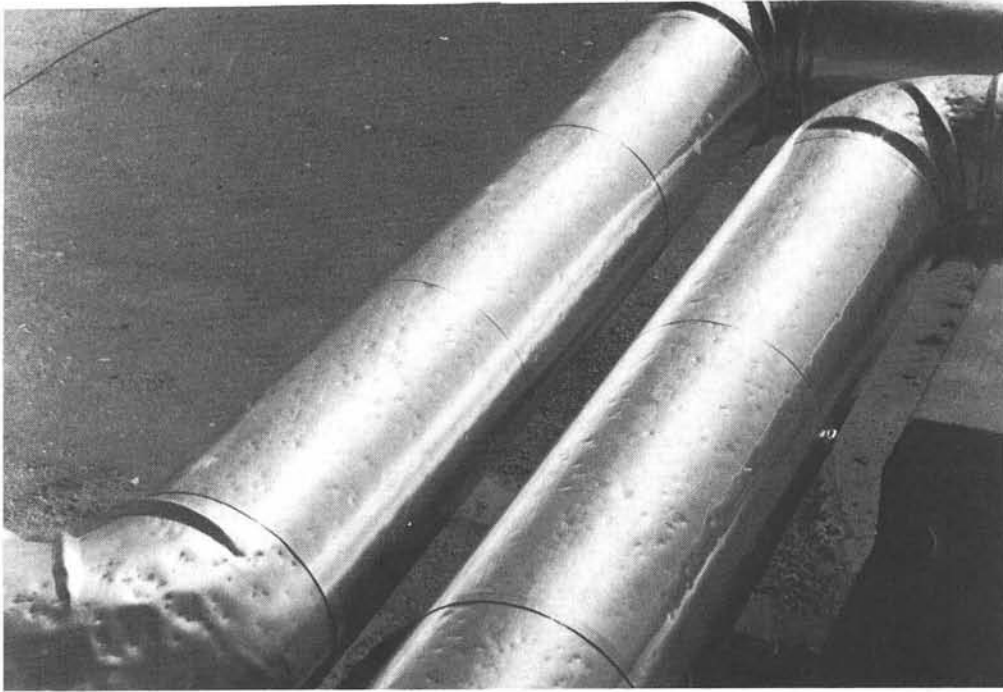
- Aluminum-Covered: Moderate dimpling of the aluminum (Figure 11)
- Plastic-Covered: Newer plastic undamaged but older plastic (Figure 12) generally pulverized
- Heavy Foil-Backed Paper: Penetration and tearing of the top surfaces

Figure 11. Effect of Hail on Aluminum-Covered Insulation

Fluid Loop -- With few exceptions, the insulation on the pipelines for all collector systems was covered by 0.15-mm (0.006-in.)-thick rolled-aluminum sheet. The aluminum is dented noticeably on the west side of the pipelines but was not damaged to the point that repair was necessary or that performance of the insulation is expected to change. In the exceptions where foam insulation was not covered with aluminum, the foam was damaged heavily. The damaged insulation had in all cases been exposed to the weather for more than 2 yr (see Figures 11 and 12).

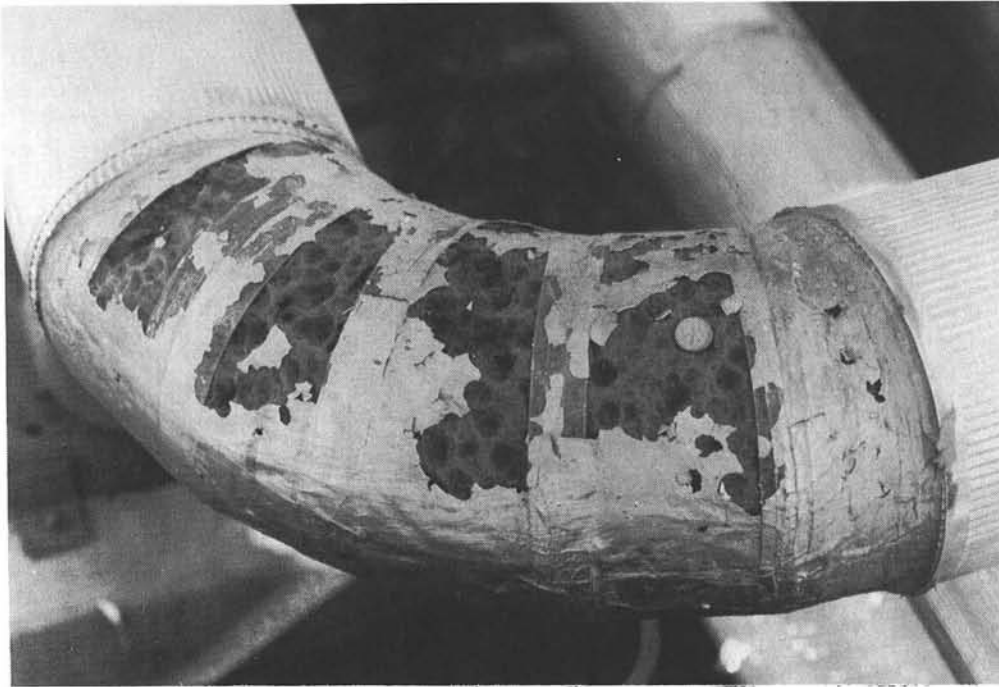
Figure 12. Effect of Hail on 2-Yr-Old Plastic-Covered Insulation

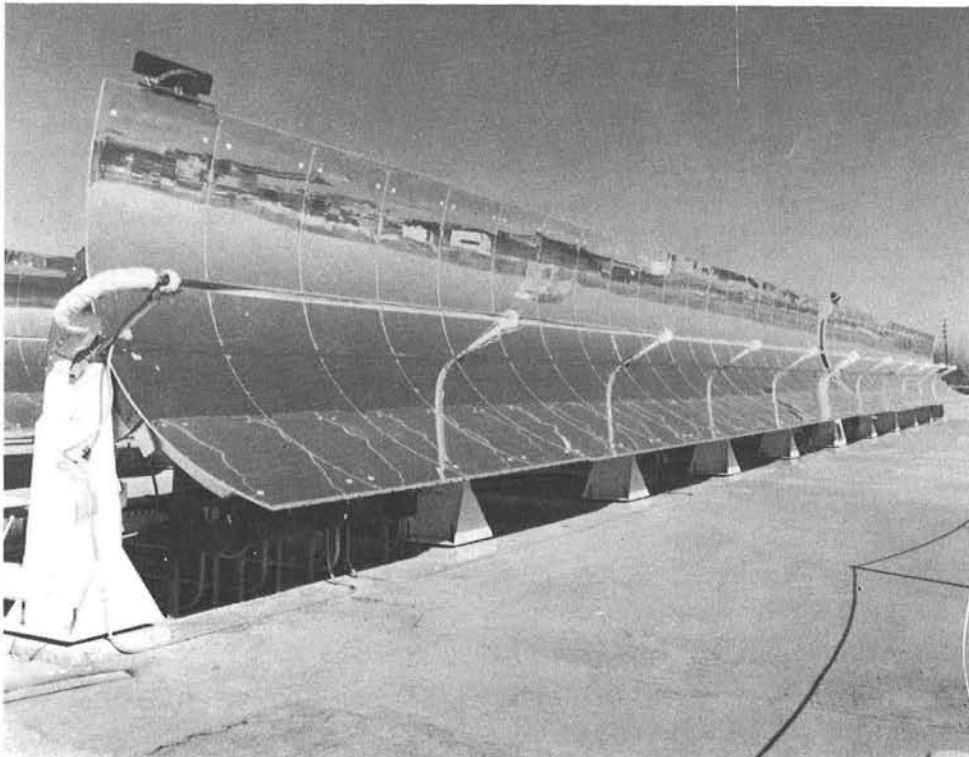
Figure 14. E-W Parabolic Trough Collector Field Subsystem

E-W Parabolic Trough Collector Field Subsystem -- This subsystem (Figure 14) comprises four strings, each 18.3 cm long. Two strings are south of the other two. The reflectors were stowed facing south with the aperture vertical. All surfaces on the bottom half contain shallow dents about 6 mm (1/4 in.) in diameter. The reflector surface is a sandwich of Mylar and aluminized Teflon on an aluminum sheet backing 0.6 mm (0.025 in.) thick. Two days of testing after the storm indicated that the short-term effects were negligible. However, long-term effects are possible if the hail caused microscopic breaks in the Teflon. By the end of August 1978, breaks in the Teflon were beginning to show. Peak efficiency tests conducted through October in the 2-1/2 mo after the hailstorm showed no degradation in efficiency attributable to the hail.

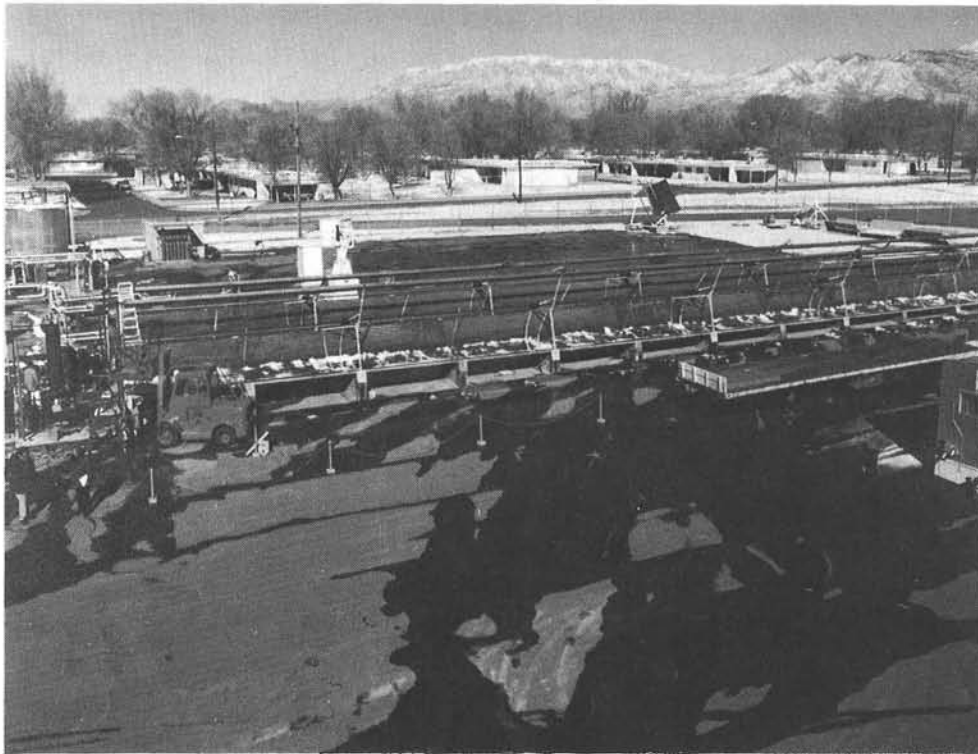
Figure 16. General Atomic FMSC Field Subsystem

General Atomic FMSC Field Subsystem -- This subsystem (Figure 16) comprises two rows, each 61 m long by 2.1 m wide. One row is south of the other. The FMSC concentrator consists of a series of fixed concrete troughs 3.8 m long by 2.1 m wide. The troughs have 5-cm-wide flat facets molded into them that run the length of the troughs. The flat facets have 5 x 127-cm flat-glass mirrors bonded to them with double-sided adhesive strips. The glass mirrors are Corning 0317 fusion glass 1.5 mm thick. Twenty-five percent of the glass mirrors were cracked or chipped in at least one place by the hail (Figure 17). This is expected to have a measurable effect on collector efficiency. The damage was concentrated at or near the tangent slat (center facet). The facets in this area underwent the most damage during construction and therefore provide the poorest support to the glass. A close examination of the cracked areas showed that there was indeed poor support for the glass at these points. The damage to the south row was greater than that to the north row, leading to the speculation that the south row provided some protection for the north row when the wind was from the south at maximum speed.

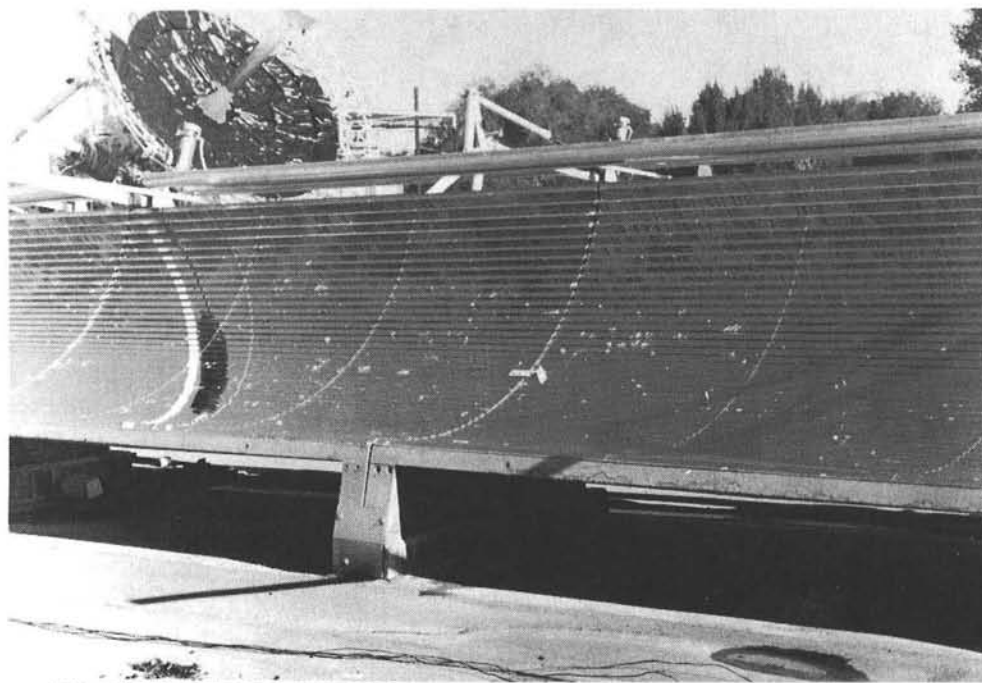
1. The only immediate functional damage from the hail was to the fixed-mirror collectors. The 260-m² General Atomic FMSC lost up to 5% of the mirror surface. The Scientific Atlanta FFMC had ~ 10% of its mirrors broken. Potential long-term damage occurred to the E-W parabolic-trough collectors in the small dents on the reflective surface. If a break in the Teflon occurs as a result of these dents, experience shows that delamination and loss of reflectivity around the break follow.

Figure 17. Hail Damage to FMSC

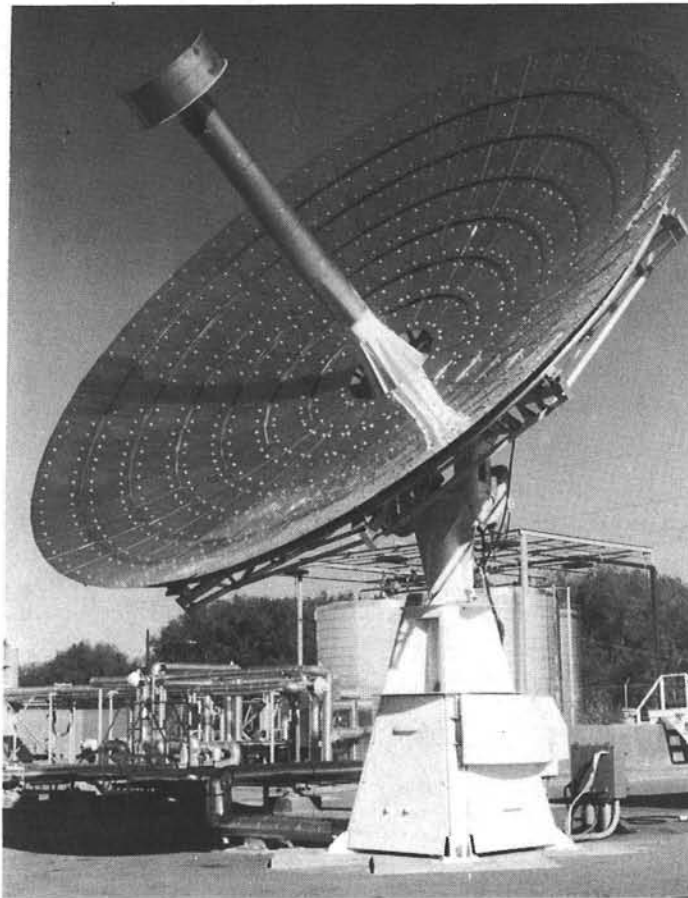
Figure 18. Raytheon Dish Collector

Raytheon Dish Collector -- The Raytheon collector (Figure 18) had 117 of its 228 glass-mirror segments mounted on its parabolic dish. The collector was stowed with the dish facing upward to the sky. The mirror segments are a maximum of 45.7 cm (18 in.) on a side and 0.3-cm (0.125-in.) thick, supported at four points by rubber grommets and bolts. The collector sustained no damage. There is a temptation to speculate that the high wind and shape of the dish may have given the glass some protection. However, evidence gathered from around the low-temperature thermal storage tanks indicates that some of the hail fell vertically, probably when there was little or no wind (see Figure 3 for wind velocity).
