## Silver Deterioration in Second Surface Solar Mirrors

V. P. Burolla, S. L. Roche

SAND79-8276  
Unlimited Release  
Printed January 1980

ABSTRACT

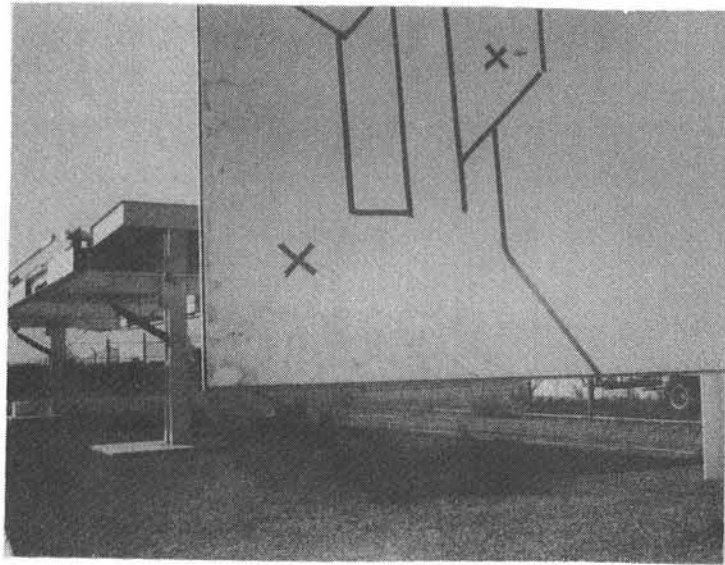
Figure 2. Photo Showing Deterioration Pattern on MM Module

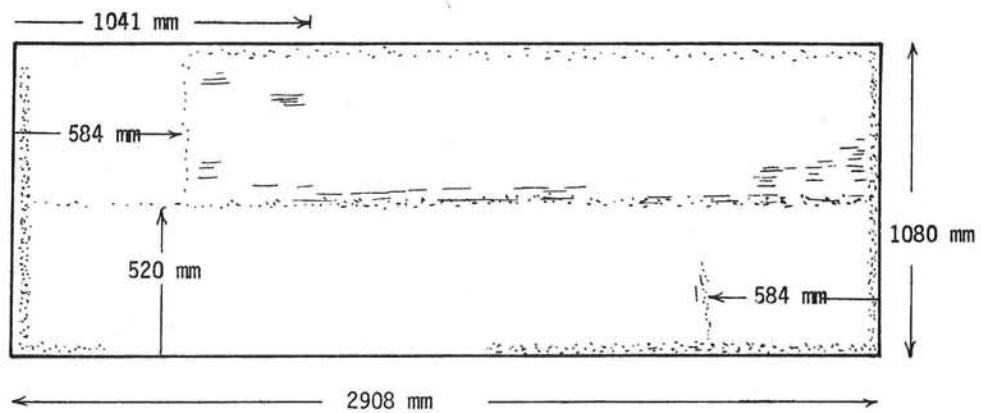
Figure 3. Drawing Depicting Deterioration Pattern on MDAC Module

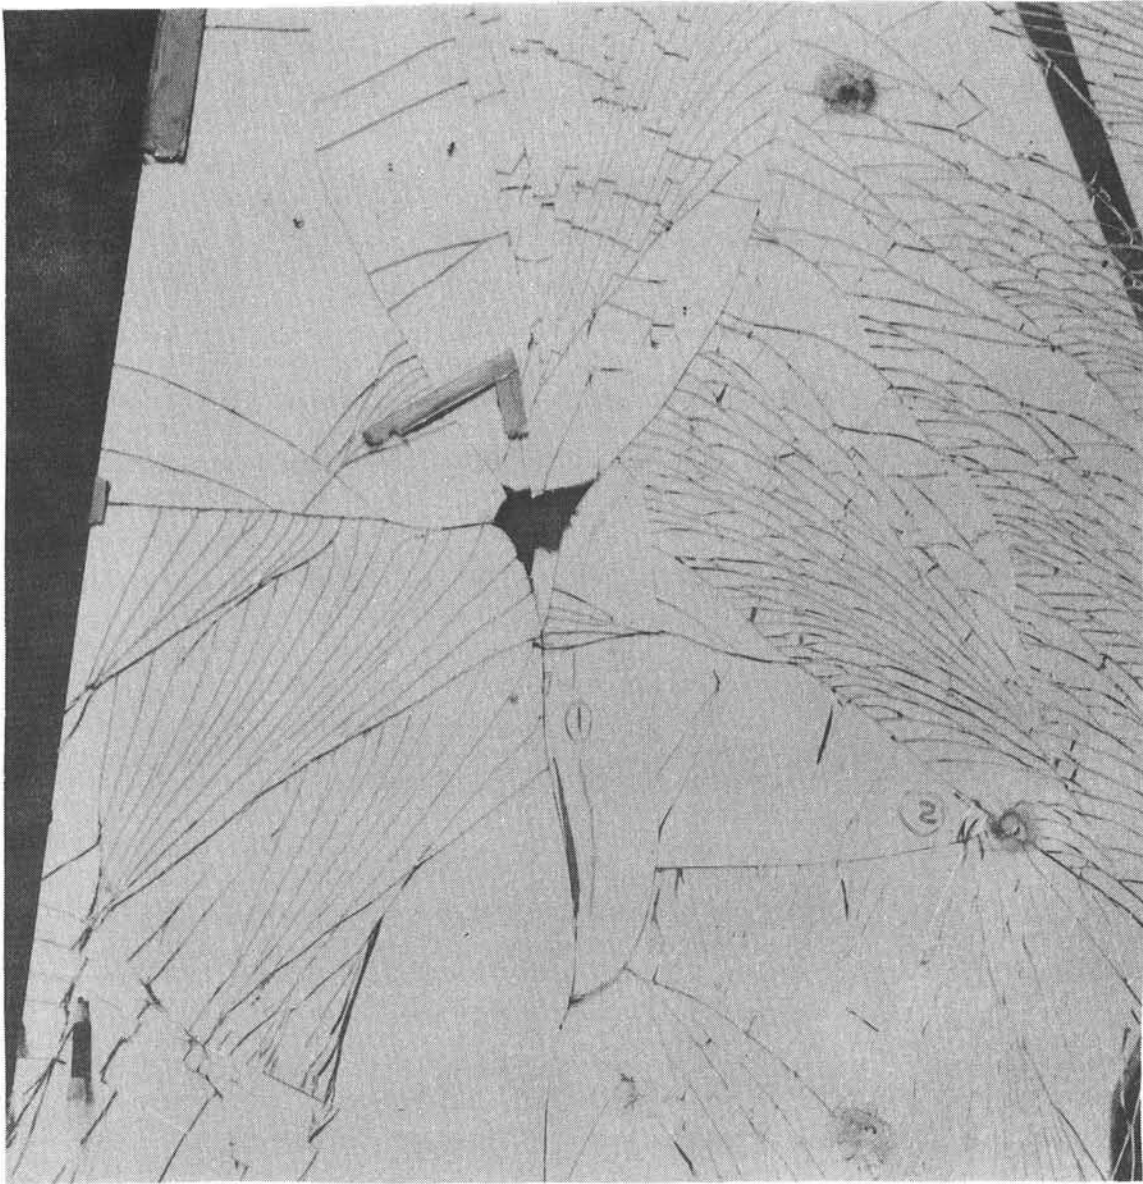
Figure 4. Vandalized MM Module Showing No Deterioration

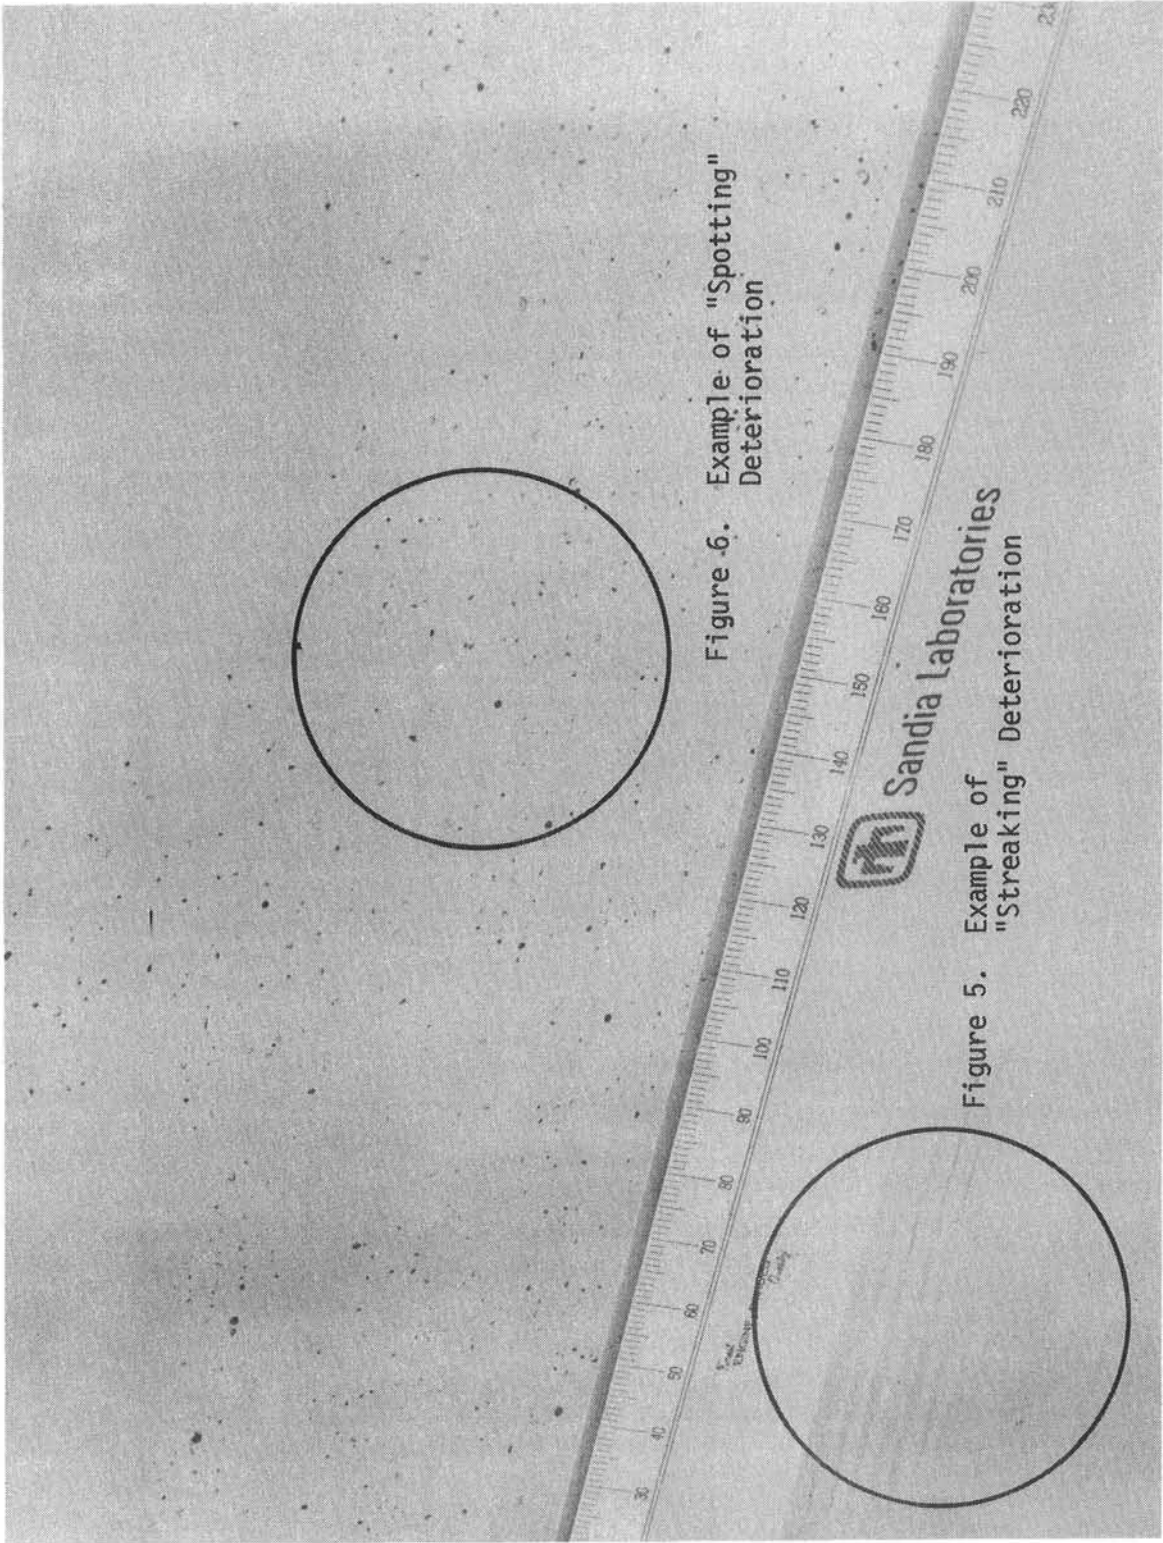
The deterioration observed was categorized three ways: streaking, spotting and delamination. The streaks appear as grayish bands on the silvered surface (effects on the silvered surface can be distinguished from dirt or anomalies on the first surface by the absence of a second, reflected image) the spots appear as dark irregular areas and the delamination which is literally the separation of the silver from the glass appears as water droplets on the silvered surface. Figures 5 through 7 show examples of each.

Figure 6. Example of "Spotting" Deterioration

Figure 5. Example of "Streaking" Deterioration

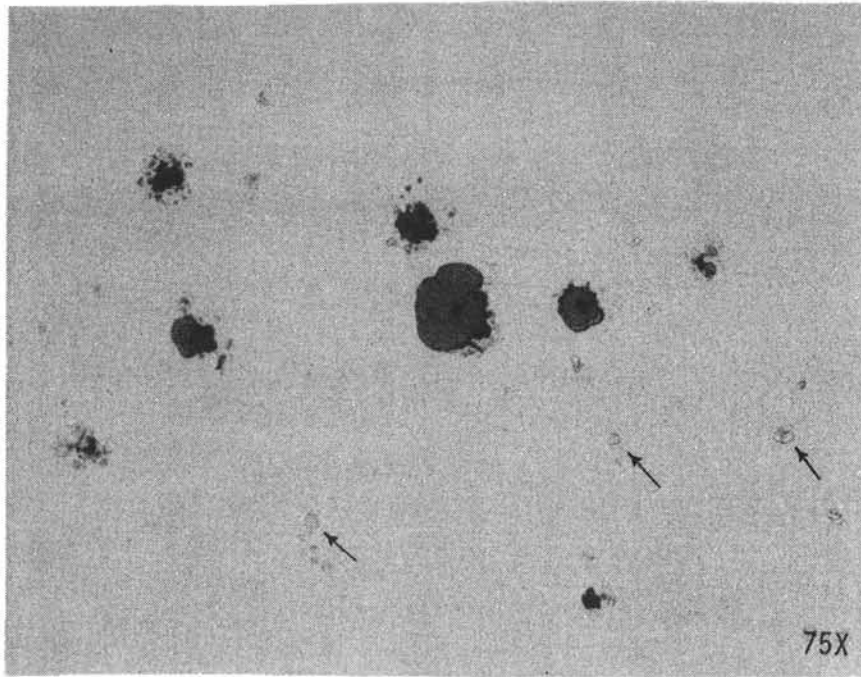
Figure 7. Magnified View of Deterioration Showing Delamination Sites (Arrows)

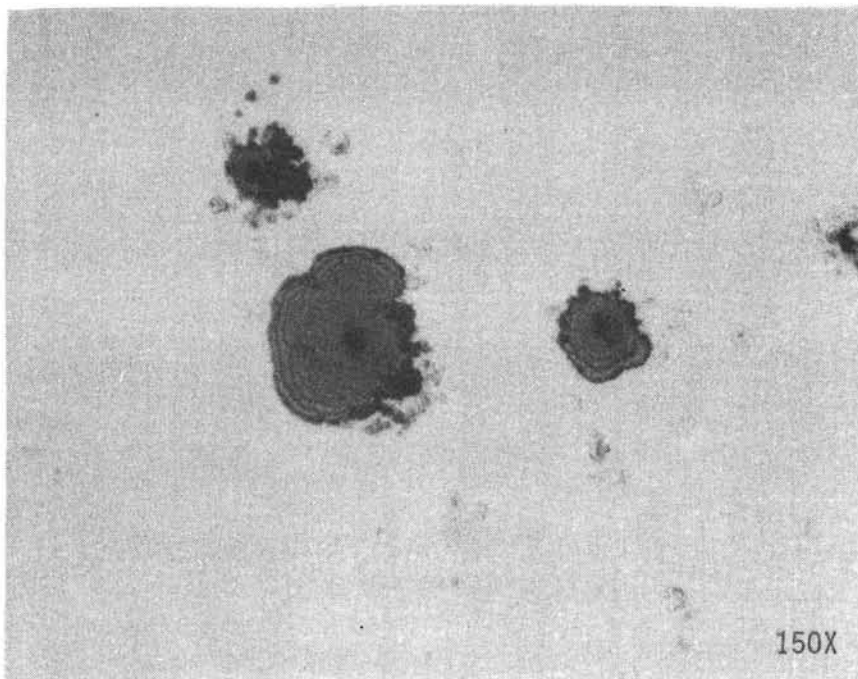
Figure 8. Magnified View of Several Deterioration Spots

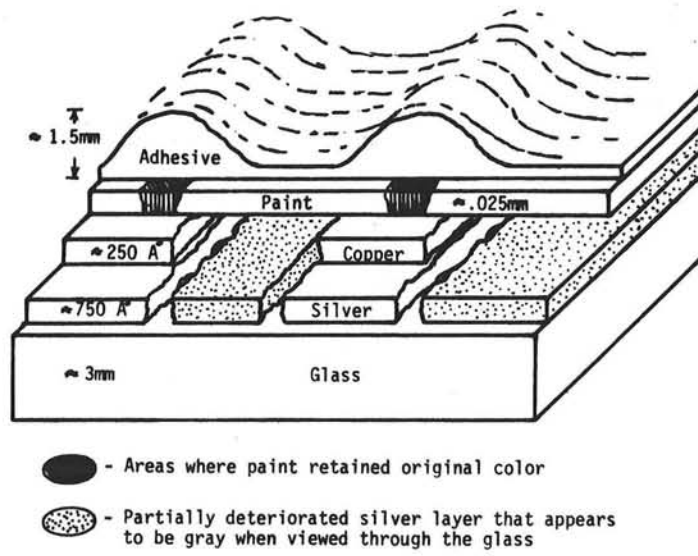
Figure 9. Exploded View of Deterioration Found on Field Sample (Not to Scale)

In every instance, wherever deterioration was present, the uniform copper layer was mostly absent and wherever there was silver remaining there was no discoloration of the silver layer. In fact what was actually being seen from the front surface was the gray backing paint. In other words the streaks or spots were actually areas devoid of silver and copper (see Figure 9).

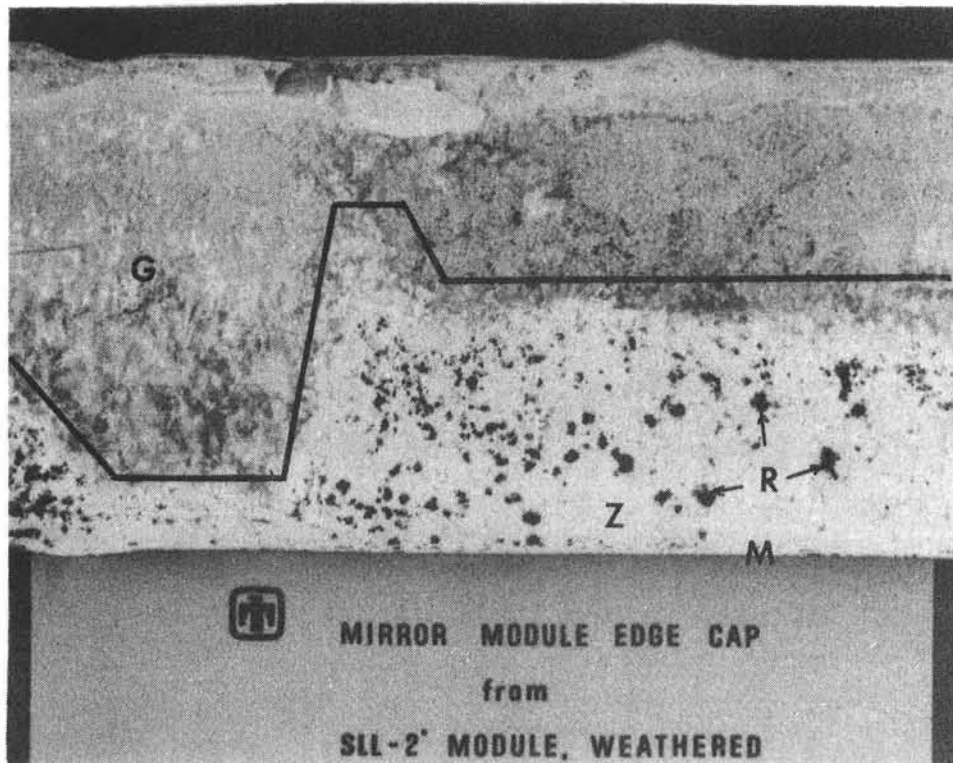
Careful examination of this module revealed no failure of the sealant visible to the eye. However, once opened sufficient water was found in the module to cause severe corrosion on the inside of one of the galvanized edge caps (see Figure 10) and to be sensed by touch. The other three edge caps had no corrosion noticeable. In all cases the deterioration seemed to start as a very small spot which grew larger with time. In some cases the spots (if in a line) would seem to grow and merge to form a continuous dark streak. This linear arrangement of spots to form a continuous streak was attributed to the adhesive lay down pattern used in some of the modules as shown in Figure 9. At times the bonding pressure was sufficient to flatten the adhesive ridges into a continuous fairly even film in which case the deterioration, if any, would take the form of randomly distributed spots. The adhesive in a portion of the deteriorated area had not been flattened and hence still formed ridges allowing a direct path for water to migrate in from the edge. The deterioration was confined to one area of the module (adjacent to the corroded galvanized edge) but contained both streaking and spotting. Several microliters of liquid were extracted from the region between adhesive ridges and subjected to infra-red (IR) analysis. Microscopic examination gives reason to believe that all deterioration begins with some form of delamination, so small as to be undetectable to the unaided eye.

Figure 10. Galvanized Edge Cap From Deteriorated Sandia Module

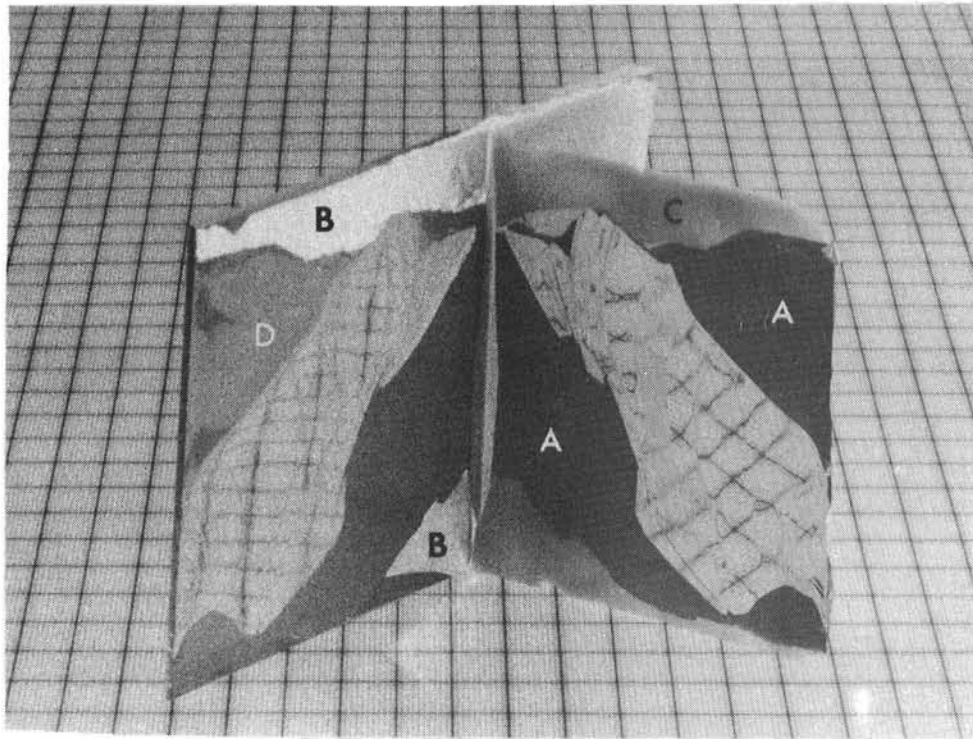
If a specific adhesive proves itself to be compatible chemically with the mirror, it must also be tested for mechanical compatibility as was demonstrated by the last series of deterioration tests. One epoxy adhesive had sufficient strength to cause the glass to fail internally while another managed to remove the silver quite nicely (see Figure 13 and 14). This may

Figure 13. Mirror (15 cm x 15 cm) Fractured in Glass (During Thermal Cycling) by Adhesive: A-Mirror Backing Paint, B-Aluminum Foil, C-Epoxy Adhesive, D-Copper Layer

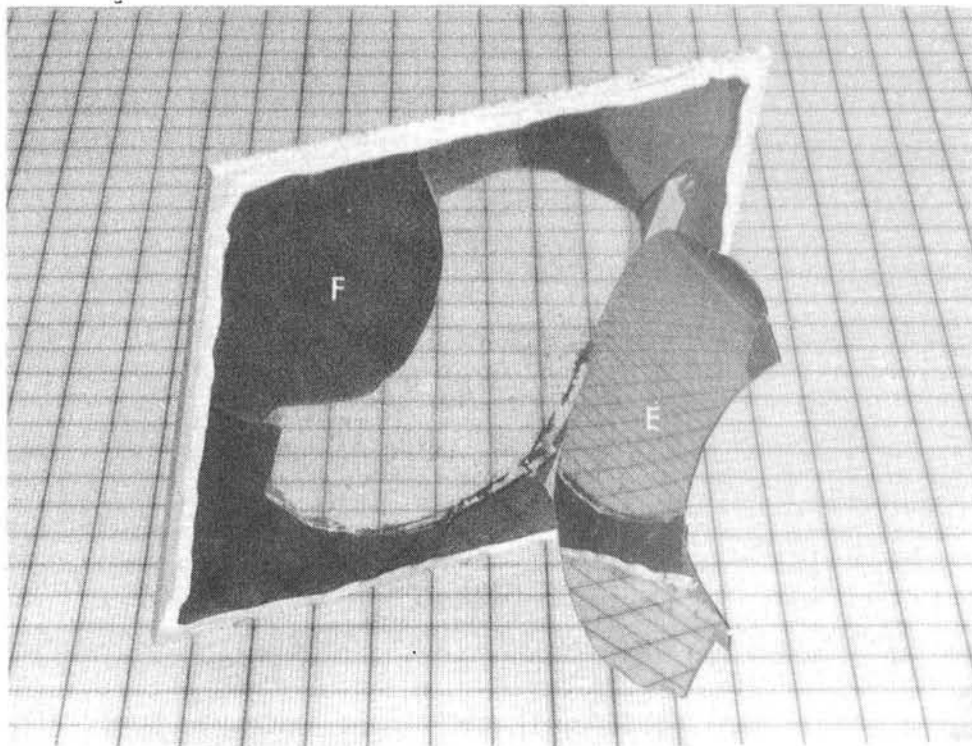
Figure 14. Mirror (15 cm x 15 cm) with Silver Delamination Due to Thermal Cycling: E-Silver Layer Intact F-Epoxy Adhesive

imply that some adhesives have the ability to penetrate the silver layer if indeed the copper and silver layers are porous and bond directly to the glass. However, it may also be indicative of the importance of adhesive layer thickness.

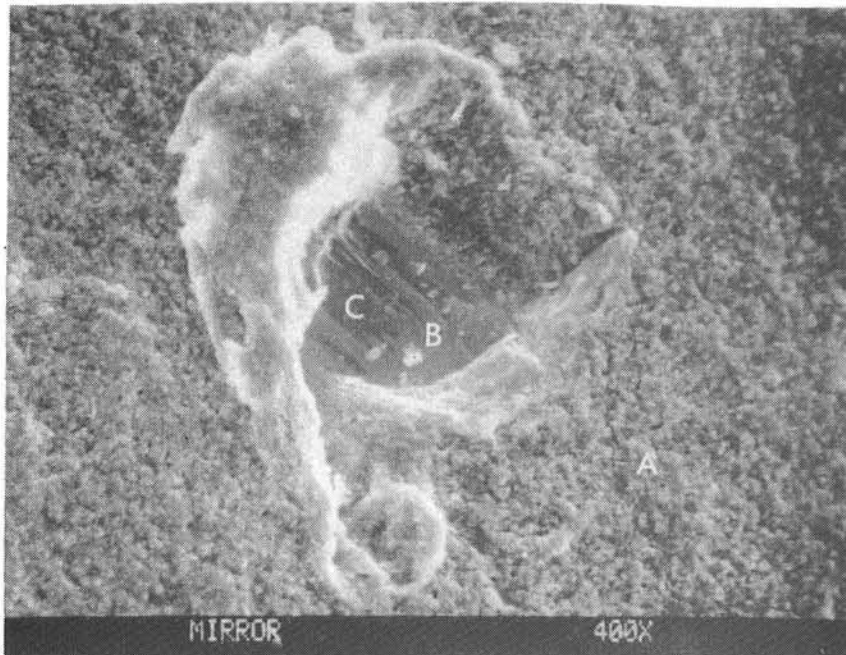
Microscopic Examination--In all the observations made, it was never clear what caused the nucleation of the spots. It was originally thought that the spots located themselves at pinholes in the paint layers. Very careful examination of several selected mirrors revealed pinholes only due to rough handling and in numbers, orders of magnitude less than what would be required for the spotting effect (see Figure 15). Indeed accelerated deterioration tests run on mirrors samples with intentionally created pinholes had deterioration start invariably at some location other than the pin holes.

Figure 15a. Magnified SEM View of Mirror Pinhole  
A-Mirror Backing Paint  
B-Metal Layer(s)  
C-Glass

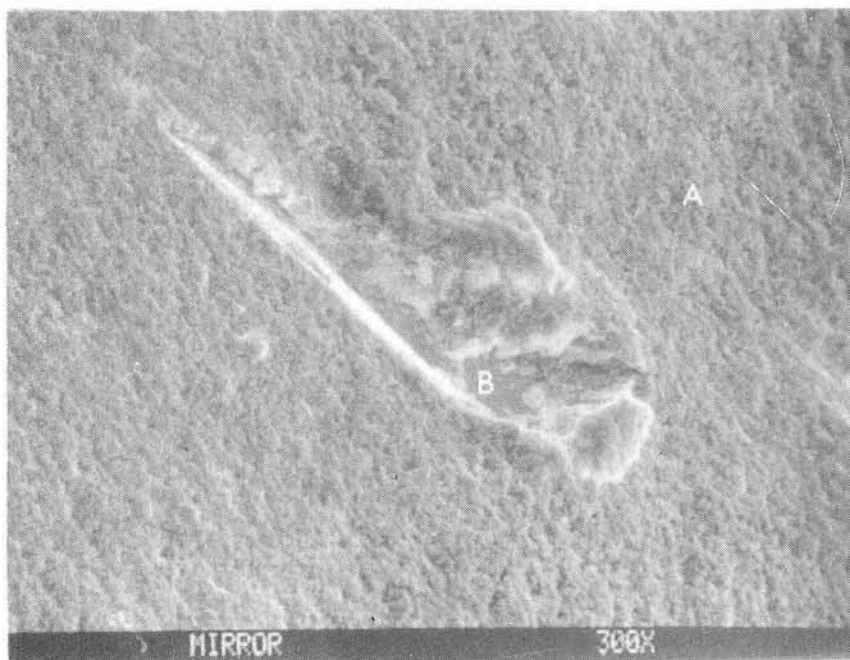
Figure 15b. Magnified SEM View of Mirror Pinhole  
A-Mirror Backing Paint  
B-Metal Layer(s)
