FINAL REPORT

SECOND GENERATION HELIOSTAT

LIFE CYCLE AND OPERATIONAL TORQUE CAPABILITY
OF THE SECOND GENERATION AZIMUTH DRIVE

TEST REPORT
ELEVATION ACTUATOR, MDAC SECOND
GENERATION HELIOSTAT

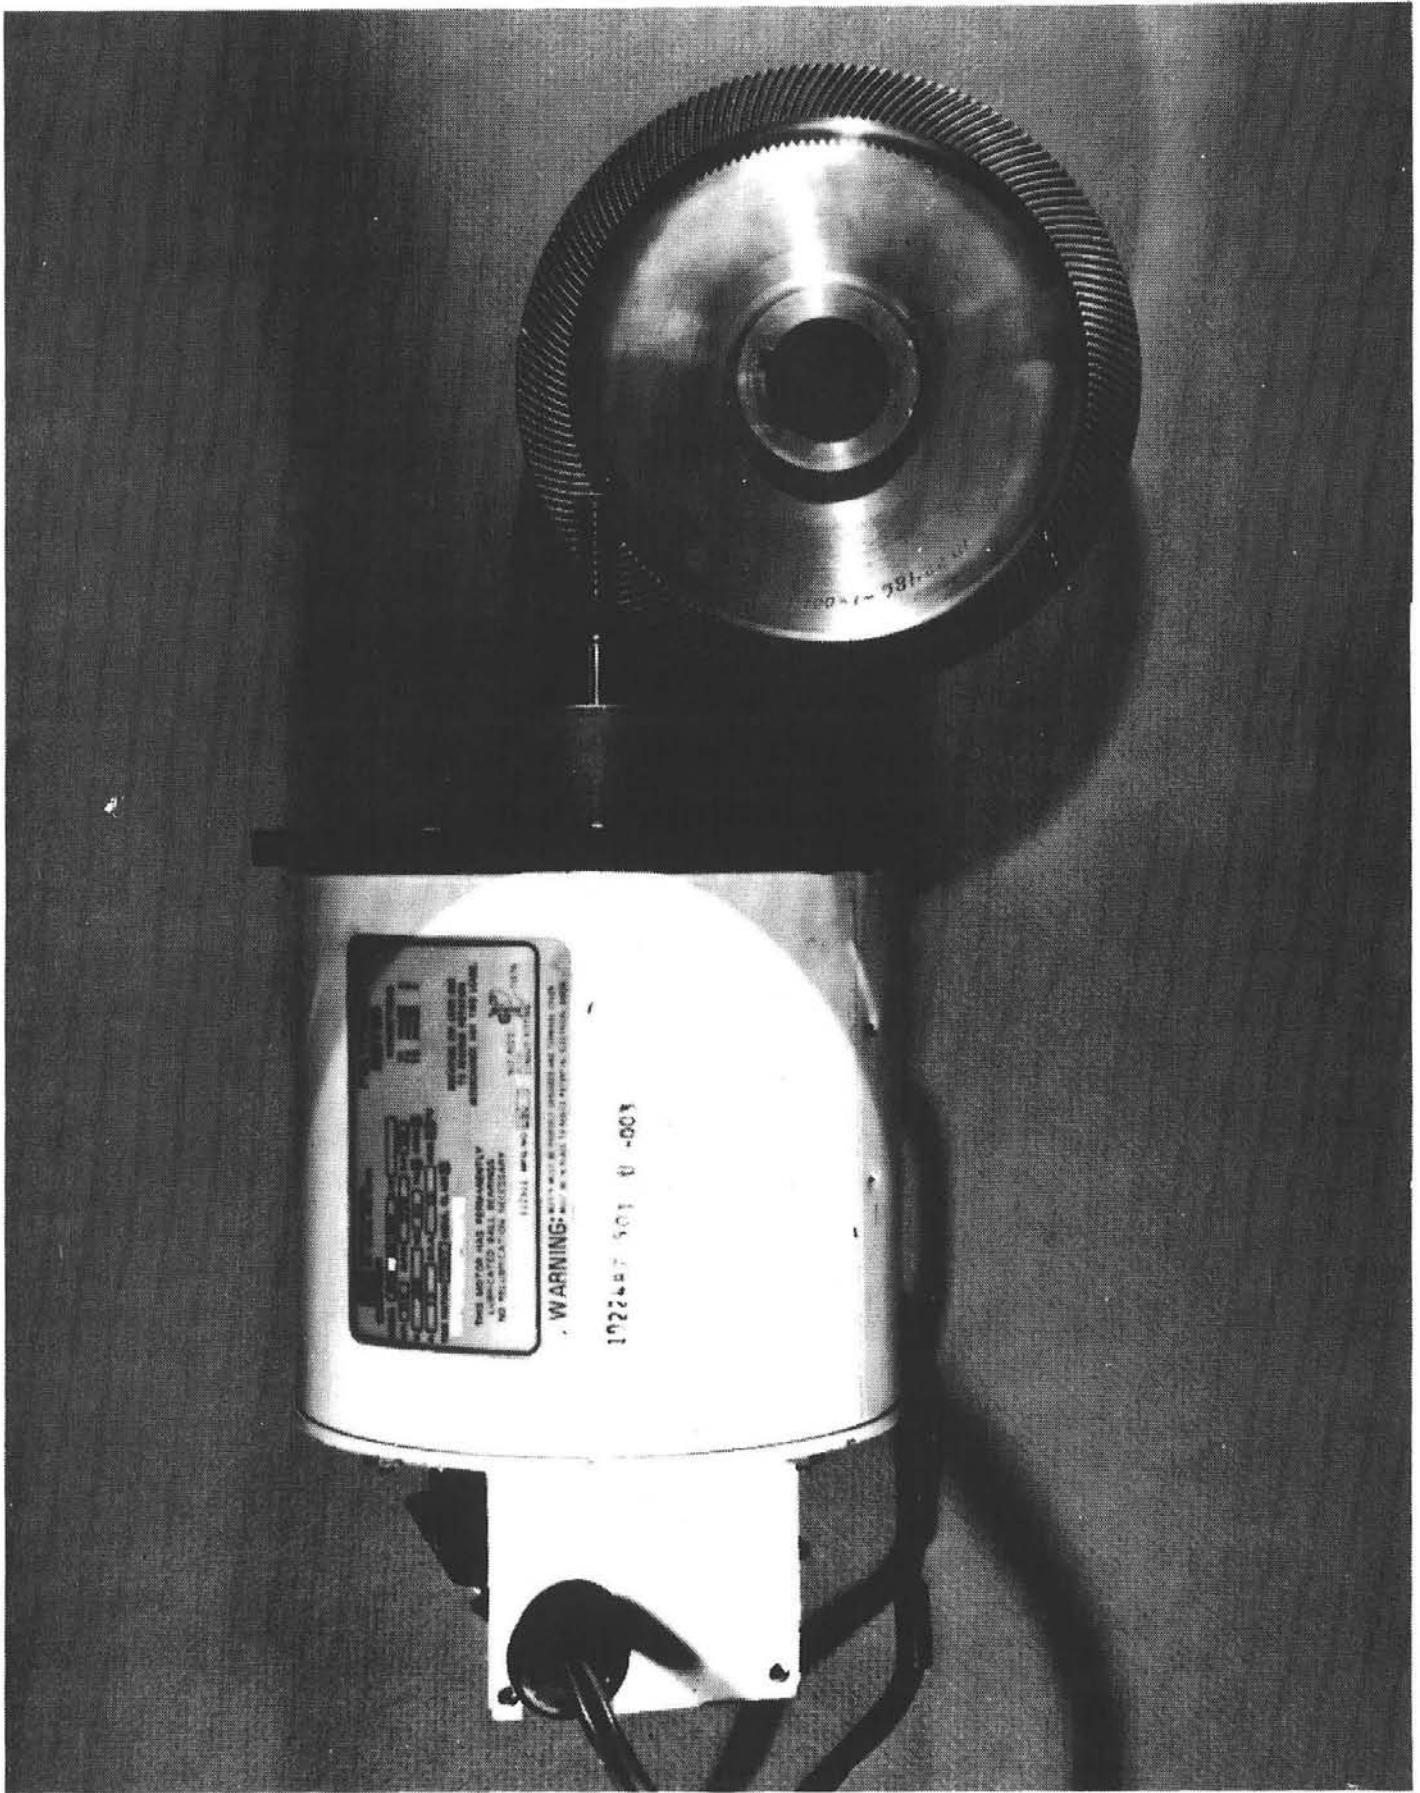
FIGURE 6 - MOTOR AND HELICON GEAR SET

The motor performed satisfactorily throughout the life test. No disassembly of the motor was performed because the unit would require return to the supplier, Emerson Electric, for reassembly. The pinion and helicon gear were in excellent condition following the life test. The pinion had a very polished appearance with no evidence of pitting. The helicon gear was found in excellent condition without any significant wear pattern evident on the teeth for either direction of rotation. These units will be used as is when the azimuth drive unit is reassembled for future testing. Refer to photographs presented in Figures 6, 7 and 8 for close-ups of the noted components.

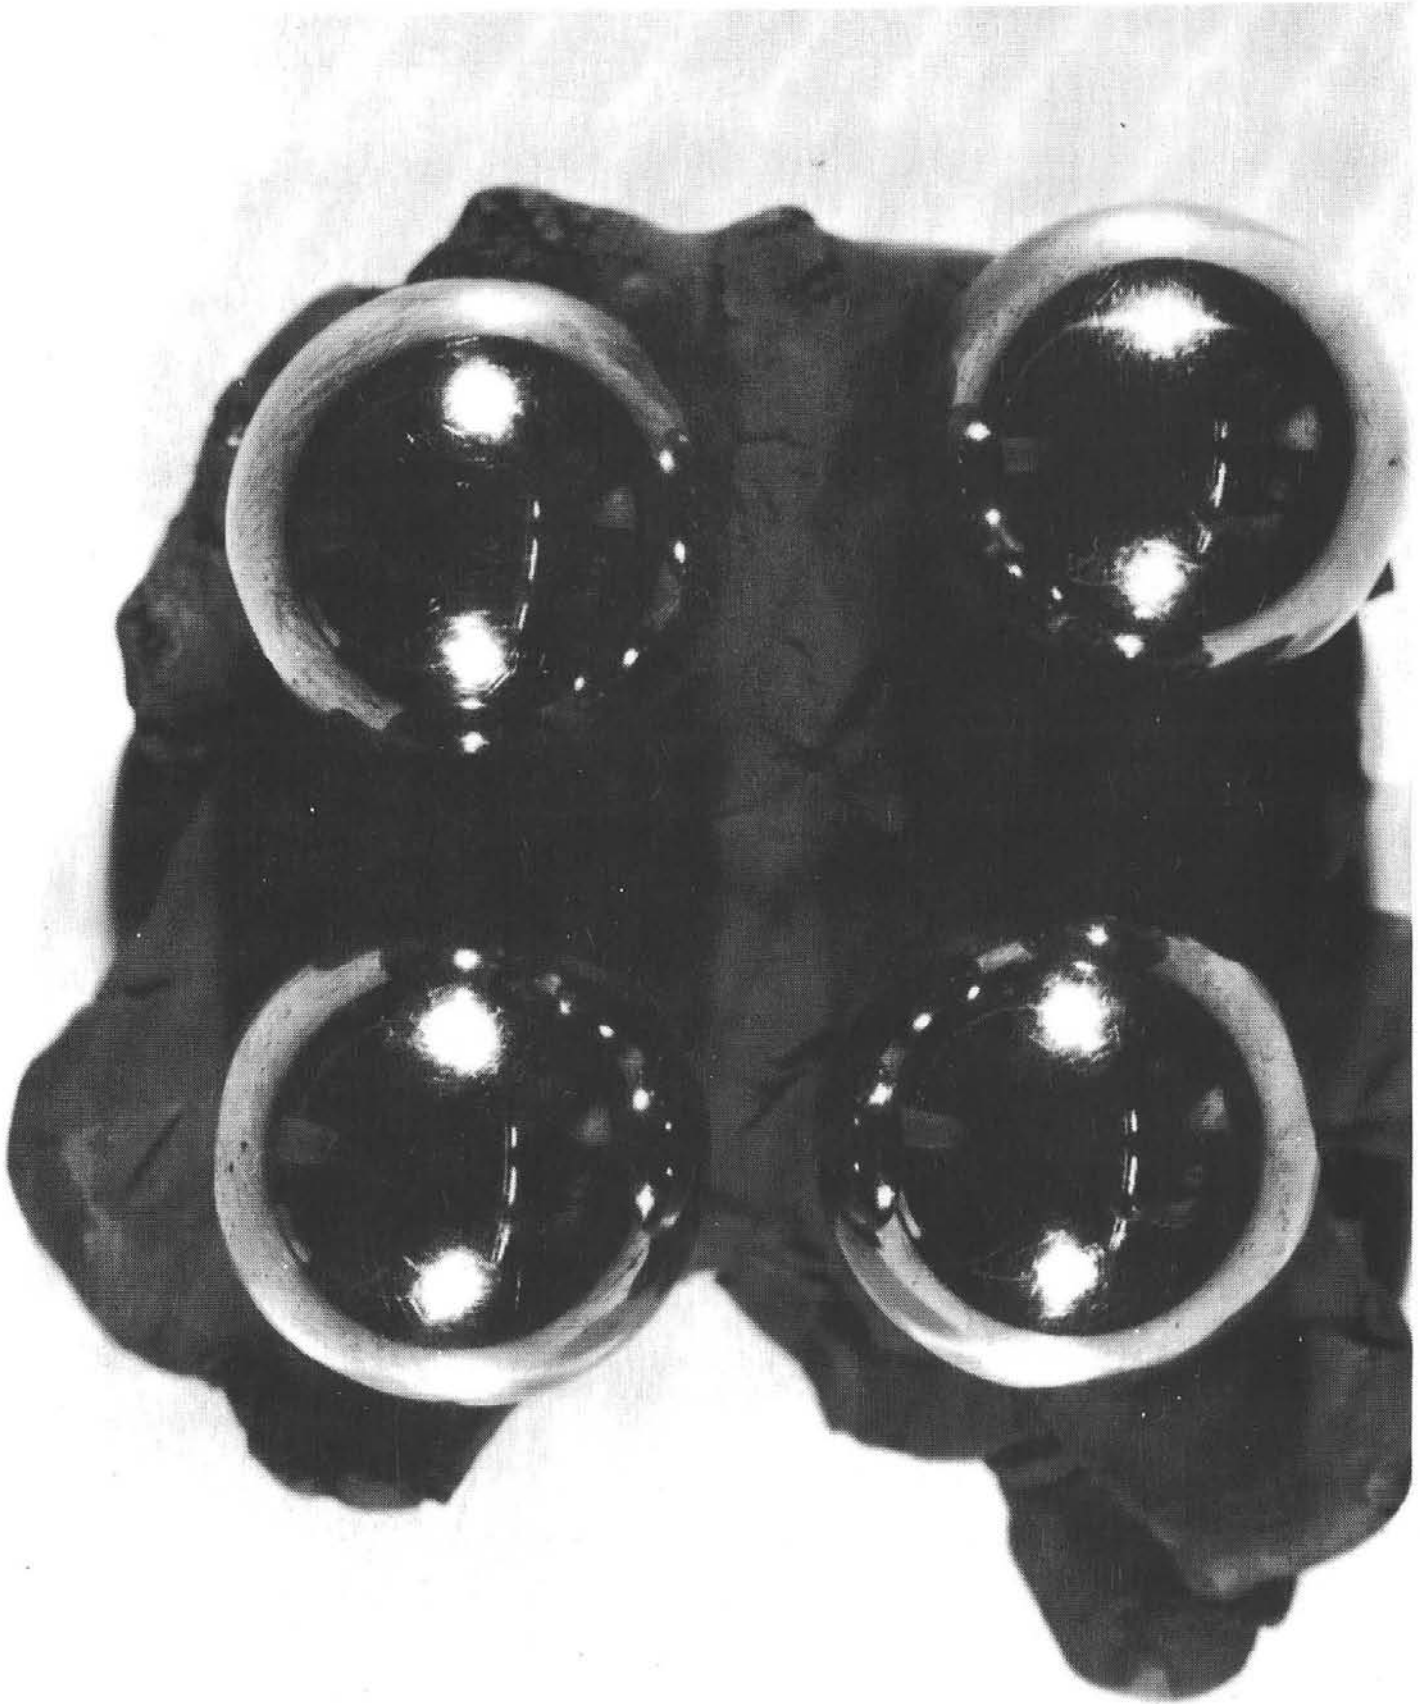
FIGURE 9 - TYPICAL WIRE RACE BEARING BALLS

The wire races were found to be highly polished in the loaded areas. The surfaces were highly burnished from the repeated ball travel and had an appearance similar to a decorative chrome plate. No evidence of pitting or surface failure could be detected. The back sides of the races and grooves that they rested in also showed some burnishing. The burnishing was a surface leveling of the machining on the new parts and most probably the result of the high loads during the ratchet test and the superimposed overturning moment applied throughout the 30 year life test. No pitting or surface failure was found. The wire race bearing balls were in good condition with slight scratches

on their surfaces. The scratches are most probably caused by ball-to-ball rubbing seen in previous tests conducted on the wire race bearing. The overall condition the wire race bearing and related components is good and these parts will be installed in the azimuth drive unit for future testing. Post life details are shown in Figures 9, 10 and 11.

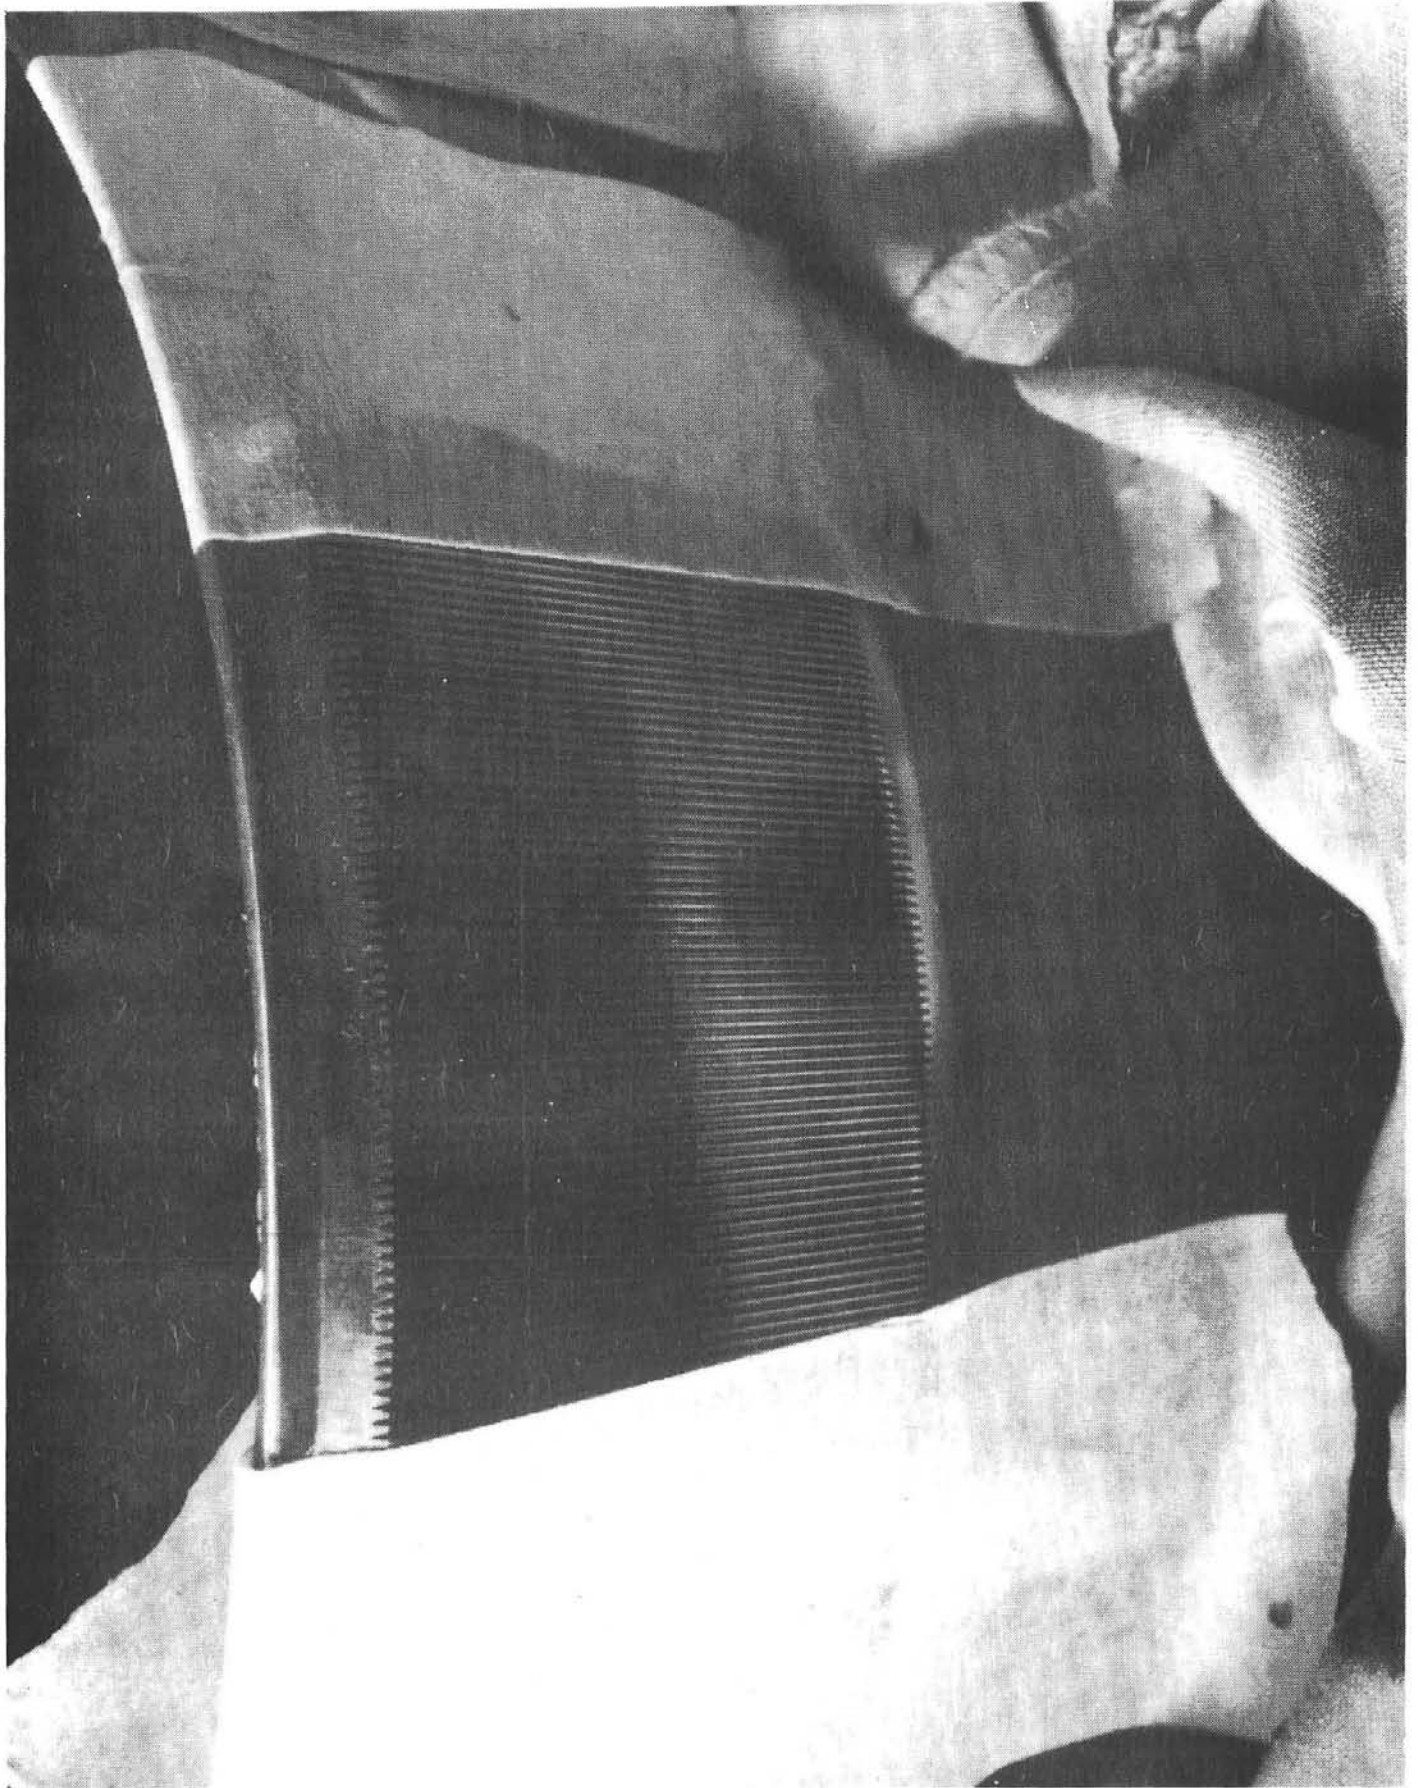
FIGURE 14 - FLEX SPLINE (POST LIFE CYCLE)

The flex spline teeth were in excellent condition with practically no evidence of wear. Silicone molds of the splines were obtained and sectioned slices were projected on a shadowgraph. Refer to photographic coverage in Figures 14 and 15 for flex spline details. The respective slices were obtained .25, .50 and 1.00 inches down from the top of the flex spline as shown in Figure 13. No readily discernable wear can be seen. The flex spline/wave generator interface looked good. The contact area was burnished, but no deep grooves or other damage were found.

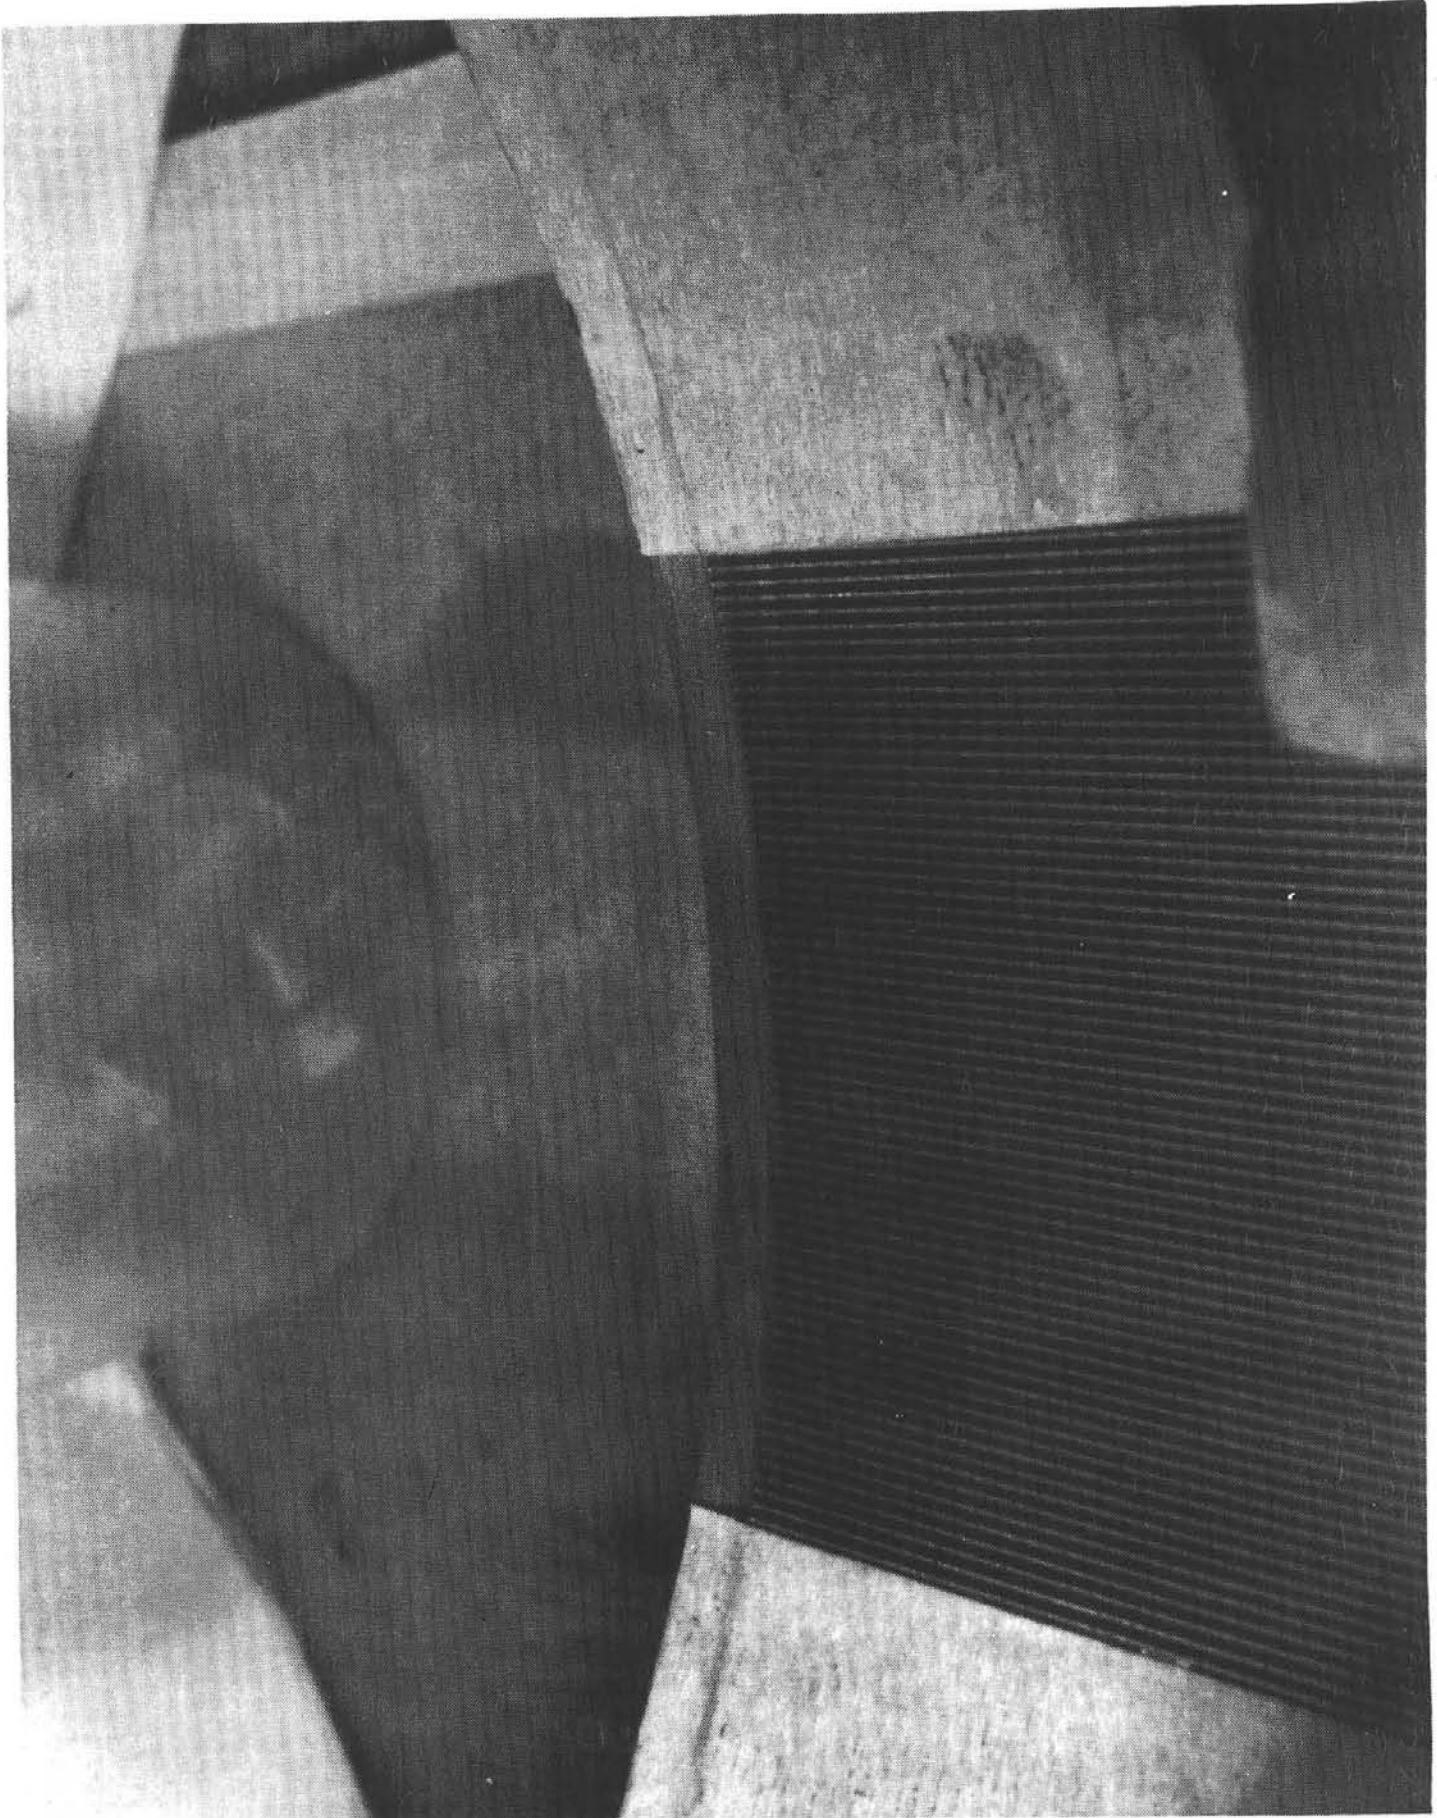
FIGURE 16 - CIRCULAR SPLINE

The circular spline photos in Figure 16 shows a slight narrowing of the spline teeth approximately .375 inch from the top. The top .25

inch of the circular spline is not in mesh with the flex spline and represents no wear. The shadowgraph sections in Figure 17 are taken .12, .375 and 1.25 inches from the top of the circular spline. The .12 inch slice represents the control since no wear is achieved at this point. Comparison of the .12 slice with the .375 inch slice shows some narrowing of the spline teeth. The .375 inch slice should show the greatest wear because this area achieves the greatest deflection and highest load. The slight wear observed suggests that considerable life remains in the harmonic drive.

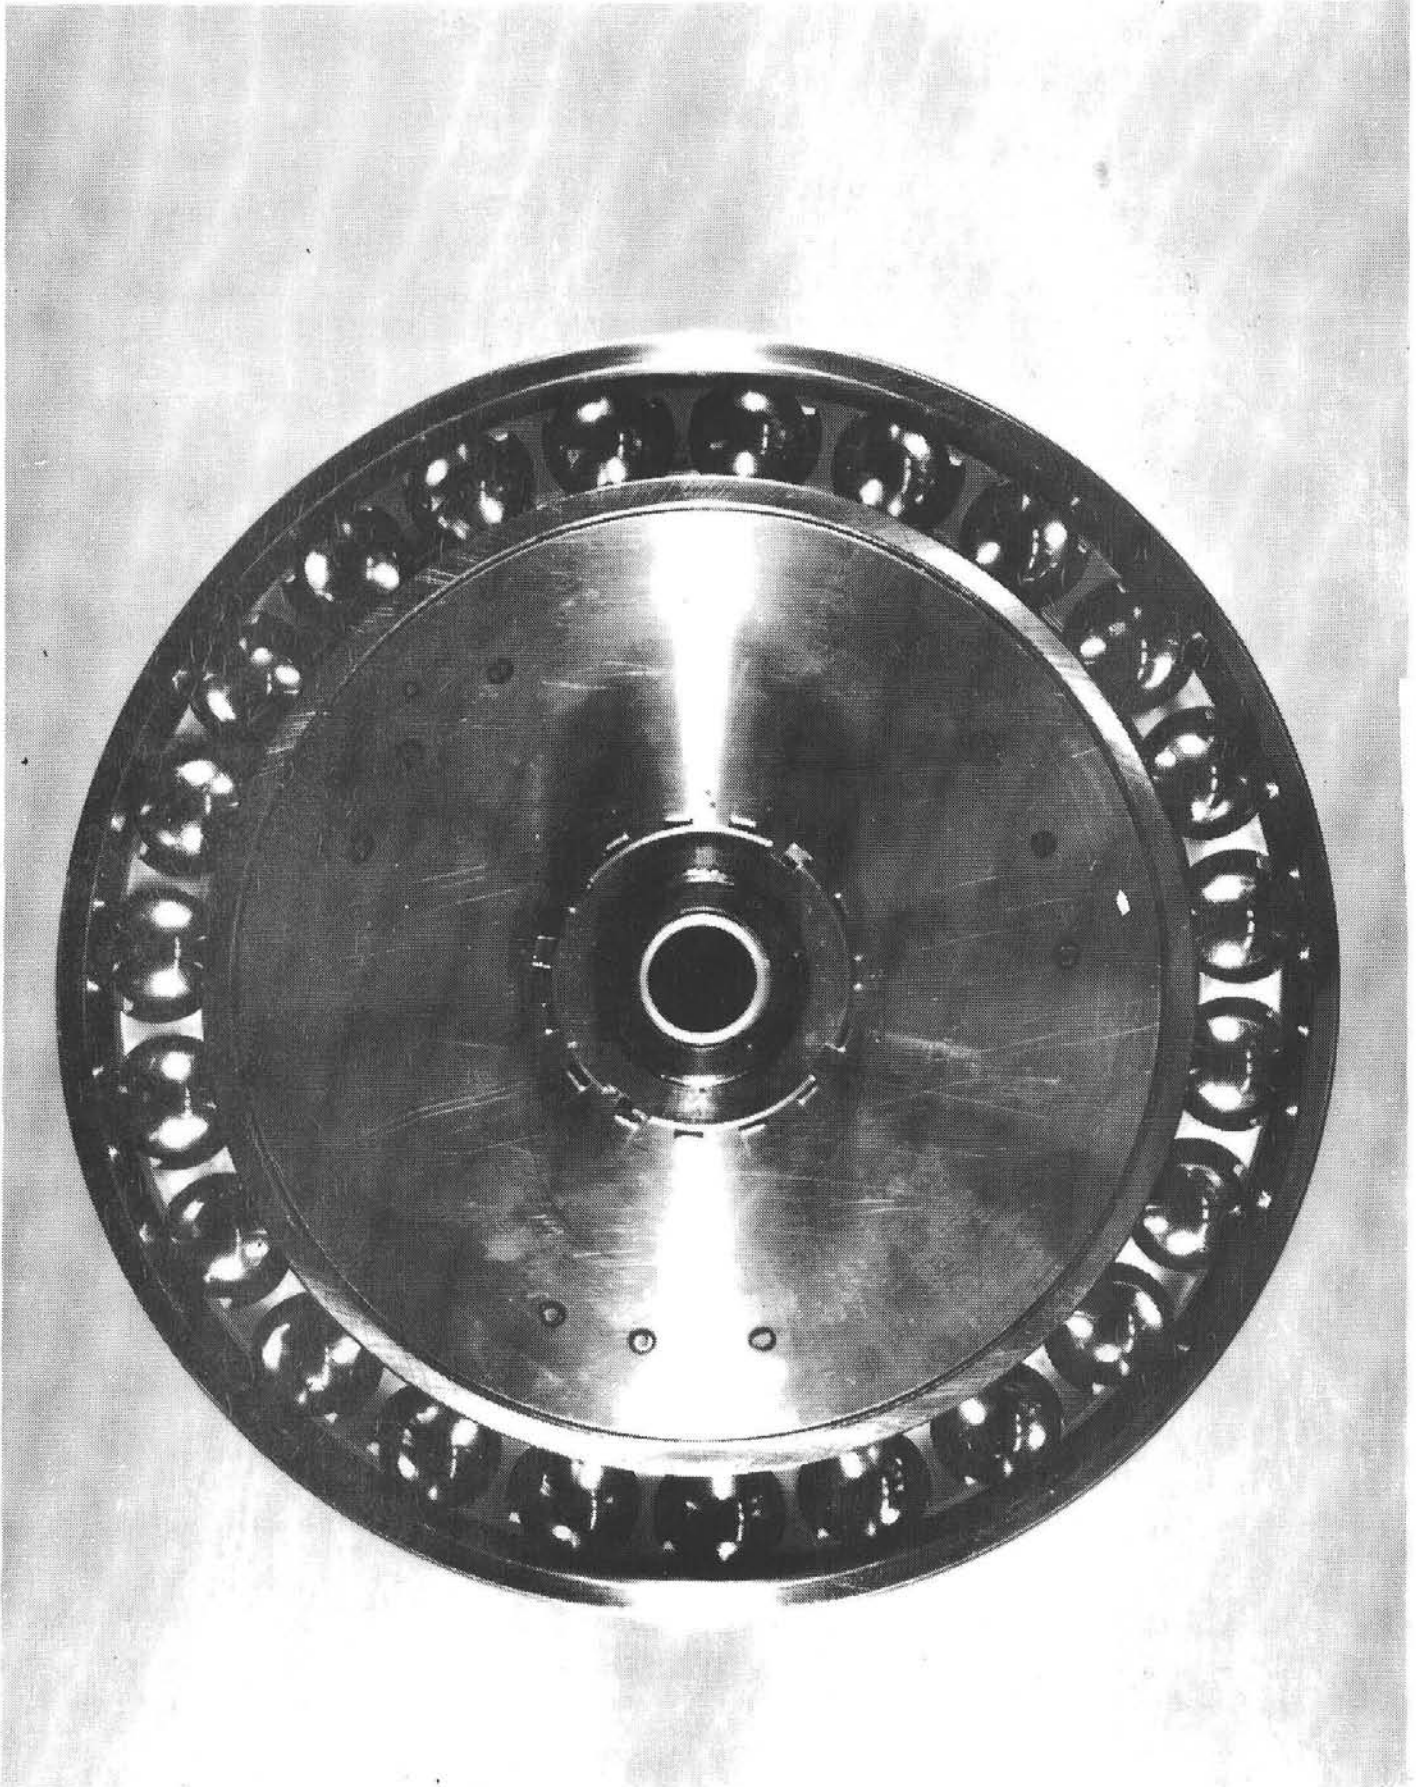
FIGURE 18 - WAVE GENERATOR

The wave generator anti-friction bearing was in excellent condition. The ball separator, balls and races did not show any damage and are satisfactory for further testing.
