SAND87-8175  
Unlimited Release  
UC-62a

# 10 MWe Solar Thermal Central Receiver Pilot Plant Repaint of a Single Receiver Panel Test Report

10 MWe SOLAR THERMAL  
CENTRAL RECEIVER PILOT PLANT  
REPAINT OF A SINGLE RECEIVER PANEL  
TEST REPORT

ABSTRACT

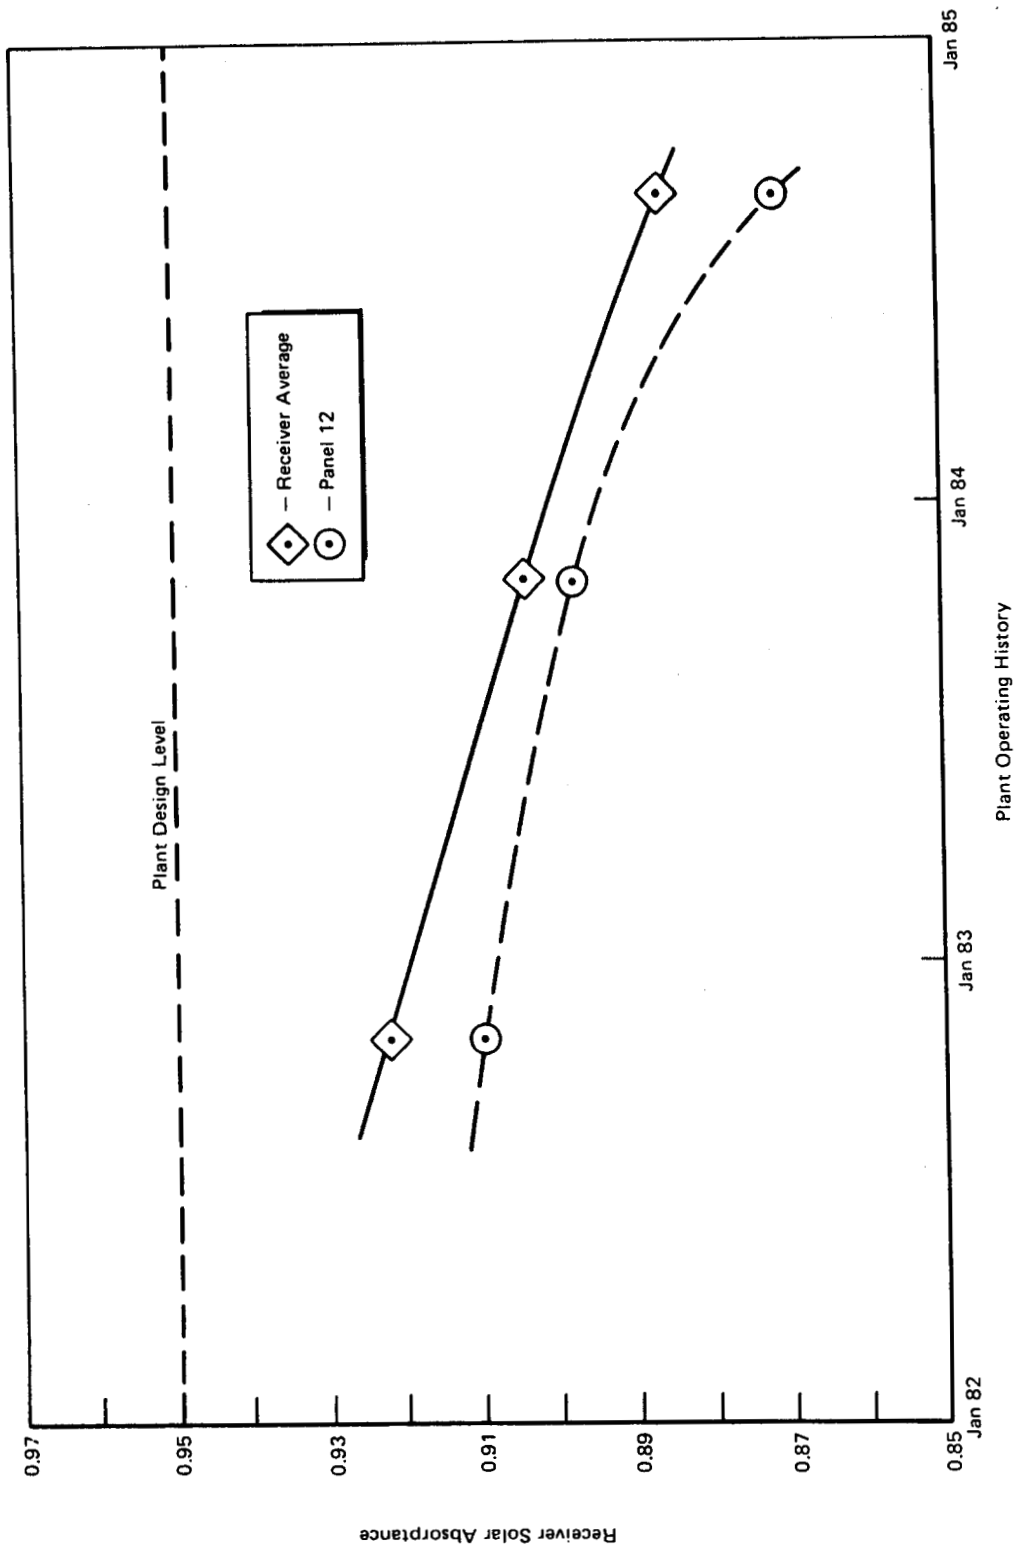
Figure 1-1. Receiver Solar Absorbance History

During that 3 year period, the absorptance characteristic of the paint, however, deteriorated from the new value of 0.95 to an average value of approximately 0.88 due to some type of weathering mechanism. A plot of this deterioration for panel 12 and on a receiver-average basis is shown in Figure 1-1. This loss in solar absorptance directly impacted the plant's solar-to-electric conversion efficiency with a corresponding penalty in power generation.

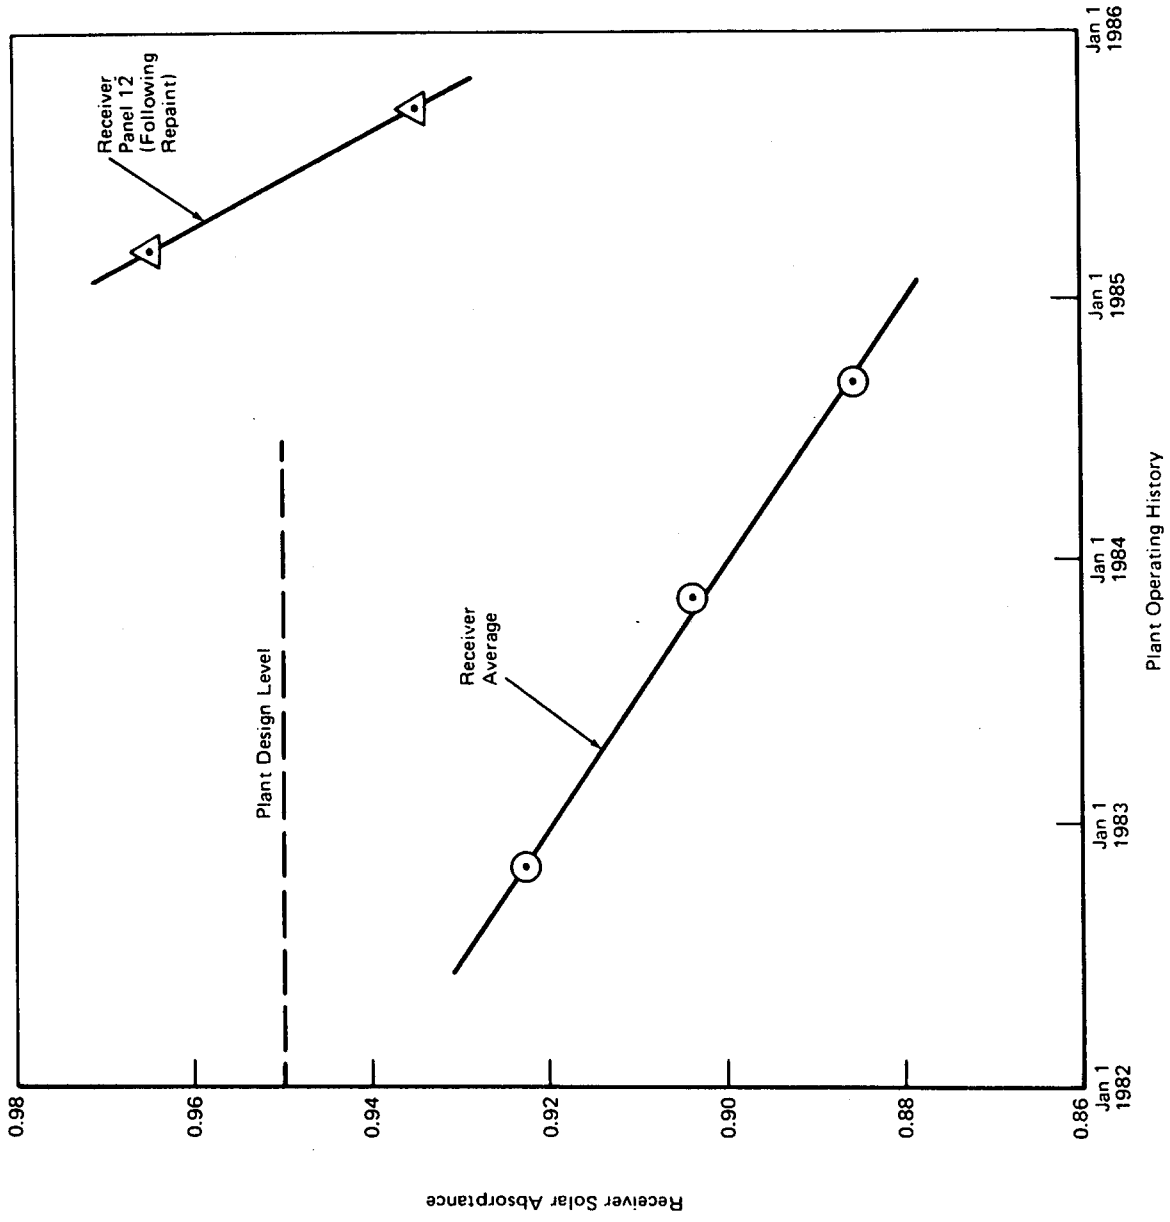
Figure 5-2. Receiver Absorbance History

From the stand point of overall panel performance, absorptance measurements were made April 12 and August 23, 1985 to determine the initial performance deterioration characteristics. A total of 55 absorptance (reflectometer) measurements were made over 5 tubes. The resulting average absorptance values are shown in Figure 5-2 along with data points which represent the overall receiver average absorptance. The data show as expected that the absorptance associated with panel 12 is well above that exhibited for the rest of the receiver. It also shows a significantly steeper deterioration rate than that indicated for the rest of the receiver. Since comparable early receiver data are not available, it is unclear at the present time whether the panel 12 deterioration rate will continue its steep descent until it intersects the receiver average condition or whether it will deteriorate at a slower rate which is more representative of the receiver average deterioration rate following an initial "burn in" period.

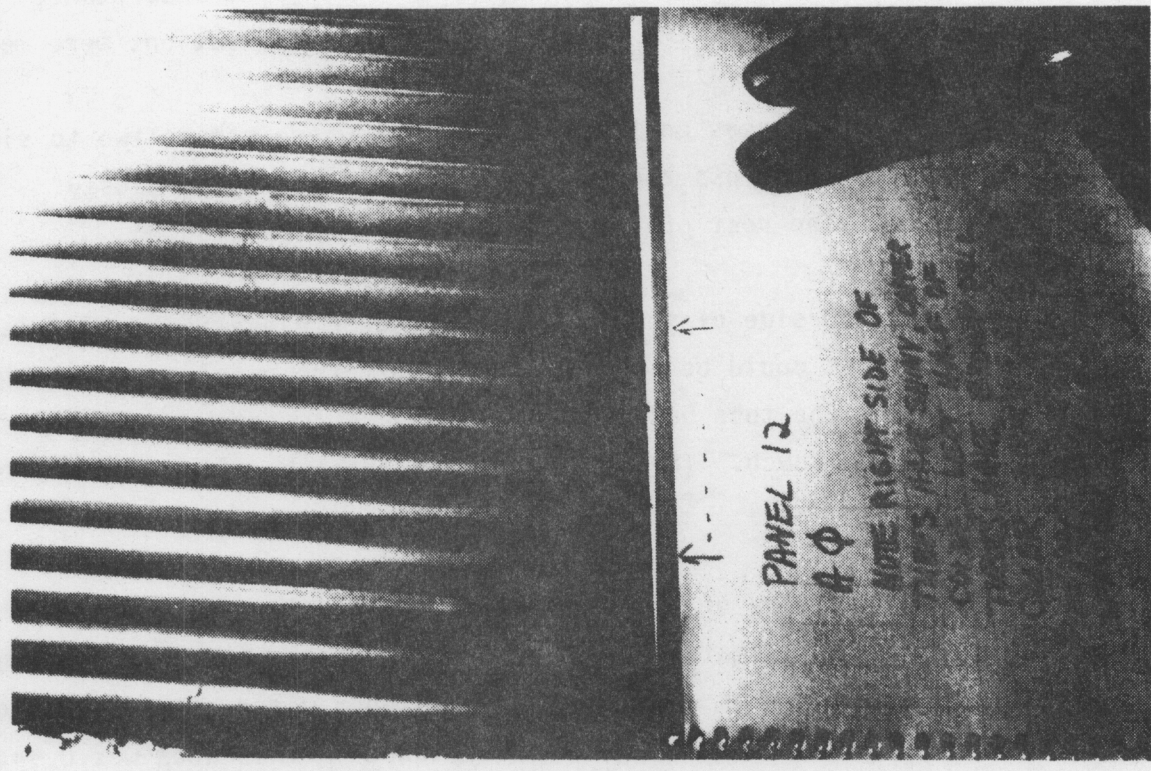
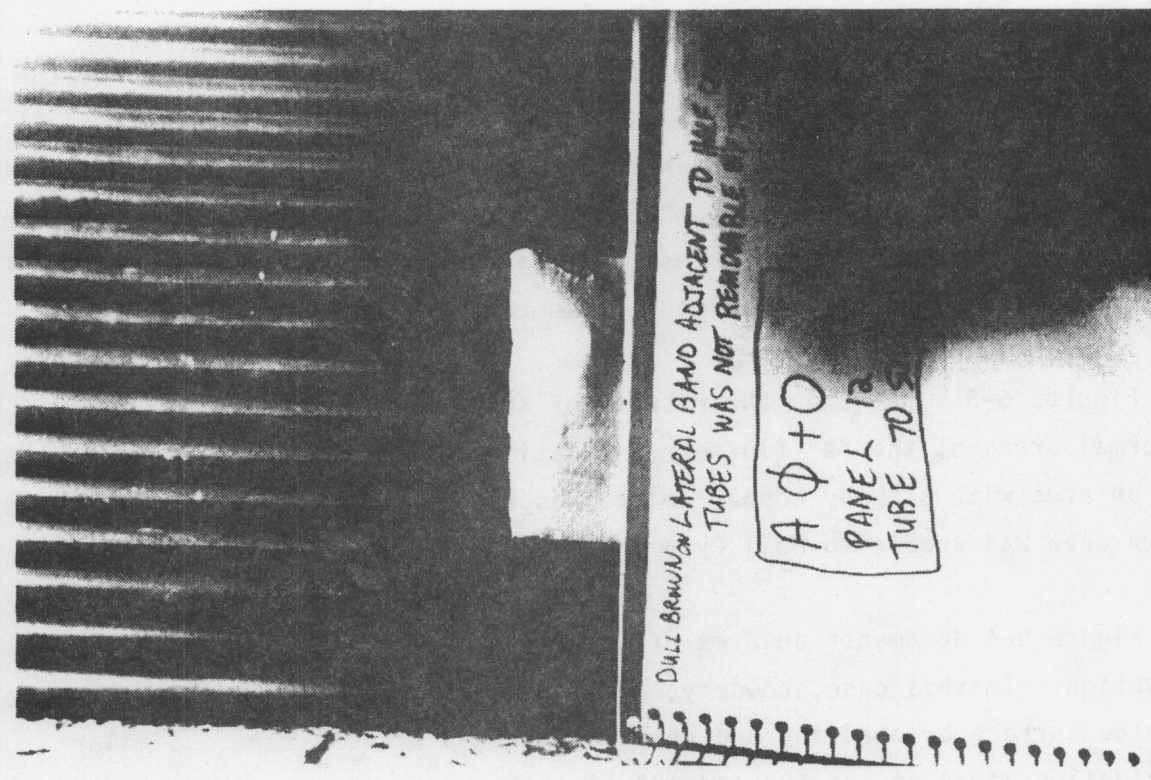
Figure 5-3. Panel 12 Overcoat Paint Discoloration — A Fluxmeter Elevation

Figures 5-3 - 5-6 show the results of this work. Figure 5-3 documents two abnormal areas at the "A" fluxmeter elevation. They involve a dull brown band and an area with a shiny copper-colored appearance. Tape applied to the dull brown area was unable to pull Pyromark material from the painted surface.

Discolored Area — Below Tape Test

Discolored Area — Tape Test

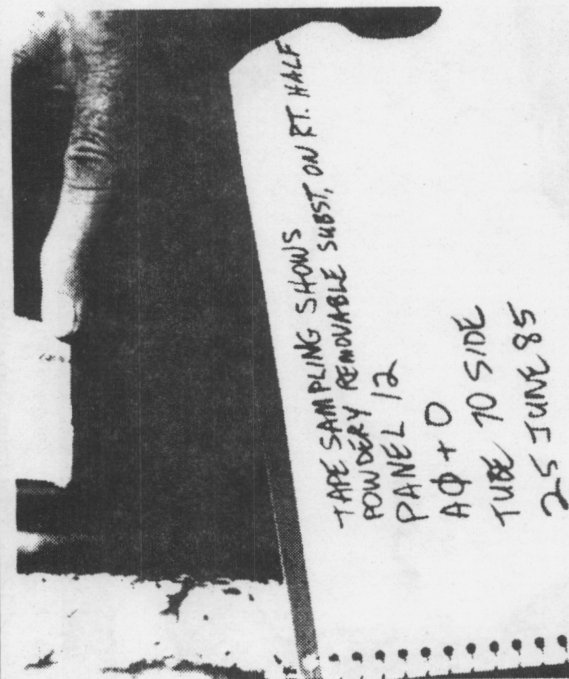
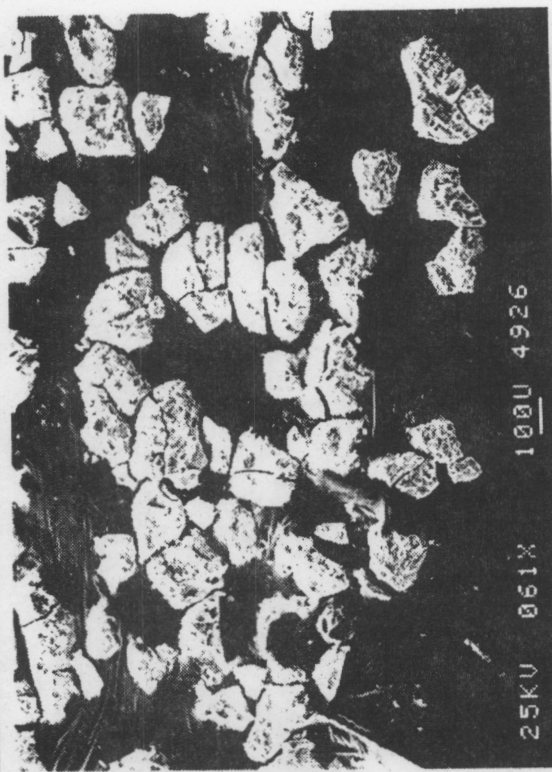
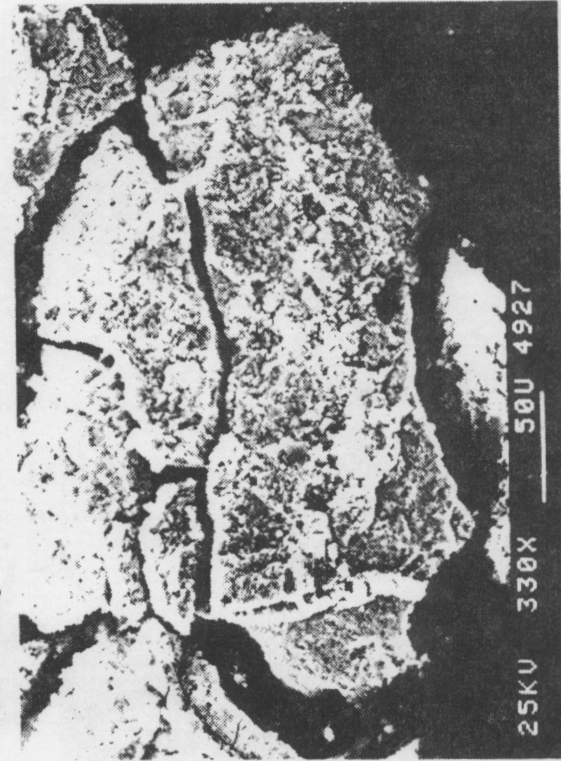
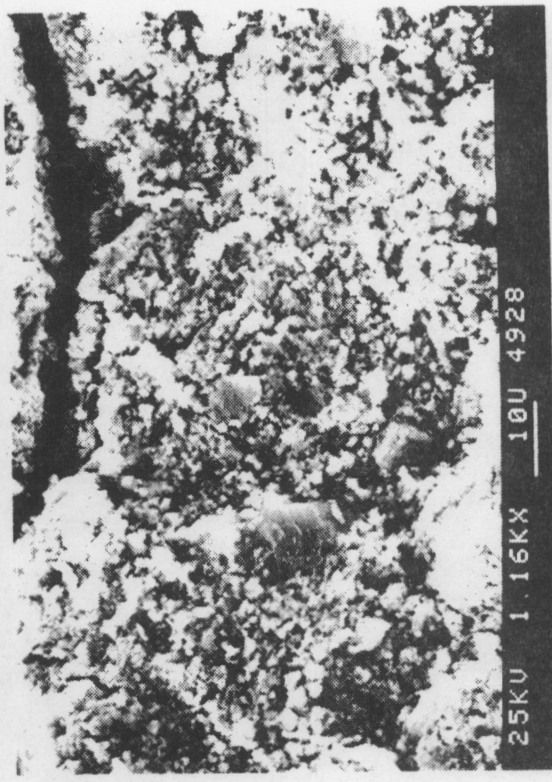
Figure 5-4. Panel 12 Overcoat Paint Degradation - A Fluxmeter Elevation

Figure 5-4 documents an area of paint degradation at the "A" fluxmeter elevation. In this case, powdery, gritty material was removed from the painted surface by applying and removing a strip of test tape. Similar degradation zones at the "B" and "C" fluxmeter elevations are shown in Figures 5-5 and 5-6.

Paint "Flaking" - Tube 70 Side (Tape Test)

Residue samples taken from all three degradation zones were returned to McDonnell Douglas for further analysis. Photographs of the paint flakes as taken through a scanning electron microscope at various magnification levels are shown in Figures 5-4 - 5-6. The 61 X magnification photo in each case shows the jagged nature of the individual paint flakes which appeared to be broken due to mechanical action. Photographs taken at higher magnification levels also show additional details of individual paint flakes.

Additional laboratory analysis was conducted to gain insight as to the cause of the flaking process. The analysis of the flakes did not reveal any significant paint deterioration in terms of a chemical change. It did however reveal traces of aluminum and silicon. It was postulated that the aluminum may have been residual material from the original grit blasting operation carried out prior to original painting of the panel in 1980. The silicon could have also been attributed to residuals of the grit blasting operation or incomplete paint vitrification.

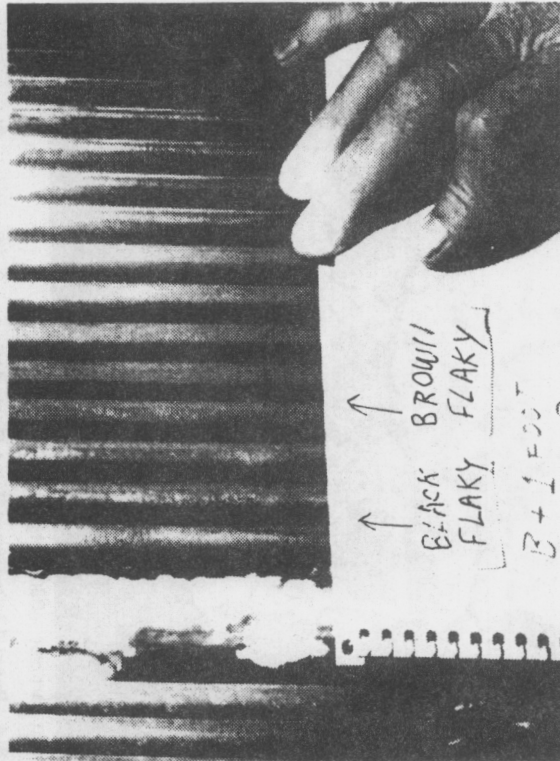
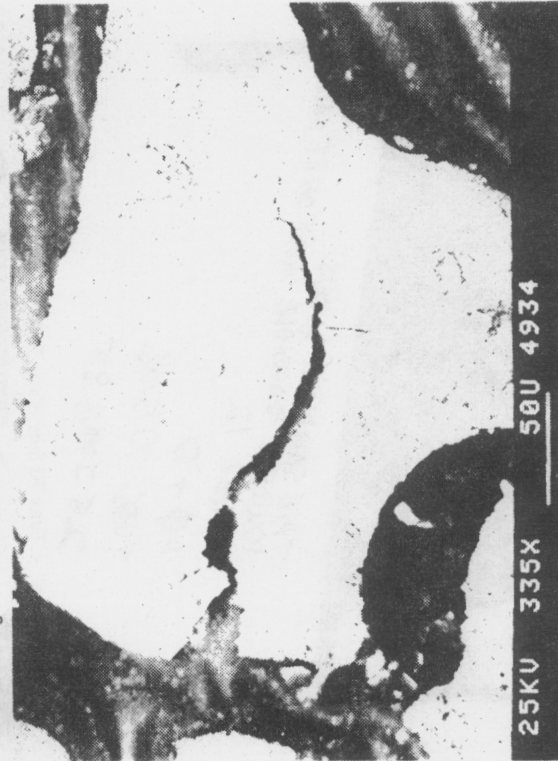
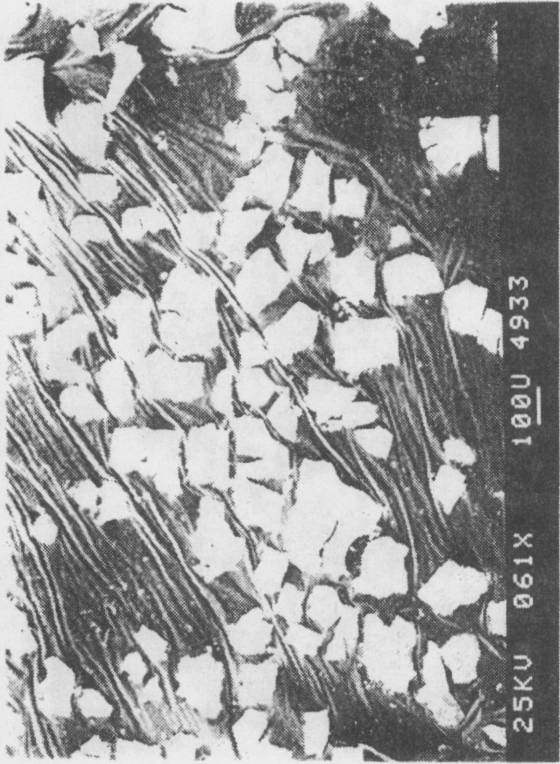
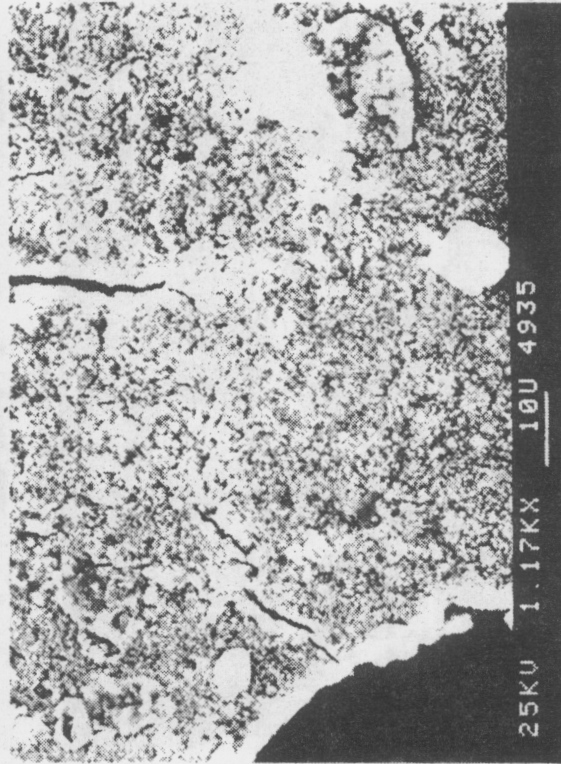
Figure 5-5. Panel 12 Overcoat Paint Degradation - B Fluxmeter Elevation

Paint "Flaking" - Tube 70 Side

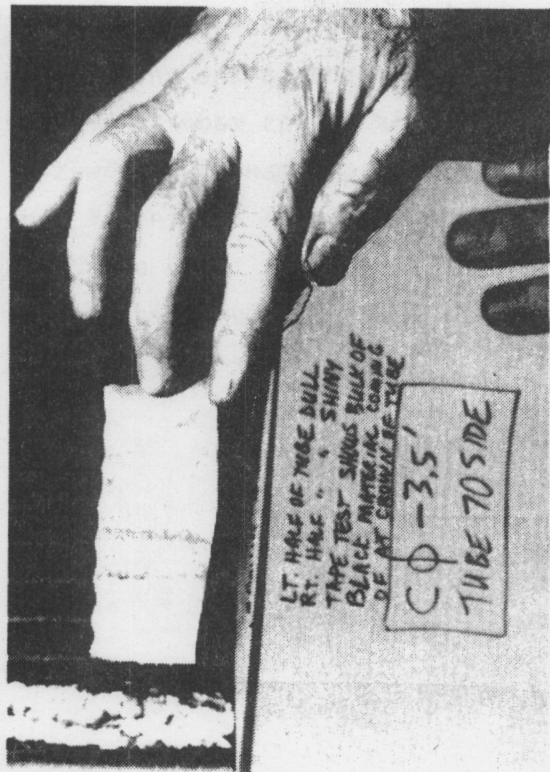
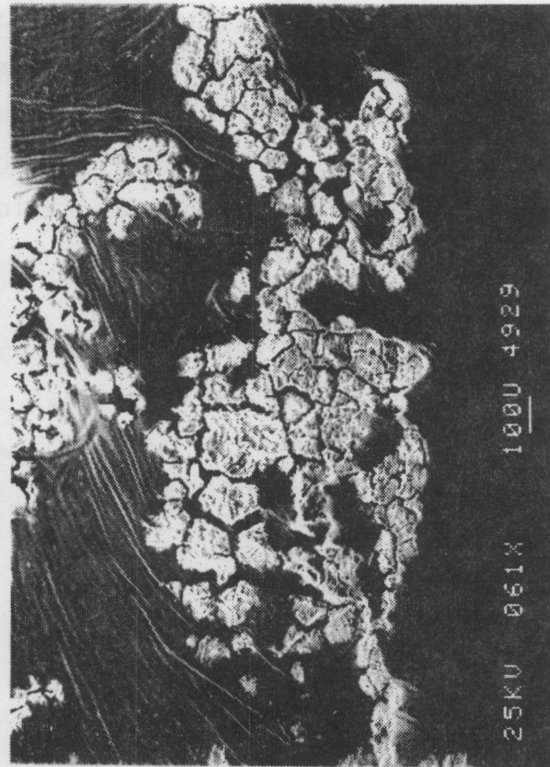
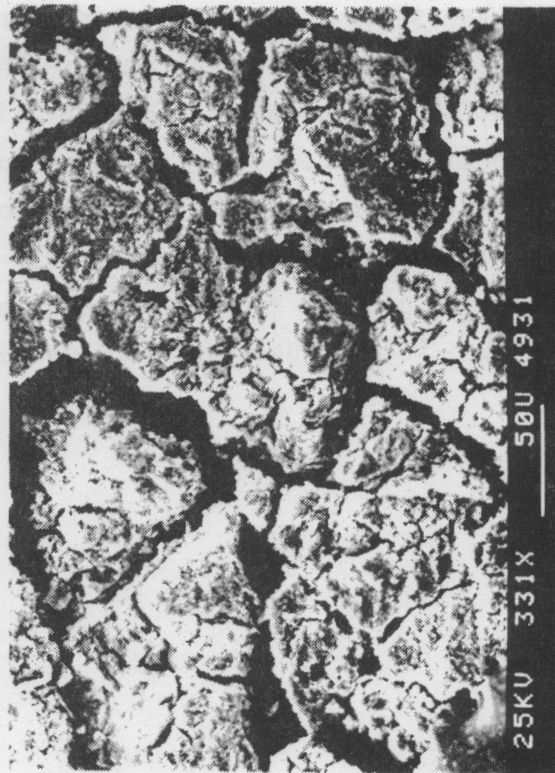
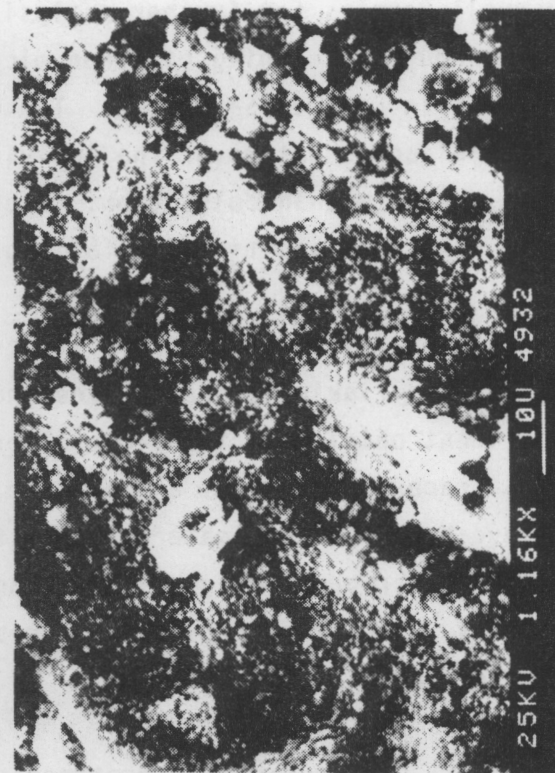
Figure 5-6. Panel 12 Overcoat Paint Degradation — C Fluxmeter Elevation

Paint "Flaking" - Tube 70 Side (Tape Test)
