SAND87-8226 • UC-62a
Unlimited Release
Printed September 1987

10 MW_e Solar Thermal Central Receiver Pilot Plant Mirror Module Corrosion Torque Tube Damage and Vent Tube Assessment Survey July 1985 and July 1986

M. A. Danzo, R. L. Velazques, and C. L. Mavis

M. A. Danzo
R. L. Velazquez
Southern California Edison Company
Rosemead, California

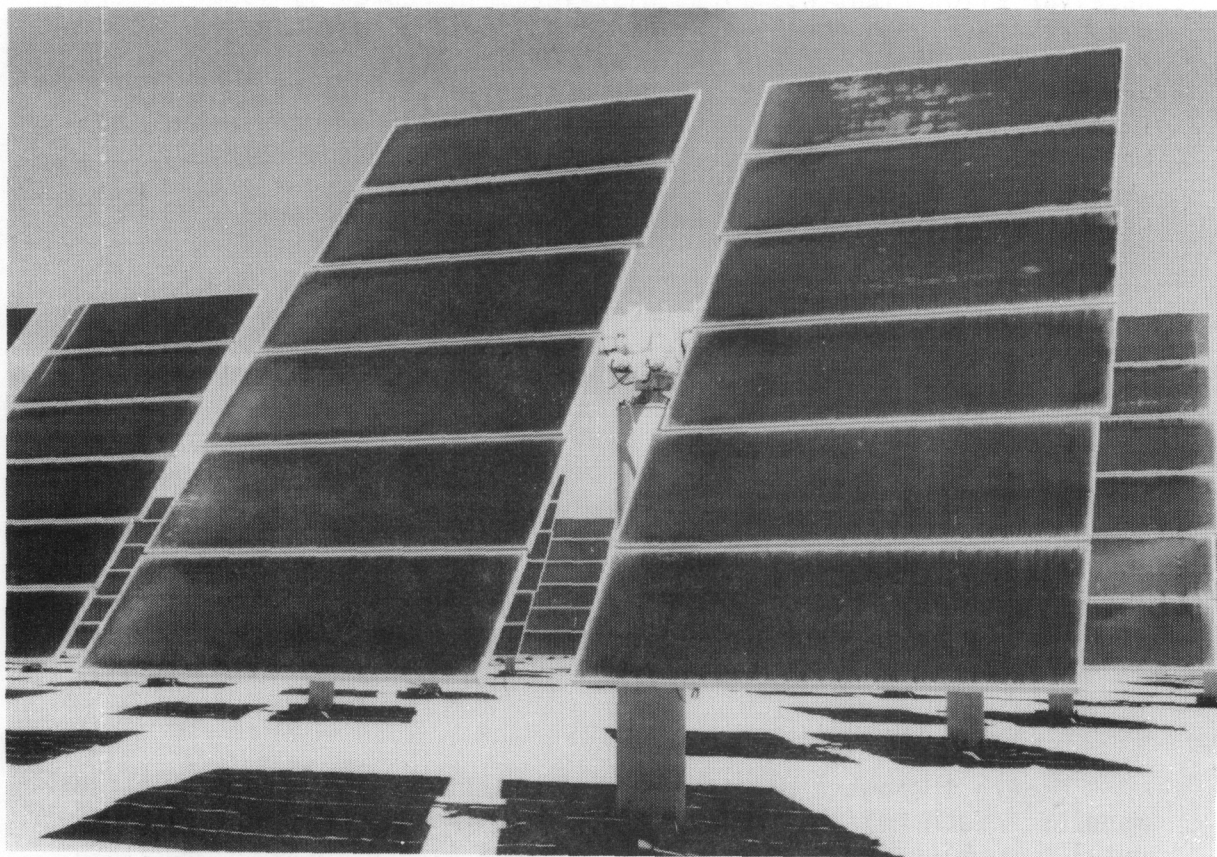
Figure 1. Pilot Plant Heliostats

Figure 1 shows a pilot plant heliostat with two corroded mirror modules. Each heliostat has twelve mirror modules consisting of a metal pan which forms five of the module's six surfaces. The sixth surface is the glass mirror which is supported by the aluminum honeycomb structure contained within the pan. Because expansion of air contained within the pan would place a high load on the adhesive that holds the mirror assembly together, the pan was originally equipped with a small vent. However, shortly after initial plant operation, the glass mirror silver surface was found to be corroding. It was then determined that the originally installed vents did not have sufficient capacity. The test found that when the mirror module was suddenly cooled by a simulated rain, a differential pressure between the atmosphere and the pan's interior existed for a sustained period. As a consequence, any moisture accumulation along the edge seal leaked into the module through edge seal imperfections.

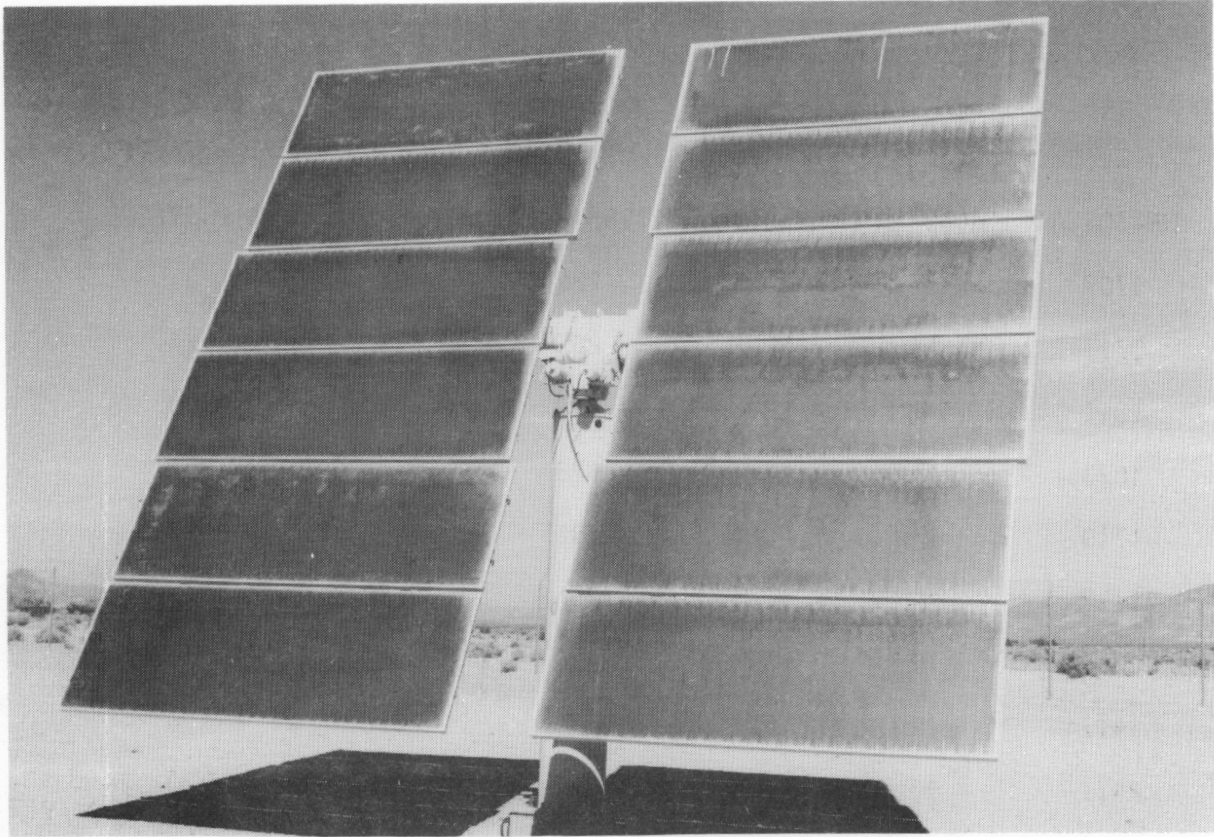
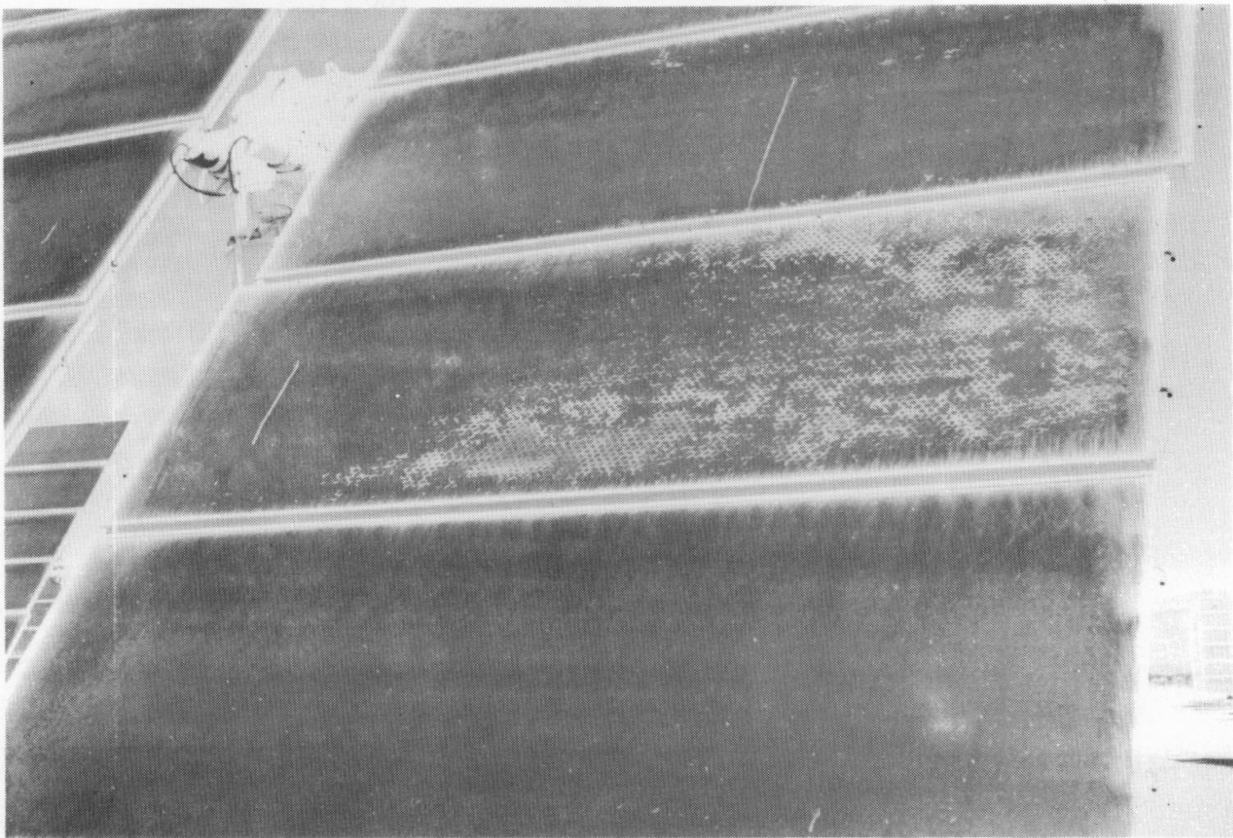
Figure 9. Photograph of Corroded Mirror Modules

Heliostat No.	Quadrant	Area,(Sq. in.)	Venting By	Corrosion Distribution By Facet
2912	NW	382	L	2 Facets for 75% (#1, #9)
2902	NW	347	L	1 Facet for 46% (#5)
1823	NE	325	L,R	Evenly Distributed
2906	NW	303	L	2 Facets for 60% (#7, #9)
1811	NE	299	L,R	1 Facet for 54% (#10)
1711	NE	265	NONE	1 Facet for 50% (#2)
2910	NW	265	L	2 Facets for 69% (#1, #5)
1412	NW	255	NONE	1 Facet for 100% (#4)
2417	NE	240	L,R	Evenly Distributed
1719	NE	236	NONE	1 Facet for 59% (#2)
2908	NW	233	L	Evenly Distributed
2411	NE	232	L,R	Evenly Distributed
1709	NE	222	NONE	Evenly Distributed
2005	NE	220	L,R	Evenly Distributed
1873	SE	212	L	1 Facet for 49% (#6)
