Reliability of the Solar One Plant During the Power Production Phase

August 1, 1984 — July 31, 1987

Sandia National Laboratories

SAND88-2664
Unlimited Release
Printed October 1988

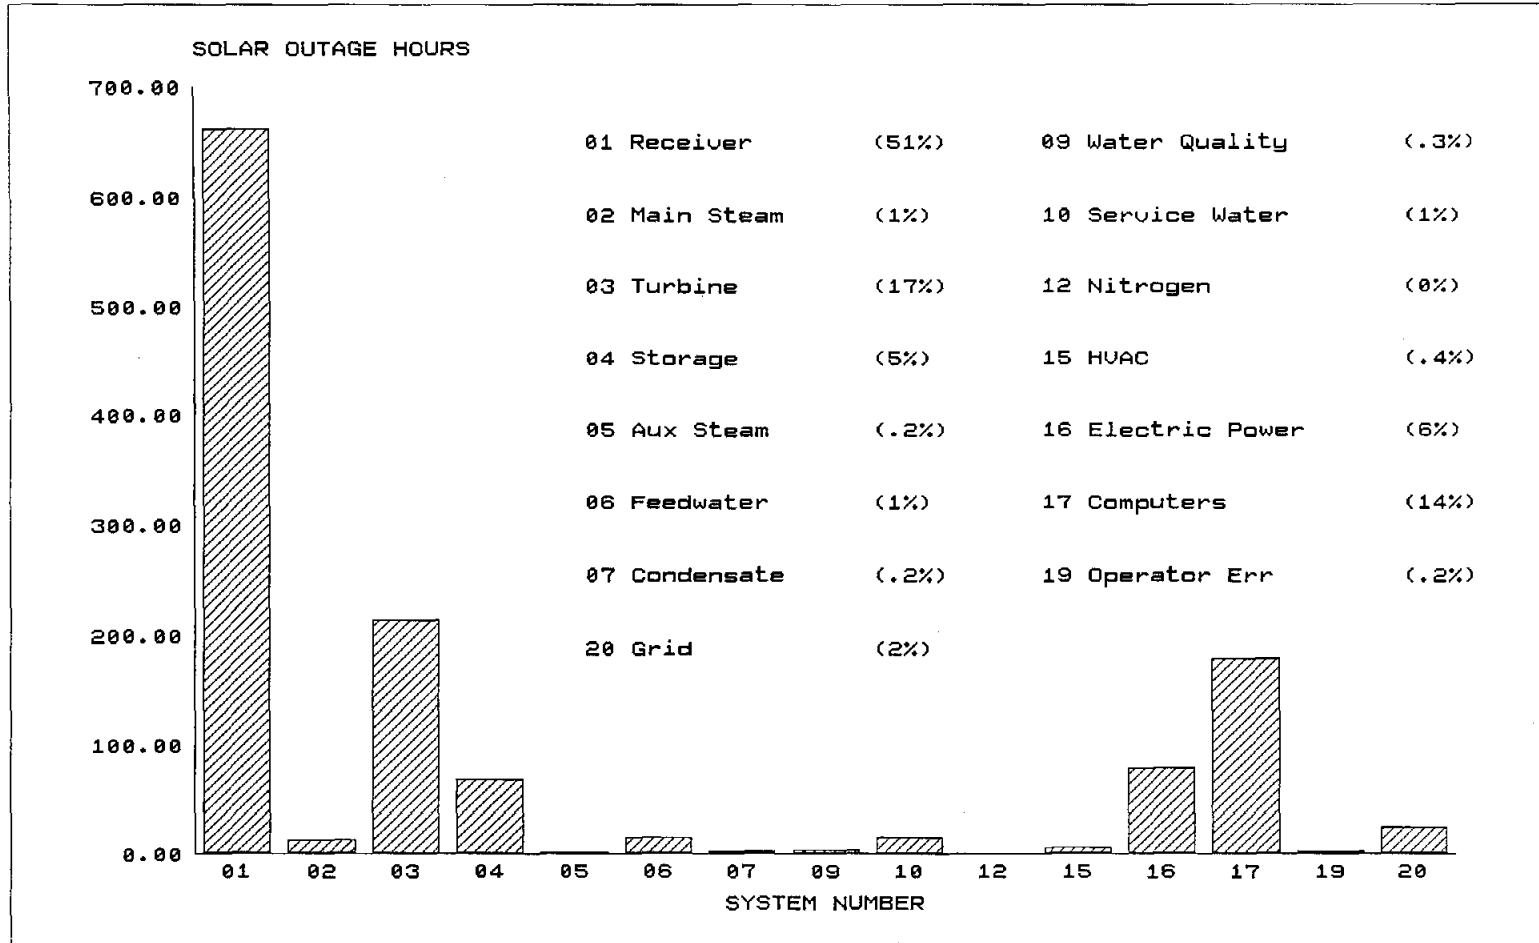
Figure 2-1 Plant Outages by System

It can be noted that receiver unavailability accounted for approximately one-half of the plant outages. Unavailability of the turbine, storage, electric power, and control systems was also significant. Receiver and control system outages were due to several different types of problems. Unavailability of the other three systems was dominated by a single problem. The systems and system numbers listed are the same as those defined in Nagel (1986).

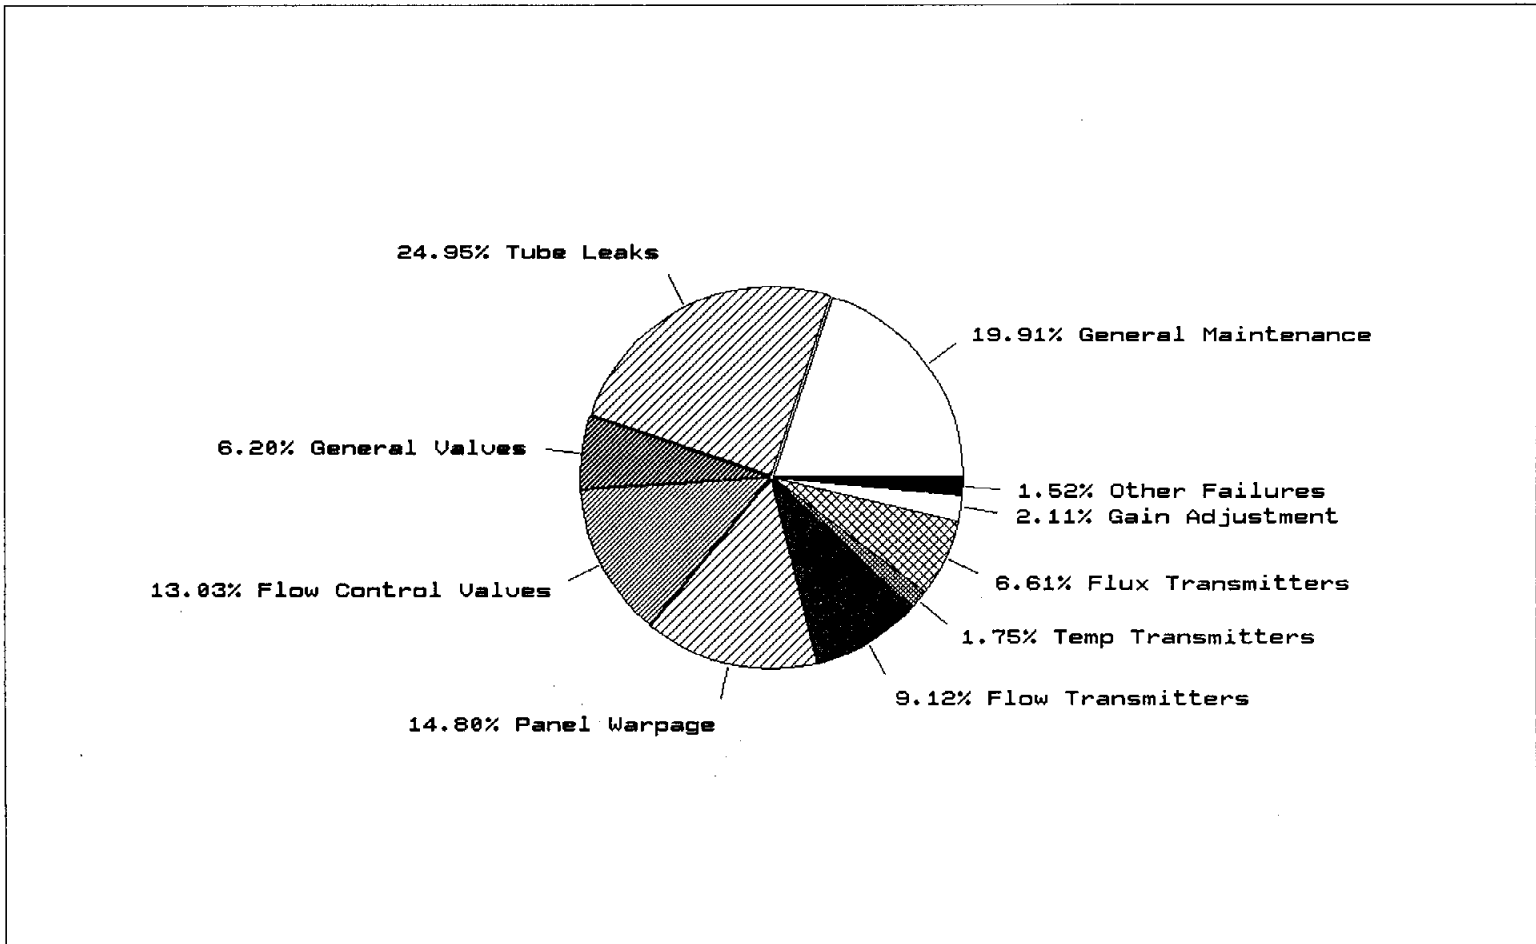
Figure 2-2 Plant Outages Caused by Receiver Problems

Figure 2-1 shows that receiver events caused the plant to be down for 662 hours. The pie chart in Figure 2-2 provides the specific causes for this down time. It can be noted that unscheduled and scheduled tube leaks account for about 25% of the receiver outages. Problems with various types of valves, flow and flux transmitters, and general receiver maintenance are also significant. Most categories were composed of several events, except for panel warpage. The latter category is dominated by a single event, which occurred in January 1987. These receiver problems are discussed in Chapter 3.

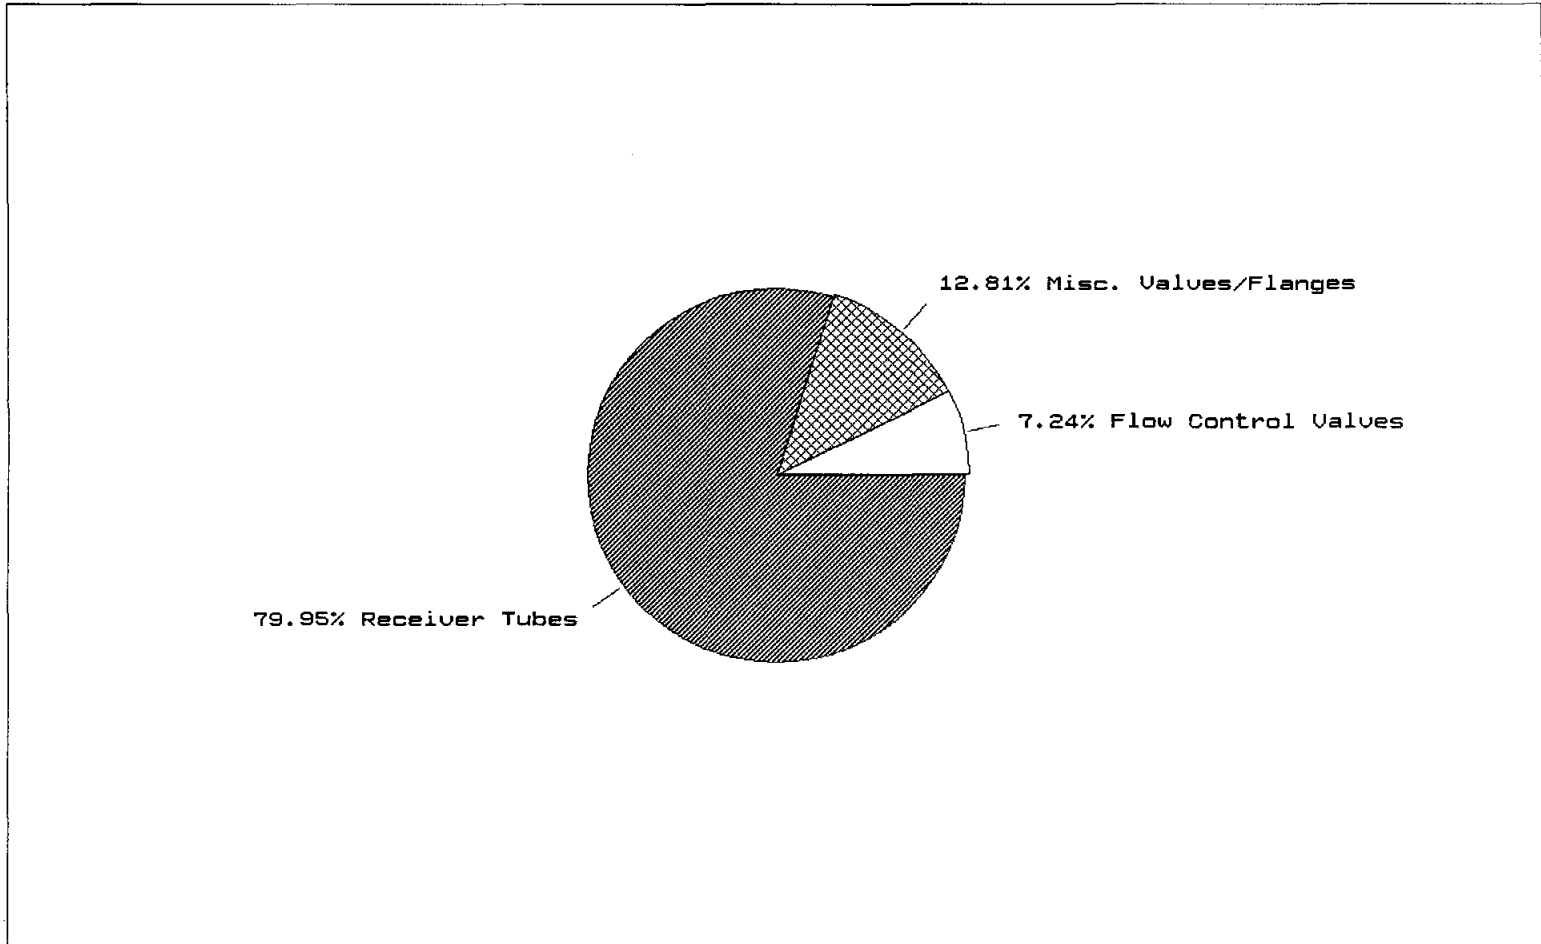
Figure 2-3 Plant Outages Caused by Receiver Leaks

The plant was down for 206.5 hours due to various types of receiver leaks. (This outage time can be determined from Table 2-3.) Receiver leaks occurred more often than in other systems because the receiver was exposed to a much more extreme operating environment. The pie chart provides the specific causes of these leaks. Tube leaks constitute 80% of the outages. It should be noted that Solar One routinely operates with some tube and valve leakage. We only included leakage events in our analysis if they were severe enough to cause a plant shutdown.

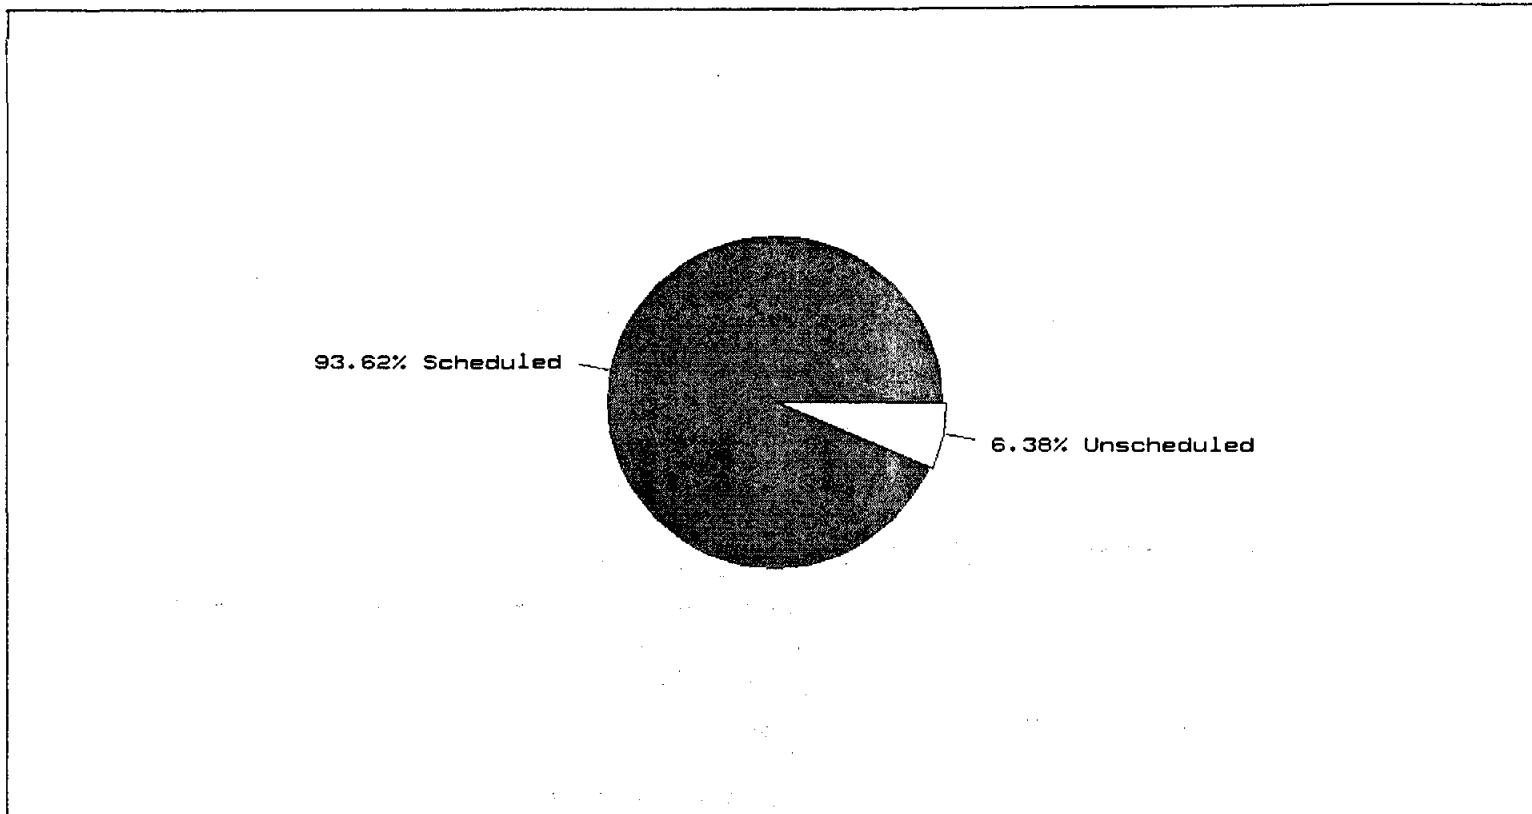
Figure 2-4 Plant Outages Caused by the Unavailability of the Turbine-Generator

activity at all its steam plants after the first year of operation and approximately every 4 years thereafter. This event is discussed in Chapter 3. The turbine-generator system experienced very few problems during the entire 3-year period. This was a pleasant surprise to the SCE maintenance staff. Prior to the power production phase, they were concerned that the daily thermal cycling experienced by the turbine would cause many problems.

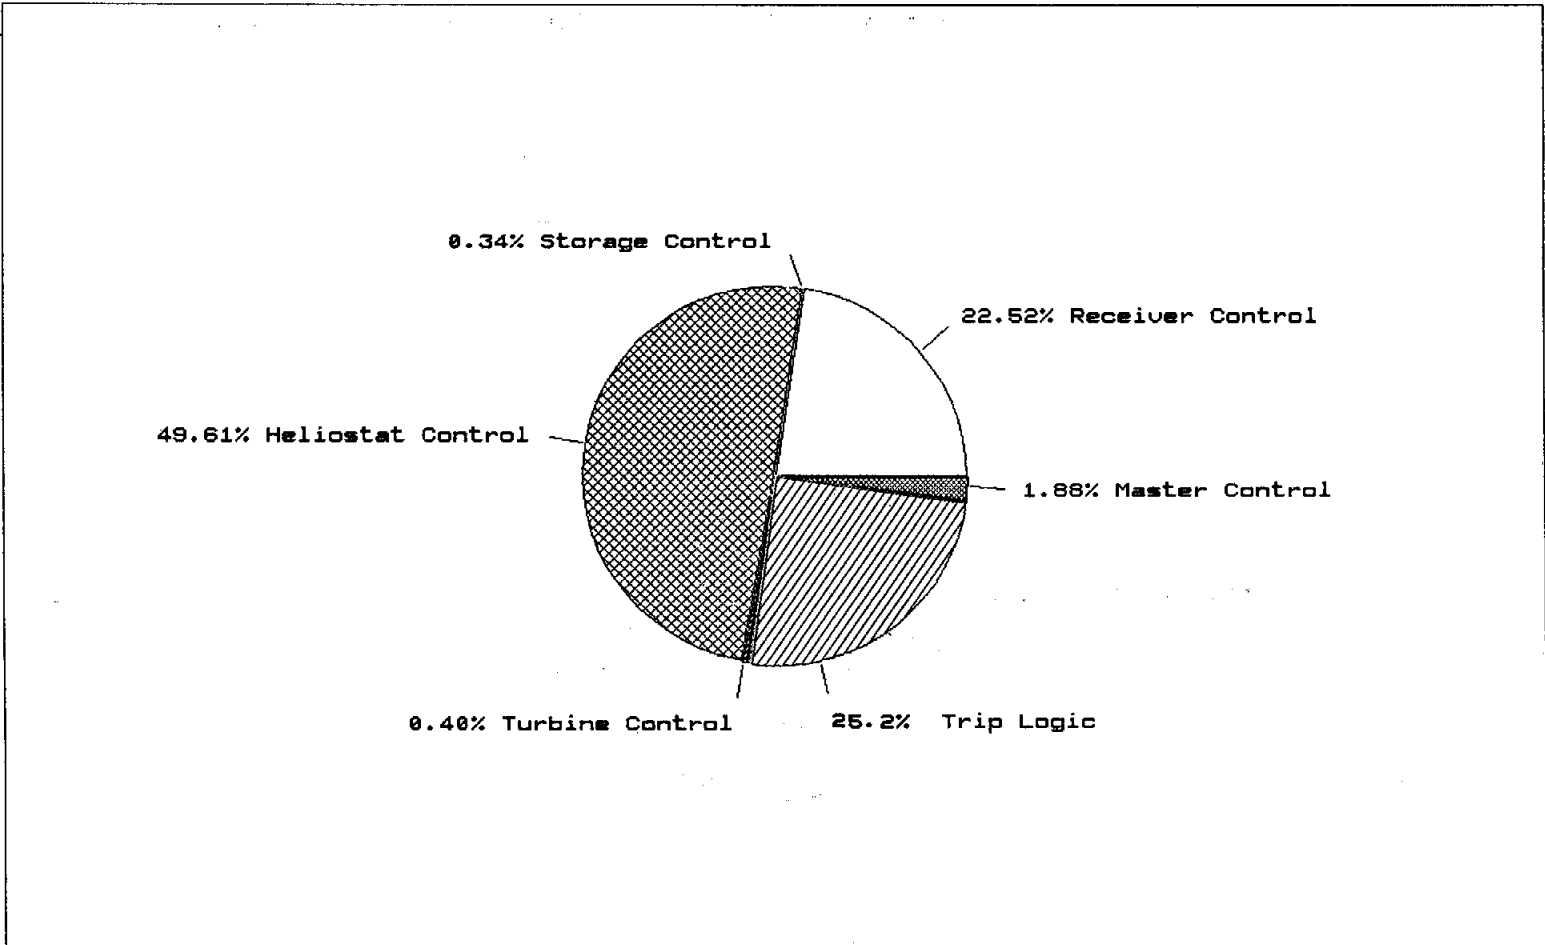
Figure 2-5 Plant Outages Caused by Computer Failures

The heliostat array control computers (HAC) accounted for approximately one-half of the computer-related outages. HAC failures occurred regularly throughout the entire power production phase and the redundancy designed into the HAC system was generally not effective. Failure of the subsystem distributed process control (SDPC) for the receiver and the plant trip system (i.e., the programmable logic controllers contained within the interlock logic system and red-line unit) was also significant. Failures of these systems are discussed in Chapter 3.

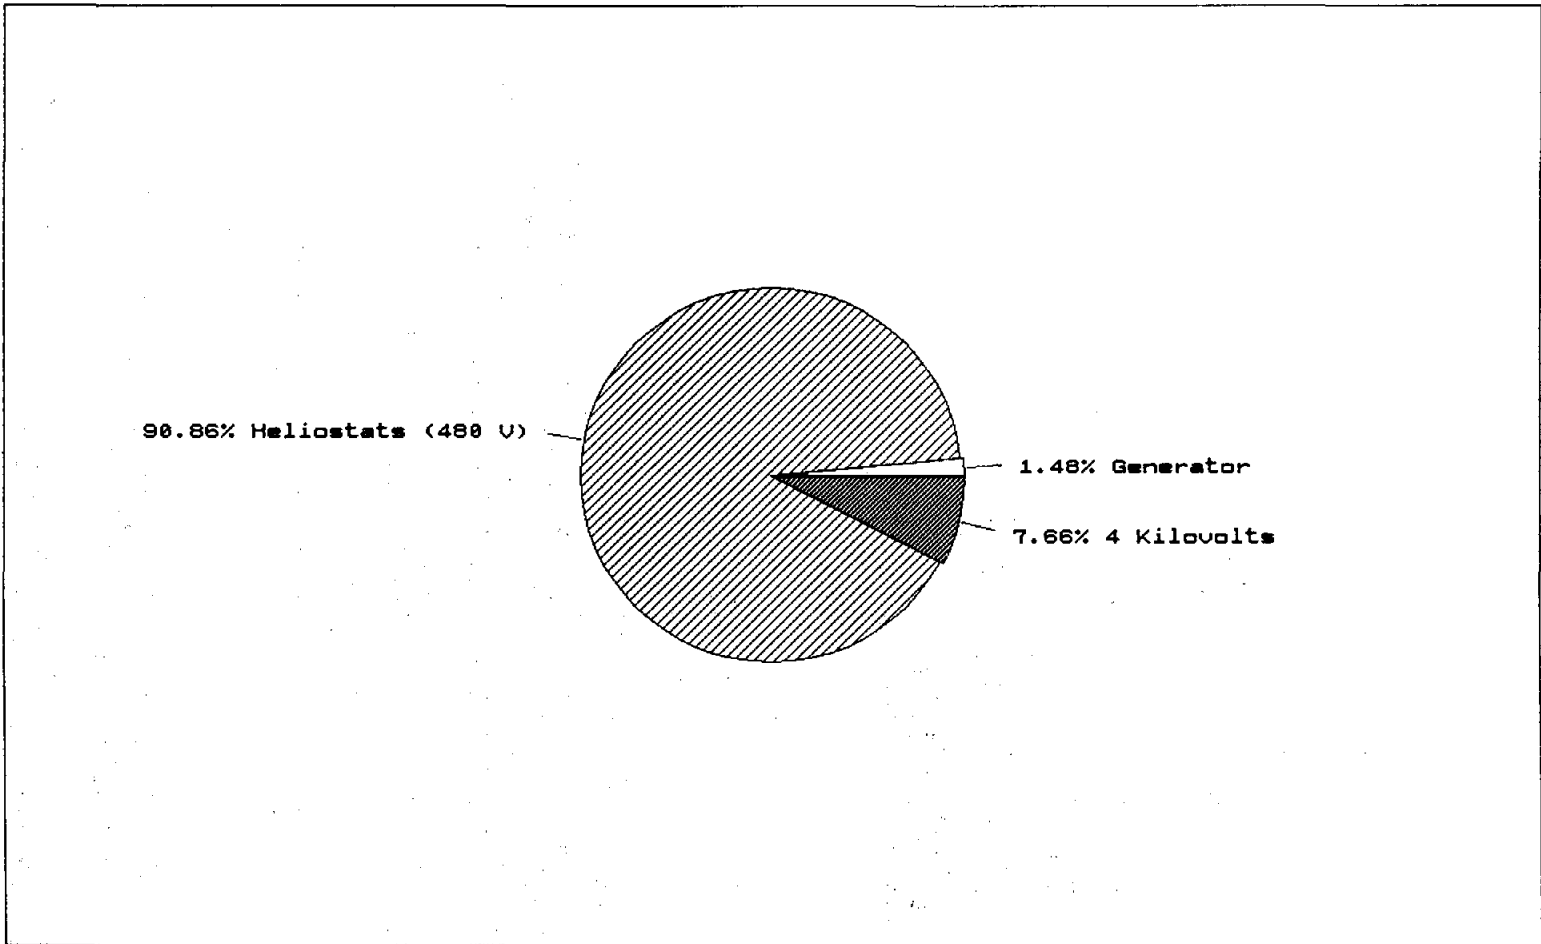
Figure 2-6 Plant Outages Caused by Failures of Electrical Switchgear

Electrical switchgear outages were dominated by a failure of the heliostat interface switchgear that occurred in November of 1985. This event is described in Chapter 3. The remainder of the switchgear (4.16 KV, 480 V, and turbine) experienced only a few problems of short duration.
