SAND94-8235 • UC-404
Unlimited Release
Printed January 1995

NaK Pool-Boiler Solar Receiver Durability Bench Test, Vol. 2: Metallurgical Analysis

S. H. Goods, R. W. Bradshaw

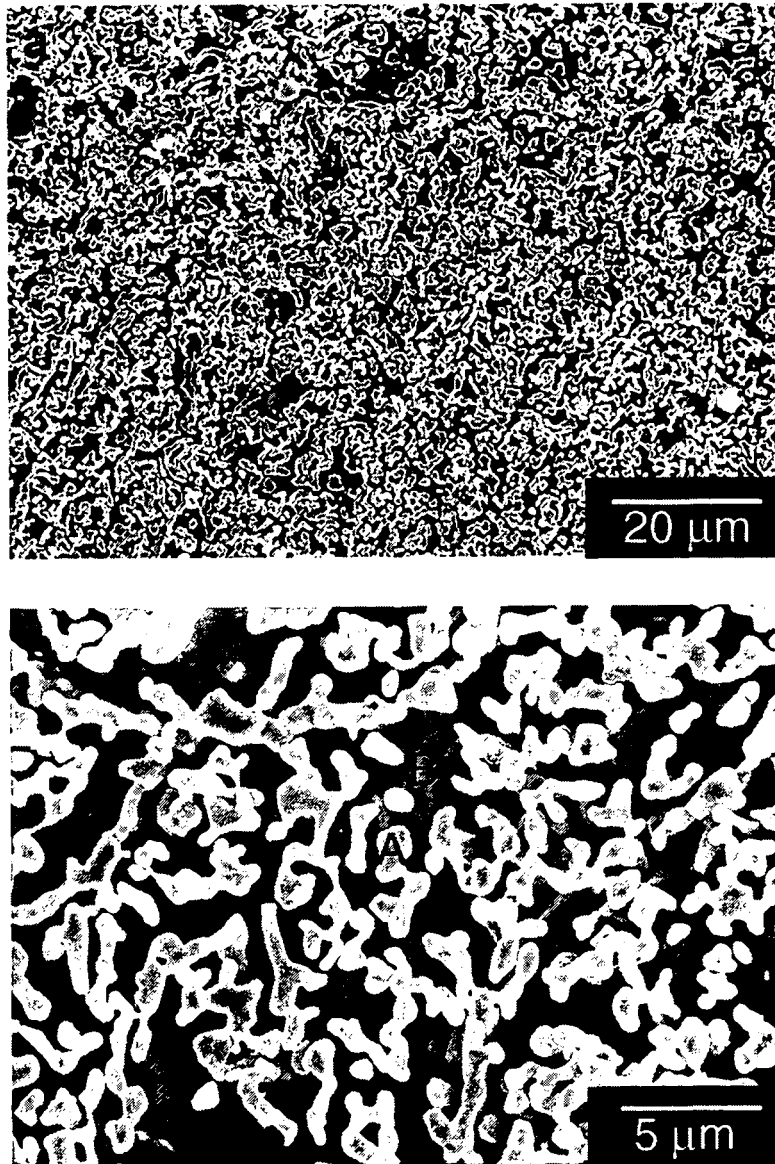
Visual inspection of the pool-boiler surface exposed to boiling NaK for 7500 hours revealed a distinctly "matte" finish unlike the relatively bright finish of the as-received tubing. Scanning electron micrographs of this surface are shown in Figures 6a and b. Figure 6a, a low magnification image, shows a complex surface structure clearly altered from that of the as-received tubing. At higher magnification, Figure 6b reveals that the structure consists of particulates uniformly decorating the surface. As above, EDS analysis was used to assess the composition of these features and the base material to which they are attached. The particulates (indicated in Table II as REGION A) have a composition similar to the second phase particles described in the previous section.

The prominence of these features results from the recession of the alloy matrix. It is reasonable to attribute the recession of the alloy surface to the preferential dissolution of matrix nickel and chromium into the liquid metal pool (relative to the tungsten-rich precipitates). Reliable solubility data for the transition metals and tungsten in liquid NaK are quite limited. Such data as are available for the principal constituents in the alloys studied here are summarized in Figure 7.[10-14] Note that these data concern sodium or potassium as the solvents, rather than NaK. The data in Figure 7 indicate that tungsten should be the most soluble of the principal alloying elements of Haynes 230 at the temperature of the present test, 750°C. These data are contrary to our present observations in that the W-rich precipitates appear to be less soluble than the nickel and

Figure 6. Internal surface of pool-boiler exposed to NaK liquid after 7500 hours at temperature. a) Features on the surface are W-rich precipitates exposed by the recession of the alloy matrix. b) Higher magnification reveals the morphology of the surface structure and the presence of grain boundary dissolution. Regions A and B refer to locations of EDS analysis in Table II.

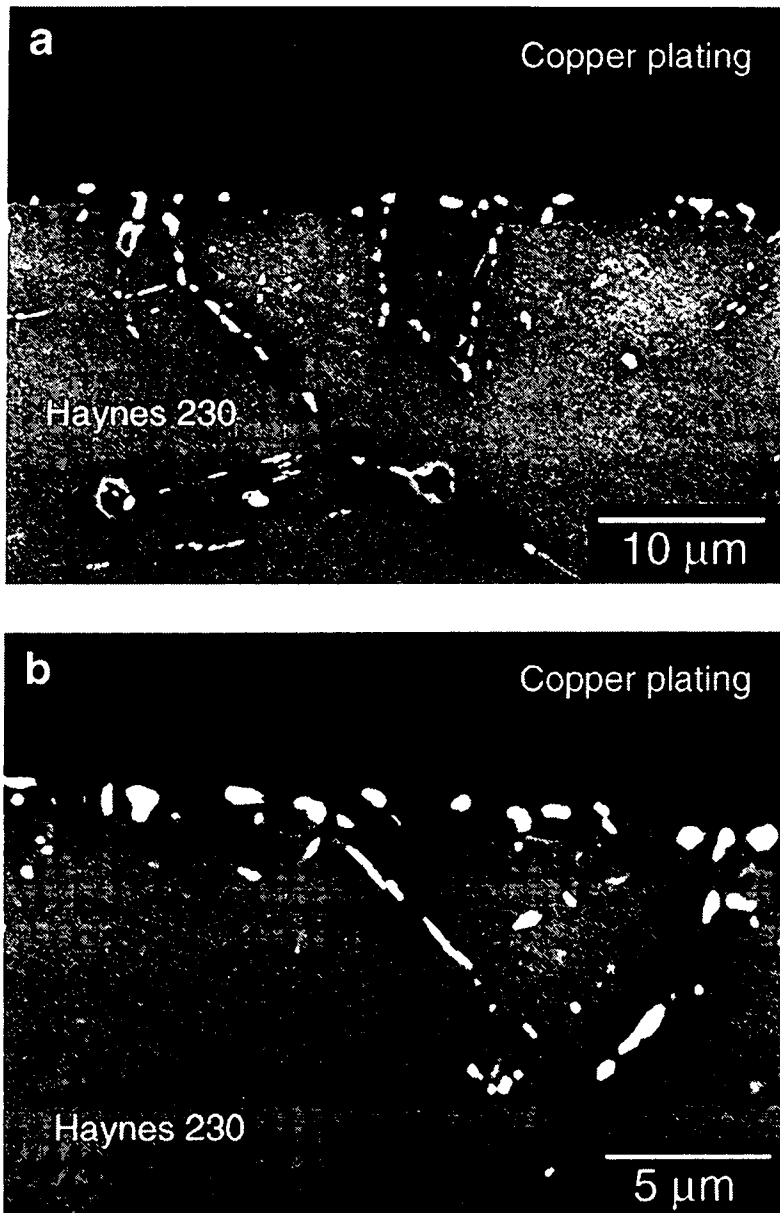
Figure 8. Backscatter electron images of metallographically prepared cross-section of Haynes 230 exposed to NaK liquid. Copper plating was applied prior to sectioning to protect fine surface features. a) Haynes alloy surface is decorated with W-rich precipitates. Grain boundary cavitation is present as the result of the heat treating and surface cleaning procedure. It is not the result of NaK exposure. b) Recession of the alloy matrix from the NaK-exposed surface is evident at higher magnification.

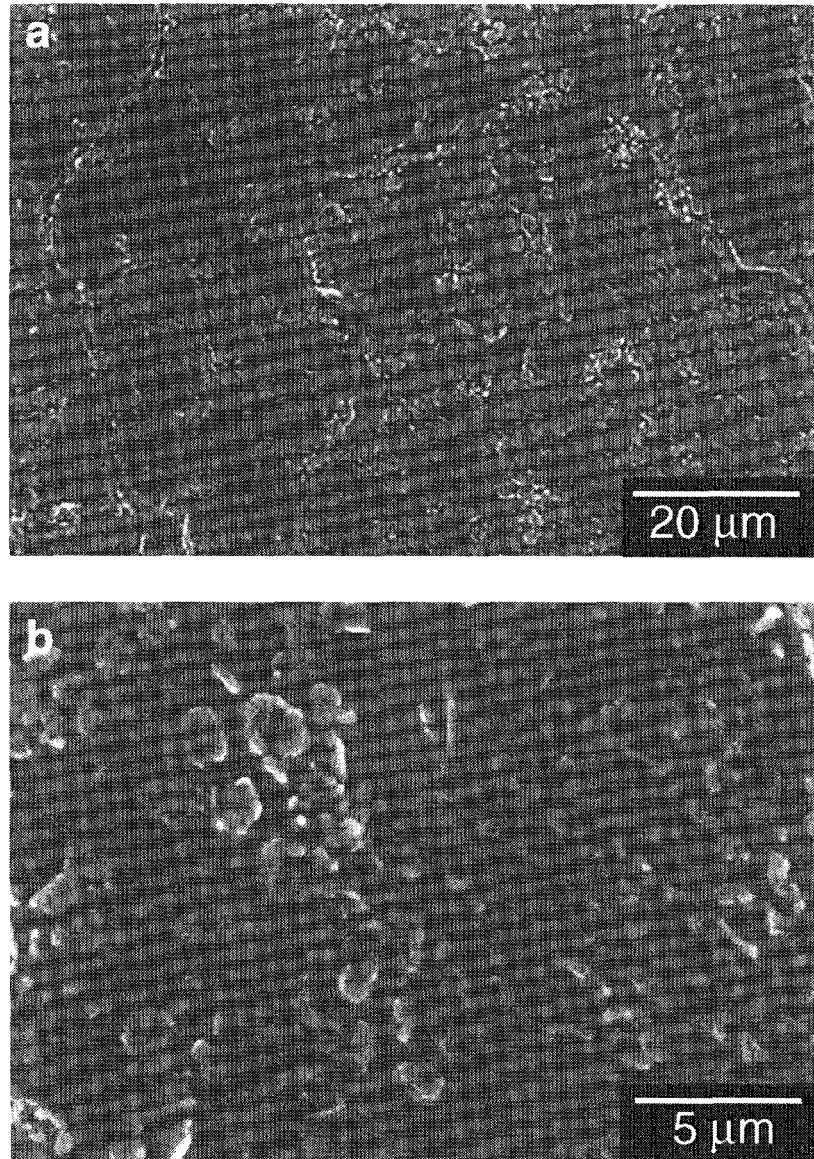
Visual examination of the interior surface of the vessel revealed a distinct "waterline" delineating the pool-boiler from the condensing region. Figures 9a and b are scanning electron micrographs that show the surface of the vessel well above the liquid level. The surface had a morphology intermediate between the as-received material and the surface exposed to liquid NaK. The tungsten-rich particles are less well defined than those shown in the previous figures suggesting that the degree of dissolution of the matrix by the vapor phase was somewhat less extensive. However, the grain boundary etching is more apparent than before simply because the precipitate structure is less well defined and does not mask the grain boundaries. The composition of both the particles and of the underlying matrix are essentially identical to that reported above for the surface

Figure 9. a) Internal surface of pool-boiler exposed to NaK vapor after 7500 hours at temperature. W-rich precipitates are less well pronounced due to less recession of the alloy matrix. Grain boundary dissolution is apparent. b) Higher magnification reveals the morphology of the surface structure.

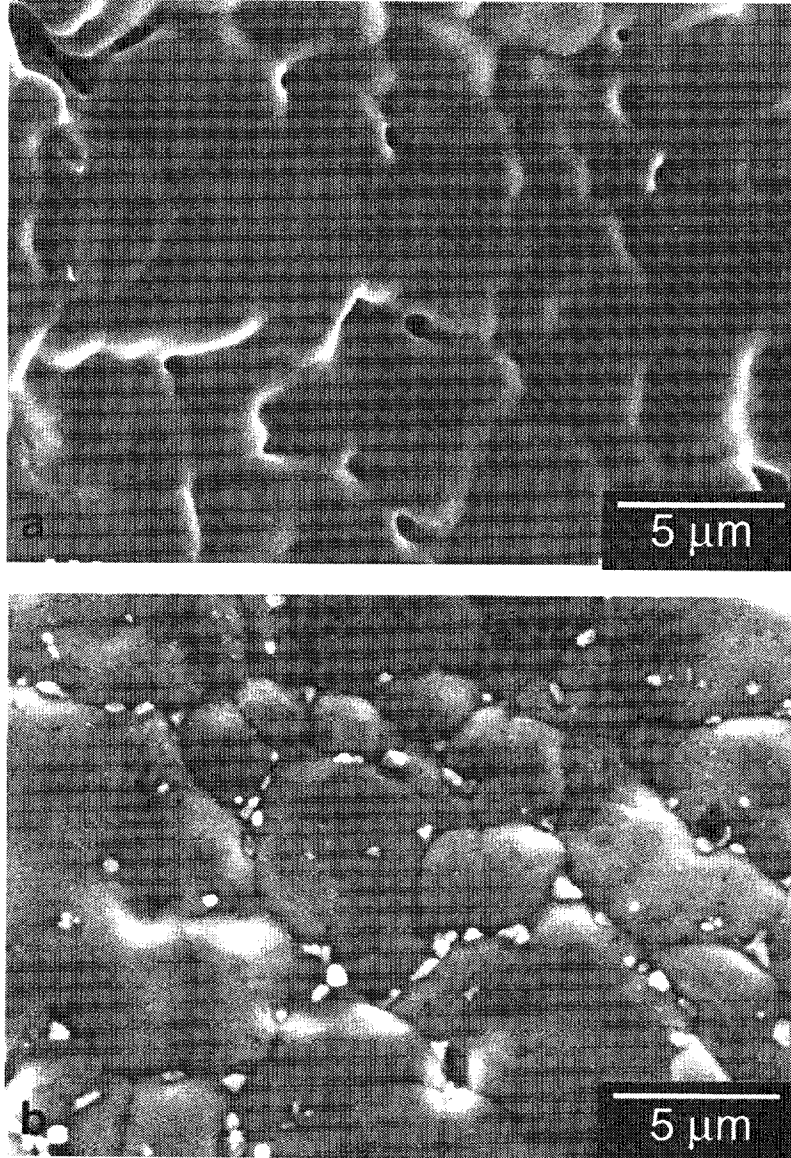
Figure 10. Internal surface of the Haynes 230 fill tubing. a) The grain structure on the ID of the as-received fill tube is revealed as the result of the descaling procedure. b) Deposit is present along the grain boundaries of the fill tube from the pool boiler.

Figure 10. c) ID of fill tubing further away from end cap than that shown in (b). Surface deposition is greater in these colder regions.

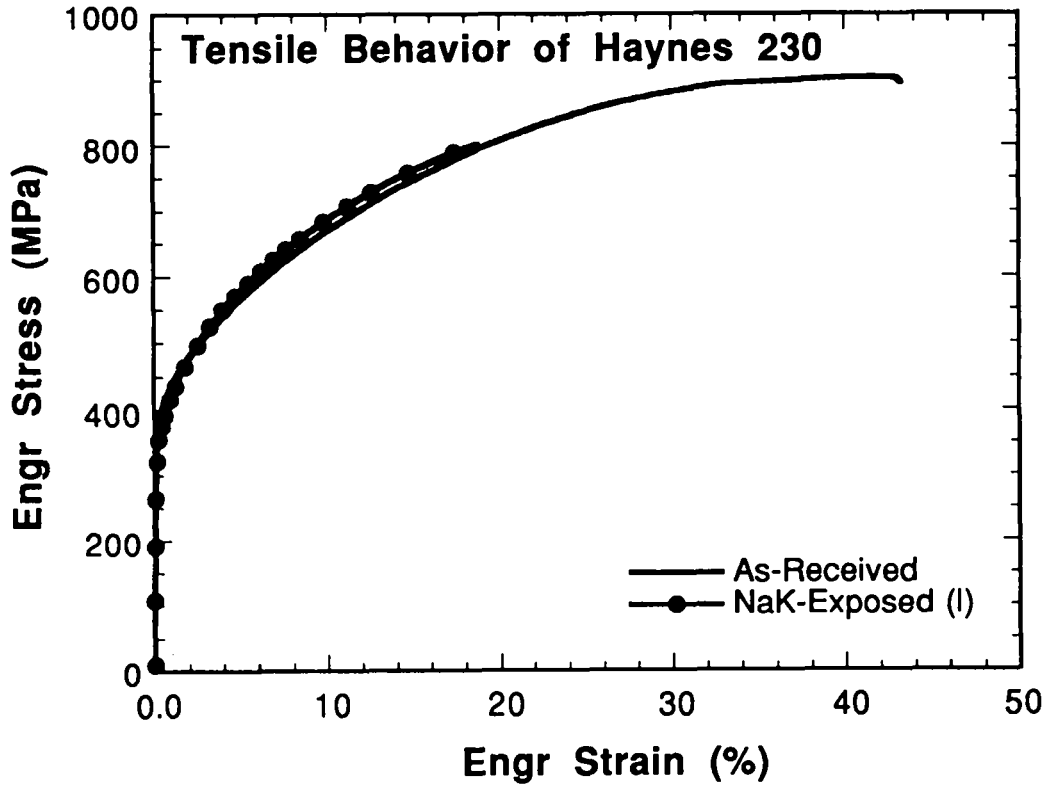
Figure 11. Comparison of uniaxial tensile behavior of as-received Haynes 230 specimen compared to specimen cut from the sidewall of the pool-boiler vessel beneath the liquid level of the NaK. Specimens extracted from the condenser section of the pool-boiler exhibit identical behavior. The data for as-received Haynes 230 presented in Table III was taken from Ref. 15

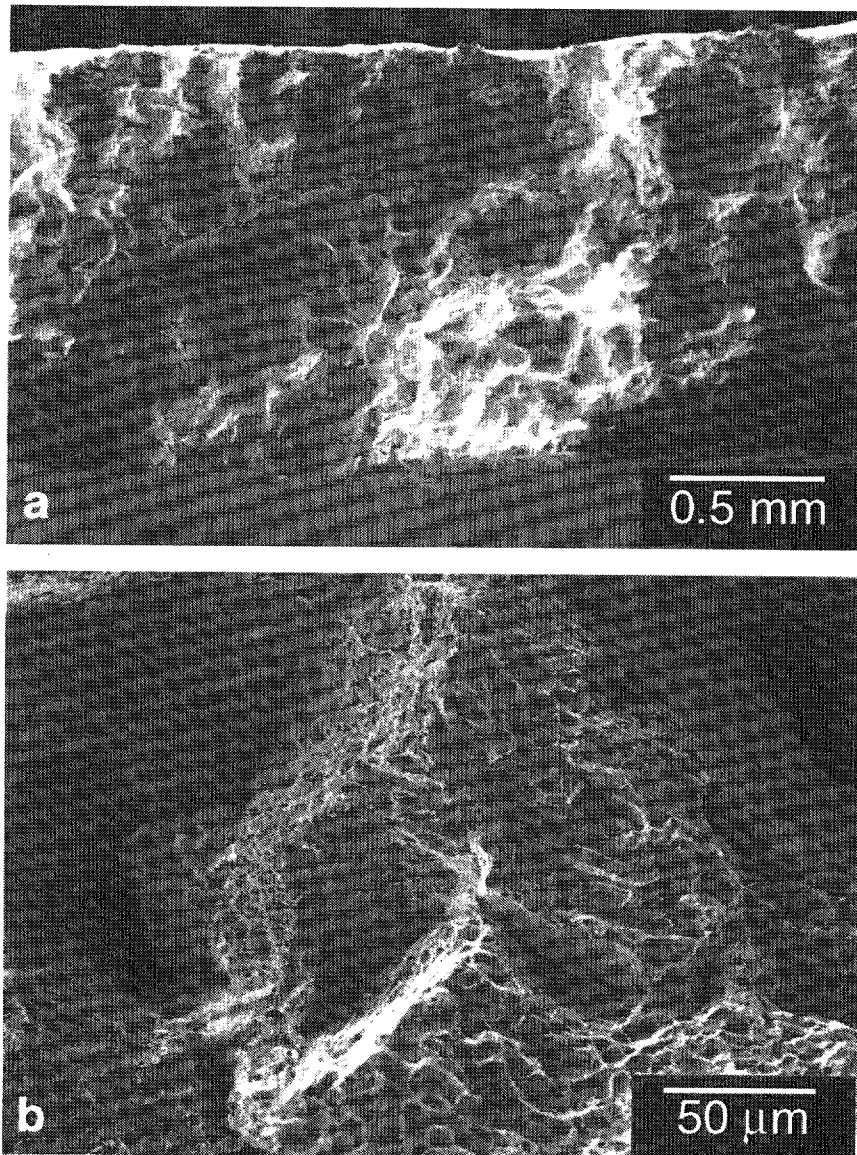
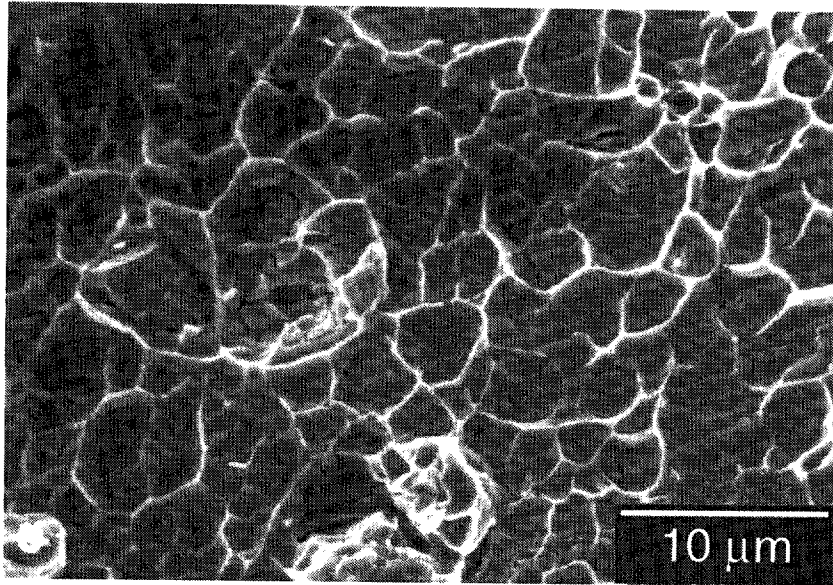
carbides. The fracture surface of the NaK-exposed alloy is shown in Figure 13a. In this instance the fracture surface was intergranular. At higher magnification, Figure 13b reveals that the fracture was still ductile in nature. Figure 13c reveals that the grain boundary facets were decorated with a uniform distribution of dimples with only a few fractured carbides visible.

Figure 13. Fracture surface morphology of NaK exposed-Haynes 230. a) Fracture surface is intergranular. b) Grain boundary facets are decorated with dimples indicating that fracture was still ductile.

Figure 13. c) Grain boundary facets are decorated with a uniform distribution of dimples with only a few fractured carbides visible.

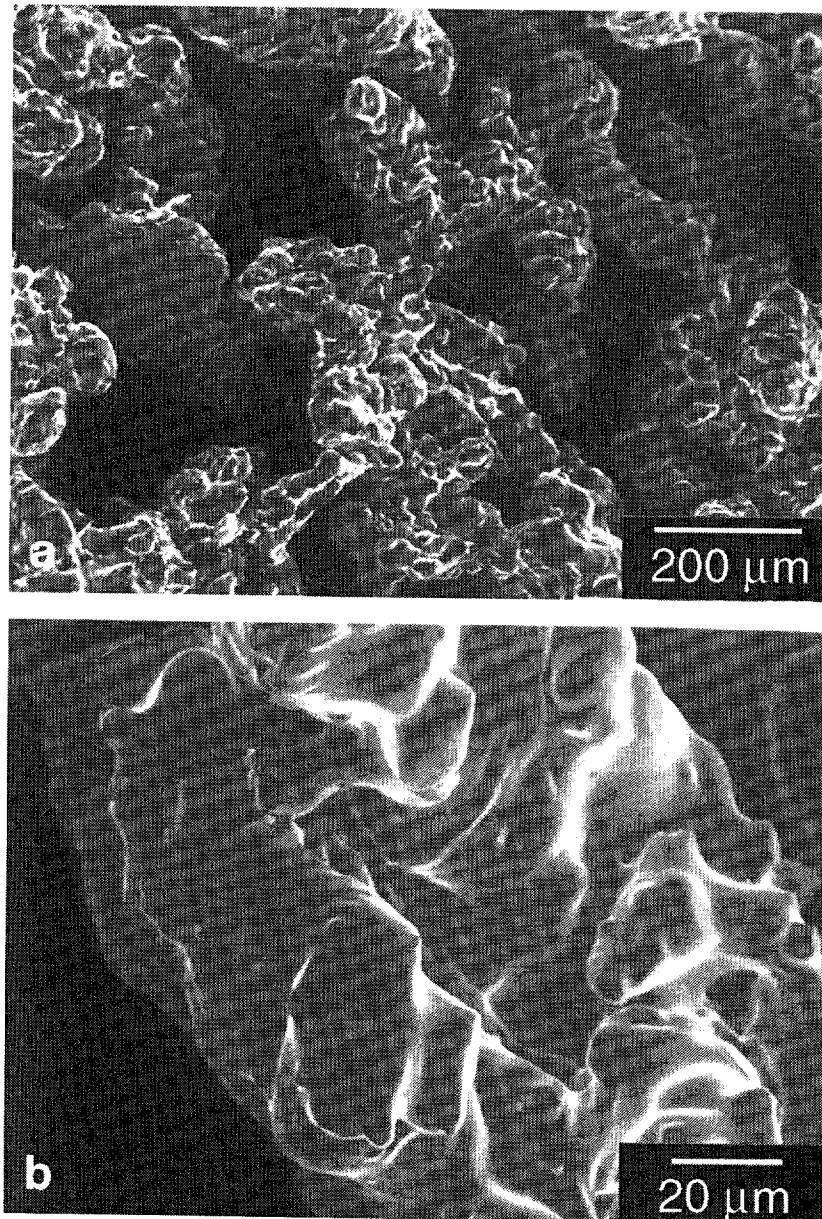
The brazed patch was examined in detail. There was no evidence of spalling, cracking or any other structural degradation resulting from repeated thermal cycling. This was somewhat surprising in light of the relatively rigorous thermal cycling profile imposed on the patch over the operating history of the pool-boiler. Figures 15a and b are micrographs taken from the brazed patch in the pool-boiler. Figure 15a shows that the patch maintained the same general high surface area, open morphology of the as-brazed patch. The surface contamination shown in Figure 14b and c is no longer apparent. Silica will not be reduced by NaK as the alkali metal oxides are less thermodynamically stable than SiO_2 . [16] The absence of the silica contamination is therefore likely the result of some minimal dissolution of the underlying stainless steel allowing the contamination to break free or of thermal cycling which could promote the detachment of weakly bound particles. In addition, the zirconium getter can reduce silica which would facilitate its removal by either loss of adhesion or, possibly, dissolution. Figure 15b shows that the terraced structure on the original stainless steel powder surfaces was no longer visible, suggesting that the stainless steel suffered a very small amount of dissolution due to NaK exposure. This observation supports the argument that the loss of the silica contamination was the result of dissolution of the stainless steel.

Figure 15. Surface morphology of the NaK-exposed enhanced boiling surface. a) The patch maintained the same general high surface area and open morphology of the as-brazed structure. b) Surface contamination and terraced features are no longer apparent after long-term NaK exposure.

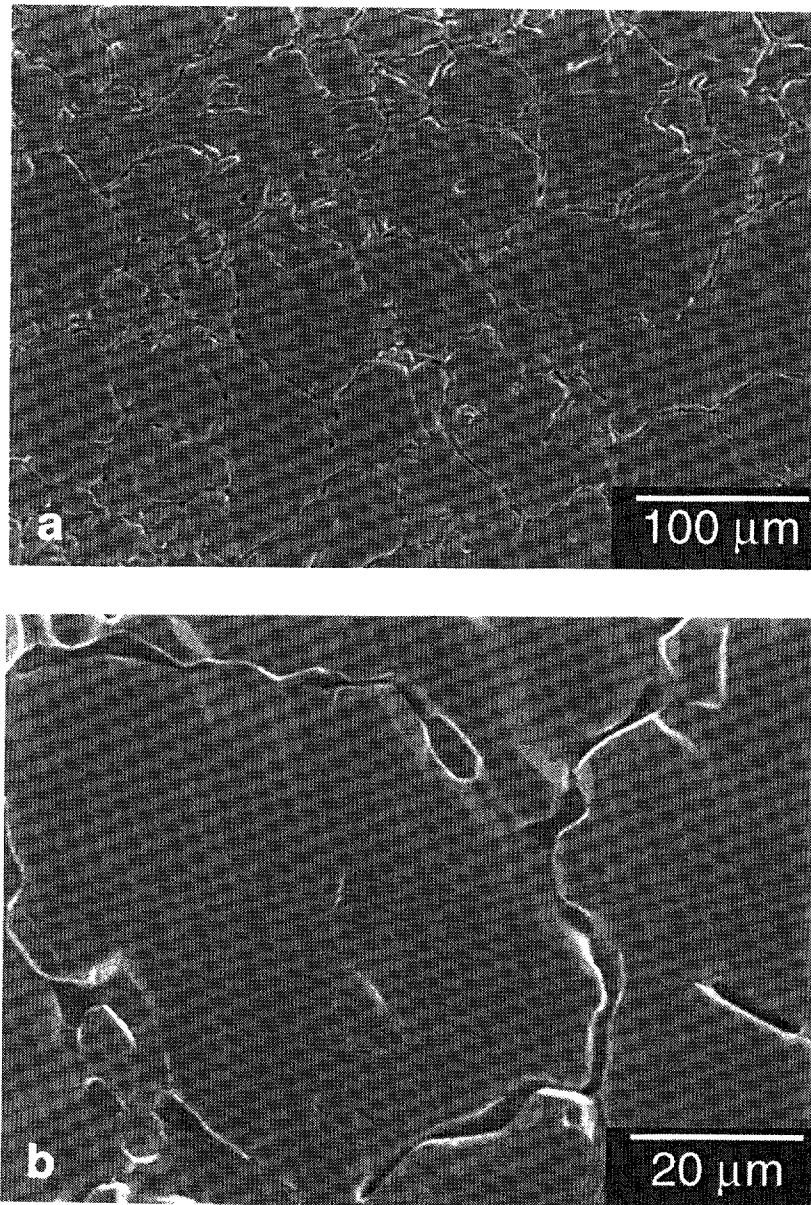
Figure 17. Surface of an IN600 thermowell that was located below the liquid level of the NaK. a) At low magnification, the grain boundary structure is clearly revealed as the result of grain boundary dissolution. b) Dissolved grain boundaries and grain surfaces have a faceted appearance indicated that there was preferential dissolution along certain crystallographic orientations.

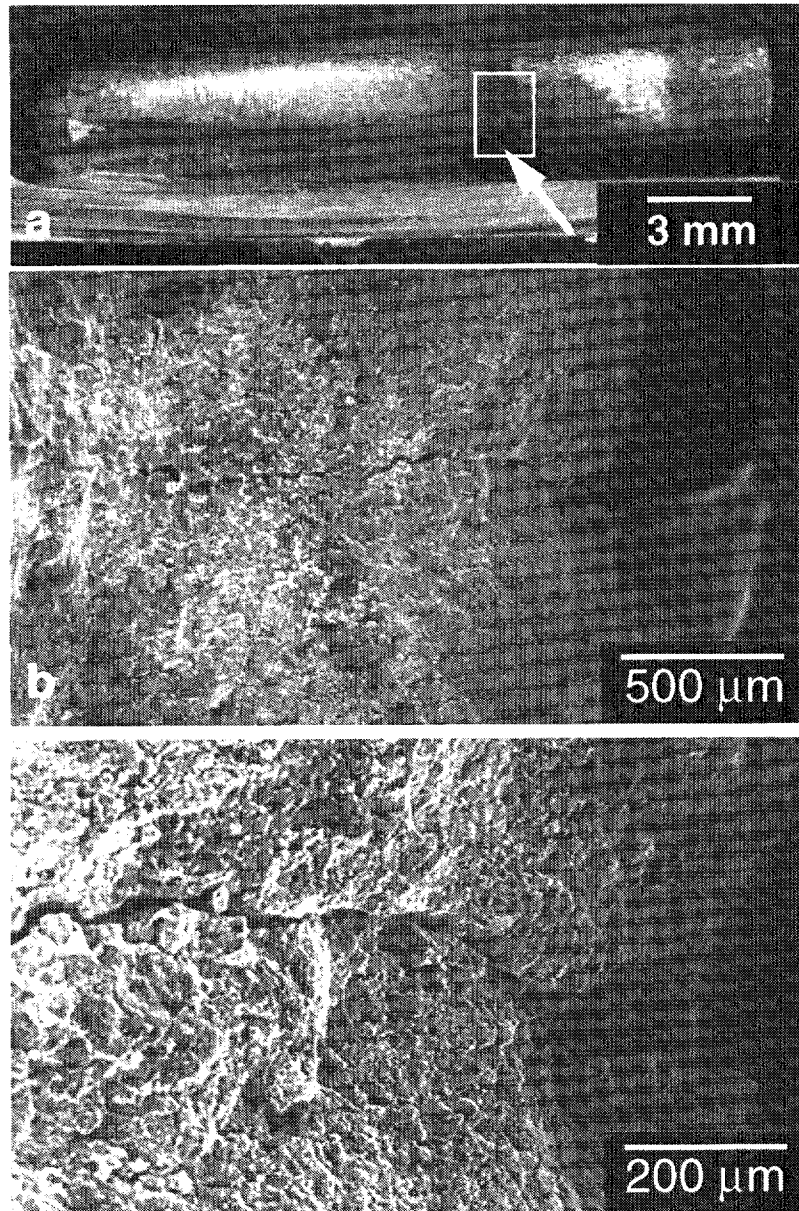
The pool-boiler test was terminated after a small change in the characteristic temperature response was recorded.[2] It was determined that this change resulted from the loss of vacuum due to a very small leak. The recorded pressure rise was ≈ 10 torr. The source of this vacuum leak was identified during the course of this analysis. The leak occurred in one of the IN 600 thermowells used to record the temperature of the vessel sidewall in the condenser. In addition to being brazed to the endcap of the pool-boiler, this thermowell was brazed to the vessel sidewall in order to improve thermal coupling and insure continuous contact over the lifetime of the test. The rigid attachment of the thermowell at both ends gave rise to a mechanical fatigue profile induced by thermal cycling. Although the thermal expansion coefficients of Haynes 230 and IN 600 are quite similar [4, 18], the heating rate of the thermowell is likely to have been much more rapid because of its location within the vessel (and therefore the absence of any heat loss) and because of its considerably smaller mass than the pool-boiler vessel. It was this difference in heating rate rather than in thermal expansion coefficient that gave rise to the continuous thermo-mechanical fatigue cycle. The ensuing initiation and growth of a fatigue crack caused the loss of vacuum. Within the pool-boiler, the alloy was particularly sensitive to mechanical fatigue failure due to its susceptibility to grain boundary dissolution as illustrated above.

Figure 18a shows the actual location of the leak site immediately beyond the brazed end of the thermowell. The tube shows clear evidence of "necking" in a fashion similar to a conventional mechanical test specimen and confirms that there was a significant concentration of strain at the point of failure. This thermowell alloy may have been particularly sensitive to mechanical deformation if the brazing procedure annealed the tube, weakening it relative to the rest of the thermowell. The leak site is identified in Figure 18a by the arrow. The leak was located at the minimum diameter in the neck and initiated in the side of the tube opposite (facing) the pool-boiler sidewall. Figure 18b

Figure 18. Scanning electron micrographs of the leak site in the IN600 thermowell. a) Leak is located at the arrow and runs vertically in the necked (boxed) regions of the tube. b,c) Higher magnification images are rotated 90° from that presented in (a). The crack extends nearly half way around the diameter of the tube.

and c are scanning electron micrographs of the section of the thermowell highlighted in Figure 18a. These micrographs show the sidewall of the thermowell $\approx 90^\circ$ away from the initiation site of the crack. Note that images in Figure 18b and c are rotated relative to the image of the thermowell in Figure 18a for ease of presentation. Figure 18b shows that the crack was quite long, extending nearly half way around the diameter of the tube. Rigorous characterization of the fatigue crack (i.e., intergranular vs. transgranular) was not possible for several reasons. First, the crack experienced a tension-compression fatigue profile. The mechanical damage to the crack faces during each compressive loading would obscure their detailed structure. Second, as the NaK was exposed to air, sodium and potassium oxides would form locally. These oxides are quite reactive with respect to the alloying elements of IN 600 and can rapidly obliterate even more of the detailed structure of the leak site. Regardless of the precise details of the thermowell failure, the leak through the IN 600 tube is further reason to preclude its use in similar liquid metal environments. Other studies have reported similar grain-boundary corrosion of IN 600 exposed liquid potassium at 890°C after 500 hours that was especially pronounced at the liquid-vapor interface. [19]

Other nickel-based materials exhibited poor compatibility with this liquid metal environment. IN 600 suffered substantial intergranular attack, while the nickel ribbon experienced extensive dissolution, resulting in the formation of large internal cavities. Although the failure of an IN 600 thermowell resulted in the termination of the experiment after \approx 7500 hours, its use in pool-boiler designs is not essential. Other alloys more suitable for use in this application should be substituted in future experiments.

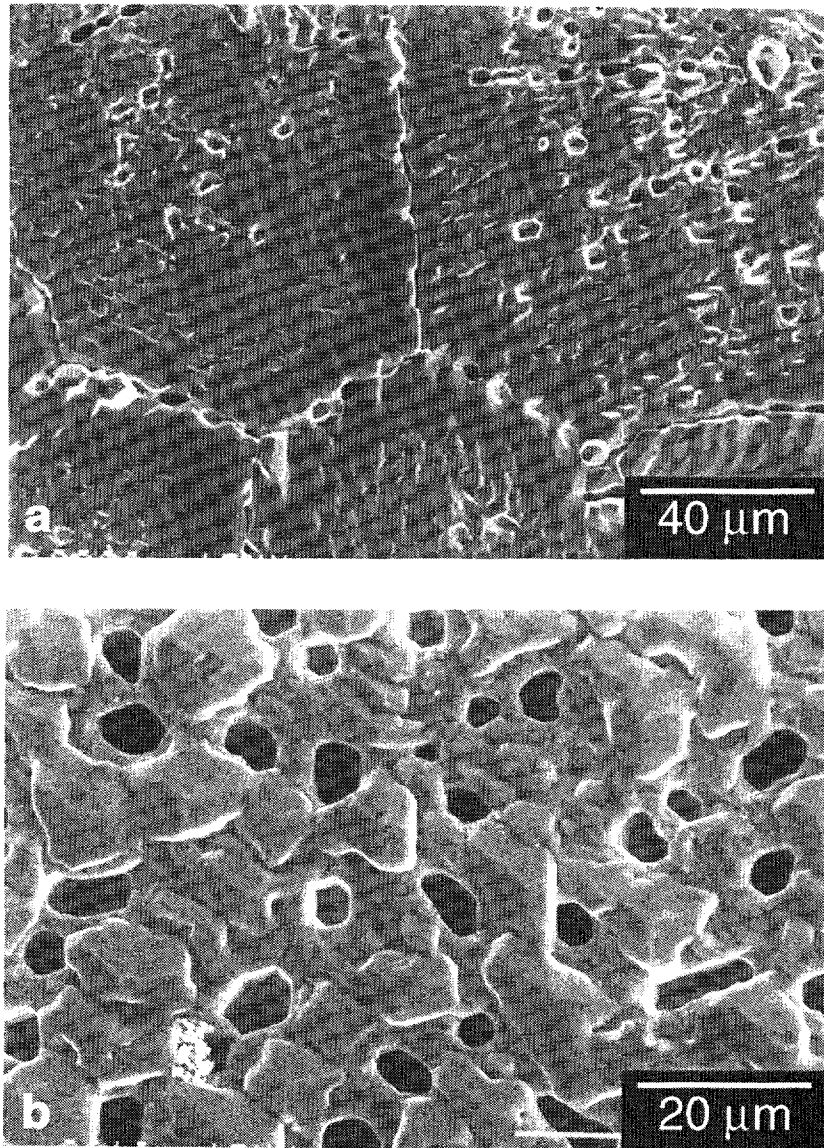
Figure 19. a) SEM micrograph of nickel ribbon immersed in the NaK exhibits evidence of catastrophic attack after 7500 hours at 750°C. The grain boundary structure of the nickel is revealed as the result of pitting and selective dissolution of the nickel near the boundaries, while away from the grain boundaries there is additional pitting. b) At higher magnification, it is clear that dissolution has occurred along preferred crystallographic planes giving rise to the sharply faceted surface features and angular pits.

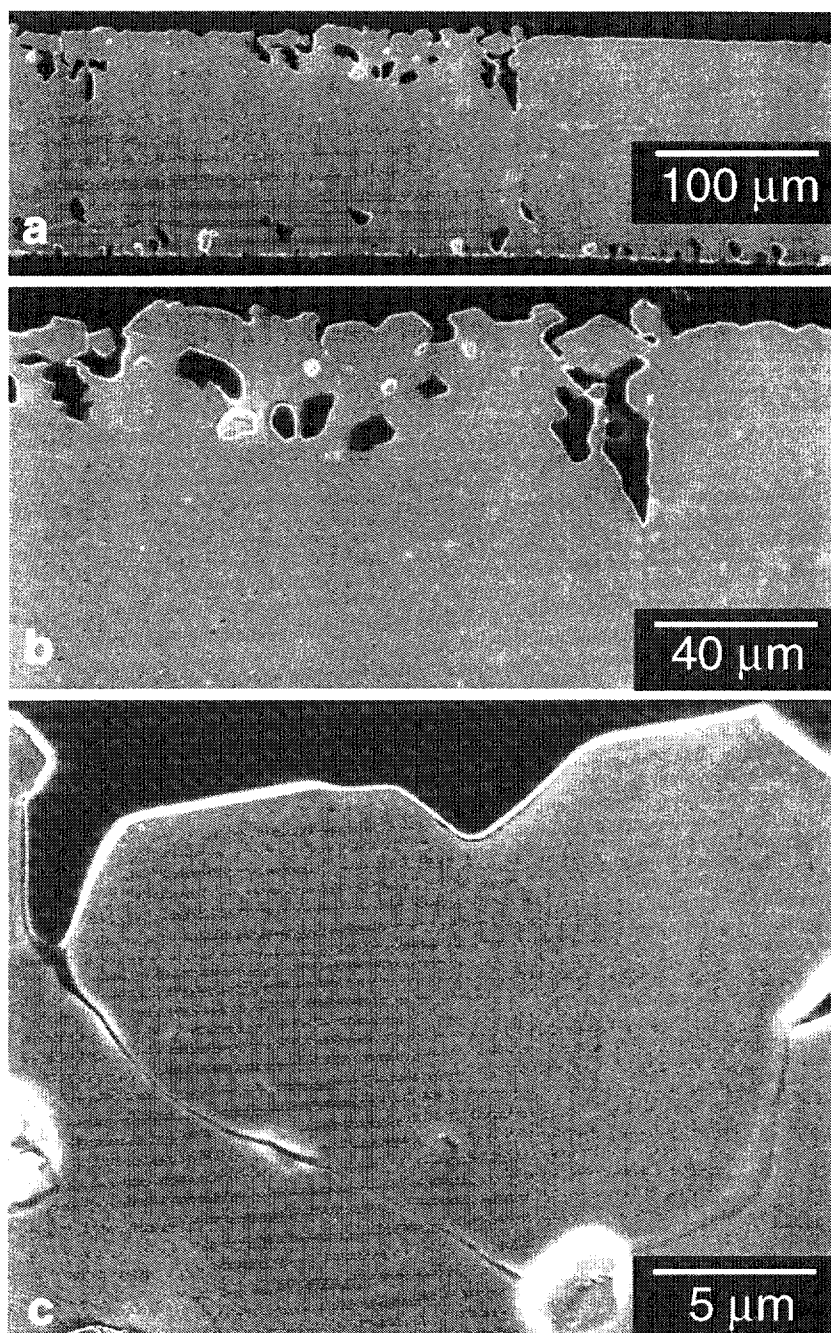
The extent of damage and the depth of pitting is shown in Figures 20a, b and c which are scanning electron micrographs of a polished cross-section of the nickel ribbon. Figure 20a reveals that the cavitation resulting from dissolution of nickel extended more than 30 μm below the ribbon surface. The faceting of the free surfaces of the nickel ribbon in Figure 19b is made more evident in Figure 20b. Figure 20c clearly shows that the dissolution is occurring along the grain boundaries of the nickel ribbon. The cavity microstructure is interconnected, allowing for the rapid dissolution of nickel from deep within the interior of the ribbon. EDS analysis revealed the presence of small concentrations (≤ 1 wt.%) of Cr, Fe and Zr in a surface layer several microns thick. The presence of these elements in the nickel ribbon arise from their dissolution in the NaK (Fe and Cr from the Haynes 230 vessel and IN 600 thermowells and the Zr from the oxygen getter) and subsequent deposition on and diffusion into the nickel foil. While the absolute amounts of these constituents were quite small, their presence was additional confirmation of the occurrence of mass transport within the pool-boiler.

Figure 20. Scanning electron micrographs of a polished cross-section of NaK-exposed nickel ribbon. a) Cavitation extends more than 30 μ m below surface. b) Exposed surface exhibits facets suggesting crystallographic dissolution. c) Grain boundary dissolution is apparent at high magnification.

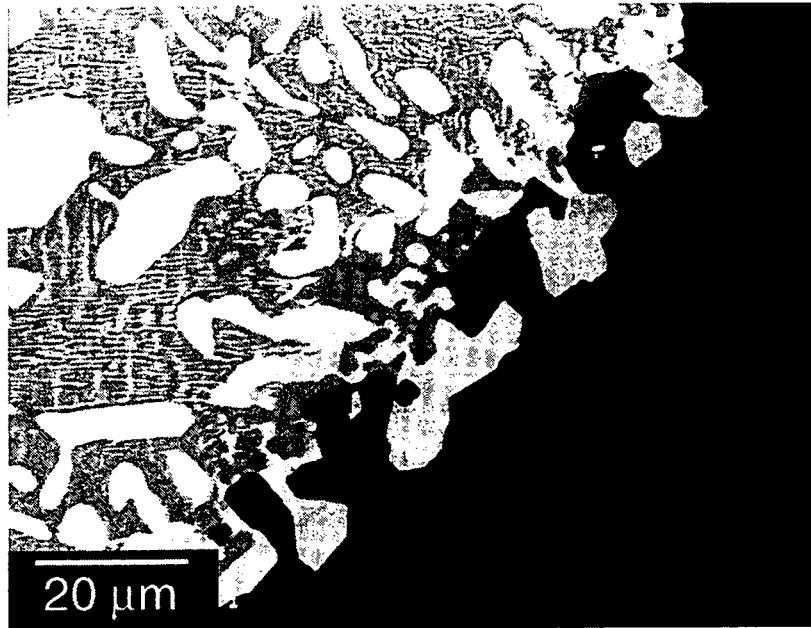
The principal effect of long-term exposure to NaK can be seen in Figure 22 which reveals that there was dissolution of braze alloy at the NaK-exposed surface. It is apparent that most of the loss was confined to the darker, Ni-Si phase. This dissolution was confined to the near-surface of the braze as there was no evidence of the formation of internal porosity beyond that which was observed in the unexposed brazes. The preferential attack of the Ni-Si phase arises from its microstructure – specifically its partitioning into regions of nearly pure nickel and nickel-silicon alloy. The regions of nearly pure nickel within the Ni-Si phase are as susceptible to attack as was the nickel ribbon described in the previous section. It is through these regions of nickel that NaK aggressively attacks the braze.

EDS analysis of the cross-section shown in Figure 22 revealed that chromium was present in a narrow band extending from the NaK-exposed surface to a depth of approximately 20 μm . The only source of chromium in the system is that which was dissolved into the NaK from the Haynes 230 vessel or the IN 600 thermowells. While this observation is only of incidental importance in relation to the interaction of the braze alloy with NaK, it is noteworthy in that it is yet another instance of mass transport and deposition identified in this pool-boiler system.

Figure 22. Backscatter electron image reveals loss of braze alloy at NaK-exposed surface. The darker regions in the micrograph are composed of a nickel-boron phase while the generally lighter regions are a nickel-silicon phase. The complex structure of the Ni-Si phase arises from the partitioning of the silicon into regions of relatively greater and lesser concentrations.

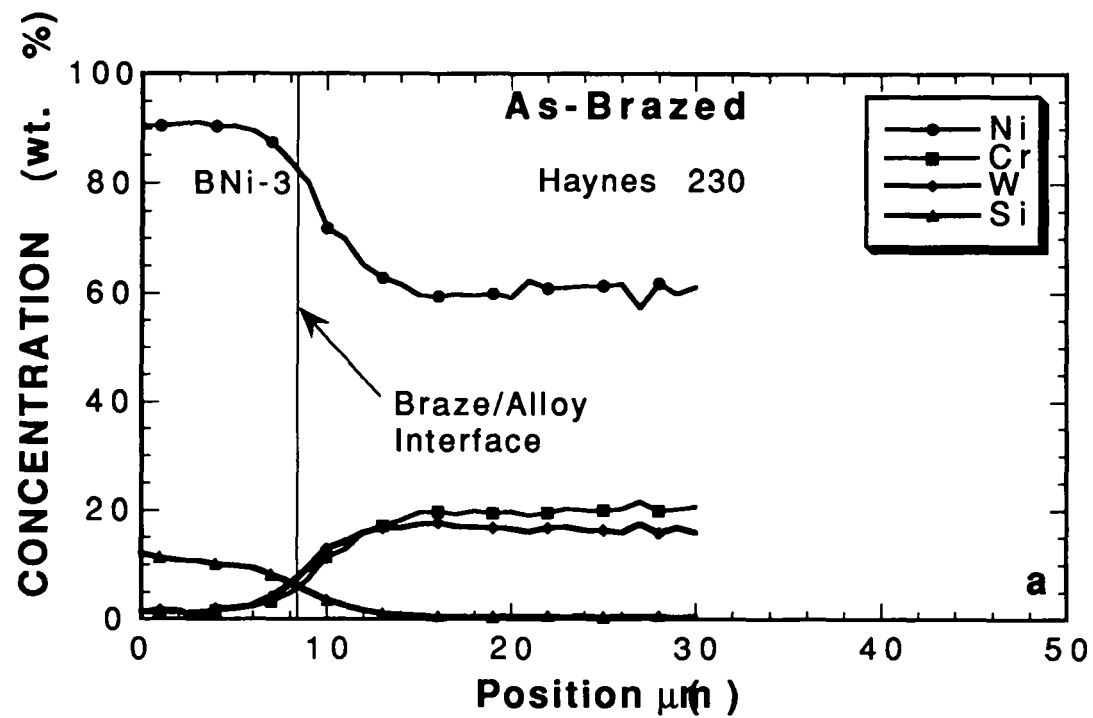
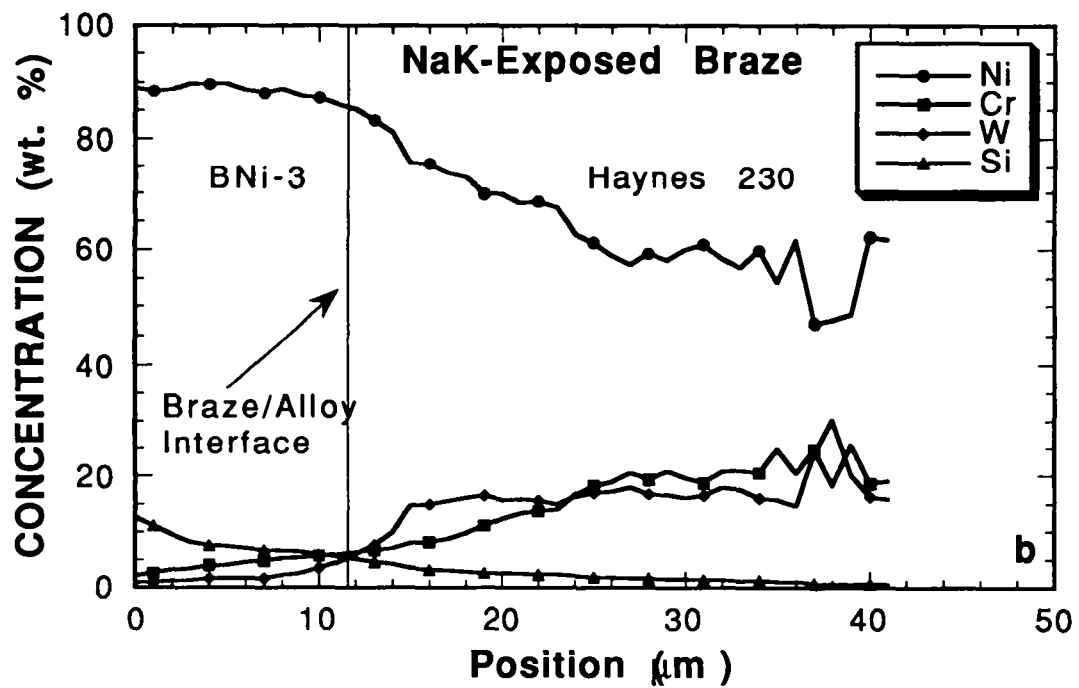
Figure 23b, an elemental trace analysis, illustrates the first effect. After the prolonged exposure, the interdiffusion zone was much broader than that shown in Figure 23a. The diffusion of silicon and boron into the Haynes 230 could be of particular concern if it were to result in the formation of silicides and borides, thus depleting the matrix of alloying constituents or promoting the formation of brittle grain boundary phases. In the present instance though, we have no evidence (e.g. cracking or porosity) of the braze structures or of the vessel alloy being compromised in any way by such processes.

Figure 23 a) EDS analysis of principal alloying constituents at as-received braze/Haynes interface. b) Similar elemental analysis across braze/Haynes interface from pool-boiler.

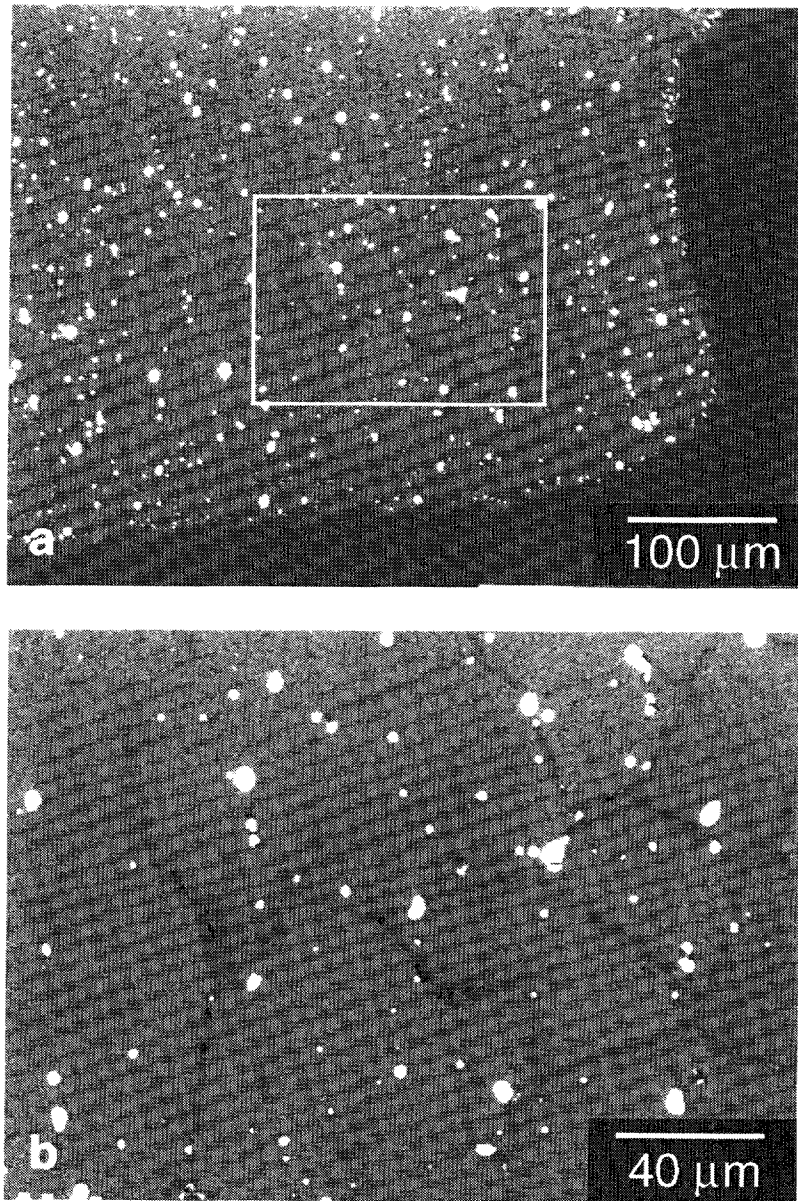
Within the pool-boiler, the interface between the braze and the Haynes 230 exhibited evidence of thermal aging effects. The resulting microstructure was quite complex and an exhaustive analysis of all of the microstructural changes was beyond the scope of the current work. However, it is useful to review the two principal effects: (1) the broadening of the interdiffusion zones on either side of the braze/Haynes interface and (2) the formation of low-Z intragranular and grain boundary structures in the Haynes to a depth of several grain diameters from the interface.

Figure 24. a) Backscatter electron images of the Haynes 230 endcap near a BNi-3 braze from the pool boiler showing low-Z grain boundary structures. b) The extent of segregation is seen more clearly in this higher magnification image of the highlighted region in (a).

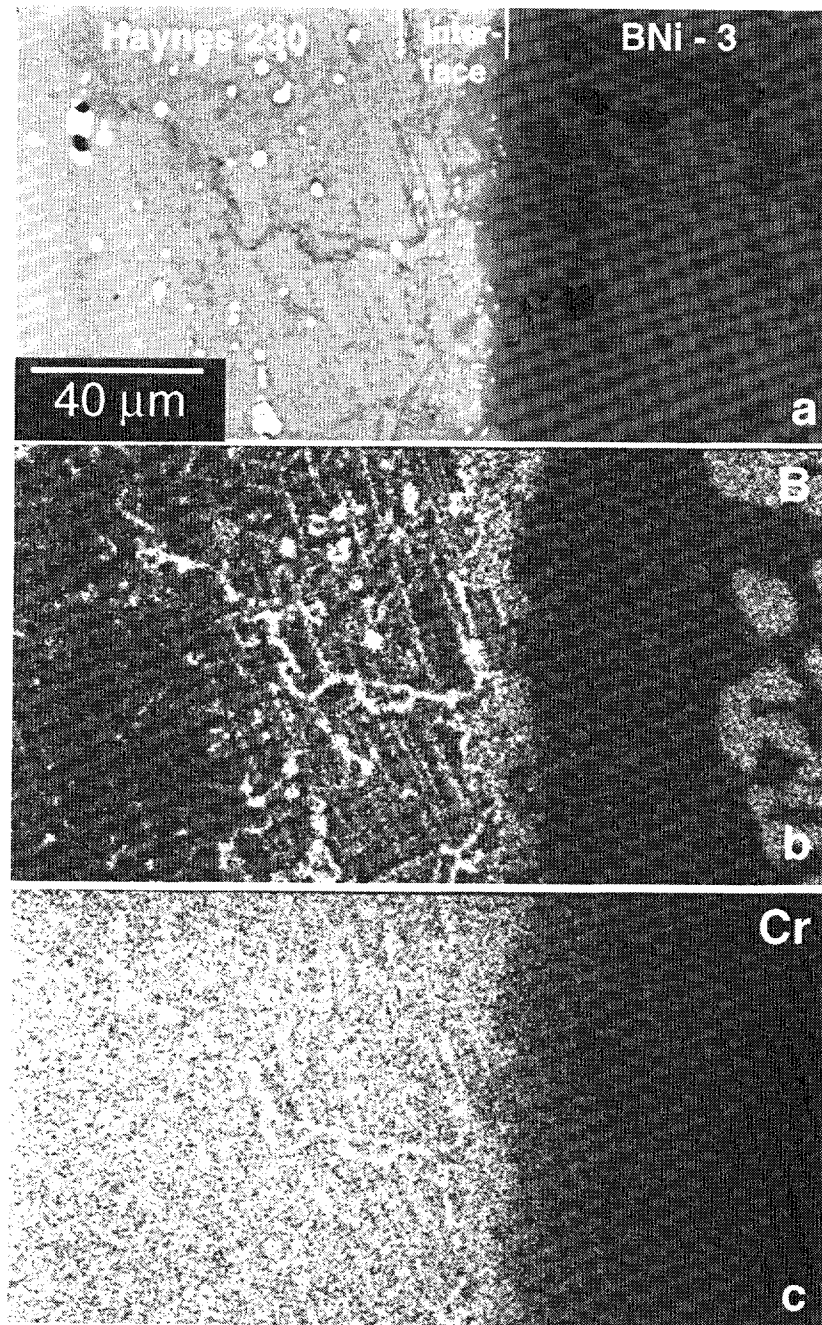
Figure 25a is a backscatter electron image of the braze/Haynes 230 interface after 7500 hours at temperature. As in the previous instance, the specimen shown in this figure was examined in the polished and unetched condition, so that contrast in the micrograph results only from compositional variations between regions within the sample.

Figure 25a reveals both the dark grain boundaries extending to a depth of 100-200 μm illustrated in the previous figure and the dark needle-like intragranular features mentioned above. X-ray mapping of this region was performed in order to identify which elemental species were segregating to these dark features. Such maps for boron and chromium are shown in Figures 25b and c. These maps reveal that the dark intragranular needles, as well as the darkened grain boundaries, contained elevated levels of boron and chromium relative to the surrounding Haynes matrix. No preferential segregation of silicon was observed. In addition, the braze alloy adjacent the interface exhibits a 40 μm wide band

Figure 25. a) Backscatter electron image of the braze/Haynes 230 interface after 7500 hours at temperature. b) Boron X-ray map of the region shown in (a). c) Chromium X-ray map of the same region.

that is depleted in boron. This boron depleted region is the source of the boron found in the Haynes.
