SAND81-0781
Unlimited Release

Fire Hazard Study of the Coolidge, Arizona, Solar-Powered Irrigation Facility

Gary A. Sanders

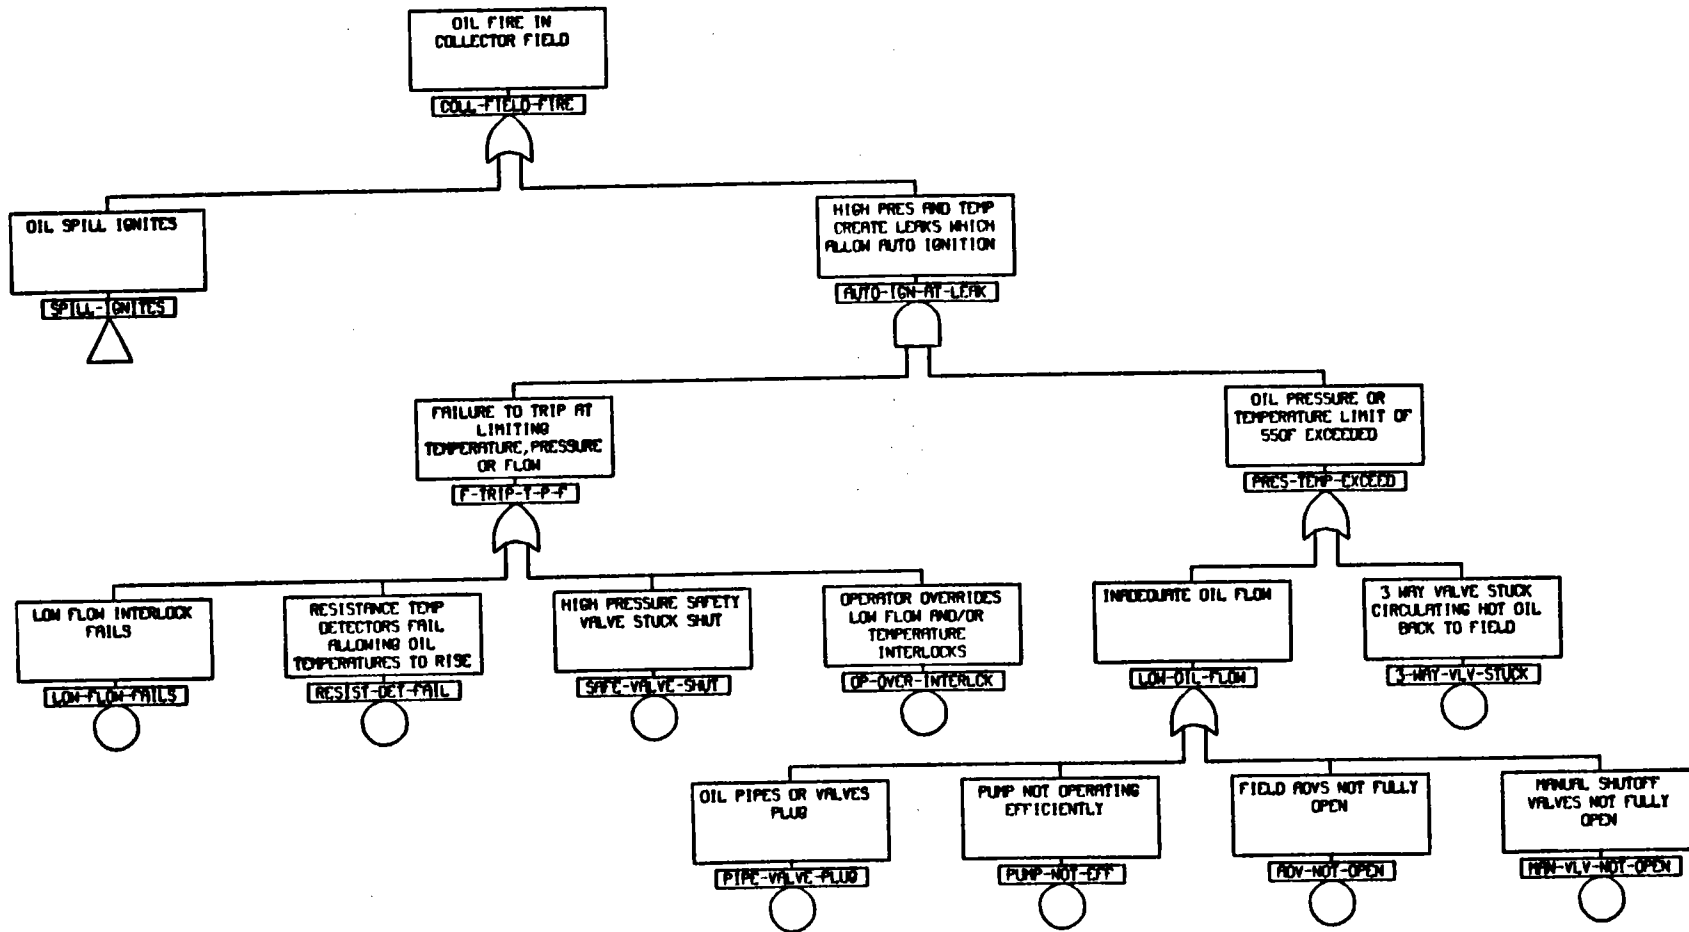
Diagram 1A. Fault Tree Logic for Collector Field Fire.

Diagrams 1A through 1F show the fault tree logic for an oil fire in the collector field. The diagrams show that a collector field fire can result from either an oil spill from a leak igniting or from high pressure and temperature conditions causing a component rupture which auto-ignites.

In the case of the high pressure and temperature causing a component rupture and auto ignition, the system must exceed the design conditions in conjunction with a failure of safety systems to trip at the limiting temperature (550°F), pressure, or flow rate. The failure to trip may result from several system malfunctions. The interlock which detects insufficient flow rates may fail, the resistance temperature detectors could allow the oil temperatures to rise beyond design criteria, or the high pressure safety valve could stick shut. In addition to these malfunctions, the operator could override the low flow or temperature interlocks and prevent a trip of the system.

Oil spills can occur from the high pressure relief valve, crossover pipes, flexible tubes or their attachments, receiver tubes, receiver tube compression fittings, air operated shutoff valves, or the manual shutoff valves.

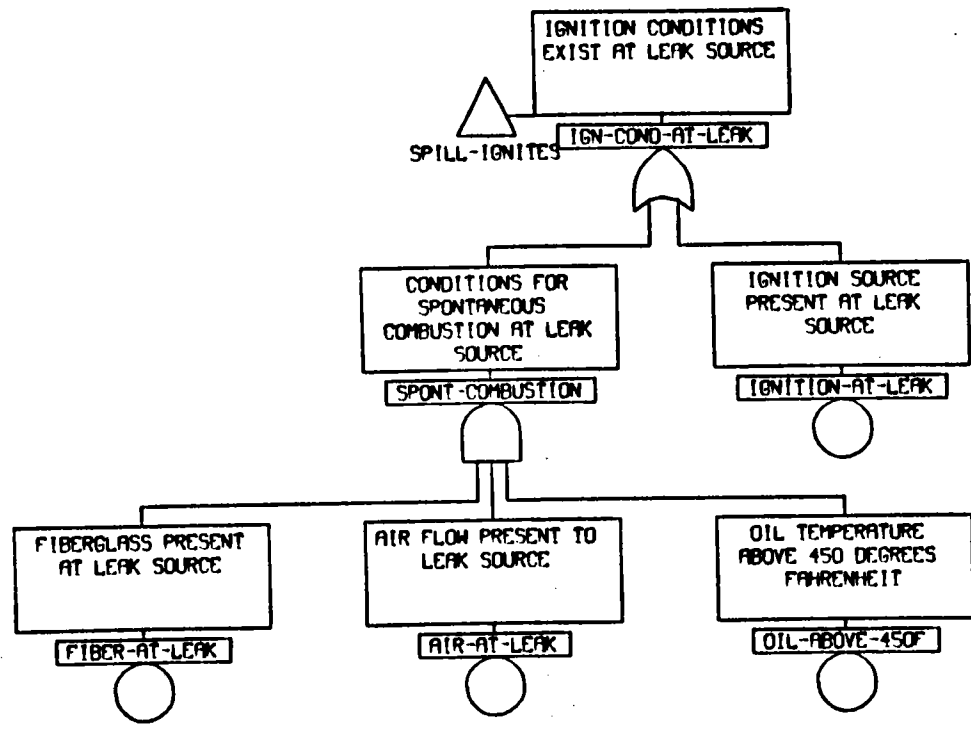
Diagram 1C. Fault Tree Logic for Collector Field Fire.

All of these component leaks will spill oil, but ignition conditions must be present to start a fire. As seen in Diagram 1C, there are two ways that ignition conditions could exist at the leak point: there could be an external source or spontaneous combustion. The conditions for spontaneous combustion include there being fiberglass present at the leak along with a sufficient air flow and oil temperatures above 450°F. Ignition sources at a leak include such things as cigarettes, welding sparks, or sparks from the gas fired heater.

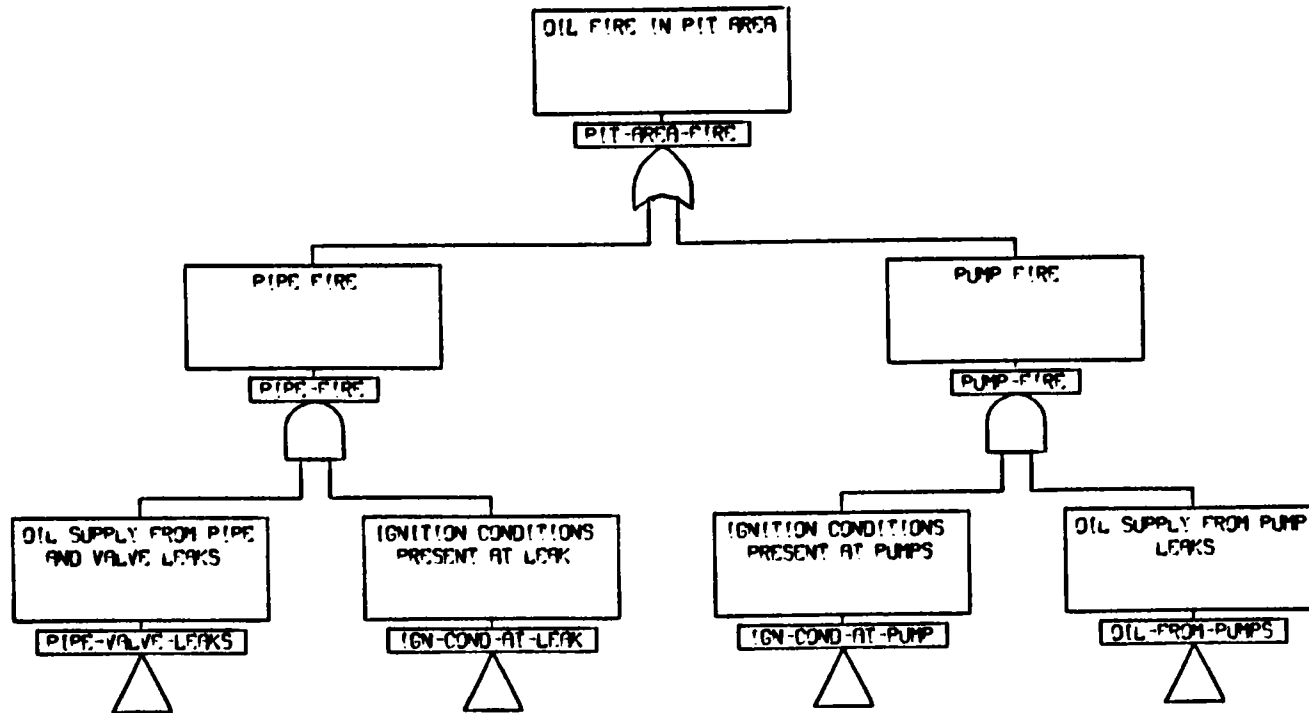
Diagram 2A. Fault Tree Logic for Pit Area Fire.

Diagrams 2A through 2E present the fault tree logic for an oil fire in the pit area. The diagrams show that an oil fire in the pit area can be the result of either a pipe fire or a pump fire. In either case, both an oil supply from leaks and the proper ignition conditions at the leak are necessary for a fire to occur.

In the case of a pipe fire, the ignition conditions are the same as those presented in the collector field fault tree, i.e., either an ignition source may be present or spontaneous combustion conditions are available. The flames from the gas-fired heater constitute the major ignition source since it is in operation about 10 percent of the year.

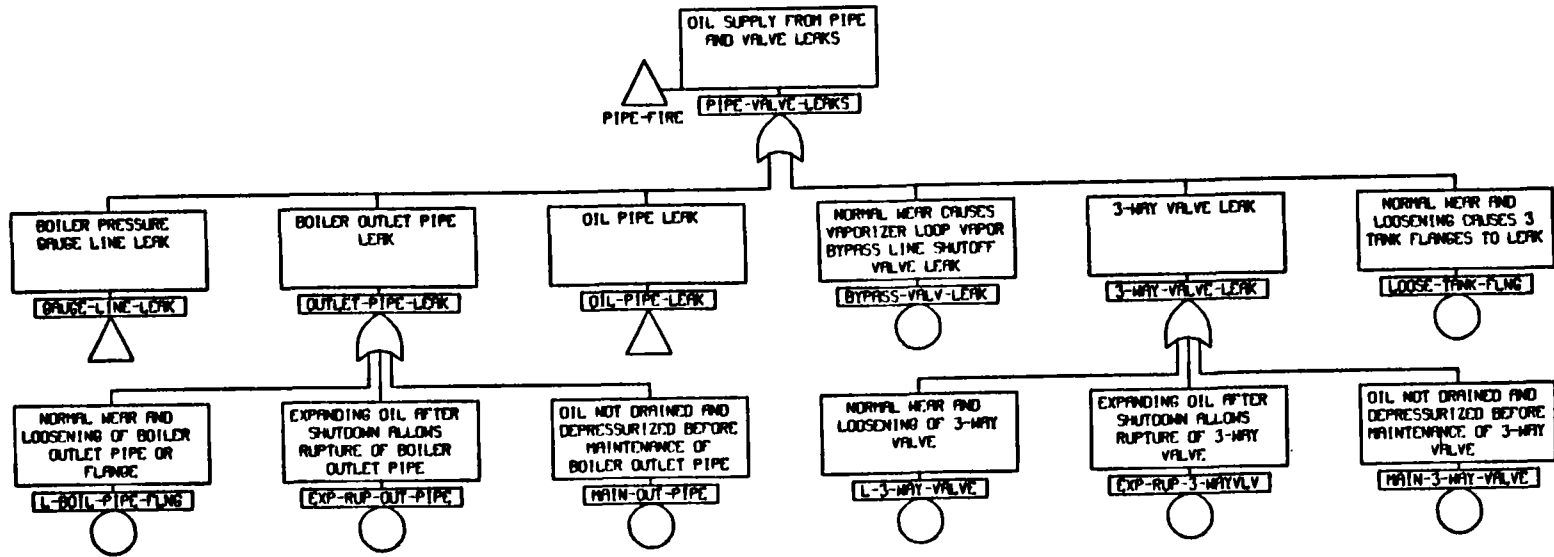
Diagram 2C. Fault Tree Logic for Pit Area Fire.

Diagram 2C shows that the oil supply from pipe and valve leaks in the pit area of the solar facility could come from the boiler pressure gauge line, boiler outlet pipe, oil piping, vaporizer loop vapor bypass line shutoff valve, three-way valve, or the three storage tank flanges. The vaporizer loop vapor bypass line shutoff valve and the storage tank flanges would be expected to leak only due to normal wear and loosening. The other components listed above are subject

not only to normal wear and loosening, but also to rupture by expanding oil after a longterm shutdown without draining oil and to spills when the oil is not drained and depressurized before maintenance work begins.

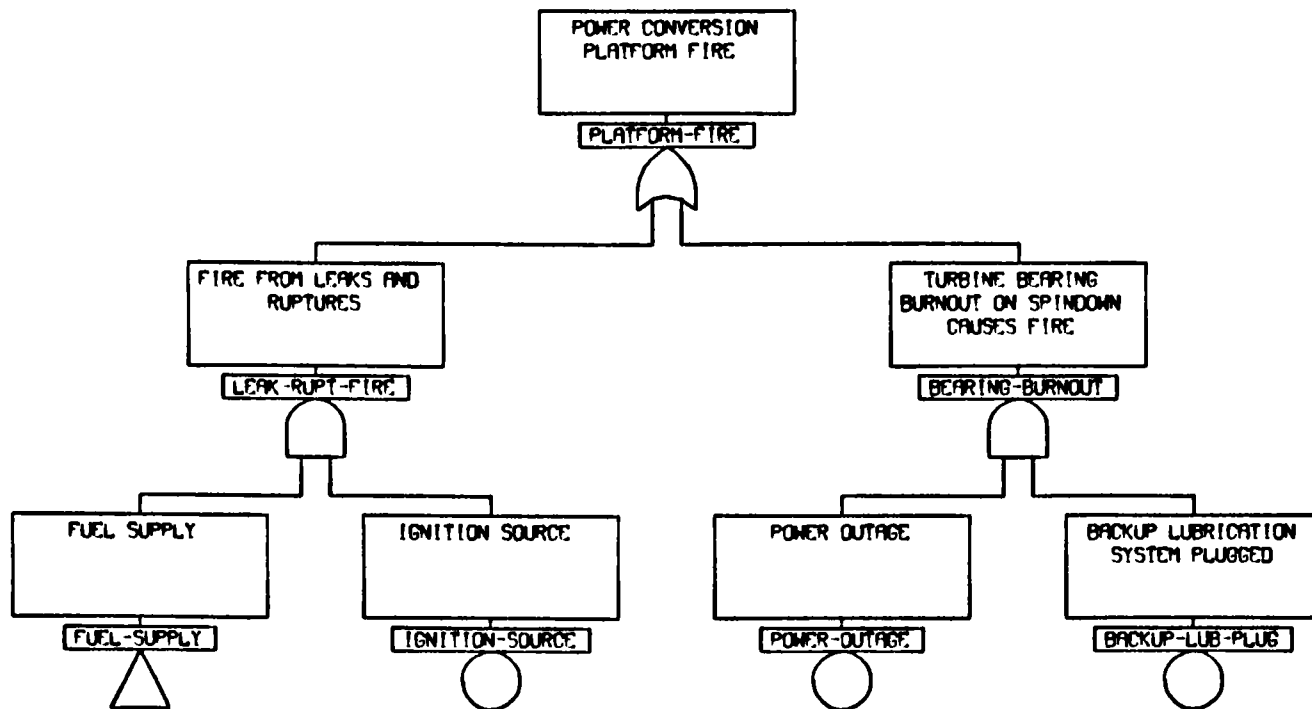
Diagram 3A. Fault Tree Logic for Power Conversion Platform Fire.

Diagrams 3A through 3C present the fault tree logic for a toluene fire on the power conversion platform. It is evident that such a fire may result from either a leak or rupture of toluene coming in contact with an ignition source, or from a power outage while the back-up lubrication system is plugged allowing the turbine bearings to burnout on spindown and ignite the turbine oil present.

The danger from leaks and ruptures stems from the regenerator or the vaporizer burst discs, component joint leaks, and organic Rankine cycle lubrication system leaks. The regenerator burst disc may rupture if the condenser pumps fail thus causing the regenerator to overpressurize or if a faulty toluene level sensor
