Monograph Series, No. 1: 10 MWe Solar Thermal Central Receiver Pilot Plant Heliostat Experiences November 1981 – February 1983

C. L. Mavis

SAND83-8220
Unlimited Release
Printed May, 1983

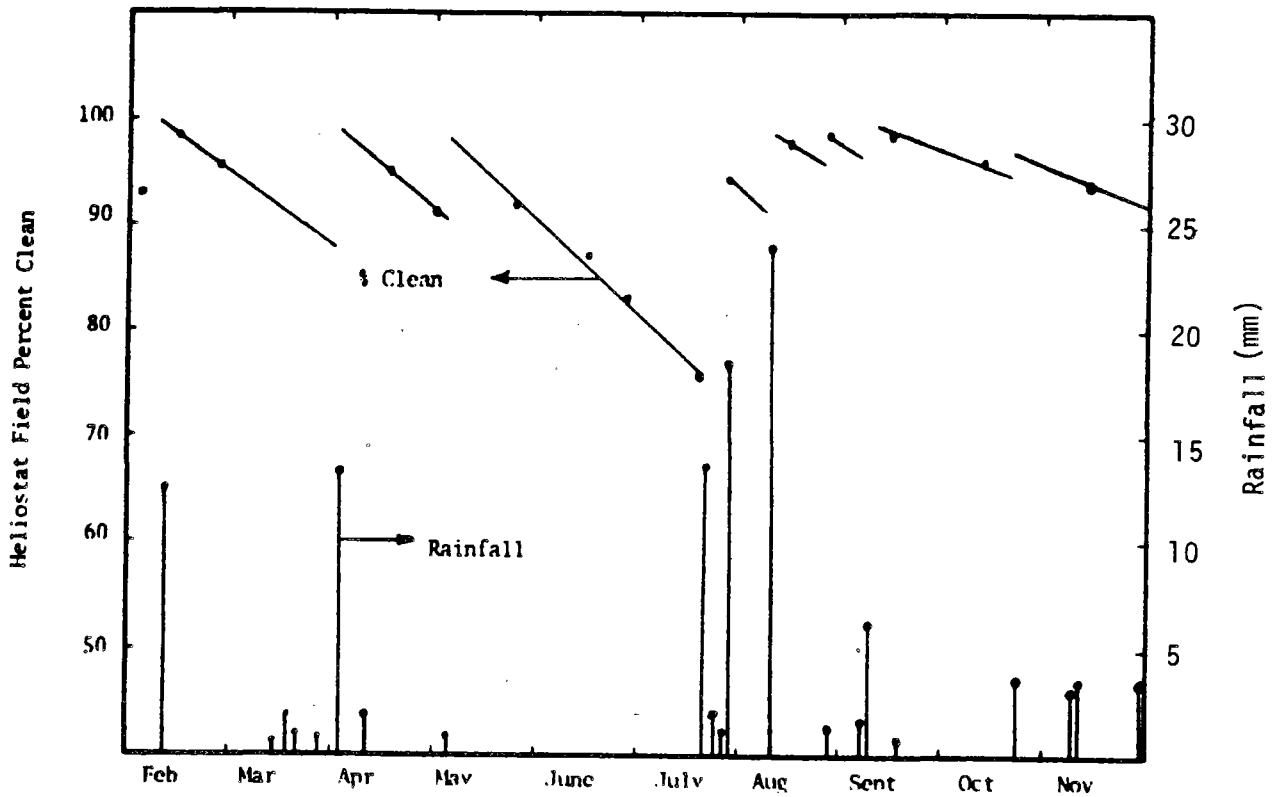
Figure 6. Barstow Rainfall and Mirror Cleanliness

The clean reflectivity for the majority of the pilot plant mirrors is 91.1%; however, there are 1500 mirrors which use low transmissivity glass which are 79.8% reflective. In both cases the reflectivity is for an air mass 1.5 solar spectrum. The cleanliness of approximately 10 mirrors was measured 14 times between January 31 and December 1, 1982, using a portable single wavelength reflectometer. The data are corrected to estimate the solar weighted reflectivity with an accuracy of about 1%. Because of the two types of glass the percent clean value is reported as shown in Figure 6 along with the amount of rainfall. The slope of the percent clean lines (the rate of the decrease in cleanliness) is estimated from the measured data points which are shown. When there was little rainfall, the decrease in cleanliness is about 0.25% per day (8%/month), and 0.1% per day (3%/mo) during the months that have more frequent occurrences of rain. As discussed previously, 700 heliostats were washed with an insulator washing truck just prior to the rain in July when the reflectivity was down to about 75% of clean. The mirrors regain about 97% of their clean reflectivity when there is 12 mm (0.5 in.) or more of rain.

The rainfall at the Daggett, California, airport is shown in Table IV, along with the data for 1956-1970. During 1982, more rain than average fell and more occurrences of rain took place during most of the months. Based on the cleaning results in 1982 and the historical rainfall data, the field will require 3 to 6 artificial washings per year to maintain the reflectivity above 90% of clean.
