5105-146
Solar Thermal Power Systems Project
Parabolic Dish Systems Development

Bearing Development Program for a 25-kWe Solar-Powered Organic Rankine-Cycle Engine

September 15, 1985

JPL Publication 85-81

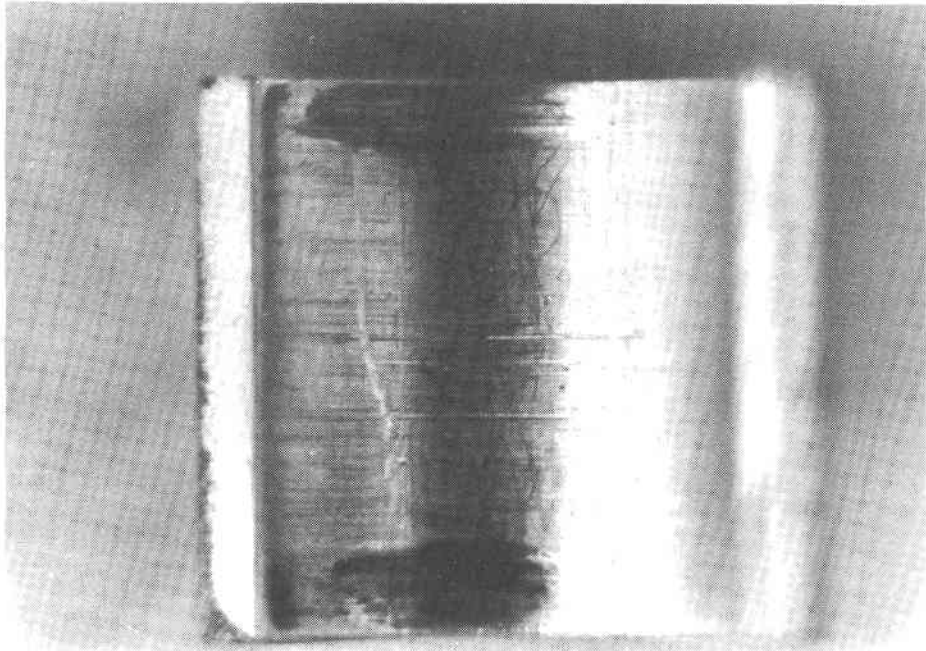
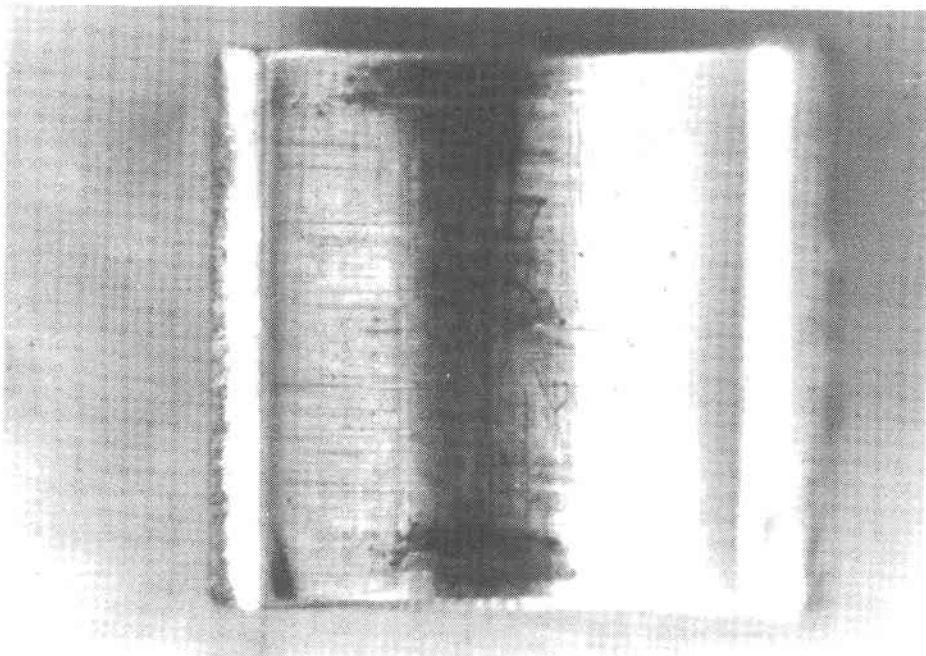
Figure 3-3. Edge Wear on Tilting Pads, Possibly Caused by Excessive Yaw Motion

Tin-antimony babbitt provided a more forgiving metal-to-metal contact surface than bronze for initial start-up and lift-off of the pads. The two most severe wear patterns on the turbine end thrust bearing coincided with the two gimbal pin locations on the bearing. This raised a suspicion that the thrust bearing was deflected under load at all locations except where supported by the gimbal pins. The locations of the thrust bearing gimbal pins were changed so that they would not coincide with the lubrication grooves in each thrust bearing. Because there was no measurable improvement in PCS performance in builds 4 or 5, the slinger ring was removed. Immediately upon reaching design speed for the first run of TAP build 6, the turbine wheel rubbed the turbine housing because of plastic deformation of the wheel at high speed. Apparently at high operating speeds the wheel plastically deformed and redistributed the mass of the wheel, thus continuously changing the rotor balance. The excessive imbalance caused severe bearing loads that resulted in pounded and worn journal bearings. Barber-Nichols followed the Inconel 718 supplier's recommendations by heat treating and brazing the turbine wheel and shroud in two separate consecutive processes; unfortunately, this technique resulted in excessive grain growth and an overall reduction in material strength. The process was corrected by simultaneously heat treating and brazing in a single process to minimize grain growth and increase material strength.

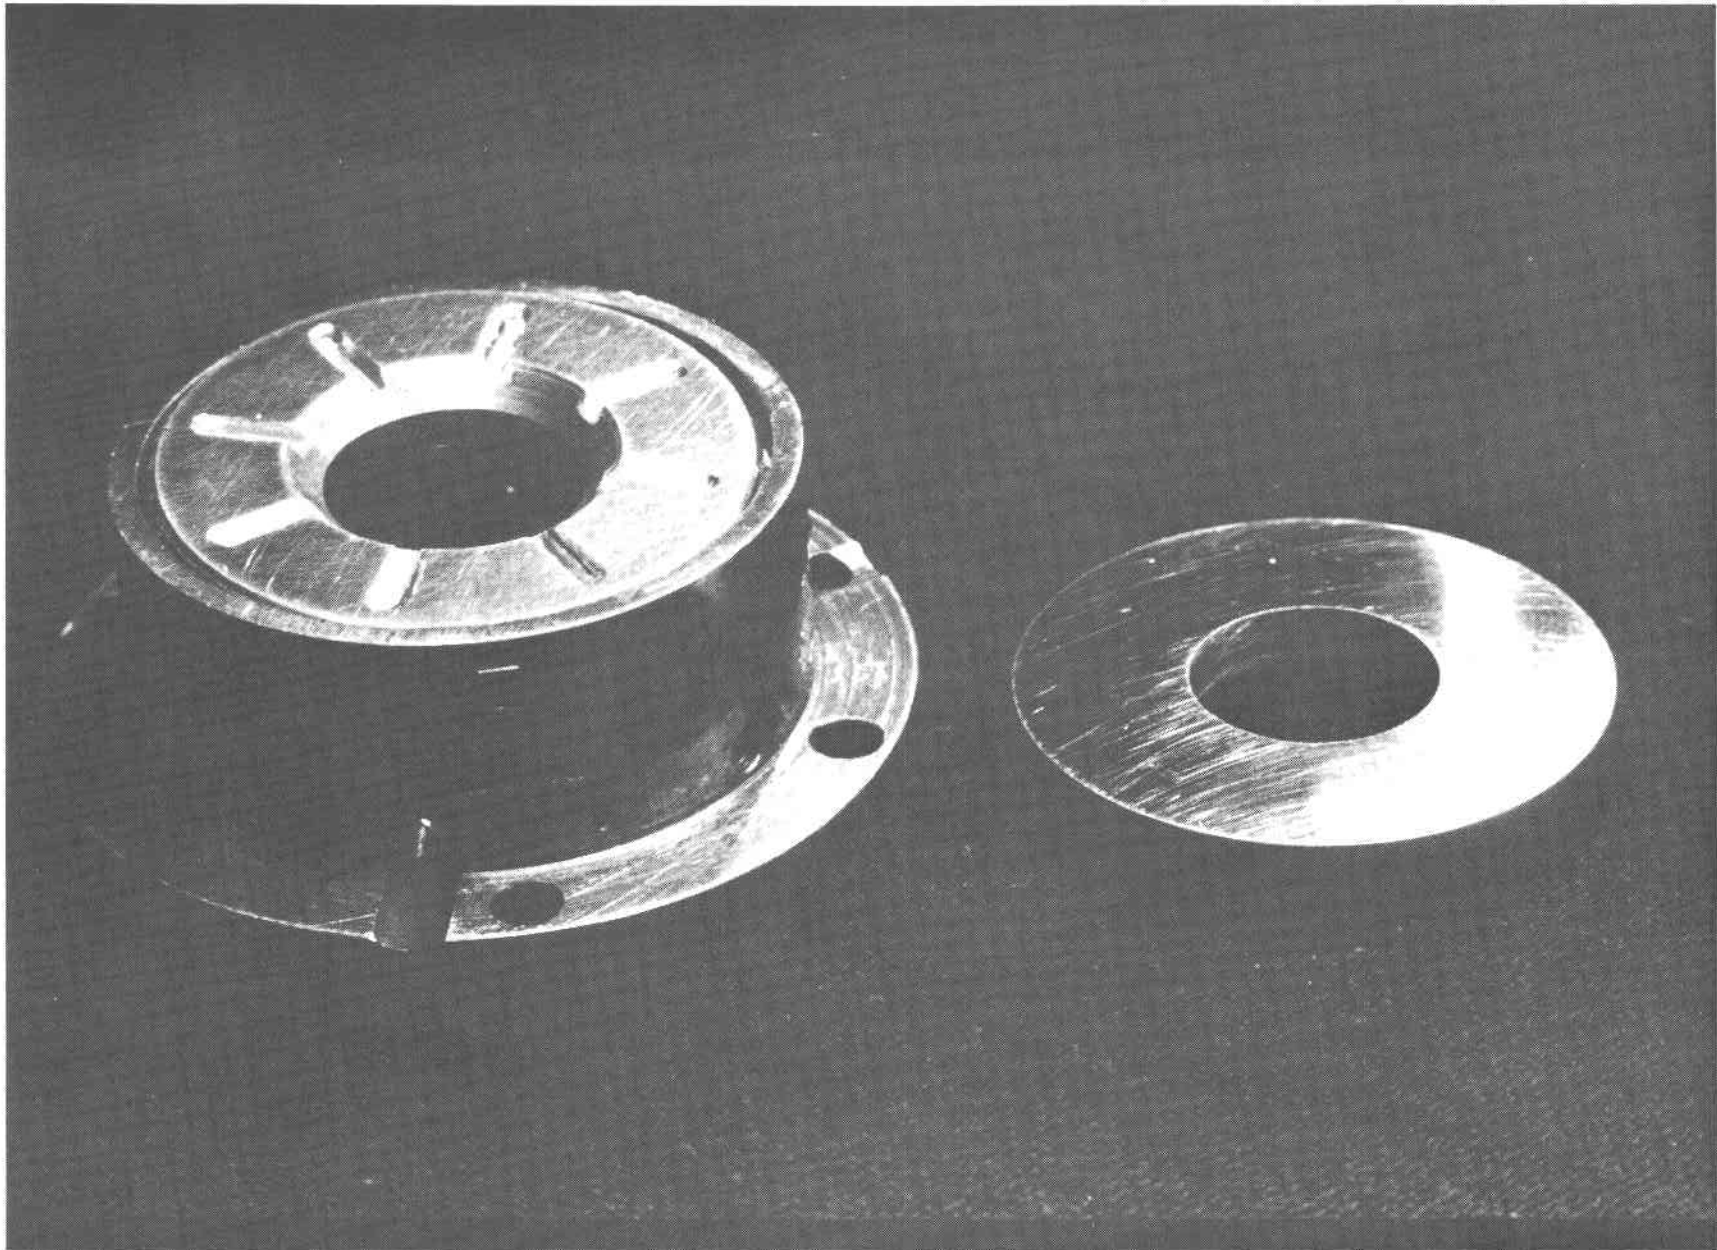
Inspection of TAP build 7 after 11.6 h of test revealed minimal wear on the journal bearings and severe wear on the turbine end thrust bearing that resulted in wear on the back side of the pump impeller because of significant axial displacement. During normal operation, the net axial force on the rotor tended to load the turbine end thrust bearing regardless of TAP orientation. The pump end thrust bearing was only loaded briefly during engine start-up and shutdown and therefore was never damaged.

Figure 3-4. Thermal Wedge (Fogg) Turbine End Thrust Bearing (left) made of 52100 Steel with Flame-Sprayed Babbitt Surface and Thrust Runner (1.5-in. diameter) made of 17-4 PH Steel

All accelerometer measurements were extremely high and fluctuating both in frequency and amplitude, making conclusive results impossible. In TAP build 8 the turbine end thrust bearing was redesigned to increase the diameter from 1.19 to 1.5 in., and the bearing material was changed from bronze to flame-sprayed babbitt on 52100 steel (Figure 3-4). The thrust runner diameter was also increased, and the material was changed from 304 stainless to 17-4 PH steel. A silver flash coating was applied over the babbitt on the journal bearing pads in an effort to further minimize start-up and shutdown contact wear.

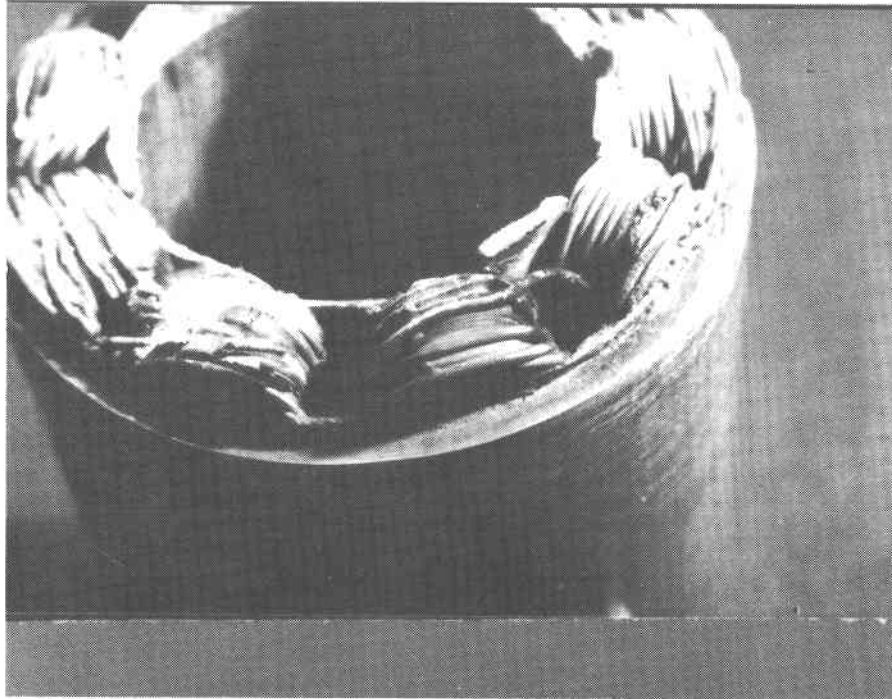
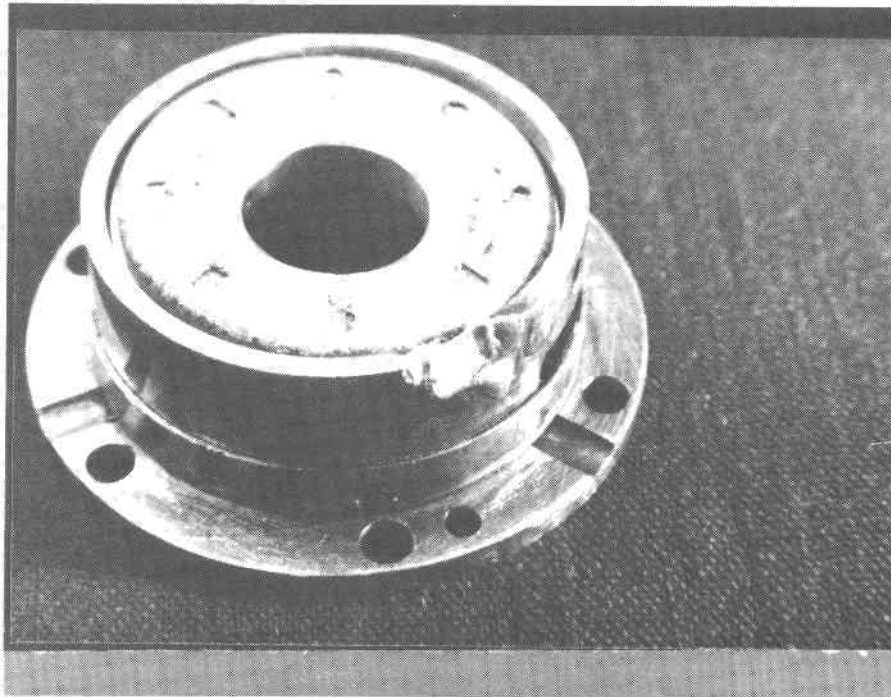
Inspection of TAP build 11 revealed severe electrical arcing between the PMA stator end turns and the outside diameter of the turbine end thrust bearing (Figure 5-6). The arcing was severe enough to melt and remove a section of the turbine end bearing carrier. The outer diameter surface of the thrust bearing was severely worn, and deep pits were observed in the center of

Figure 5-6. Electrical Arcing Damage between (a) the PMA End Turns and (b) the Turbine End Thrust Bearing Carrier

A number of concurrent tasks were initiated to resolve the problems discovered in TAP build 11. A Rayleigh step thrust bearing was designed and installed on the turbine end for all future builds to replace the relatively lower load-carrying flat pad (Fogg) bearing currently used. A second-generation bearing test stand was fabricated to verify the maximum load-carrying capacity of both radial and thrust bearing designs with internal shaft-fed lubrication and with external flooded lubrication. The failed PMA stator was rewound with upgraded insulation wire, potted with insulating material, and finally encapsulated in an additional toluene-resistant black stycast 2850 material (Figure 5-7). The unused spare PMA stator was only encapsulated in stycast material for future use. A TAP test stand was developed that could measure the applied torque on the tap, which in turn could be used to derive the efficiency of each tap component as it is added or removed to determine the cause of the lower-than-predicted performance. The feed pump was to be performance-tested with various back clearances to determine the effect of increased clearance on pump efficiency. It was hoped that the larger feed pump impeller back clearance would reduce the probability of contacting the TAP housing without significantly reducing the pump efficiency.

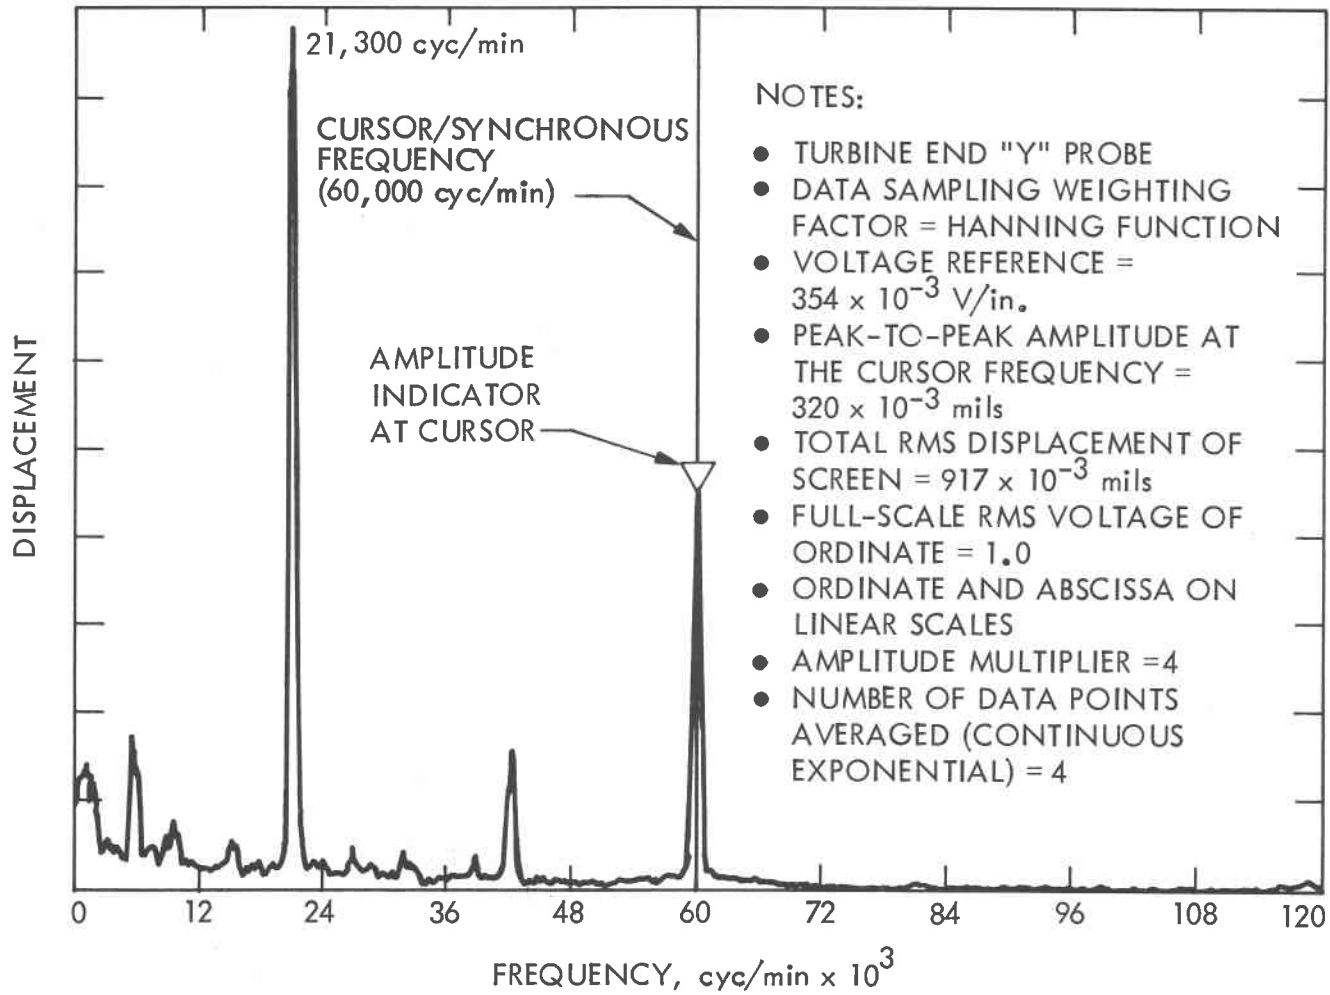
During operation of TAP build 14, the proximity probe data indicated a serious subsynchronous rotordynamic instability. Figure 7-3 gives the spectrum plot from a TAP optical proximity probe showing this effect. Disassembly and inspection revealed wear on the trailing edge of each tilting pad and polishing on the turbine end thrust bearing.

Figure 7-3. Spectrum Plot from Tests of a Barber-Nichols Three-Pad Tilting-Pad Bearing

After extensive analysis of the proximity probe data, three concurrent courses of action were initiated in an attempt to resolve the rotordynamic instability problem. The squeeze-film-damped journal bearings (designed, installed, and tested by B-N) were the first to be tested because they had the shortest lead time (Figure 7-4). It was thought that by providing the proper amount of external damping to a simple journal bearing, the rotor bearing system could be stabilized. This was considered to be only a temporary fix to continue testing because vertical operation eventually would be required, and the journal bearing would probably be unstable in that position. The second parallel approach was a fully flooded five-pad tilting-pad journal bearing (from Waukesha Bearings Corporation) that was lubricated by externally supplied fluid from a dedicated bearing lube pump. This more conventional approach would eliminate all bearing and shaft dynamic uncertainties introduced by the lubrication system. A final backup approach was for Mechanical Technology, Inc. (MTI) to analyze and design a four-pad tilting-pad bearing and deliver drawings to Centritek for fabrication if the first two approaches failed.

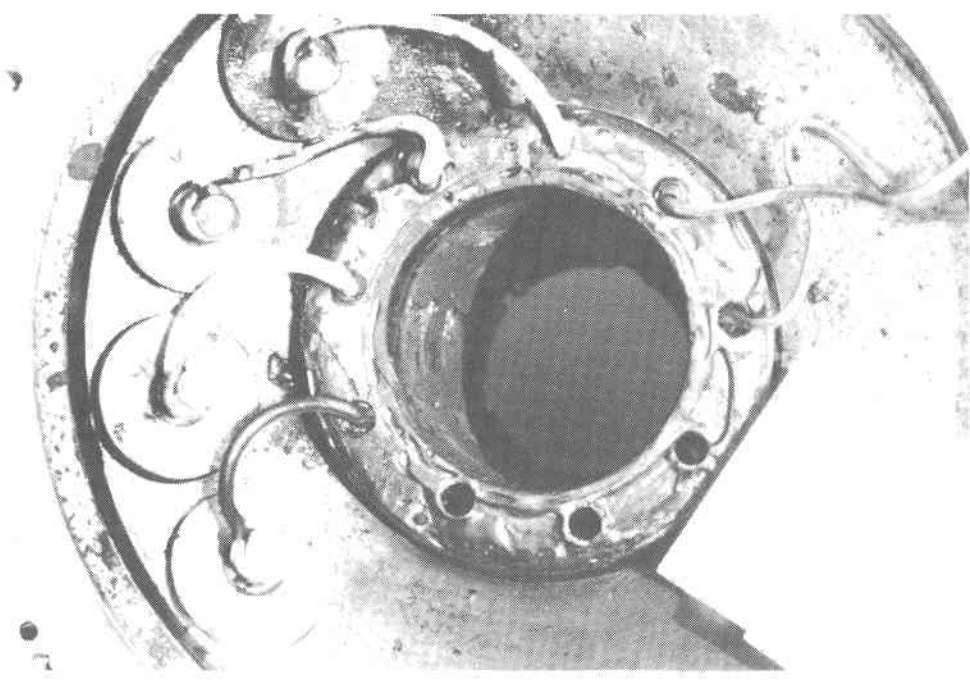
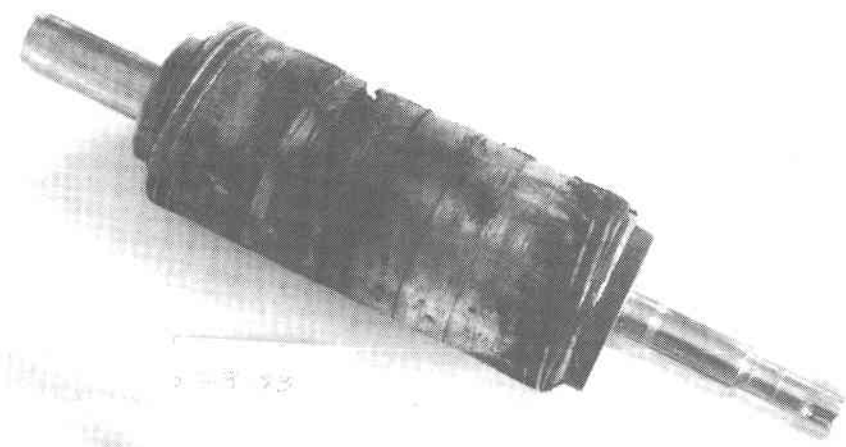
Figure 7-7. Permanent Magnet Alternator Failure Caused by Arcing between Adjacent Stator Coils

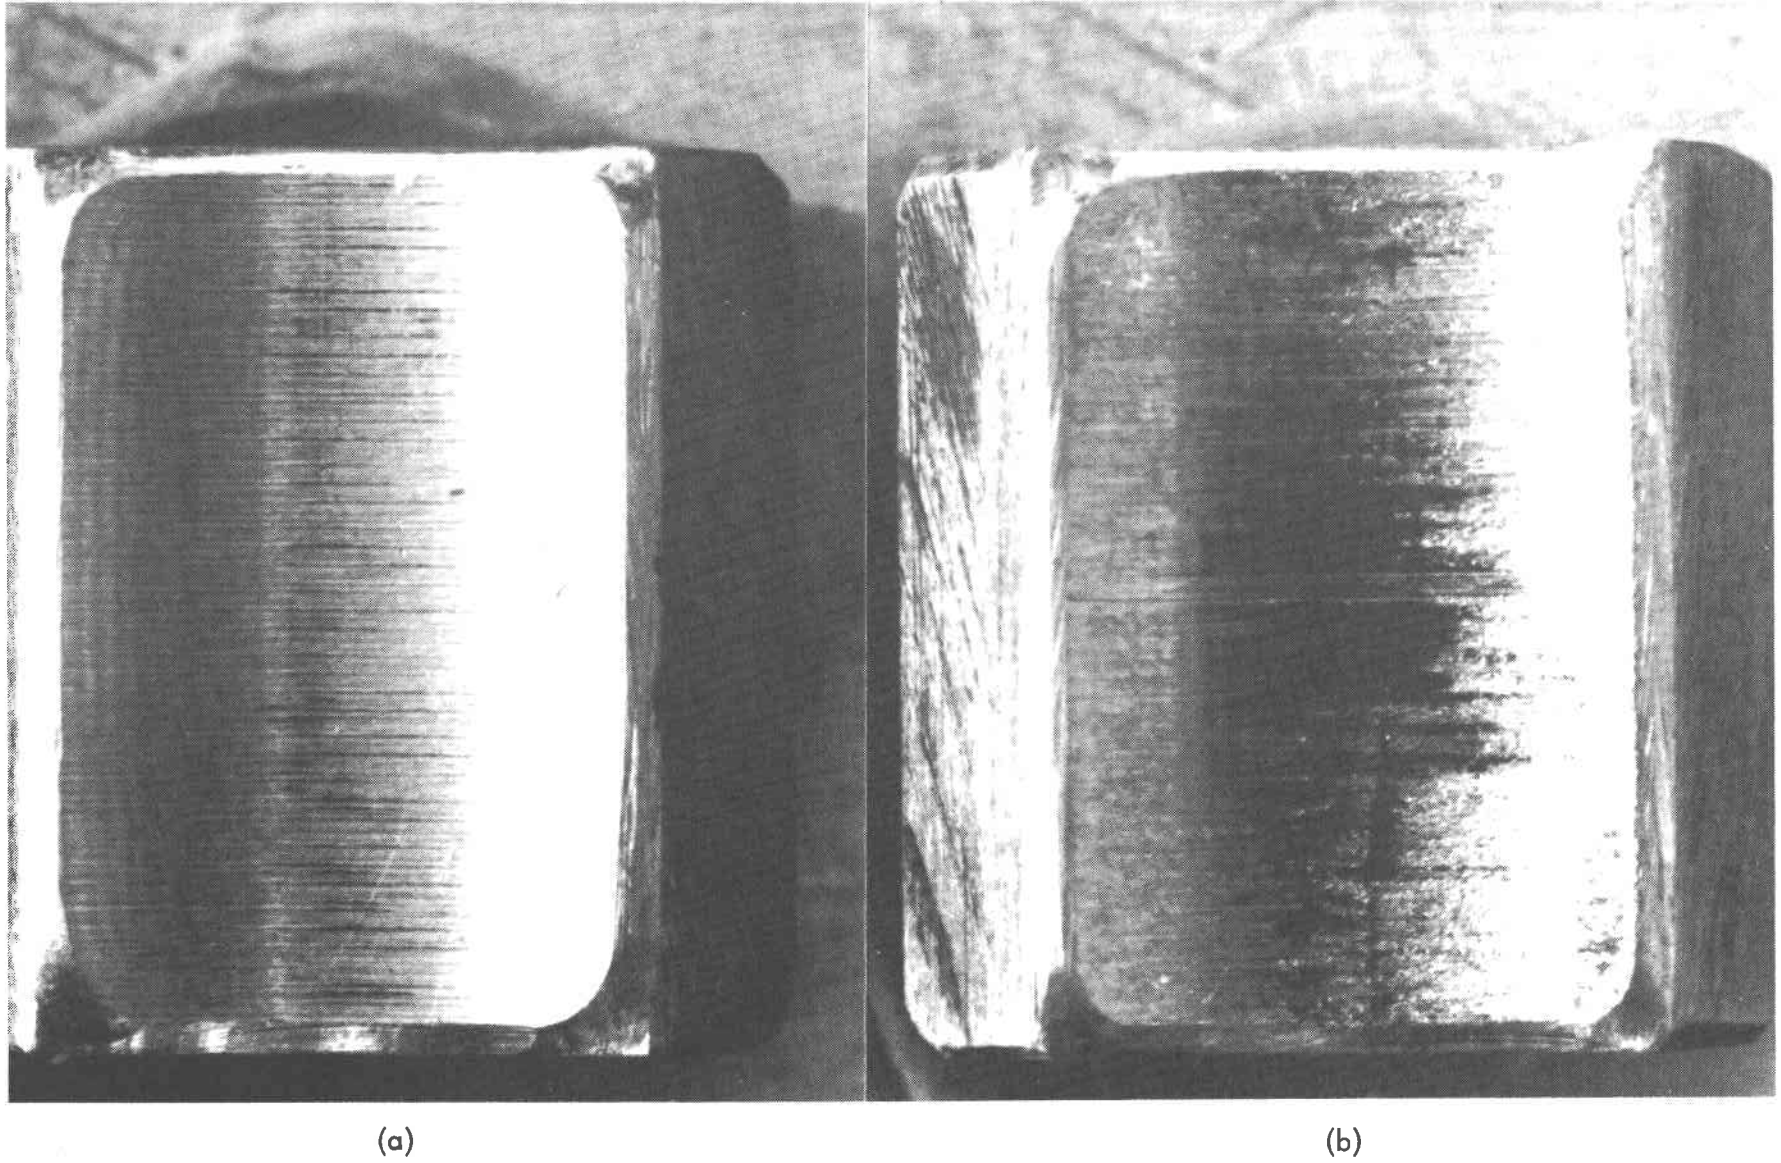
Figure 7-11. Waukesha Journal Bearing Pad (a) Before and (b) After Testing

An extensive analysis of the build 21 damaged bearing surfaces was conducted by FACC using an electron beam microscope. The damaged surface on each pad had a frosted appearance, which was determined to be a number of separate but closely packed pits. Figures 7-12 and 7-13 show various magnifications of the pitted surfaces and compare them to unpitted zones. A chemical analysis inside the pits revealed high concentrations of zinc and chlorine, which were not present in the virgin babbitt or bearing material. This change is shown in Figure 7-14 where the virgin material analysis and an analysis inside a single pit are compared on one plot.

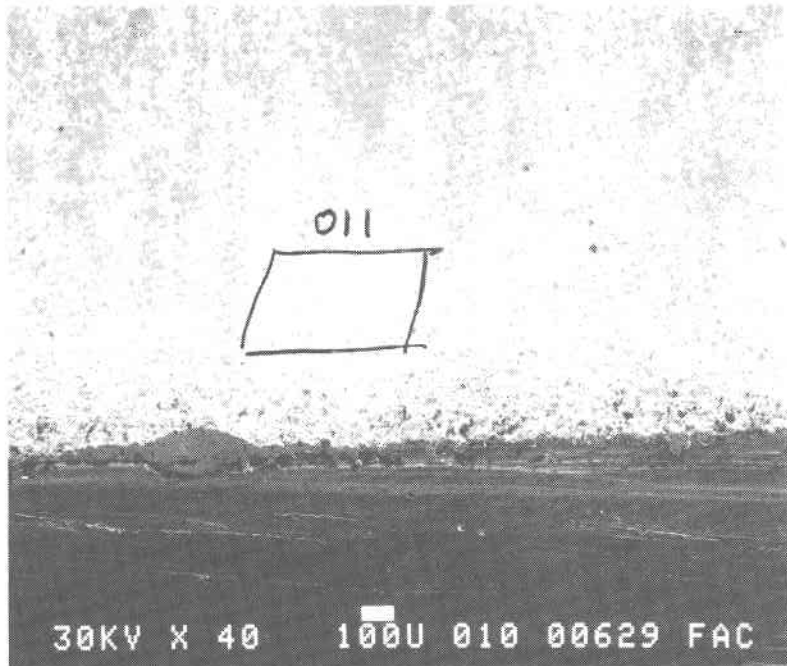
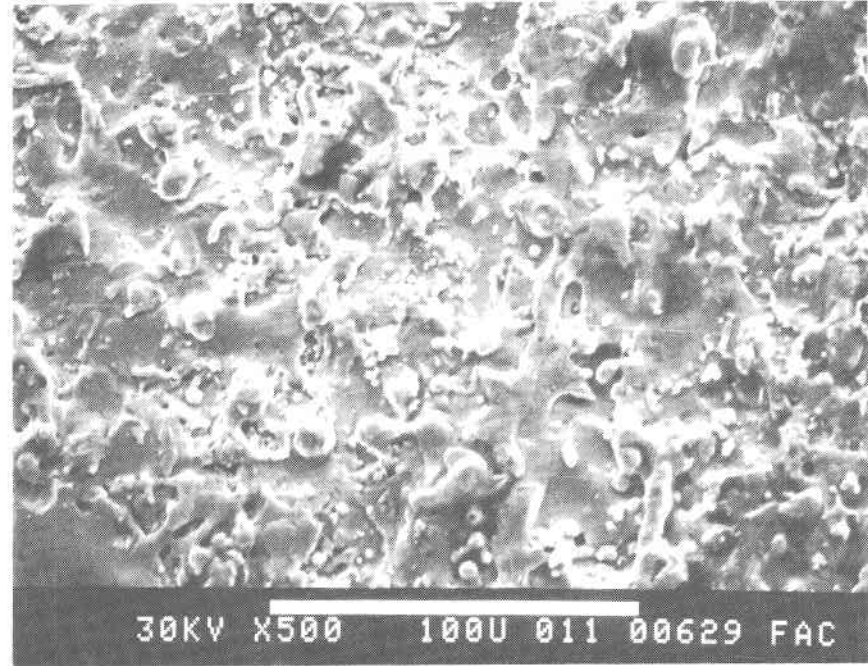
Figure 7-12. Trailing Edge Surface of a Waukesha Pad with Electrical Discharge Pitting

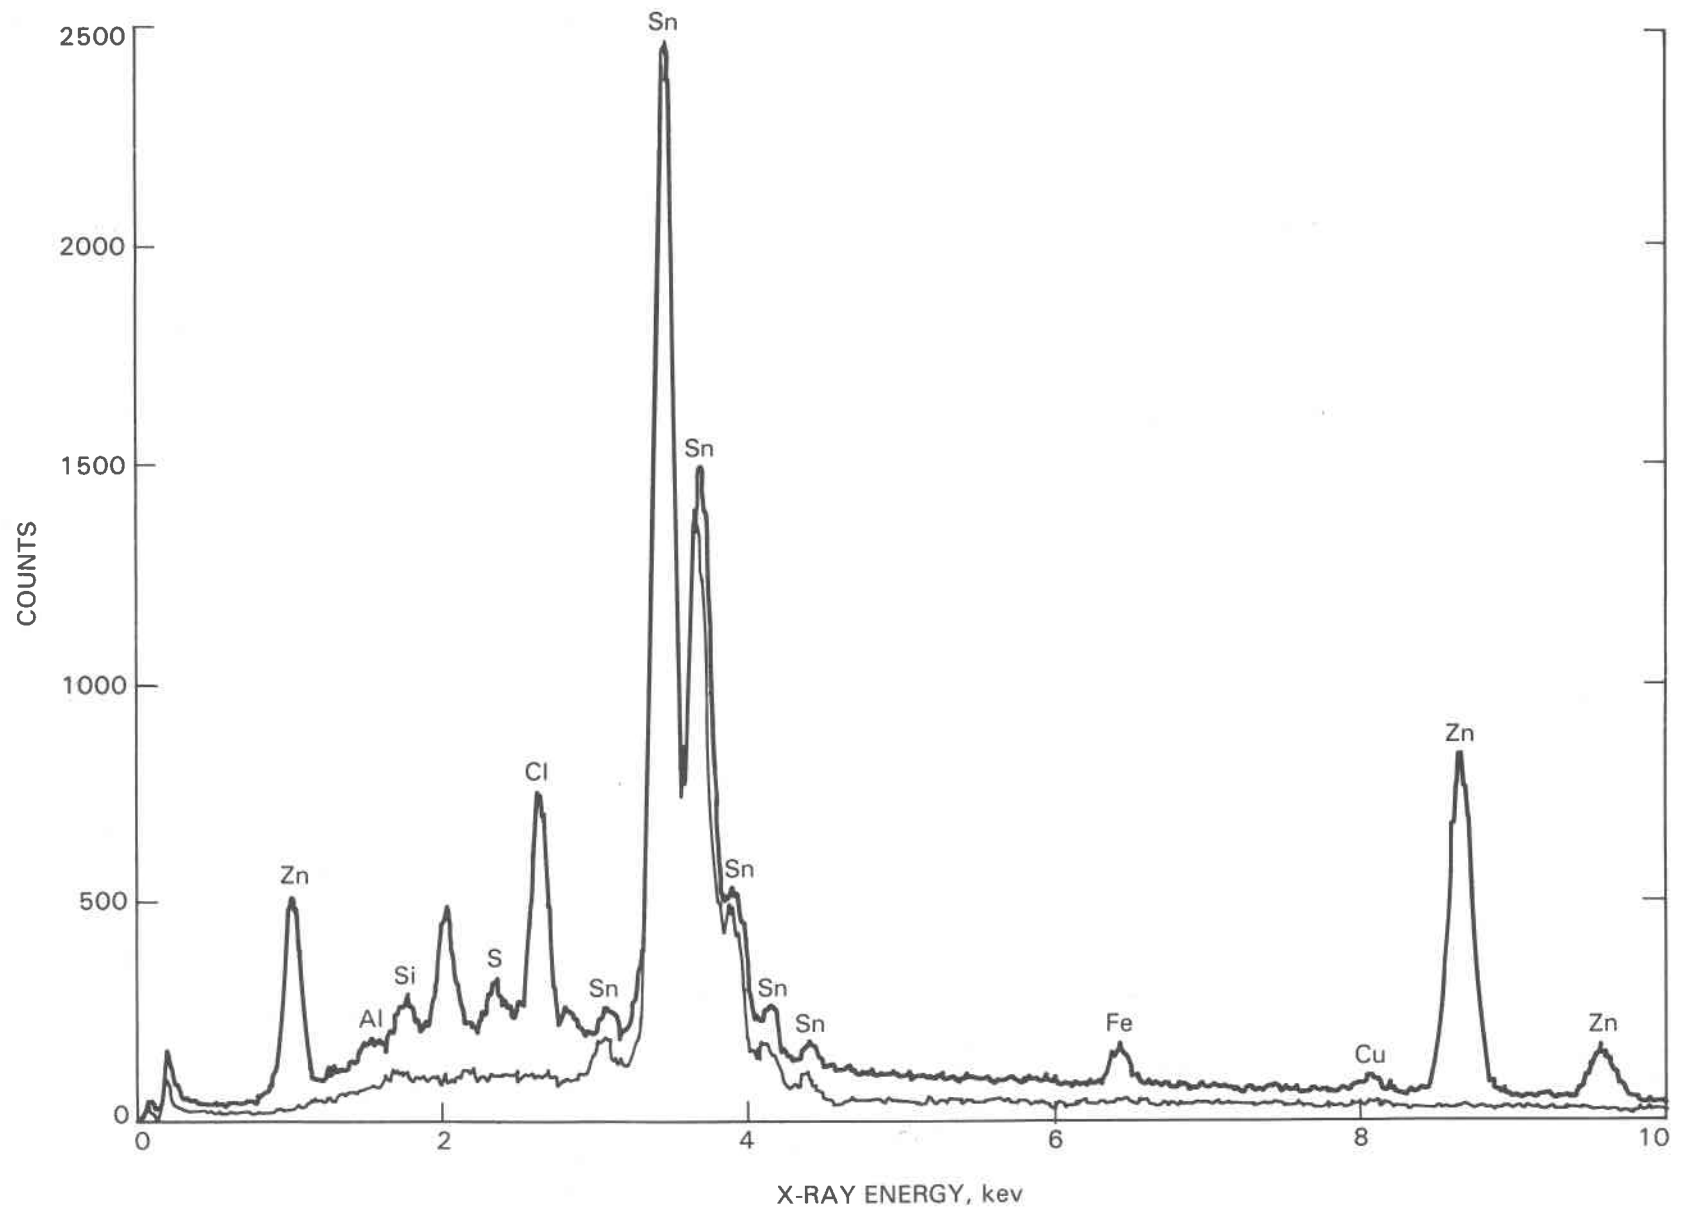
Determining the source and mechanism of transferring zinc to the bearing surface became the primary concern (a grounding strap was placed on the shaft turbine end center line prior to TAP build 2, and it remained intact for all PCS tests). Similarly, all test stand testing required an external drive shaft, which was grounded to the test stand. These two facts were the primary reasons for dismissing electrical discharge as a failure mechanism in earlier TAP builds. It also seemed apparent that the subsynchronous whirl and subsequent bearing wear may have destroyed most of the evidence of the frosted and pitted surface. The evidence was overwhelming, pointing to some form of electrical discharge as the mechanism of zinc transfer and the source of the material seemed to be the brass end seals. These seals maintained the lubricant around the bearings and operated in close proximity to the rotating shaft and the non-rotating bearings. Further analysis indicated that the grounded shaft would prevent electrostatic buildup and discharge but would not necessarily prevent electrodynamic discharges generated by the PMA. It was suspected that the PMA was generating and circulating stray current around a closed loop from the PMA stator to one set of bearings, to the shaft (or ground) to the other set of bearings, then back to the PMA stator.

Figure 7-14. Comparison of Pitted (upper line) and Unpitted (lower line) Surface X-ray Spectra from a Scanning Electron Microscope in Spot Mode. Note the Higher Zn and Cl Concentration in Pitted Surface

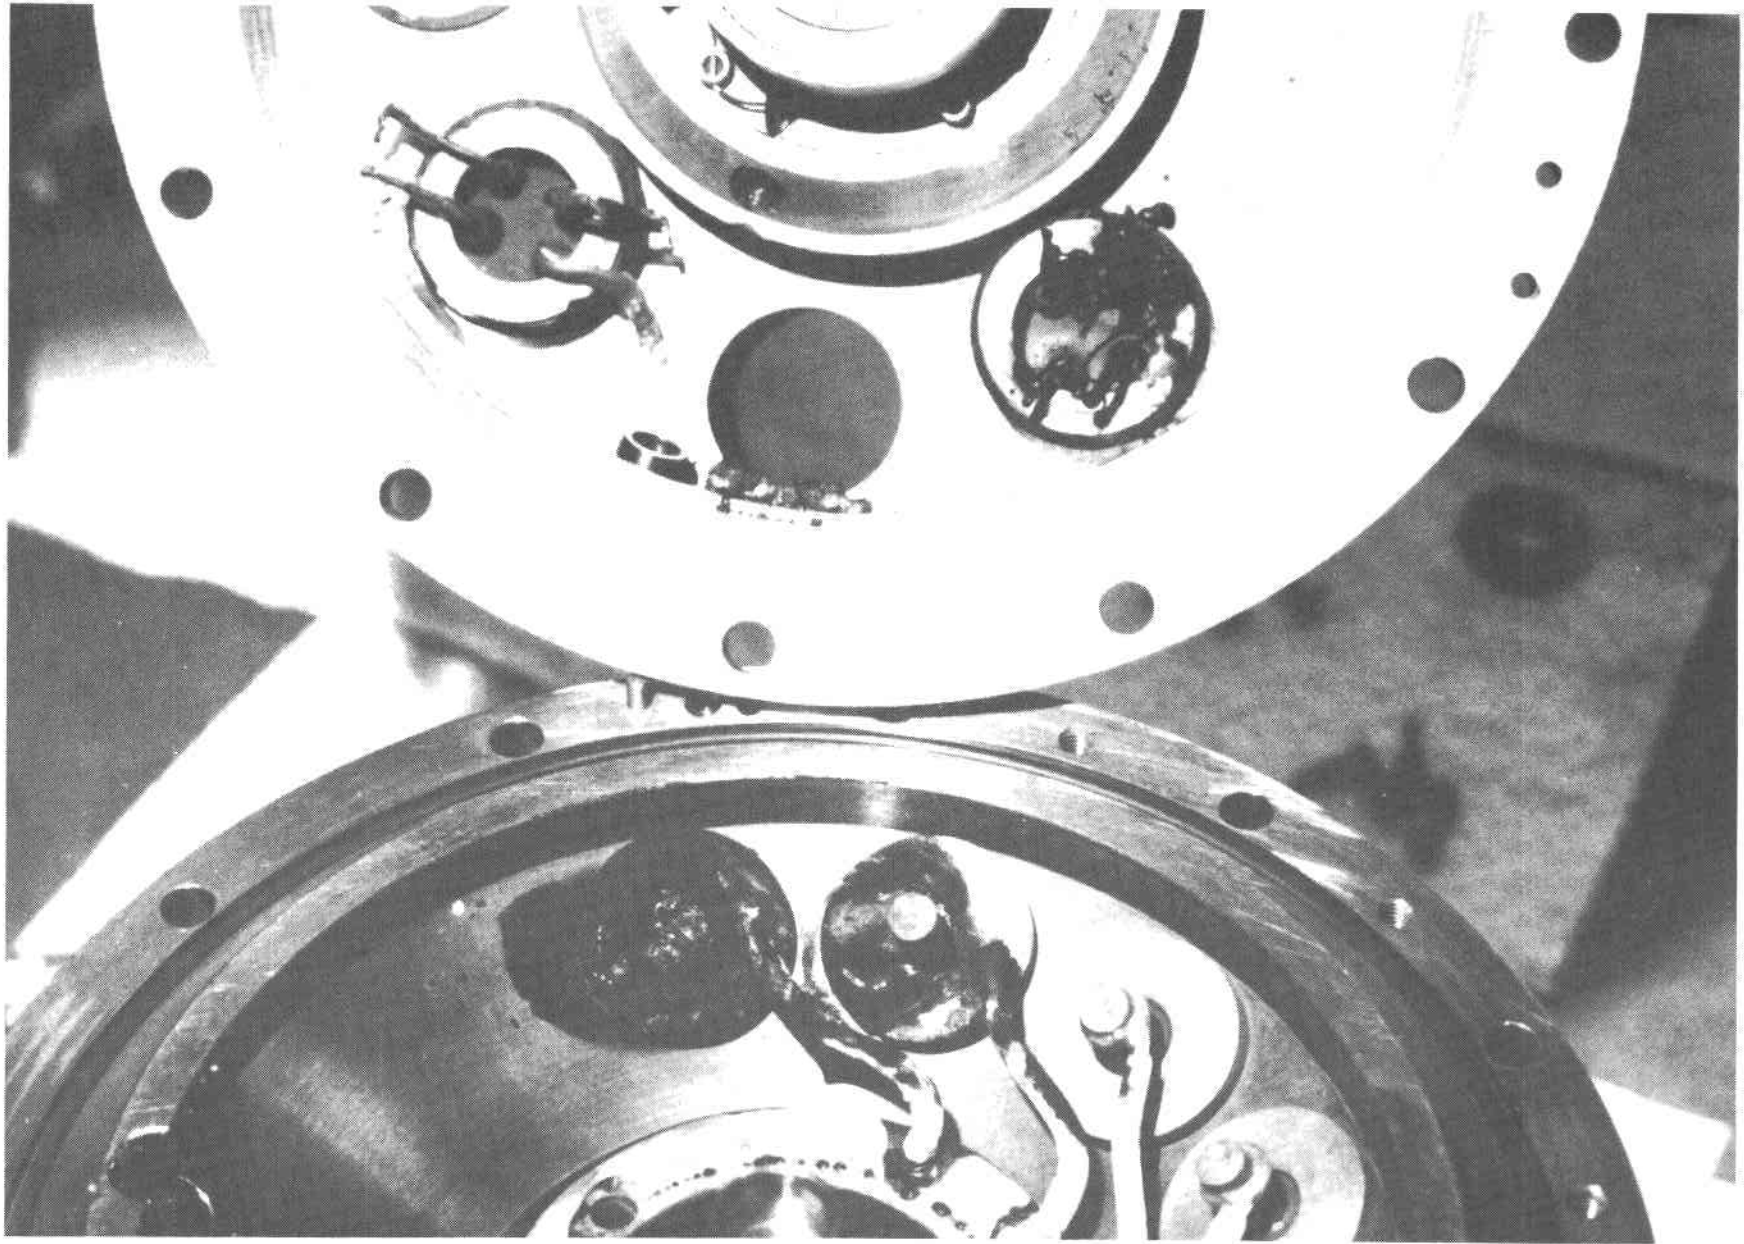
Figure 7-15. TAP Build 23 Electrical Feed-Through Failures of the Neutral and One of Three Phases from the Permanent Magnet Alternator

power phase may have dripped material onto the neutral, causing a simultaneous failure. Unfortunately, the failure damaged the bearings and invalidated the test to determine if and in what manner the magnetic rotor effected bearing wear.

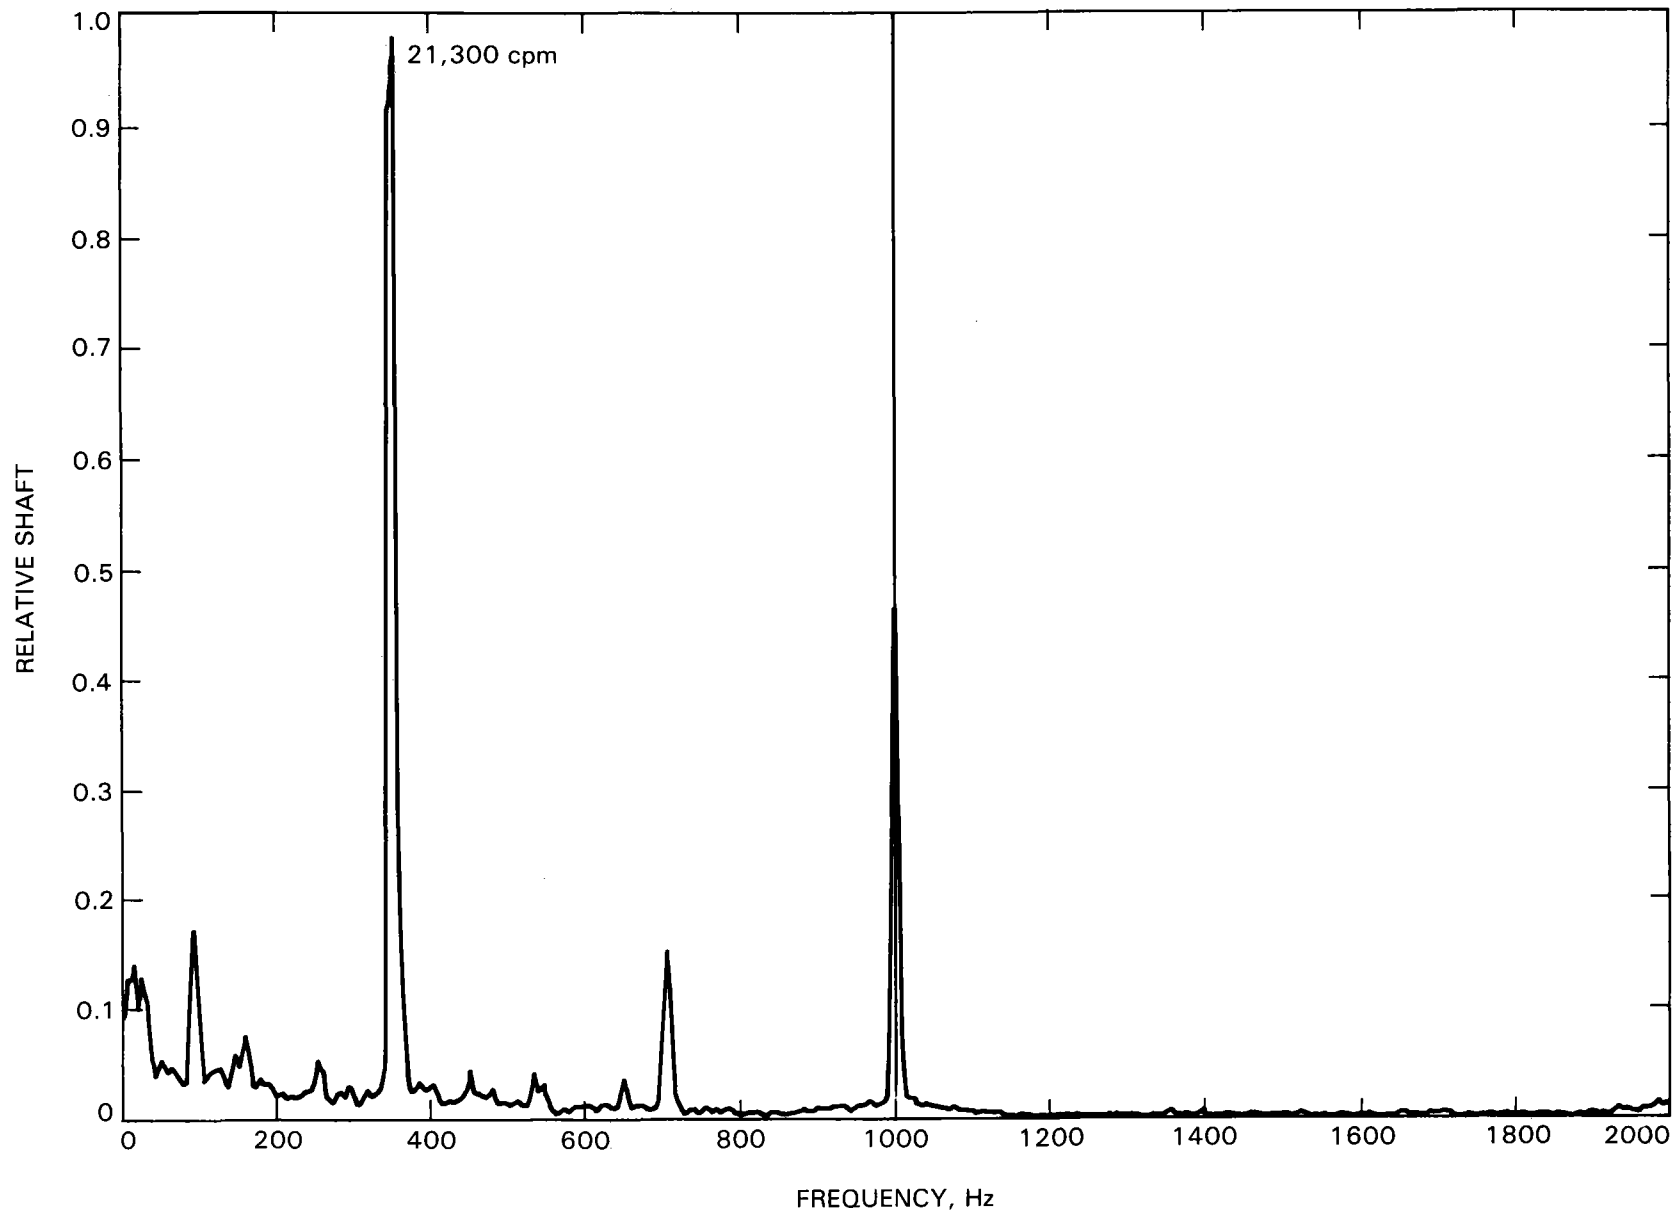
The rotor bearing problems experienced in this high-speed, toluene-lubricated bearing high-power density engine development program resulted from combined rotordynamic instability and electrical dynamic discharge across the bearing surfaces. The rotordynamic instability was observed to varying degrees in all TAP builds with the lubricant flowing down the center line of the shaft and discharging fluid radially out onto the bearing surfaces. This instability phenomenon is easily seen when shaft proximity probe amplitude versus frequency plots are compared for TAP build 14 (Figure 9-1) and TAP builds 38 and 39 (see Figures 8-1 and 8-2). All three of these figures are on directly comparable amplitude scales, and the largest peak in Figure 9-1 represents a rotordynamic instability. Fully externally lubricated five-pad tilting-pad journal bearings, a Rayleigh step turbine end, and a Fogg flat pad pump end thrust bearing were included in the final design. The effects of the electrical discharge across the bearing surfaces are readily observable even after the rotordynamic instability was corrected (see Figures 7-11 and 7-12). The solution to the electrical discharge problem was to mount all bearings onto an electrically insulated bearing carrier. This design interrupted the electrodynamic circuit through the PMA stator, bearings, and shaft and forced all stray currents to flow through their respective grounding straps.

Figure 9-1. Typical Shaft Displacement Spectrum of Barber-Nichols Three-Pad Bearings, December 1982 (Turbine End "Y" Probe, TAP Build 14)
