## Heliostat Mirror Survey and Analysis

September 1979

Prepared for  
Sandia Laboratories, Livermore, CA  
under Related Services Agreement 300A01308  
and the U.S. Department of Energy  
under Contract EY-76-C-06-1830

This report is the result of comprehensive surveys and technical analyses performed for Sandia Laboratories in support of the U.S. Department of Energy Solar Thermal Large Power Systems authorized under Sandia Livermore integrated order 92-8165. The purpose of this work is to provide background information and procurement specifications for materials and processes which have potential applications in heliostat construction. This report covers the work performed under three tasks: the mirror industry survey, mirror degradation analysis, and advanced concepts for mirror protection.

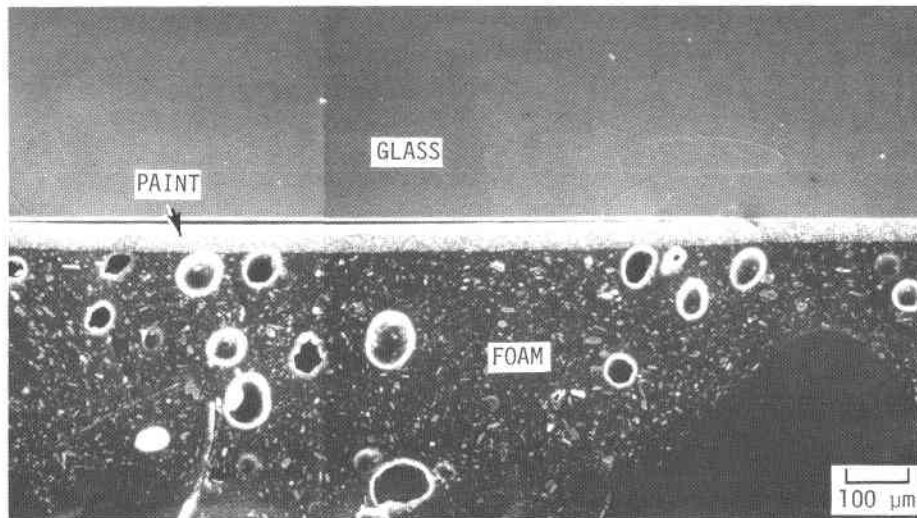
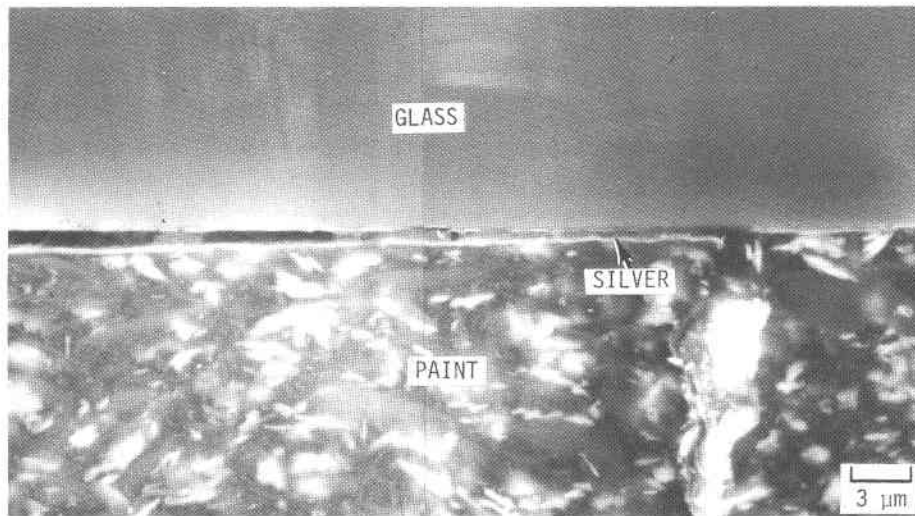
FIGURE 2.19. Separation of Silver from Glass in an Undeformed Area of the Sandia Mirror. Even in some nondegraded areas the silver is partially debonded from the glass, with separations of up to 10 μm.

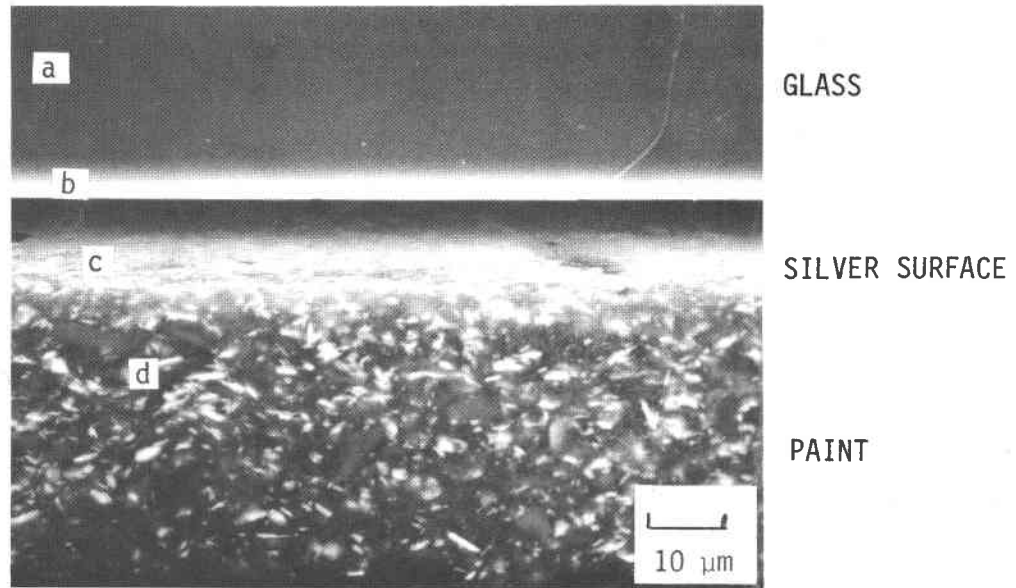
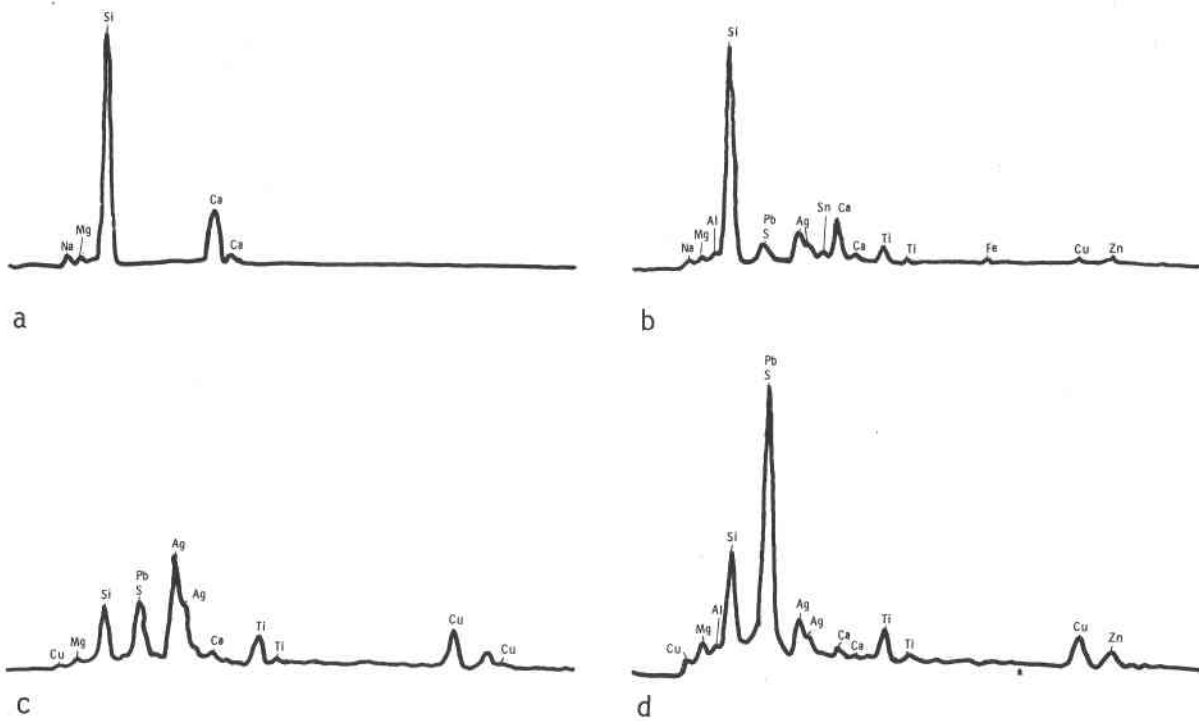
FIGURE 2.20. Looking Down into Opening Between Glass and Silver. The exposed silver surface looks relatively smooth, suggesting that the initial bond to the opposing glass surface was very weak. The composition as a function of position is indicated below.

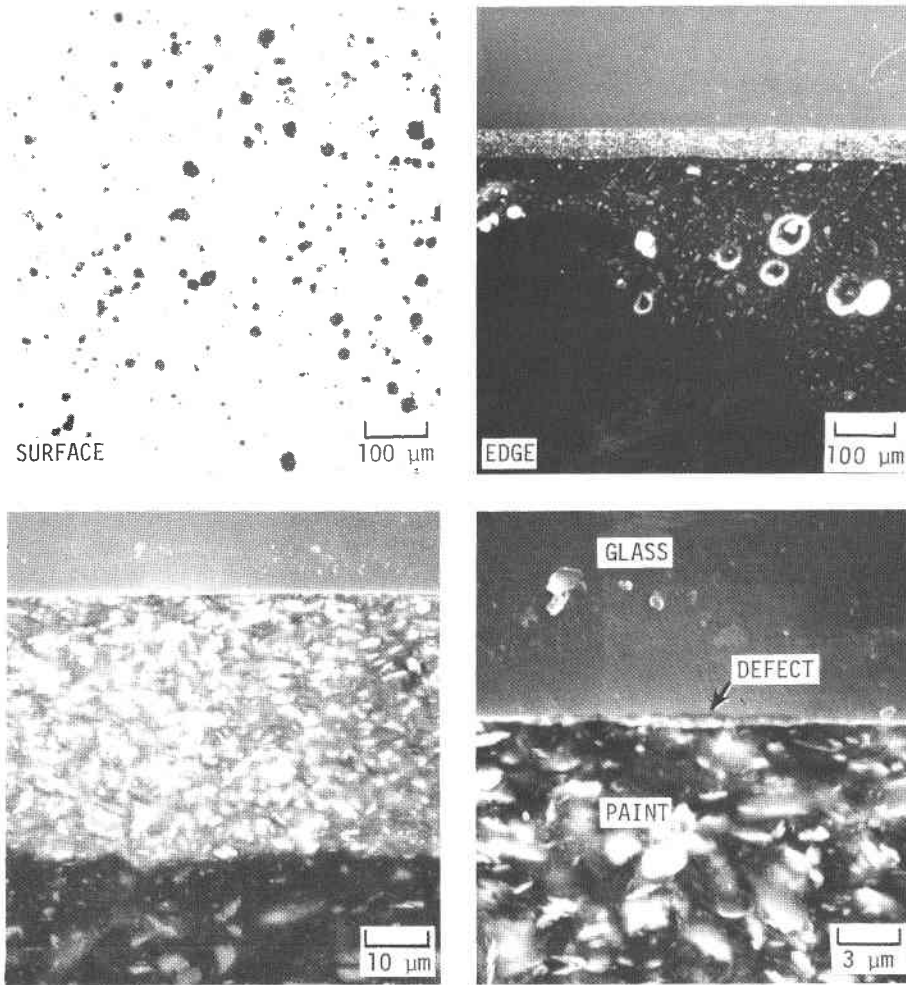
FIGURE 2.21. Fine-Spot Degradation on Sandia Mirror. This mode of degradation occurs to some extent over the entire specimen of field-tested mirror, and is very abundant in the vicinity of the large defects.

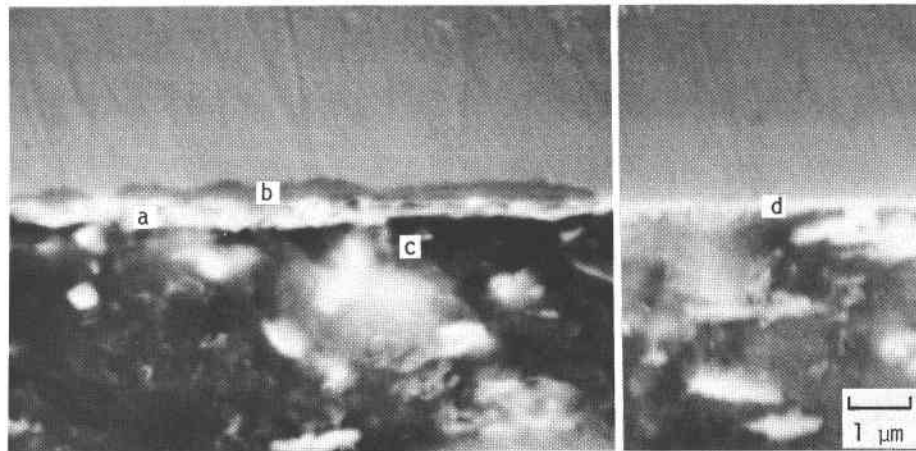
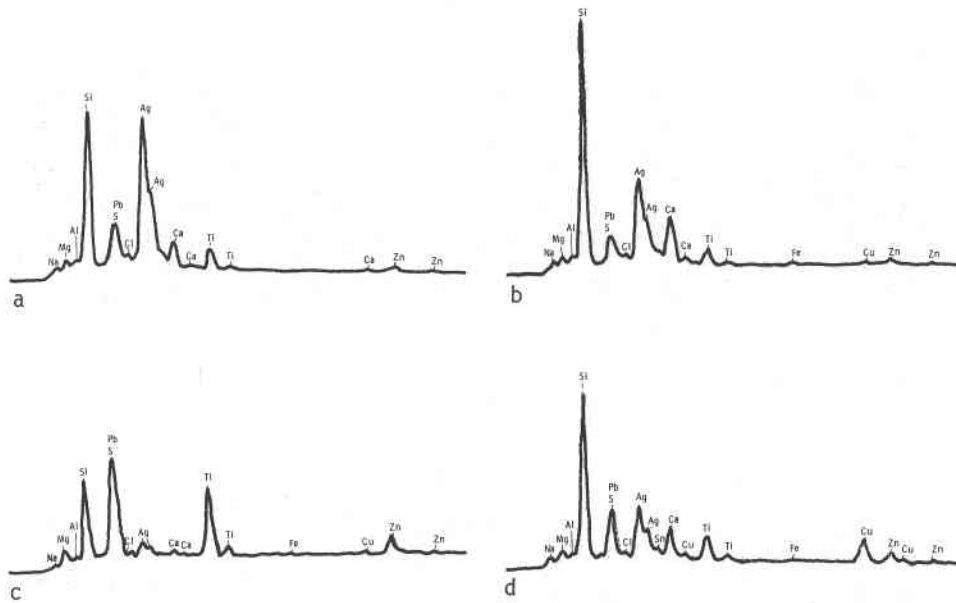
FIGURE 2.22. Edge View Details of Fine Spot Degradation. In the defect areas the silver layer is thickened. The attack zone appears to penetrate into the glass surface about 2000 Å. Copper is essentially absent in the spot region, although it occurs in its normal proportion in the nondefect areas immediately adjacent.

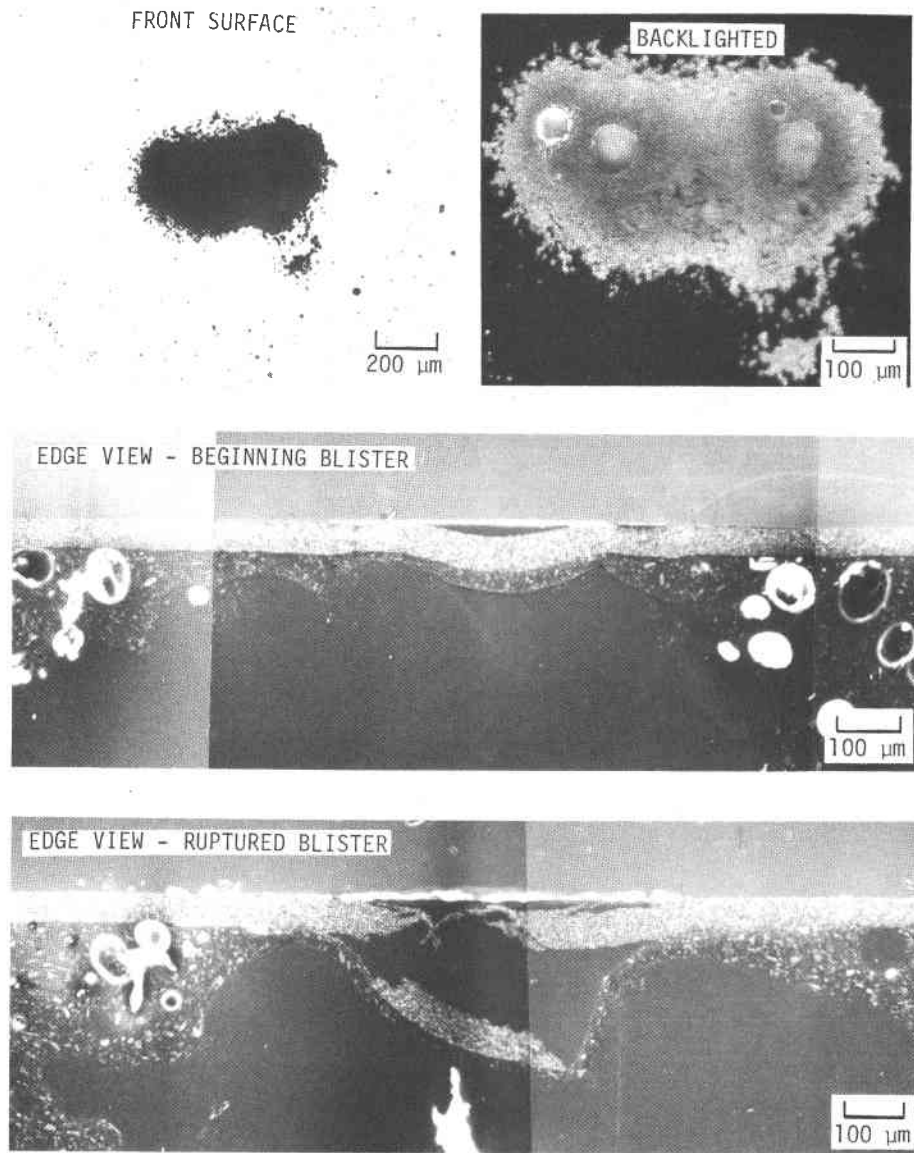
FIGURE 2.23. Typical Large Spot Degradation. The large spots are always surrounded by fine spots and contain one or two nucleation centers. The paint backing blisters over the large spot, and eventually ruptures as degradation progresses.

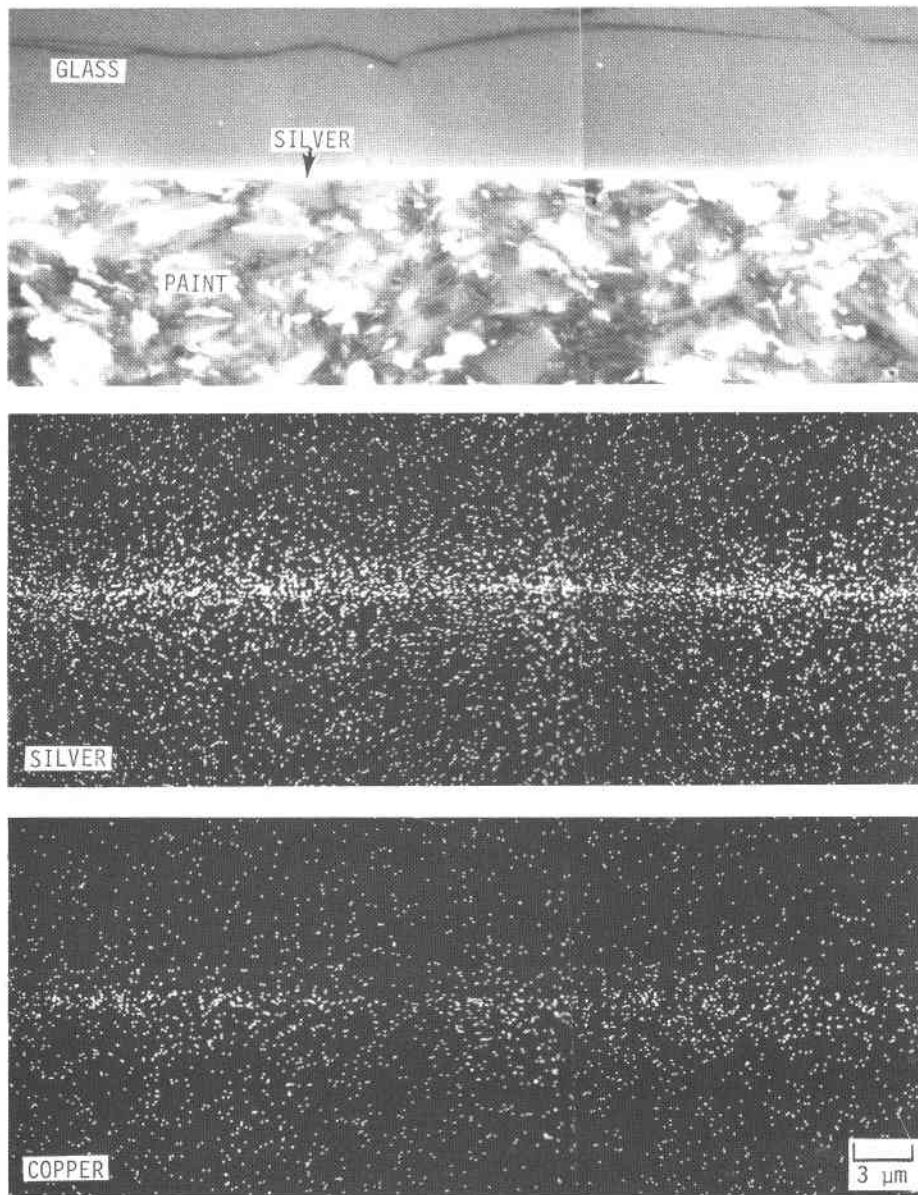
FIGURE 2.24. X-Ray Fluorescence Maps of Edge View of Glass/Silver/Copper Bond. In nondefect areas immediately adjacent to a large spot, the glass/metal bond is tight and intact.

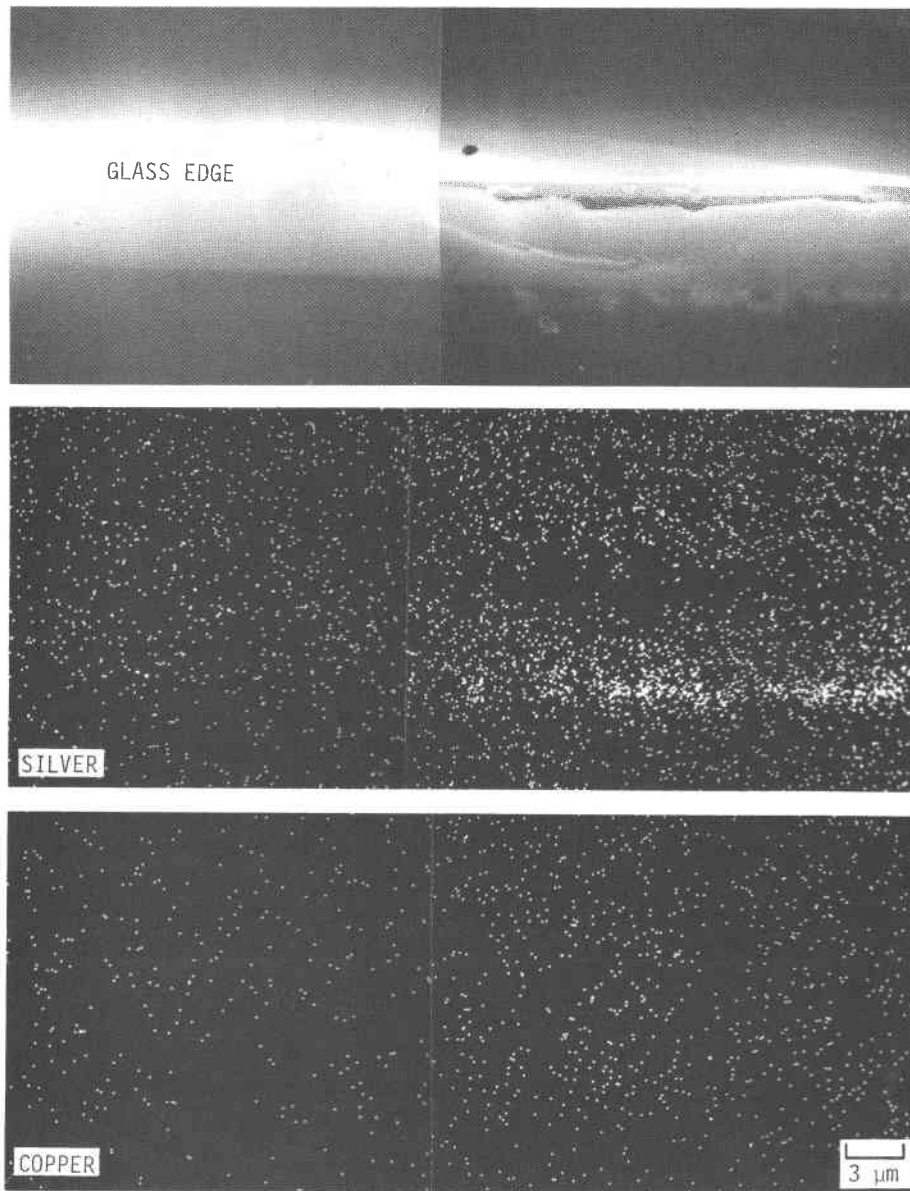
FIGURE 2.25. X-Ray Fluorescence Maps of Edge View of Large Defect Spot. At the center of large degradation spots both silver and copper are absent, although a little silver shows around the edges. The adjacent glass appears corroded and embrittled.

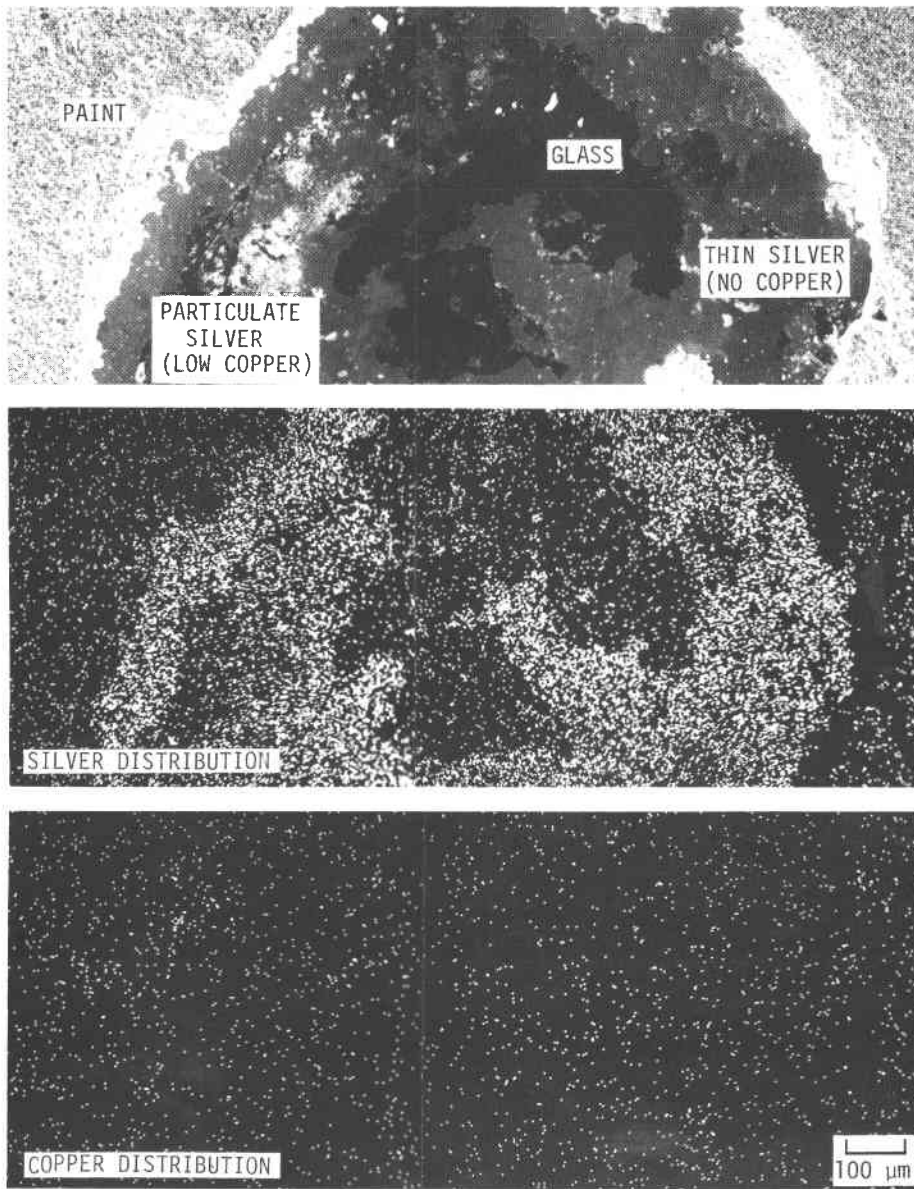
FIGURE 2.26. Details of Paint-Side View of Large Defect Spot. The center is bare glass surrounded by a fine silver layer and clusters of large silver particles. Copper is entirely absent across the full spot diameter.

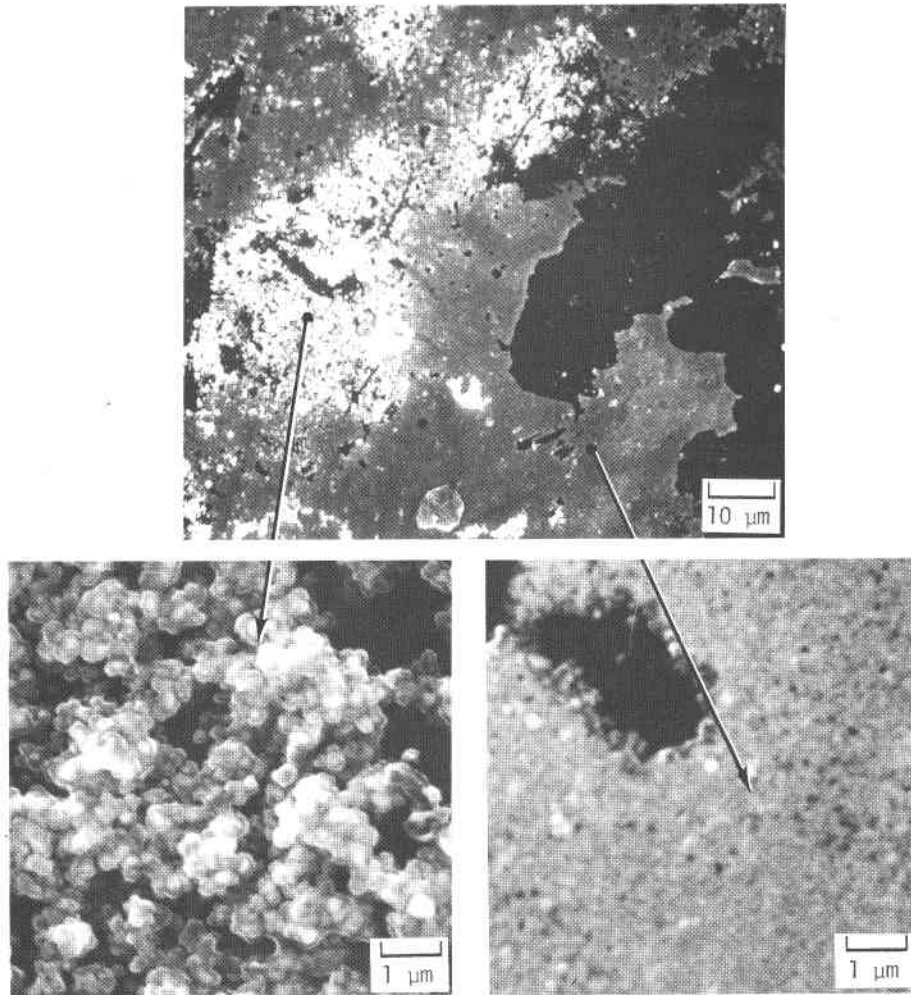
FIGURE 2.27. Microstructure of the Silver Layer at Large Mirror Defects. In the circumferential areas of large defect zones some of the silver has been converted to much larger agglomerated particles. The resulting form is similar to that which might result from heating and partial sintering of the original silver layer.

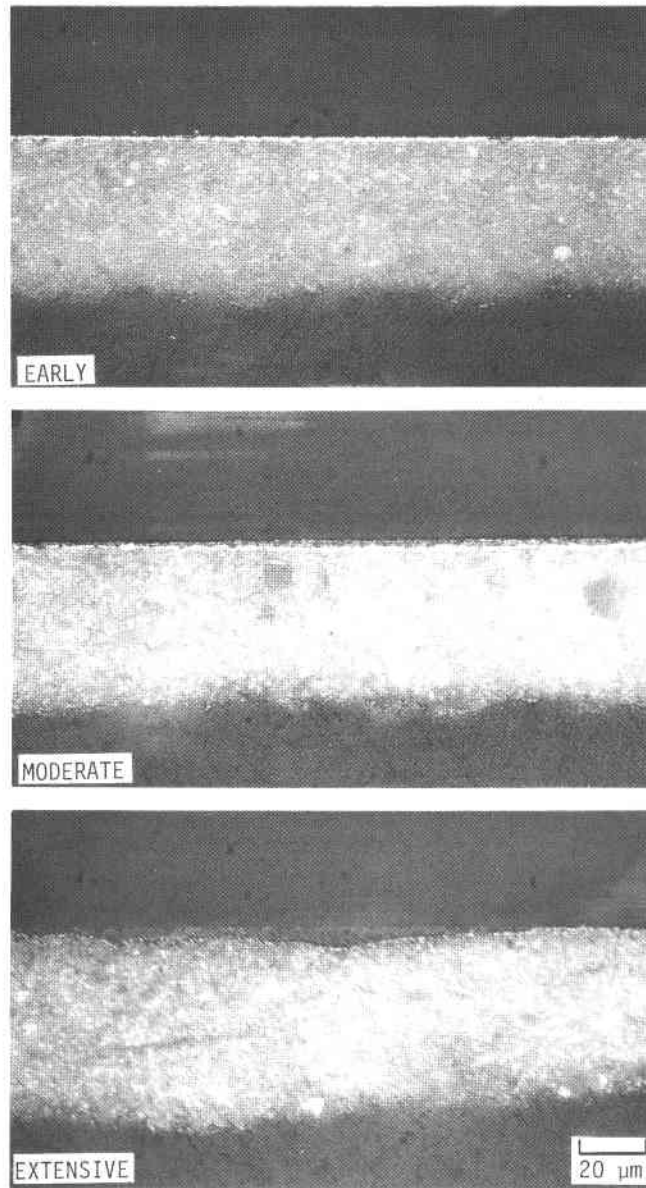
FIGURE 2.29. Failure of Glass/Silver Bond with Progressive Degradation. The silver layer broadens and disintegrates as the glass-silver interface gap widens with continuing degradation.

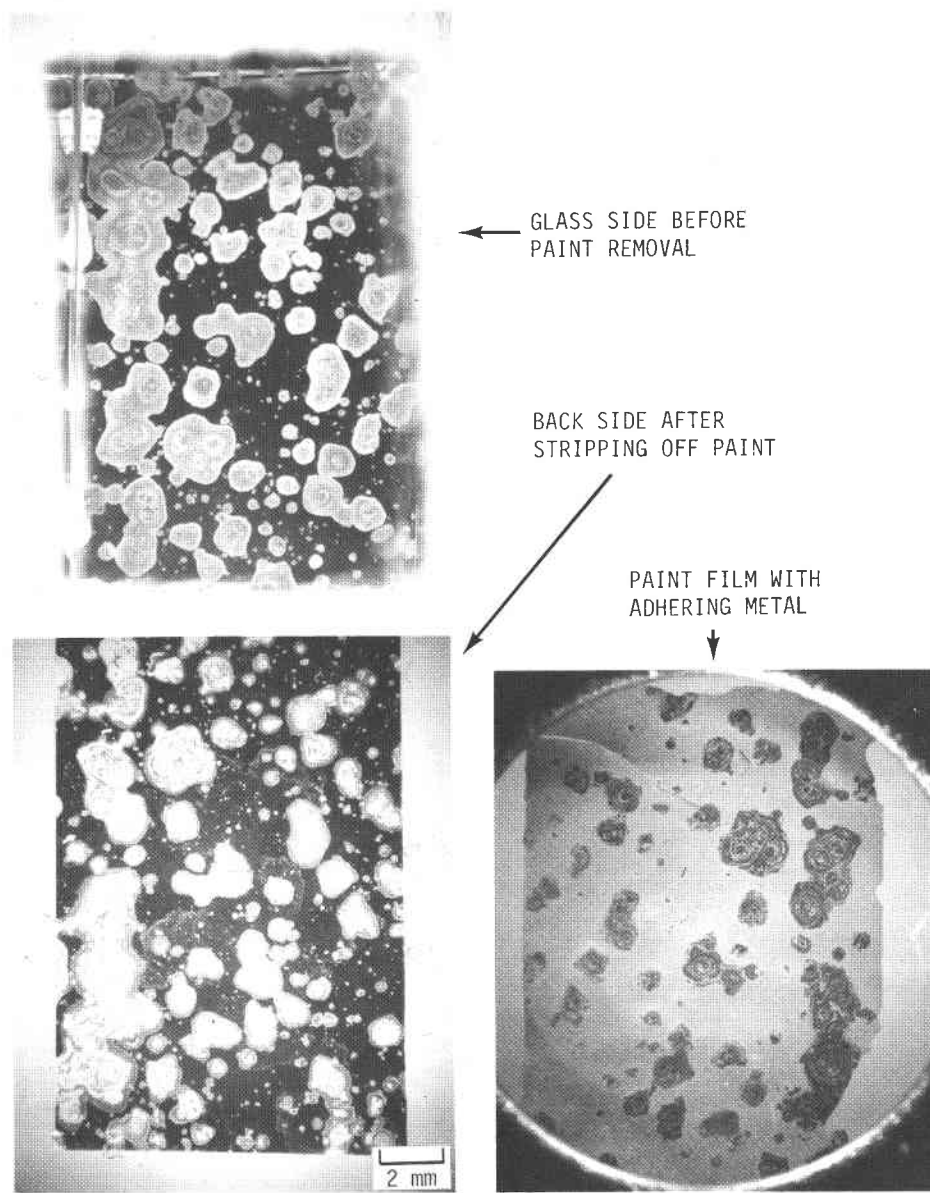
FIGURE 2.30. Features of an Extensively Degraded Aged Mirror. As seen through the glass, the degradation consists of individual and adjoining spots each composed of concentric rings surrounding a central dark nucleus. After stripping the glass retains some of the spot rings, but the nuclei and alternate rings remain firmly attached to the paint.

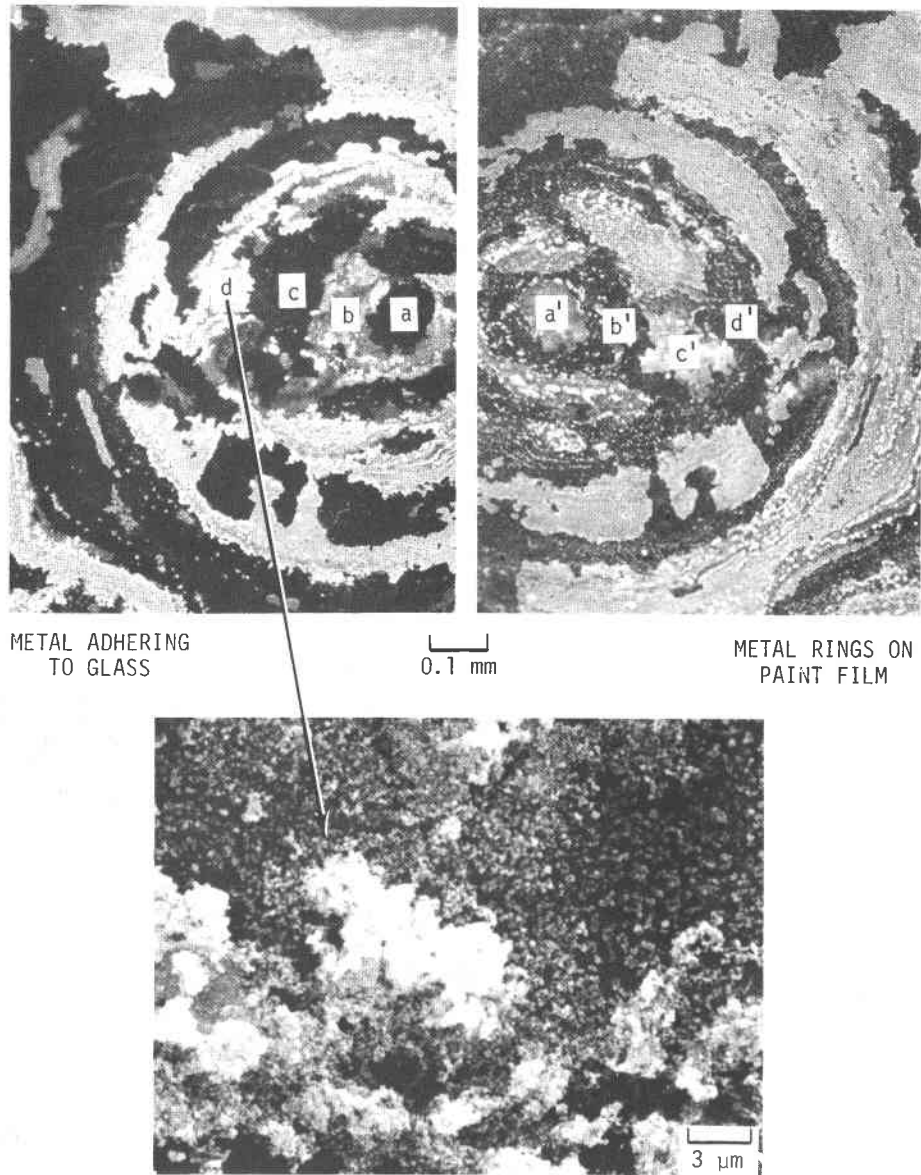
FIGURE 2.31. Details of Ring Structure of Old Mirror Degradation. The center core in this large defect spot is silver chloride. The black rings on the glass have been completely stripped; the corresponding (light) rings on the paint are primarily silver chloride (see Figure 2.32).

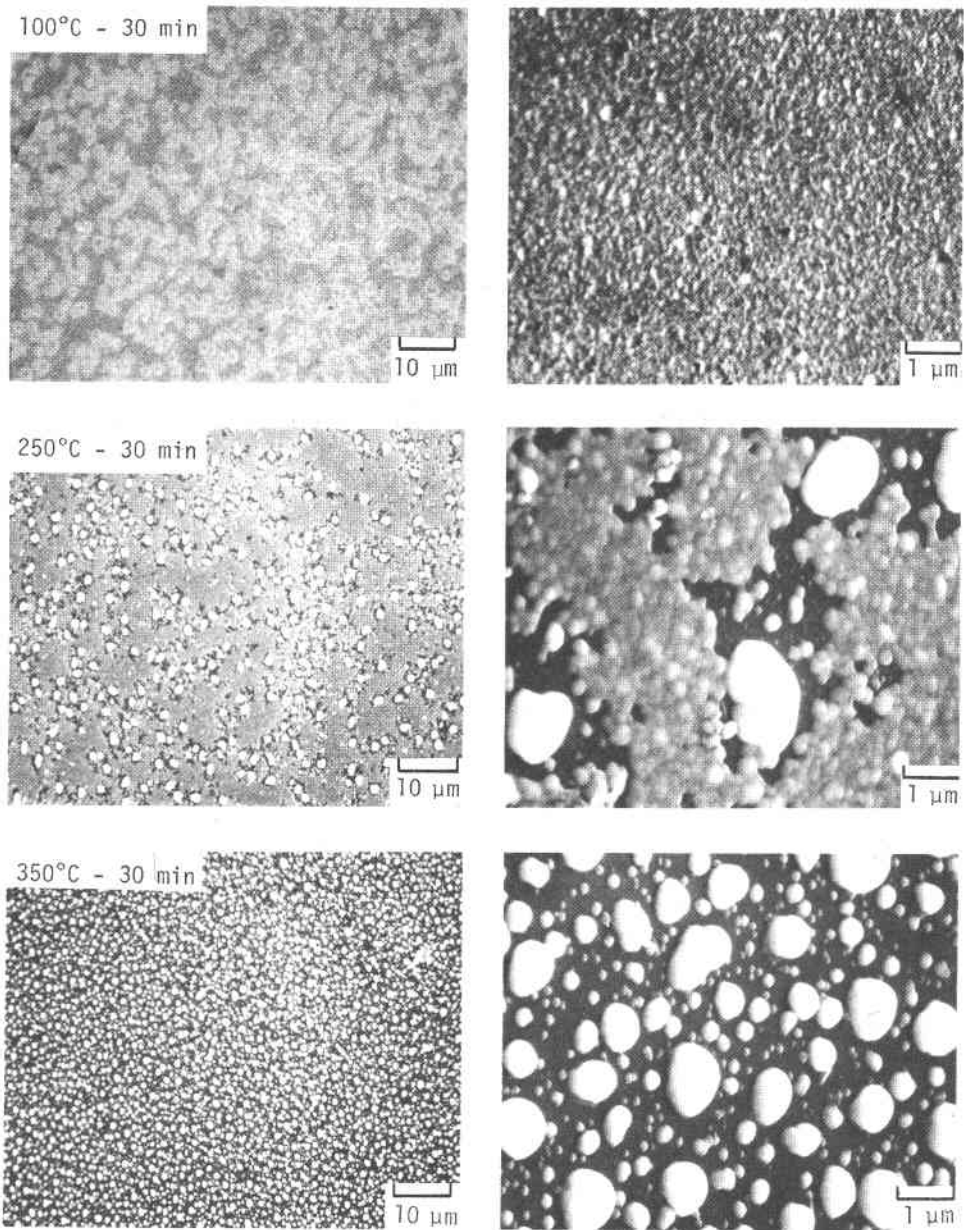
FIGURE 2.34. Silver Agglomeration. The effects of heating the silver layer in dry air for 30 minutes at 100°C, 250°C and 350°C are shown in the SEM photographs.

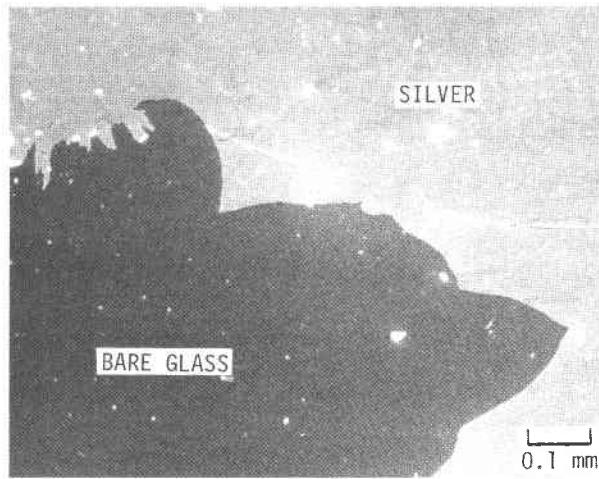
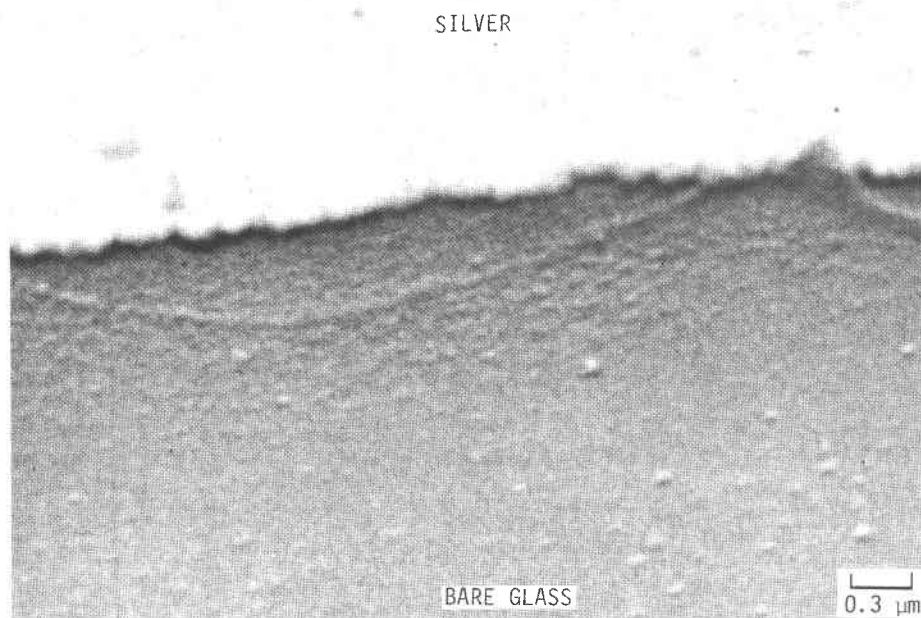
FIGURE 2.35. Mirror Degradation in Hot Water. The silver layer on a commercial mirror gradually peels away as it is heated in water at 100°C. Silver nodules initially about 700 Å in diameter and spaced about 1000 Å apart gradually disappear after continued exposure.

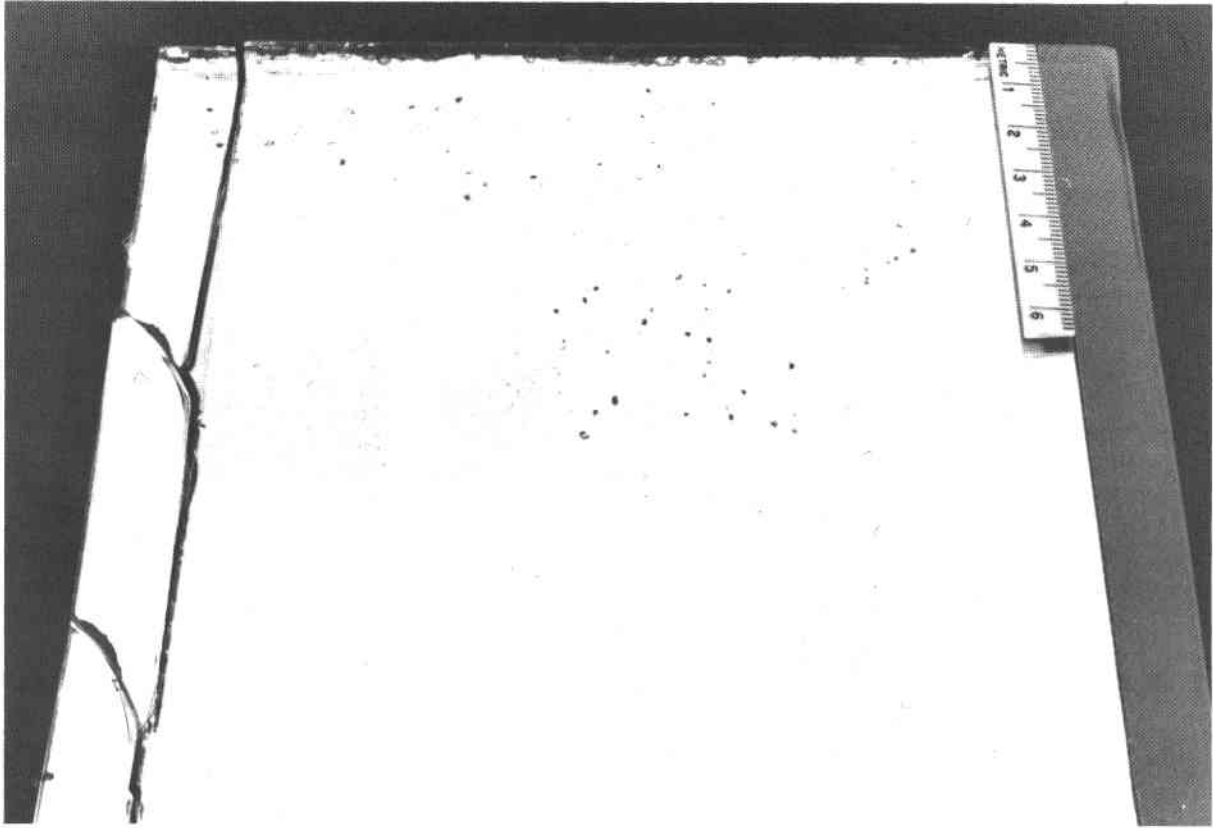
FIGURE 2.36a. Front (Glass) Side of the Degraded Sandia Heliostat Mirror. Samples on the left hand side were cut for analysis from both corroded and uncorroded sections of the mirror.

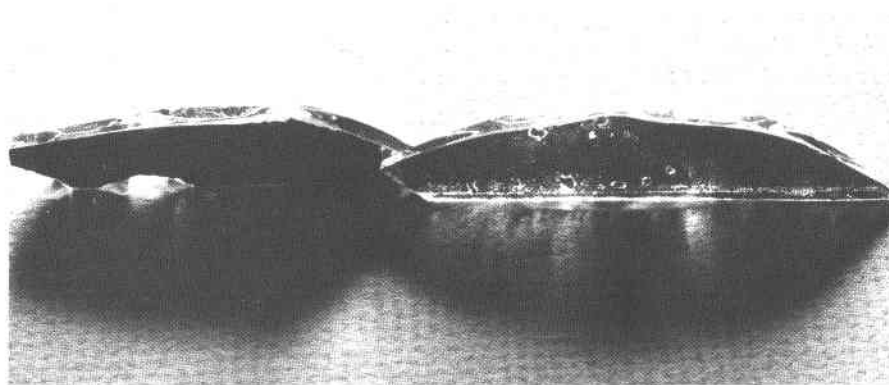
FIGURE 2.36c. Two Sections With Backing Paint Stripped Using  
P-Xylene. The sample on the left shows little  
degradation, while the sample on the right  
exhibits extensive corrosion.

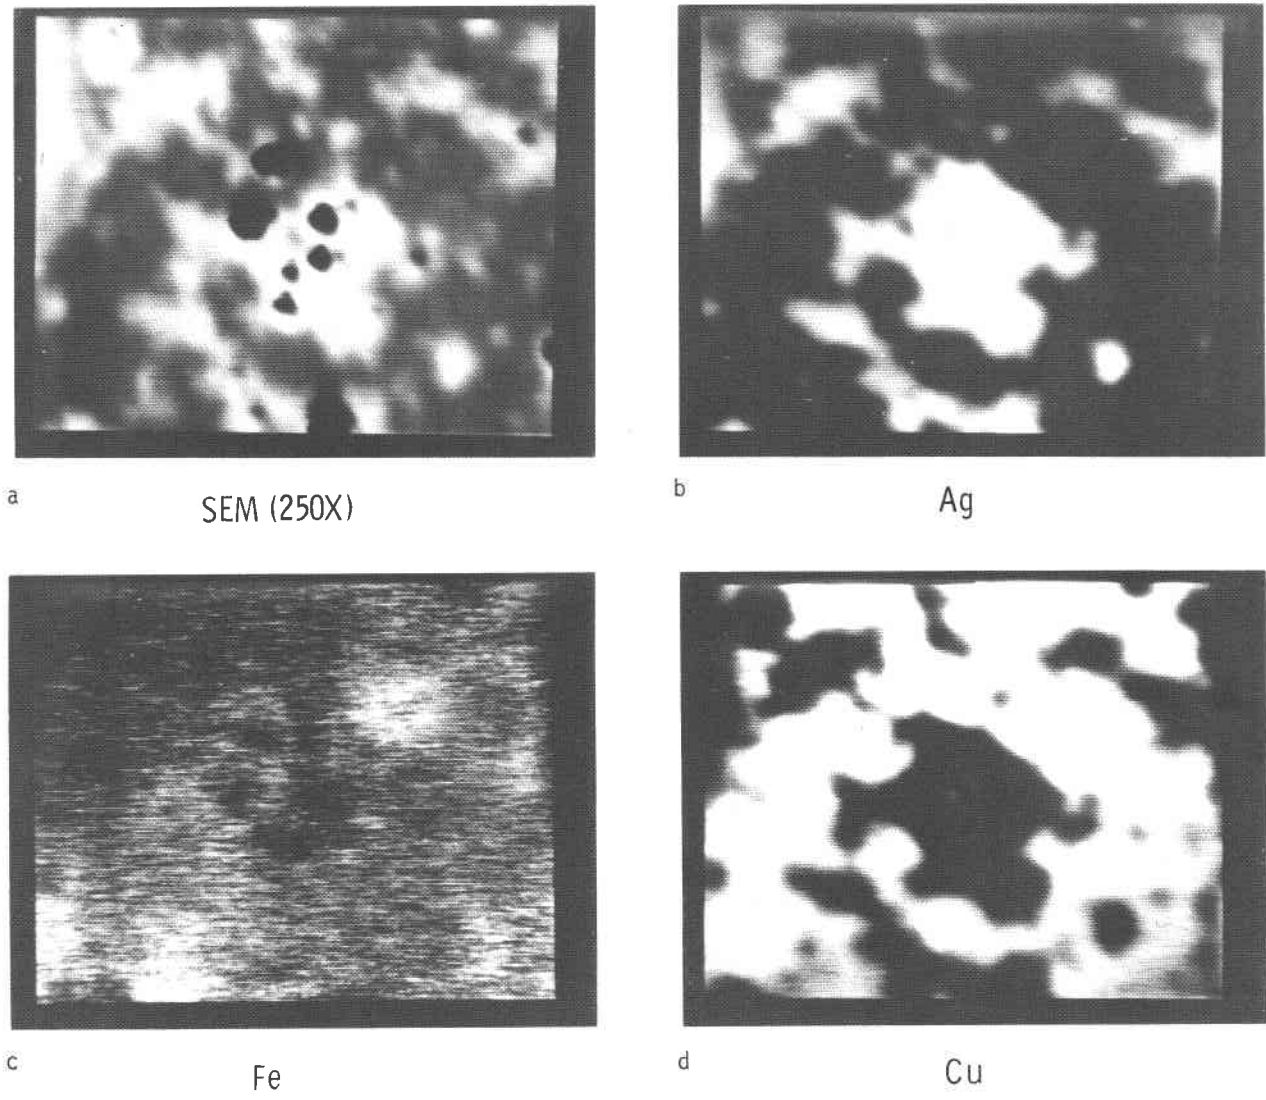
FIGURE 2.37. SEM and Scanning Auger Micrographs of a Degraded Section of the Sandia Mirror Showing the Inverse Relationship Between Copper and Silver

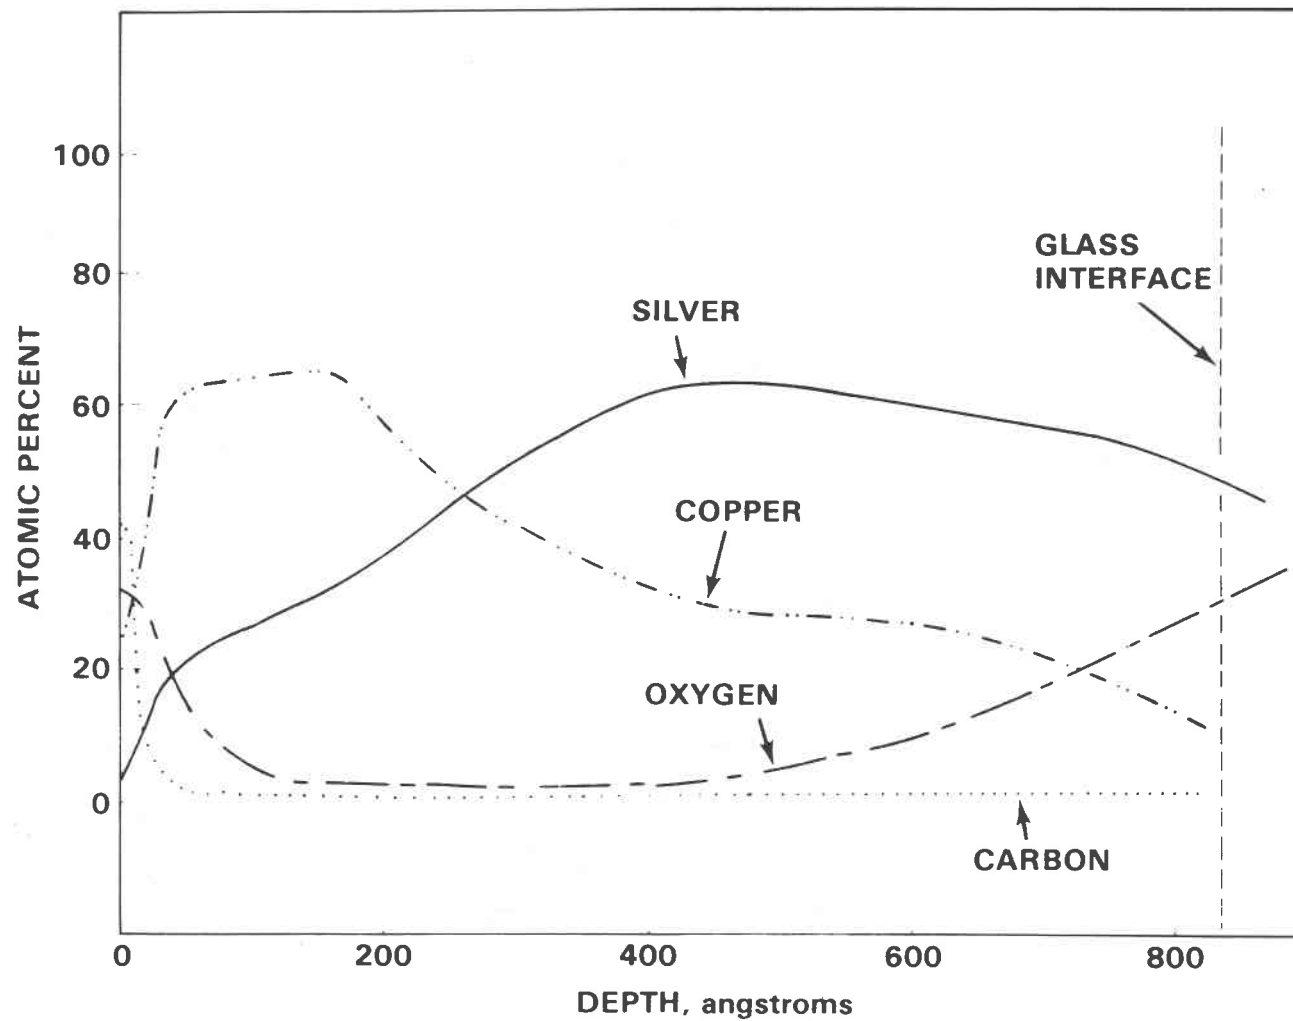
**FIGURE 2.39.** Auger Depth Profile of a Section of the Sandia Mirror Having Numerous Corrosion Pits. The total amount of copper is considerably less than that found in uncorroded areas.

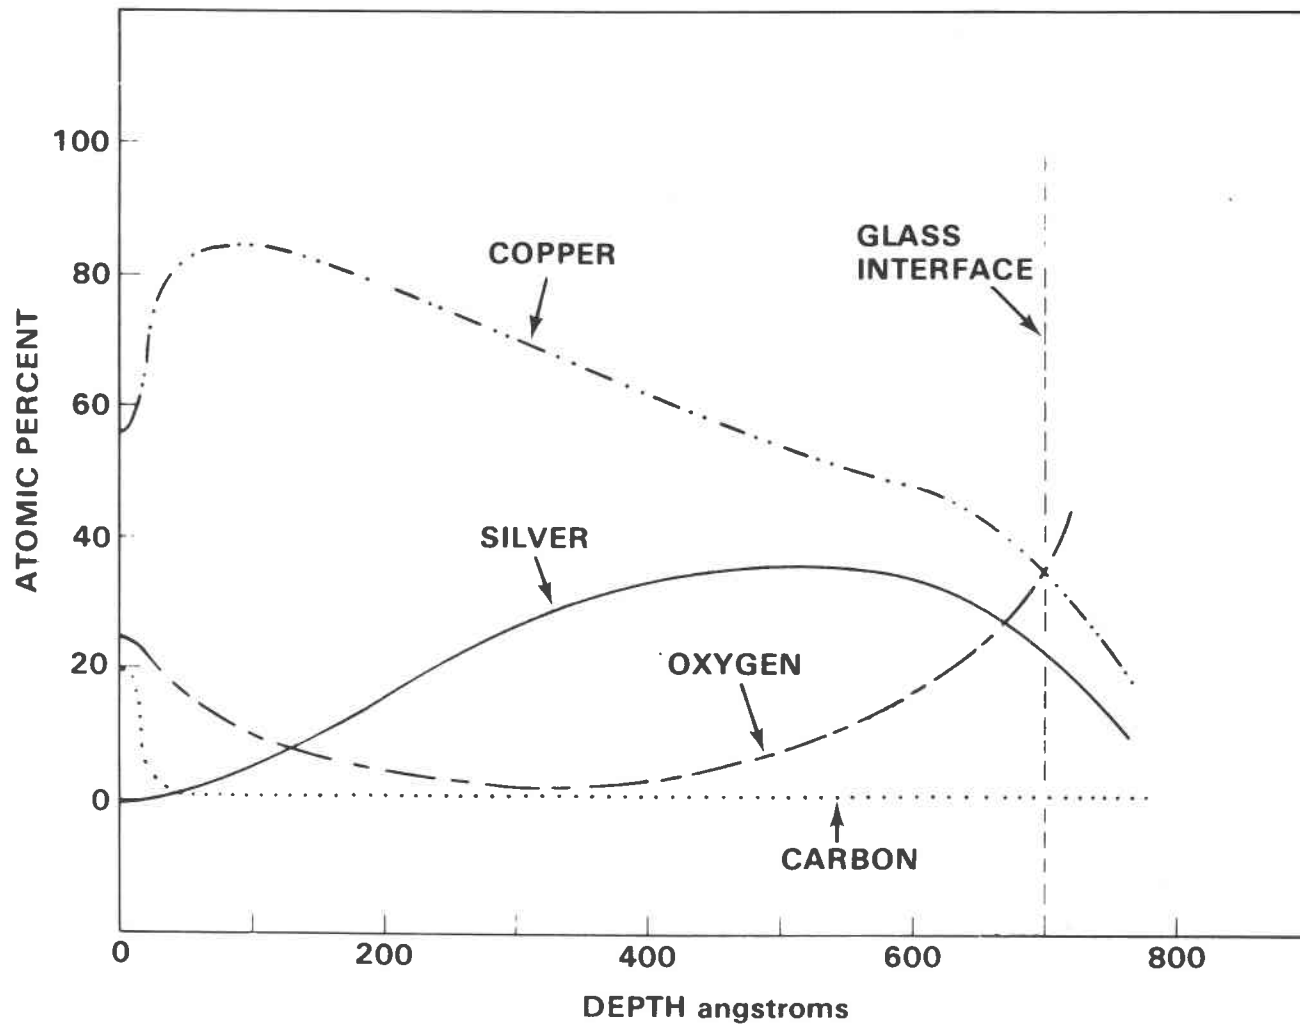
FIGURE 2.40. Auger Depth Profile of a Section of the Sandia Mirror Showing More Extensive Degradation. The total amount of silver is considerably less than observed in uncorroded regions.

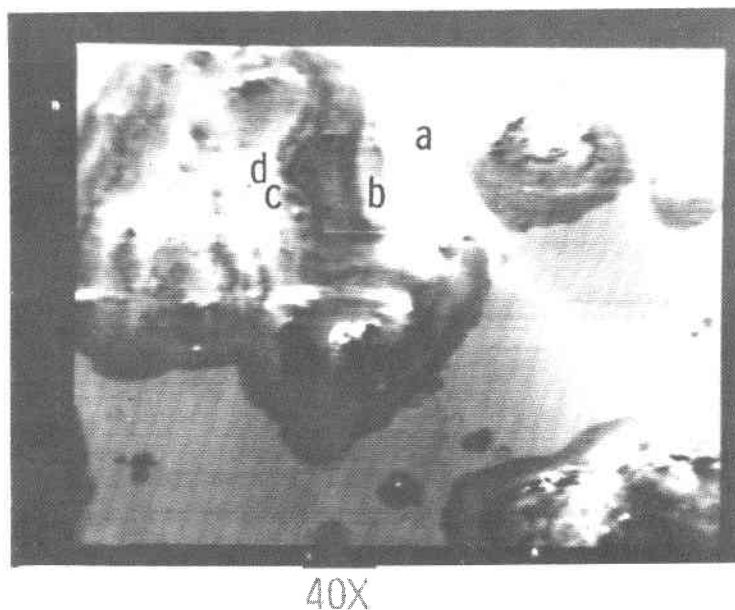
FIGURE 2.41. SEM Micrograph of a Degraded Section of the Sandia Mirror in Which the Paint Backing was Mechanically Removed
