## Heliostat Mirror Survey and Analysis

September 1979

Prepared for  
Sandia Laboratories, Livermore, CA  
under Related Services Agreement 300A01308  
and the U.S. Department of Energy  
under Contract EY-76-C-06-1830

This report is the result of comprehensive surveys and technical analyses performed for Sandia Laboratories in support of the U.S. Department of Energy Solar Thermal Large Power Systems authorized under Sandia Livermore integrated order 92-8165. The purpose of this work is to provide background information and procurement specifications for materials and processes which have potential applications in heliostat construction. This report covers the work performed under three tasks: the mirror industry survey, mirror degradation analysis, and advanced concepts for mirror protection.

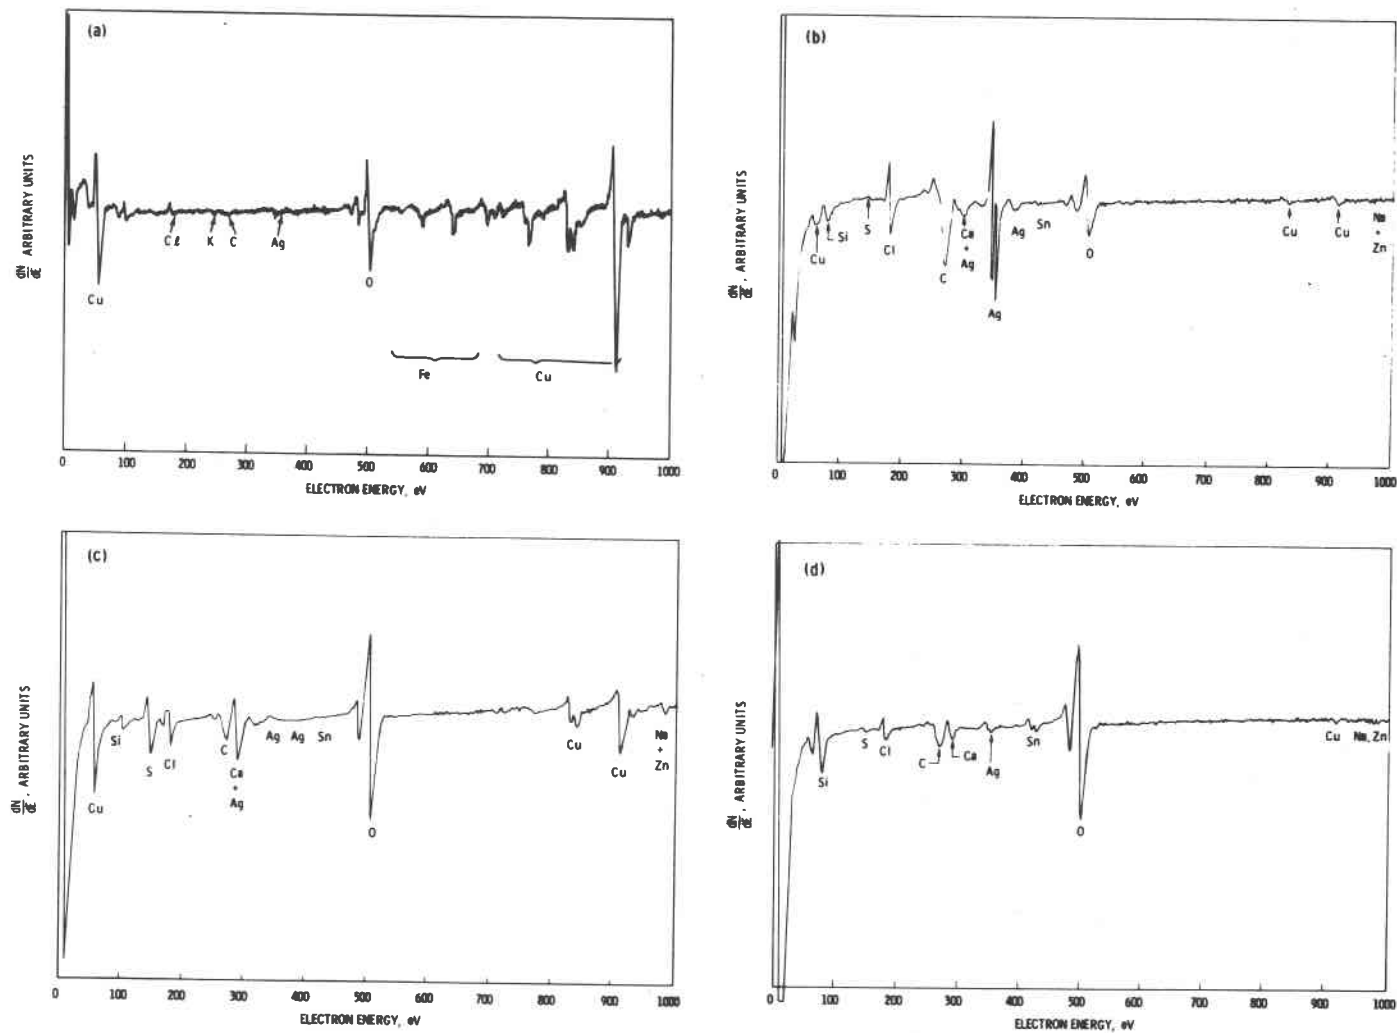
**FIGURE 2.42.** Auger Point Scans Taken at Positions a-d of Figure 2.41. The spectra range from that of copper oxide outside of the corrosion spot (position "a") to that typical of a weathered soda-lime-silicate glass in the center of the corrosion spot (position "d"). Note the relatively strong tin signal in spectra "d"

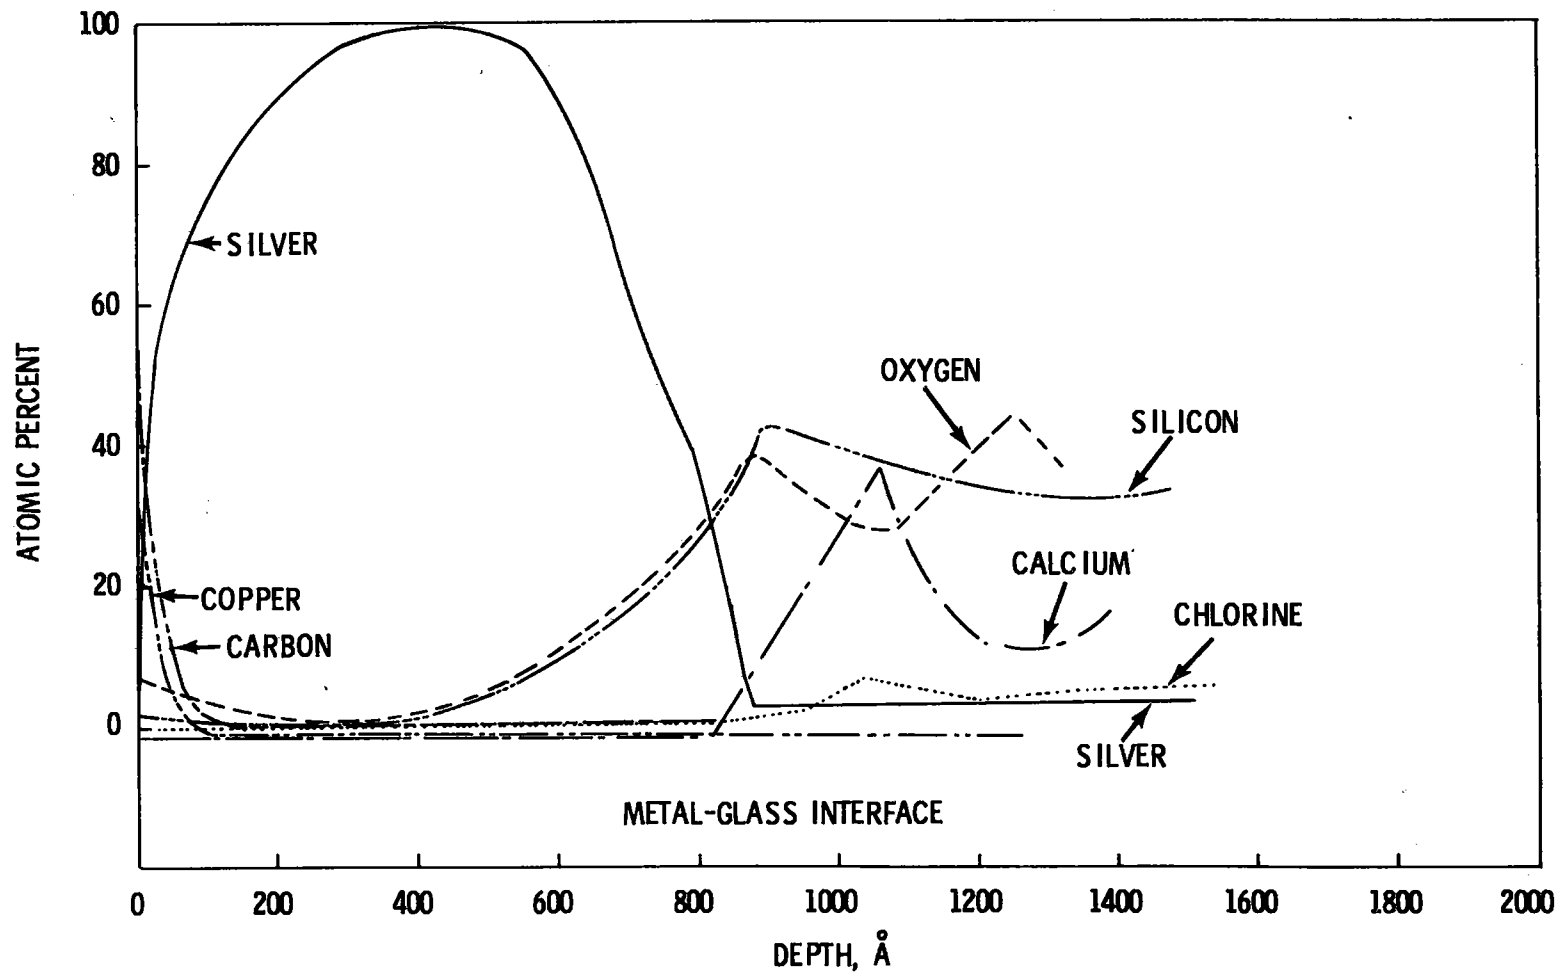
**FIGURE 2.43.** Auger Depth Profile of the Sandia Mirror Taken Adjacent to a Corrosion Spot. The silver layer is quite pure in spite of the close proximity to extensive corrosion. Silver and chlorine are present in approximately equimolar quantities several hundred angstroms deeper than the silver-glass interface.
