TECHNICAL REPORT

No. 3/87

LESSONS FROM THE
SSPS - CRS
SODIUM FIRE INCIDENT

Motor Columbus
Consulting Engineers Inc.
CH-5401 Baden, Switzerland

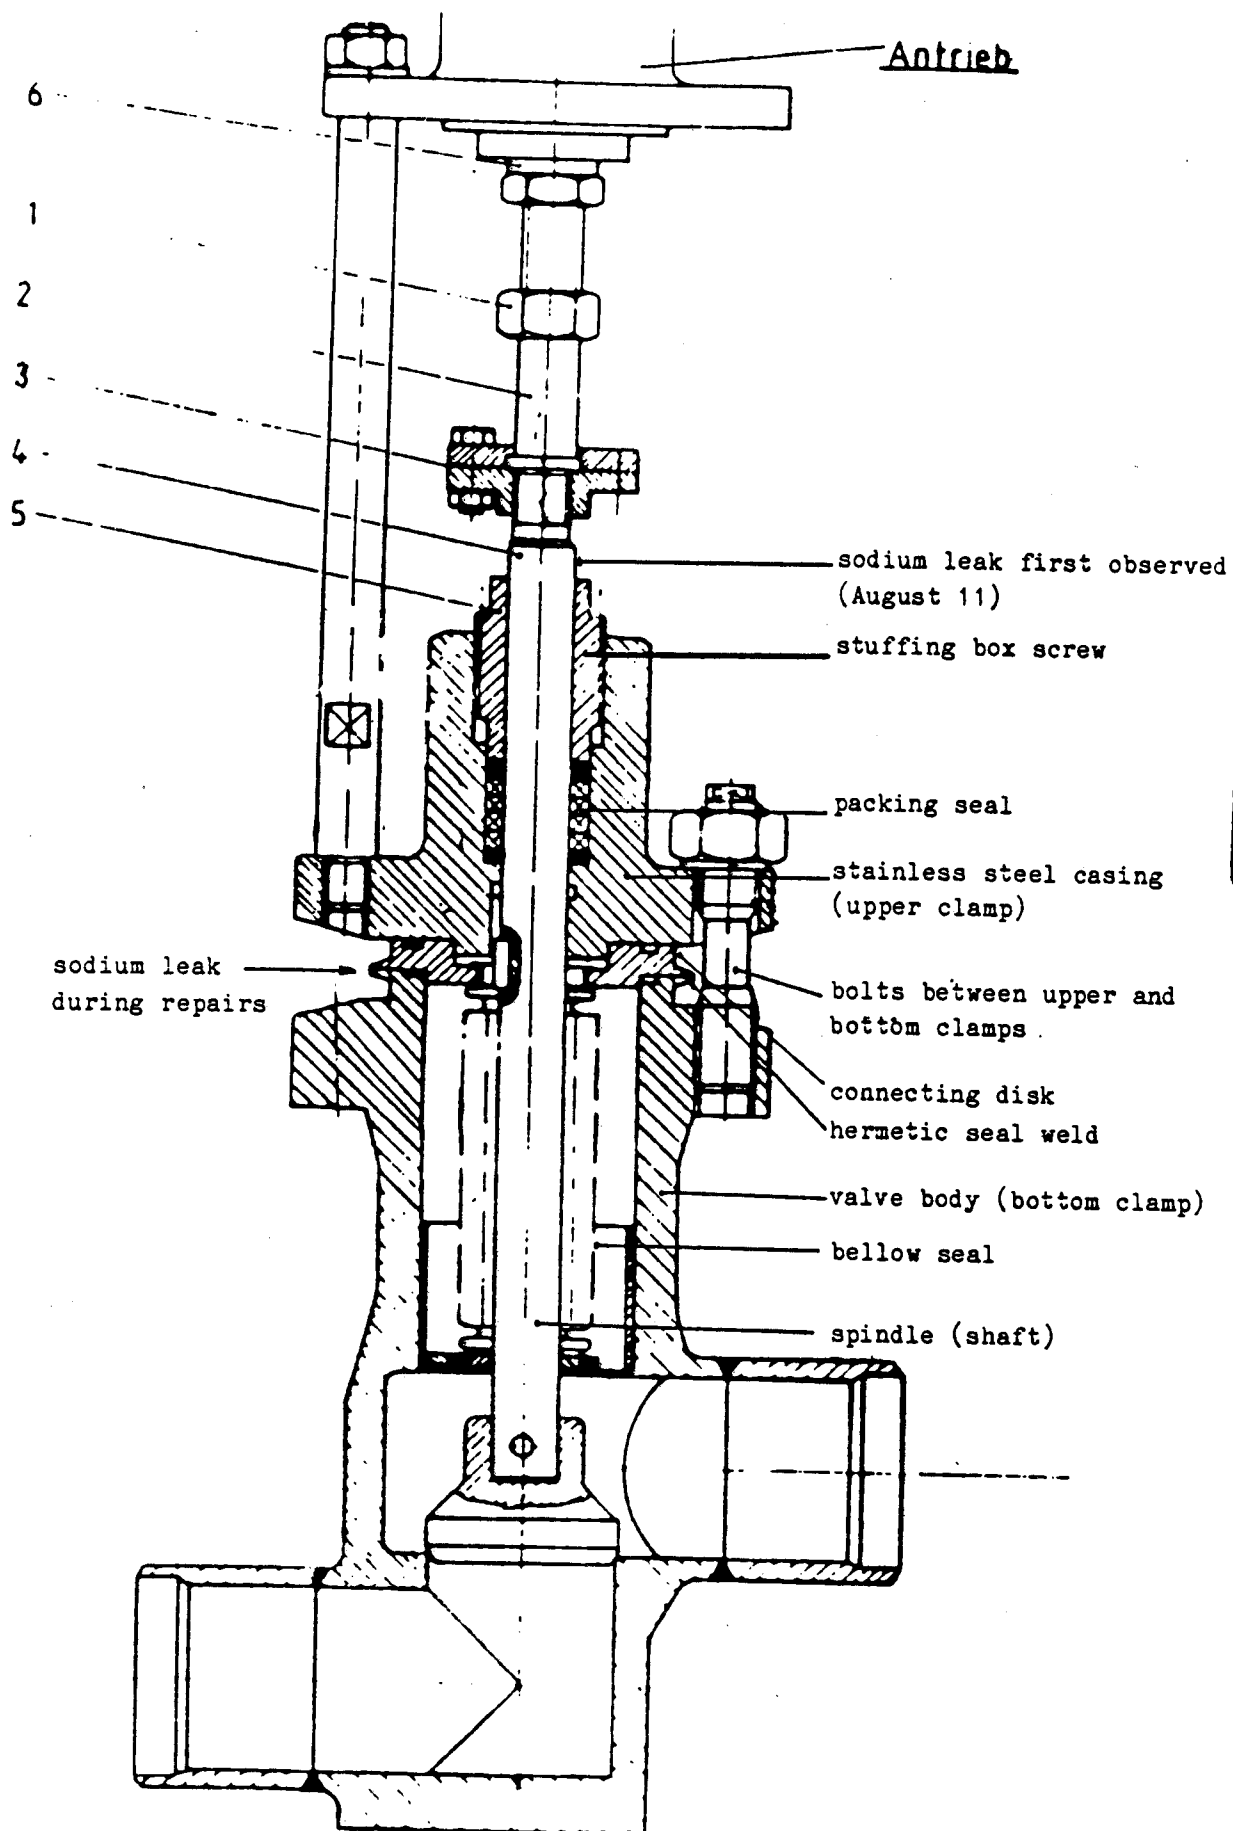
FIGURE 4

During the routine daily inspection of the sodium plant on August 11, 1987, solid sodium or sodium hydroxide was observed on the spindle of valve LK01-AA06 between the valve body and the motor. A drawing of the valve is shown in Figure 4. This valve is in the line between the receiver and the hot storage tank, and is located 18 m from the latter. This observation implied that sodium was leaking past the spindle packing seal which in the past had meant that the bellows' seal was leaking. It was, therefore, decided to repair the valve. This would necessitate removing the bolts between the upper and lower clamps, machining-off the hermetic seal weld, and replacing the spindle, bellows and connecting disc with a new prefabricated subassembly.

Valve LK01-AA06

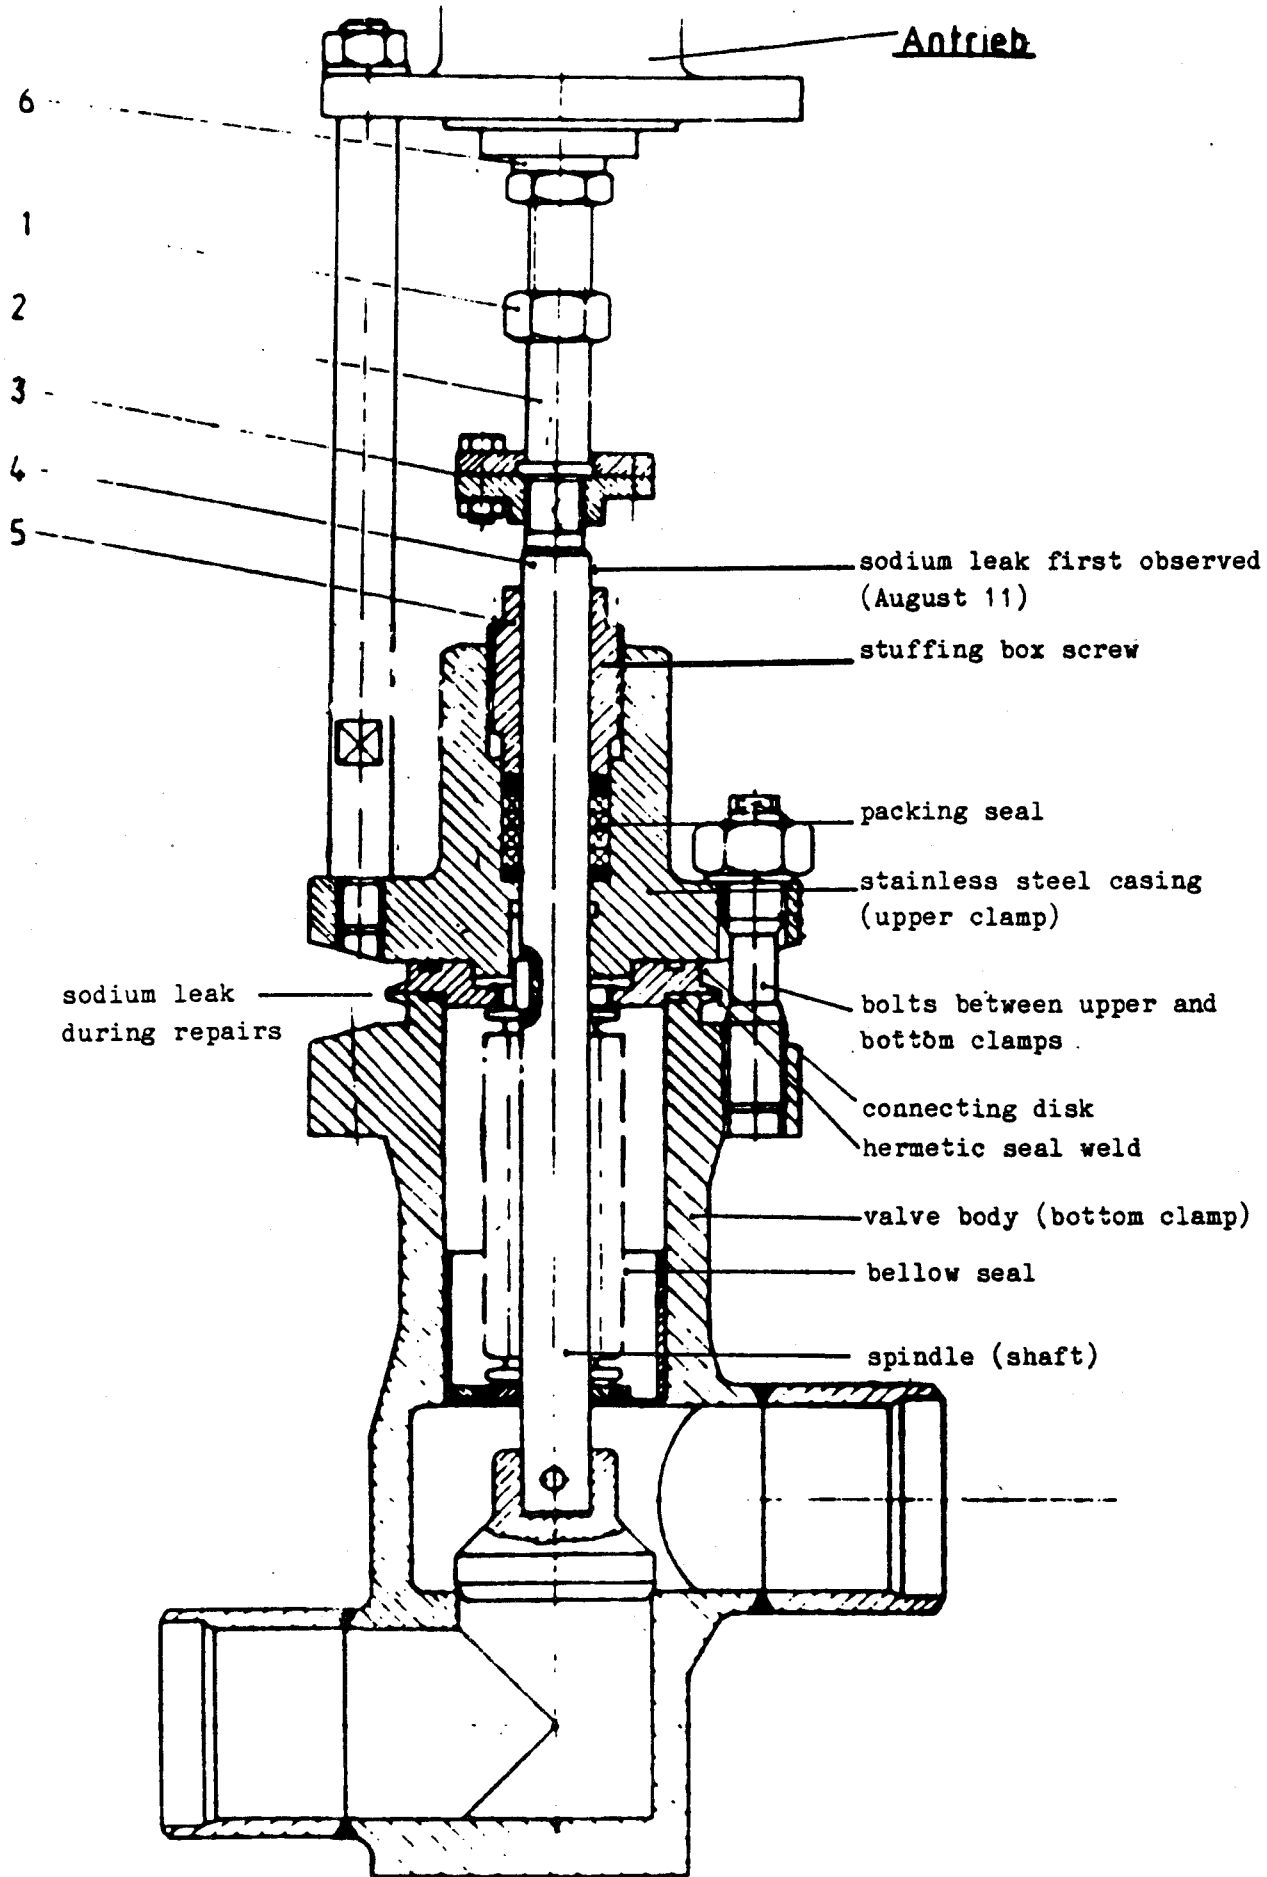
Figure 1

During the routine daily inspection of all the valves and components of the sodium circuit, solid or 'frozen' sodium (sodium hydroxide) was observed in the spindle (valve shaft) of valve LK01-AA06 between the valve body and motor (Figure 1) This valve is located between the receiver and hot sodium storage tank, and is located 18 m from the latter.

The reparation started at 10:00. The spindle, bellow, and connecting disk are attached to the valve body by means of the stainless steel casing and the connecting disk (Figure 1). The casting disk is clamped to the valve body (bottom clamp) with ten bolts. To ensure a hermetic seal, INTERATOM welded the connecting disk to the valve body (Figure 1), making any repair work in this area difficult.

sodium leak first observed
(August 11)

sodium leak
during repairs

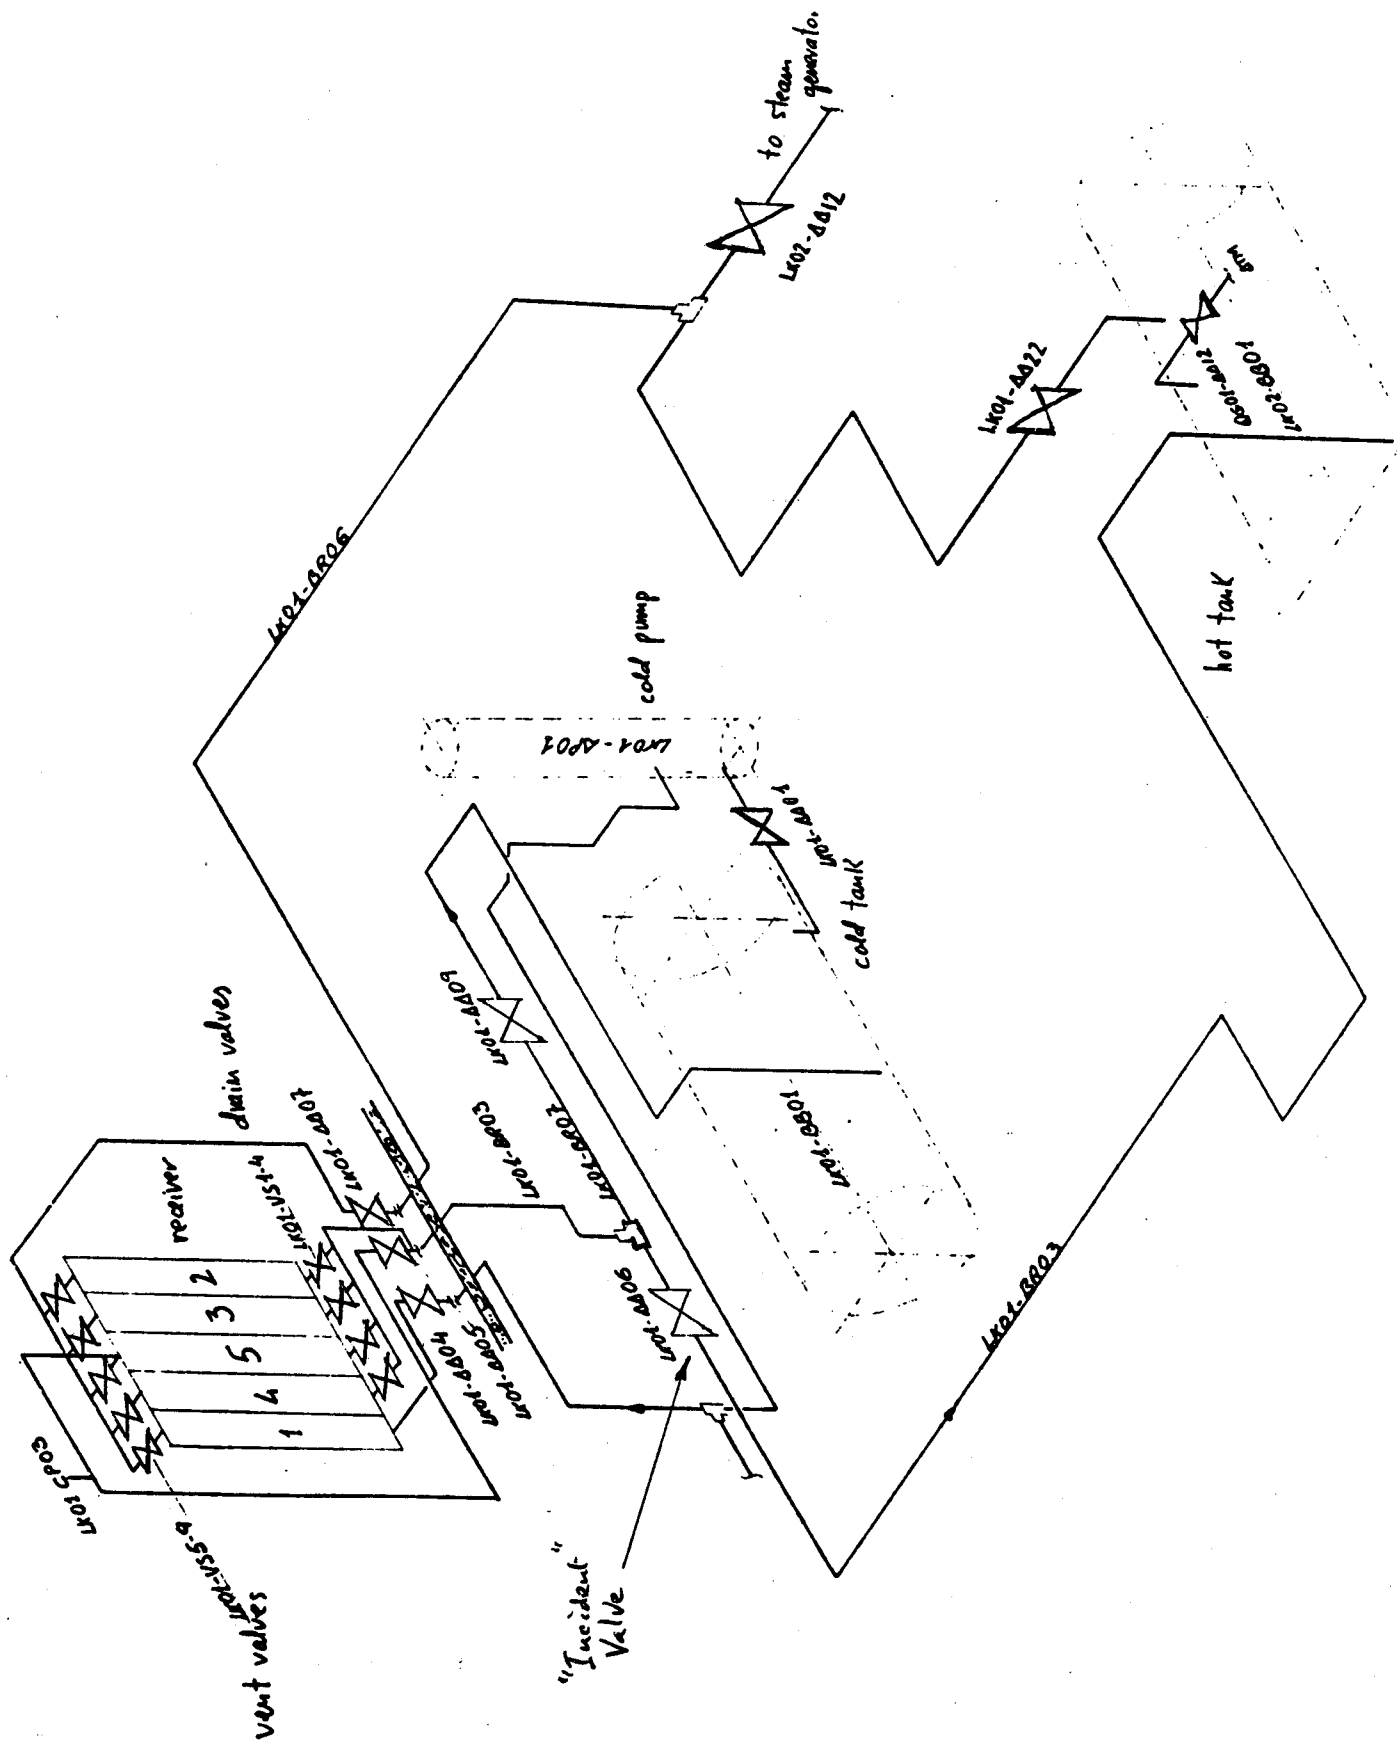
Figure 2

Once it was decided to repair the valve, operation personnel performed the necessary tasks to freeze the piping section (LKO1-BRO3) between the hot tank and the valve (Figure 2); these tasks were composed of the following:

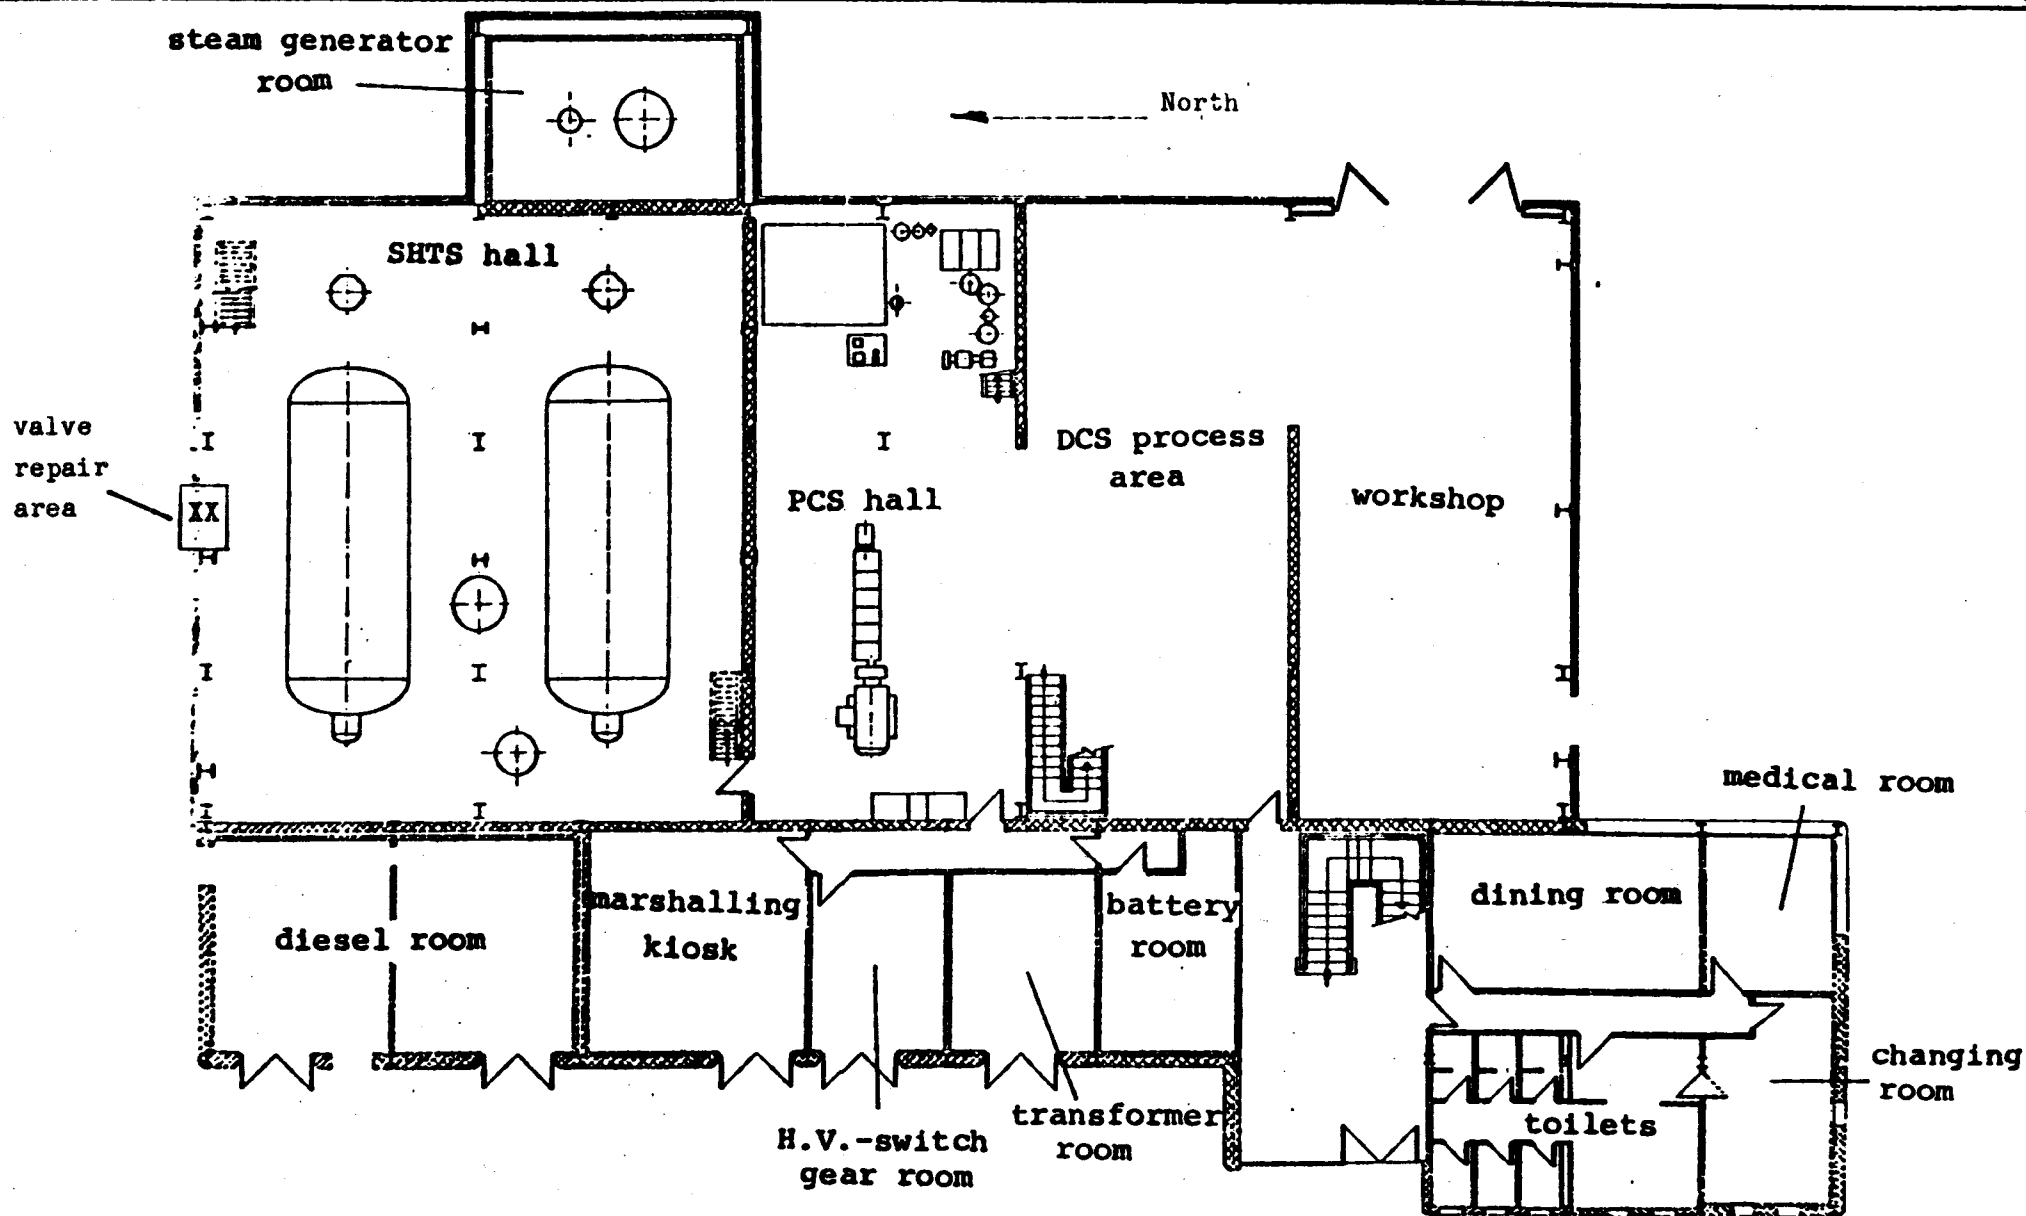
IEA - SSPS PROJECT CRS
 FIGURE 3: 0.0 m Level Main Building Plot Plant

The valve being repaired was located at the North end of the SHTS Hall (Figure 3).

- At 13:00, the steam generator room (Figure 3) was inspected and apparently this had suffered no damage. It was decided to take the graphite from this area and use it to control points where the fire reignited.
- At the same time, the fire in the Computer Room which had started again was fought from the outside by firemen, and was wholly extinguished at 13:30. This is the room where the Director of the Plataforma burned his hands and arms when the false floor fell beneath him.

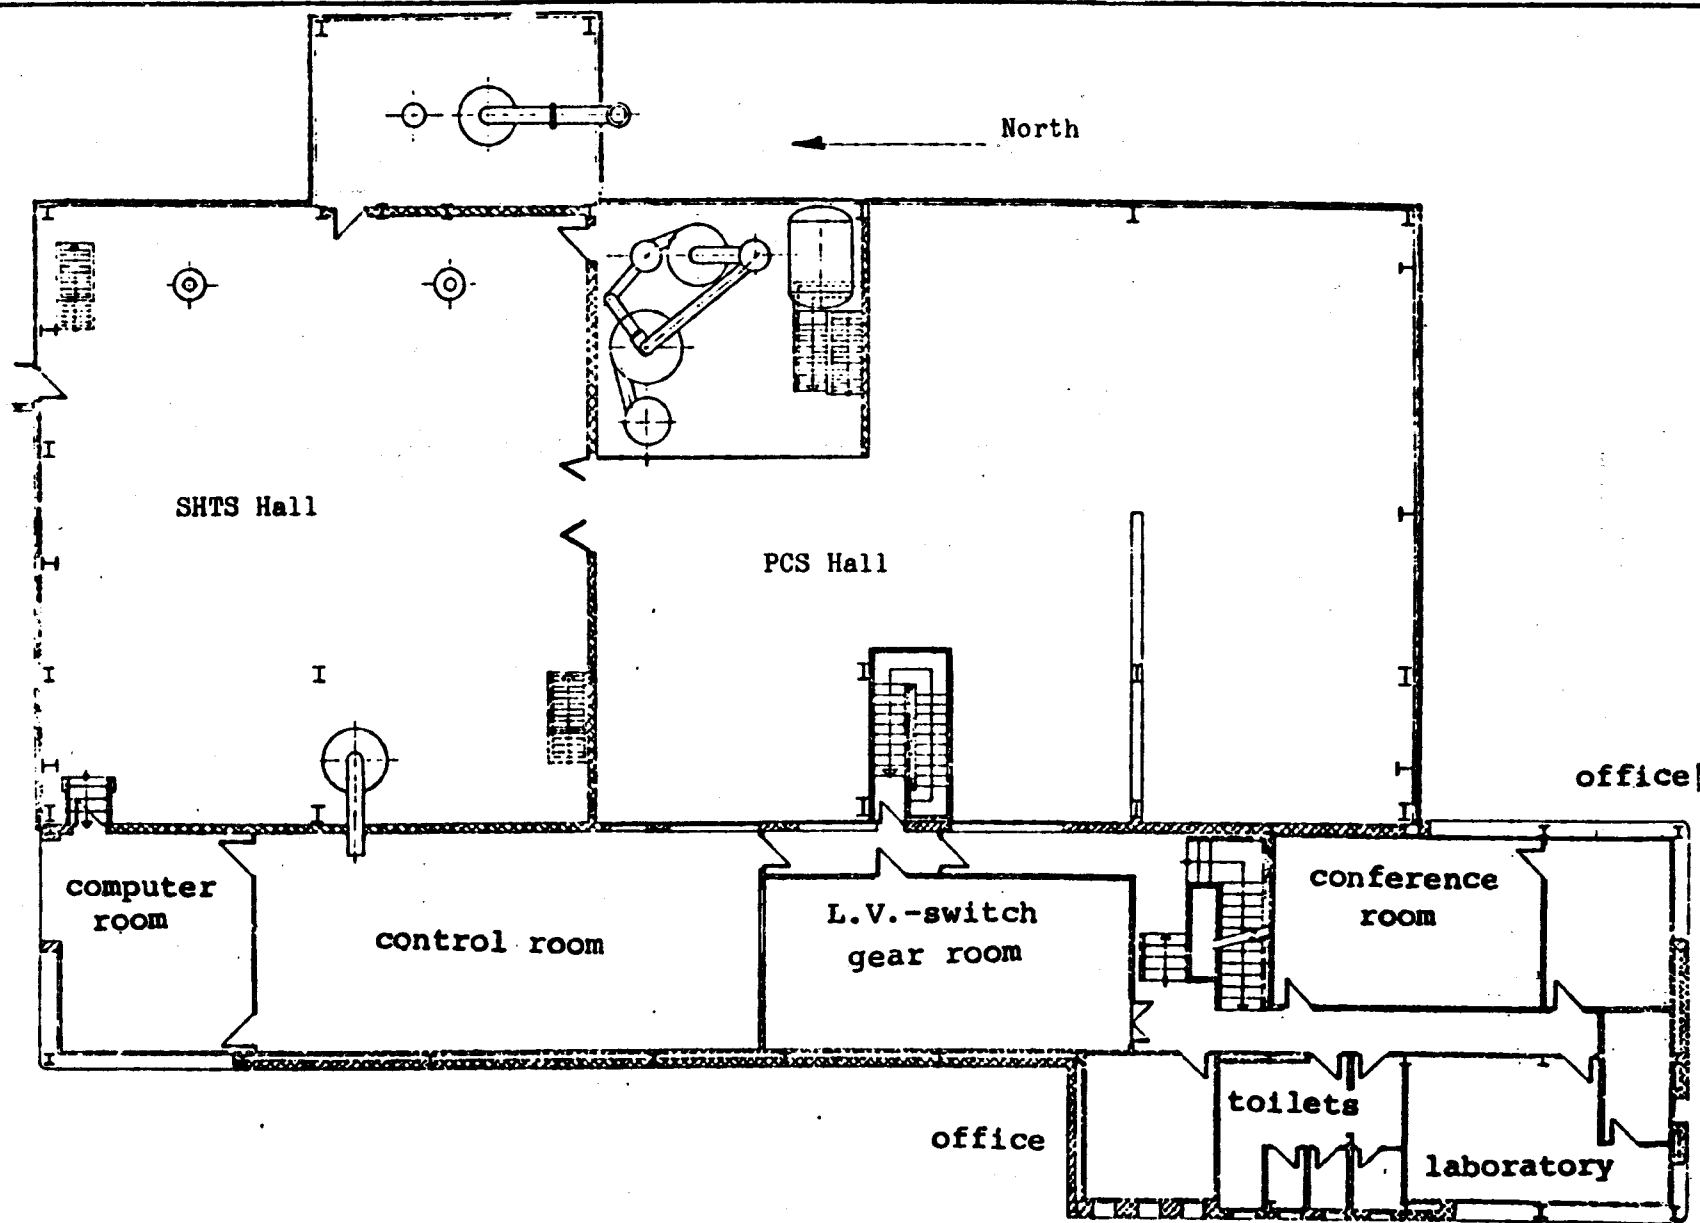
FIGURE 4

- At this time, the fire was burning at the North end of the SHTS Hall and in the computer room (Figure 4). The Control Room, adjacent to the Computer Room, was filled with smoke (Figure 4). It is assumed that the fire entered the Computer Room from the SHTS Hall through the connecting door (Figure 4).
