SSPS Technical Report No. 5/83

Investigations and Findings
concerning the
Sodium Tank Leakages

edited
by
W. Bucher
DFVLR

IEA Operating Agent, DFVLR
Cologne, Germany, July 1983

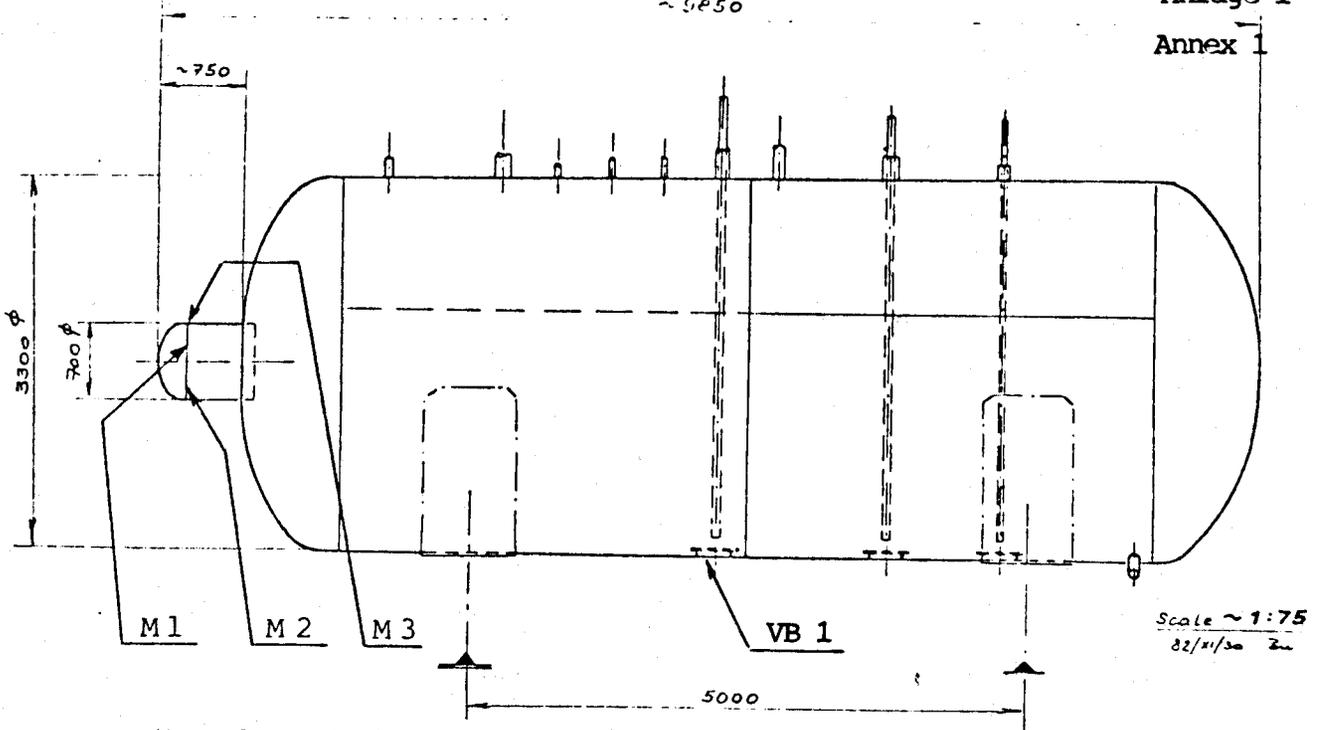
Vessel as designed and location of first cracks

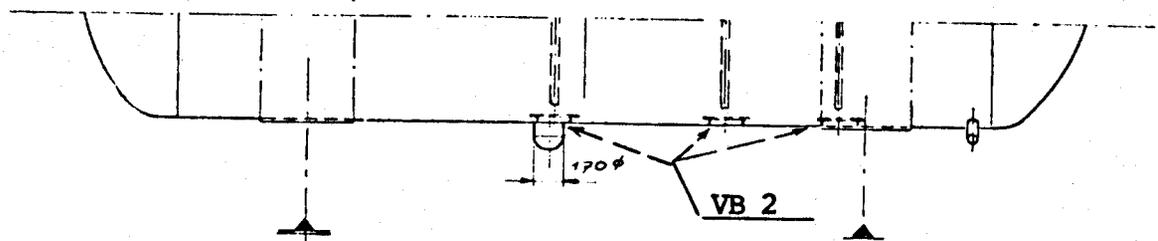
After first repair (170 mm Dia. bowl) and crack indications

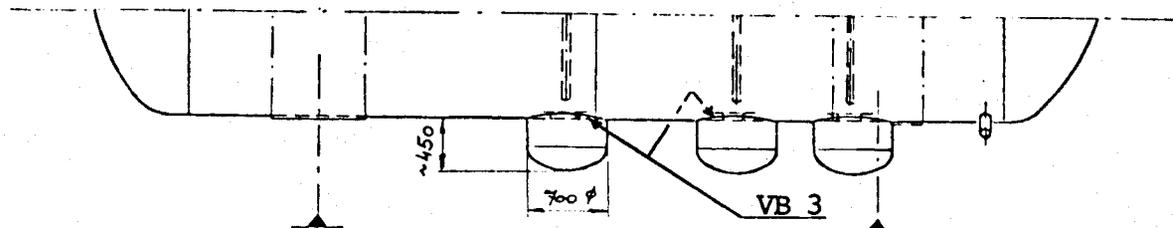
After second repair (3 domes) and cracks in these domes

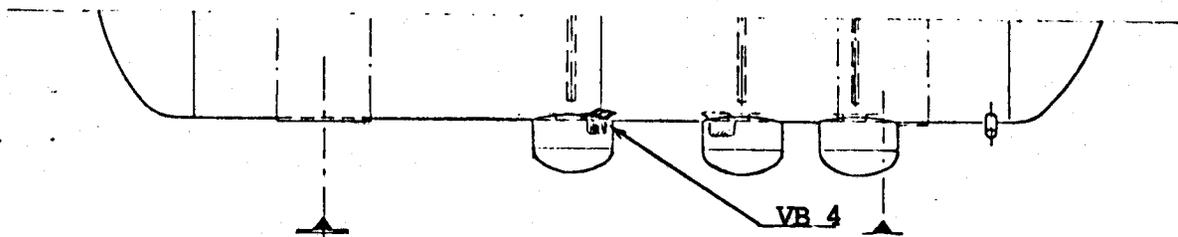
Repair by patches (preliminary measure) and cracks at the edges

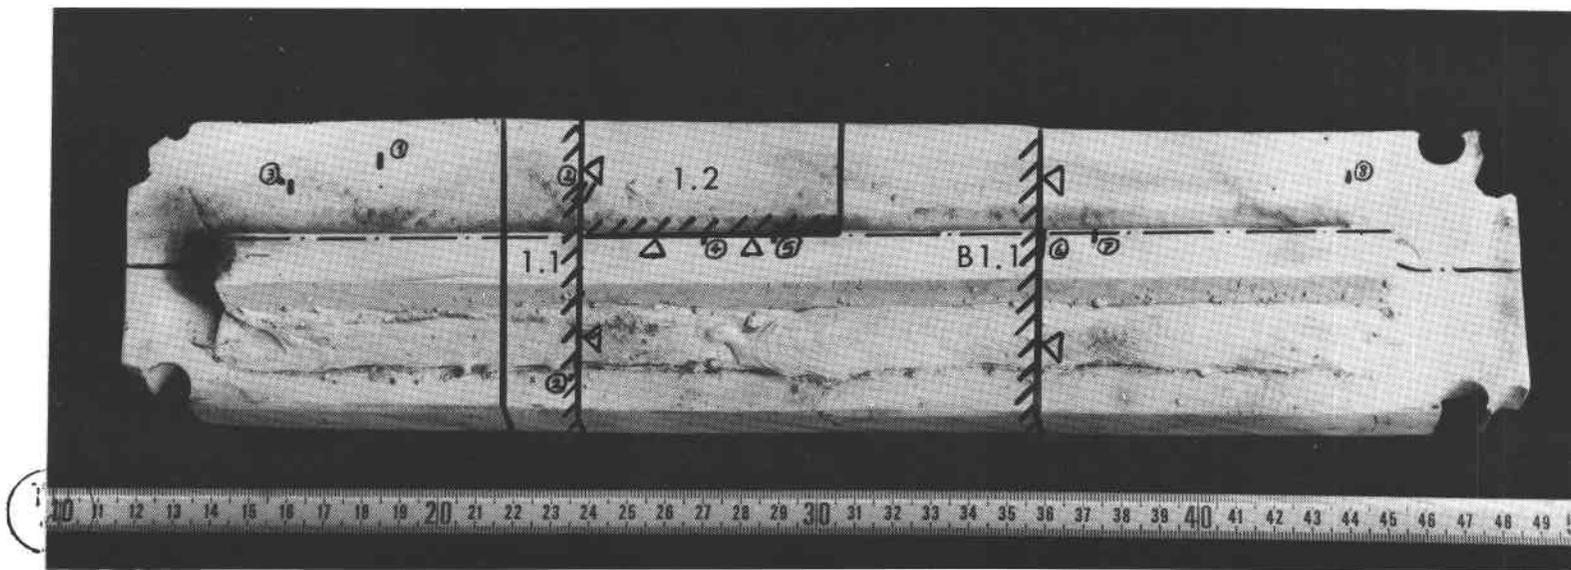
Fig. 2 Magnetic particle indications on Web No. 1
US-indications marked with I

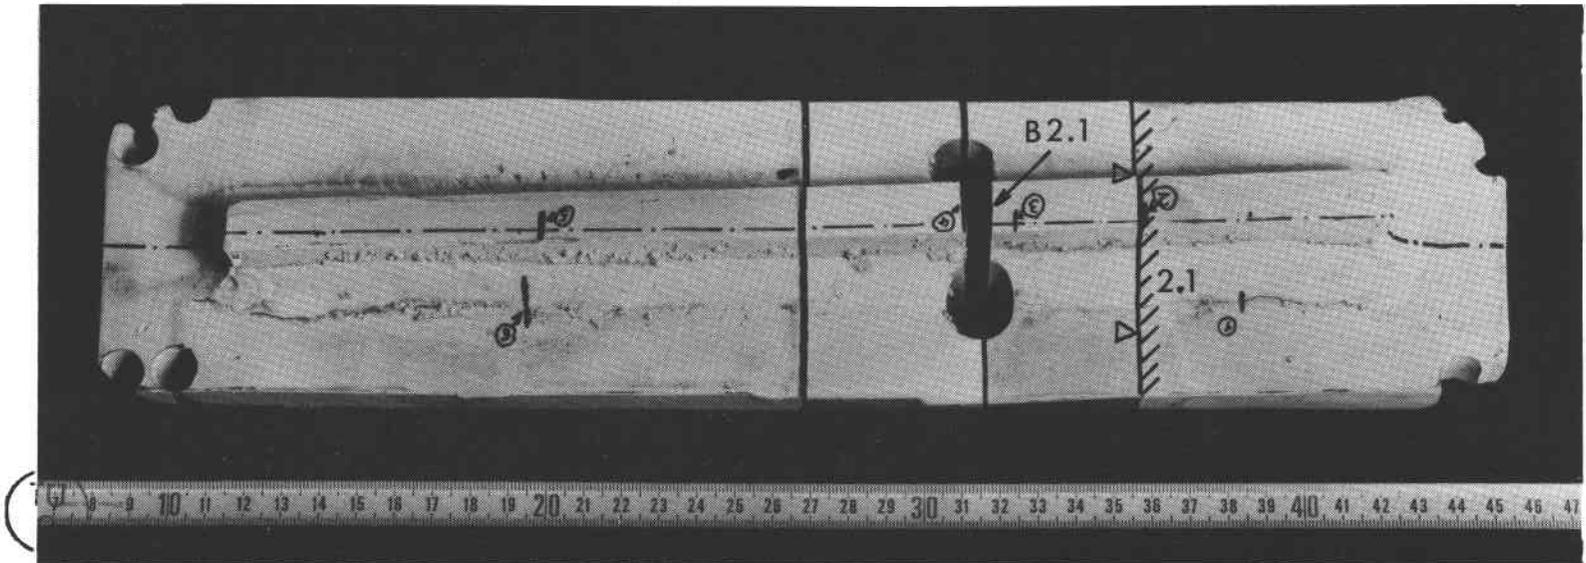
Fig. 4 Magnetic particle indications on Web No. 2
US-indications marked with I

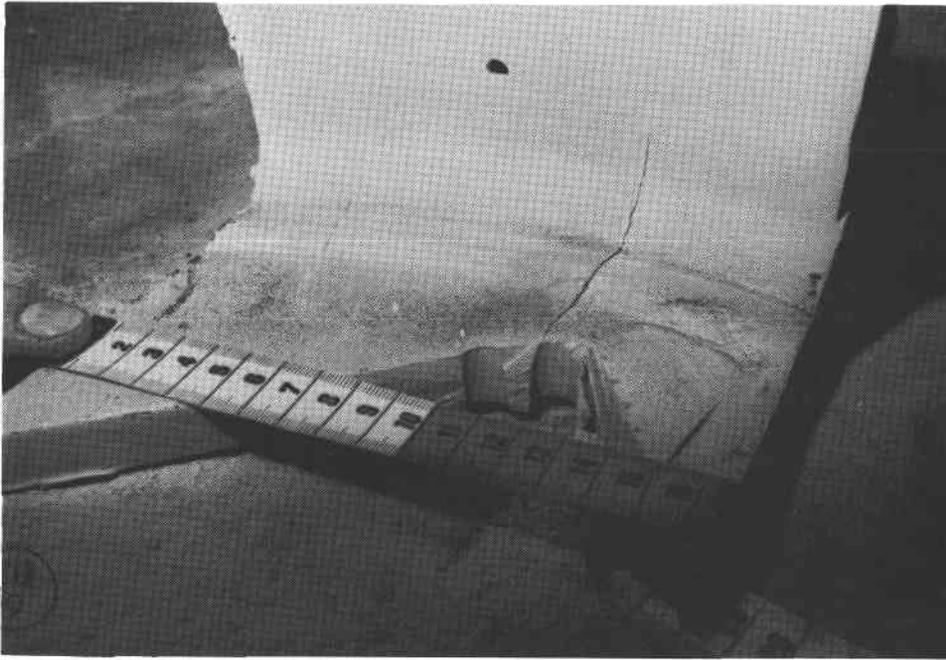
Fig. 5 Crack indications on the inside of the stud

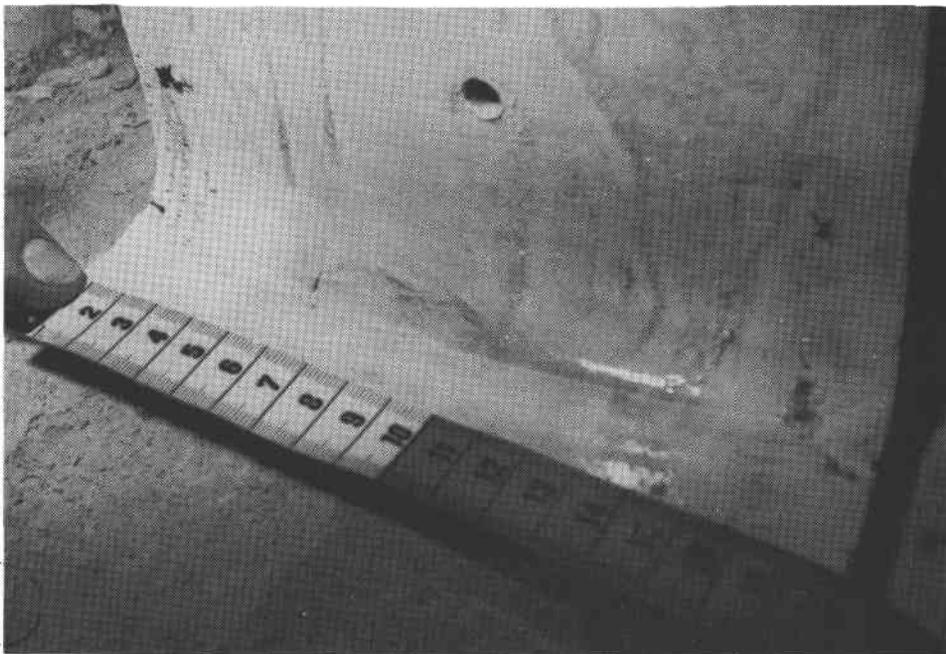
Fig. 6 Crack indications on the outside of the stud

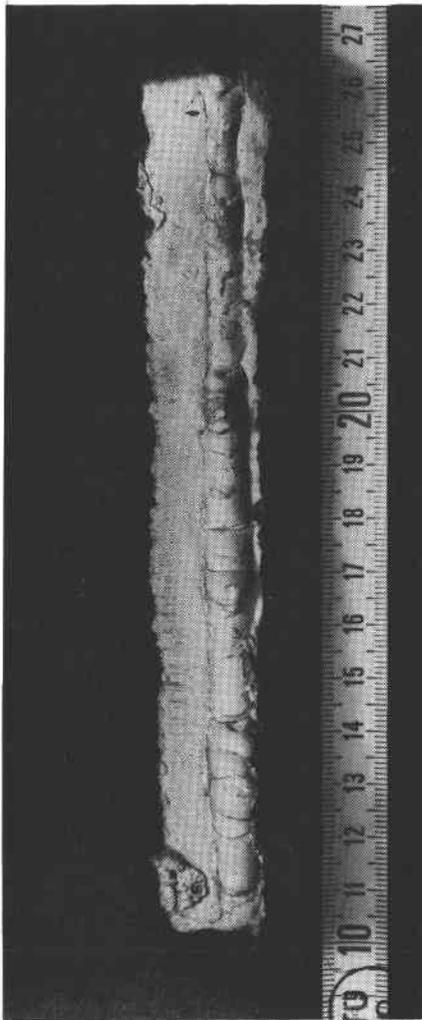
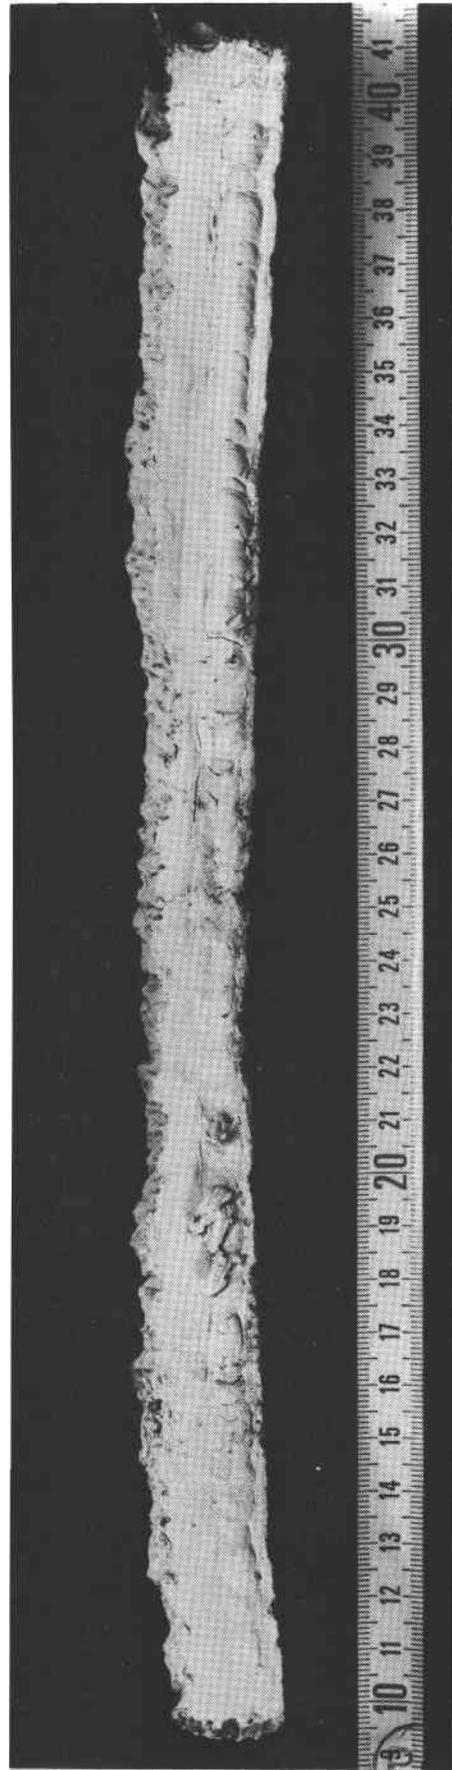
Figs. 7+8 Crack indications in the manhole welds

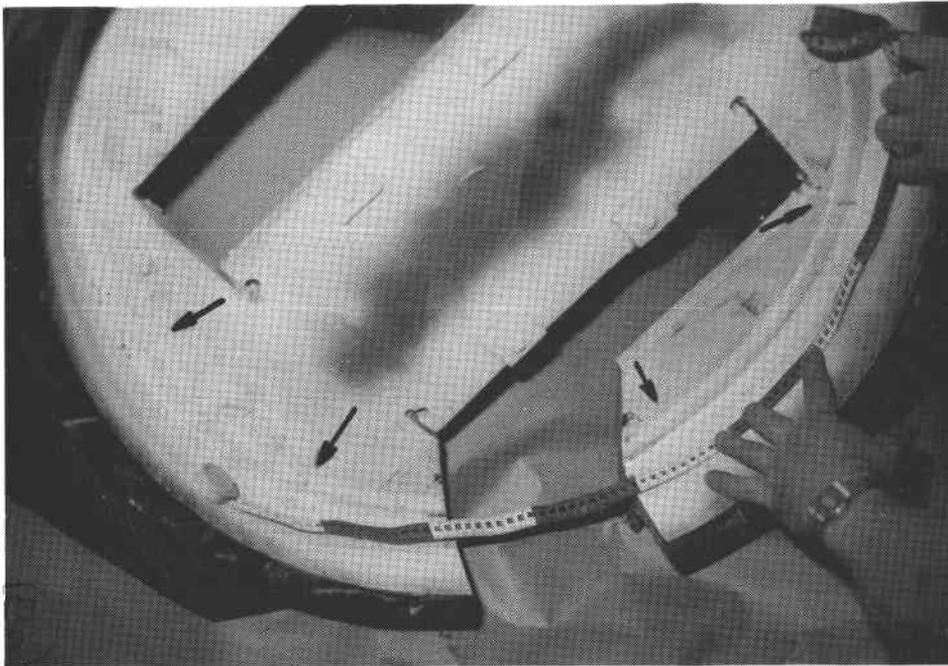
Fig. 9 Magnetic particle indications on the inside of the stud

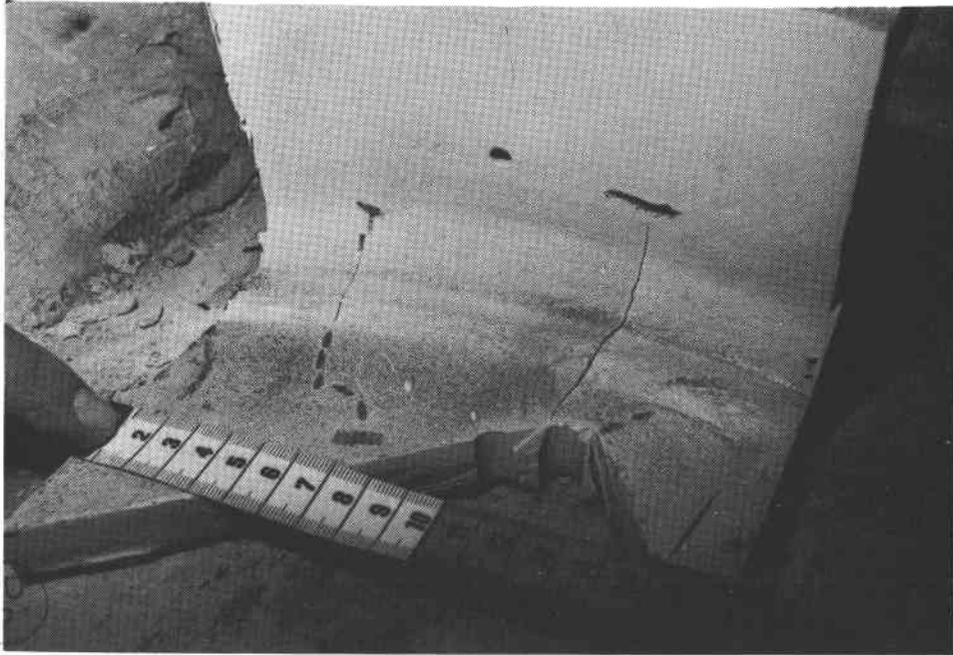
Fig. 11 US-indications in the prolongation of the surface cracks

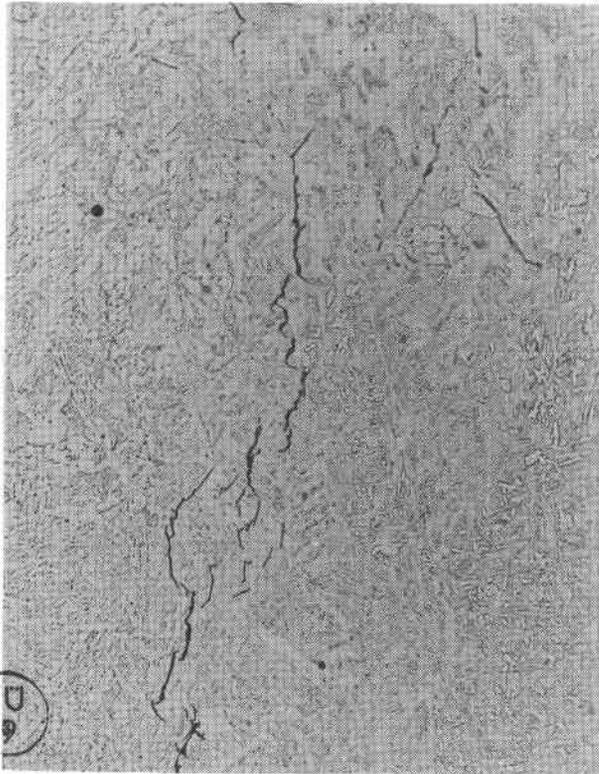
Fig. 15a

crack in weld metal

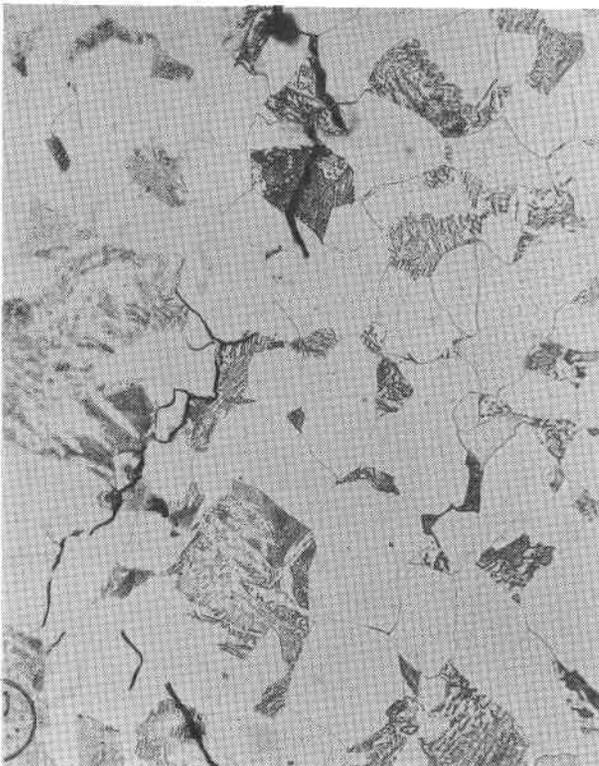
crack in base material

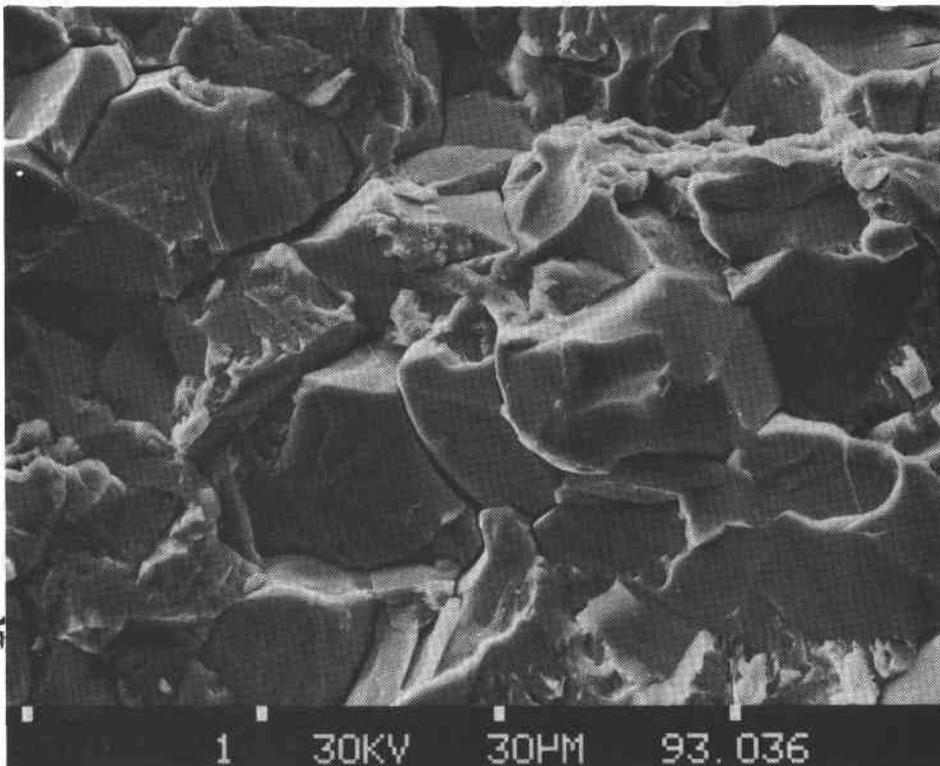
Fig. 19

Inter- and transcrystalline fracture with numerous intergranular cracks

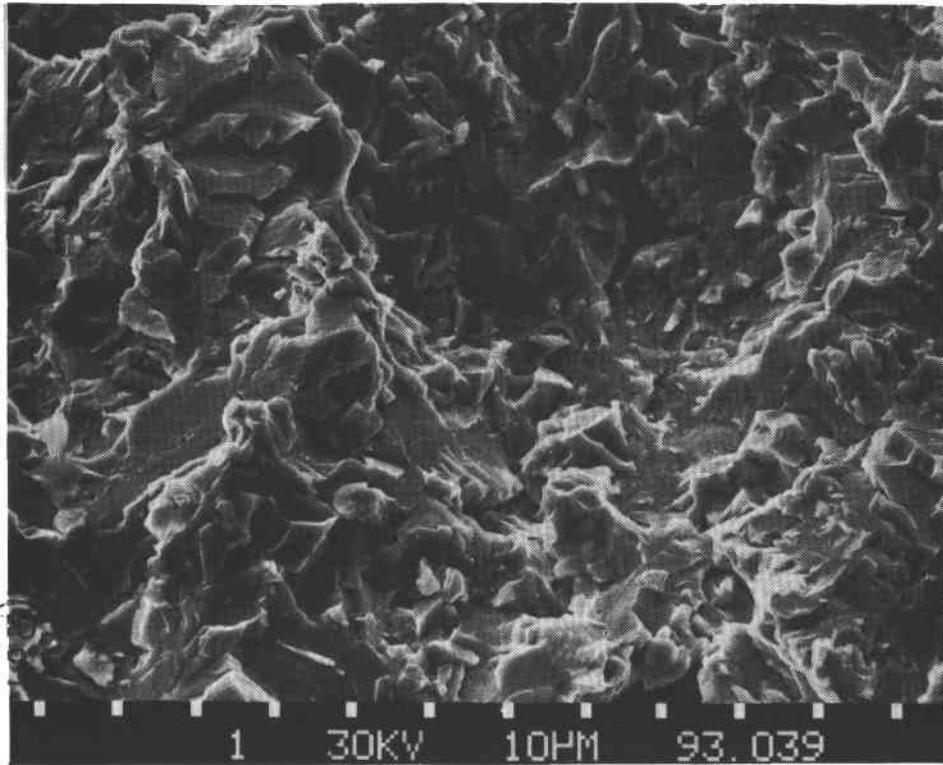
Fig. 20

Fracture surface in damaged weld metal

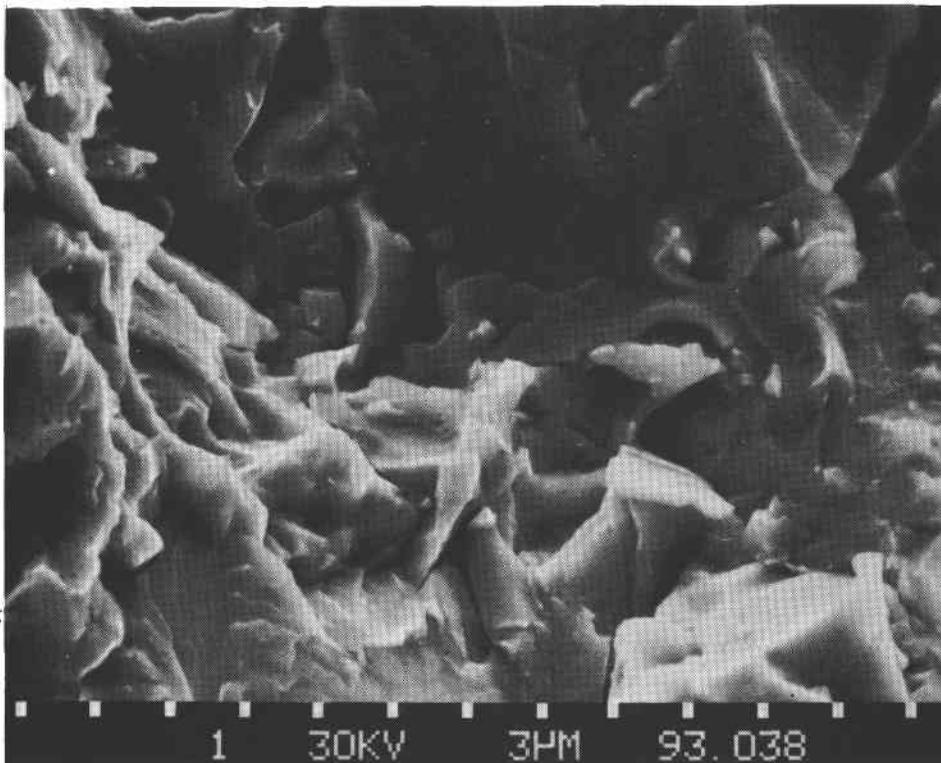
Fig. 21

Brittle fracture with intergranular cracks

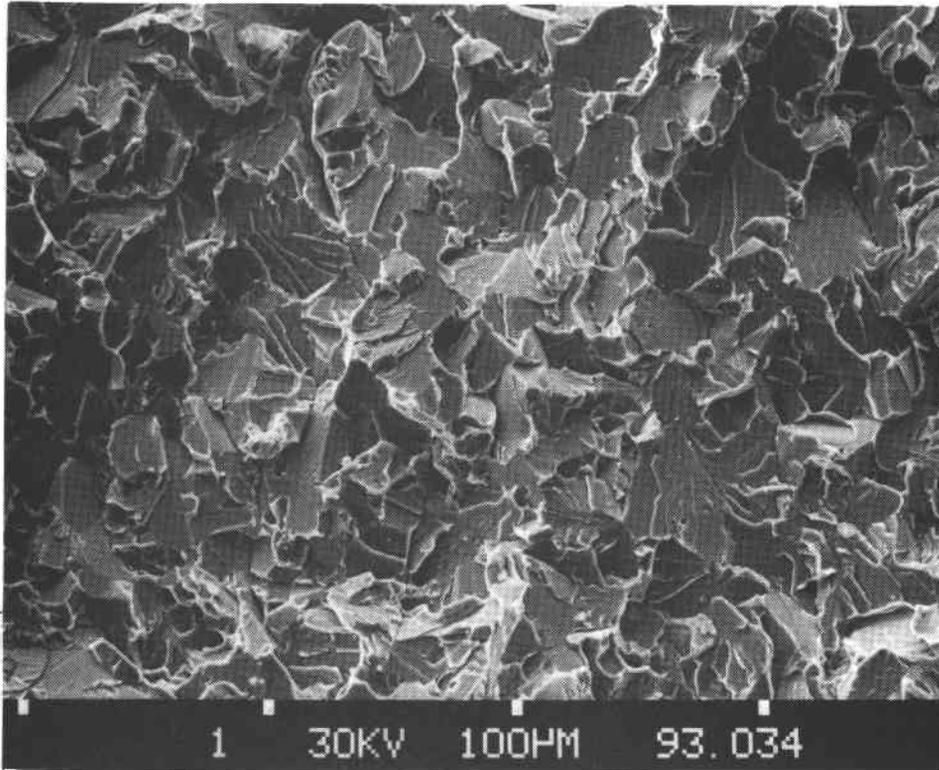
Fig. 22 Laboratory fracture surface 300:1
Cleavage fracture in base material

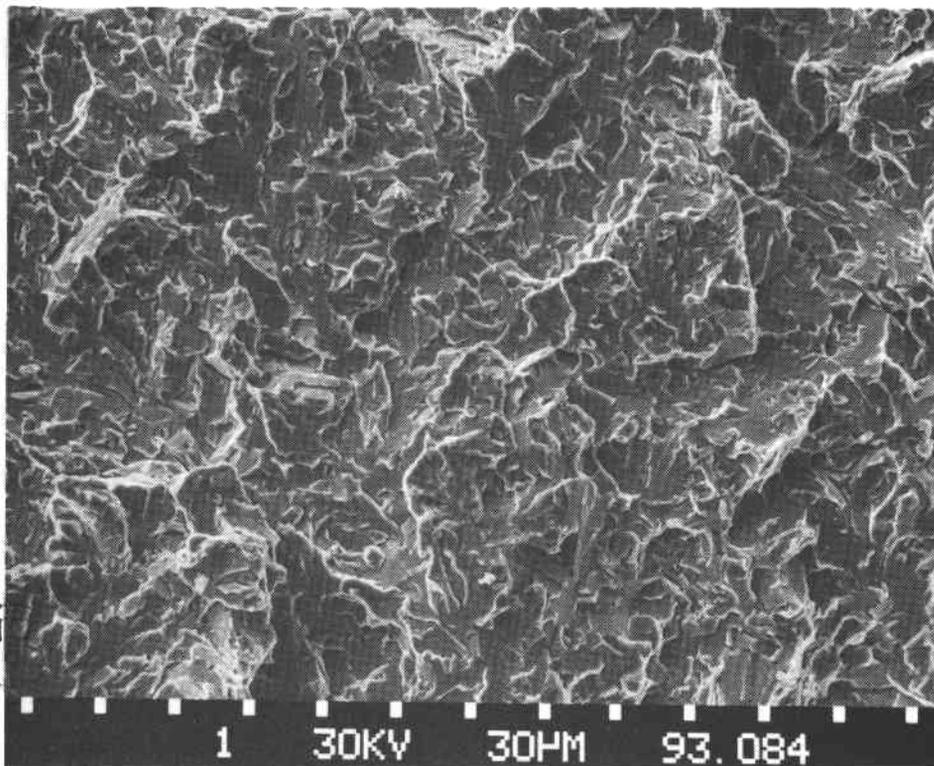
Fig. 23 Laboratory fracture surface 300:1
Cleavage fracture in weld metal

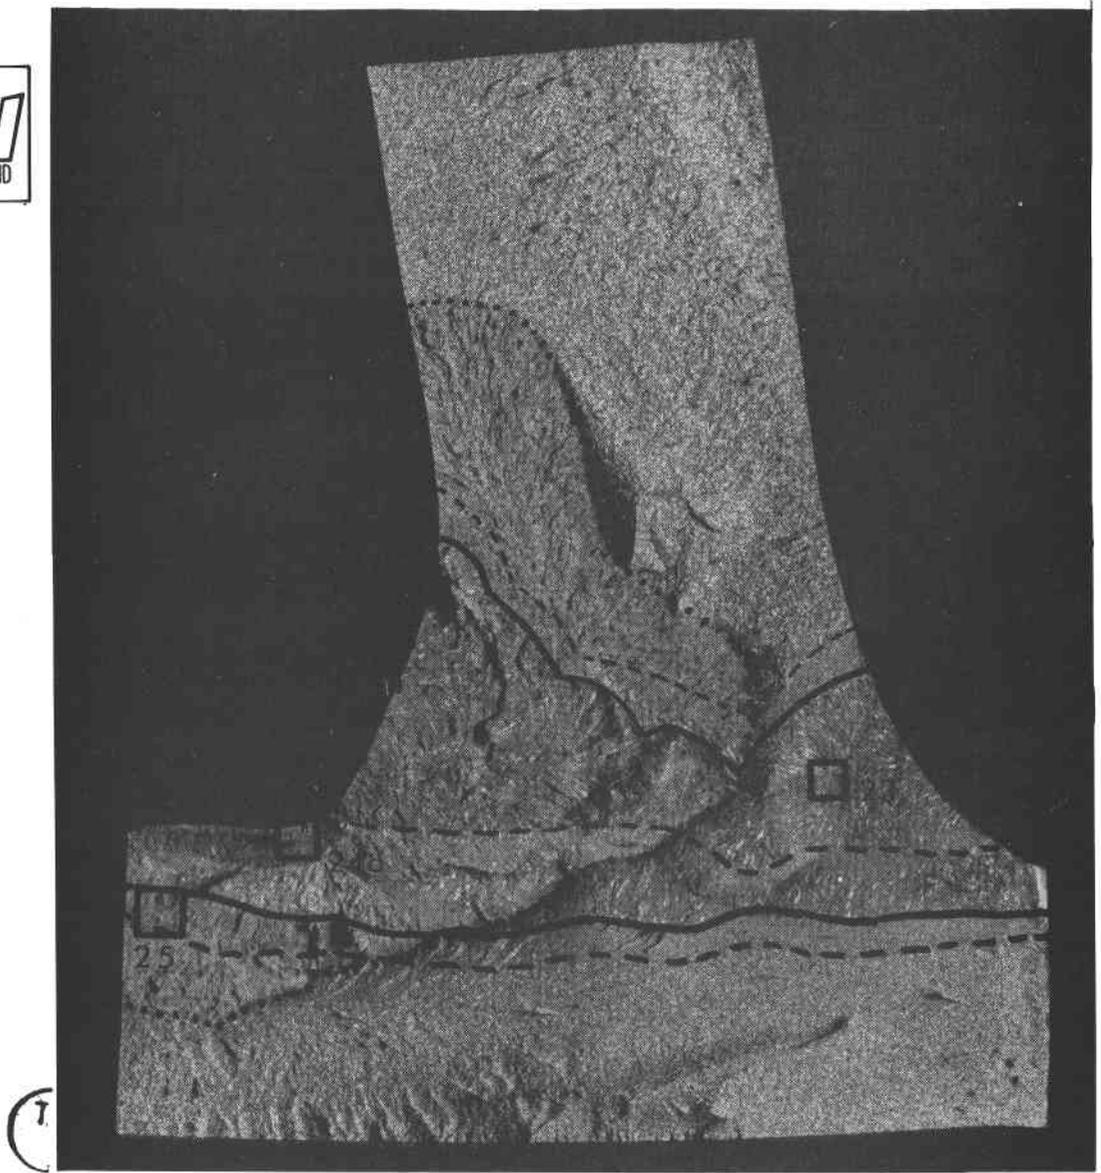
Fig. 24 Fracture surface stud weld

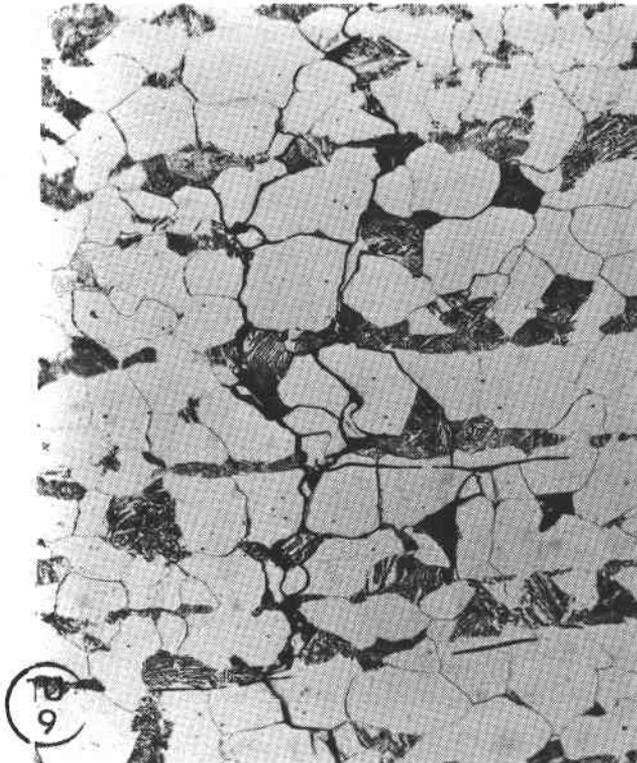
Fig. 29

Crack in base material

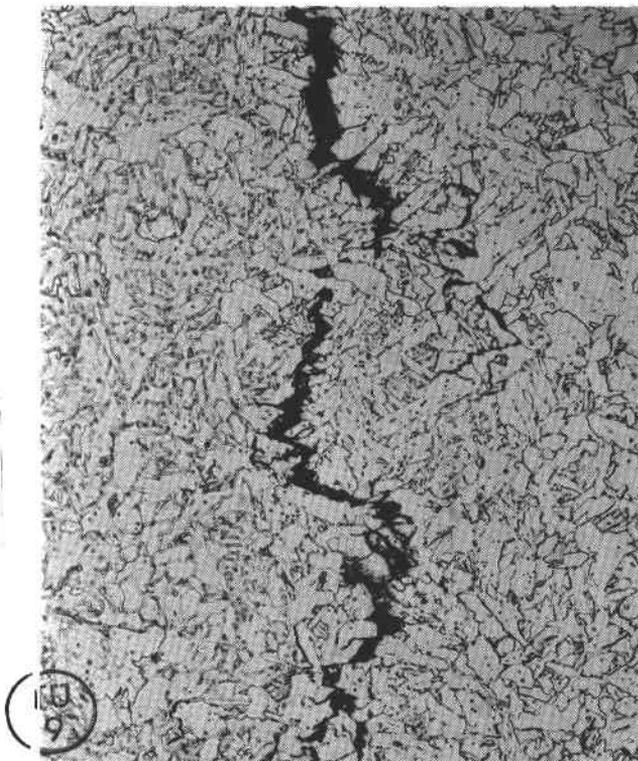
Fig. 30

Crack in weld metal
