CHARACTERIZATION OF HELIOSTAT CORROSION

J. E. Shelby, J. Vitko, Jr. and R. L. Farrow
Applied Physics Division, 8342
Sandia National Laboratories
Livermore, CA 94550

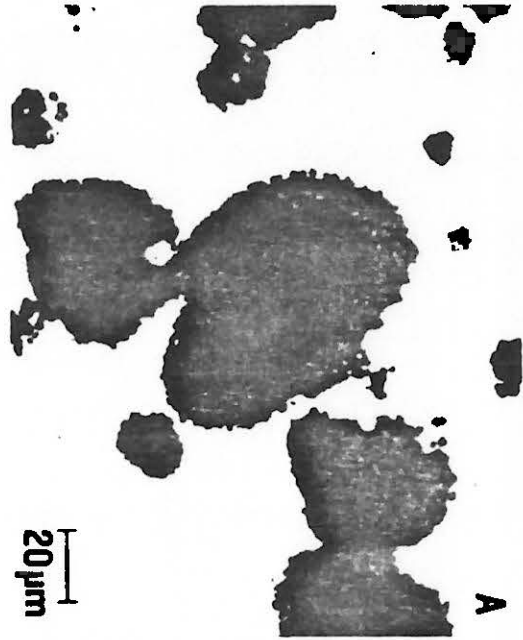
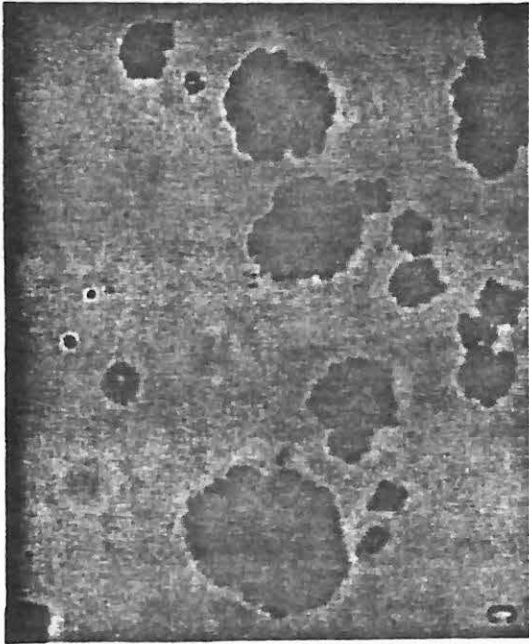
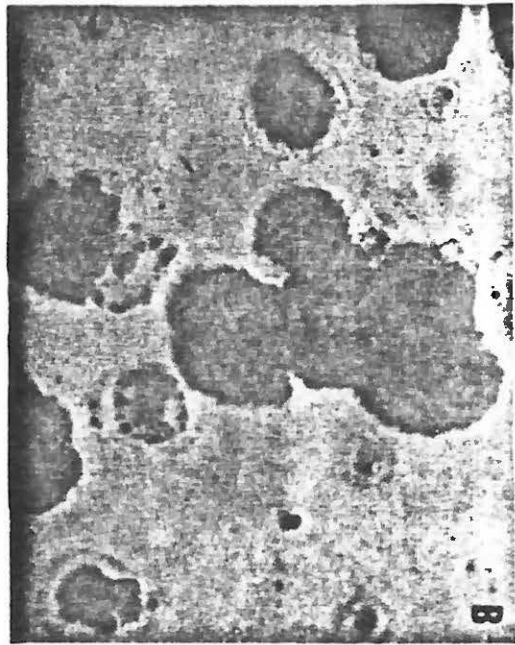
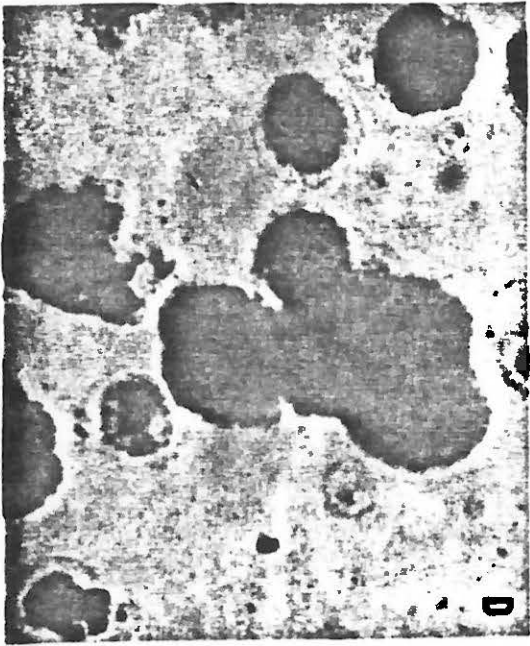
Most of the early work on the corrosion of heliostat mirrors utilized chemical methods to remove the paint from the mirror surface so that the metallic film could be viewed from the copper side. A few relatively low magnification ($\leq 150X$) micrographs taken through the glass superstrate were reported by Burolla and Roche¹ on Livermore heliostats. Similar micrographs were reported by Lind et al.² for severely corroded mirrors which had been stored for 17 years outdoors at Carolina Mirror Corp. These early attempts to view the silver-glass interface through the glass revealed that the corroded spots consisted of somewhat concentric rings surrounding a darker nucleus. Similar micrographs were obtained in the present study at much higher magnification (600X) by grinding and polishing the glass to a thickness of less than 0.5 mm so that a higher magnification lens could be used to view the sample. The results, shown in Figure 1A, indicate that the apparent ring structure is less clearly defined than was indicated by the lower magnification micrographs. The darker central portion of the corrosion spot appears to be very similar to that observed in earlier studies.

Mechanical stripping of the paint from the sample with liquid nitrogen (LN) has essentially no effect on the morphology of the corrosion areas, as is shown in Figure 1B. This result suggests that samples prepared by this technique should be much more representative of the actual condition of the undisturbed corroded mirror than those stripped of paint by other techniques. For comparison, the results of chemical stripping with glacial acetic acid is shown in Figure 1C. The removal of the corrosion product from the holes is

evident in Figure 1C. A similar effect was noted for samples stripped of paint with dimethyl sulfoxide, and for a mechanically stripped mirror which was rinsed in running water for a few seconds and then wiped dry with a paper tissue. Further study revealed that a solvent is not needed to remove the corrosion product lying within the holes in the metallic film. This material can be removed easily by wiping the sample with a dry paper tissue, as shown in Figure 1D. The reader should note that the area shown in Figure 1D is identical to that shown in Figure 1B.

- Figure 1 Optical micrographs taken by reflected light of a corroded mirror as viewed through the glass. Specimen conditions are (A) untreated, (b) mechanically stripped, (C) chemically stripped, and (D) mechanically stripped and wiped with a paper tissue. Note that B and D are the identical area of the specimen. All micrographs are at the same scale, as indicated in A.

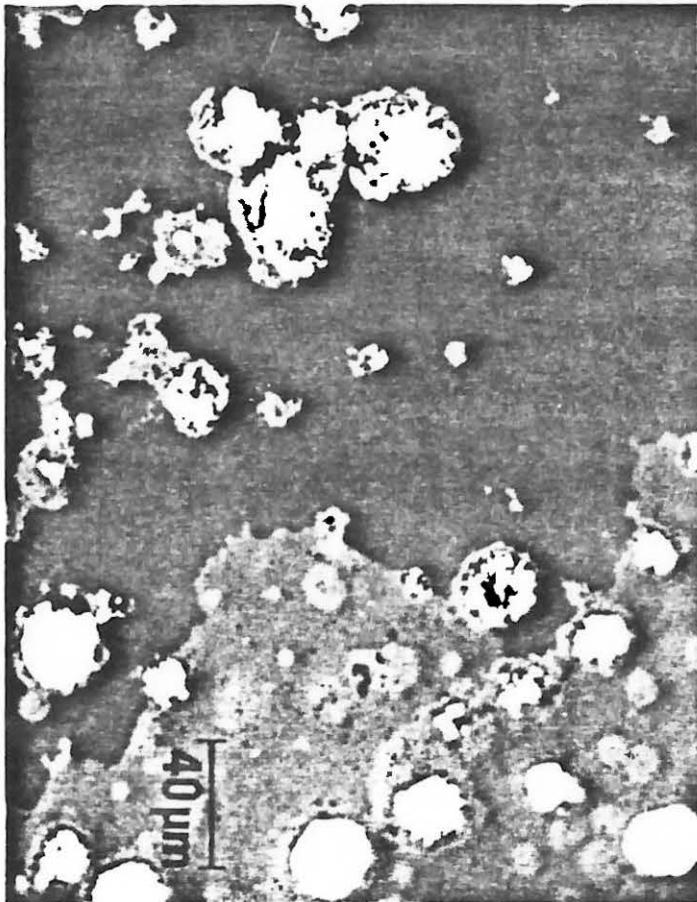
The appearance of the mirror when viewed from the silver side is also a strong function of the stripping technique used (Figure 2). The left portion of the micrograph in Figure 2 represents a region of the specimen which was stripped by the liquid nitrogen technique. The holes through the metal film were filled with material when viewed immediately after stripping. The entire specimen was then placed in warm glacial acetic acid for 60 seconds to remove the paint from the remainder of the specimen. Such an area is shown in the right portion of this micrograph. Note that the holes in the film in the area which had been mechanically stripped still contain a residue of material, whereas those in the area stripped chemically are quite clean. The light areas surrounding the holes in both regions of the sample are bare silver, whereas the darker matrix represents areas which are covered with copper. The physical appearance of the matrix, however, is also quite different in the two areas of the sample. Close examination of the mechanically stripped area reveals that many small particles of paint still cling to the metal film in this region of the specimen.

- Figure 2 Optical micrograph taken using both reflected and transmitted light of a corroded mirror as viewed from the film side. The paint was mechanically stripped from the left portion of the sample and chemically stripped from the right portion of the sample.

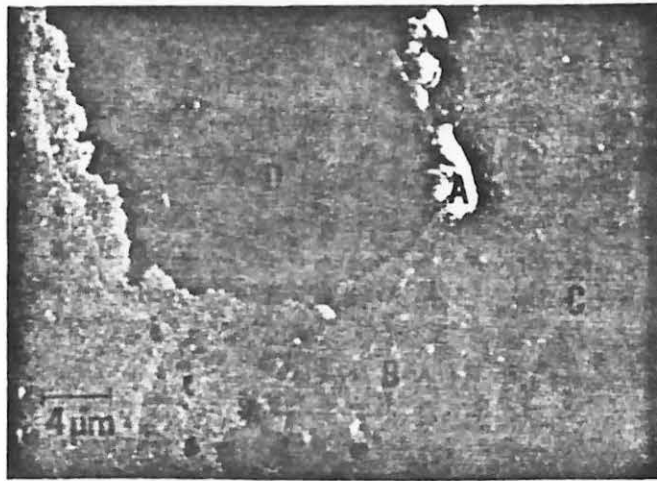
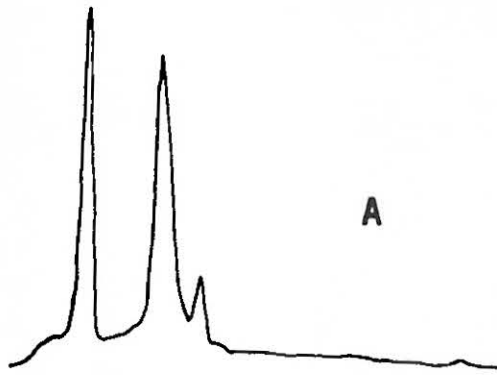
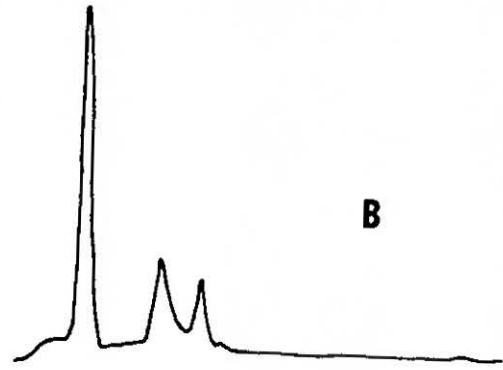
micrographs. These spectra indicate that the holes observed for chemically stripped mirrors contain only glass (Figure 3, point D), that the ring surrounding the hole is bare silver over glass (Figure 3, point B), and that the matrix represents a normal area of the mirror with films of both silver and copper over the glass (point C). The high magnification of this micrograph relative to that of the optical micrographs, however, reveals that there is a small (1-2) micrometer) area of material along the edge of the hole which could not be detected in the optical micrographs. EDX analysis (point A) reveals that this material is very rich in silver, with no indication of the presence of any other elements except those found in the underlying glass. While this type of features is not found near all of the holes through the metal film, such features are by no means unusual.

- Figure 3 Scanning electron micrograph of a chemically stripped corroded mirror. EDX spectra for the points indicated on the micrograph are shown below the micrograph.

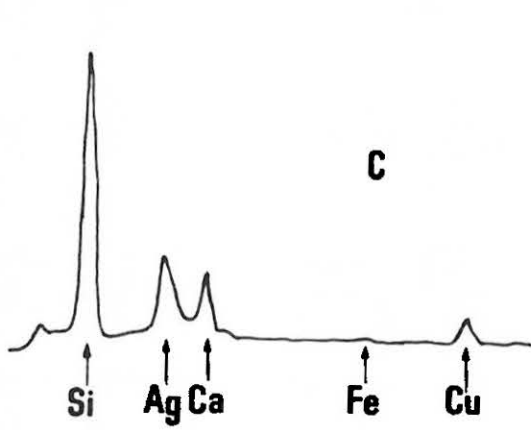
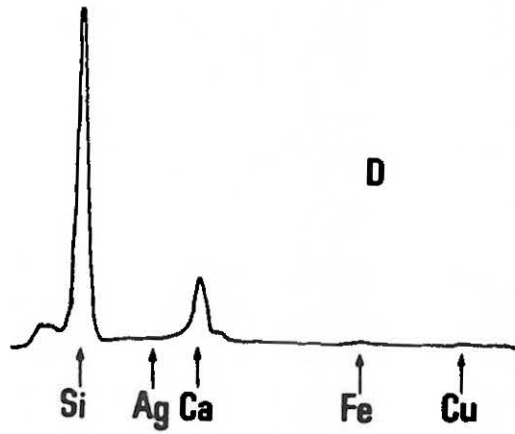
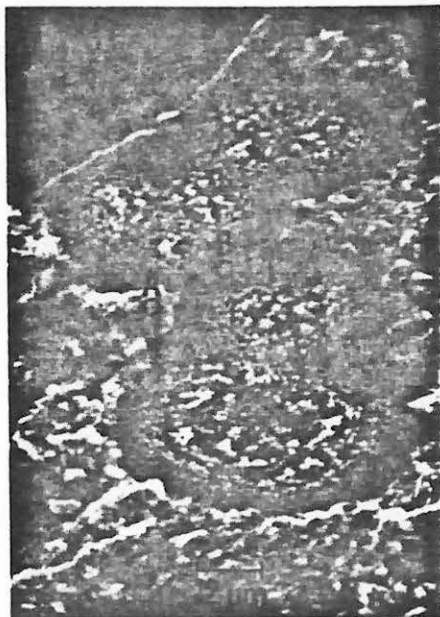
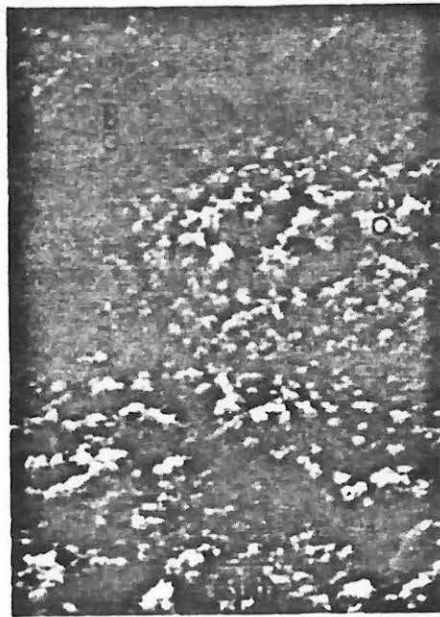
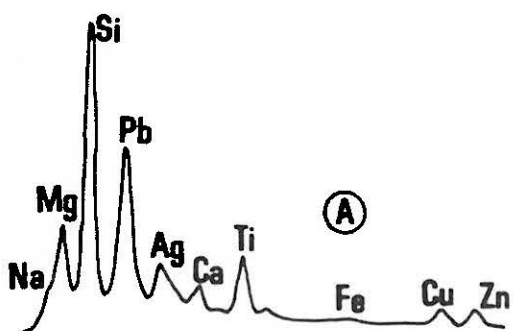
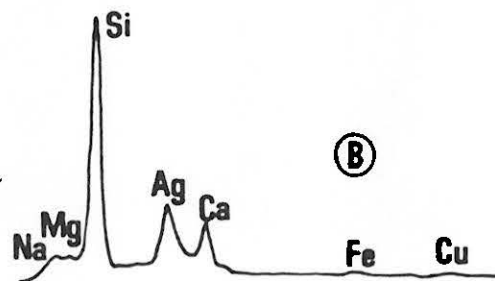
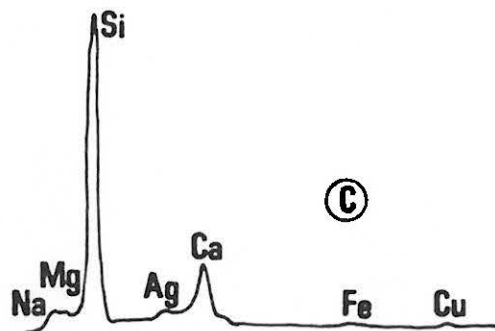
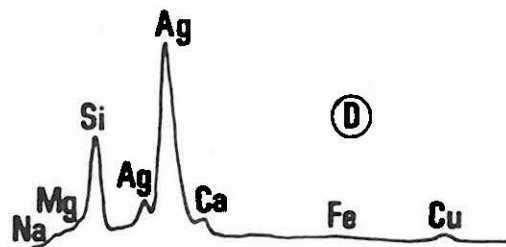
Some features observed in the SEM micrographs of the mechanically stripped mirrors are identical to those observed for the chemically stripped samples. The area surrounding the holes appear to be a smooth film of silver over glass (point B in Figure 4). The areas within the corrosion spots which are not covered with particles (point C) appear to be primarily glass with a very small amount of both silver and copper. The particles themselves (point D) appear to be strongly enriched in silver, suggesting the formation of silver particles thicker than the sampling depth ($\sim 1\mu\text{m}$) of the electron beam. There is no indication of other foreign elements such as sulfur or chlorine which might indicate the presence of silver compounds. (It should be noted that EDX will not detect elements below sodium in atomic number, so that the presence of carbon, oxygen, nitrogen, and fluorine cannot be eliminated by these results). The matrix area surrounding the corrosion spots is covered with paint, as is indicated by the EDX spectrum for point A in this figure.

The identification of the material lying within the corroded holes in Figure 4 has been confirmed by transmission electron microscopy and electron diffraction of material removed during replication of this surface. The diffraction pattern clearly indicated that most of this material is metallic silver. There were also traces of another material in the diffraction patterns which may be a silver halogen (either chloride or bromide) compound. The intensity of the diffraction pattern for the minor phase decreased with time. Further work is underway to identify this material and to ascertain its source.

- Figure 4 Scanning electron micrographs of a mechanically stripped corroded mirror. The micrograph on the right is an enlargement of the central area of that on the left. EDX spectra for the indicated points are given below the micrographs.

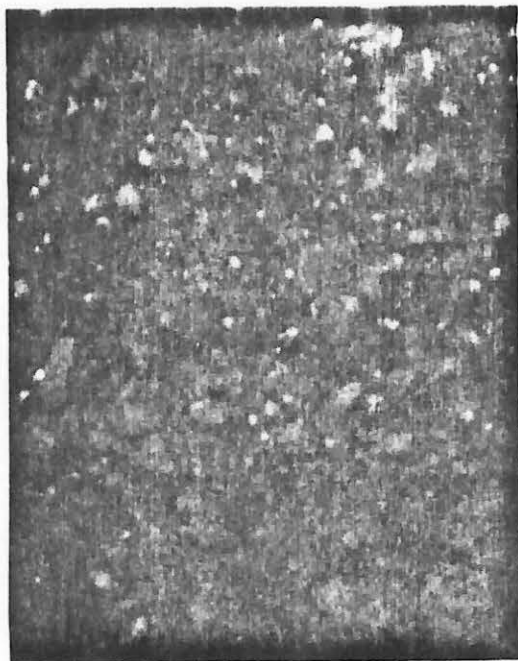
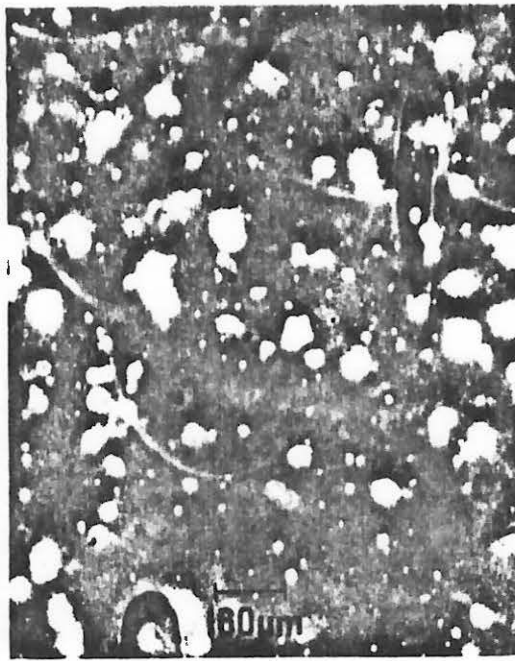
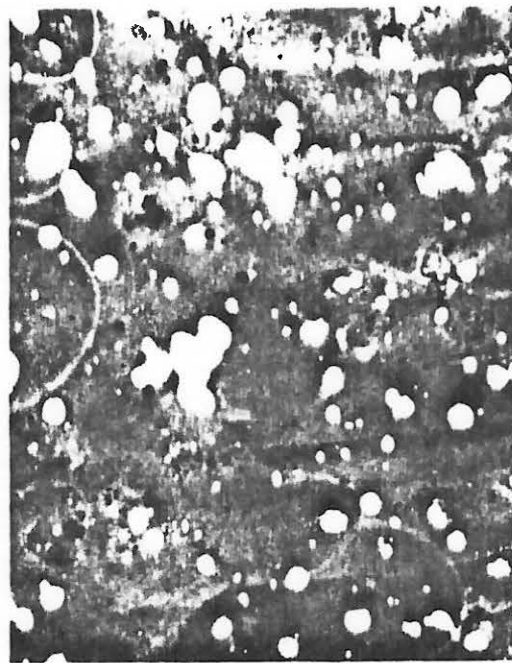
Thermal treatment of uncorroded mirrors yields some features which bear a remarkable resemblance to that of corroded mirrors. The micrographs shown in Figure 5 exhibit structures with a morphology very similar to that shown by the corroded mirrors. (A direct comparison at identical magnification of a corroded specimen with a heat treated specimen is shown in Figure 6). The number density, size, and distribution of the light areas (which are bright blue when viewed in transmitted light) in the micrographs of the heat-treated specimens are all quite similar to those of the holes through the metal film in the corroded specimens. Heat treatment of an uncorroded specimen at 275°C or above, in fact, results in the formation of what appear to be holes in the metallic film. These holes appear to result from the disappearance of the blue regions observed in specimens heat-treated at lower temperatures. Examination of these holes at 1000X indicates that the "holes" are actually filled with many small particles (approximately 1 micrometer in diameter). The morphology of the material within these areas is very similar to that observed when silver films without a copper overcoat are given a similar heat

- Figure 5 Effect of thermal treatment on the morphology of uncorroded mirrors heated in air for one hour at the indicated temperature. Micrographs were taken with transmitted light.

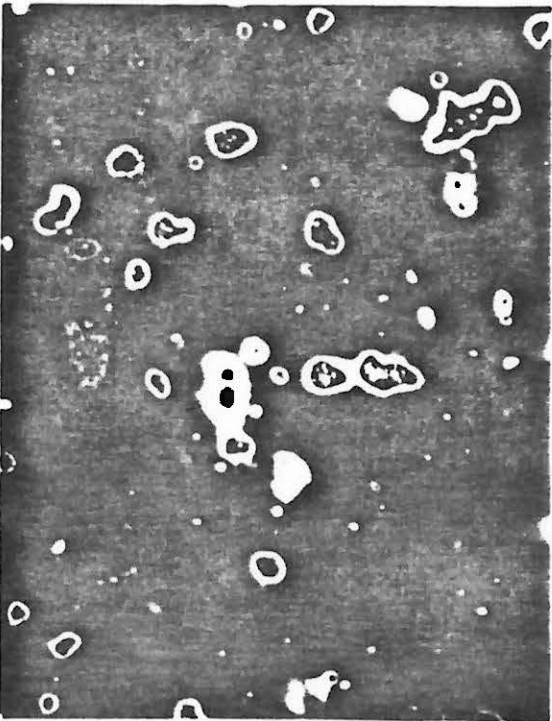
morphology to that observed in corroded mirrors. Heat treatment at higher temperatures (275°C) in air results in the formation of holes which are filled with agglomerated silver. This result strongly suggests that the process observed during heat treatment is related to that occurring during corrosion in this field.

- Figure 6 A comparison of the morphology of an (A) corroded mirror and (B) a heat treated uncorroded mirror.
- Figure 7 Optical properties of uncorroded (solid lines), outdoor exposed (CM1 and CM2, dashed and chain-dashed lines, respectively) and accelerated aged (CM3, dotted lines) mirrors. (A) Specular reflectance of the mirrors. (B) Transmittance spectra of the glass superstrates. (C) Specular reflectance of the silver-glass interface. (D) Difference spectra, obtained by subtracting the reflectance of the corroded interface from that of the uncorroded interface.

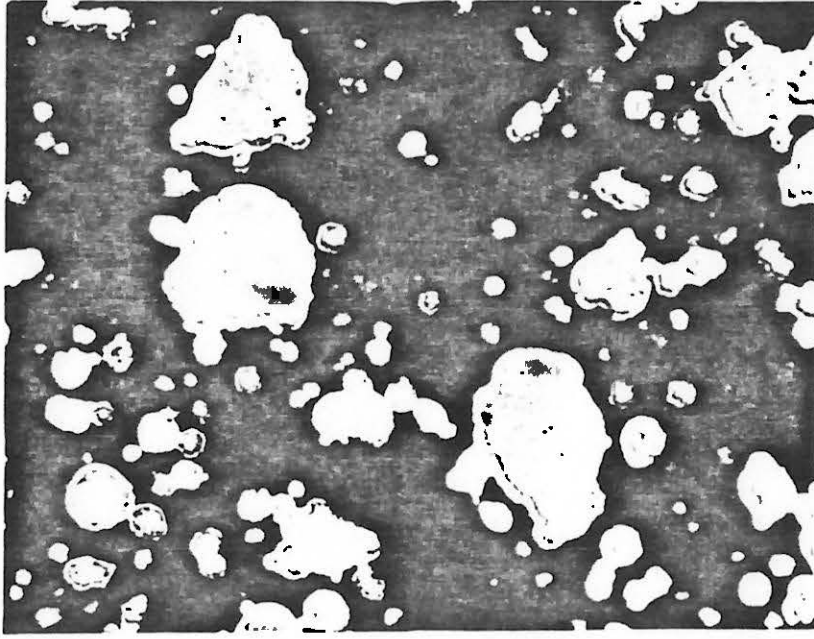
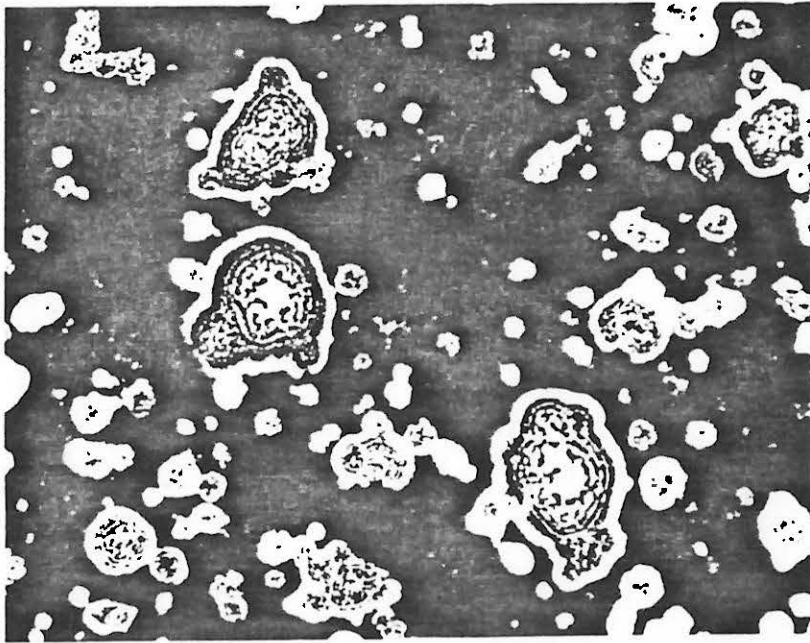
However, allowing for these diffraction effects, certain conclusions can be drawn from the data of Figure 8: (a) removal of the agglomerated material significantly increases the transmittance of the sample; (b) the transmittance of the rinsed sample is in reasonable agreement with the measured fractional hole area and reflectance for wavelengths less than $0.7 \mu\text{m}$ appears insufficient to explain the corresponding decrease in reflectance, suggesting that this portion of the reflectance decrease is associated with absorptive losses; and (d) there are no sharp spectral features associated with the agglomerated silver over the wavelength region $0.35\text{-}2.5 \mu\text{m}$.

- Figure 9 Micrographs of the samples used to obtain the spectra shown in Fig. 8.
- Figure 10 Raman spectra of heliostats. The heat treated spectrum was obtained from a stripped mirror after removal of the copper layer and subsequent exposure to wet air at 300°C (the index mark at left is the zero level). The two lower curves were obtained from an intact mirror exhibiting corrosion spots, and represent spectra from corroded and uncorroded areas on the reflective silver surface. The vertical scale and zero level for these two curves are the same, but unrelated to the top curve.

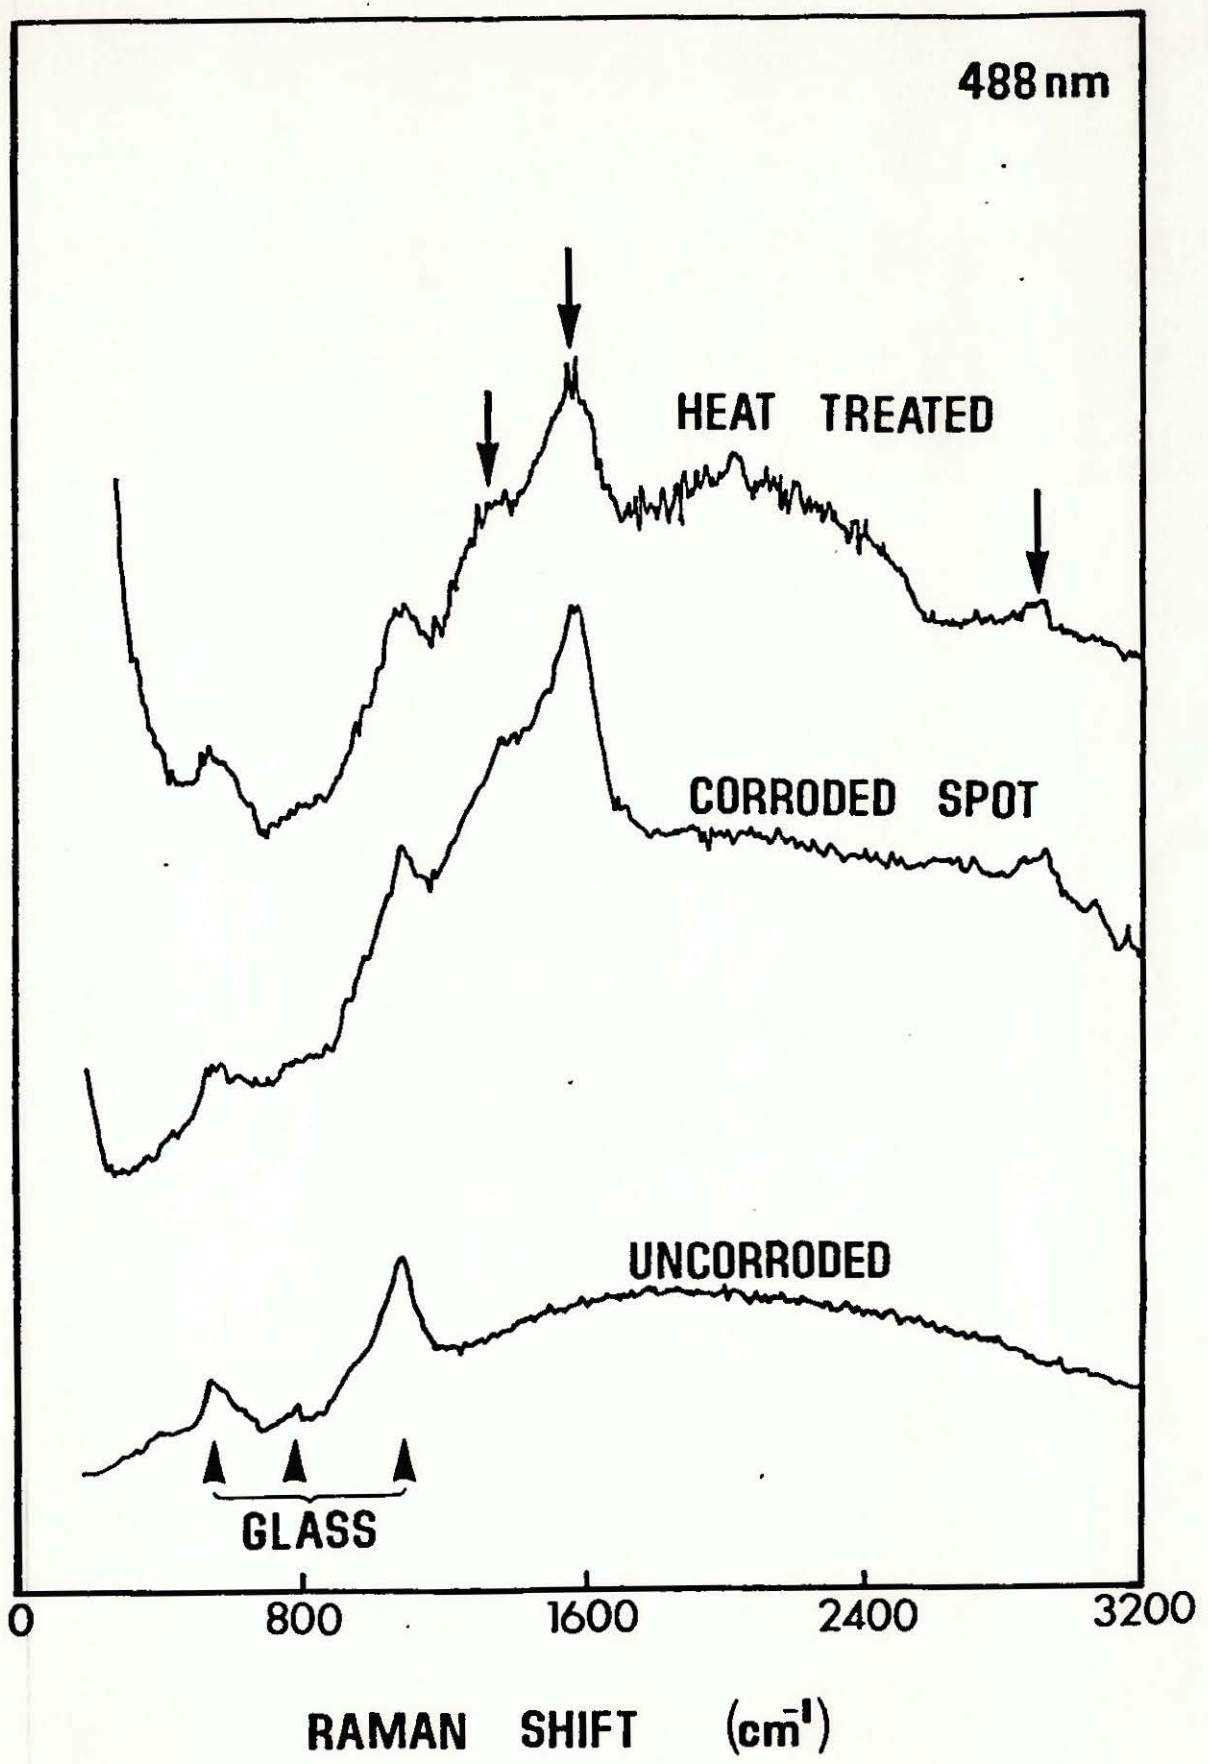
Raman spectra from a heliostat exhibiting large ($\sim 1\mu\text{m}$) dark corrosion spots are also shown in Figure 10. The lower spectrum was obtained from an uncorroded region of the reflective silver layer. The peaks labeled "glass" and the smooth background intensity result from Raman scattering and fluorescence in the glass, respectively (the laser was incident from the glass side of the unstripped mirror). The lack of surface enhanced scattering is attributed to the relative smoothness of the uncorroded silver surface.

Examination of a corroded region revealed additional peaks similar to those observed in the heat-treated mirror (see the middle curve in Figure 10). An added background intensity was also observed which is believed to result partly from fluorescence by the protective paint backing. This result is consistent with the previous observation (3.1.1.) that light is transmitted through the silver and copper layers in severely corroded regions. The appearance of prominent surface enhanced features further suggest that metallic silver is also present within the degraded region. Spectra taken with the laser focused to a point at different locations in the region show increased surface enhanced intensities in the outer, rather than central areas. These results are consistent with particulate or roughened metallic silver existing within the corroded area, and possibly less abundant in the core region. The similarity of the corroded spot spectra with the spectra from heat-treated mirrors suggests a similarity in silver morphology, i.e., agglomerated or
