# Solar Total Energy System Facility Project Semiannual Report April 1976 - September 1976

Solar Total Energy Test Facility Division

Prepared by Sandia Laboratories, Albuquerque, New Mexico 87115  
and Livermore, California 94550 for the United States Energy Research  
and Development Administration under Contract AT (20-1) 780

SOLAR TOTAL ENERGY SYSTEM TEST FACILITY PROJECT  
SEMIANNUAL REPORT  
April 1976 - September 1976

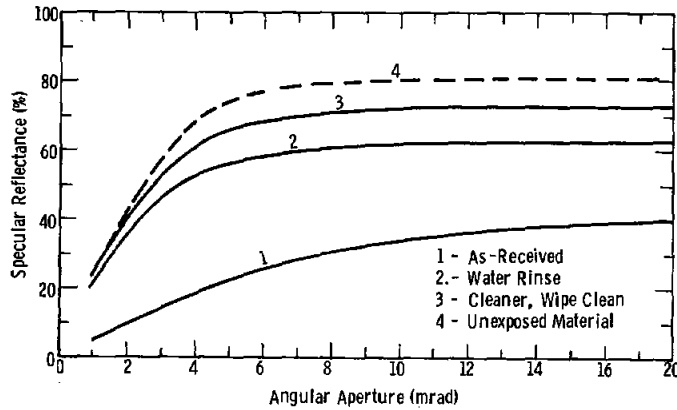
The specular reflectance properties at 500 nm are shown in Figures 3-2 and 3-3. The results at 800 nm are similar to those at 500 nm except that the decrease in reflectance due to the dirt is less at 800 nm than at 500 nm. This is to be expected since scattering from small particles is generally inversely proportional to the wavelength.

Figure 3-2. Specular Reflectance Properties of Reflector Sheet No. 20 Together with Unexposed Material at 500 nm

The extreme amount of dirt on sheet No. 20 reduced the specular reflectance below 30% out to 8 mrad. However, after water rinsing, the reflectance at the same aperture jumped to 61%; with more careful cleaning, the reflectance rose to 71%. For sheet No. 31, the reflectance was 66% at 8 mrad in the as-received condition, and increased to 78% after careful cleaning. Note that in both cases the reflectance never reaches the asymptotic value of 87%. For unexposed material at this wavelength, the specular reflectance at large angular apertures is only 81% as shown in Figure 3-3. Therefore, even after careful cleaning, a residual reflectance loss of 2 to 8% remained. Because the hemispherical reflectance values remain unchanged after cleaning, the decrease in the specular reflectance must be due to a change in the surface condition of the reflector. Additional experiments, involving premeasured samples, are in progress.

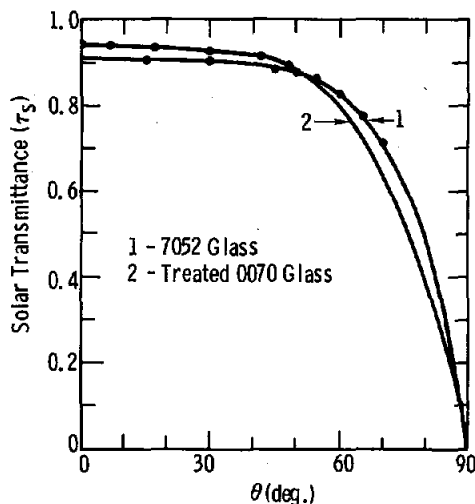
Corning 0070 glass, 0.4 mm (0.069 in.) thick: This glass is treated with fluoboric acid (vapor process) to produce an antireflector coating on both sides of the sample. Because of sample size limitations, data were obtained from 0 to 48 deg. incident angle; the transmittance has been extrapolated to 0% at 90 deg. incident angle.

Figure 3-4. Solar Transmittance as a Function of Incident Angle For 7052 Glass and Treated 0070 Glass

The transmittance data have been curve fit to a polynomial of the form

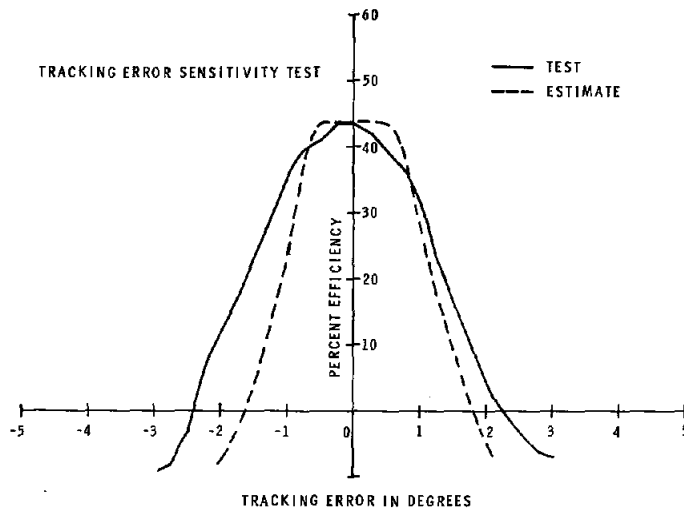
Figure 3-8. Tracking Error Sensitivity Test, Southwest Quadrant

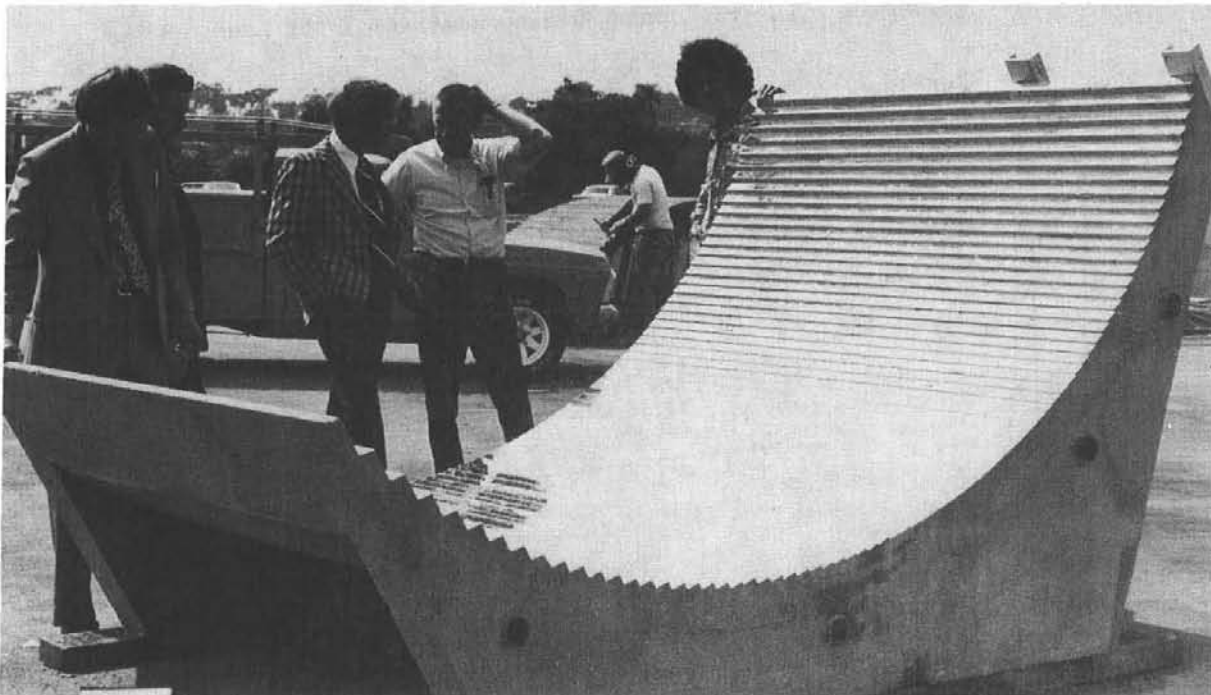
Figure 4-1. General Atomic Fixed Mirror Reflector

The individual company concepts are illustrated in Figures 4-1 through 4-4.

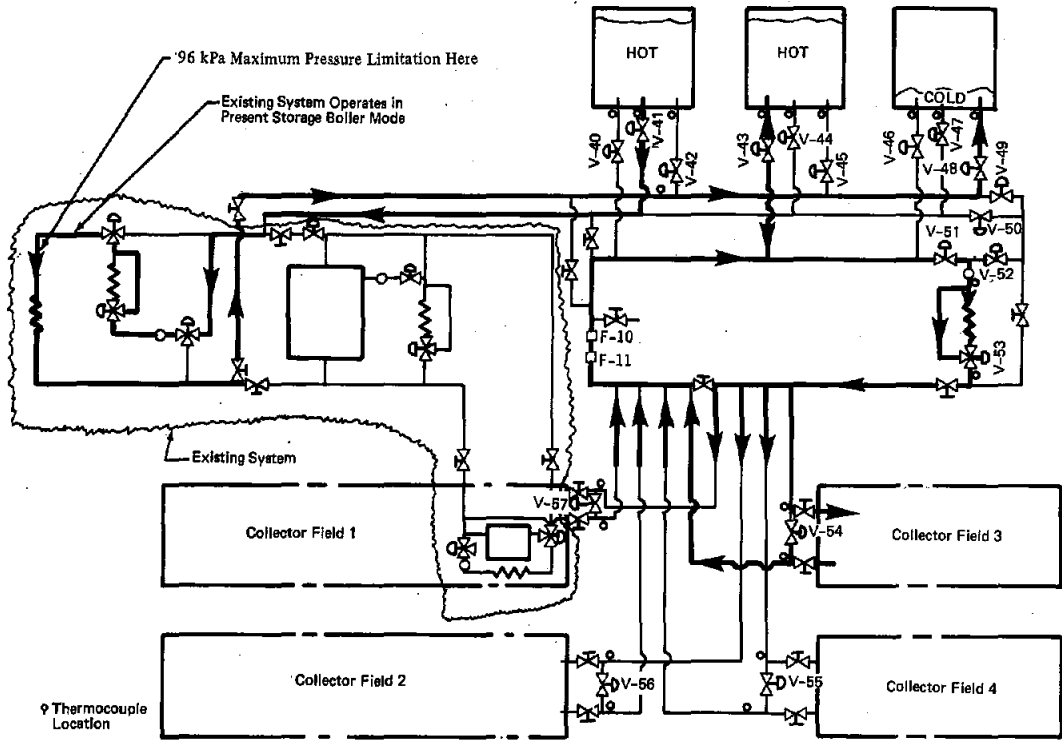
Figure 5-4. Storage Full (Mode 22)

Option 3 allows for withdrawal of fluid from a cold tank simultaneously with operation of the boiler. This option is necessary if collector preheat is to be only to 243°C (470°F). Option 3 will be selectable remotely from the control room.
