SAND81-8008

Testing of the Prototype Heliostats for the Solar Thermal Central Receiver Pilot Plant

TESTING OF THE PROTOTYPE HELIOSTATS
FOR THE SOLAR THERMAL CENTRAL RECEIVER PILOT PLANT

ABSTRACT

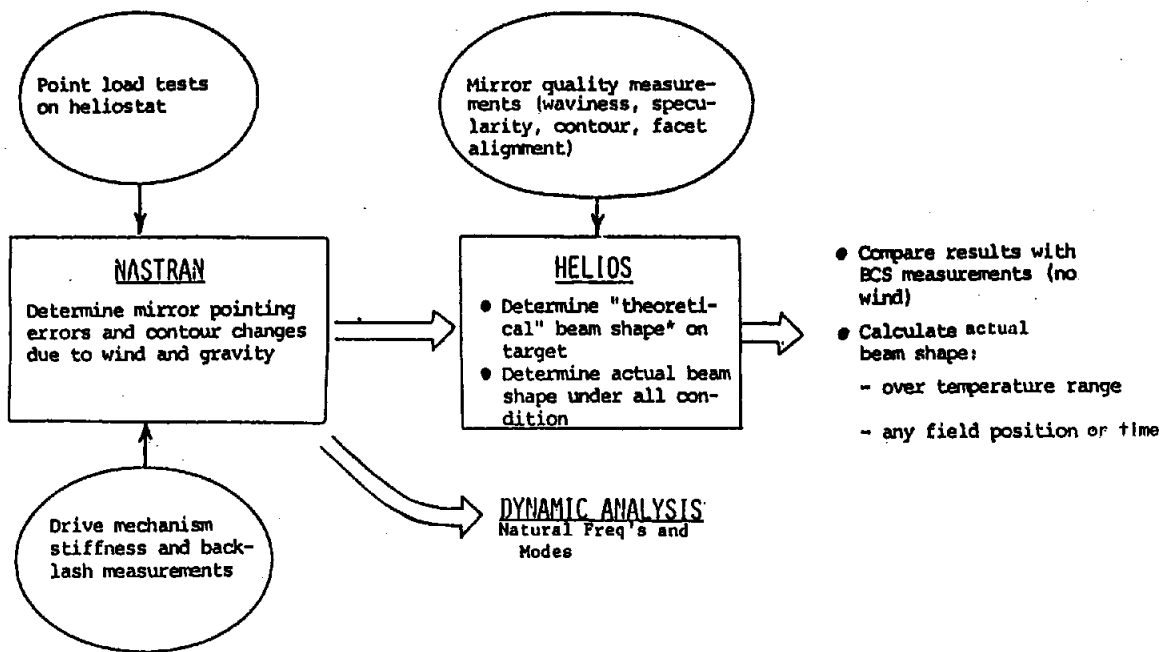
Figure 12. Pilot Plant HelioStat Performance Evaluation Analysis

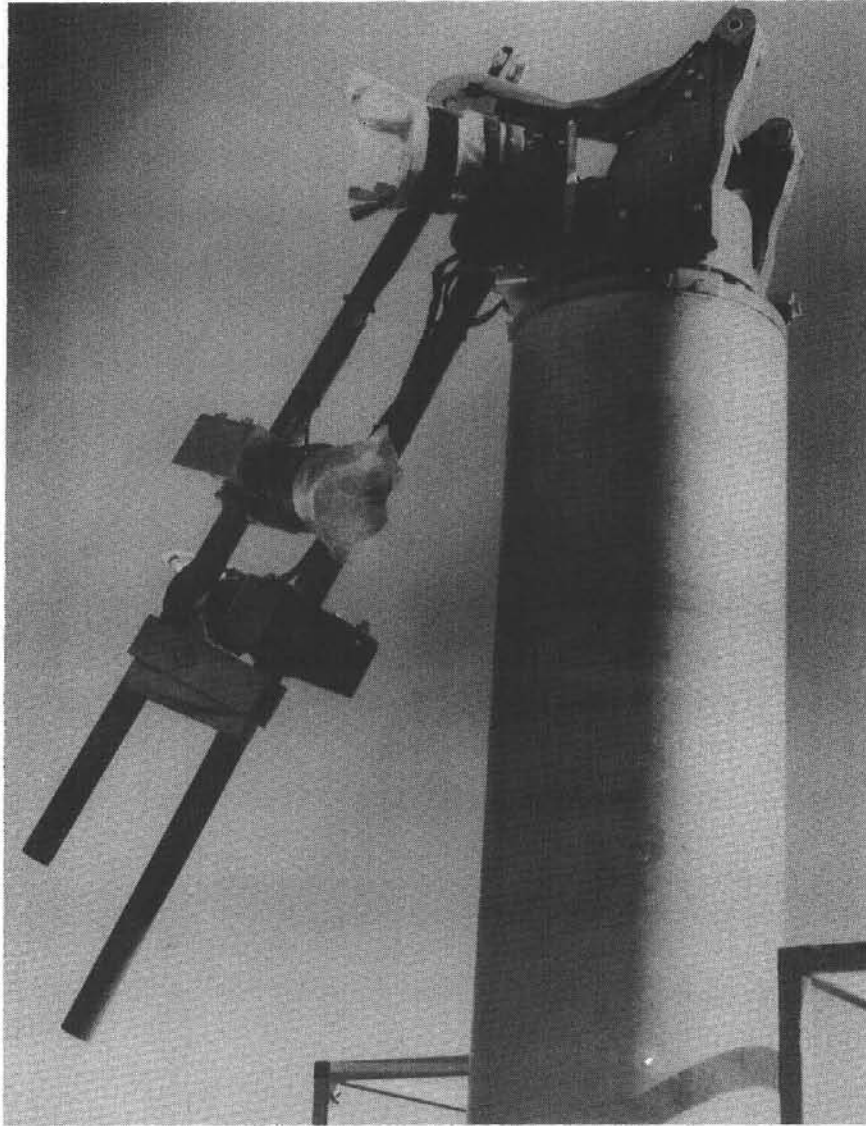
Figure A-10. MDAC Drive Unit Installed on Pedestal

On 6/5/79 MDAC personnel began assembling heliostat hardware at the CRTF. Initially, the pedestals were installed on the CRTF foundations as shown in Figure A-9. During installation the pedestals were roughly leveled by using a level across the top end of the pedestal. The MDAC approach to field installation involved only a rough leveling of the drive unit in the field with subsequent compensation for azimuth axis tilt done in the control software (a further discussion of this approach will be given during description of tracking accuracy testing). The drive units were then installed to the top of the pedestals, as shown in Figure A-10, with the elevation tube of the helio-

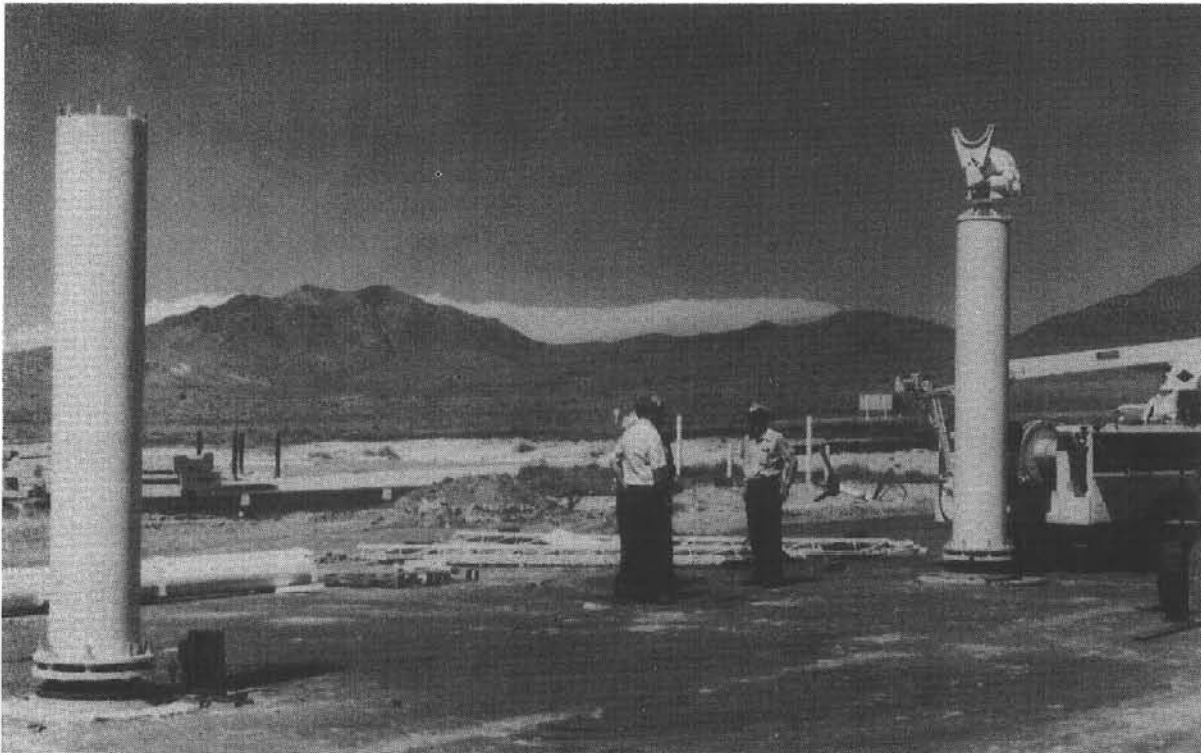
Figure A-15. Field Assembly of MMC Prototype Heliostats

MMC personnel began assembling their heliostats at the CRTF on 6/12/79. All hardware was off-loaded at the foundation site and the pedestals and drive units were installed on the foundations (Figure A-15). After the drive units were secured to the pedestals they were leveled to within 0.14 milliradians (30 seconds) using an electronic inclinometer. Leveling was achieved by adjusting the mounting bolts at the base of the heliostat pedestal as the drive unit was rotated to different azimuth positions. This procedure is indicated in Figure A-16 where the inclinometer can be seen sitting on the top of the drive unit.

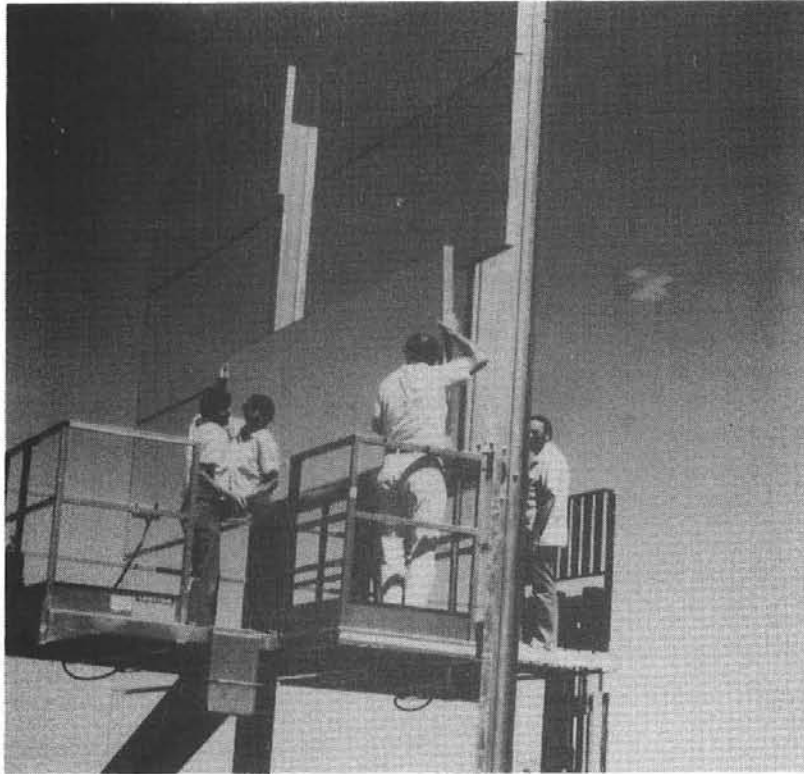
Figure A-3.1. Mirror Modules Being Exchanged on MDAC Heliostat #1

On 7/12/79 Mirrors 6 and 12 on MDAC Heliostat #1 were exchanged as shown in Figure A-3.1. The MDAC approach to mirror replacement involved relying on strict manufacturing tolerances on mirror module dimensions between the mounting cups and the mirror face. Recanting then only involved the switching of predetermined spacers from the mirror being replaced to the replacement mirror. This procedure was used during testing at the CRTF.

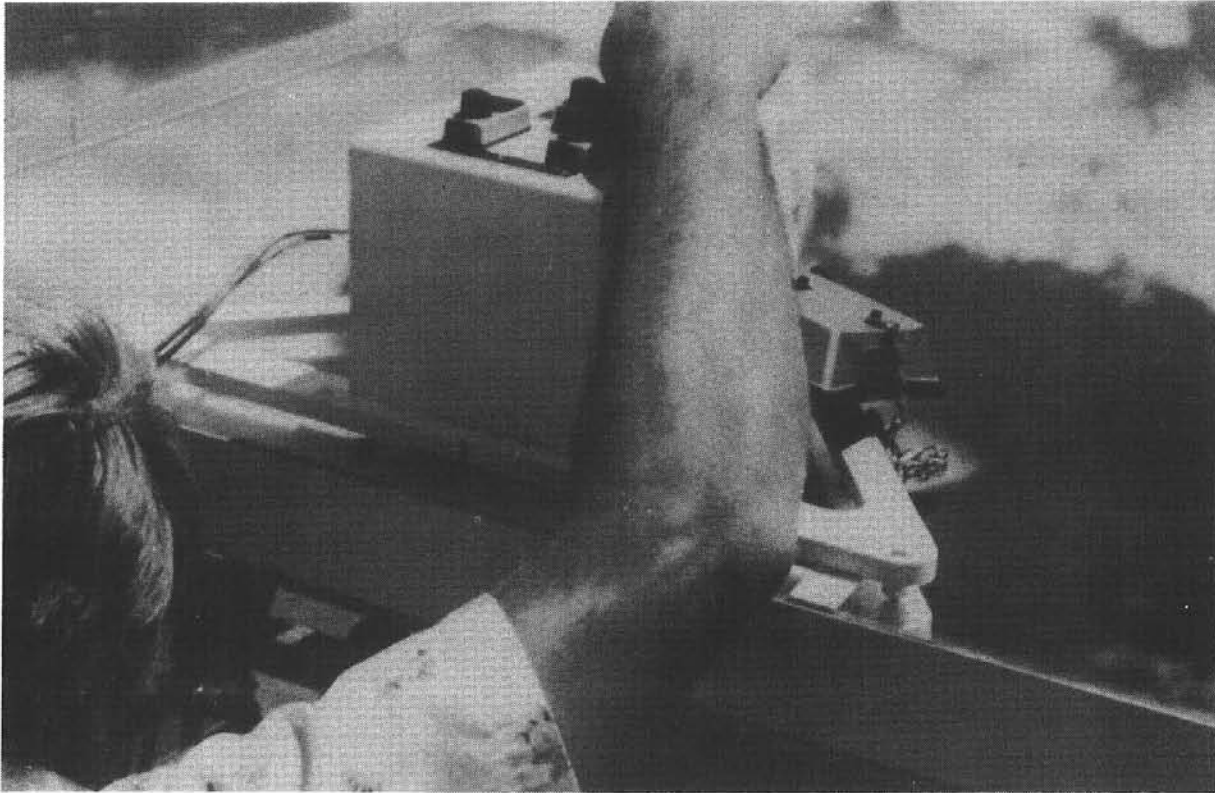
Figure A-3.4. MMC Recanting Tool in Use During MMC Mirror Module Exchange

After mirror replacement, the heliostat was rotated in elevation to a horizontal (mirror face up) orientation. One of the recanting tool base units was placed on the heliostat reference mirror (typically Number 5) and the second unit was placed on the mirror to be aligned. The angular orientation of any mirror with respect to the reference mirror was predetermined. Therefore, two predetermined angles for the replacement mirror were set on the digital dials on the top of the inclinometer housing, as shown in Figure A-3.4. The

three mirror mounting adjustment bolts were adjusted until the meters were nulled and then the bolts were tightened. This test was performed for an off-axis mirror alignment as previously defined in Table A-2.I.

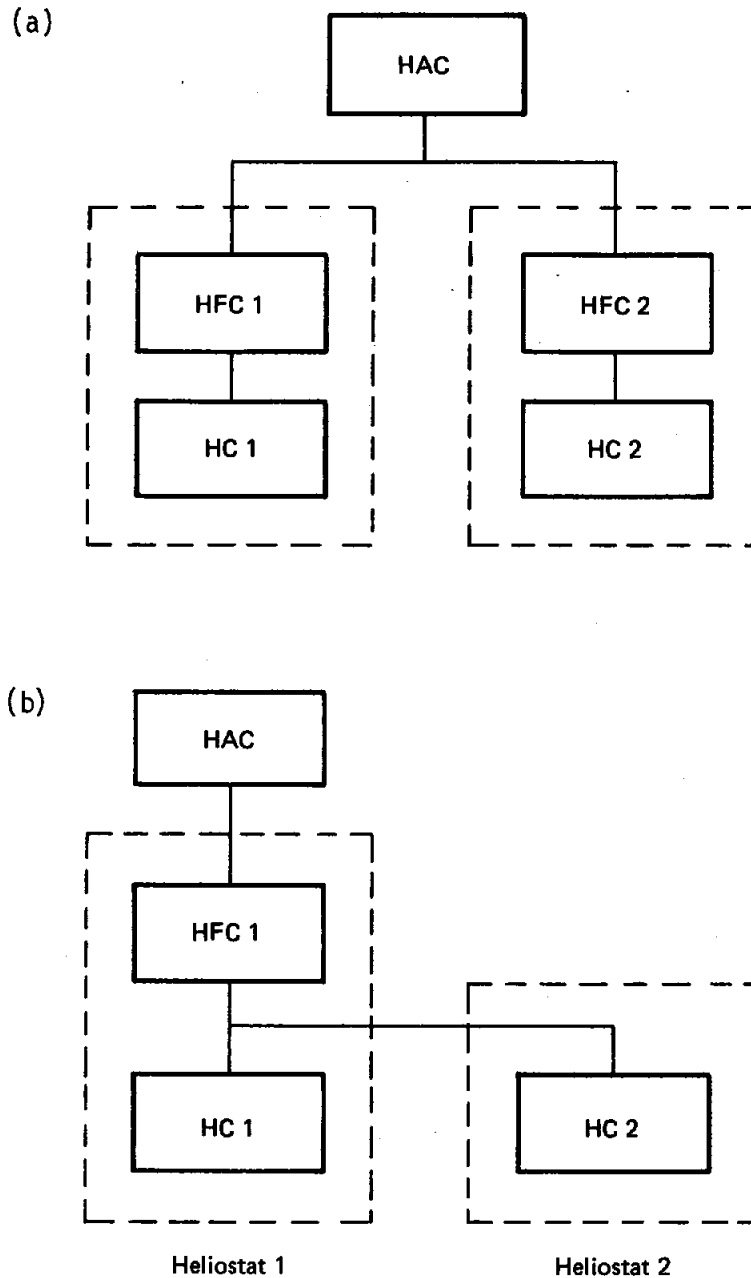
Figure A-4.1. Helio 1 and Helio 2 Control Configurations Used at the CRTF during Testing. (a) Dual HFC and (b) Single HFC.

In the MMC design, the computational requirements are shared by the HAC and the HC. The HAC calculates the sun position and sends this information via the HFC to the HC. The HC uses the sun position to calculate the required azimuth and elevation position. The required position is compared with the actual position from the incremental encoders on the heliostat and the motors are turned on as needed to reach the desired position. The encoders have a 13-bit or 0.76-mR resolution. The heliostat absolute position is determined from a separate, single-encoder bit. This bit or mark is located a few degrees from the normal, face-down stow position. The absolute position is corrected when the heliostat encounters this bit.

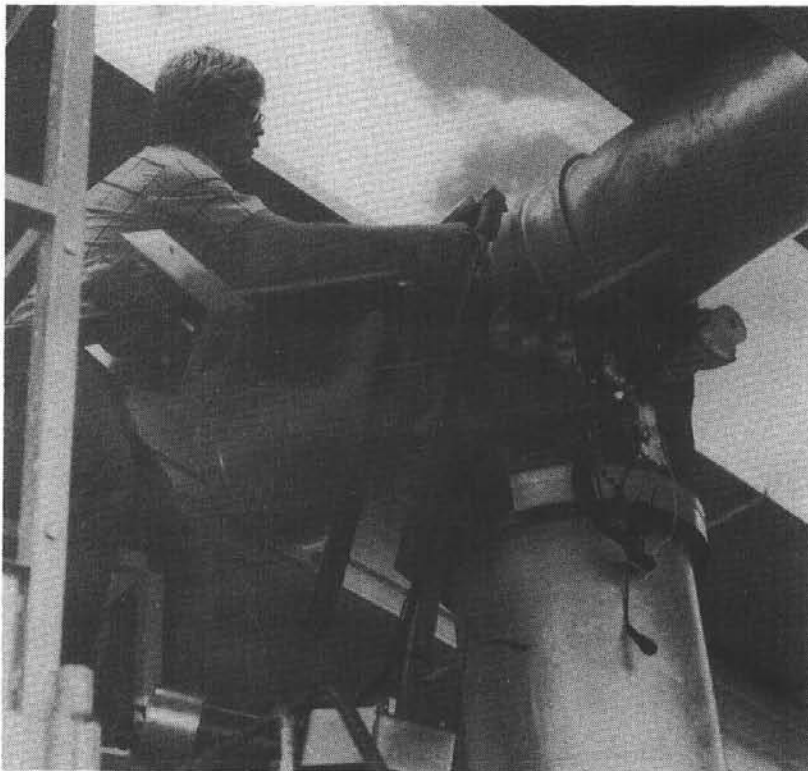
Figure A-8.2. MDAC Damaged Stow Jack Being Replaced

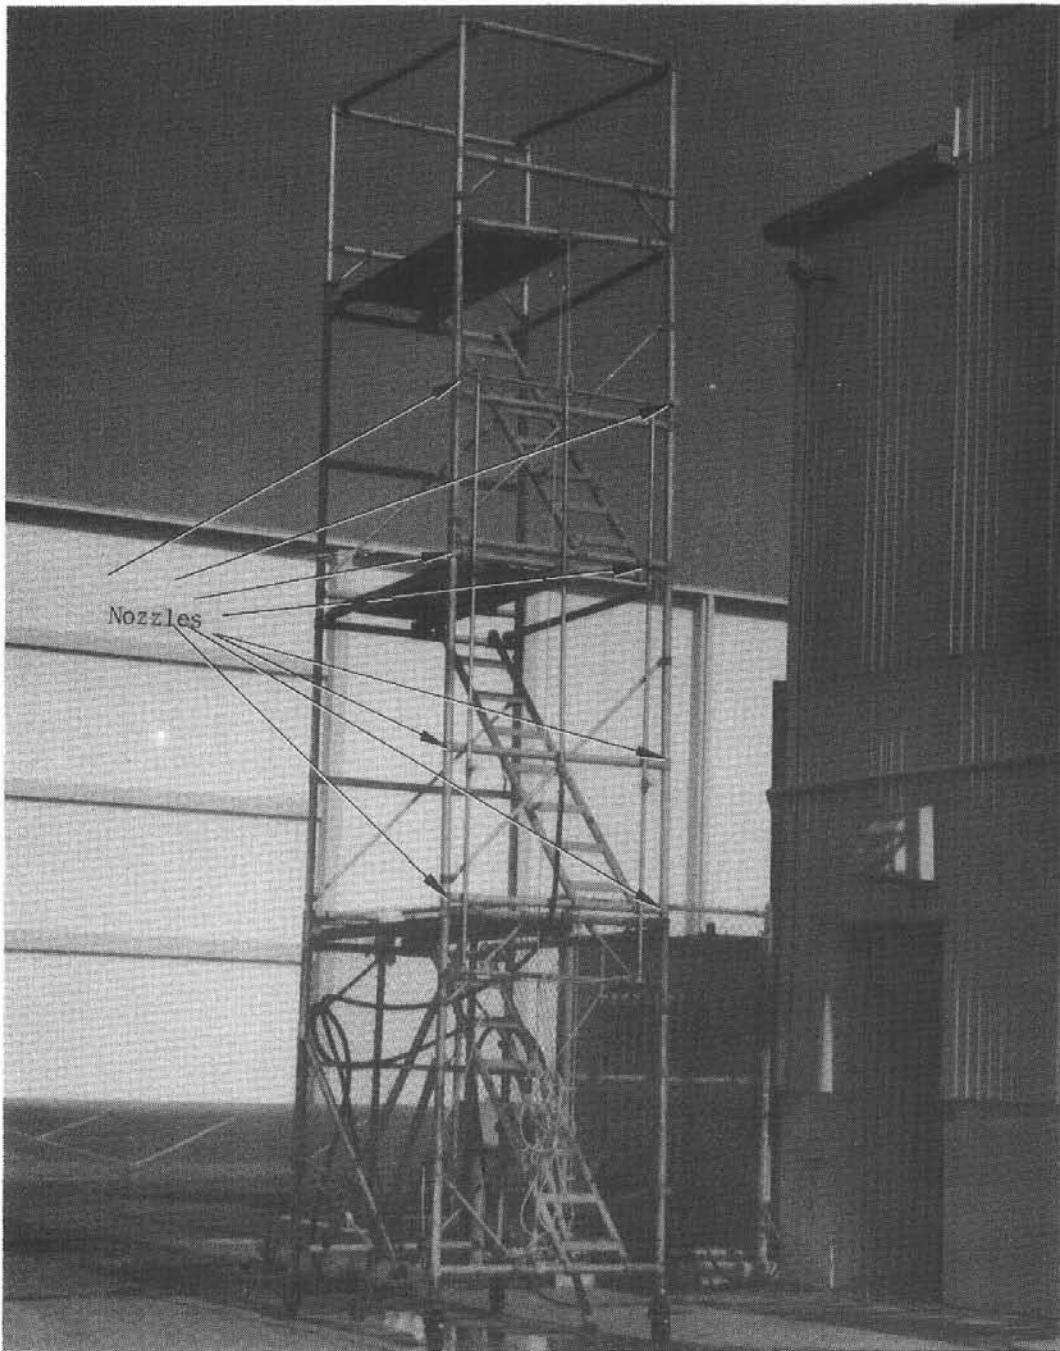
Figure C-3. Rain Fixture

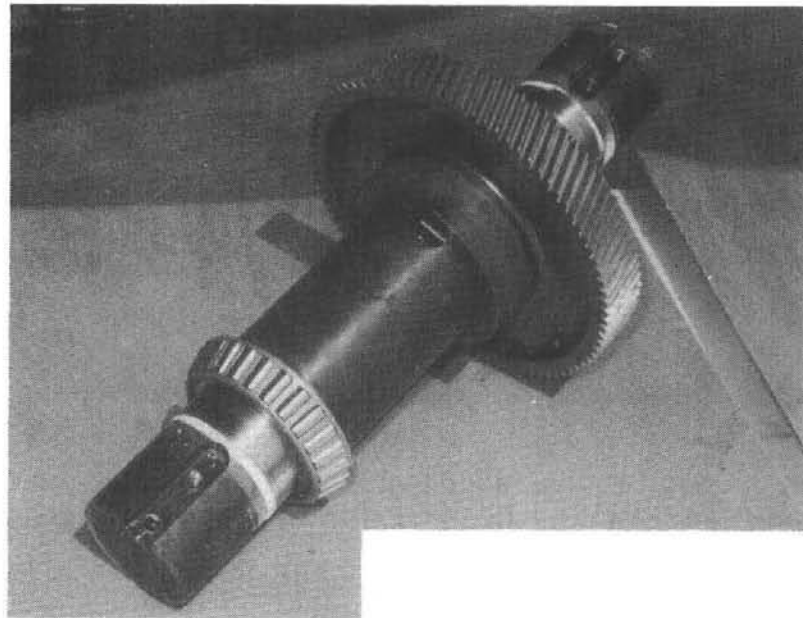
Figure C-8.8. MMC Elevation Output Shaft and Gear

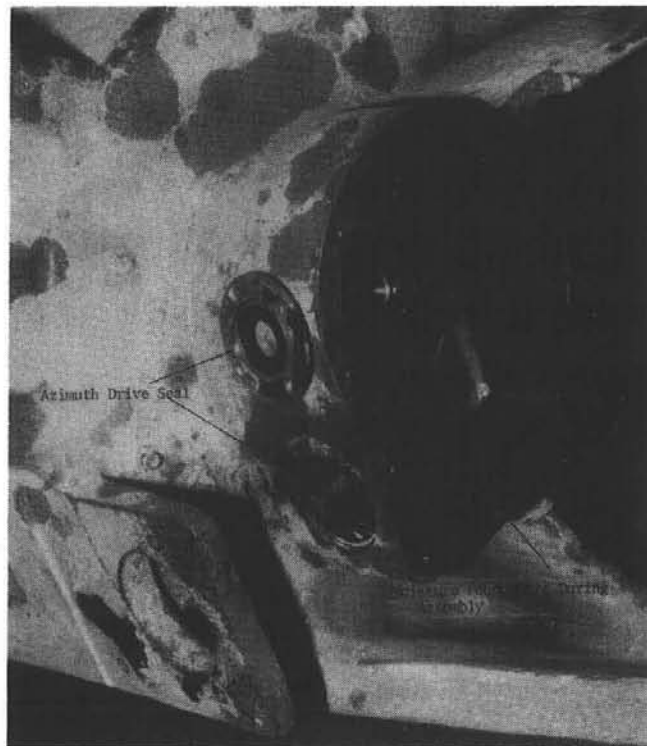
Figure C-8.25. MDAC Azimuth Drive Housing
