Slow Strain Rate Testing of Alloy 800 in Molten Nitrate Salts

SAND82-8201
Unlimited Release
Printed January 1982

SLOW STRAIN RATE TESTING OF ALLOY 800
IN MOLTEN NITRATE SALTS

S. H. Goods
Materials Science Division
Sandia National Laboratories, Livermore

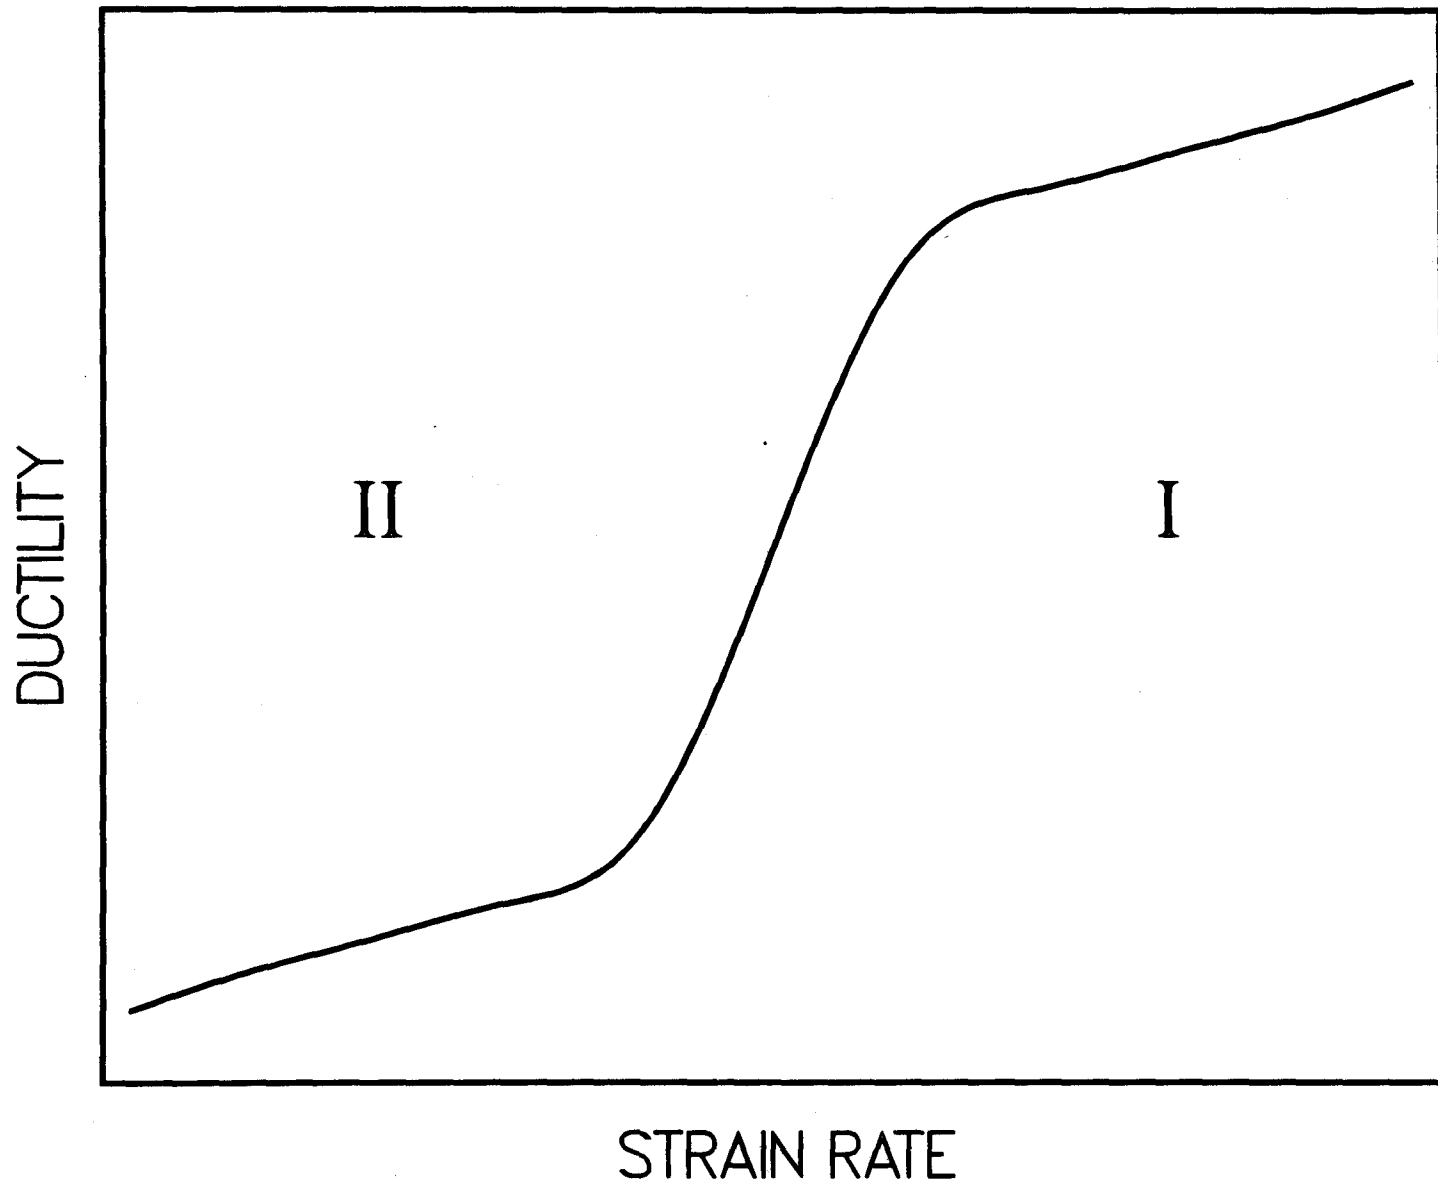
Figure 1. Schematic representation of the effect of strain rate on material ductility as measured in a SSRT experiment for a material which suffers from an environmentally induced embrittlement

Strain rate is a critical variable in the detection of a localized cracking phenomenon in a material which undergoes uniform surface attack in an aggressive medium. Figure 1 schematically illustrates the expected strain rate dependence of a material which suffers from an environmentally induced loss of ductility. In Region I the strain rate is so rapid and the resulting test time is so short that a specimen can deform and fracture before it can interact with the environment. Failure therefore occurs in a normal ductile mode. In Region II environmentally induced embrittlement occurs and the loss of ductility can be due to any of several factors. The continuous deformation results in a porous or cracked oxide scale and thus allows for an increased rate of corrosion. The concomitant loss of load bearing cross-sectional area may result in the earlier onset of necking and fracture. Alternatively, the buildup of residual stresses within the surface scale as it forms can, when coupled to the imposed deformation, allow the oxide to scale or flake off the specimen surface and expose fresh base metal. This would also tend to increase the overall rate of scale formation and increase the rate of metal loss. Finally, deformation-induced cracking of near surface grain boundaries can allow the aggressive environment to penetrate to regions deep within the specimen thereby leading to earlier fracture.

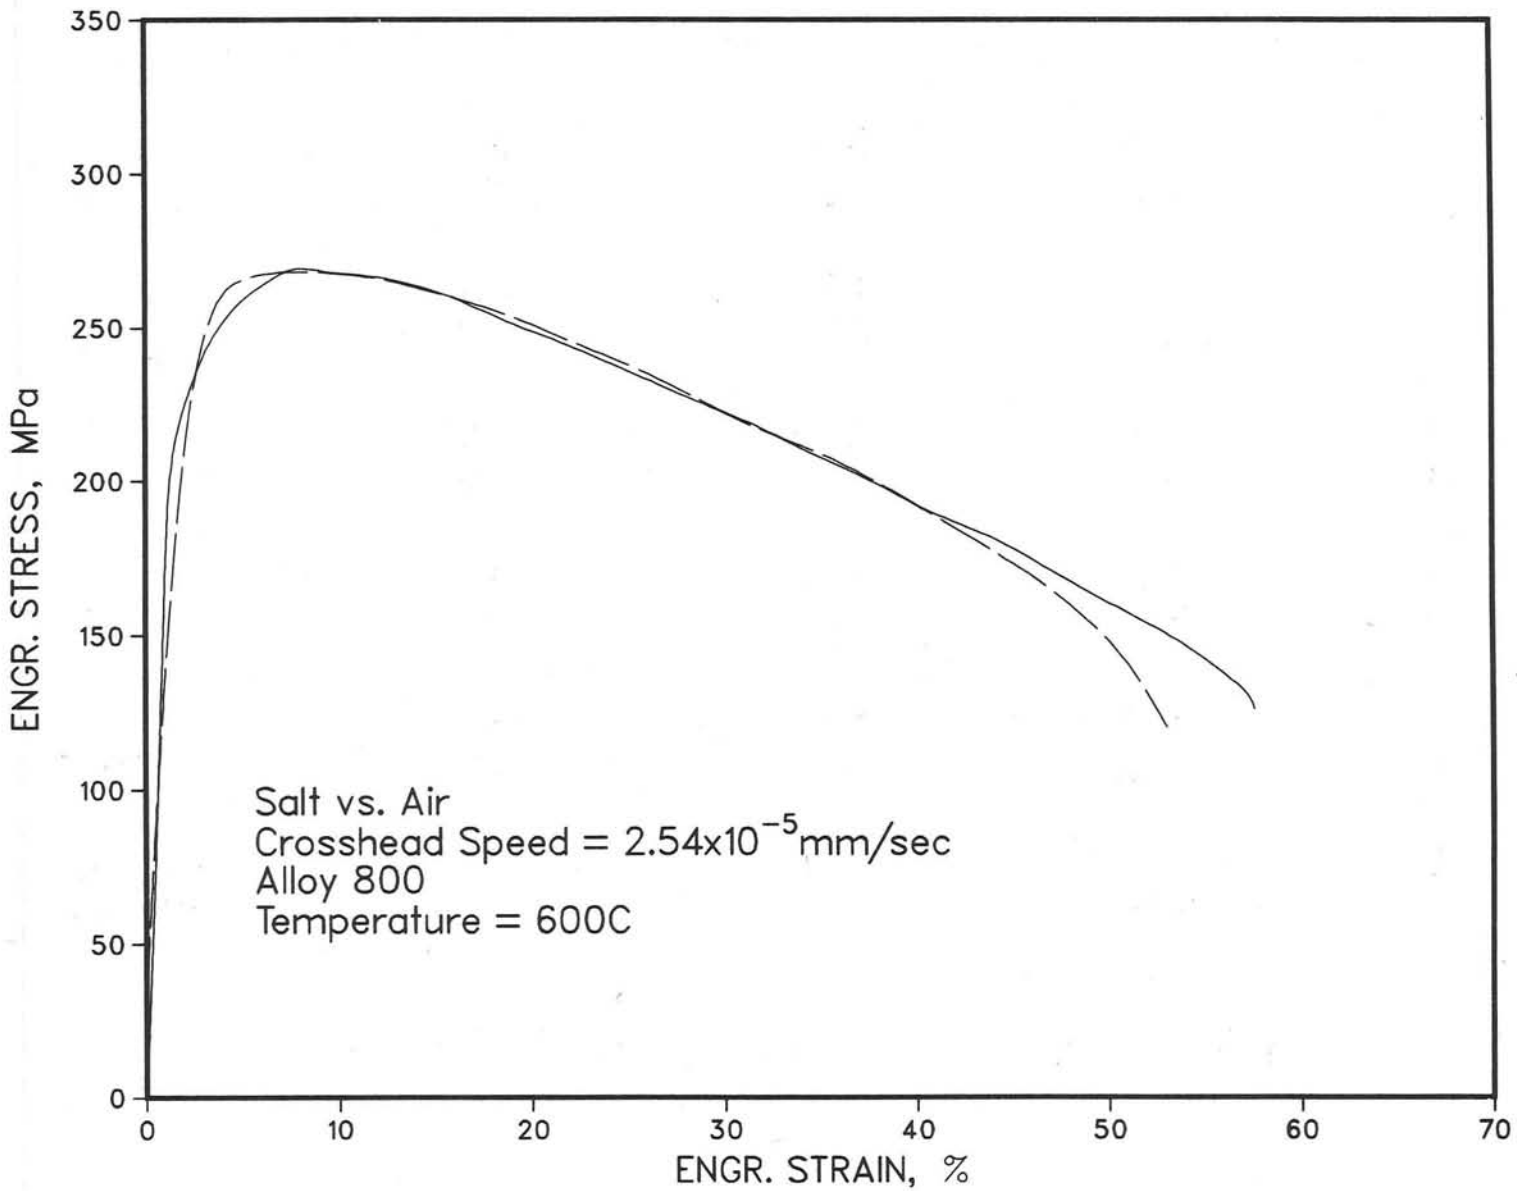
Figure 5. Comparison of two typical specimens, one tested in salt (solid curve), the other tested in air (broken curve). The superposition of the curves indicates the absence of any major environmental effect.

Figure 5 compares directly the tensile curves for Alloy 800 at 600°C tested in salt (the solid curve) and in air (broken curve) at the same initial strain rate of $1 \times 10^{-6} \text{ sec}^{-1}$. The curves virtually superimpose, thereby indicating the absence of any measurable environmental effect. The small difference in strain-to-fracture is clearly within the expected scatter for this quantity and not indicative of a change material behavior. The data for all the mechanical testing is summarized in Table 2. From this table it can be seen that there was no appreciable degradation in material behavior as the result of prolonged salt exposure. This is more clearly shown in Figure 6 which shows the influence of initial strain rate on total elongation (Figure 6a) and reduction in area (Figure 6b). Measured in this way, the ductility in both salt and air was comparable. As the strain rate was decreased the ductility of the salt exposed samples did not markedly decrease as would be expected if environmental or stress corrosion cracking was occurring.

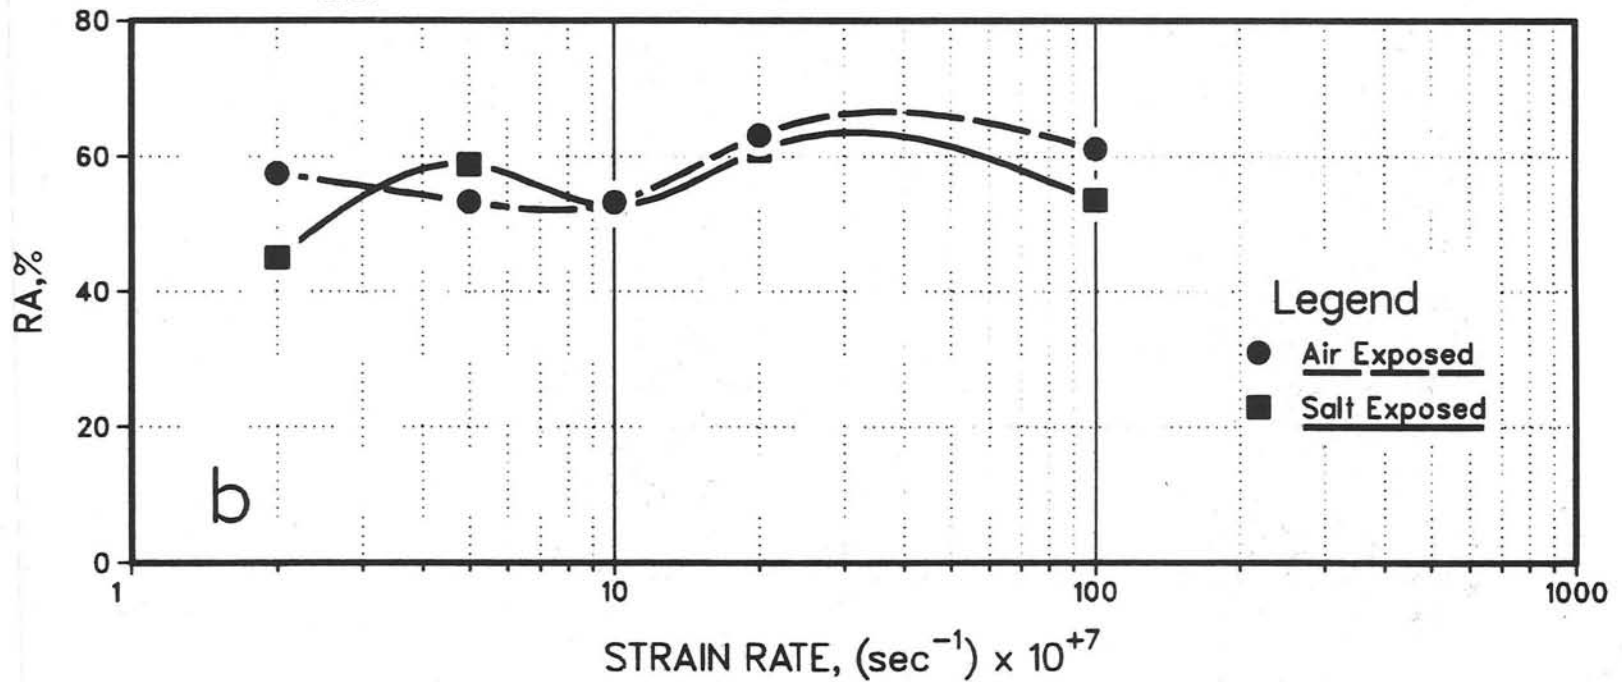
6b. Effect of strain rate on reduction in area (RA) for Alloy 800.

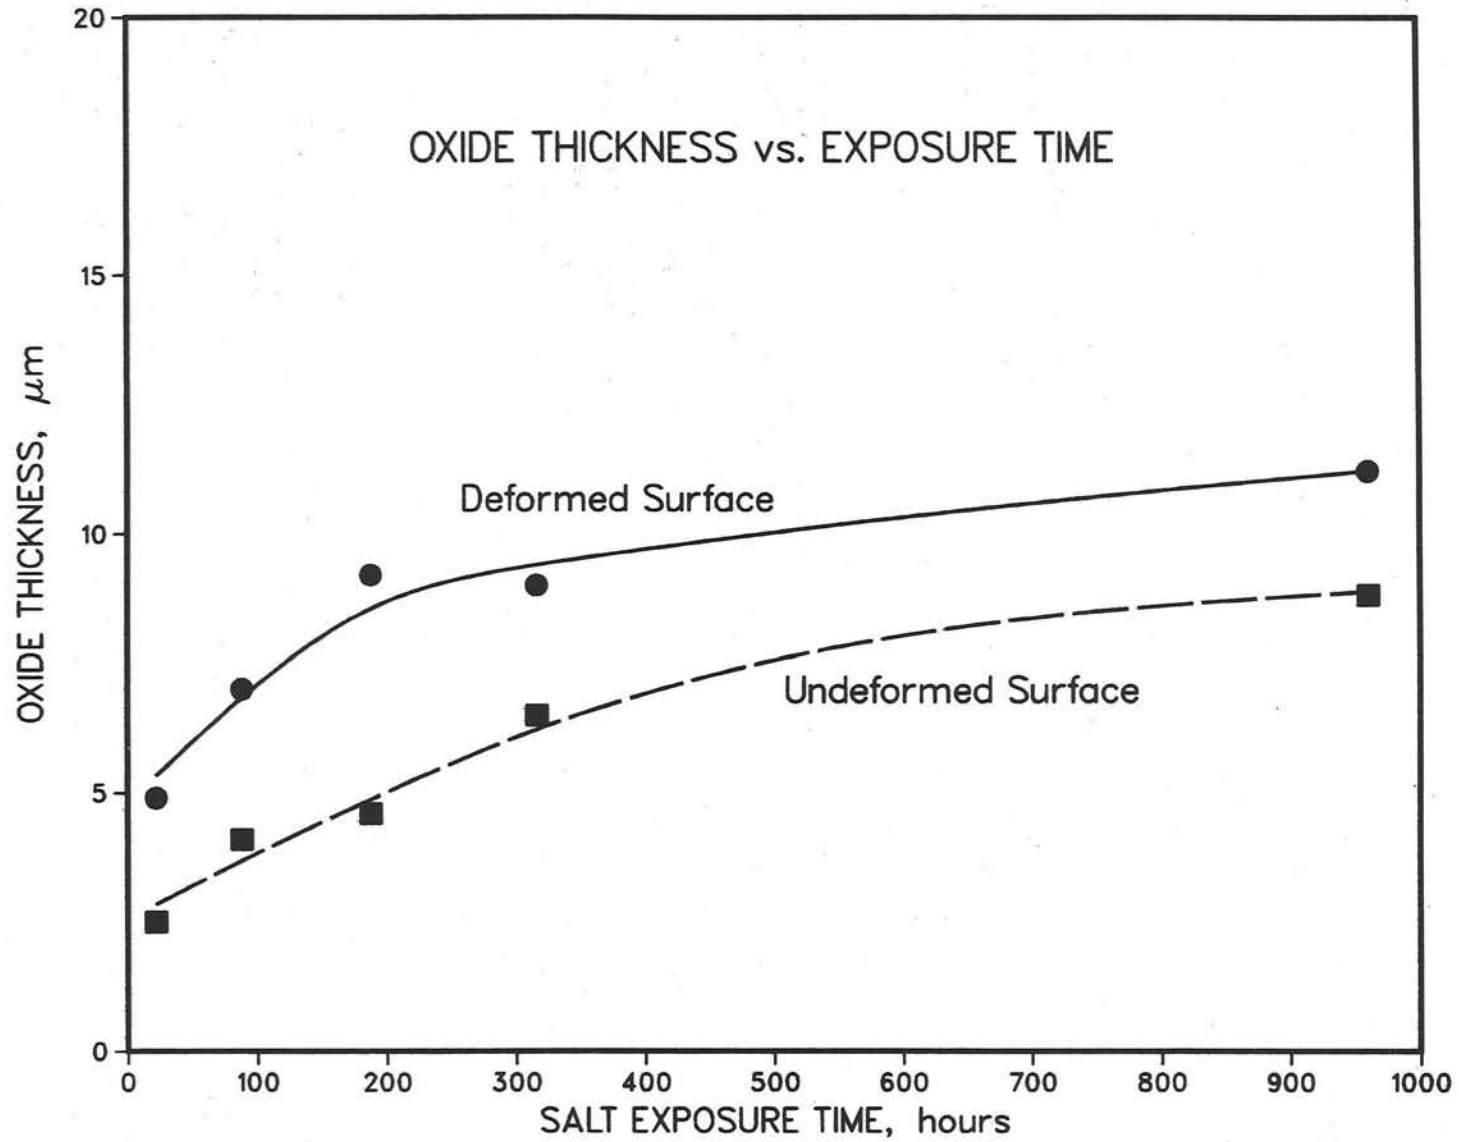
Figure 10. Effect of deformation on oxide thickness as a function of salt exposure time. For the testing performed, deformation results in an oxide which is uniformly thicker than those formed on the undeformed surfaces.

film formed on the gage sections was $\sim 11\mu\text{m}$ in average thickness while the oxide formed on the undeformed surface section was only $\sim 70\%$ as thick. In addition, the figure indicates that deformation results in more extensive microcracking of the surface scale than that present in the undeformed oxide. The oxide remains tenacious to the base metal. Flaking or spallation was not found to occur even at the high strains involved in the testing. The increased rate of oxidation on the deformed surfaces was observed at all strain rates for tests of all durations, as summarized in Figure 10. Note that in both cases the rate of oxide formation is rapid at first but then drops off dramatically with increased exposure time.

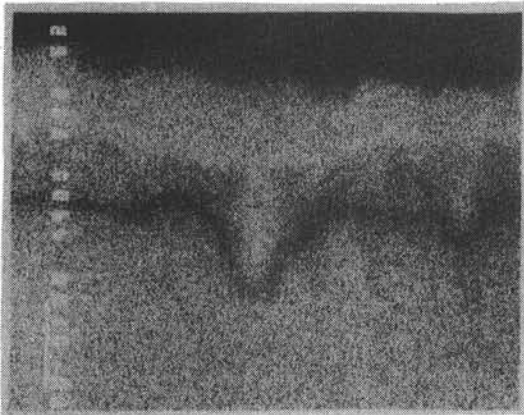
Salt Exposed Gage Section
Deformed 960 hours, 600°C

a) Electron

b) Fe

d) Cr

c) Ni

e) O

Figure 12. EDX characterization of the surface oxide formed after exposure to the molten salt for 960 hours at 600°C. Fe and Cr preferentially segregate within the oxide while Ni concentrates within the near oxide base metal.

The surface oxides which form have a complex multiphase composition as evidenced by the multiple contrast features visible in the oxides shown in Figures 9 and 11. The multiphase regions within the oxides are apparent in the micrographs taken from the specimens exposed for short times (Figure 11d, e) as well as within the oxides formed on those specimens exposed for the longest times. Figure 12 illustrates the complexity of the oxide and near-oxide interface region of the base metal obtained via EDX analysis of the region corresponding to the electron image shown in Figure 12a. The near-surface oxide was found to be iron-rich and iron-poor. Nickel appears to be relatively immobile at this temperature, not occurring in the oxide at any significant concentration. The exact stoichiometry of the oxide phases is dependent on both the exposure temperature and exposure time.
