Thermal Fatigue Tests of 'Solar One' Receiver Tube Weldments

Darcy A. Hughes

Prepared by
Sandia National Laboratories
Albuquerque, New Mexico 87185 and Livermore, California 94550
for the United States Department of Energy
under Contract DE-AC04-76DP00789

Tubing for "Solar One" receiver panels is joined by longitudinal welds using a low heat input welding process. Concern existed that lack-of-fusion defects (crack-like notches at the root of the weld) created by this welding process would propagate during diurnal thermal cycling. If crack propagation occurred at these defects, it could shorten the life of the receiver tube panels. An experiment which simulated key elements of the receiver cyclic thermal strain environment was designed to address this concern. During the experiment, receiver tube weldments (welds prepared in the laboratory) were thermally cycled for 15,000 cycles. They were subsequently examined metallographically for crack propagation. Results of this examination revealed that no crack propagation occurred during the test.

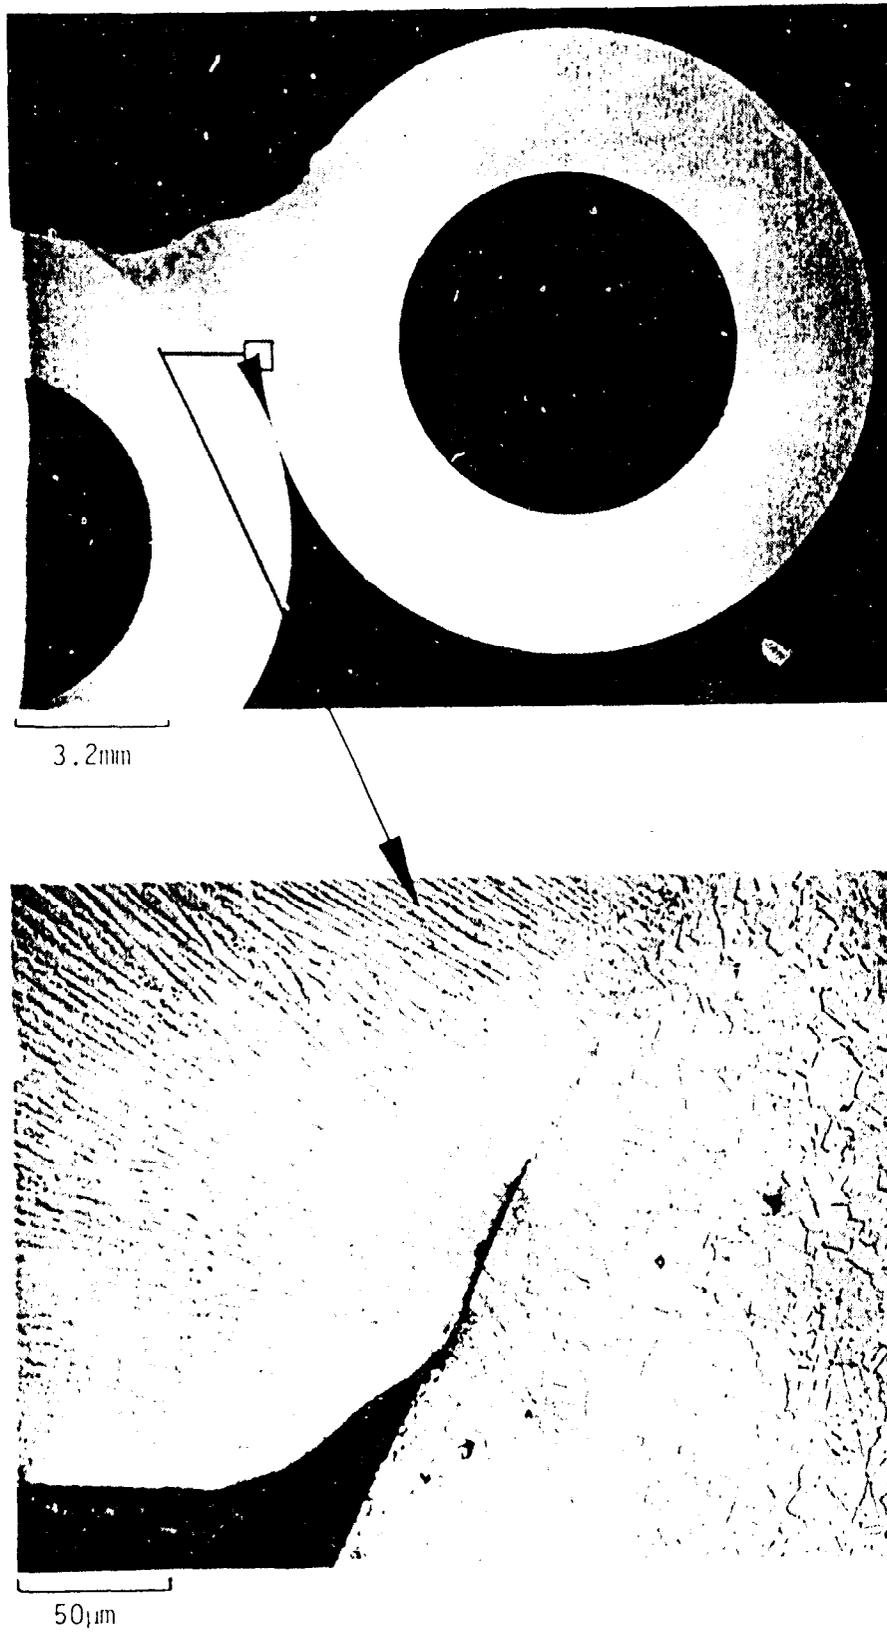
Figure 1. Micrograph of lack-of fusion weld defect prior to testing.

There was concern that the lack-of-fusion defects (crack-like notches at the root of the weld, Fig. 1) created by this welding process could propagate during diurnal thermal cycling. The direction of such possible crack propagation was also of importance because through-wall cracking may be more detrimental than longitudinal unzipping of the welds. Both crack growth rate and propagation direction are determined by the cyclic thermal stress state at the tip of the defects induced by differential thermal expansion. The differential expansion results from the combined effect of one-sided heating and different coefficients of thermal expansion between the alloy 800 base metal and IN82 weld metal (Fig. 2). The complexity of the stress state and history precluded an analytical assessment of the extent of possible crack growth; thus, a laboratory experiment was designed and set up to address this problem.

Destructive examination of all samples did not reveal the occurrence of any crack propagation. It did confirm the expected presence of potential nucleation sites, i.e., lack-of-fusion defects and solidification cracks in the GTA tack welds. Figures 8 through 10 are micrographs of some typical lack-of-fusion defects from the tested specimens. These defects do not differ in any observable way from those in the untested condition, shown in Figure 1. An example of the solidification cracks is presented in Figure 11.

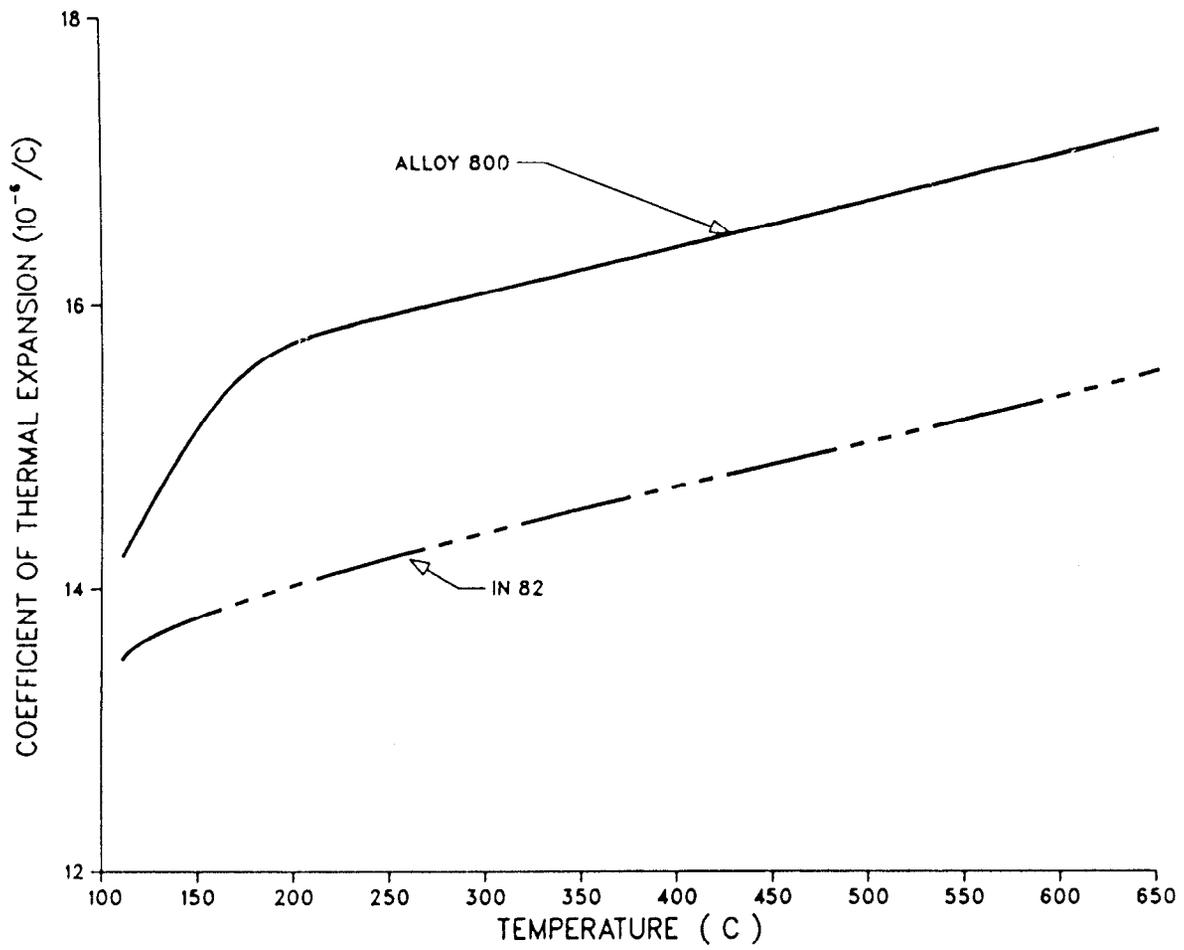
Figure 2. Average coefficient of thermal expansion for IN82 weld metal and alloy 800 versus temperature.

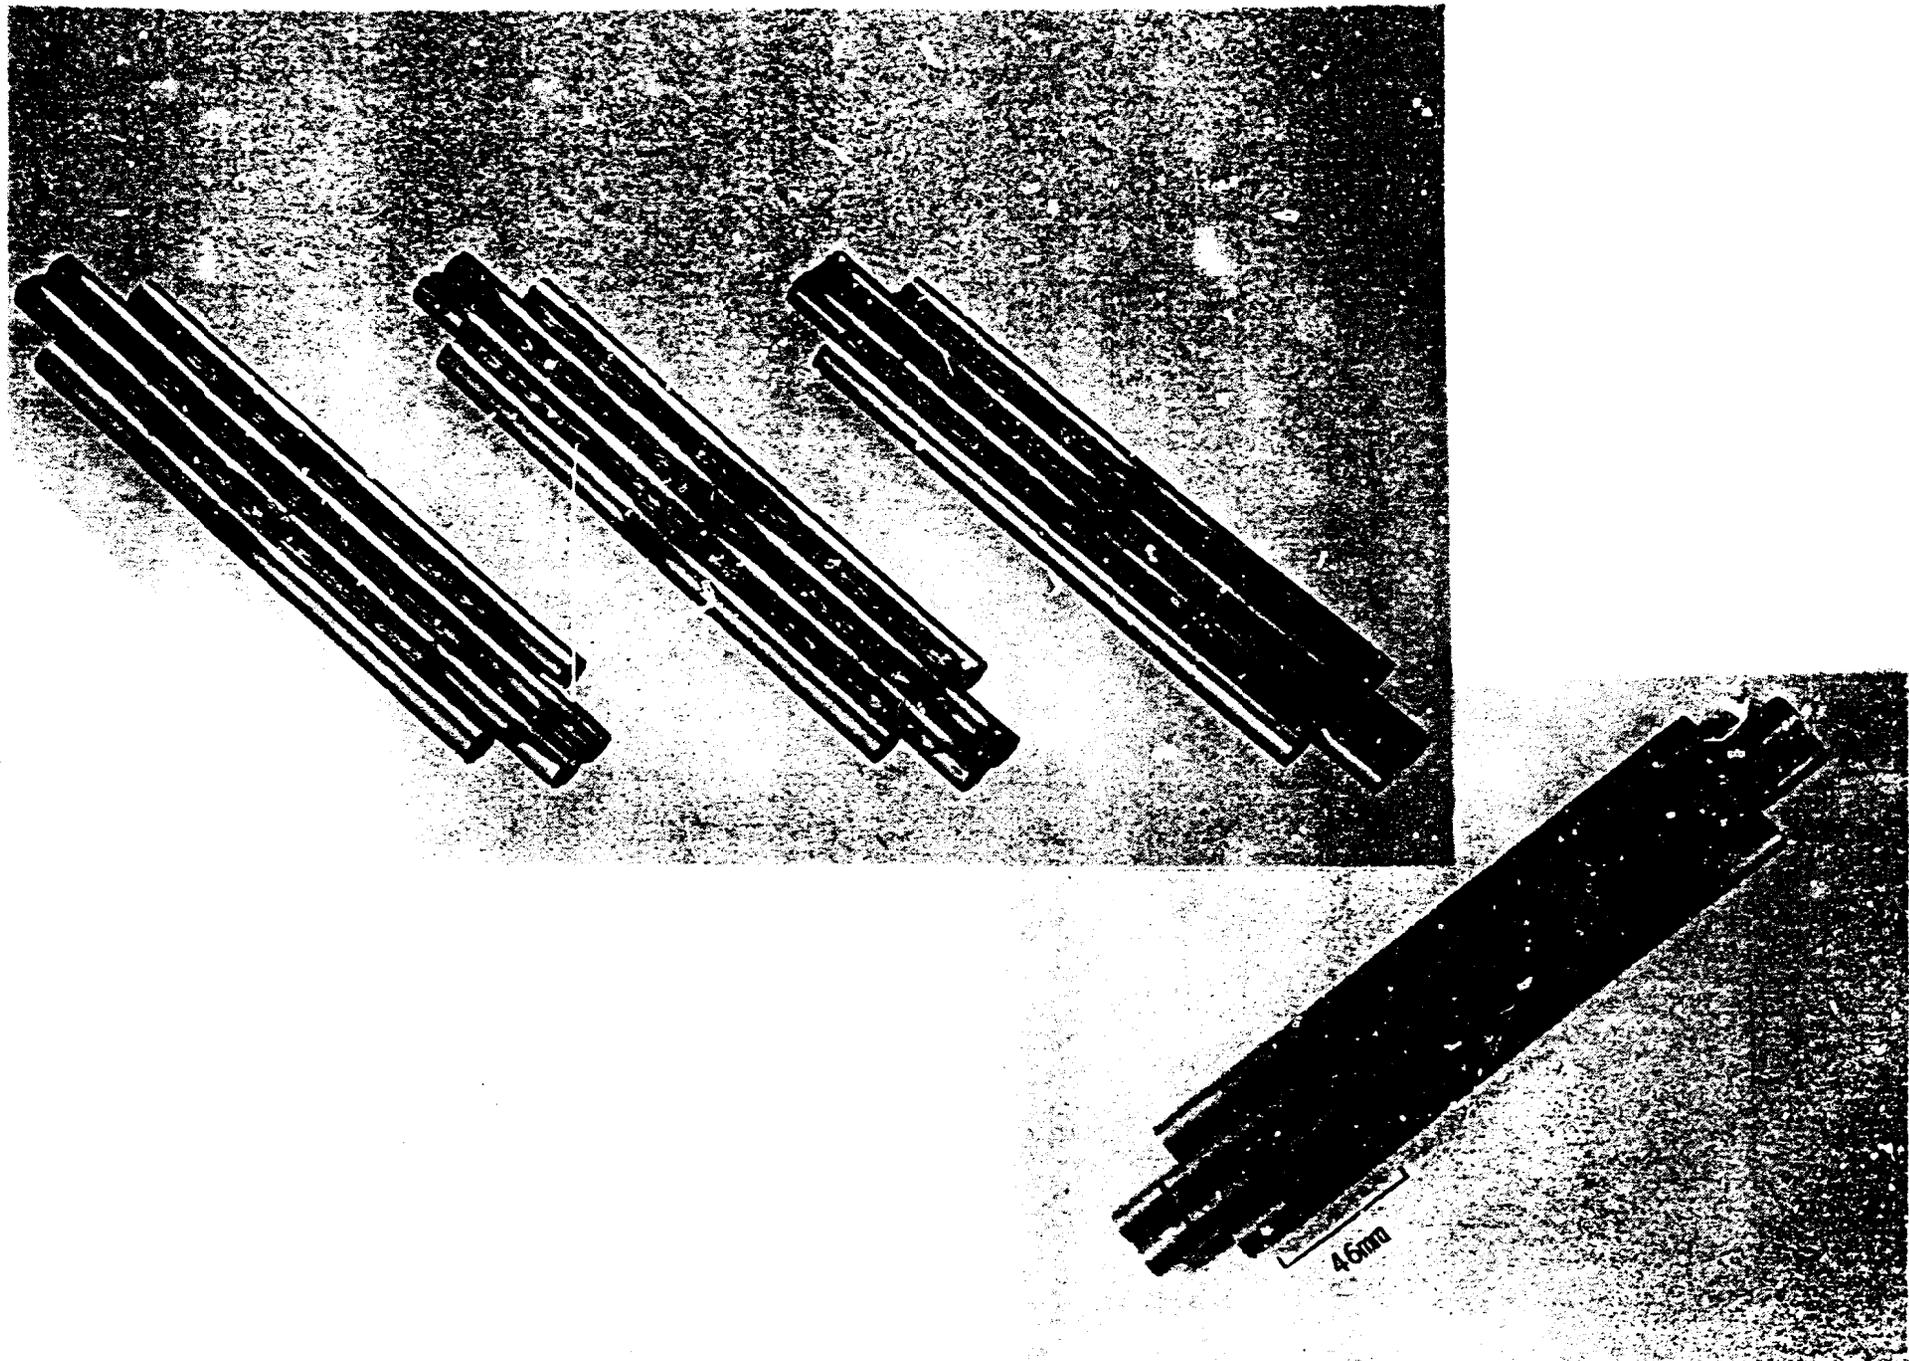
Figure 5. Receiver tube weldment specimens for test.

Thermal cycling during the experiment was induced by passing tube weldments alternately through a radiant lamp furnace and cooling chambers (Fig. 3 and 4). Weld panels 200 mm long, comprised of four tubes each, were attached in pairs at four stations as illustrated in Figure 5. The tube assemblies were mounted back-to-back with a support rack in between which admitted forced air inside the support rack to cool the back side of the weldments; this scheme created the necessary front-to-back ΔT on heating. The specimens were cycled on a timed basis, which included a three-minute stop in the furnace chamber to bring the specimens up to peak temperature; total cycle time was 15 minutes.

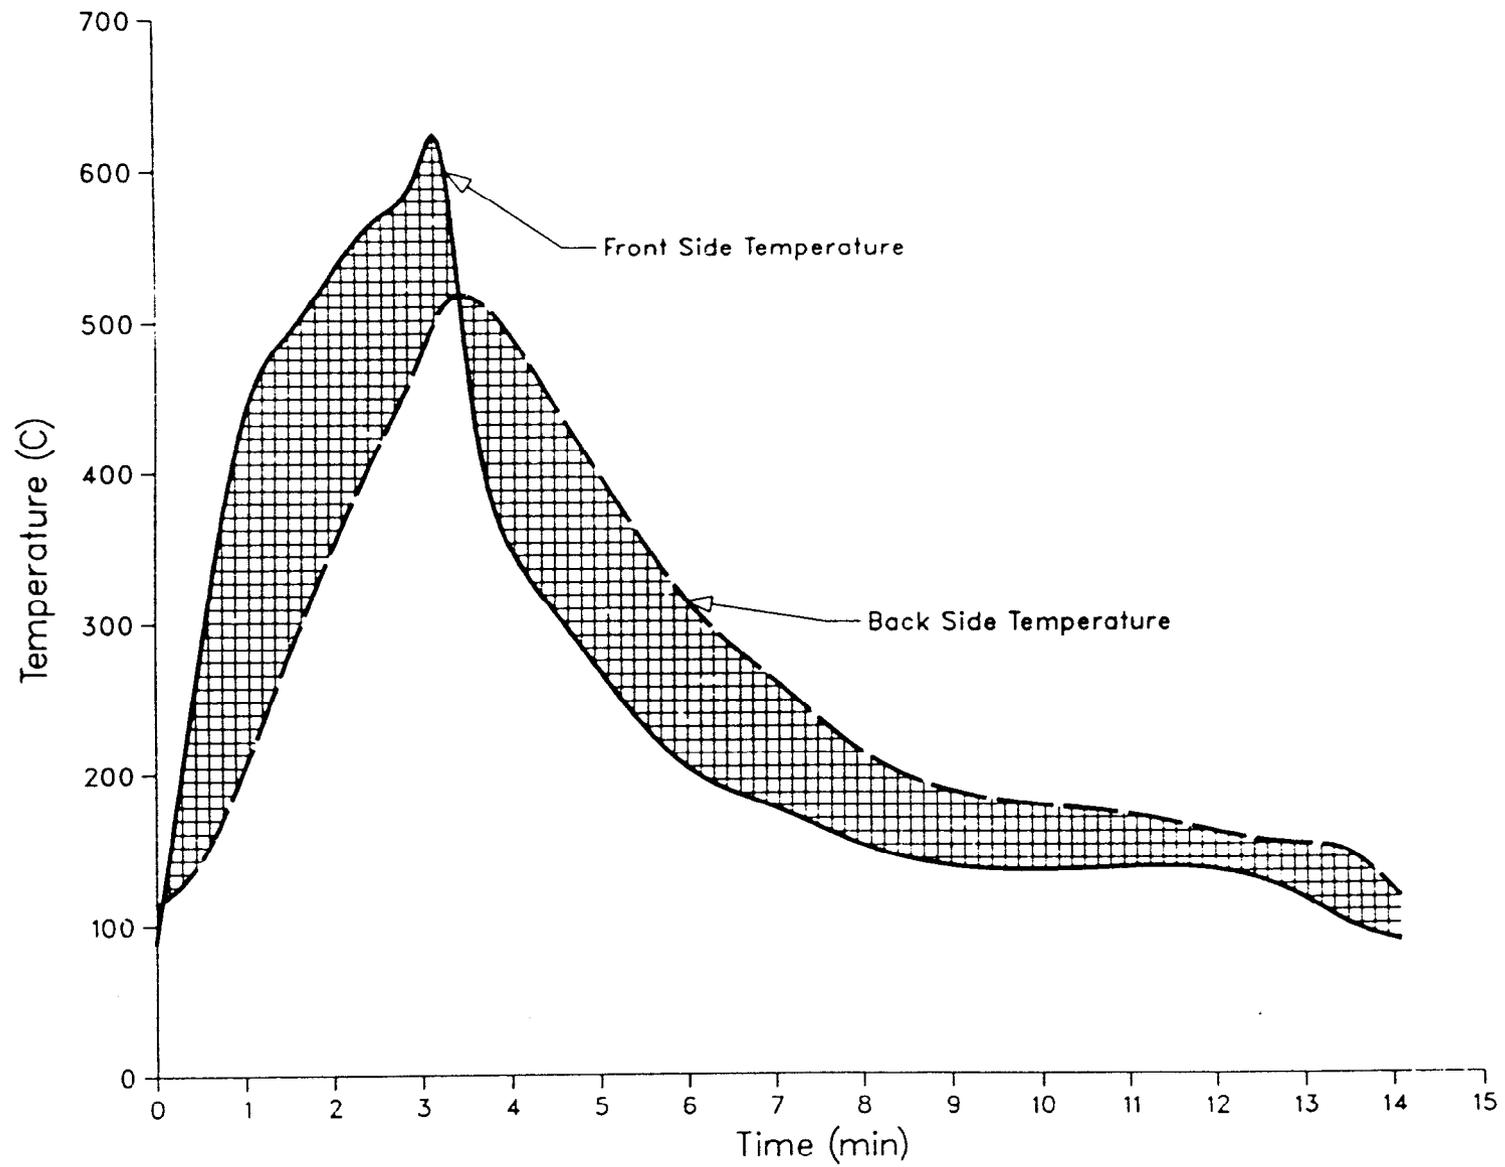
Figure 6. Typical temperature history of weldment specimen for one cycle.

Temperatures during the test were measured on two end specimens. Thermocouples were placed on the specimens at four locations: 2 cm from each end on the furnace side and at the center on both the furnace and support side. A representative temperature history for one cycle of the tube crown on the front side of the panel and the weld bead on the back side of the panel is represented in Figure 6. During the test the front side of the panel, which is toward the radiant lamps, heats quickly and then is cooled quickly at the end of the cycle. On the other hand the back side (against the cooling rack) heats and cools more slowly during a cycle. This results in the required $\Delta T_{\text{front-back}}$ of 111°C at the peak temperature of the cycle. An initially large $\Delta T_{\text{front-back}}$ of 200°C and a negative $\Delta T_{\text{front-back}}$ of -100°C in the middle of the cycle also occur. The larger initial ΔT and the negative ΔT are more severe than the pilot plant conditions. However, they occur at lower temperatures where the yield strength is higher and thus probably do not contribute significantly to the accrued damage.

The minimum temperature in a cycle (Figure 6) was approximately 100°C. Peak temperature varied from cycle to cycle within an envelope of 12°C around 621°C due to fluctuations in ambient temperature (at the start of each set of 5000 cycles, this envelope was 40°C for the first few cycles before settling down to 12°C). The temperature distribution along the length of the specimens was also measured to determine the length of the temperature flat zone. At peak temperature this zone (Figure 7) was approximately 150 mm long for the first set of 5000 cycles, 100 mm for the second, and 200 mm for the third. The flat zone was not perfect for all of the tests because cold air entered through one side of the furnace (equivalent to right side of Figure 7). This flow of cold air from the cooling chambers was partially blocked in the first and third stages of the test. However, relocation of the apparatus in the laboratory prior to the second stage prevented us from blocking the flow of air during the second stage, thus the shorter temperature flat zone.

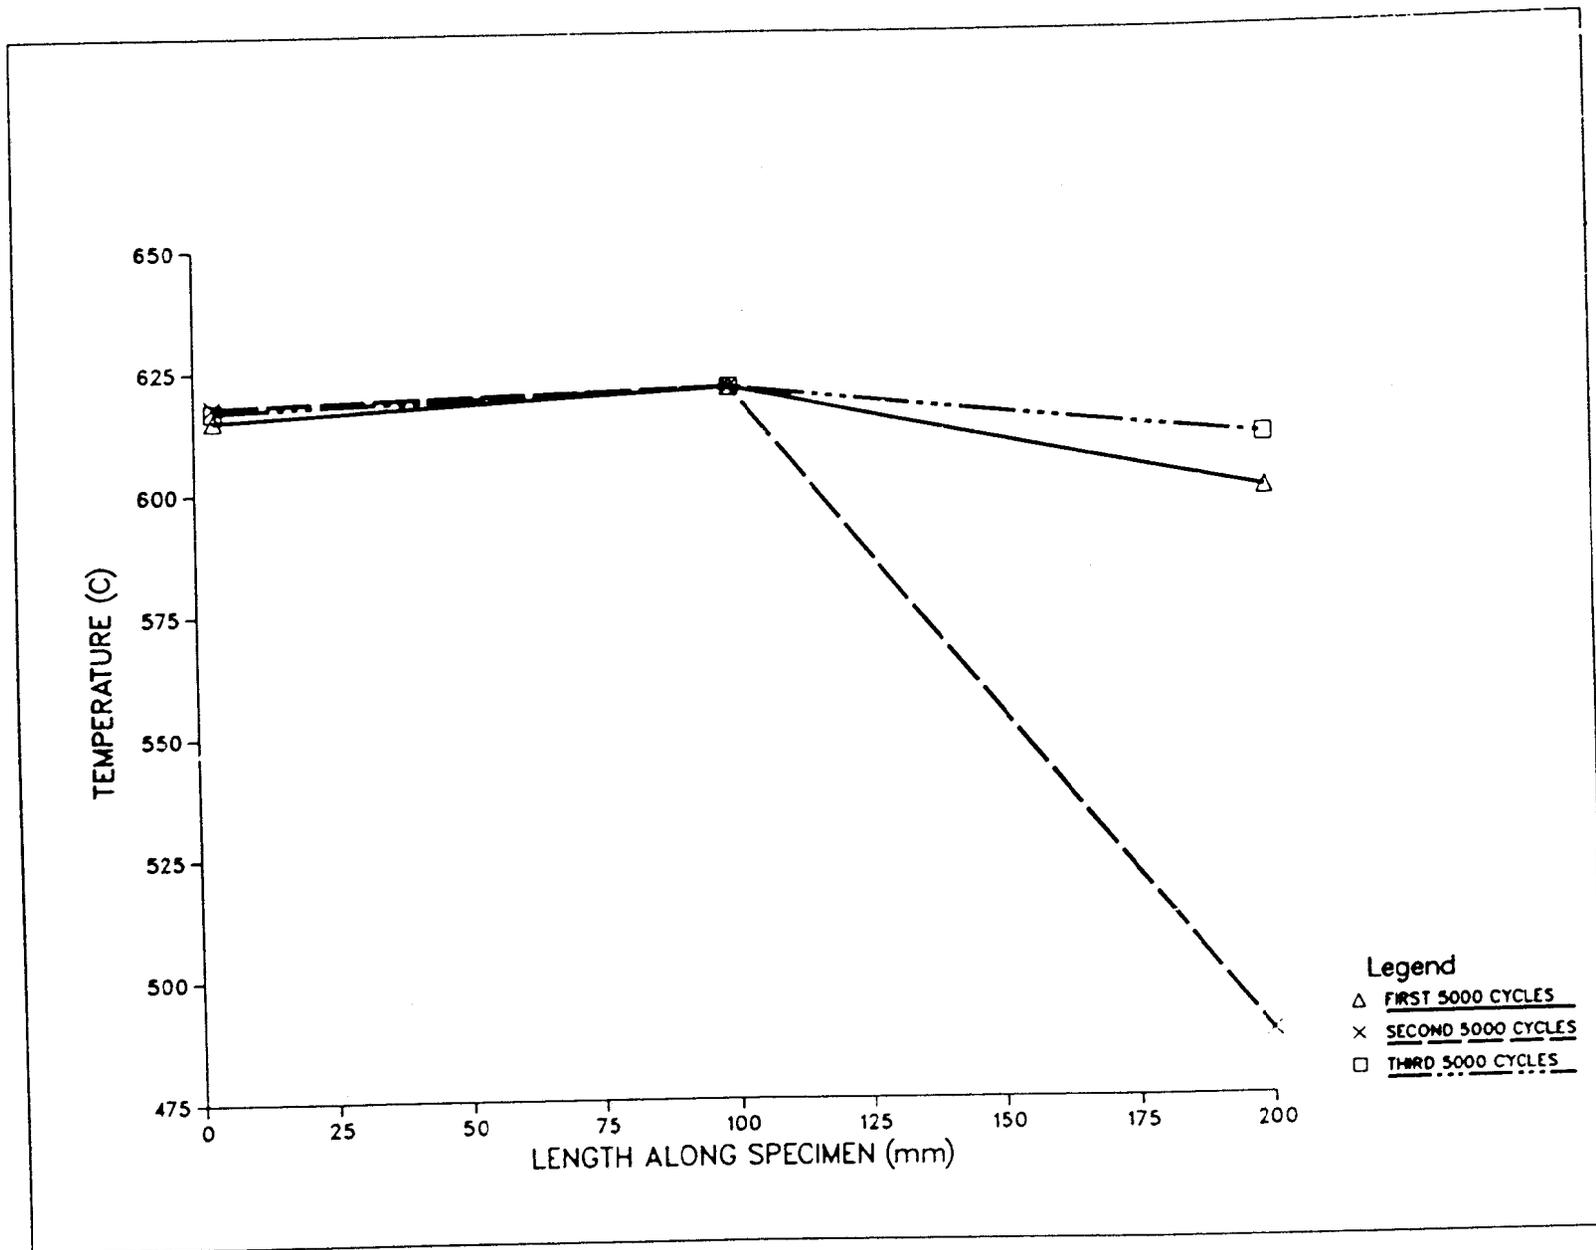
Figure 7. Variation of temperature along the length of specimens at peak temperature.

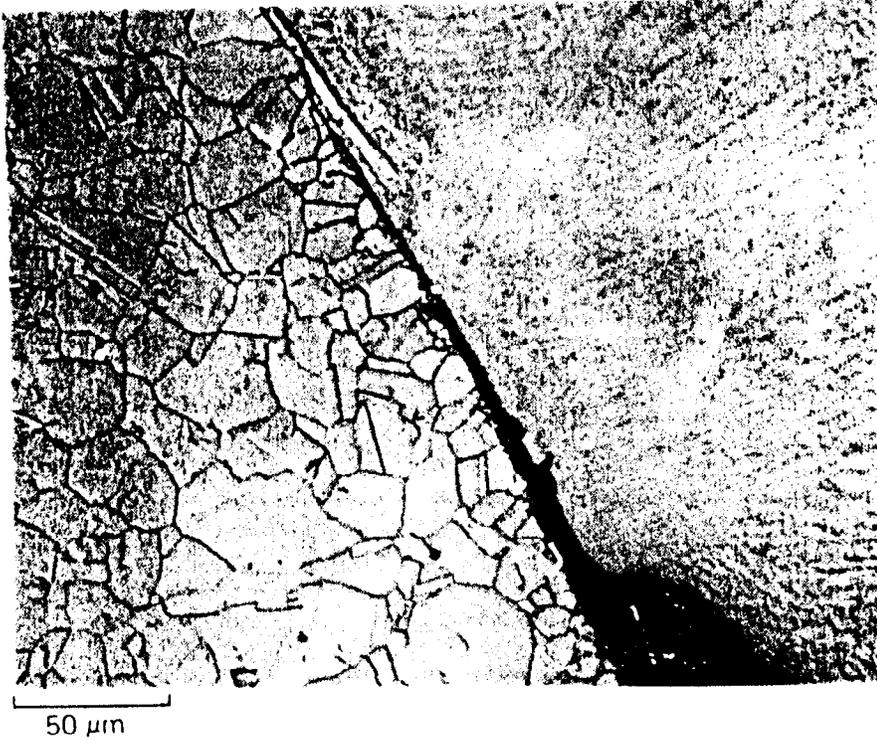
Figure 9. Lack-of-fusion weld defect, specimen removed after 10,000 cycles.

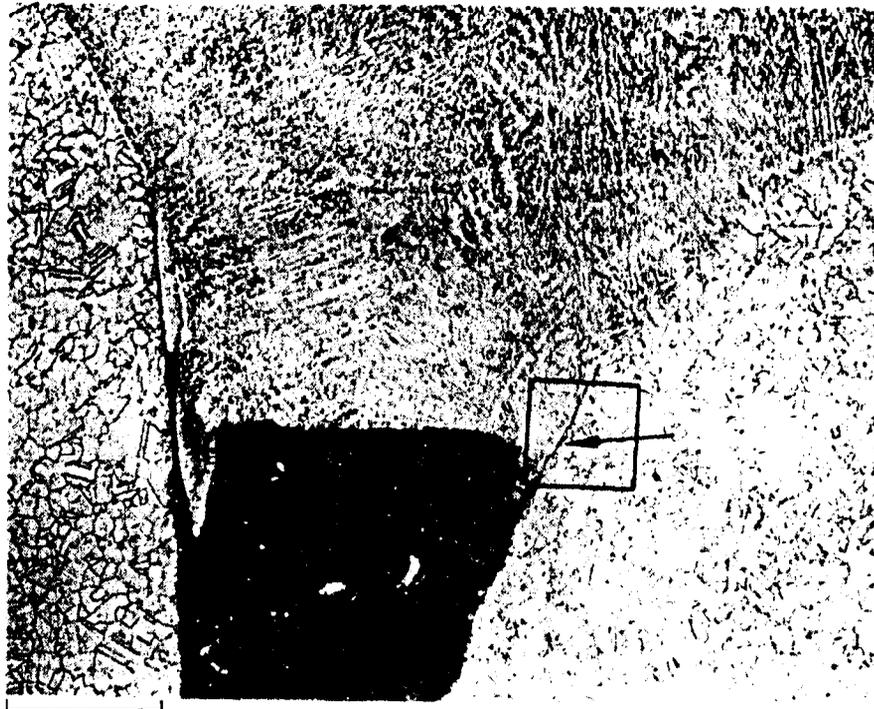
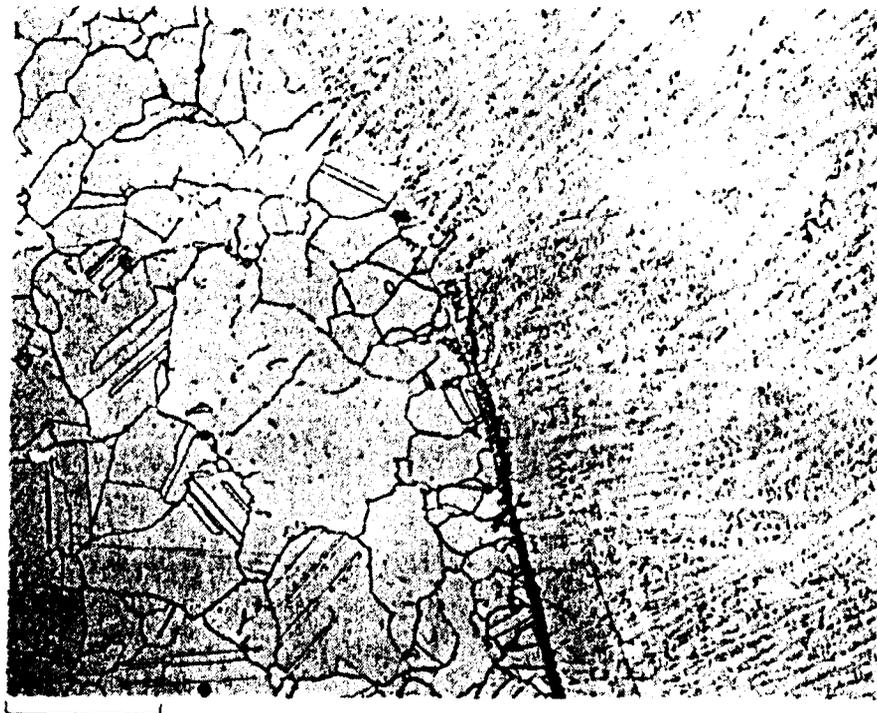
Figure 10. Lack-of-fusion weld defect, specimen removed after 15,000 cycles.

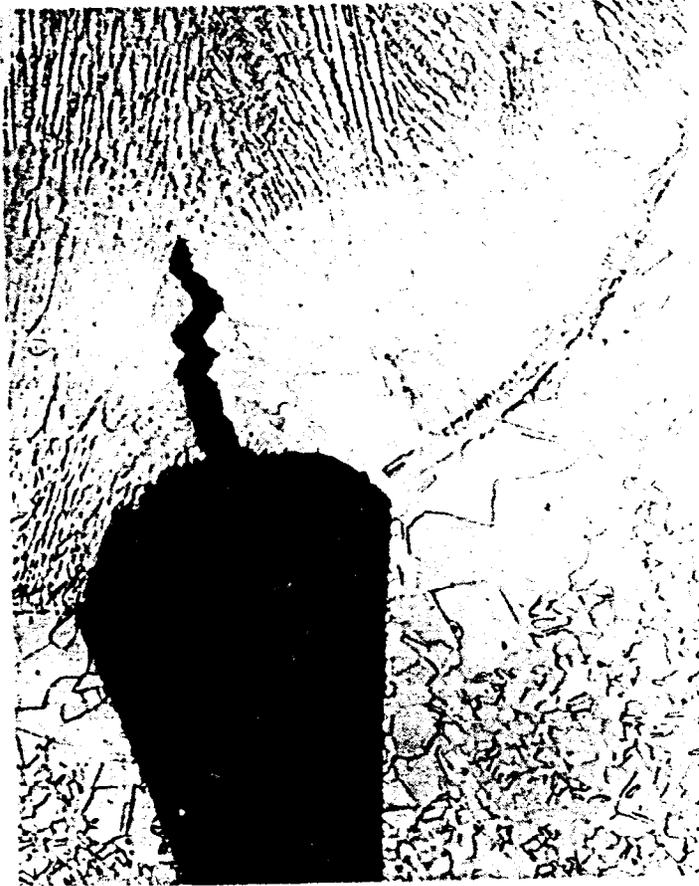
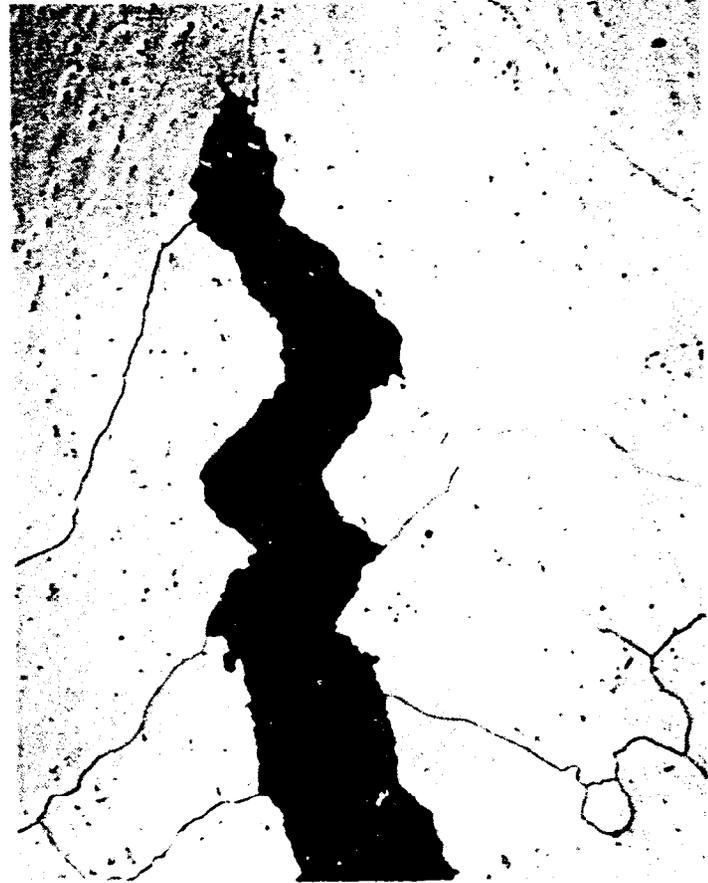
Figure 11. Example of solidification crack in GTA tack weld, crack occurred during welding. Specimen tested for 10,000 cycles.

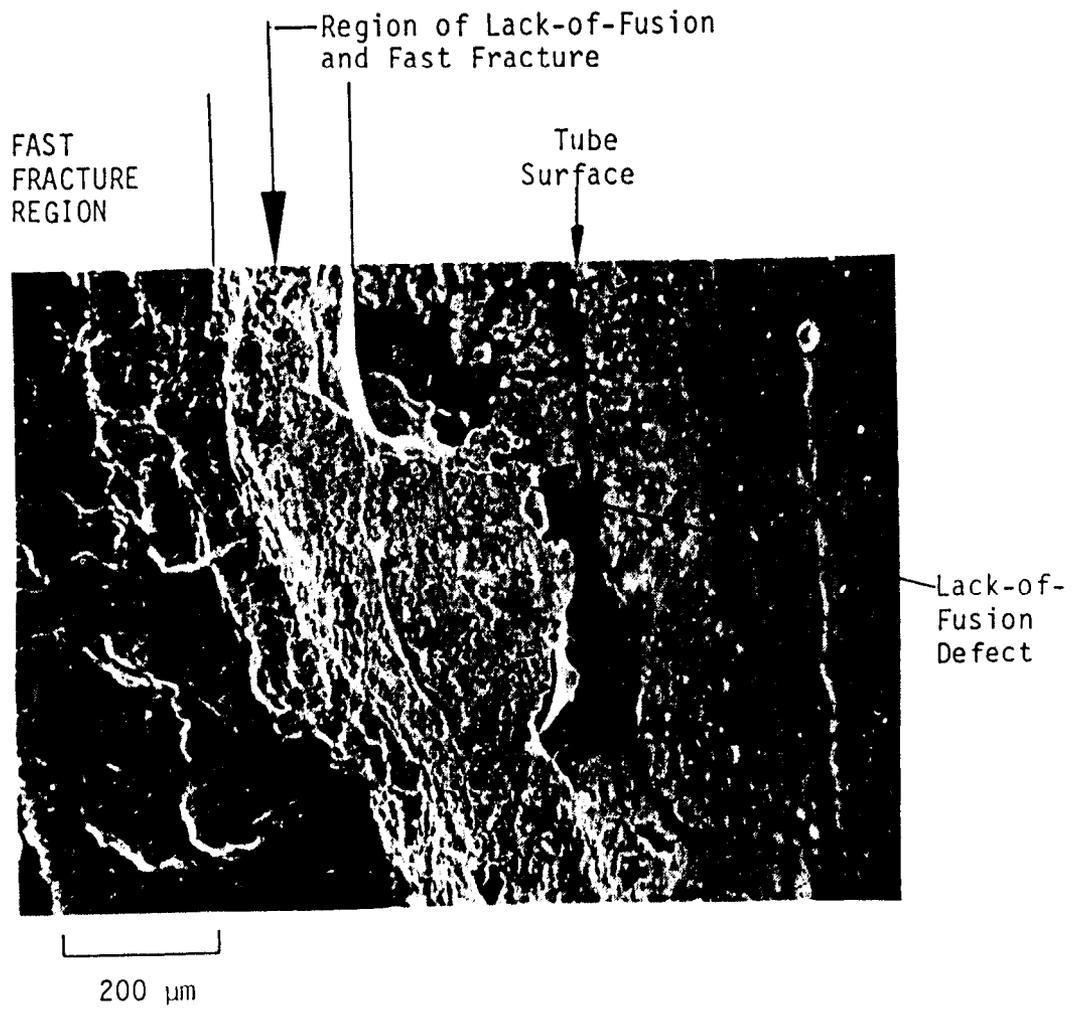
Figure 13. SEM micrograph of fractured surface showing lack-of-fusion region. Specimen notched and pulled apart after testing.

EDM flaws were machined in two of the specimens; although these flaws increased local stresses by reducing the cross-sectional area of the interfaces, cracks still did not propagate as a result of these flaws (Figure 12). Although other weld parameters and tube configurations (as listed in previous section) were tested, no negative effects of these parameters could be identified since no cracks were found. Scanning electron microscopy of notched and fractured sections revealed a surface morphology reminiscent of that observed in the uncycled weldments, thus indicating that little or no crack propagation occurred during thermal cycling (Figure 13).

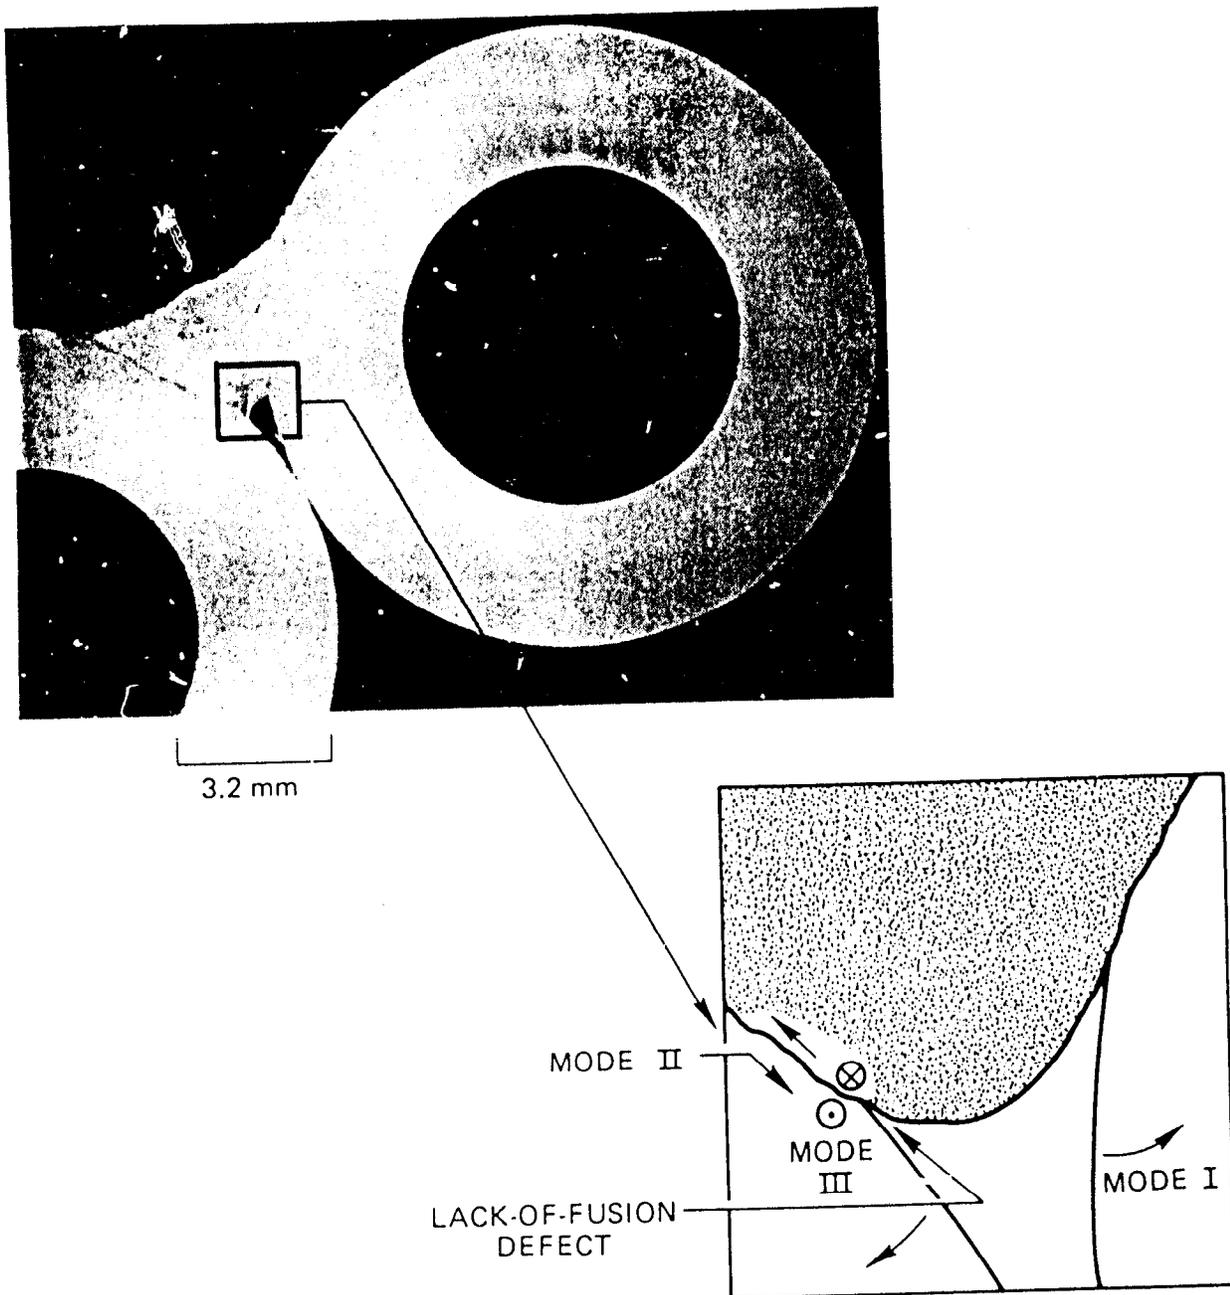
Figure 14. Schematic of strain/stress modes present at lack-of-fusion defects during test.

The stress state at the lack-of-fusion defect/notch is a combination of Modes I (opening), II (shear), and III (anti-plane strain). Mode III, which contributes the largest component, has a nominal strain of approximately 0.1%. This strain component in the laboratory experiment is the same magnitude as for the receiver panel. It arises and was calculated from the difference in expansion coefficients between the weld and base metal. The smaller Mode I or crack opening strain component occurred in the test due to unconstrained bending of the tubes which open up the notch (Figure 14). Experiment design provided inadequate constraint against bending in the test for the first two sets of 5000 cycles. Increased constraint against bending was added for the third set of 5000 cycles. While the added constraint moves the experiment closer to actual receiver conditions and increases the nominal strains in the weldment, it actually decreases stress at the lack-of-fusion defects by removing the Mode I stress component.

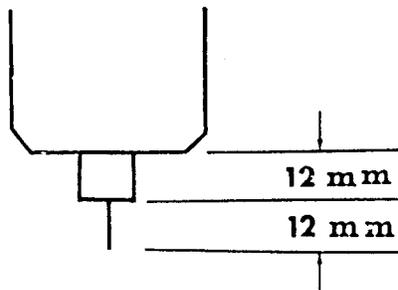
STICKOUT LENGTH:

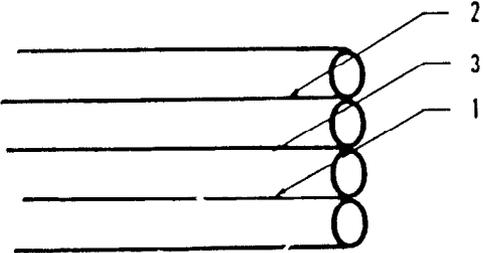
WELD SEQUENCE: (For straight tubes)
