SAND87-0696 • UC-62a

## Thermal Fatigue of Stainless Steel

Two austenitic steels, 316 Stainless Steel and Alloy 800, have been examined under conditions of both isothermal low cycle fatigue (LCF) and thermomechanical fatigue (TMF). The TMF tests were conducted between 649 and 360°C with a carefully controlled triangular waveform. The LCF tests were performed at 649°C and both kinds of tests were subjected to a strain range of 0.5%. TMF shortened life to 40% for 316 Stainless Steel and to 5% for Alloy 800. The microstructural evolution occurring in both alloys has been examined and we conclude these do not play a role in the life shortening caused by TMF. The TMF does produce asymmetric hysteresis loops with large tensile peak stresses in tests where the maximum temperature corresponded with the peak compressive stress. The influence of TMF on fatigue crack growth rates has been measured and it was found that TMF accelerated crack growth in Alloy 800 and slowed it down slightly in 316 Stainless Steel. The dominant influence of TMF appears to be in fatigue crack initiation, with the tensile peak stress development driving early crack initiation.

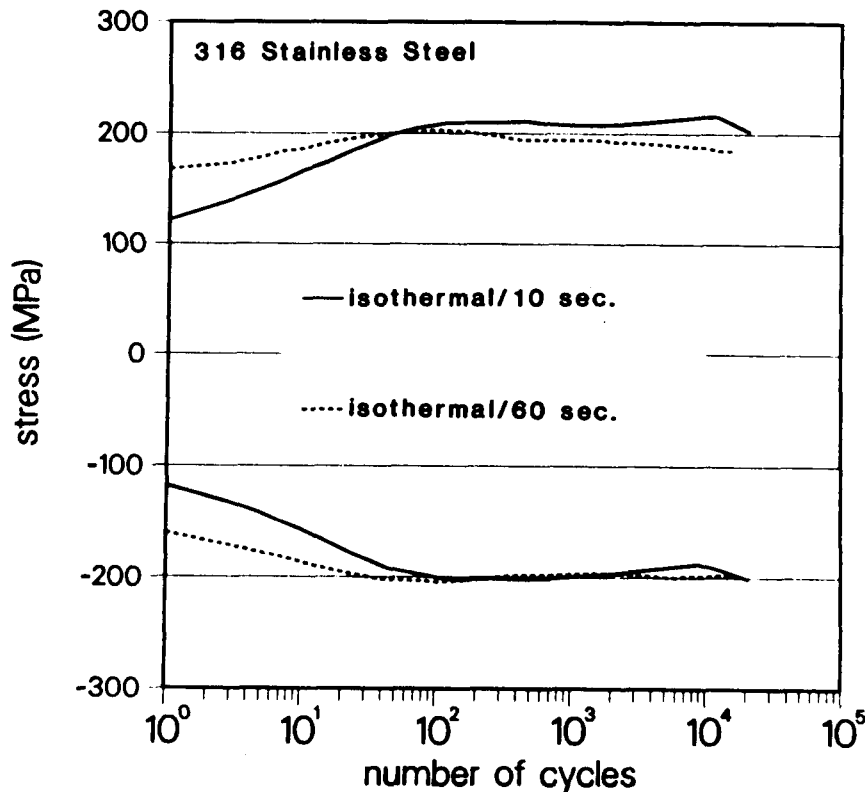
Figure 3. Cyclic hardening of 316 Stainless Steel in isothermal fatigue, 649°C,  $\Delta\epsilon=0.5\%$ .

**Cyclic Hardening.** The cyclic hardening of 316 Stainless Steel and Alloy 800 are summarized in Figures 3 through 7. The isothermal cyclic hardening response of both materials is nearly identical, showing roughly balanced cyclic stress peaks throughout the tests and saturation in stress range early in the tests. Decreasing strain rate for 316 Stainless Steel results in an expanded stress range during initial cycling (Figure 3). By 100 cycles, this difference has essentially disappeared and the two tests nearly overlay for most of the test duration.

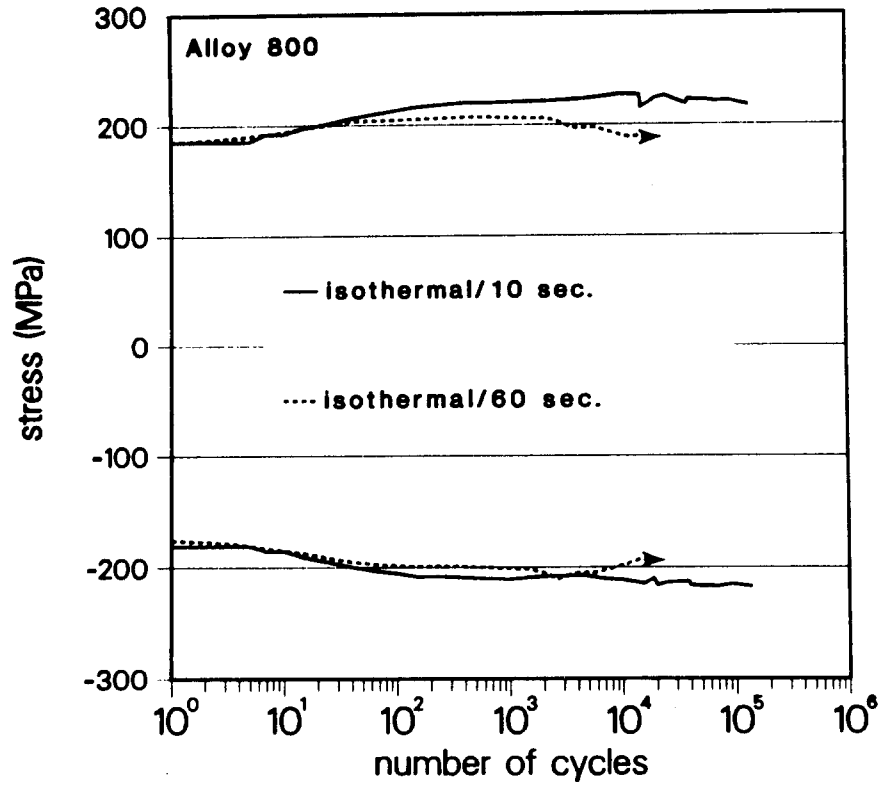
Figure 4. Cyclic hardening of Alloy 800 in isothermal fatigue, 649°C,  $\Delta\epsilon=0.5\%$ .

For Alloy 800, virtually no difference is observed in the initial isothermal cyclic hardening response for the two strain rates examined. At approximately 1000 cycles, however, the slower test (Figure 4) shows stress saturation and subsequent strain softening, while the faster test continues to slightly harden to failure.

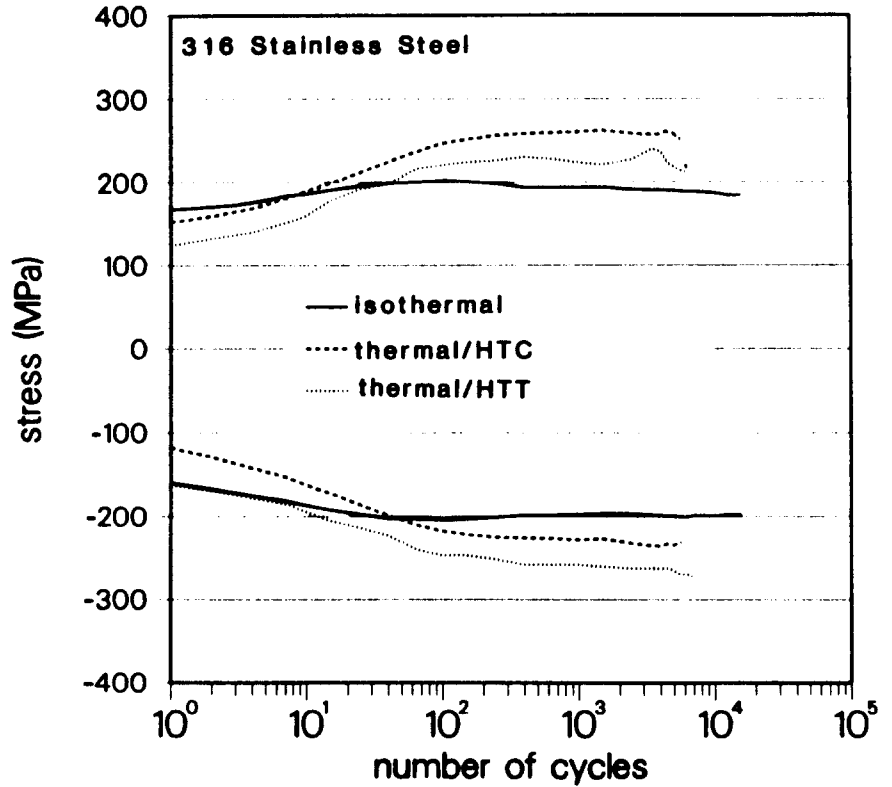
Figure 5. Cyclic hardening of 316 Stainless Steel in thermomechanical fatigue.

A major difference in the cyclic hardening response of these two alloys appears during TMF testing. Under thermomechanical cycling, 316 Stainless Steel displays a hardening response which is qualitatively similar to that it shows during isothermal testing (Figure 5). In both cases, cyclic stress

peak saturation is reached in about 100 cycles. However, the total stress range during thermomechanical cycling is about 25% larger than in isothermal tests. Stress peaks in both tension and compression are increased, with the largest difference occurring on the low temperature side of the cycle; the result is the development of 20-30 MPa mean stresses during TMF.

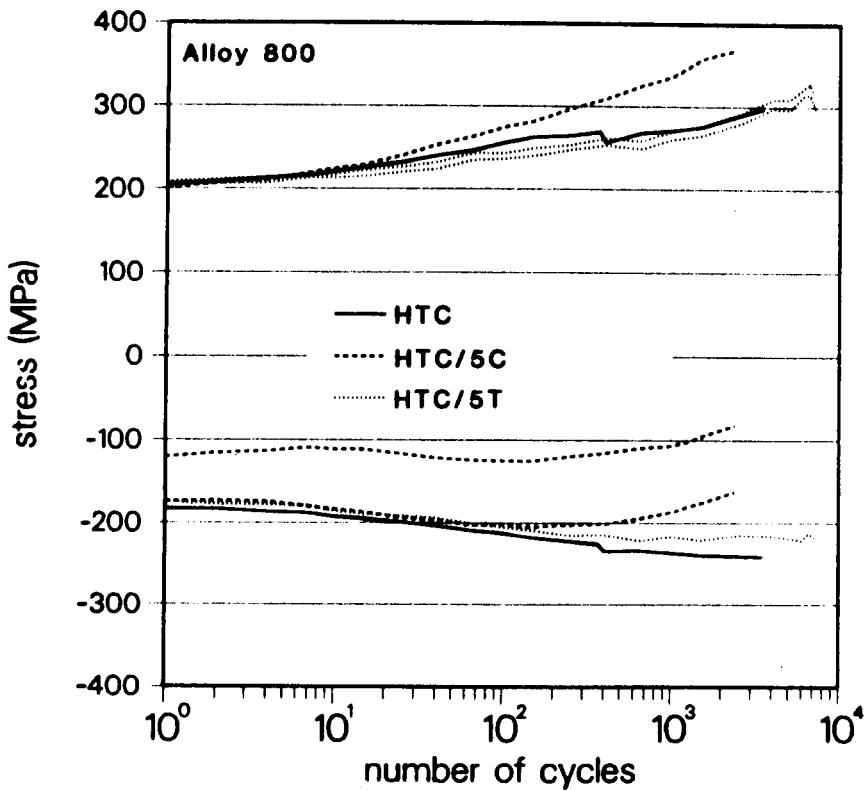
Figure 7. Cyclic hardening of Alloy 800 in thermomechanical fatigue with hold periods.

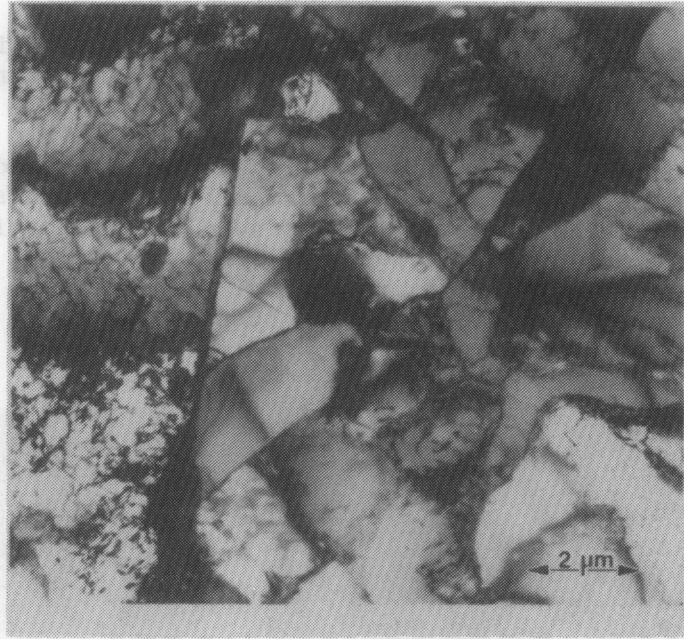
Figure 11. Transmission electron micrograph of Alloy 800 thermomechanical HTC cycled, 60 s/cycle, 75 hr. test duration.

The sample of continuous cycling TMF examined was in test for only 75 hours which is reflected in the substructure. Figure 11 shows that no additional  $M_{23}C_6$  precipitation was observed. We found clear evidence of cell formation although it was not extensive and these cells ranged in size

from 1- 2  $\mu\text{m}$ . The cell formation was more extensive in the thermomechanically cycled specimen than in the isothermally cycled specimens.

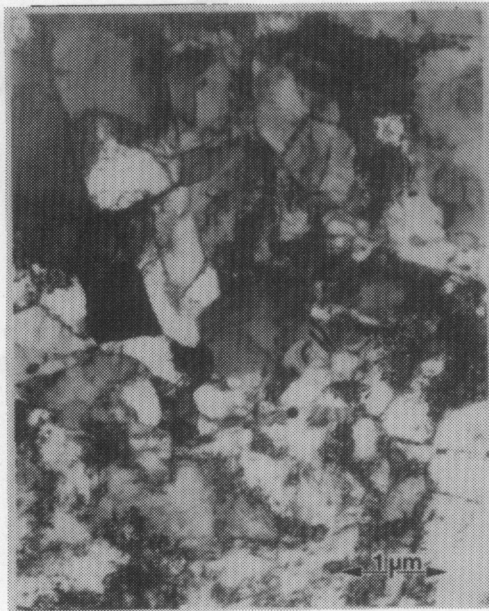
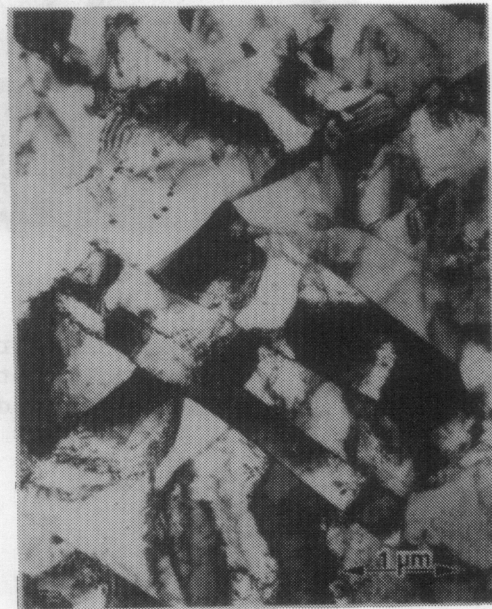
Figure 12. Transmission electron micrographs of Alloy 800 thermomechanical HTC cycled, 60 s/cycle: (a) 5 min. tensile hold, 120 hr. test duration; (b) 5 min. compressive hold, 40 hr. test duration.

The specimens thermomechanically cycled with hold periods were also examined by TEM and characteristic substructures are shown in Figure 12. Most regions of the materials showed some cell formation with many cells having well-ordered dislocation arrays in the walls. These cells tended to be about 0.5  $\mu\text{m}$  in size and, in general, smaller than those developed under continuous thermomechanical cycling conditions.

The test with a 5 minute compressive (and maximum temperature) hold period failed at 2380 cycles after 40 hours of test and the test with a 5 minute hold period in tension (at the minimum temperature) failed at about 7200 cycles or 120 hours of test. Neither specimen showed any indication of carbide precipitation during testing. This is reasonable given the short time either specimen was exposed to elevated temperature.

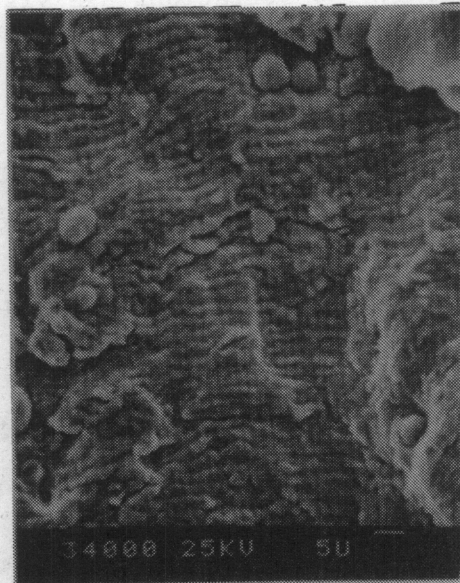
Figure 16. Fatigue fracture surface of HTC thermomechanical fatigue cycled Alloy 800 with 5 min. compressive hold period: (a) crack length = 0.77 mm; (b) crack length = 2.00 mm.

**Thermal Fatigue.** Cracking of both alloys cycled under HTC conditions occurs by the ductile striation mechanism. Figure 15 shows continuously cycled Alloy 800 and 316 Stainless Steel. Roughly spherical particles on the surface of the Alloy 800 sample are nucleated surface oxide; these grow larger and become closer together at short crack lengths. HTC thermomechanical fatigue tests of Alloy 800 with either 5 minute compressive (5C) or tensile (5T) hold periods also crack by striation formation (Figures 16 and 17).

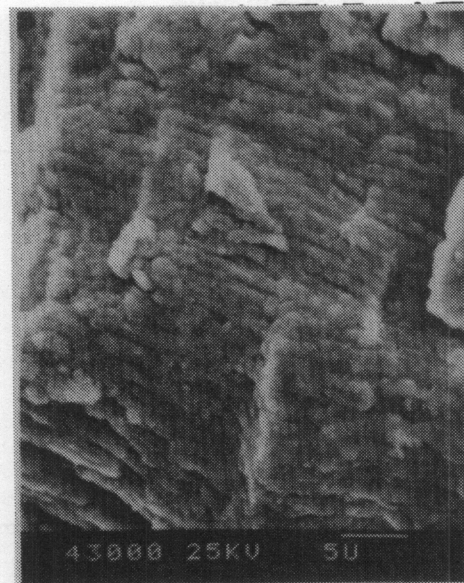
Figure 17. Fatigue fracture surface of HTC thermomechanical fatigue cycled Alloy 800 with 5 min. tensile hold period: (a) crack length = 0.66 mm; (b) crack length = 2.84 mm.
