# Solar Total Energy Test Facility Project Semiannual Report October 1976 - March 1977

SOLAR TOTAL ENERGY TEST FACILITY PROJECT  
SEMIANNUAL REPORT  
October 1976 - March 1977

Edited by  
Ben Petterson, Jr.  
Solar Total Energy Test Facility Division 5712  
Sandia Laboratories  
Albuquerque, NM 87115

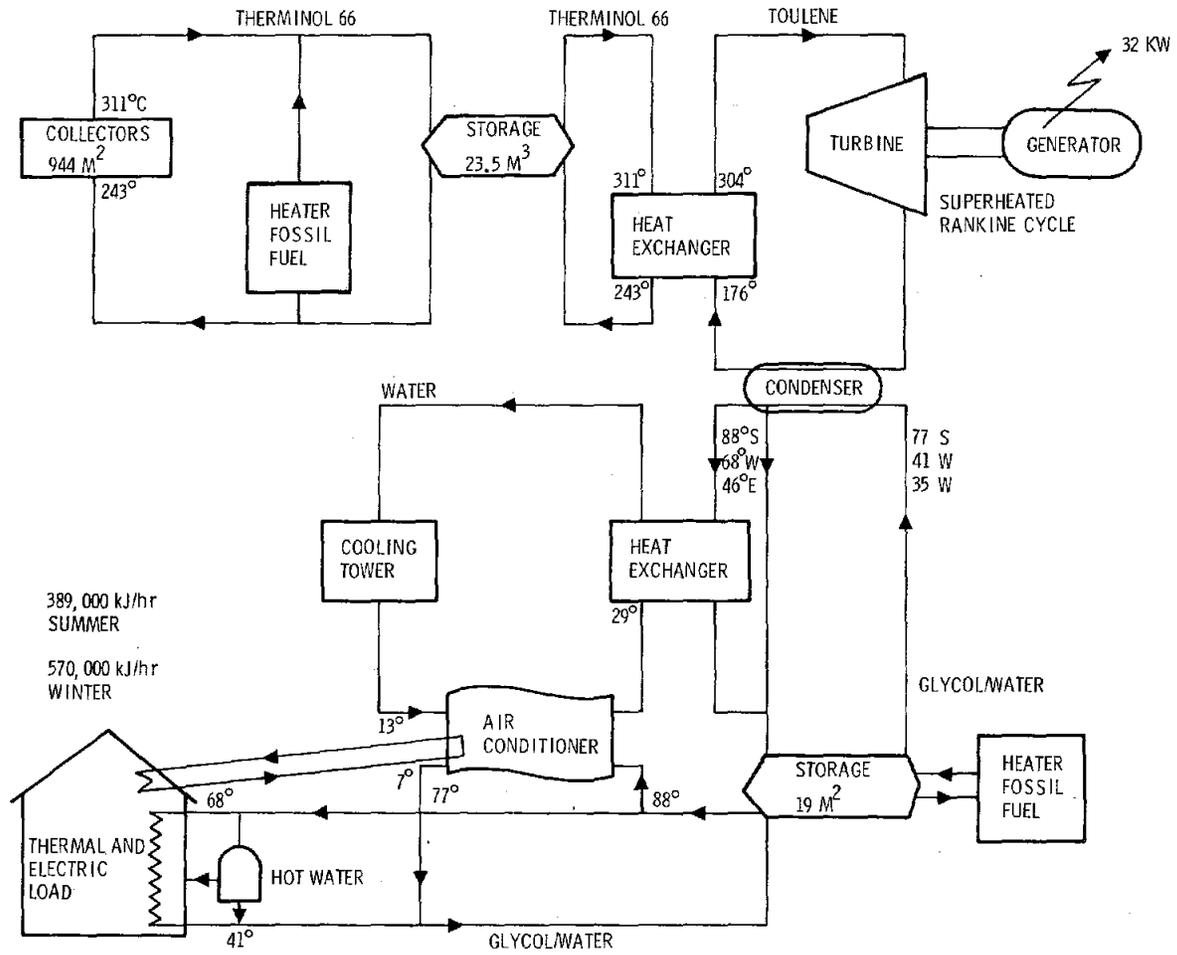
Figure 1. Cascaded Solar Total Energy System Schematic

Phases I, II, and III, which emphasized preliminary studies and designs are complete. Phase IV-A began in July 1974 and lasted through April 1976. It consisted of the design, fabrication, installation, and checkout of the first 200 m<sup>2</sup> collector field quadrant, a high-temperature stratified storage tank, a 32-kW turbine/generator and Therminol-to-toluene heat exchanger, an instrumentation and control subsystem, a cooling tower, the turbine and control building, and all necessary pumps and fluid loops to interconnect these subsystems.

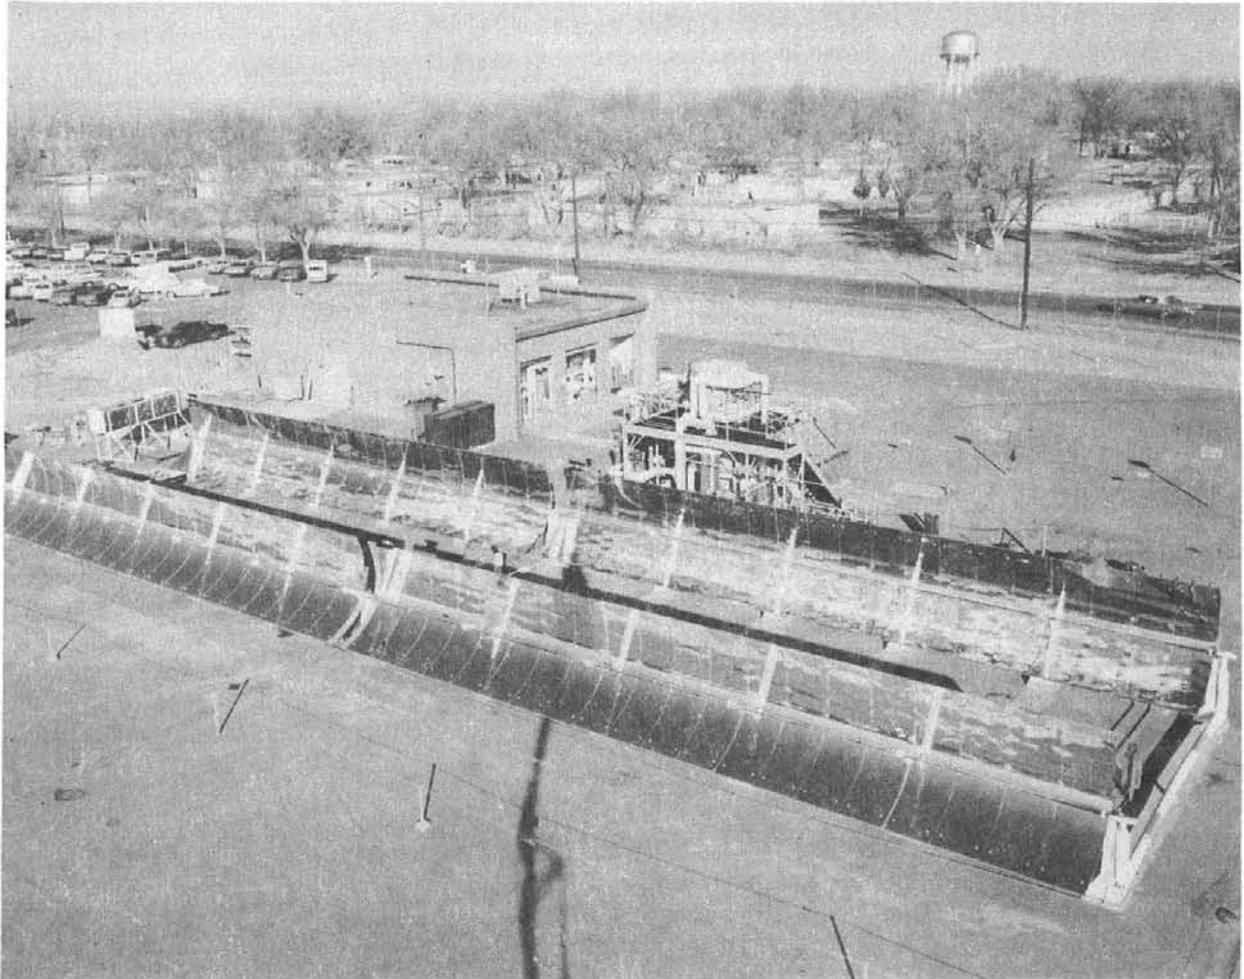
Figure 9. Solar Total Energy Test Facility with Sandia Collectors

Description -- The  $200 \text{ m}^2$  collector field of parabolic troughs installed as the first quadrant of the STESTF has been functional since February 1976. The field consists of four continuous troughs 18.3 m (60 ft) long aligned on an east-west axis in two rows as shown in Figure 9. Center to center spacing between rows is 7.6 m (25 ft). Each of the troughs consists of five  $2.7 \times 3.7 \text{ m}$  (9 x 12 ft) trough units mechanically connected to form a single trough. The parabolic units have a  $92^\circ$  rim angle and a 0.658 m (25.9 in.) focal distance.

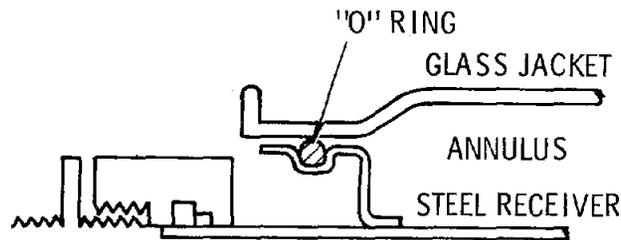
Figure 10. Sandia Phase IV-B Receiver Design

Development of the Phase IV-B receiver design has continued at Sandia. Studies have been completed on heat losses with various levels of vacuum and their effects on overall efficiency of the receiver assembly. For the purposes of experimental verification, the Phase IV-B receiver design, shown in Figure 10, was utilized; it included an O-ring seal to provide a vacuum between the glass envelope and coated receiver tube. The obvious advantages of this design over the bellows and glass-to-metal seal design are that (1) the system is less expensive and (2) replacement of a broken glass envelope does not necessitate replacing the entire receiver assembly.

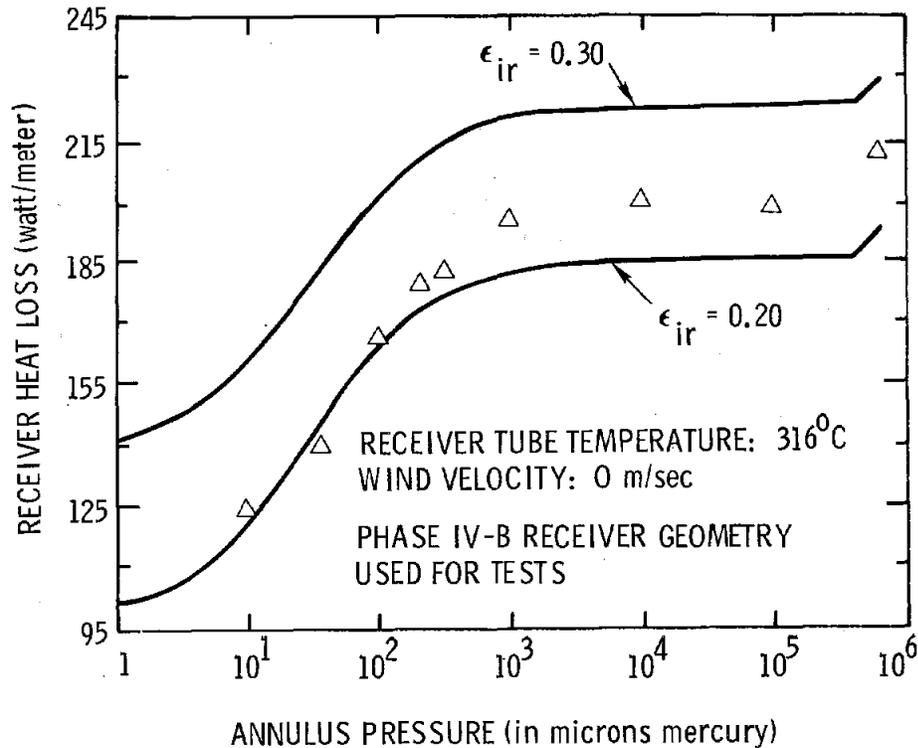
Figure 11. Effects of Pressure on Receiver Tube Heat Loss

Figure 11 presents comparative results of the analytical and experimental work undertaken to reduce receiver heat loss. Theoretical calculations are shown as solid lines with experimental data plotted with triangular points. The curves of this figure indicate that the heat loss is relatively independent of the annulus vacuum until pressures below 1000 microns Hg are reached.

Analytical modeling involved writing energy balances for the receiver tube and glass surfaces that could be used to (1) predict the resultant receiver assembly temperatures for known heat inputs or (2) predict the receiver assembly heat loss for a fixed receiver tube temperature. The analysis assumed steady state conditions and utilized correlations for the effects of pressure, wind, geometry and temperature on the heat transfer terms.

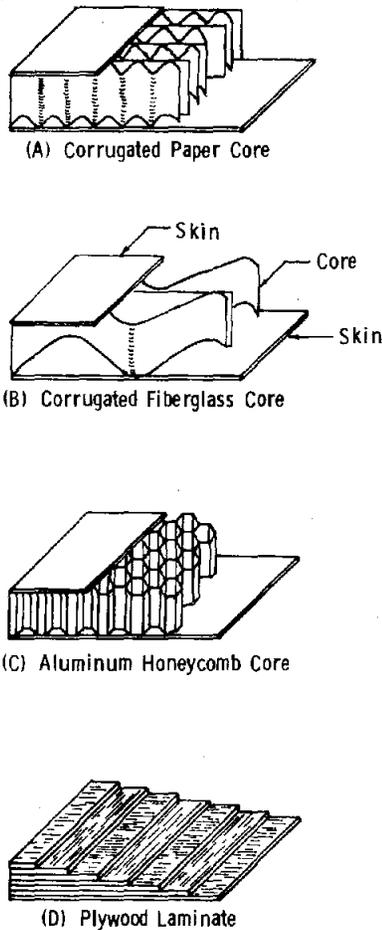
Figure 12. Sandwich Structures

Fiberglass - 30 volume percent fiberglass mat in a polyester matrix.

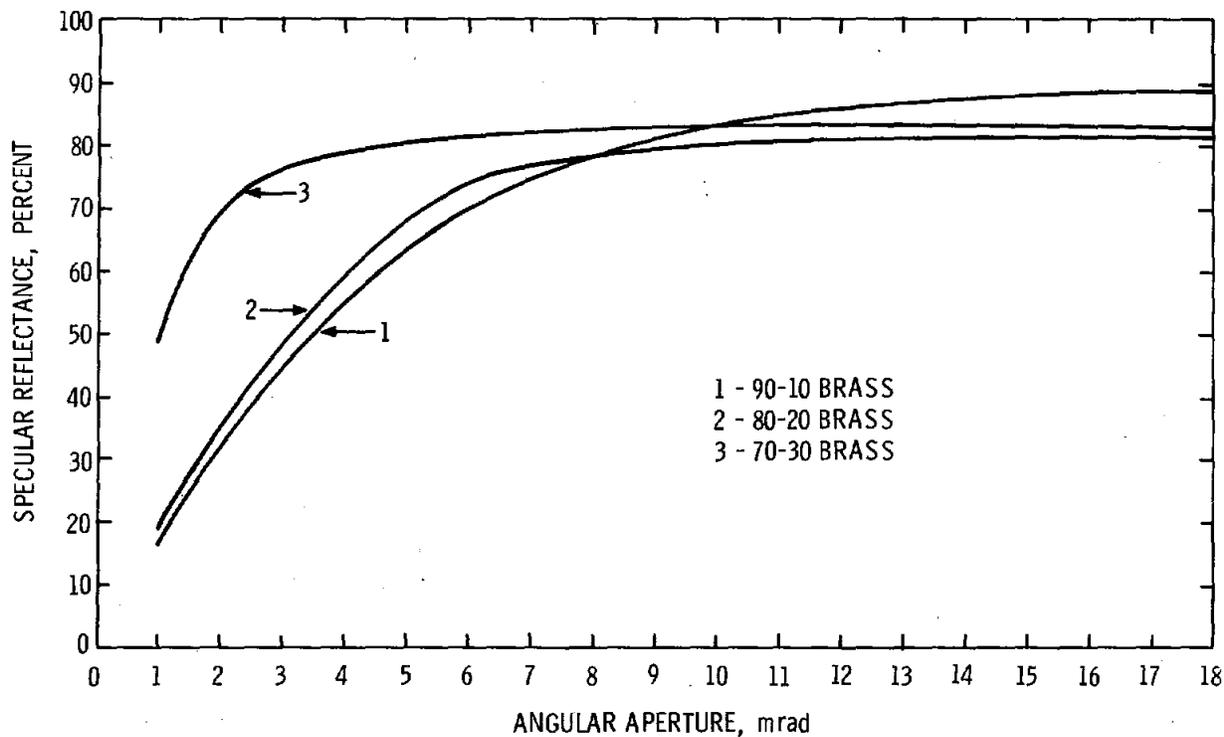
Figure 13. Specular Reflectance of Silver-Plated Brass Samples at 500 nm

The samples received included mechanically buffed and silver plated 90-10 brass (90% Cu, 10% Zn), 80-20 brass and 70-30 brass. The reflectance of silver-plated 430 stainless, 301 stainless and a (70% Cu, 22% Zn, 8% Ni) material could not be measured because the samples were too stiff to be mounted on our optically flat vacuum chuck.

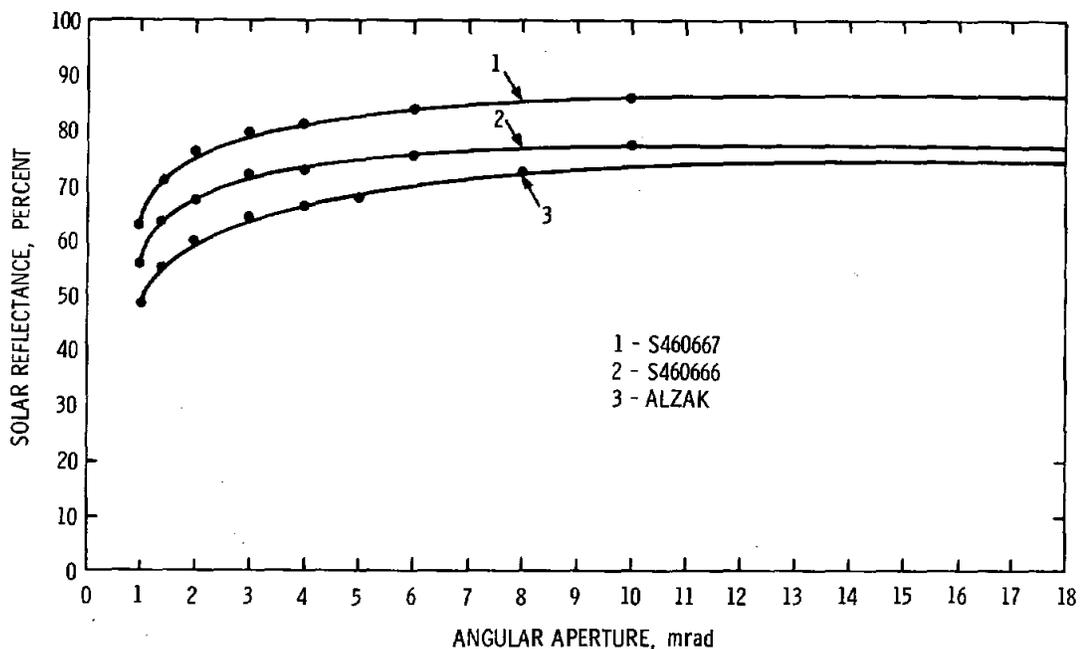
Figure 14. Solar Reflectance Properties of Special Aluminum and Alzak Reflectors

An indication of the fraction of the reflected beam that is diffusely scattered is given in Table IV, together with the approximate width of specularly reflected beam. Note that both special samples have less diffuse reflectance as compared to Alzak, while the specular beam widths are almost identical.

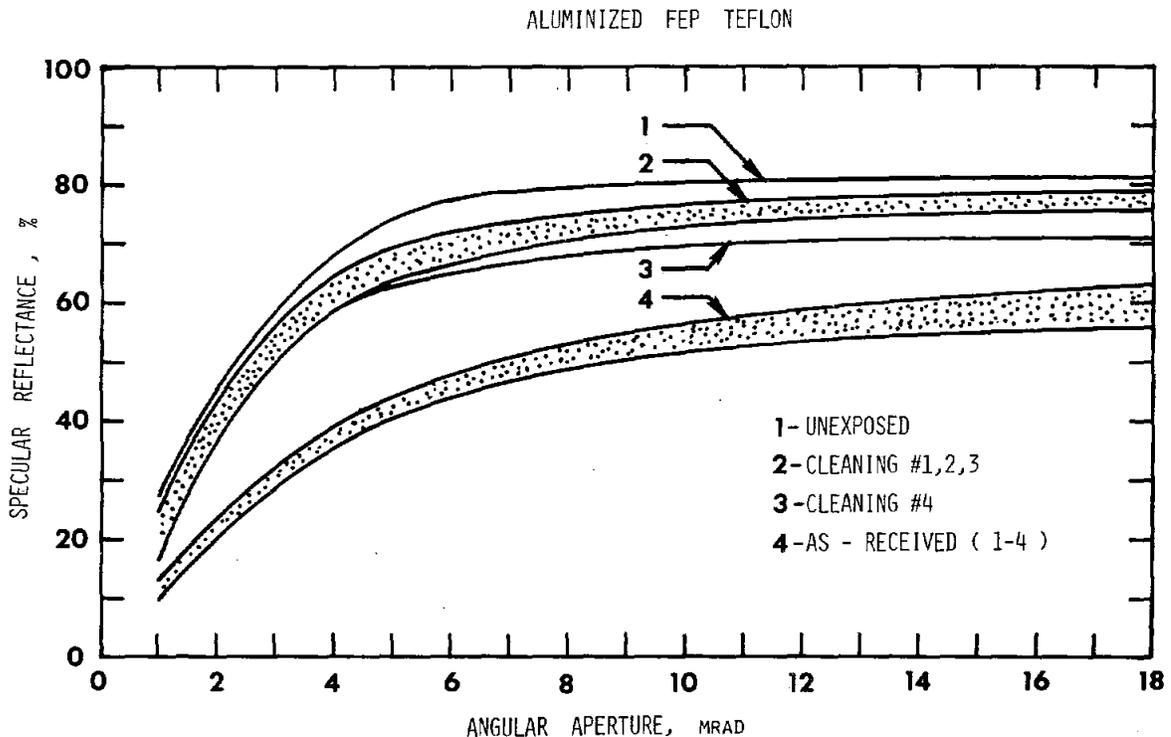
Figure 15. Specular Reflectance Properties of Aluminized FEP Reflectors

(2) After the ultrasonic cleaning, the specular reflectance at 15 mrad for mirrors R54, R56, and R60 is only 1 - 3% below the value for the unexposed material. This difference can be easily accounted for as manufacturing, material and/or sample mounting variations. However, mirror R56 has a residual reflectance loss at 15 mrad of over 7%. Optical microscope pictures of the outer teflon surface show a large number of small scratches which are not present in the other mirror samples. The scratches are all in the same direction as opposed to being random. Because this is the only material that was wiped during the field cleaning procedure, it appears as if the scratches, and thus the reflectance loss, are a result of the wiping. Therefore, wiping of these materials is not advised.

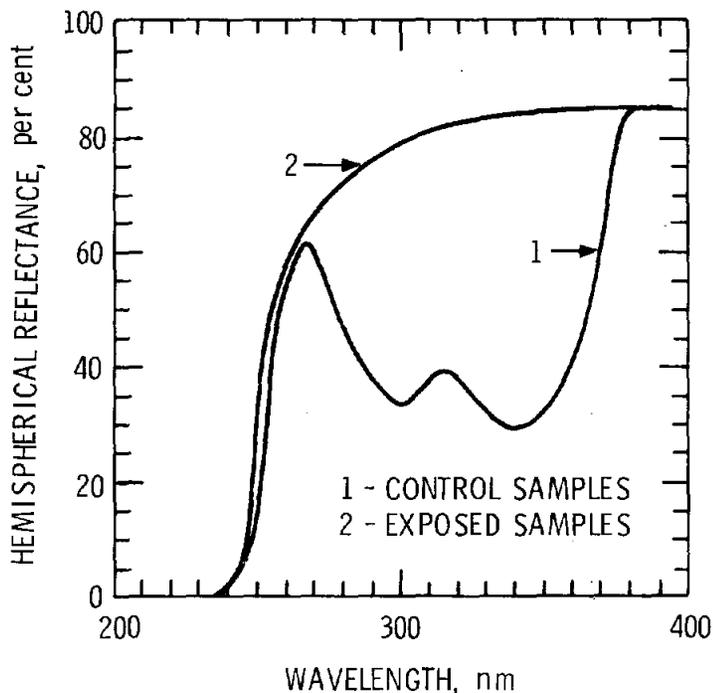
Figure 16. Hemispherical Reflectance of 3M Scotchcal 5400

The wavelength in the ultraviolet where the reflectance decreases to less than one-half the solar averaged reflectance occurs at ~360 nm for the unexposed samples, while for all the exposed samples, the cutoff occurs at ~250 nm (Figure 16). The reason for this change is unknown at the present time. Because this occurs at such a low wavelength, it has very little effect on the solar average reflectance.

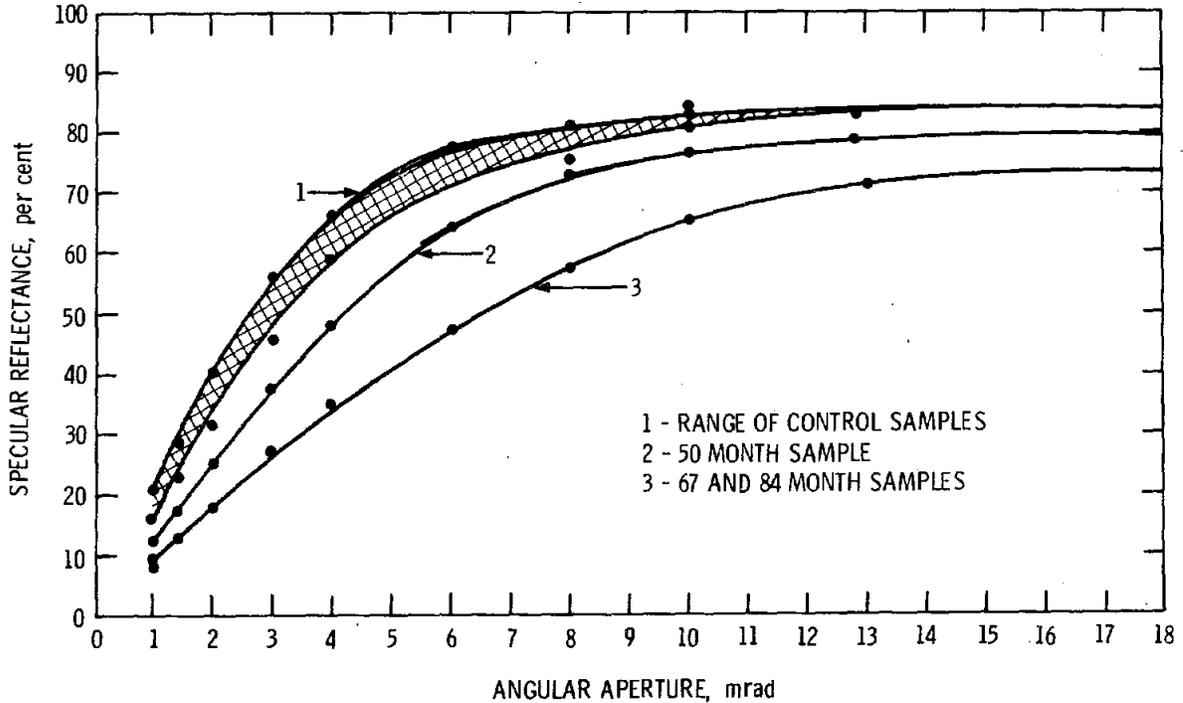
Figure 17. Specular Reflectance Properties of 3M Scotchcal 5400 at 500 nm

(4) There were very few defects at the acrylic-aluminum interface in the control or exposed panels, except for the 50 month sample. There were some defects for this panel but their density is less than  $5 \times 10^5/\text{cm}^2$  and the fractional area covered is less than 1%. However, the defects appeared similar to the defects found in the FEK-163 mirror after temperature and humidity cycling in the environmental chamber.<sup>2</sup>

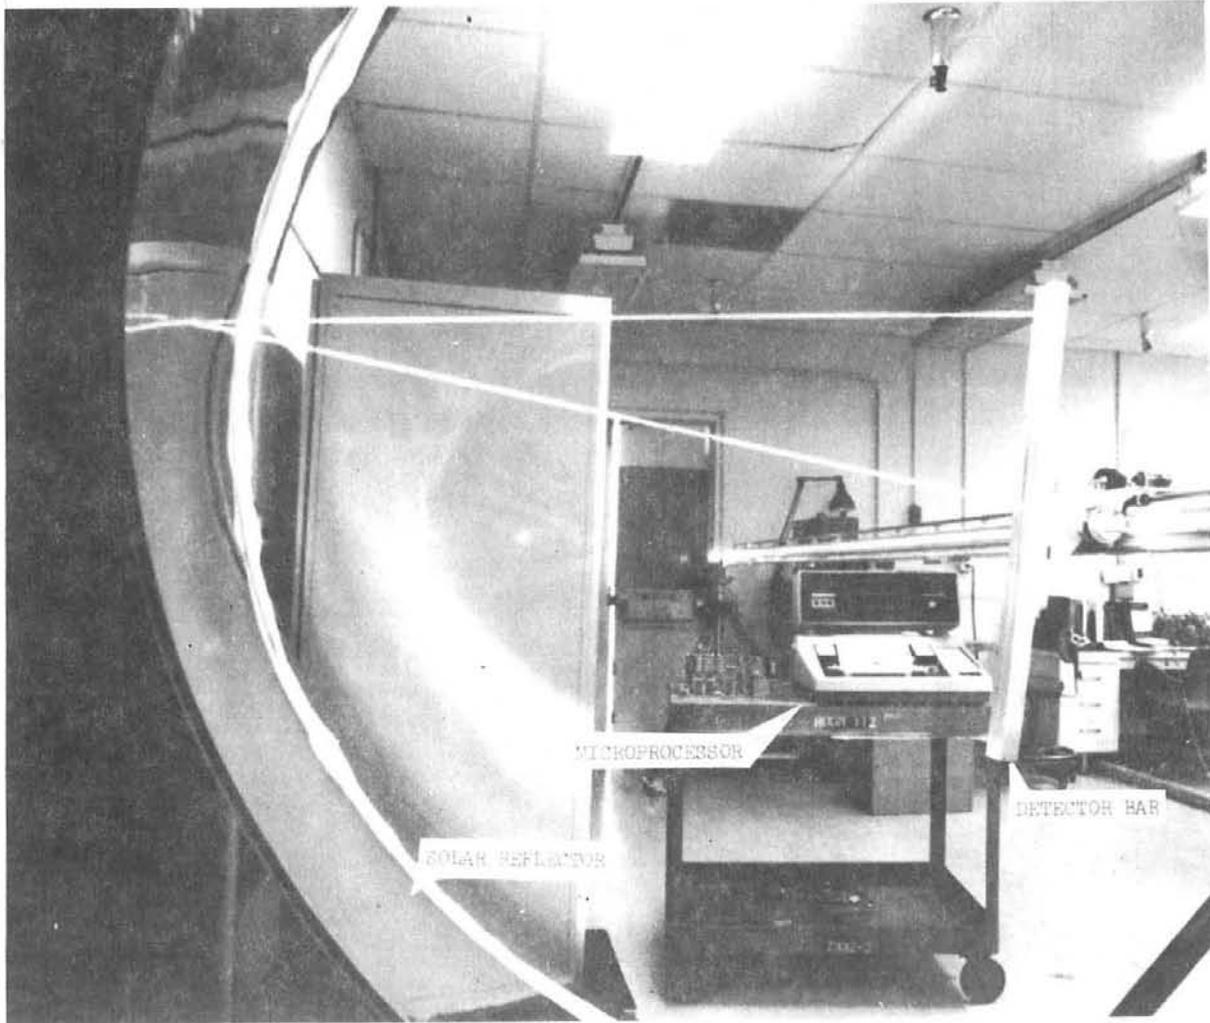
Figure 18. In-Situ Laser Ray Trace Tester

The detector bar assembly contains a linear array of 360 photodiodes spaced 2.54 mm on centers. This detector system was selected as a result of the work reported in the last semiannual report. The detector scanning electronics is being rebuilt so that high ambient light levels do not saturate the output and to allow scanning of a subarray of the entire detector array for more efficient data collection.

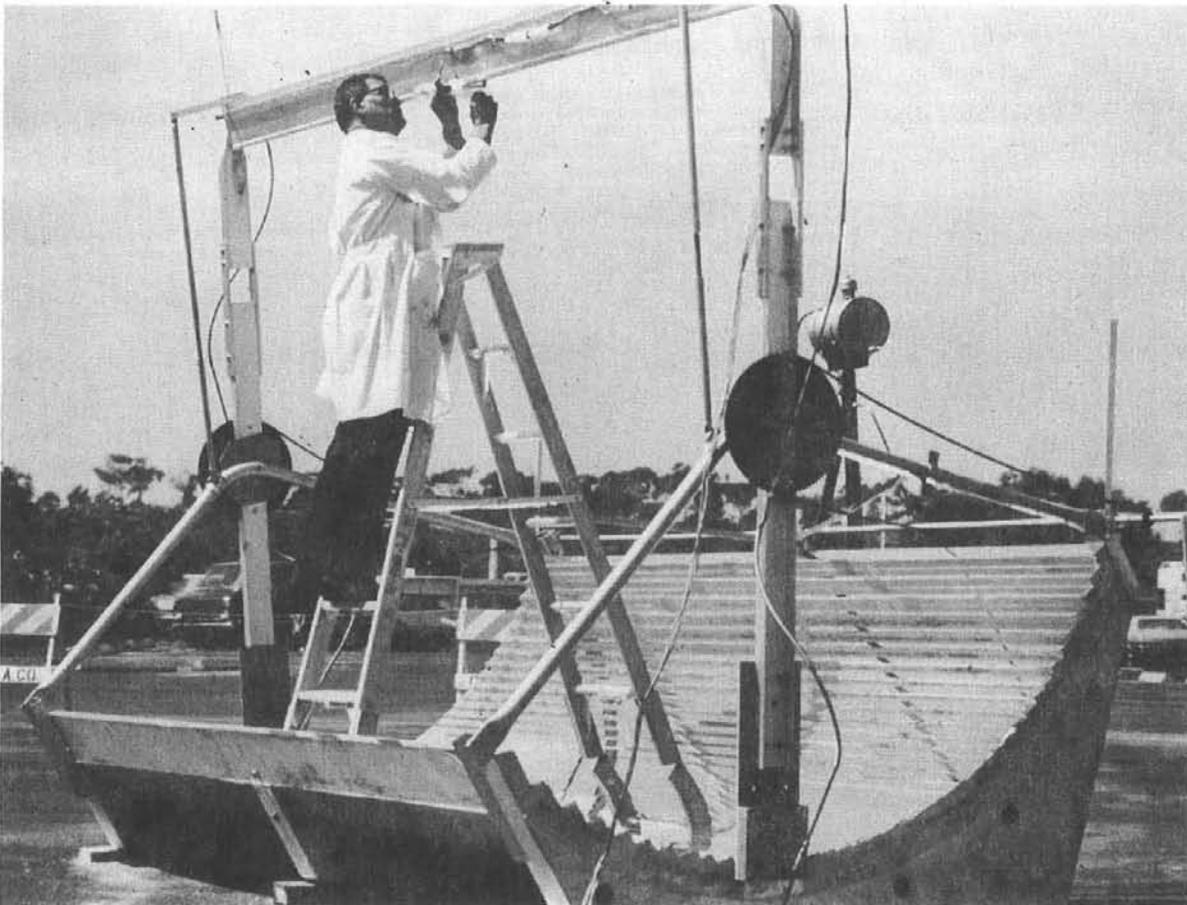
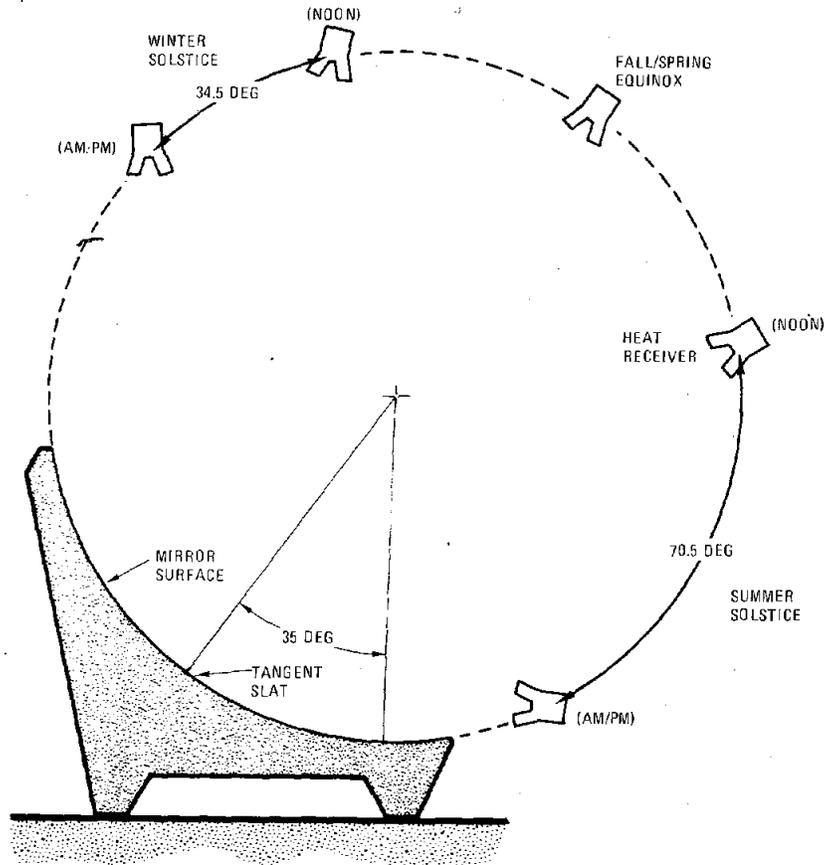
Figure 19. General Atomic Fixed Mirror Solar Collector

Figure 19 illustrates the General Atomic FMSC (Fixed Mirror Solar Collector). This collector field subsystem will be located in the southeast quadrant of the Solar Total Energy Systems Test Facility. The subsystem will consist of two rows of collectors each 61 m (200 ft) long and the associated plumbing, hardware, and control systems. Each row of collectors will be made up of 16 reflector modules positioned end-to-end and measuring 3.8 m (12.5 ft) long and 2.1 m (7 ft) wide. The receiver consists of 4 continuous sections interconnected at their ends with a piece of flexible tubing. Each section is 15.2 m (50 ft) long and the assembly swings through a circular arc as shown in Figure 20 to keep it positioned at the focal line as the sun changes elevation angle. A discussion of each of the major elements of the subsystem follows.

NOTE: 1. 90-DEG MIRROR MODULE  
 2. 35-DEG TILT  
 3. TANGENT SLAT 35 DEG FROM VERTICAL  
 4. 35-DEG LATITUDE  
 5. HEAT RECEIVER POINTS TO TANGENT SLAT  
 GA-A14209

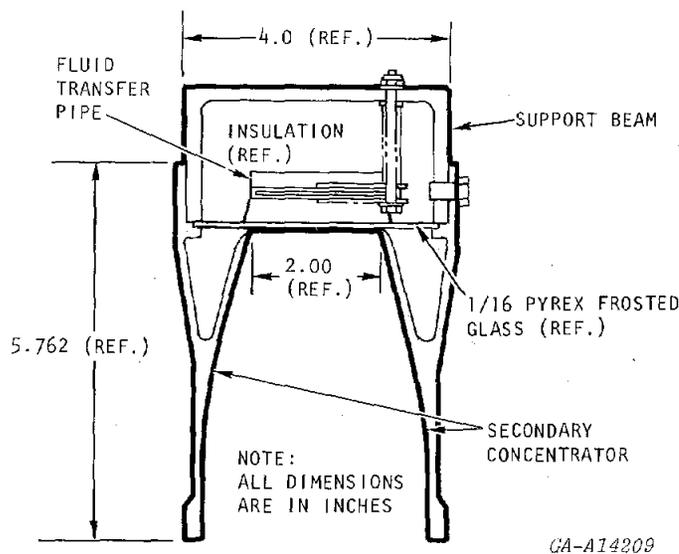
Figure 21. Cross-Section of General Atomic Receiver Design

Receiver -- A cross section of the receiver design is shown in Figure 21. The development of a secondary concentrator that will maintain high values of specular reflectivity at relatively high temperatures may be a problem. This will be examined during a one-month test series scheduled to begin in June 1977 at Sandia's Collector Module Test Facility. During this test series a 16.2 m<sup>2</sup> (175 ft<sup>2</sup>) collector module will be operated under a variety of conditions using two different reflector materials--silvered glass and Kinglux.

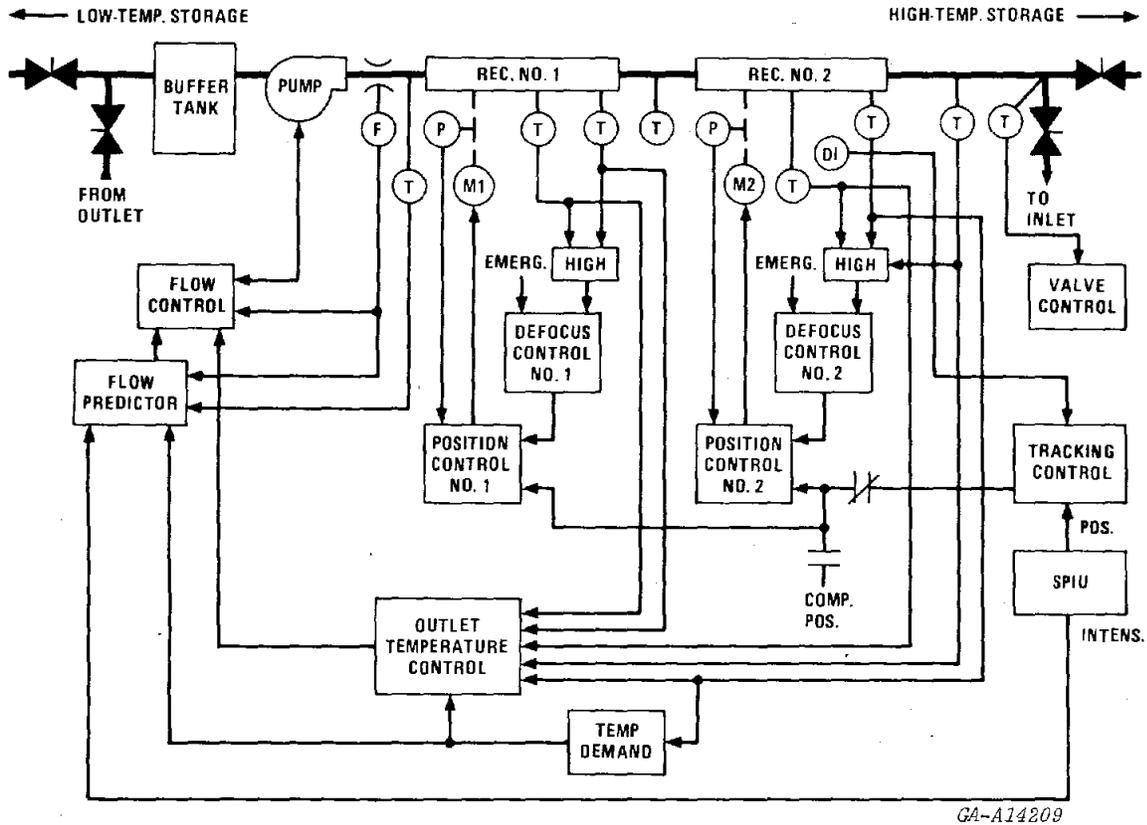
Figure 24. General Atomic Multivariable Control Schematic

A multivariable control scheme was developed in order to meet the startup and temperature control requirements. The scheme uses signals from the diagnostic and performance sensors required to monitor the collector subsystem's performance. A schematic of the multivariable control is shown in Figure 24.

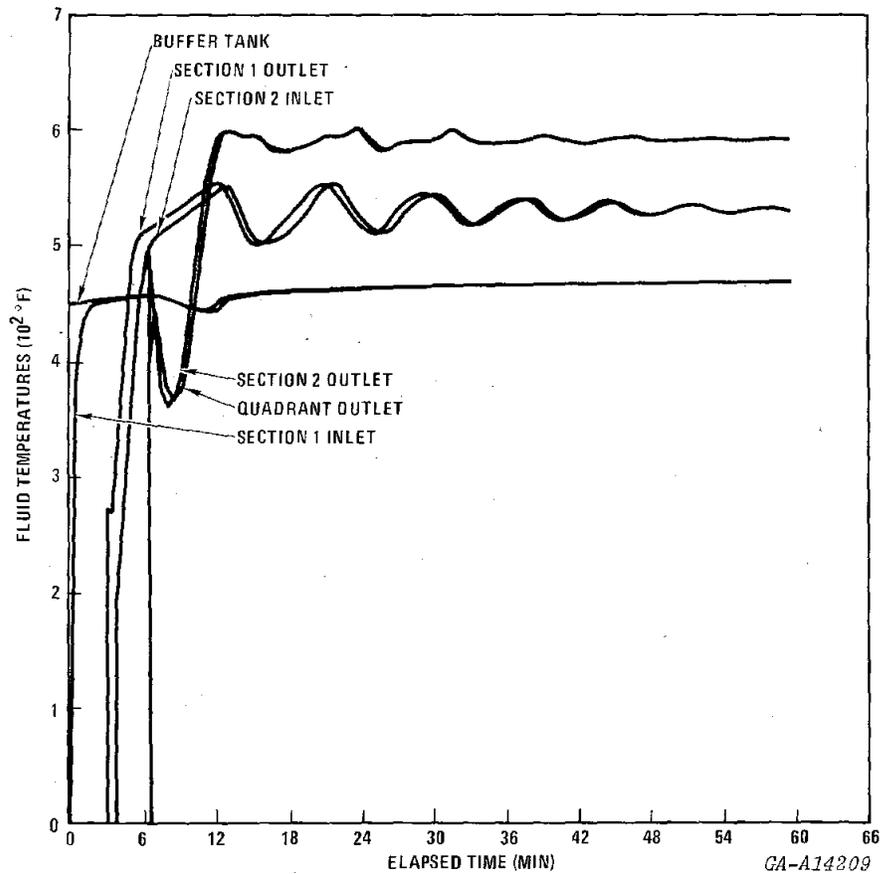
Figure 25. Fluid Temperatures for Purged System with Recirculation and Variable Minimum Flow (60-gal. Buffer Tank)

An example of the results of the multivariable control scheme applied to the FMSC system model is shown in Figure 25. In the example the problem of morning startup was examined. The initial conditions of the system were a buffer tank filled with Therminol 66 at 232°C (450°F) and the remainder of the fluid loop purged with nitrogen at ambient temperature. At time zero Therminol 66 was pumped out of the buffer tank, circulated, and recirculated through the system until warmup was complete.

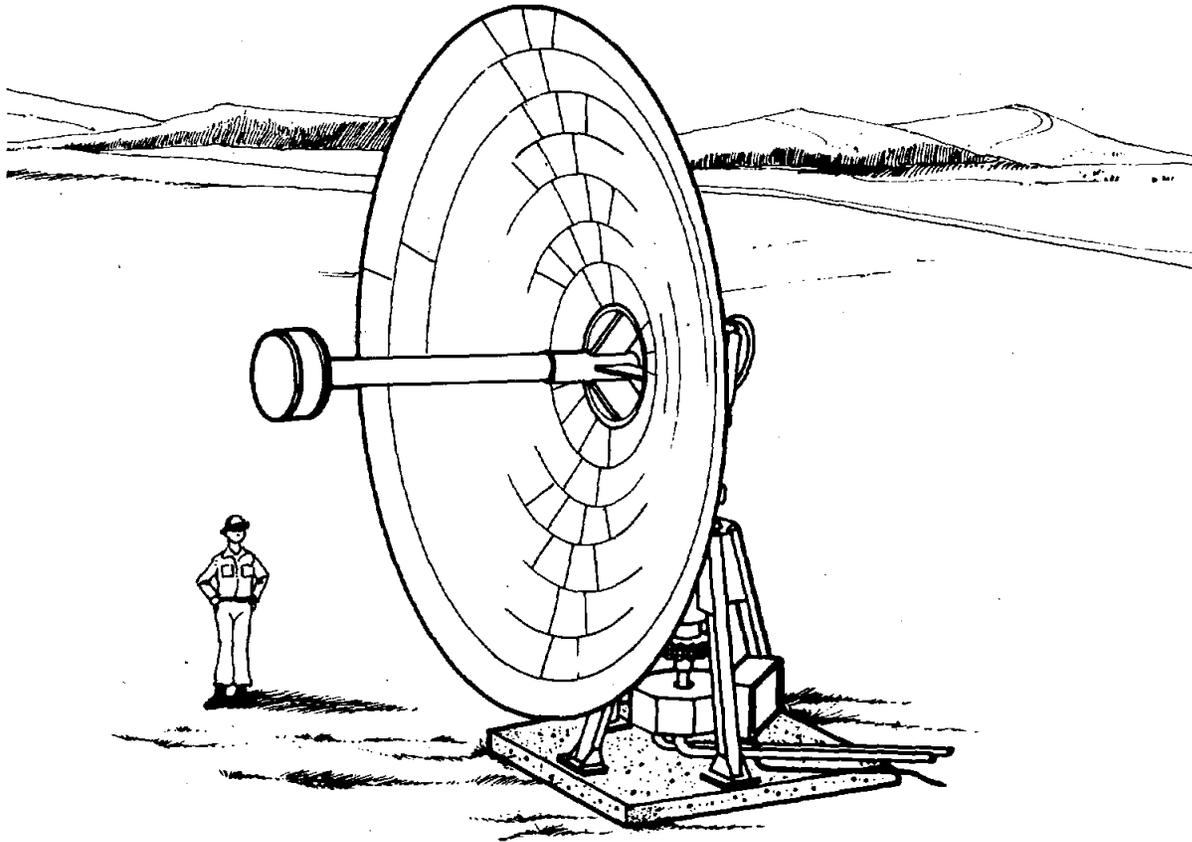
Figure 26. Raytheon Parabolic Dish Collector

Figure 26 illustrates the Raytheon parabolic dish solar collector. This collector field subsystem will be located in the northeast quadrant of the Solar Total Energy Test Facility. The subsystem will consist of three individual collectors and the associated plumbing, hardware and control systems. Raytheon has a contract to deliver one collector this fiscal year. The other two will be provided when funds become available.

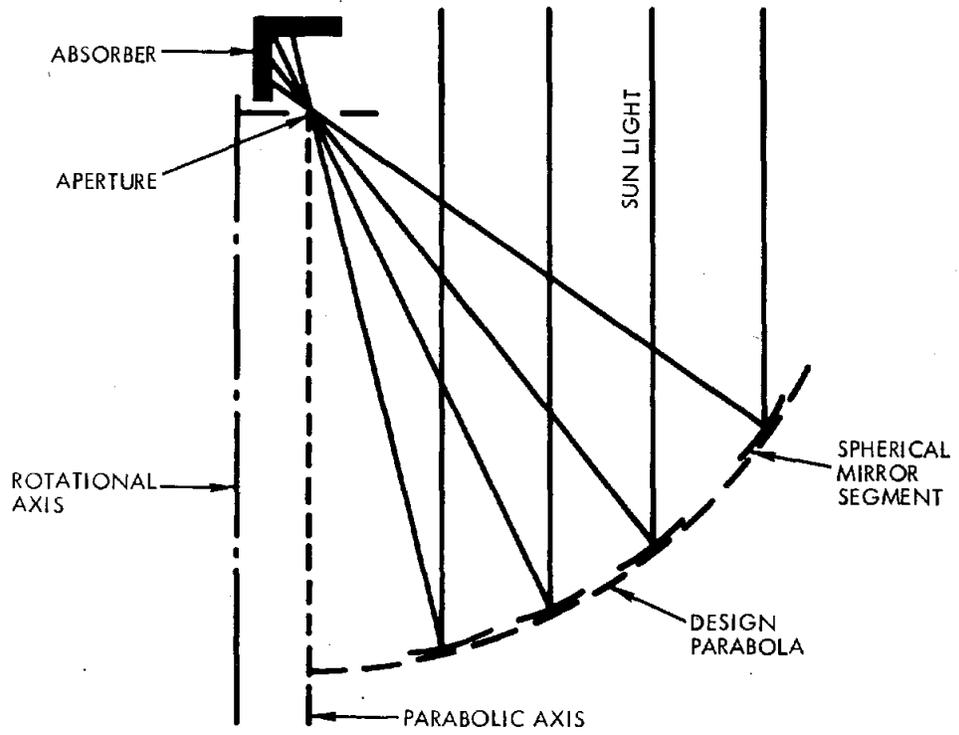
Figure 27. Toric Parabola Collector

The parabolic dish reflector consists of a toric parabola, Figure 27. This is a figure of revolution around the collector center line. The reflecting surface is made up of approximately 200 spherical mirror segments. The segments are 3.2 mm (.125 in.) thick water-white crystal glass, silvered on the back side for a specular reflectance of .93. The segments are fastened to the support points by cap screws with rubber grommets through holes drilled in the glass as shown in Figure 28. The selected mirror mounting configurations have been subjected to simulated wind pressure loads in excess of 90 mph. The data generated was then used to verify the structural analysis previously performed. A dynamic loading test series will also be conducted including vibration and hail impact tests.

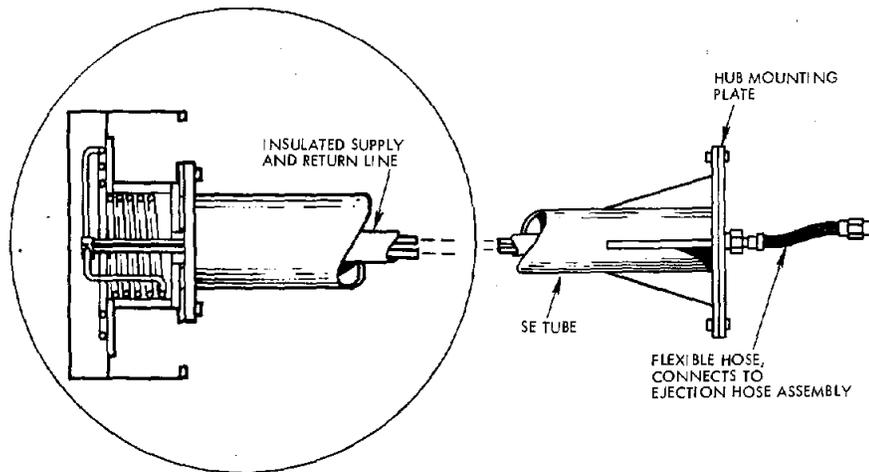
Figure 29. Raytheon Receiver Design

A cross section of the receiver design is shown in Figure 29. The annular cavity has absorbing surfaces made of zirconium/copper. Therminol 66 flows through tubing that has been bonded to the back side of the zirconium copper. The tubing will initially be made of CuNi primarily due to its availability. Ultimately zirconium copper will be used because of its superior heat transfer characteristics. Material compatibility tests are being conducted by Raytheon to evaluate the possibility of chemical reactions between Therminol 66 and the zirconium/copper or copper/nickel at elevated temperatures. The absorbing surfaces will be plated with black chrome using a process developed by Highland Plating Co., Los Angeles, CA.

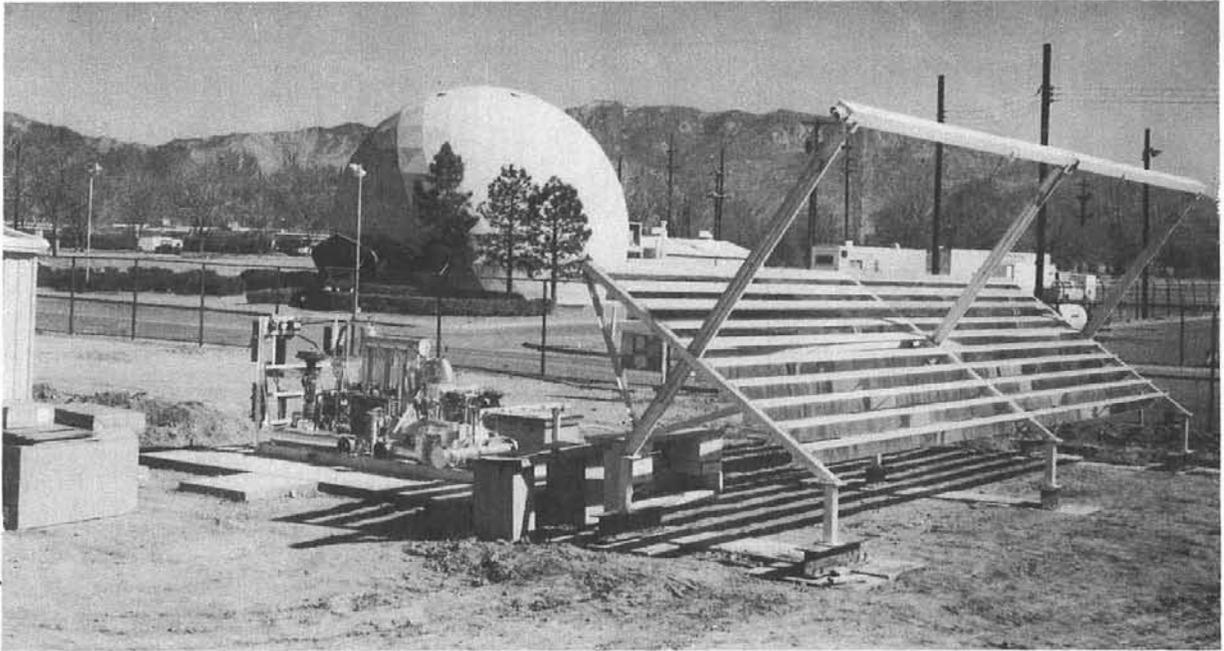
Figure 30. Sheldahl Solar Linear Array Thermal System (SLATS)

Figure 30 illustrates the Sheldahl SLATS solar collector. This collector field subsystem will be located in the southwest quadrant of the Solar Total Energy Test Facility. The subsystem will consist of two rows each 42.7 m (140 ft) long. Each row contains seven segments 6.1 m (20 ft) long. In each segment there are ten reflectors .3 m (1 ft) wide and 6 m (20 ft) long for a total reflector area of  $260 \text{ m}^2$  ( $2800 \text{ ft}^2$ ). The reflectors are concave arcs with a radius of 6.6 m (21.7 ft). This subsystem differs from the others in that it will use water as a heat transfer fluid. The thermal energy collected is transferred to the Therminol 66 in the remainder of the system via a heat exchanger. This subsystem heats the water to  $332^\circ\text{C}$  ( $630^\circ\text{F}$ ) in order to efficiently heat the Therminol 66 to  $311^\circ\text{C}$  ( $592^\circ\text{F}$ ) at the heat exchanger.

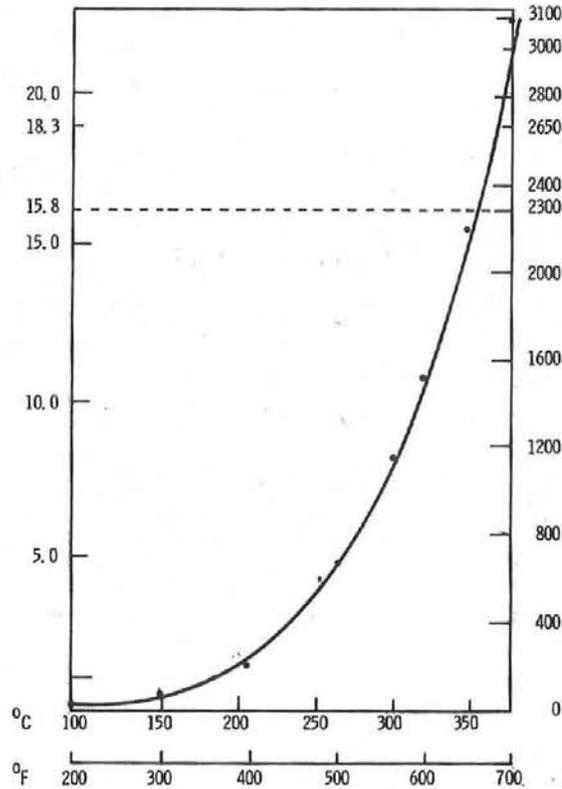
Figure 31. Pressure vs. Saturation Temperatures for Water

A distinct disadvantage of water is the high saturation pressure associated with temperatures in excess of 260°C (500°F). Figure 31 shows how saturation pressure varies with temperature. By contrast, the vapor pressure of Therminol 66 at 315°C is only 50 kPa (7.5 psi). The heavier pipelines and receiver tubes required to contain the higher pressures associated with water adds to the thermal mass of a subsystem. This resulted in a warmup time of 1.7 hours for the water subsystem compared to 0.5 hour for the Therminol 66 subsystems. The high saturation pressure of water makes a fixed receiver almost mandatory until a reliable, long life, flexible connection can be designed and demonstrated.

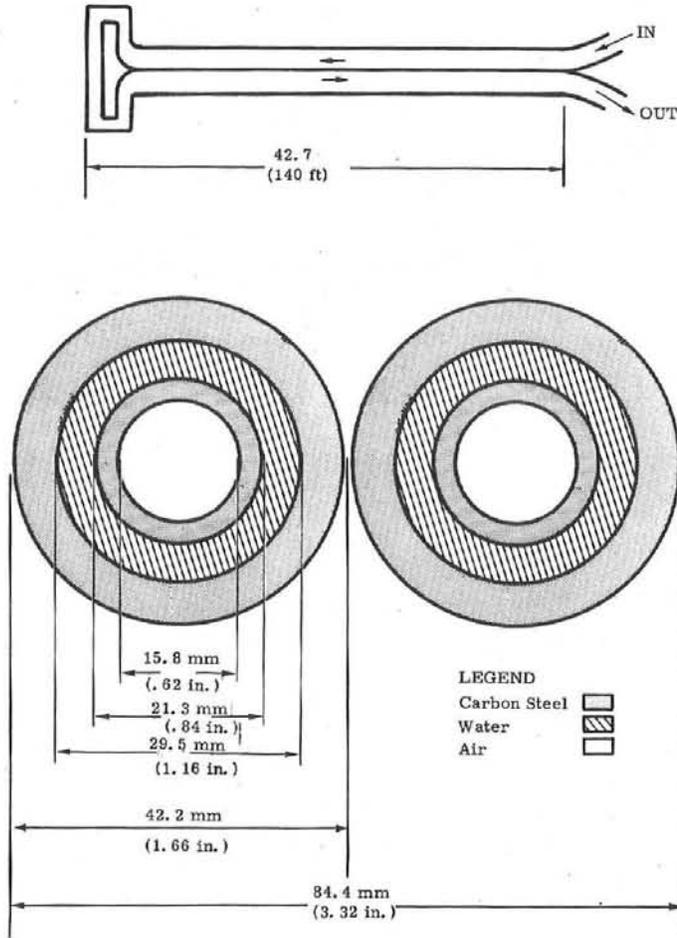
Figure 32. SLATS Receiver, Plan View and Cross Section

The receiver for each of the two rows consists of two parallel lengths of schedule 160 carbon steel pipe (ASTM A-106B) with a schedule 40 carbon steel plug inside. The annulus between the ID of the pipe and the OD of the plug is 3.2 mm (.125 in.) wide, Figure 32. Water enters the east end, traverses the 42.7 m length, makes a "U" turn and returns to exit at the east end. Empty, the receiver weighs 13.7 kg/m (9.24 lb/ft). Filling the annulus with water adds .71 kg/m (.39 lb/ft). To heat the entire receiver from an early morning temperature of 20°C (68°F) to an average operating temperature of 308°C (587°F) requires 215,000 kJ.

It should be noted that the 84.4 mm (3.32 in.) receiver width is the result of predicted dispersion of reflected light and not of any limitation imposed by the heat transfer characteristics of water. Thus, if the focus could be sharpened so that all of the reflected light would fall on one pipe, the receiver weight and the warmup time could be cut by approximately 50%.

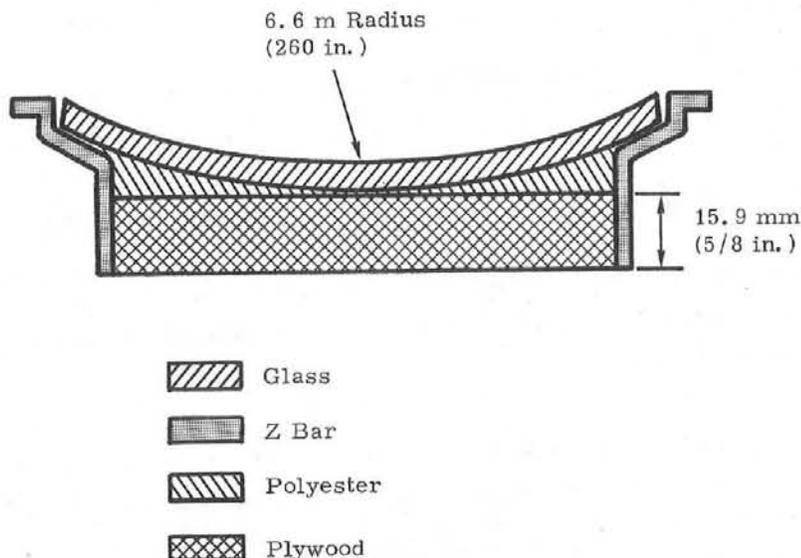
Figure 33. Reflector Bonded to Plywood

Through Corning Glass Works quantities of 1.5 mm (.060 in.) 0317 fusion glass became available. Measurements at Sandia showed this glass (when silvered) to have a specular reflectance of .94 which is better than most float glass. The glass is first silvered and then cut into rectangles 30.5 x 118.4 mm (12 x 46 5/8 in.). Next the glass is bent to shape over a mandrel using a vacuum. Polyester and a catalyst are sprayed on, then a piece of high density plywood is bonded to the glass and "Z" bar is bonded to the plywood as shown in Figure 33. In the meantime, edges are formed on a piece of 61 mm (2 ft) wide sheet of 28 gauge galvanized steel sheet. The sheet is bent into a semicircle and attached to the "Z" bar with a dimpling tool as shown in Figure 34. Caps are placed over the ends, and the reflector is ready for mounting.

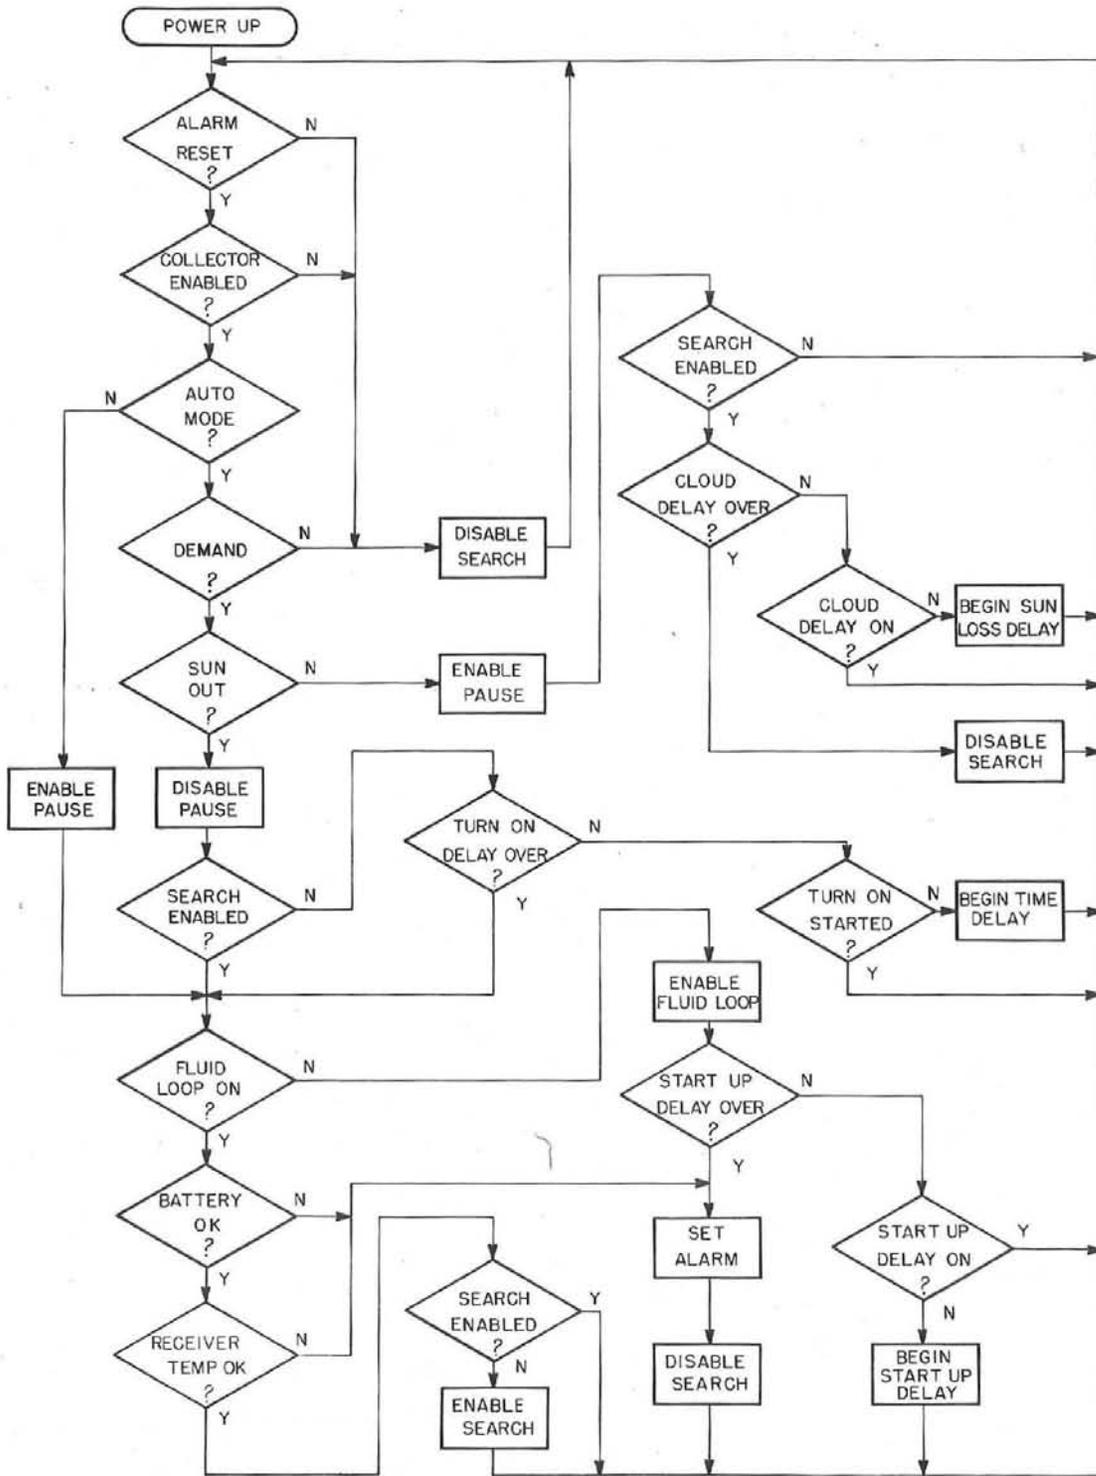
Figure 35. Field Control Logic Flow Chart

The field controller monitors the demand signal from the system user and the intensity of the sun. A control logic flow chart is shown in Figure 35. If there is a demand and collectable energy, the controller signals the fluid loop to operate. When the heat transfer medium is circulating, a signal is returned to the field controller which permits the module controllers to be enabled. If the outlet temperature from each row is within operational limits and the mode selector switch on the field controller is in the "ON-AUTOMATIC" position, the rows are then enabled (the module controllers will then focus their set of mirrors on the receiver). Failure of any of these conditions causes the "DISABLE" (or protect) signal which the module controllers respond to by rotating the mirrors into the storage position.
