# Solar Total Energy Test Facility Project Semiannual Report October 1976 - March 1977

SOLAR TOTAL ENERGY TEST FACILITY PROJECT  
SEMIANNUAL REPORT  
October 1976 - March 1977

Edited by  
Ben Petterson, Jr.  
Solar Total Energy Test Facility Division 5712  
Sandia Laboratories  
Albuquerque, NM 87115

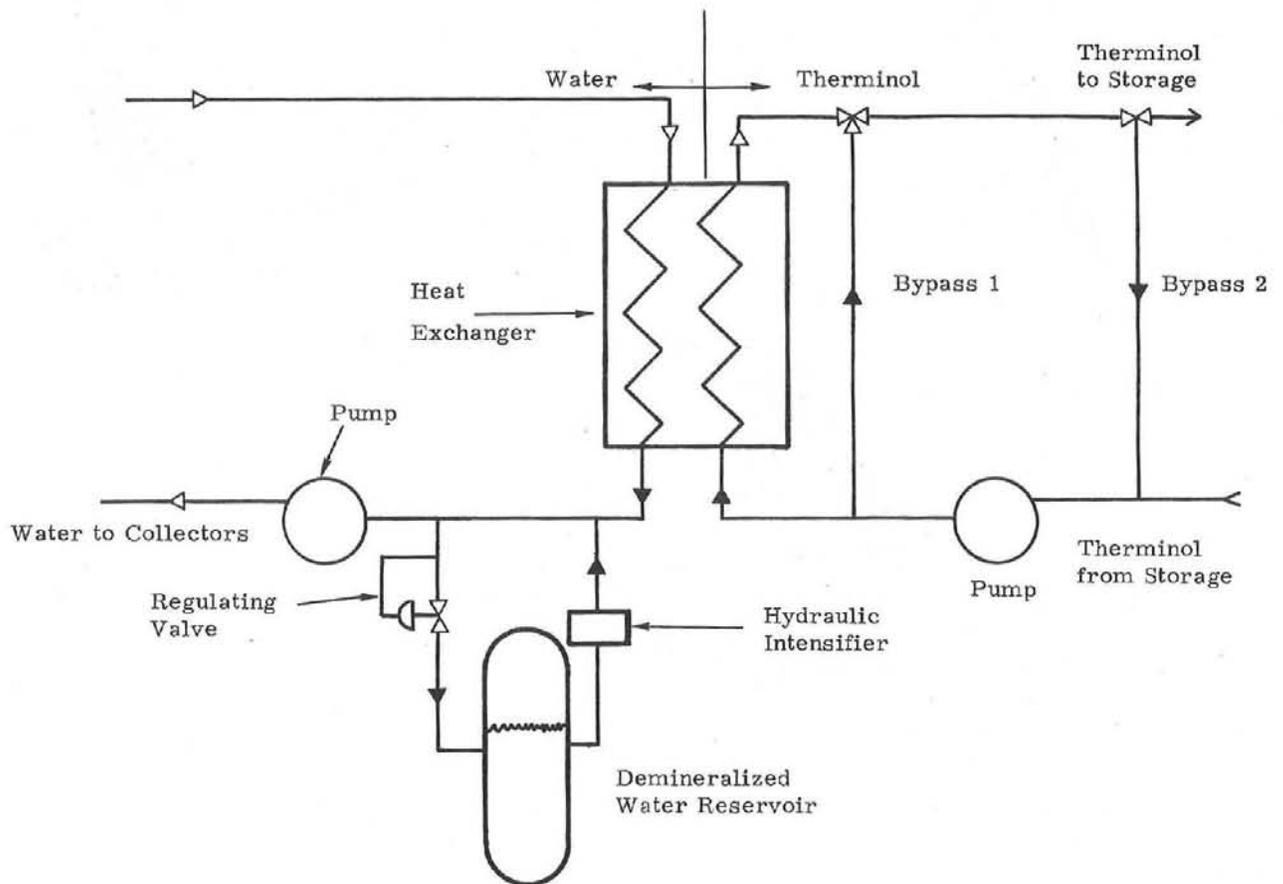
Figure 37. Fluid Loop Schematic

The fluid loop shown in a very simplified schematic in Figure 37 was designed by Barber-Nichols Engineering, Denver, CO. On the water side pressure is maintained in the line by the hydraulic intensifier which adds water when the pressure drops below a preset value. The regulating valve relieves water back into the reservoir when pressure exceeds a preset value. These two features eliminate the need for ullage to accommodate expansion and contraction of the water.

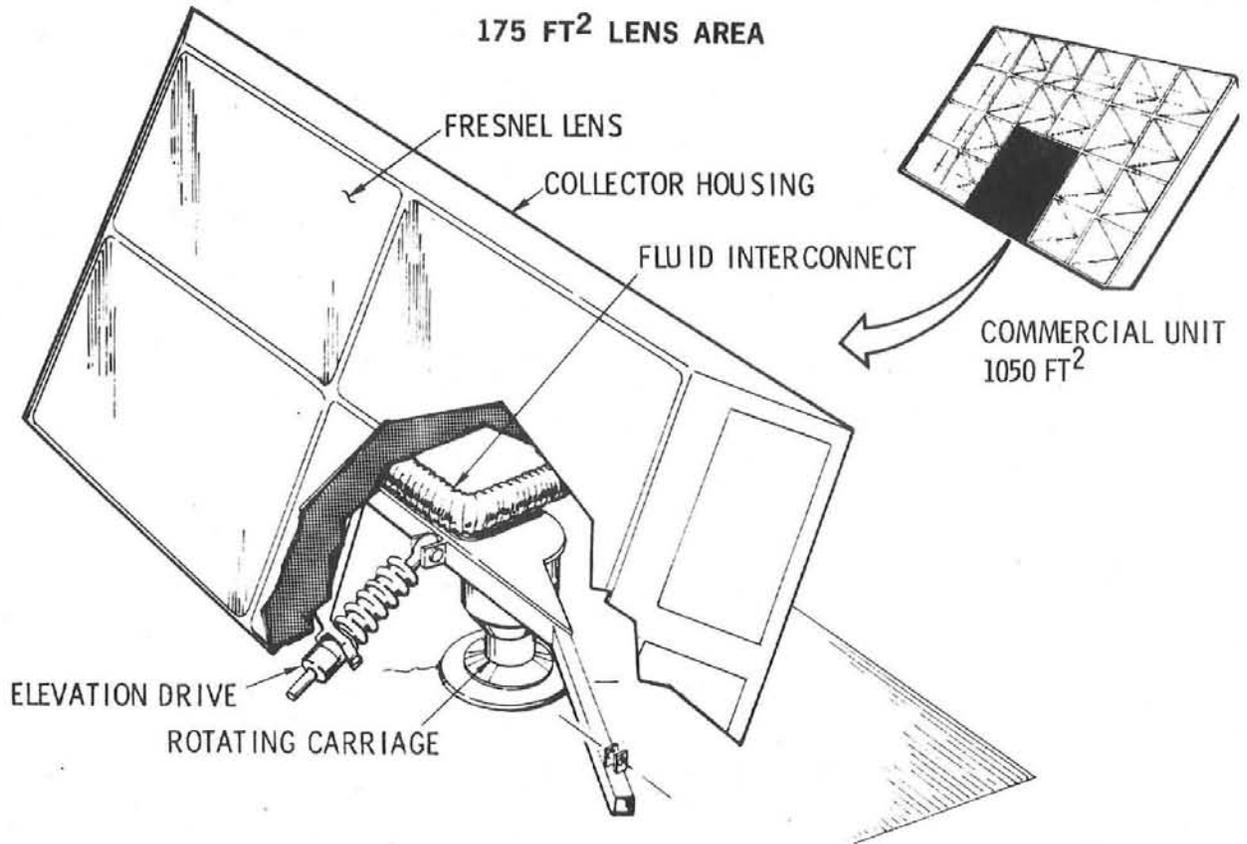
Figure 38. Fresnel Solar Collector Test Model

The collector is made up of a linear refractor, four receiver tubes and their supporting structural members. The collector is mounted on a two-axis tracking mechanism on a central pivot.

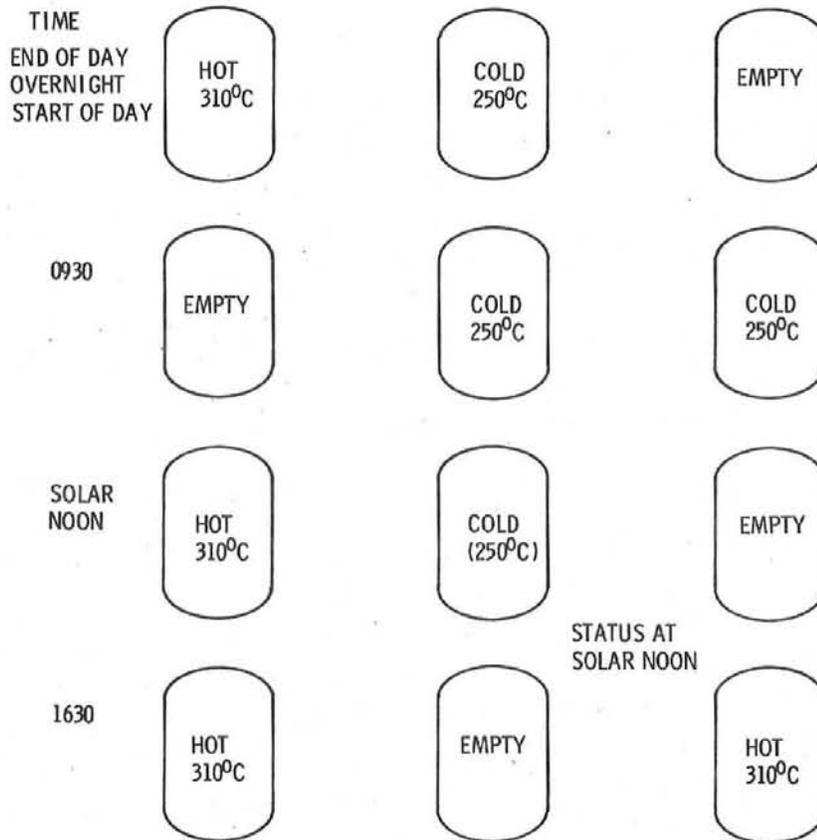
Figure 41. Status of Multiple Tank Storage at Selected Times of Day

$$\text{VOLUME OF EACH TANK} = \frac{\text{REQUIRED FLUID VOLUME}}{\text{NUMBER OF TANKS} - \text{ONE}}$$

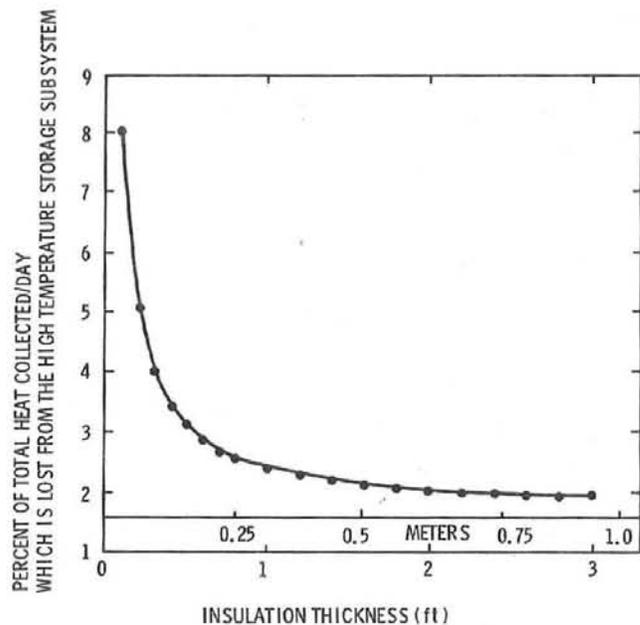
Figure 45. Percentage Heat Loss vs. Insulation Thickness for a Large System

The percentage of collected heat loss per day is shown in Figure 45 as a function of insulation thickness. As tanks become heavier, insulating them from the ground becomes more difficult. Figure 46 shows how losses through the base vary as a function of the thickness of insulation on the walls.

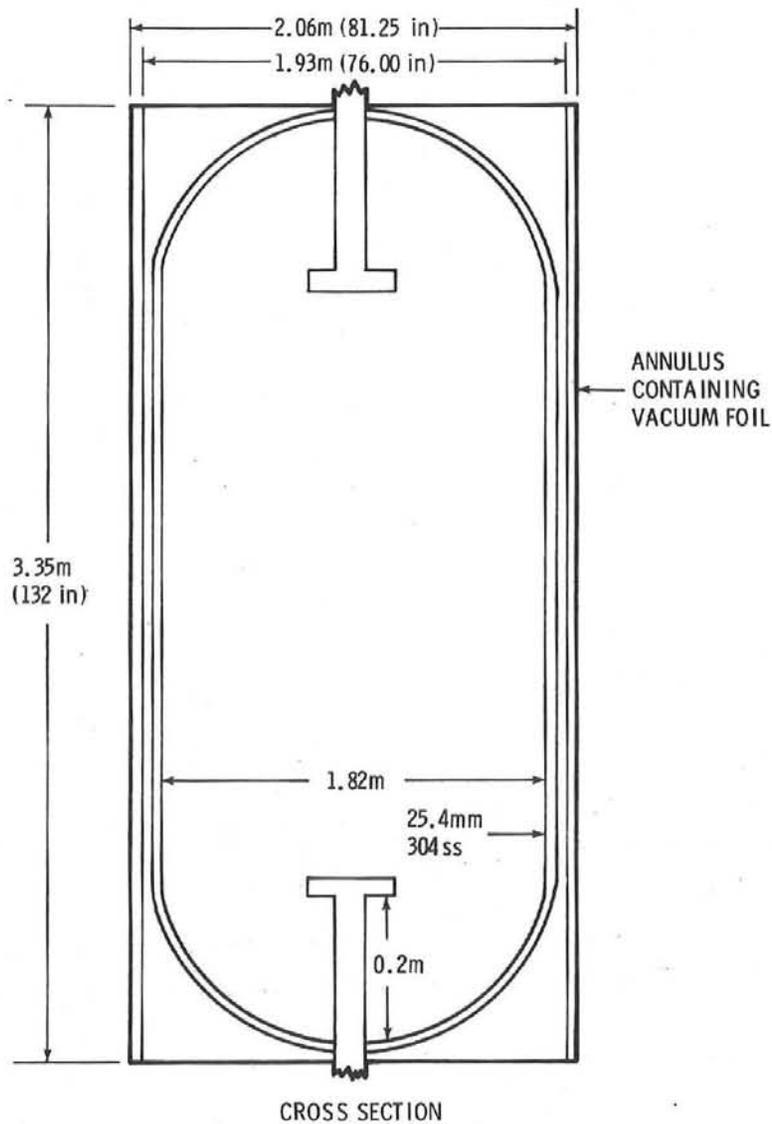
Figure 47. High Temperature Thermocline Storage Subsystem

These thick walls absorb about  $.13 \times 10^6$  kJ when the cold fluid, 243°C (470°F), is replaced with hot fluid, 310°C (590°F). This represents 18% of the theoretical maximum thermal storage capacity of  $.69 \times 10^6$  kJ.

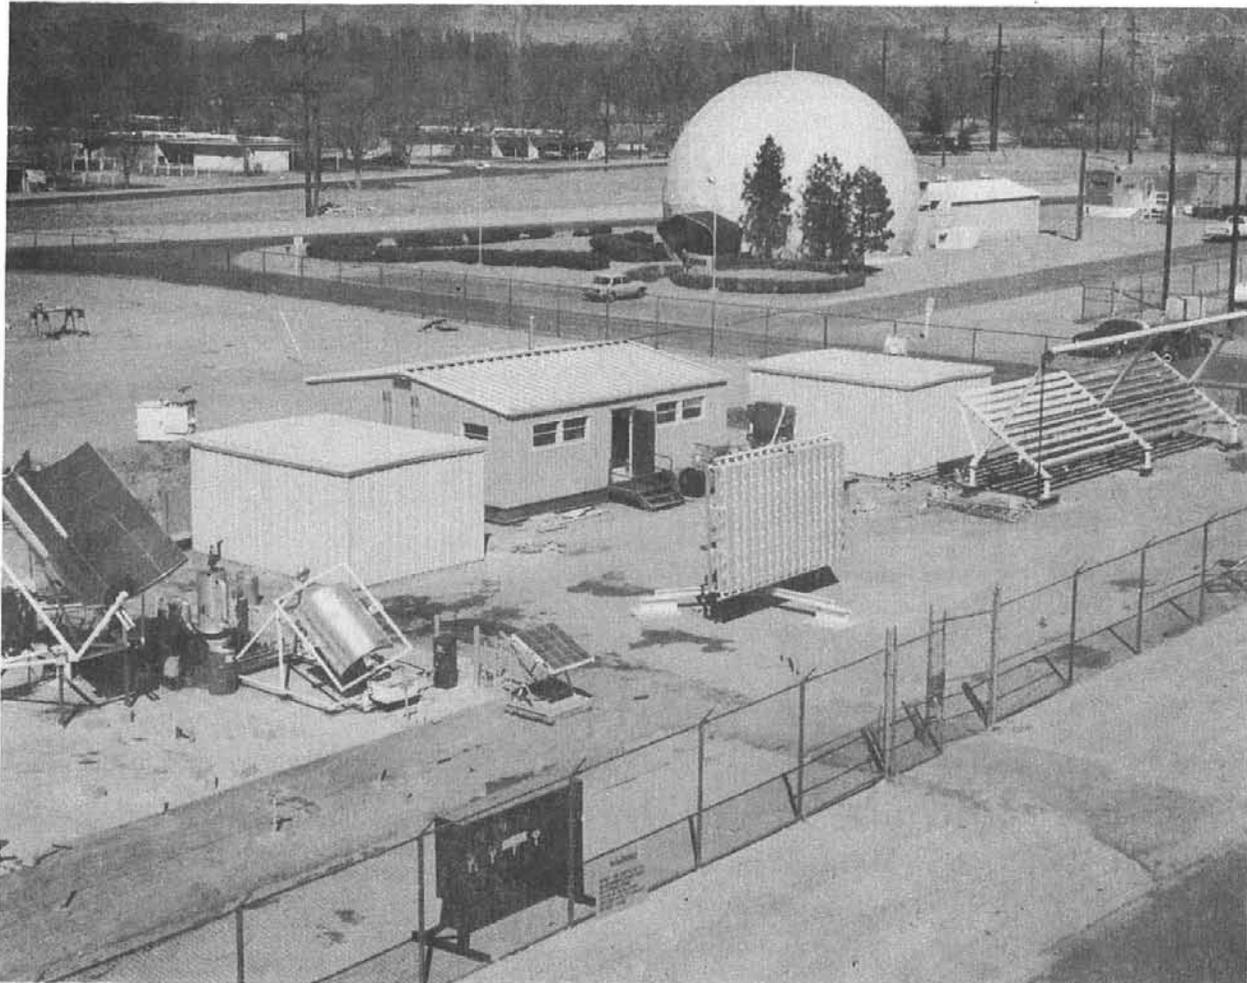
Figure 53. Collector Module Test Facility

Activities during this period were concerned primarily with expansion of the Collector Module Test Facility (Figure 53). A small amount of progress was made to improve the accuracy and precision with which we measure flow rates and temperatures. Tests were continued on arrays of photovoltaic generators. The results of these tests are documented by the Photovoltaic Systems Definition Project, Definition Division. Raytheon conducted a test to evaluate the compatibility of Therminol with the materials of their proposed receiver (see Task 4.0).

Test Loops 2 and 3, which use water (or water and ethylene glycol), are protected from the elements (particularly freezing) by 4.5 x 6 m insulated buildings (Figure 53), which can be heated to about 5°C in the winter.

By March 22, 1977, all building was essentially complete, Figure 53.

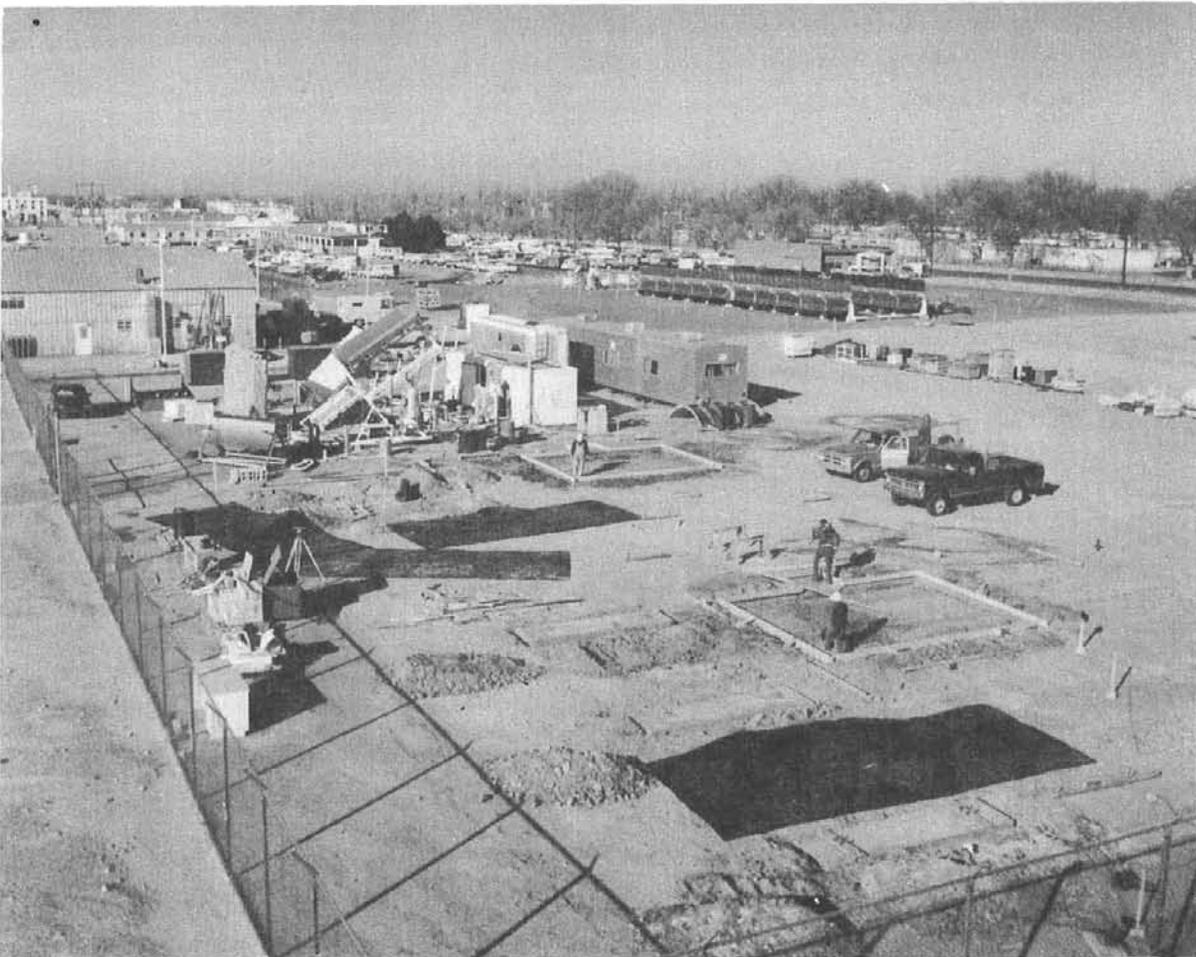
Figure 56. Test Loop Foundation Work

The Kirtland Operation of EG&G, an ERDA contractor, was assigned the task to design and install the instrumentation housing and associated electronics. As of the middle of December 1976, some preliminary work had been done in foundations (Figure 56). All testing was being done on Loop 1 (Figure 57).
