SAND80-8192
UC-62d
Unlimited Release

Volume II—Molten Salt Thermal Energy Storage Subsystem Research Experiment

Martin Marietta Corporation

**MOLTEN SALT THERMAL
ENERGY STORAGE
SUBSYSTEM RESEARCH
EXPERIMENT**

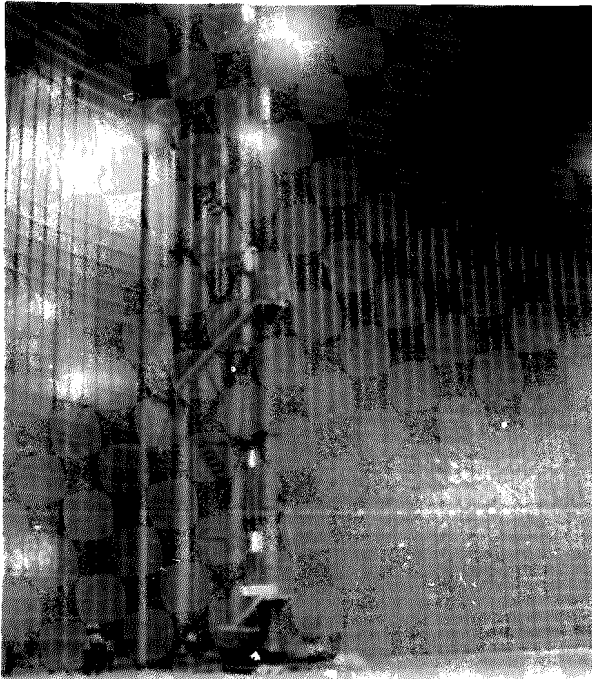
Figure 1.2.2-1
Technigaz Liner in Liquid Natural
Gas Tank

Figure 1.2.2-1 is a photograph of the inside of a Technigaz-lined LNG tank. The liner is a metal membrane with a series of uniquely folded orthogonal corrugations to allow for thermal expansion and contraction of the liner. The liner provides the necessary liquid tightness and transfers the hydrostatic load to the insulating brick and the tank shell. Thus the Technigaz system is ideally suited to contain the molten salt for a solar thermal storage subsystem.

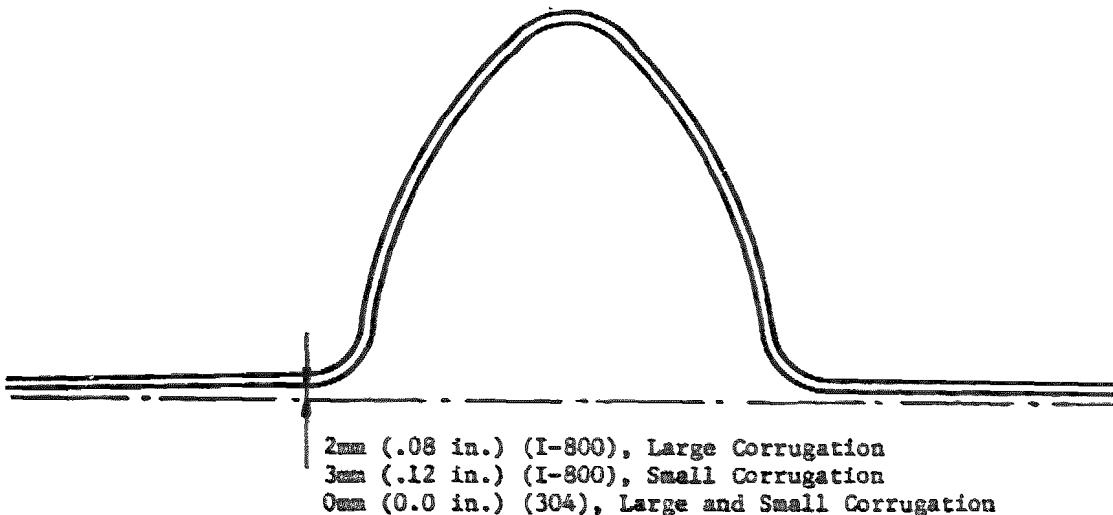
Fig. 3.1.1-2 Corrugation Profile Comparison

Comparison of the profiles of the corrugations of both materials indicated very close correlation, with both showing slight variation from the theoretical profile. Measurement did show a springback condition in the Incoloy 800 as shown in Figure 3.1.1-2.

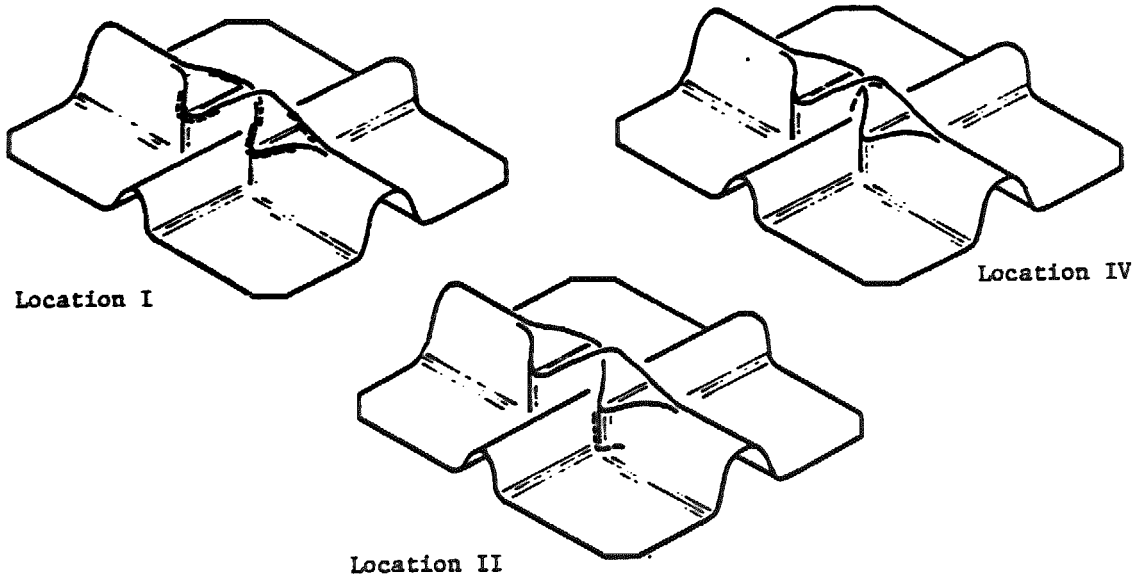
Figure 3.1.4-1 Knot Fatigue Failure Locations

Elongation		Amplitude Elongation mm.(in.)	Crack Location	Freq	Number of Cycles	Remarks
Minimum mm.(in.)	Maximum mm.(in.)					
0	1.37 (0.054)	1.37 (0.054)	I	10 Hz	189,000	Two Through Cracks
0.38 (0.015)	1.37 (0.054)	0.99 (0.039)		10 Hz	stop at 600,000	No Cracks
0	1.76 (0.069)	1.76 (0.069)	IV	10 Hz	87,000	Two Through Cracks

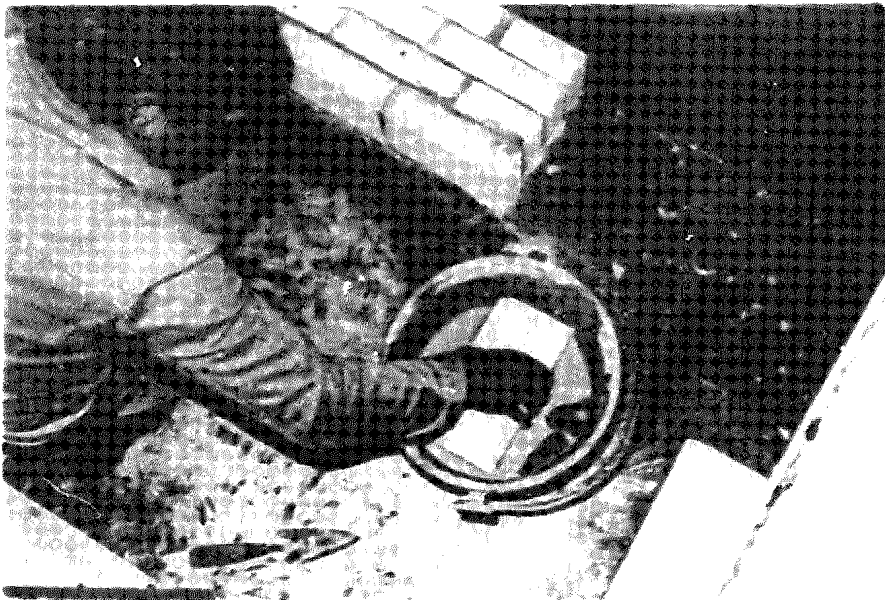
Figure 4.2.1-5 Brick Installation on Tank Floor

The entire interior surface of the carbon steel tank was lined with JM C22ZSL brick, using the shelves shown in Figure 4.2.1-4 to support the bricks. Care was exercised to locate the liner support anchor bolts in mortar joints. Two layers of brick were utilized in the assembly. The outer layer was installed vertically and an inner layer was placed horizontally. Figure 4.2.1-6 shows the assembly partially completed. Two anchor bolts can be seen at the top of the wall and the expansion joint in the middle of the wall.

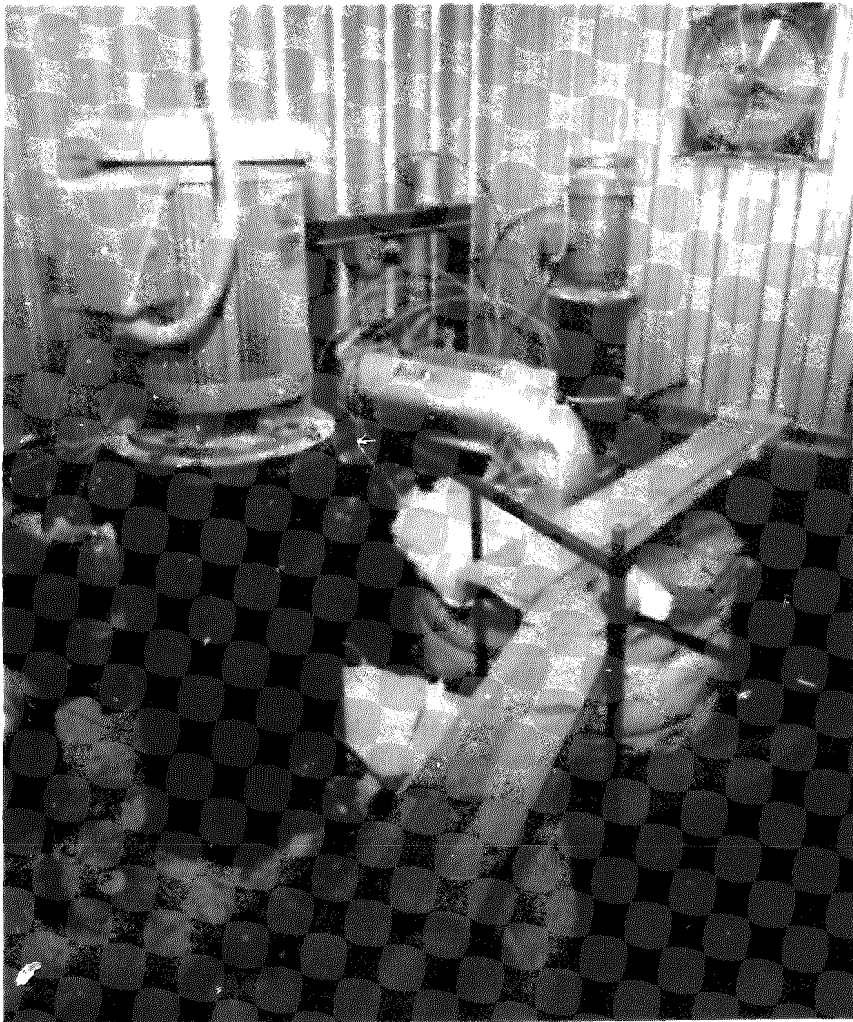
Figure 6.4-2 Sump Building Interior - Completed

The finished installation of the sumps and pumps is shown in Figure 6.4-2. Electrical hookup of the pump motors has been completed. Note the rigid and flexible conduit coming from the ceiling. The valves and piping at the base of the cold pump provide an air supply to the pumps air cooled bearing. Piping to the hot pumps water cooled bearing has also been completed. The hot sump and molten salt transfer lines have all been insulated.

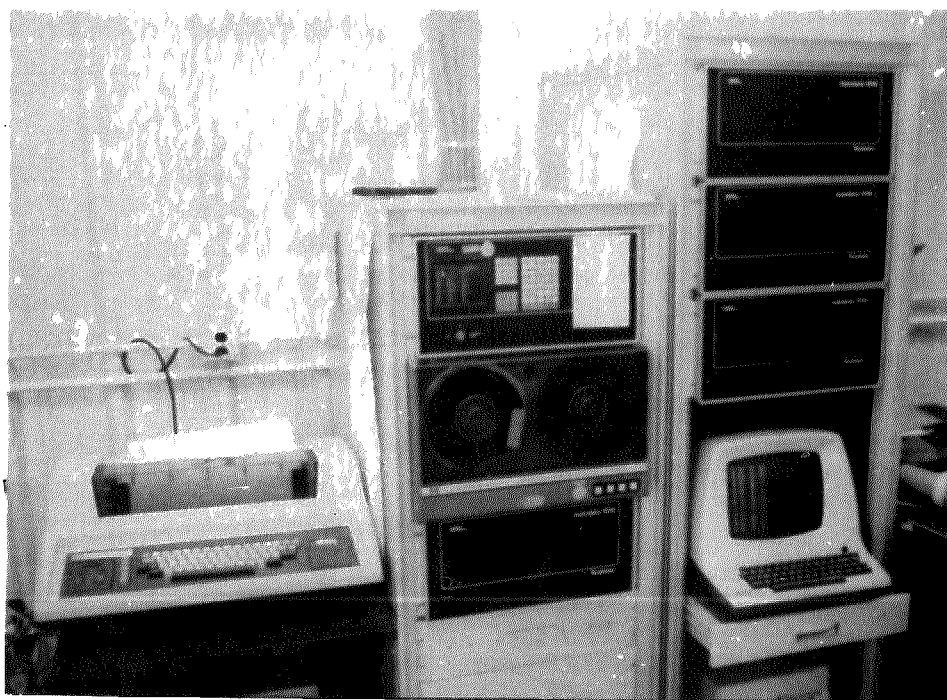
Figure 6.8-2 SRE Data Recording System

The SRE control room housed all the experiment control devices and all the instrumentation readouts. Figure 6.8-1 shows the system control panel on the left. This panel controlled the propane heater, the air cooled heat exchanger, the sump pumps, all the valves and provided readout of the hot and cold tank levels as well as various component temperatures. The smaller panel on the right provided control of the trace heaters. Figure 6.8-2 shows the SRE data recording system which provided capability to record all instrumentation readout on tape or paper printout. Only the paper printout capability was used.

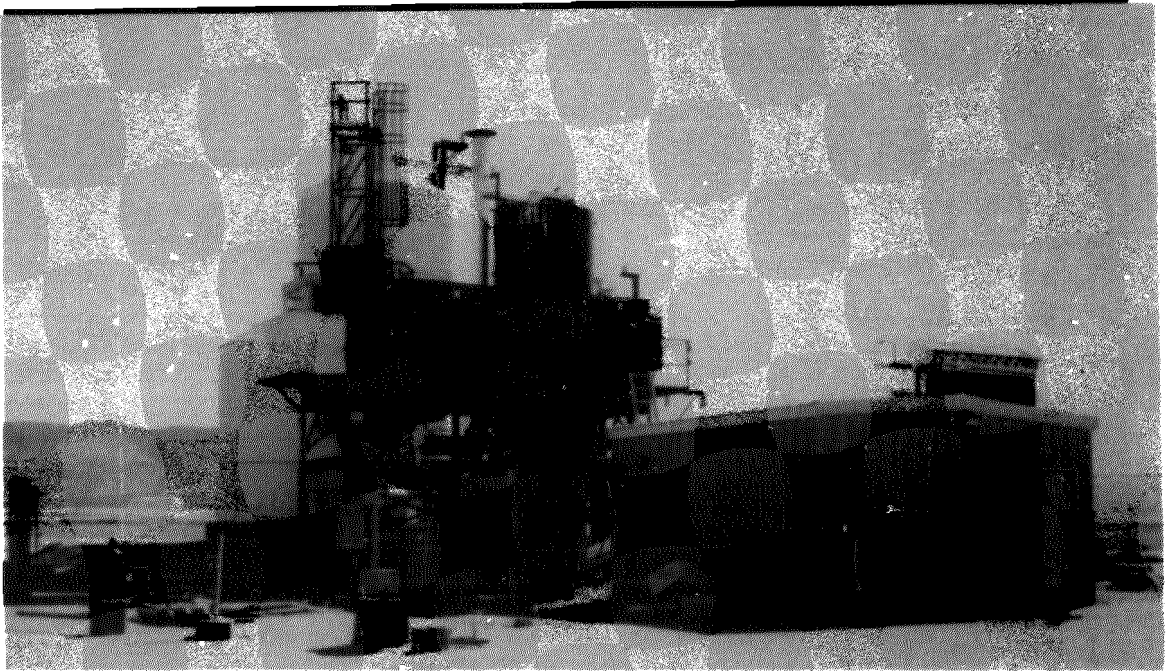
Figure 6.9-2 SRE View from Southeast

The completed SRE installation is shown in Figures 6.9-1, 6.9-2 and 6.9-3. Figure 6.9-1 is a side view looking from the north east. From right to left is the insulated hot tanks, the propane heater and the sump building. All lines and line support hangars are in place. The coolant inlet line to the water cooled foundation is located at the base of the hot salt storage tank. A view from the northwest is shown in Figure 6.9-2. To the right is the control building. In the center foreground is the air cooled heat exchanger. To the left in back of the cooler is the cold tank. The hot tank (with its ladder platform) and the propane heater are directly behind the cooler. Figure 6.9-3 is a view from the CRTF tower of the entire SRE system. SRE fabrication was started in June of 1981 and was completed by January of 1982. A more detailed schedule of the construction effort is listed in Table 6.9-1. Fabrication proceeded with no major problems, demonstrating that the proposed thermal storage tank construction techniques are feasible for commercial application.

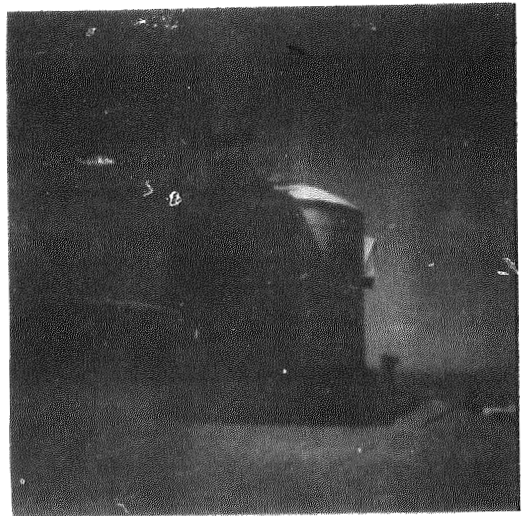
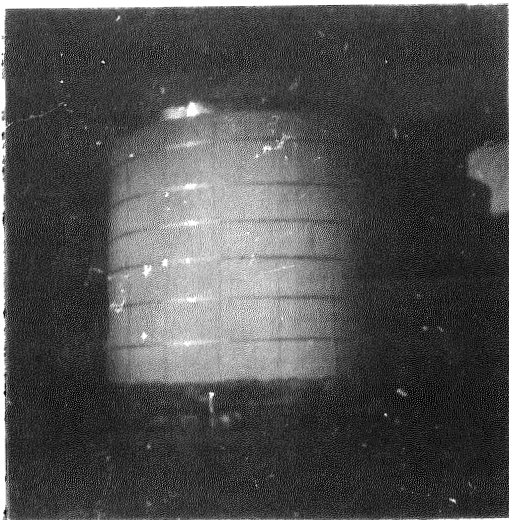
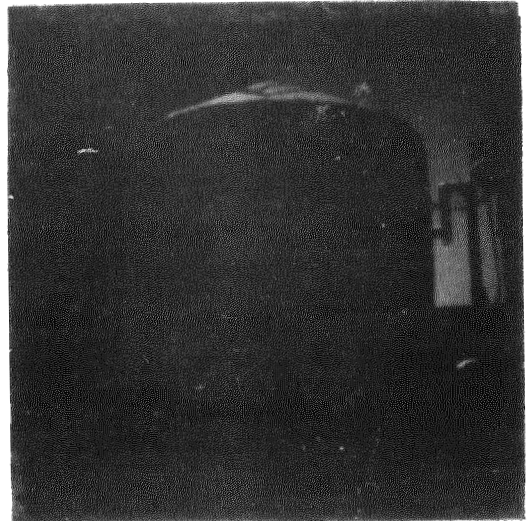
Figure 7.4.2-4 Temperature IR Scan of Cold Tank

The time at the right shows which portion of the picture is scanned. The temperature at scan line represents the coldest temperature "seen". The line at the left is 30°C (54°F) hotter than the right line. A linear scale of 30°C results.
