GAS COOLED CENTRAL RECEIVER -  
CLOSED CYCLE 1MWT BENCH MODEL TESTING

RP377-3  
FINAL REPORT

Volume: I

June 5, 1980

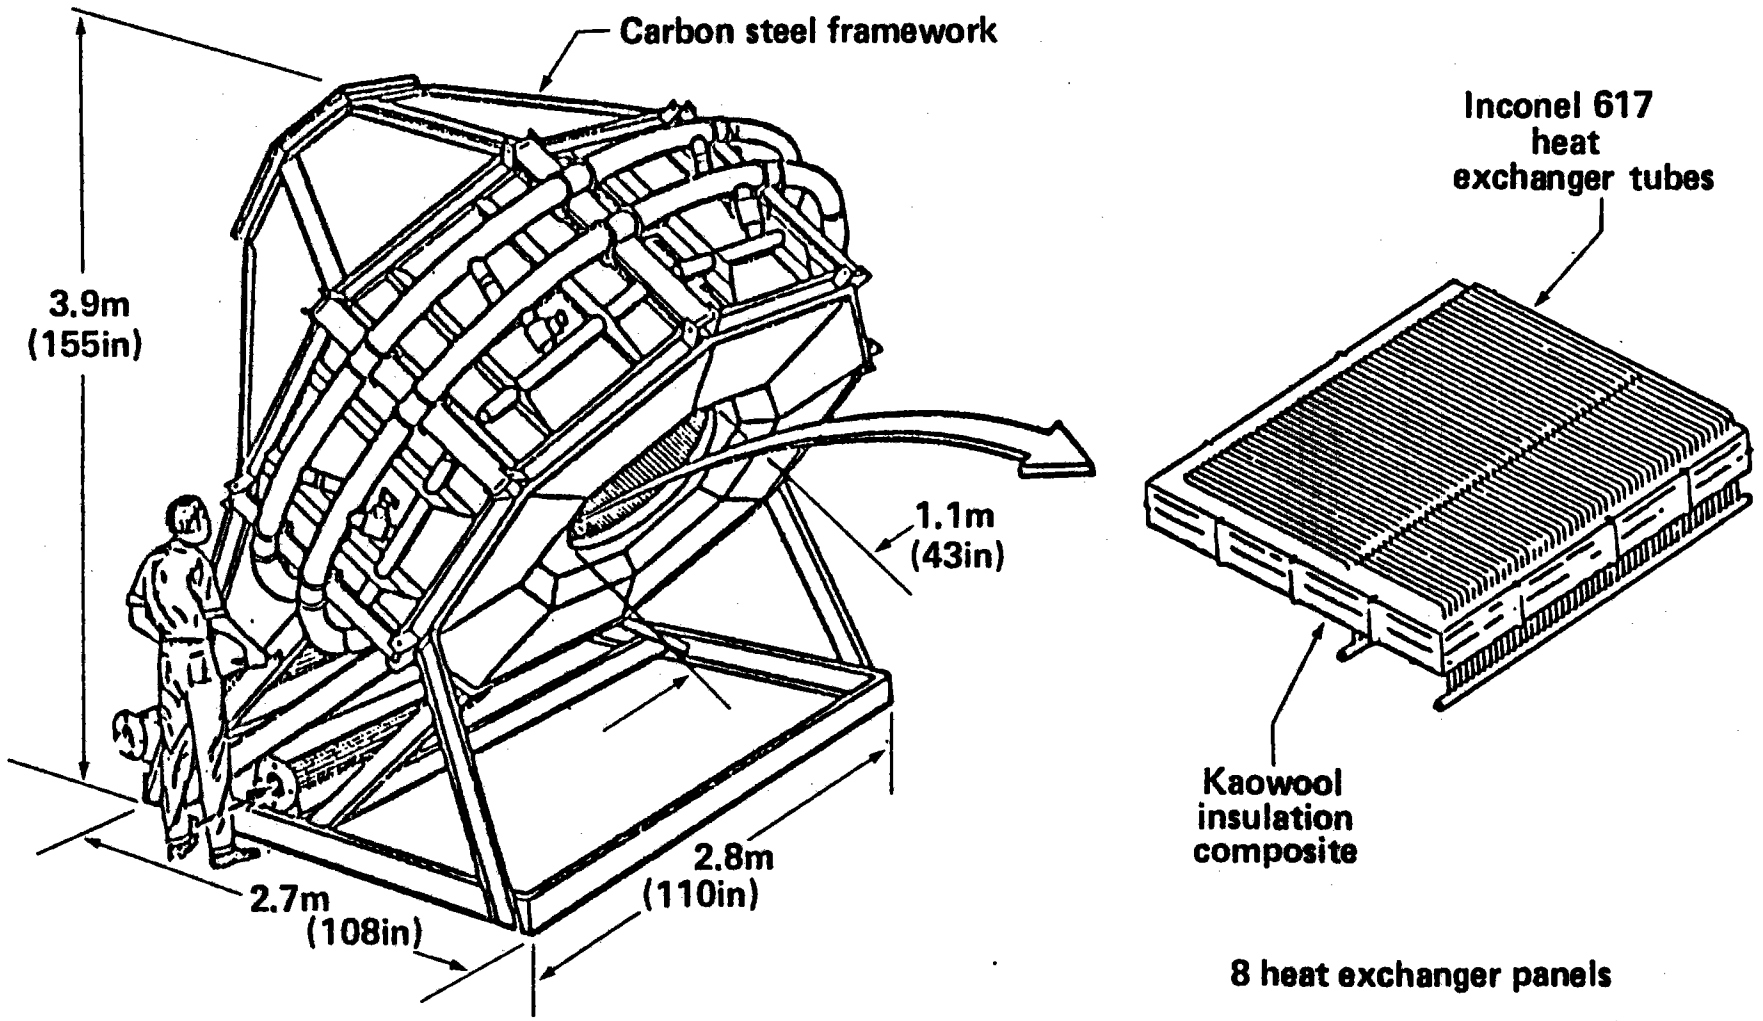
Figure 2.1-1: Artist's Concept of BMSR

The cavity insulation was a 15.2 cm (6 in) thick composite of block and blanket materials supplied by Babcock and Wilcox. The blanket materials were used in layers 2.5 cm (1 in) thick consisting of Saffil, a high-alumina (95%) content fiber and Kaowool, a 50-50 mix of alumina and silica fiber. The block material used in a 7.6 cm (3 in) layer was mineral wool made from

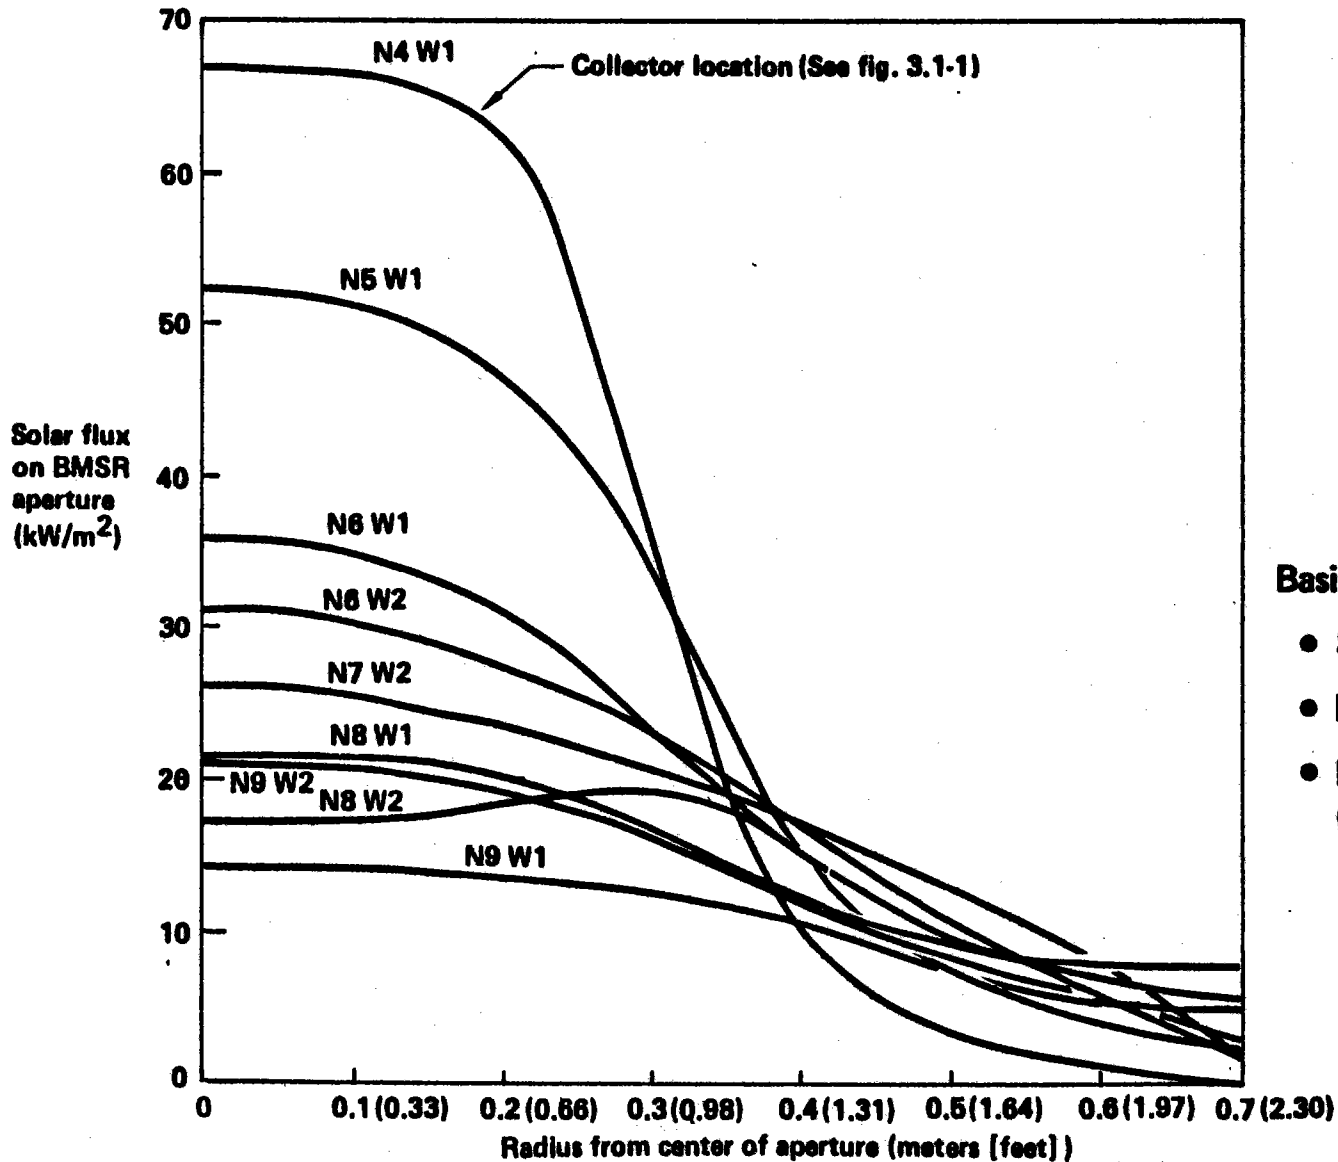
Figure 3.2-7. Aperture Plane Heat Flux Caused by Individual Collectors

To predict the heat flux in these locations, it was necessary to consider the heat-flux profile of each of the collectors that illuminated the point of interest. These individual collector heat flux profiles were provided in the Sandia Livermore data base. Some typical profiles are shown in Figure 3.2-7. The eight profiles are typical of the range of conditions for Zone A collectors.

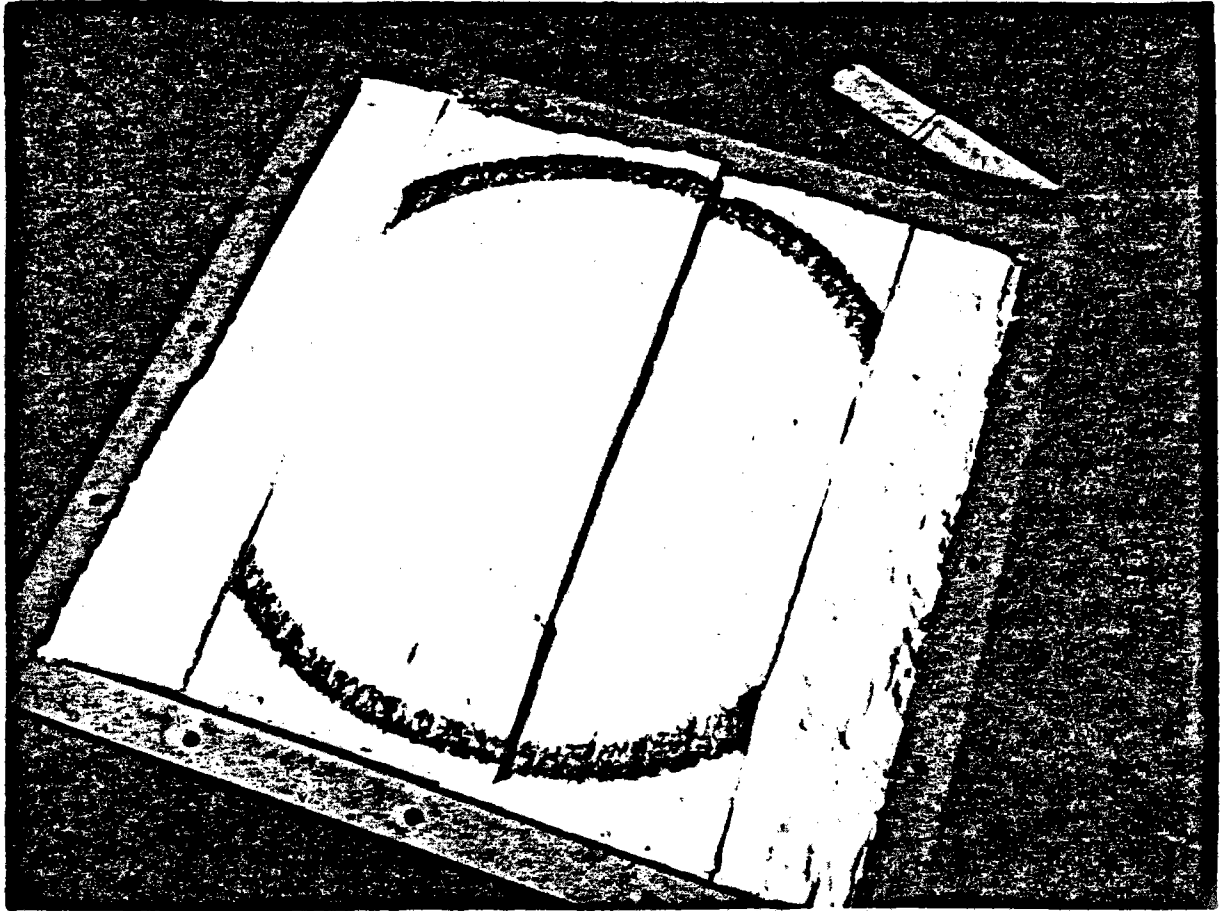
Figure 4.2-20: Photo of Lap-Joint Sample After Test 3A

A lap-joint sample was prepared to simulate the interface between adjacent sections of Saffil blanket in the BMSR. Figure 4.2-20 shows the condition of the lap-joint sample after completion of test 3A. This test used clean Saffil material heated at the BMSR design heat flux of  $425 \text{ kW/m}^2$ . The dark ring on the sample shows the effects of burnout of the organic binder in the blanket. The Saffil is white before testing. When heated to about  $260^\circ\text{C}$  ( $500^\circ\text{F}$ ), its organic binder material is charred, leaving behind a black carbon residue. Further heating burns the carbon, leaving a surface that is whiter than the original. The black ring on the test sample was located in an area beneath the side-wall insulation (Figure 4.2-4). A steady-state temperature gradient of about  $260^\circ$  to  $370^\circ\text{C}$  ( $500^\circ$  to  $700^\circ\text{F}$ ) is indicated by the black ring. The white areas of insulation on either side of the Saffil blanket are strips of Kaowool used as filler outside the circular heated

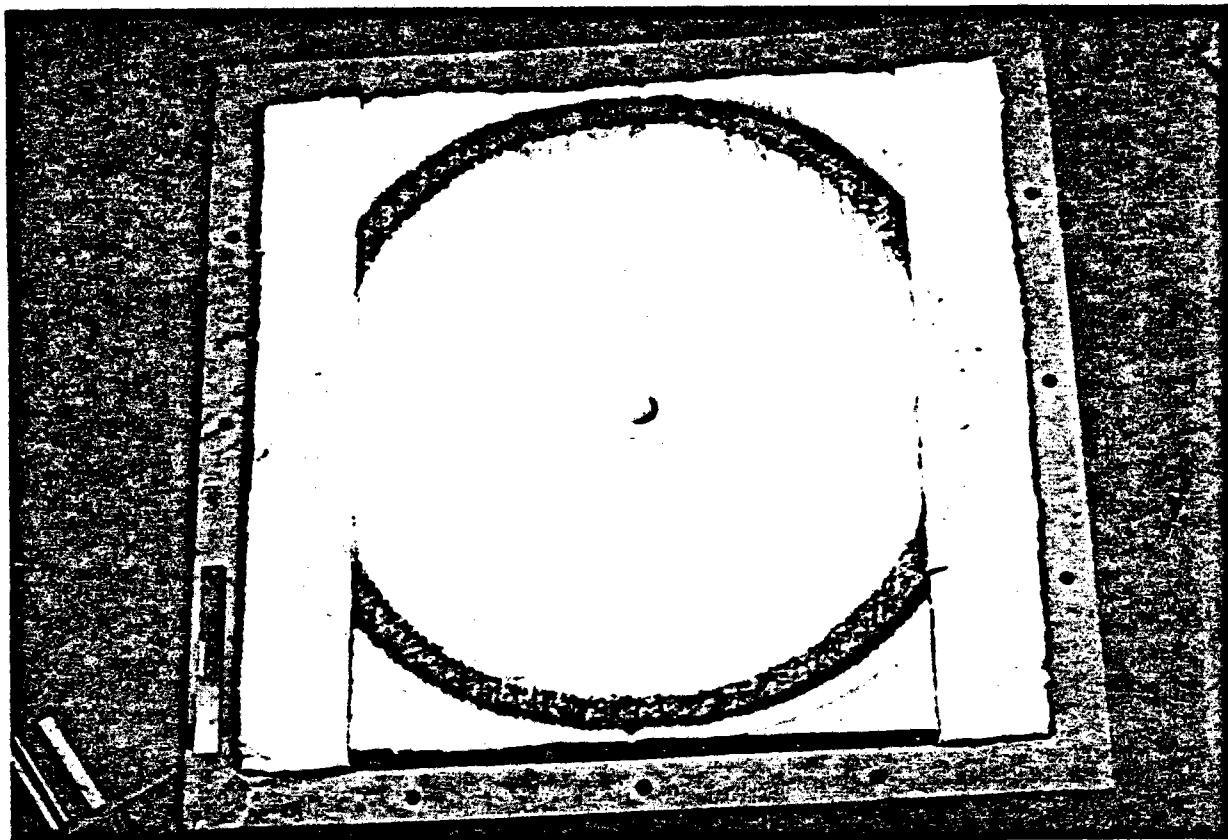
Figure 4.2-21: Fastener Sample After Test

Insulation temperatures behind the layer of Saffil were measured as before with type III thermocouples. At the BMSR design heat flux of 425 kW/m<sup>2</sup>, the

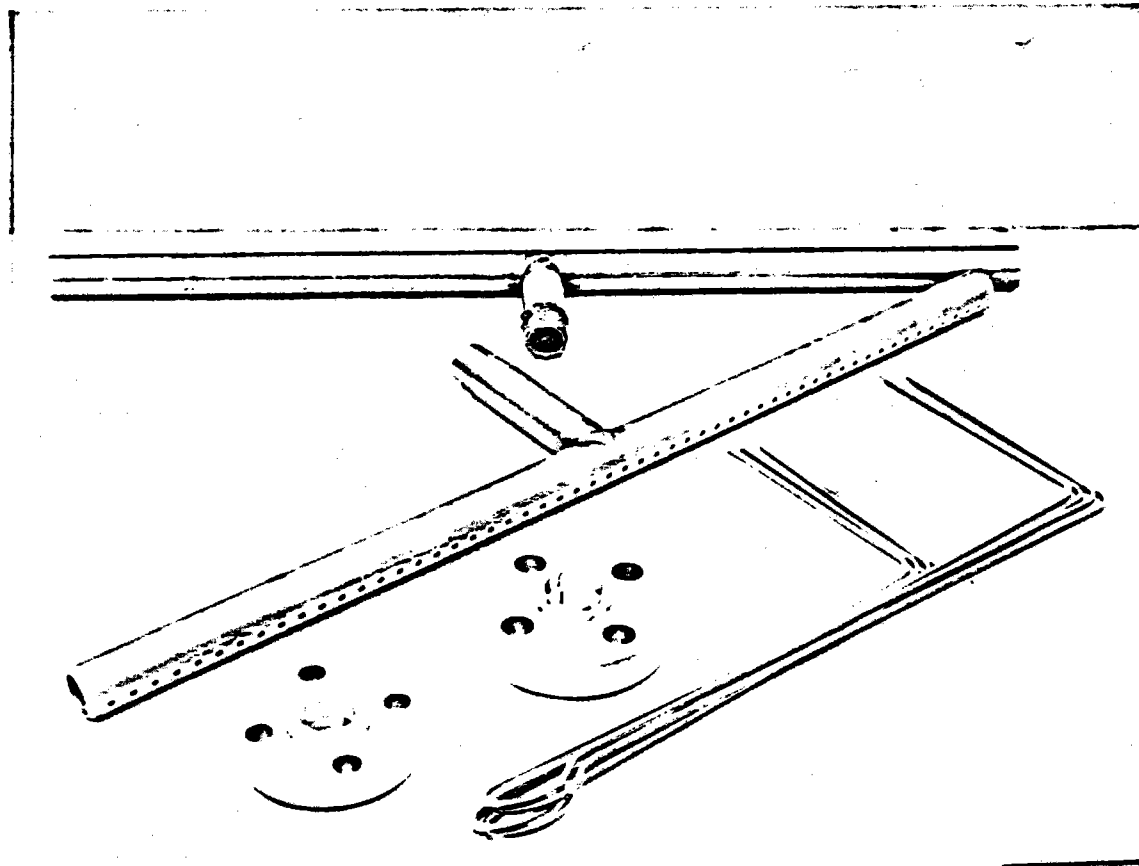
Figure 5.3-1: Heat Exchanger Components

Header assemblies (Figure 5.3-1) consisted of a T-shaped weldment constructed from tubing 5.1 cm (2.0 in) in diameter. A 45-deg bevel weld was made to add the connector tee to the header. This particular joint caused welding problems because of the varying thickness of material produced by the bevel cut. Substantial distortion was obtained in the first weld trials. The solution was to prebend the header tube, as shown in Figure 5.3-2. Subsequent weld shrinkage produced a straight header tube.

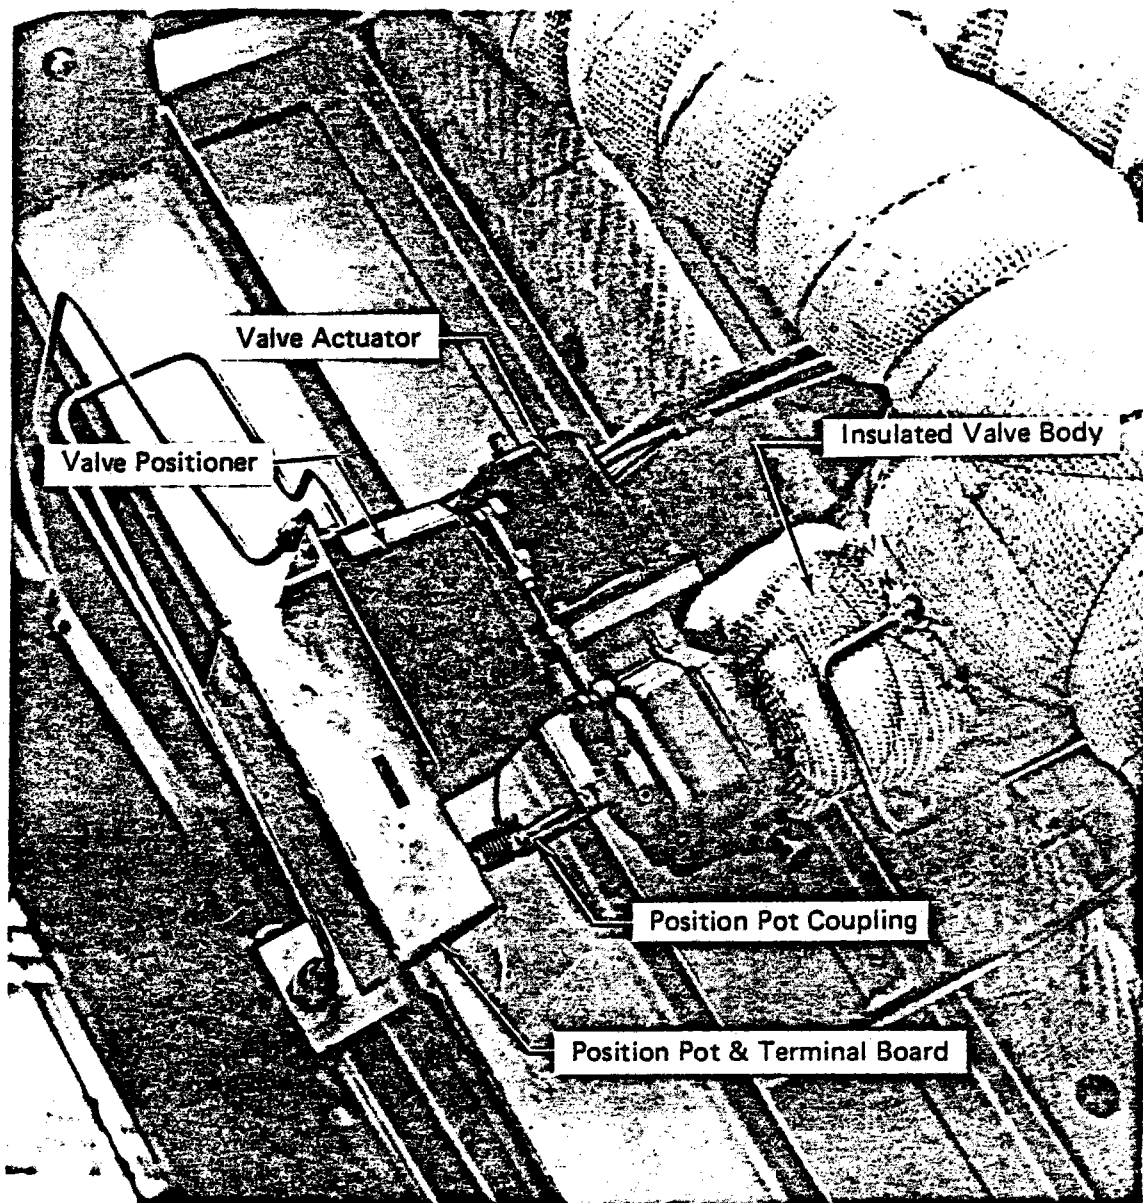
Figure 5.4-5: Flow Control Valve

Solar testing in Albuquerque revealed several shortcomings in the control and instrumentation systems mounted on the BMSR. All wiring leads should have been encased in steel tubing to protect from overheating. Additionally, the siting of instrumentation and control components on a solar test experiment should be given serious consideration in the design phase to select; (1) the most thermally benign location without compromising function, and (2) a position which permits access for repair or adjustments.

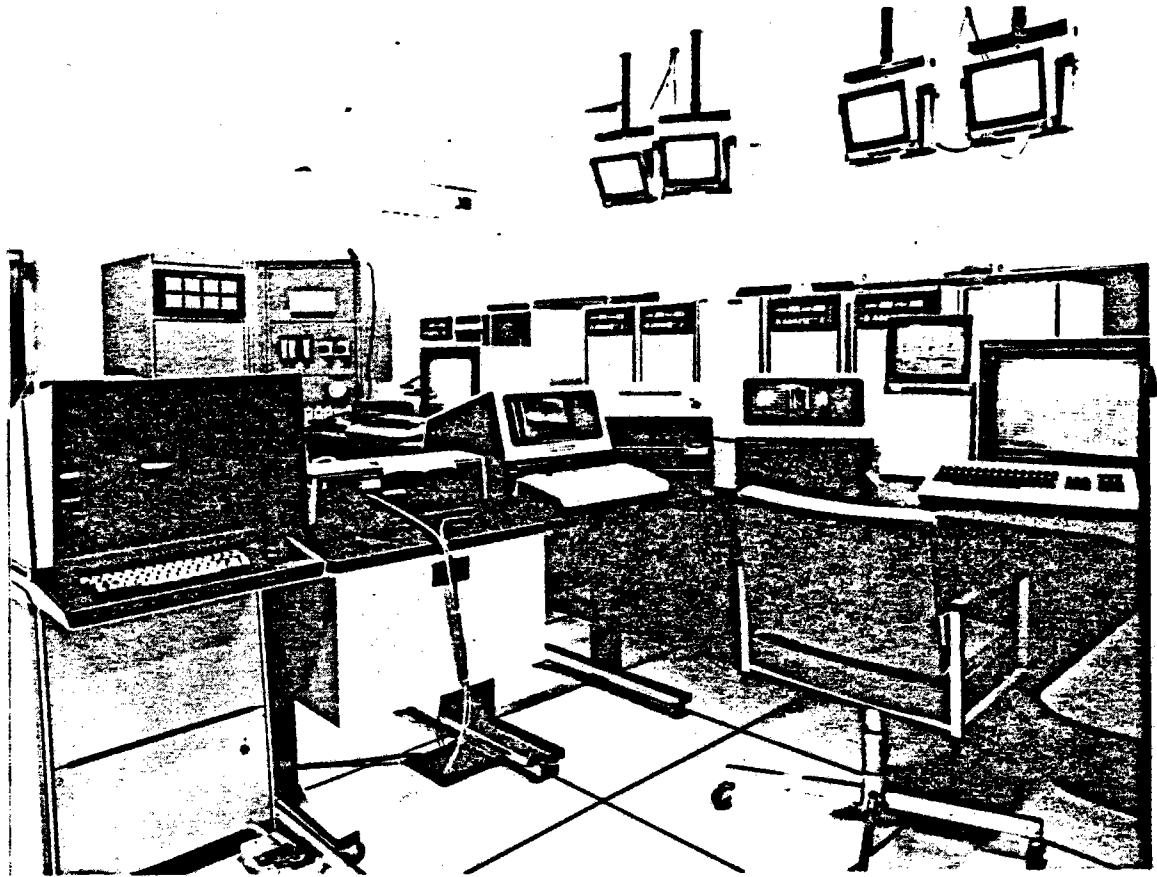
Figure 7.3-8: Experiment Control Console

Immediately after being scanned, the data channels corresponding to receiver outlet temperature were checked to see if any of them exceeded 844°C (1550°F). This was accomplished by comparing channel voltage with the thermocouple output voltage at 844°C (1550°F). In case of excessive temperature, a relay was triggered that paralleled the console operator's emergency test shutdown switch. Activating this switch caused a rapid but controlled movement of the heliostat solar images to converge at a point just east of the CRTF tower, the standby point. All heliostat solar images left the vicinity of the receiver within a period of 4 sec from initiation of this command. Severe damage to the receiver was almost certainly avoided by this automatic shutdown on two occasions when control valves on the receiver closed because of actuator malfunction.

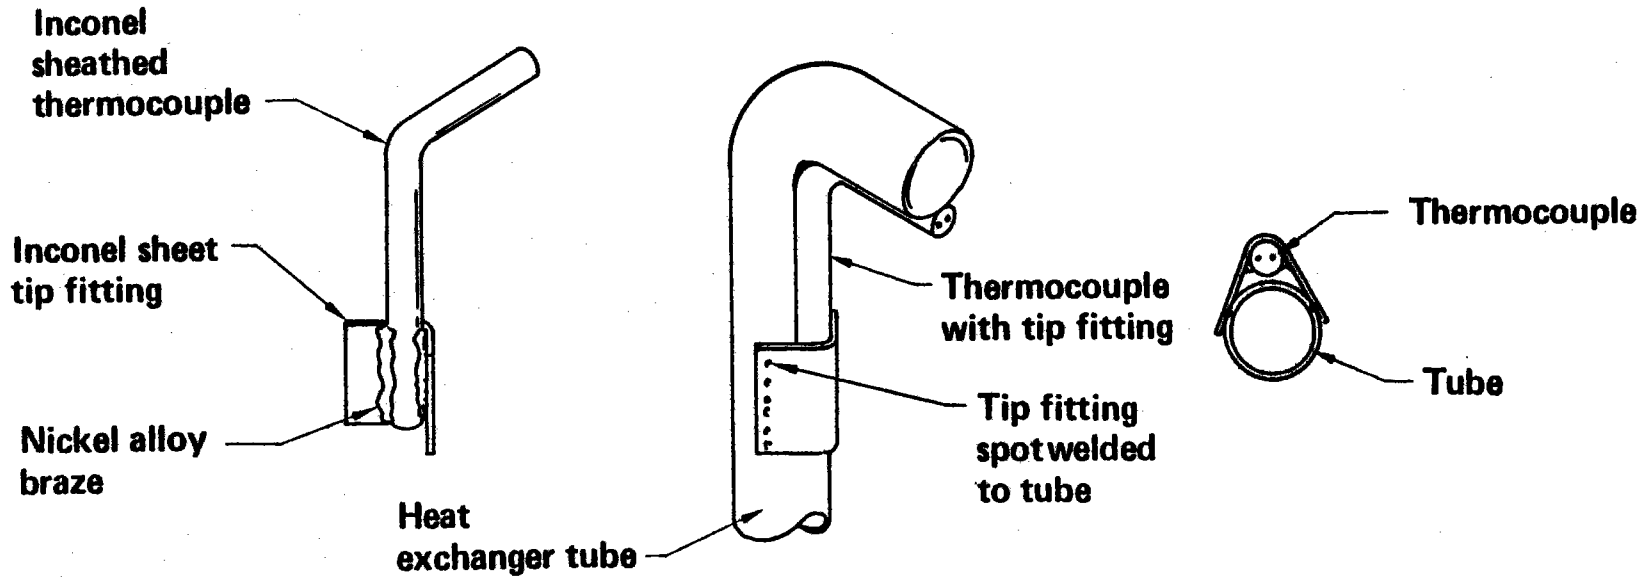
## Details of Heat Exchanger Thermocouple Installation

Figure 8.3-2 shows the results of analyses of the thermocouple installations used to indicate heat exchanger tubing temperatures. Because of their locations on the back of the heat exchanger tubes, the thermocouples were affected by the heat radiated from the adjacent region of cavity insulation wall. The temperature of this wall was always equal to or greater than the heat exchanger tubing temperature. As a result, heat from the wall increased the thermocouple temperature so that it always indicated a temperature higher than the tubing temperature. This excess temperature error is plotted in Figure 8.3-2 as a function of the indicated tube temperature and the effective cavity wall temperature.

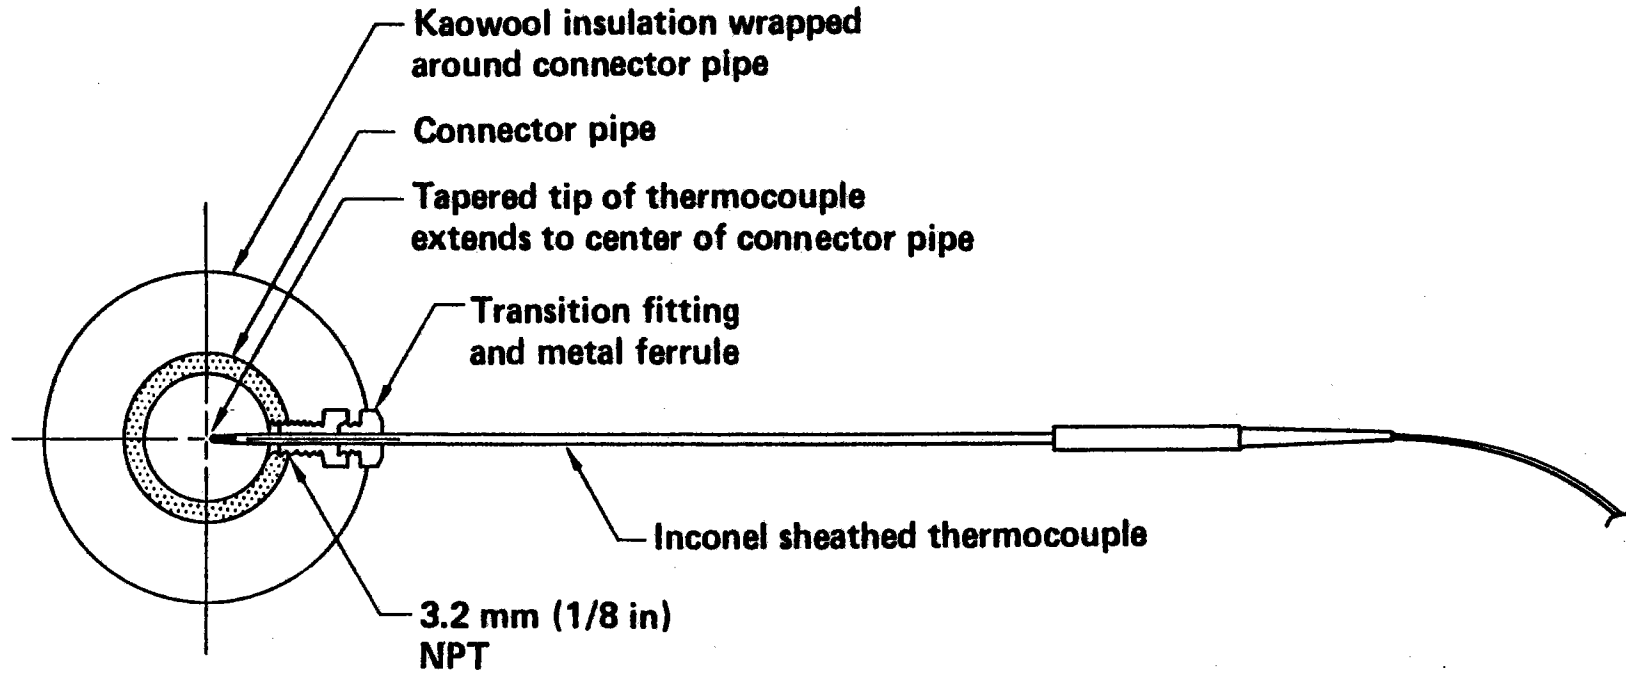
## Details of Air Temperature Thermocouple Installation

thermocouple design for these installations was an Inconel-sheathed unit with a nominal sheath diameter of 3.2 cm (0.125 in), which tapered to half this diameter at the tip. The tip of the thermocouple was positioned inside the connector pipe where it was directly exposed to the air flowing through the pipe. It was thermally coupled to the connector pipe by the stainless-steel ferrule of the wall transition fitting that crimped on the sheath during installation. Other significant heat transfer mechanisms that affected the temperature of the thermocouple junction included convective heat transfer with the air flowing through the connector, and radiative heat transfer with the surrounding interior walls of the connector pipe.

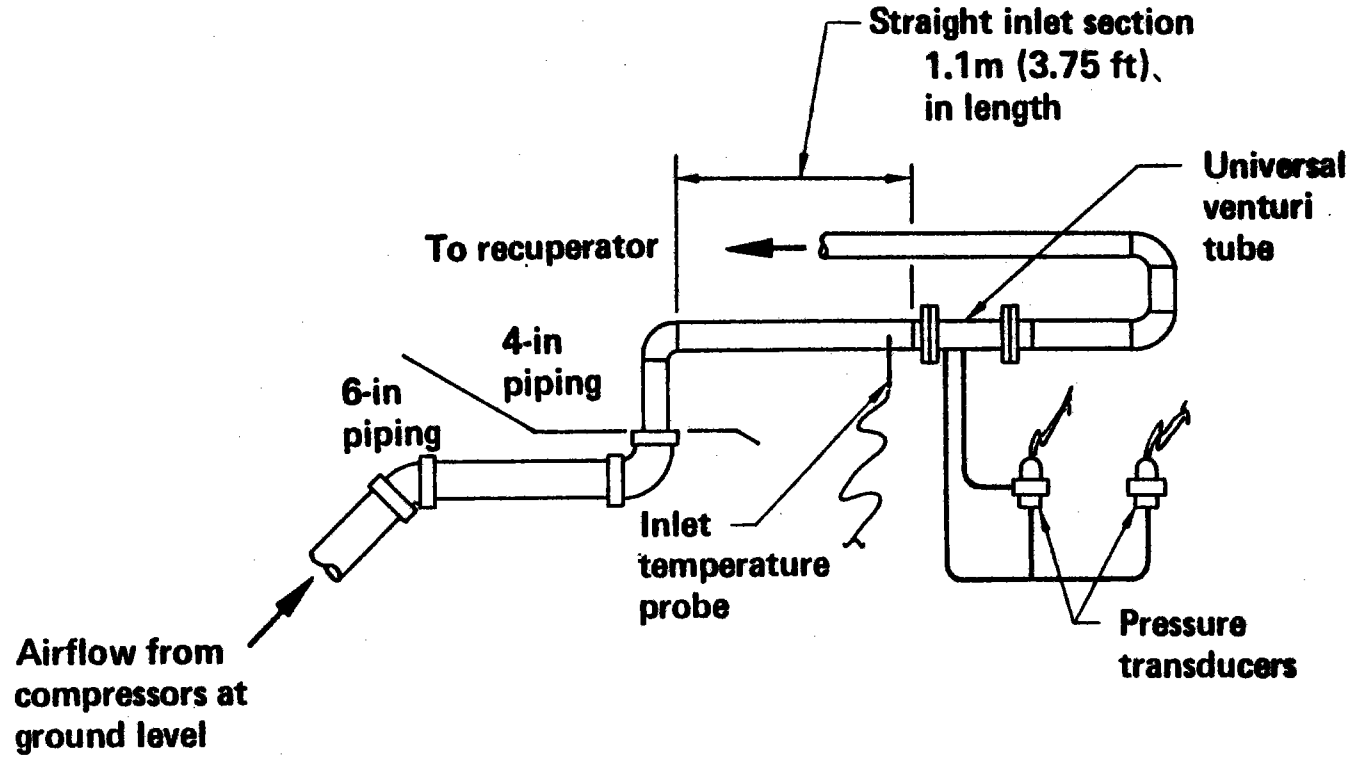
## Flowmeter Installation Details

better than could be measured by the experiment data system. Checkout testing was conducted to verify the accuracy of the flowmeters, but it must be noted that these tests were intended to uncover the type of major errors that could occur rather than act as a calibration of the UVT.

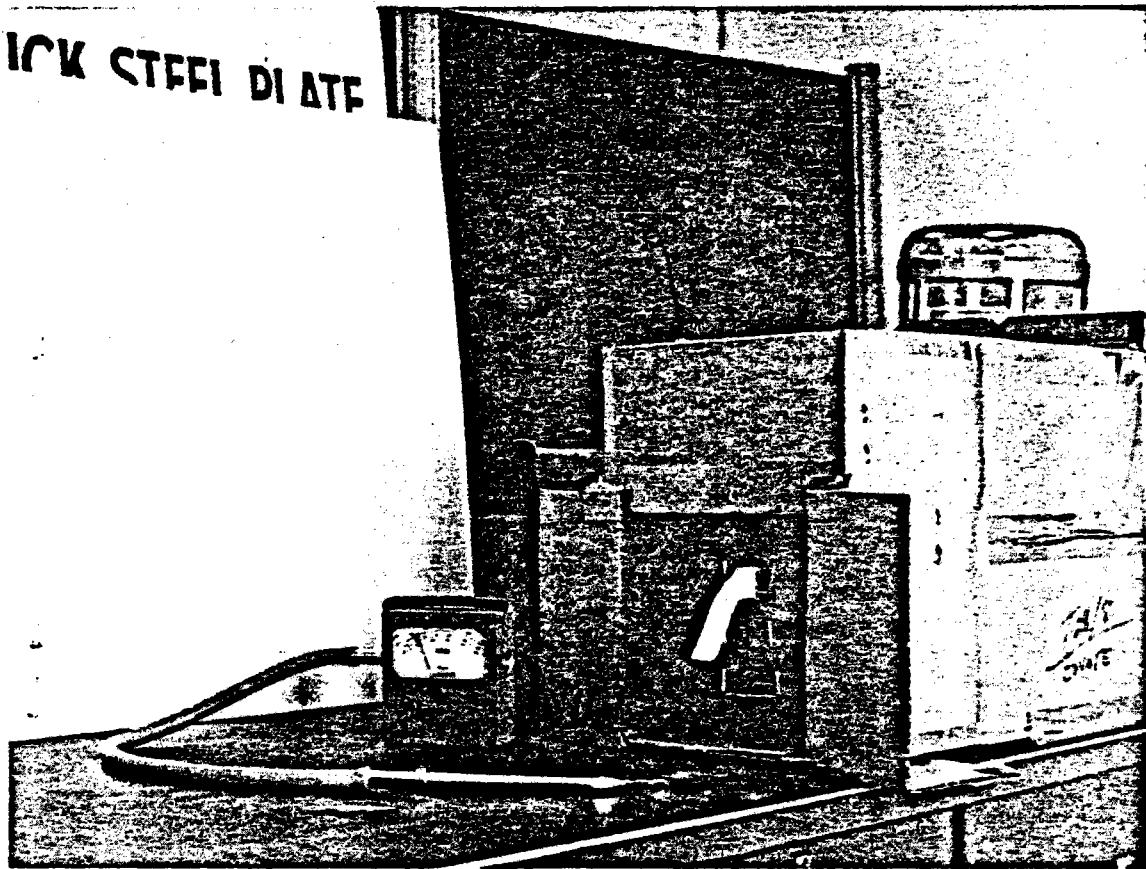
Figure 8.5-1: Aperture Rim Anemometer Calibration Facility

Anemometer measurements of the aperture-rim air velocity existed for just one of the BMSR test days. After the testing of the first anemometer, it was decided that an instrument with a velocity sensitivity in the range of 1 to 3 m/s (3.3 to 9.8 ft/s) was desired. This new anemometer was also fabricated from 3000 board. It was calibrated in the wind tunnel and installed in the aperture rim on January 19, 1979. During the day of tests, its displacement was observed through the telescope and recorded in the test
