Special Test: KJC Heliostat Wash
June 27, 1995

Test Report for KJC Heliostat Wash

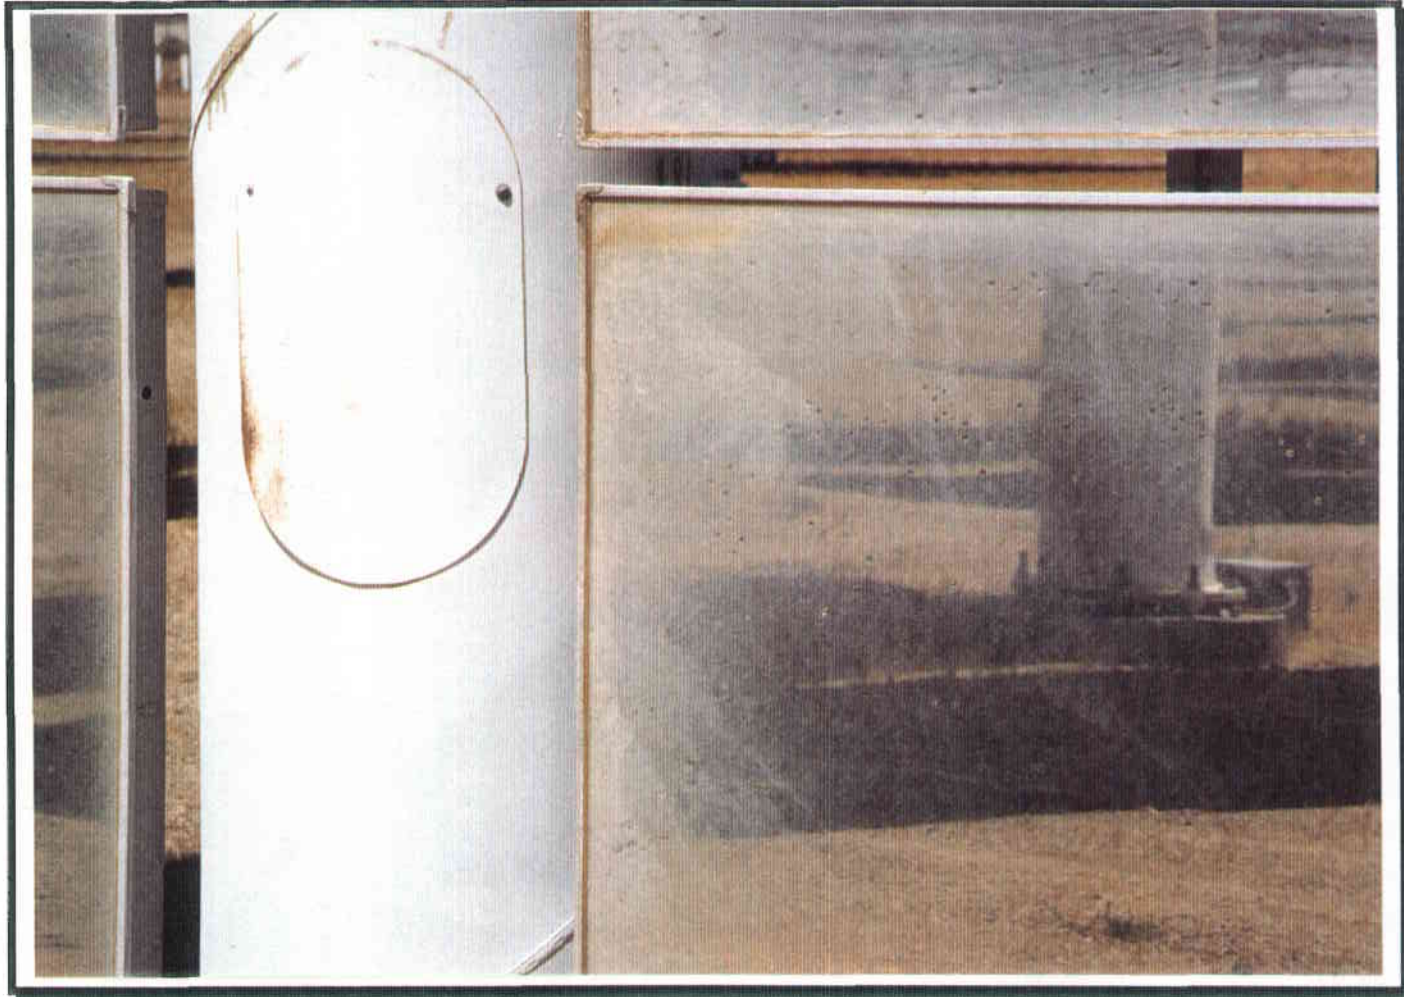
5.1.3 Heliostat 1848 Prior to Wash (Note Film)

Initial inspection of the mirror surfaces found that they were covered with dust and a thin film. It was anticipated that the reflectivity would be low based on this physical inspection.

It was observed that the use of the 1-pass or 2-pass wash did not remove the film completely and especially near the facet edges. Even with KJC's high operating pressure of 3000 psi, all the film was not removed. This confirms that for the initial cleaning of the Heliostat field, a scrub and wash is required.
