REPORT ON THE TEST OF THE MOLTEN-SALT PUMP AND VALVE LOOPS

Sandia National Laboratories

D.C. Smith
Science Applications International Corporation
Albuquerque, NM 87106

E.E. Rush, C.W. Matthews, and J.M. Chavez
Sandia National Laboratories
Albuquerque, NM 87185

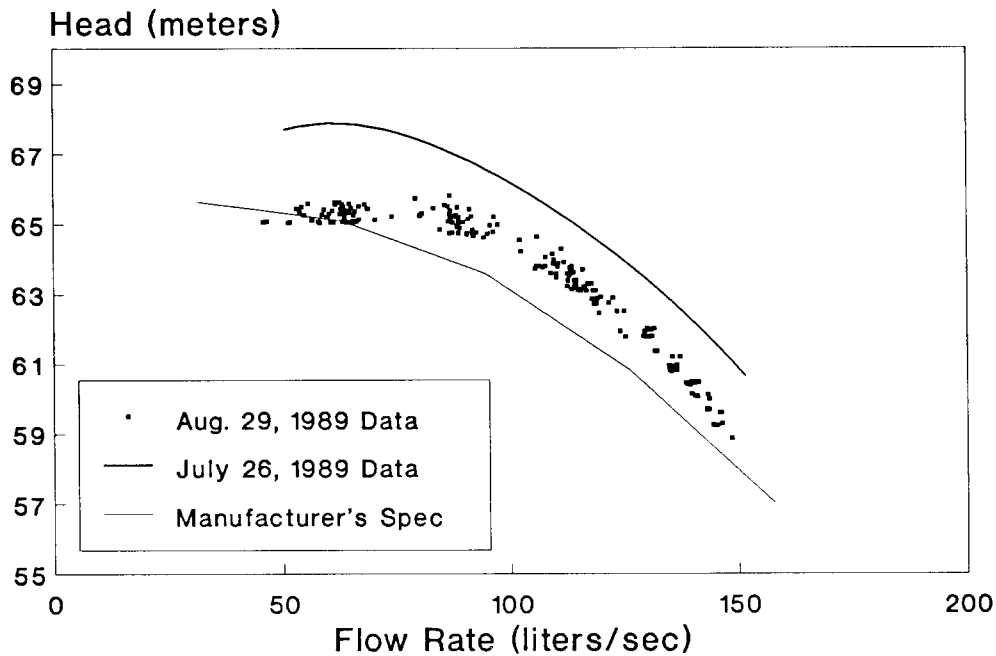
Figure 10. Hot-Salt Pump Curve Prior to the Pump Failure

in pump performance was noted, associated with increased pump vibration. Eventually, the vibration reached the trip limit. Performance curves taken approximately one week, and one month before the failure are shown in Figure 10.

Subsequent to the failure, the pump was removed from the loop, disassembled, and inspected. It was found that the shaft had a permanent deflection of 1.52 mm (0.060 inches) and that excessive wear had occurred in the close-tolerance rotating pump seal. The suspected cause of the shaft deflection is stress relief at high temperatures. The shaft of this pump experienced some temperatures marginally higher (10°C-40°C higher) than the normal 565°C in the weeks prior to the failure. At these temperatures, stresses built in during fabrication can relieve themselves by creep, distorting the shaft. A replacement shaft for the pump was procured, with specifications that the shaft be factory stress-relieved before final machining. This shaft was installed, and the pump returned to service. With the new shaft, the pump performance returned to its original level. The pump operated 4700 hours with the new shaft.

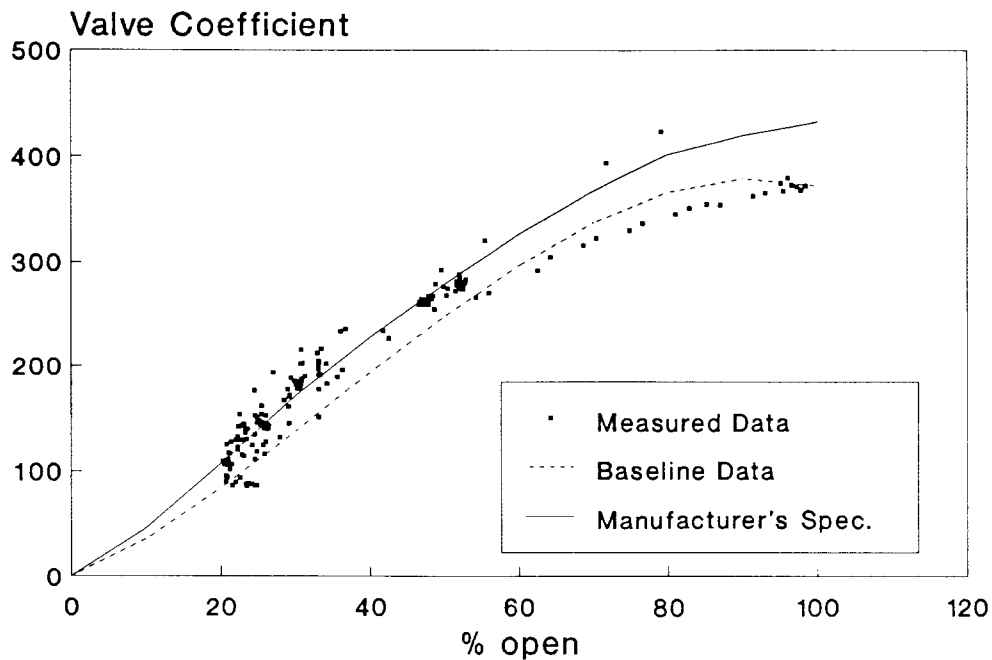
Figure 11. Valve Coefficient for FCV-658, July 18, 1990

Generally, the globe control valves performed their functions well. Flow and pressure control were achieved with reasonable accuracy, and no degradation of the valve trims or seats has been detected. The measured flow coefficient for FCV-658 is shown in Figure 11. The figure includes the manufacturer's specified curve, the baseline curve from the original water flow test, and recent data taken during

operation of the test. No degradation in performance is apparent. This is typical of the performance of FCV-653 as well.
