Evaluation of the Effects of a Freeze/Thaw Environment on Cellular Glass

P. Frickland
E. Cleland
T. Hasegawa

August 15, 1981

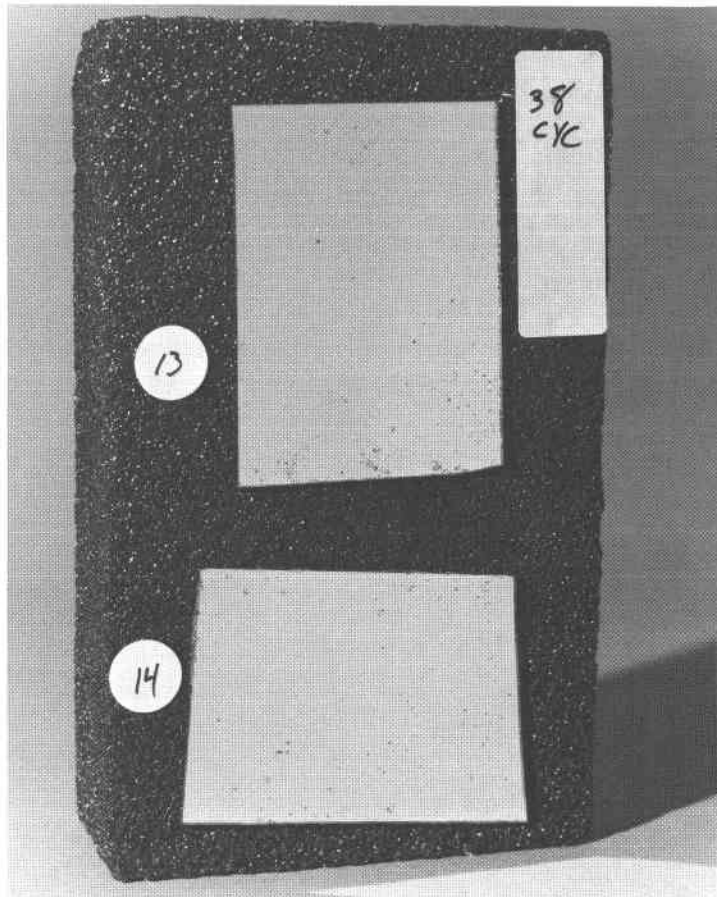
Figure 7. Foamglas® Mirror Adhesion Test (Argoud)

To support the development of the TBC reflector elements (specifically in the area of the evaluation of mirror bonding techniques) Argoud initiated another freeze/thaw test of uncoated Foamglas /mirror glass specimens.[6, 7] The cycle is shown in Figure 6. At the conclusion of the 38-day test the Foamglas® appeared sound with some slight edge spalling noted (see Figure 7).

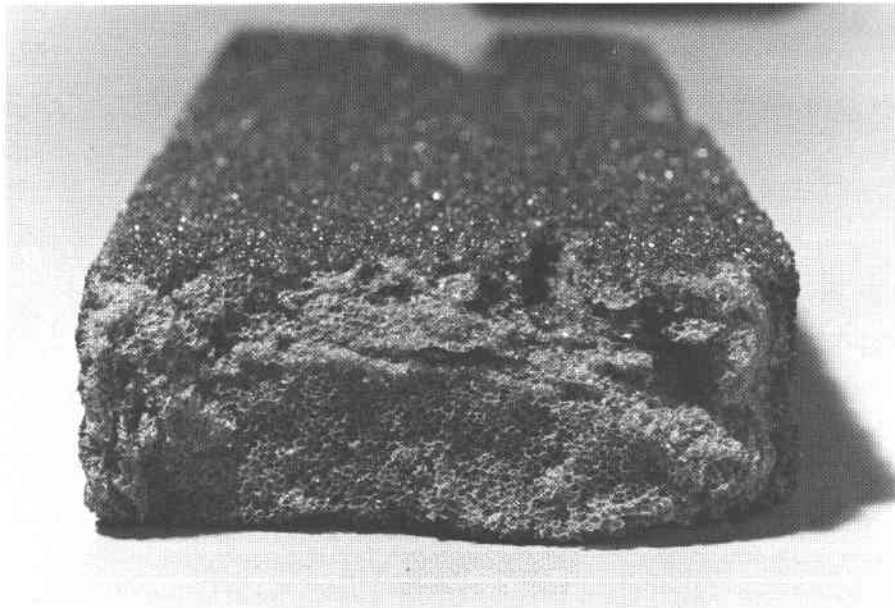
Figure 12. Degraded Cellular Glass

Shortly thereafter, Hasegawa issued a report on the failure analysis of mirrored Foamglas® panels which were coated and in some cases included mirror edge sealant[14]. These panels were conditioned by Argoud (JPL) using the cycle previously shown in Figure 6. The specimens were cycled while in a vertical orientation within the test chamber. The complete degradation of Foamglas® in the presence of puddled water, and the apparent mechanical failure at the interface of cellular glass in contact with the mirror backing, was observed.

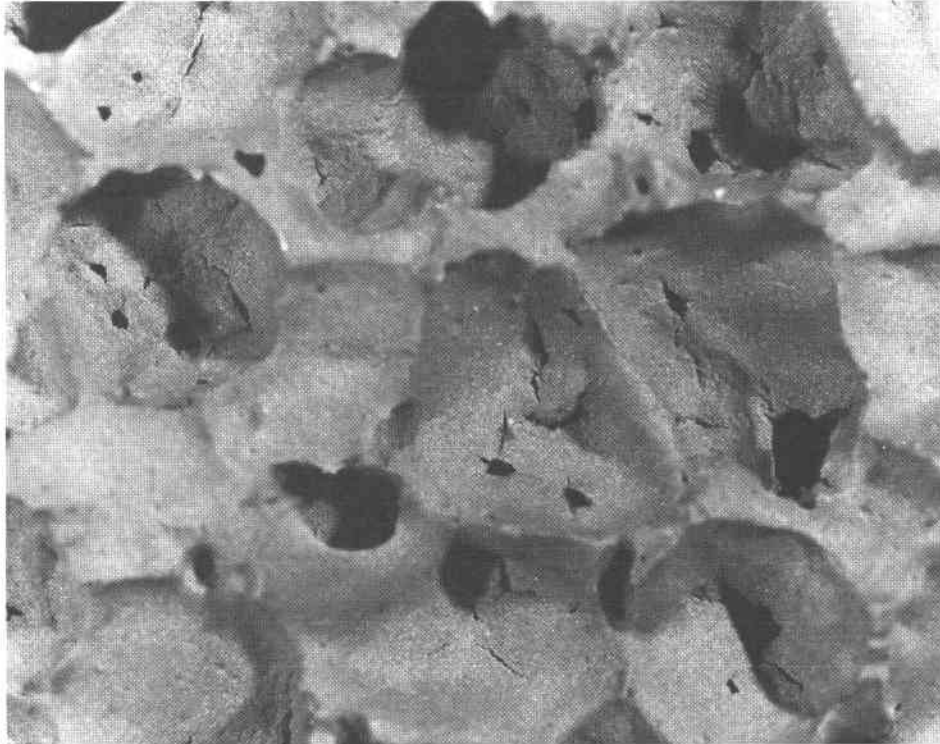
Figure 15. Cured Butyl Rubber Coating (One Coat)

Attempting to obtain a <u>continuous butyl rubber coating resulted in some</u>
difficulties, manifested by film tensile failure in the cellular "valleys"
(<u>Figure 15</u>) and on the cellular "ridges" (Figure 16). Both were postulated to

be the result of shrinkage which occurred during solvent evaporation and polymerization. This problem may have been accentuated by the butyl rubber formulation, which contained a higher content of xylene solvent than that normally used for brush applications. The problem was lessened with the addition of a second coat of material (Figure 17). The remaining surface discontinuities were apparently sealed with the silicone coating (Figure 18). A typical cross-section of a completely coated block is shown in Figure 19. The lighter coating in the figure is the silicone layer, the darker is the butyl rubber.

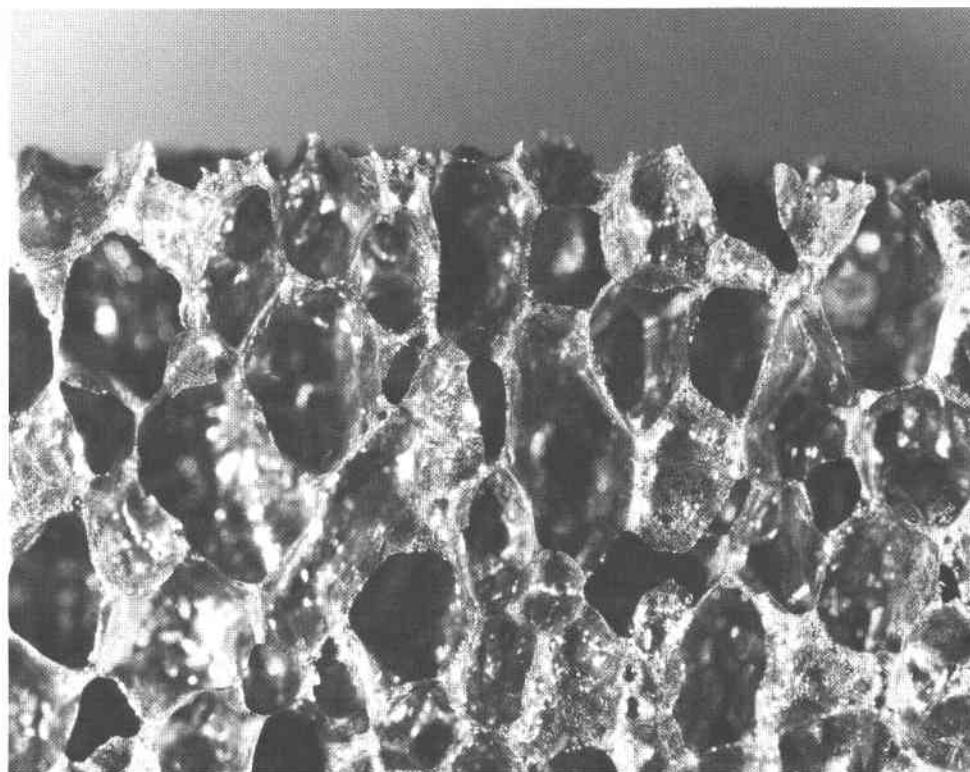
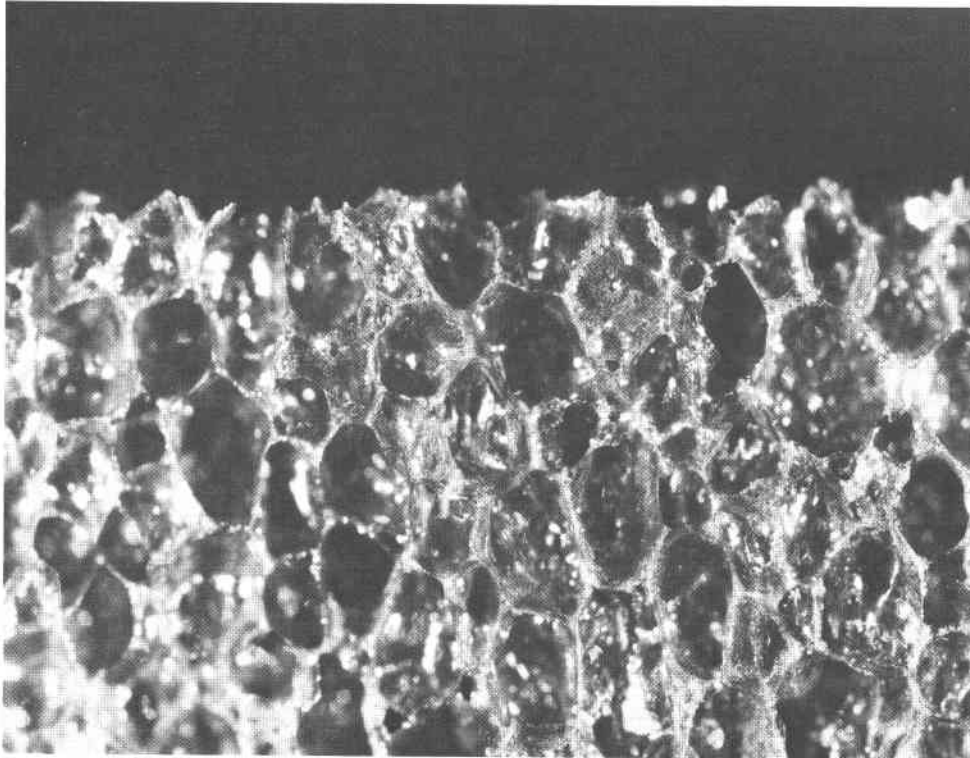
No obvious cracking, spalling or leaching of coated or uncoated Foamglas® was observed after 53 freeze/thaw cycles. Figures 33 and 34 illustrate cross-sections of the upper surfaces of typical uncoated Foamglas specimens after 0 and 53 cycles, respectively. Figures 35 and 36 are top views of the same specimens. The specimens were virtually indistinguishable.

Figure 33. Foamglas® Control, Cross Section (0 Cycles)

Figure 34. Foamglas® Conditioned, Cross Section (53 Cycles)

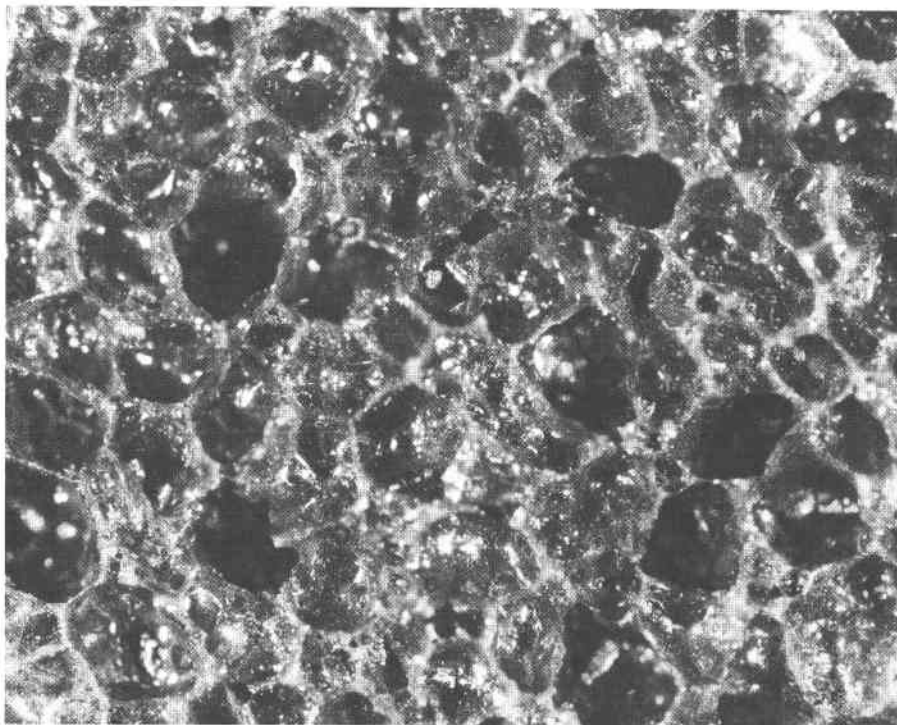
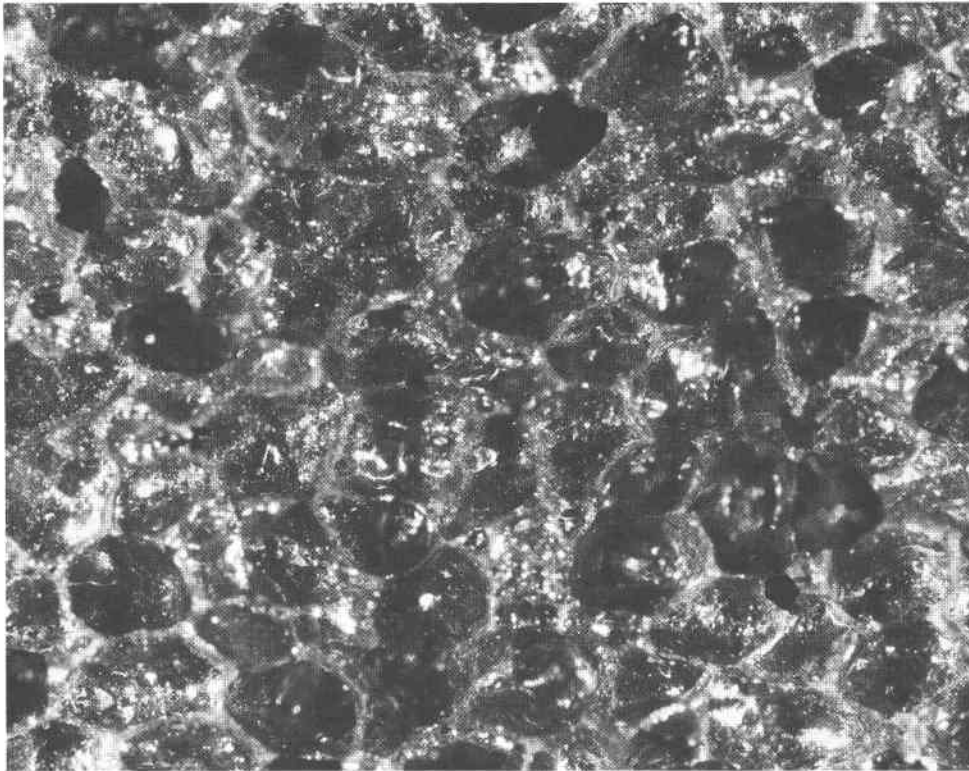
Figure 35. Foamglas® Control, Top View (0 Cycles)

Figure 36. Foamglas® Conditioned, Top View (53 Cycles)
