Midtemperature Solar Systems Test Facility Test Results: Effects of Severe Hailstorm on August 9, 1978

Thomas D. Harrison

Thomas D. Harrison
Experimental Systems Operation Division 4721
Sandia Laboratories
Albuquerque, NM 87185

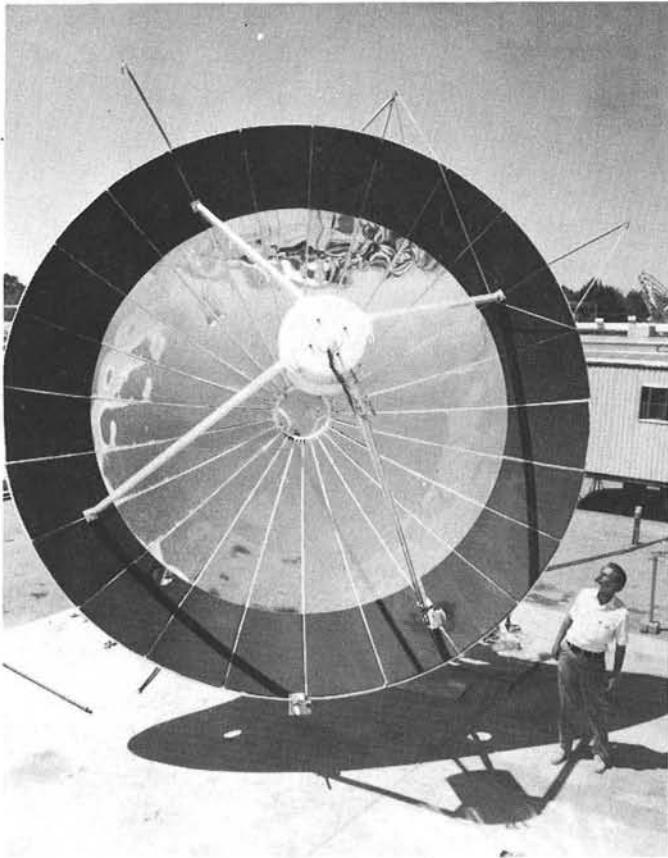
Figure 5.
GE/Scientific Atlanta Parabolic Dish

GE/Scientific Atlanta 5-m Parabolic Dish -- This dish (Figure 5) is formed by twenty-four 2.3-mm-thick aluminum "petals" covered with FEK 244 acrylic film. It was stowed facing SSW. The face was covered with its heavy rubberized tarpaulin; no part of the dish including the exposed back side of the petals showed any damage.

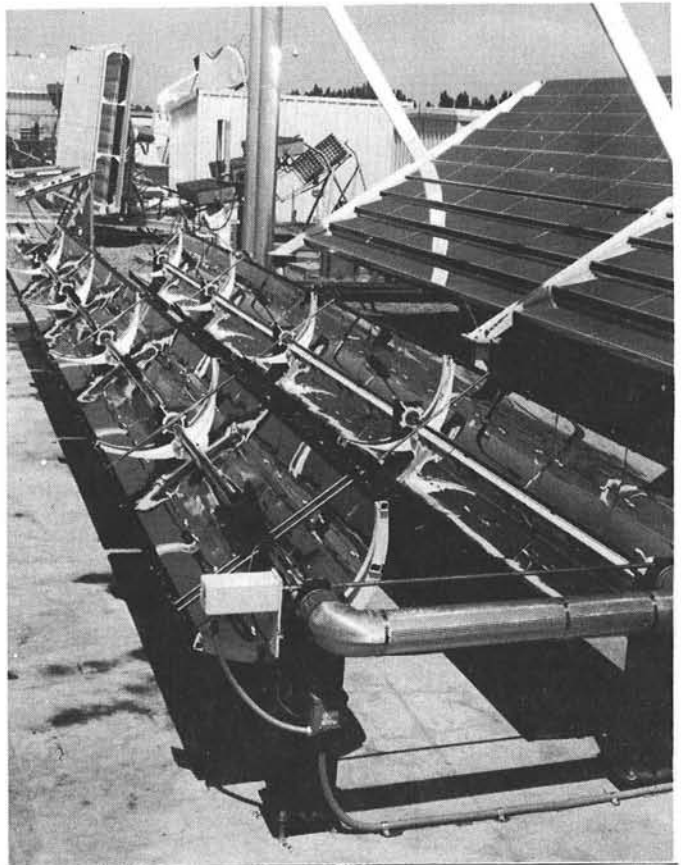
Figure 6.
Del Parabolic Trough

Del Parabolic Trough -- This 11.5-m² array (Figure 6) has 128 pieces of 3.22-mm-thick sagged double-strength glass. There is partial rim support for the glass along stringers and sheet-metal ribs. The troughs were stowed facing down so that the backs of the mirrors were exposed between the structural members. No damage to the glass or structure was noted.

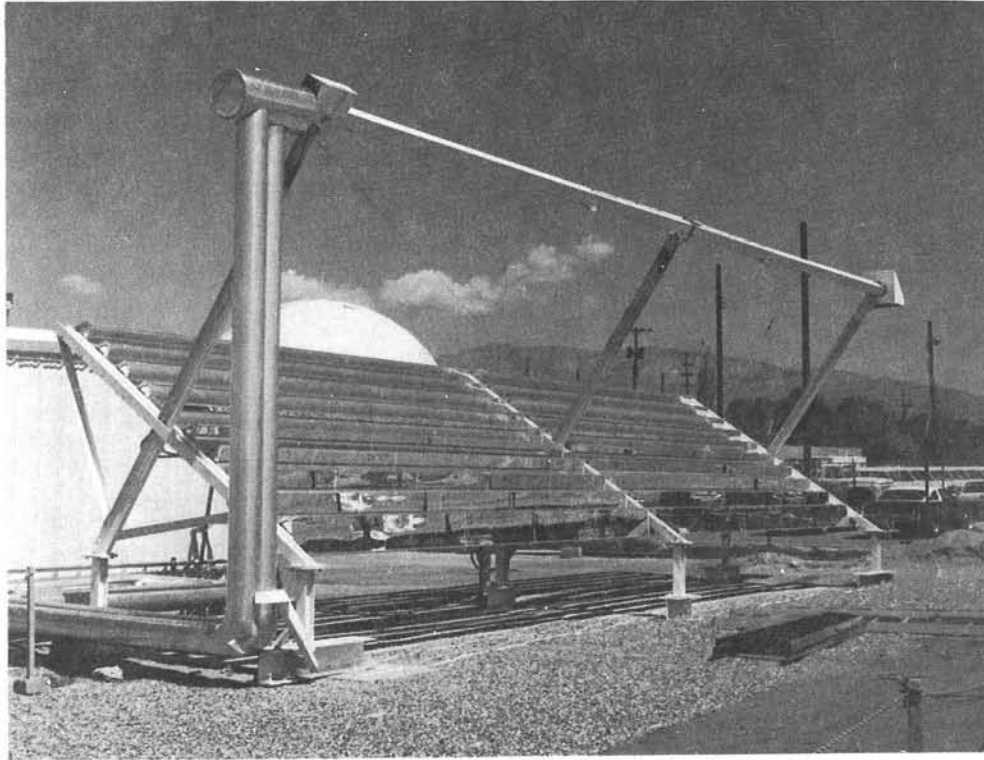
Figure 7. Suntec SLATS 35-m² Collector

Suntec SLATS -- This collector (Figure 7) consists of two sections, each with 10 reflectors 0.3 x 6 m. The reflectors are 1.5-mm 0317 fusion glass bent to a radius of 6.6 m and fastened to marine plywood with polyester. The plywood is mounted on a half-cylinder of 28-gauge galvanized sheet. The reflectors were stored facing south and down at an angle of about 20° to the vertical. There was no damage.

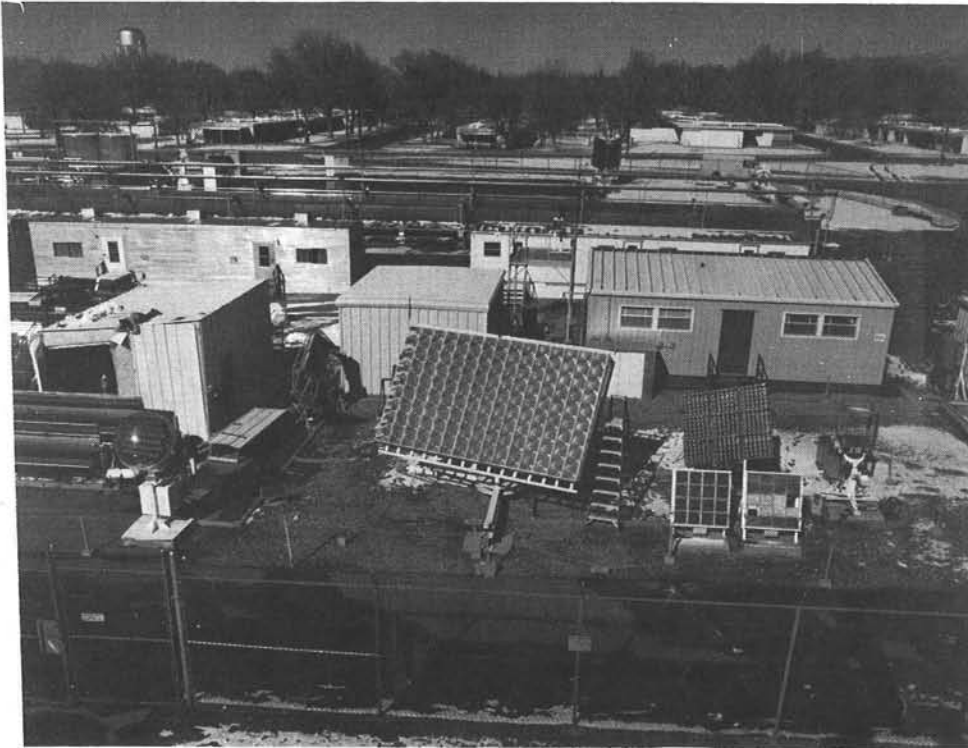
Figure 13. The PASTF

Even though the PASTF (Figure 13) is not part of the CMTF, it occupies part of the same land. The effects of the hail on equipment in the PASTF are included because they are of interest.

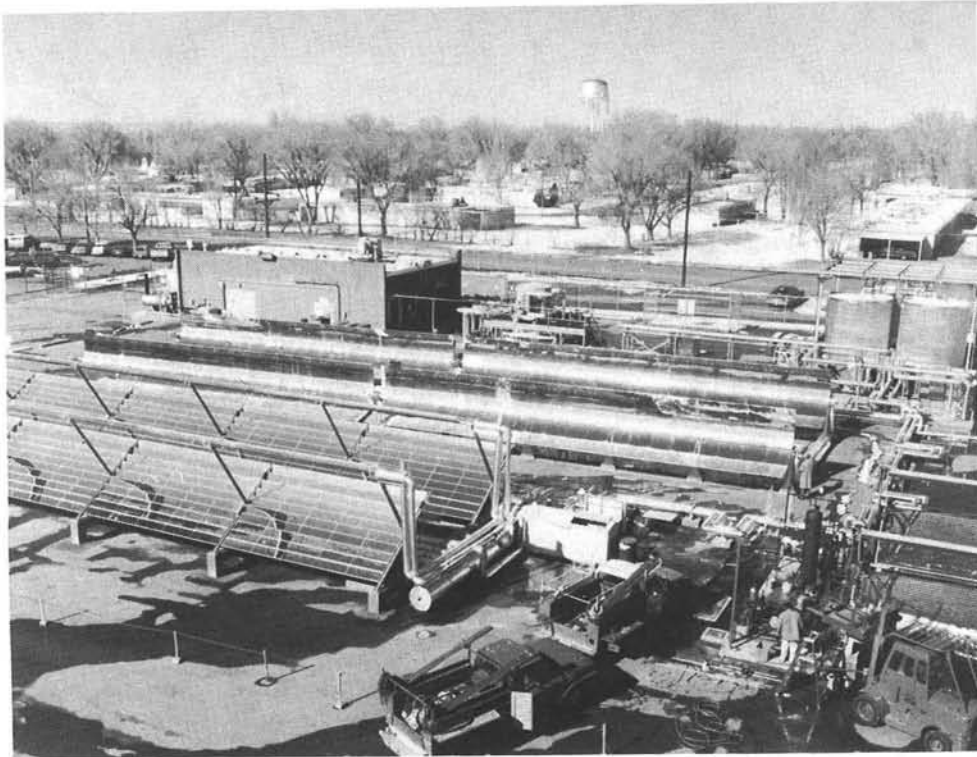
Figure 15. Suntec SLATS Collector Field Subsystem

Suntec SLATS Collector Field Subsystem -- This 260-m² subsystem (Figure 15) comprises two rows, each consisting of seven modules like those installed in the CMTF. Construction of the reflectors is the same as those in the CMTF. The SLATS reflectors were stowed with the glass reflectors facing south and down at about an angle of 20° to the vertical. No damage was visible.

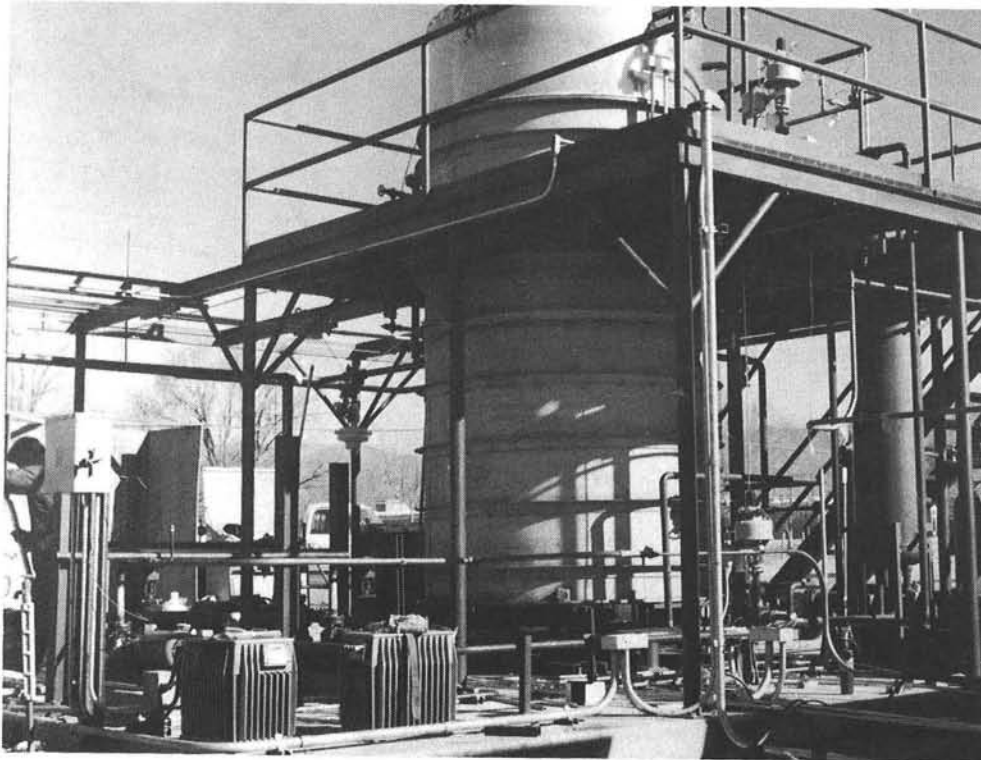
Figure 19. High-Temperature Thermocline Thermal Storage Subsystem

Thermal Storage Subsystems -- There was no visible damage to either the thermocline thermal-storage subsystem (Figure 19) or the multitank thermal-storage subsystem (Figure 20). Both are protected by metal covers with one exception -- the top of the multitank thermal storage subsystem is insulated with polyurethane foam that has been exposed to the weather for less than 1 yr. The two low-temperature thermal-storage tanks (Figure 21) are insulated top and sides, with 10-cm polyurethane foam covered with 0.5-mm Diathon protective coating. Both tanks are exposed to the west and one is also exposed to the south. The insulation, which is less than 2 yr old, showed no damage. Some of the aluminum-covered pipe around these tanks is protected from all directions except vertical. From dents in the aluminum, it can be concluded that some of the hail fell vertically.
