## Silver Deterioration in Second Surface Solar Mirrors

V. P. Burolla, S. L. Roche

SAND79-8276  
Unlimited Release  
Printed January 1980

ABSTRACT

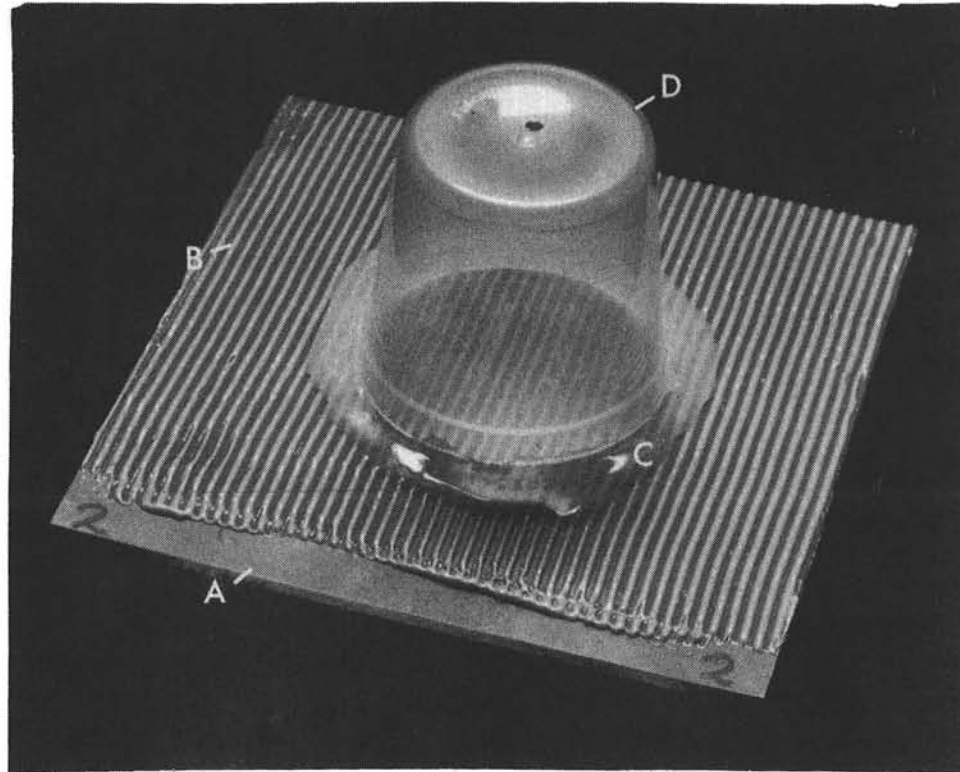
Figure 11. Inverted Cup Deterioration Test

Because of the obvious compatibility problem with the sealant and the mirror, a series of laboratory tests were designed to try to simulate and accelerate the deterioration seen in the field. The test apparatus is shown in Figure 11. This test was accomplished on mirrors with and without applied adhesive by bonding a plastic cup to the back of the mirror and inserting  $\approx$  20 ML of a solution of distilled water +1% isopropyl alcohol with and without sealant extract. The entire arrangement is then placed in an oven at 60°C. In all cases where the sealant extract was used on mirrors with adhesive, the deterioration discoloration was not the same but the pattern was. In all other cases where adhesive was applied to the mirrors the laboratory sample could not be distinguished from the exposed mirrors and the growth of small spots to larger ones was verified. In all cases when there was no adhesive, merely water, the deterioration did eventually appear but after as much as a 5 fold increase in time.
