FINAL REPORT

SECOND GENERATION HELIOSTAT

LIFE CYCLE AND OPERATIONAL TORQUE CAPABILITY
OF THE SECOND GENERATION AZIMUTH DRIVE

TEST REPORT
ELEVATION ACTUATOR, MDAC SECOND
GENERATION HELIOSTAT

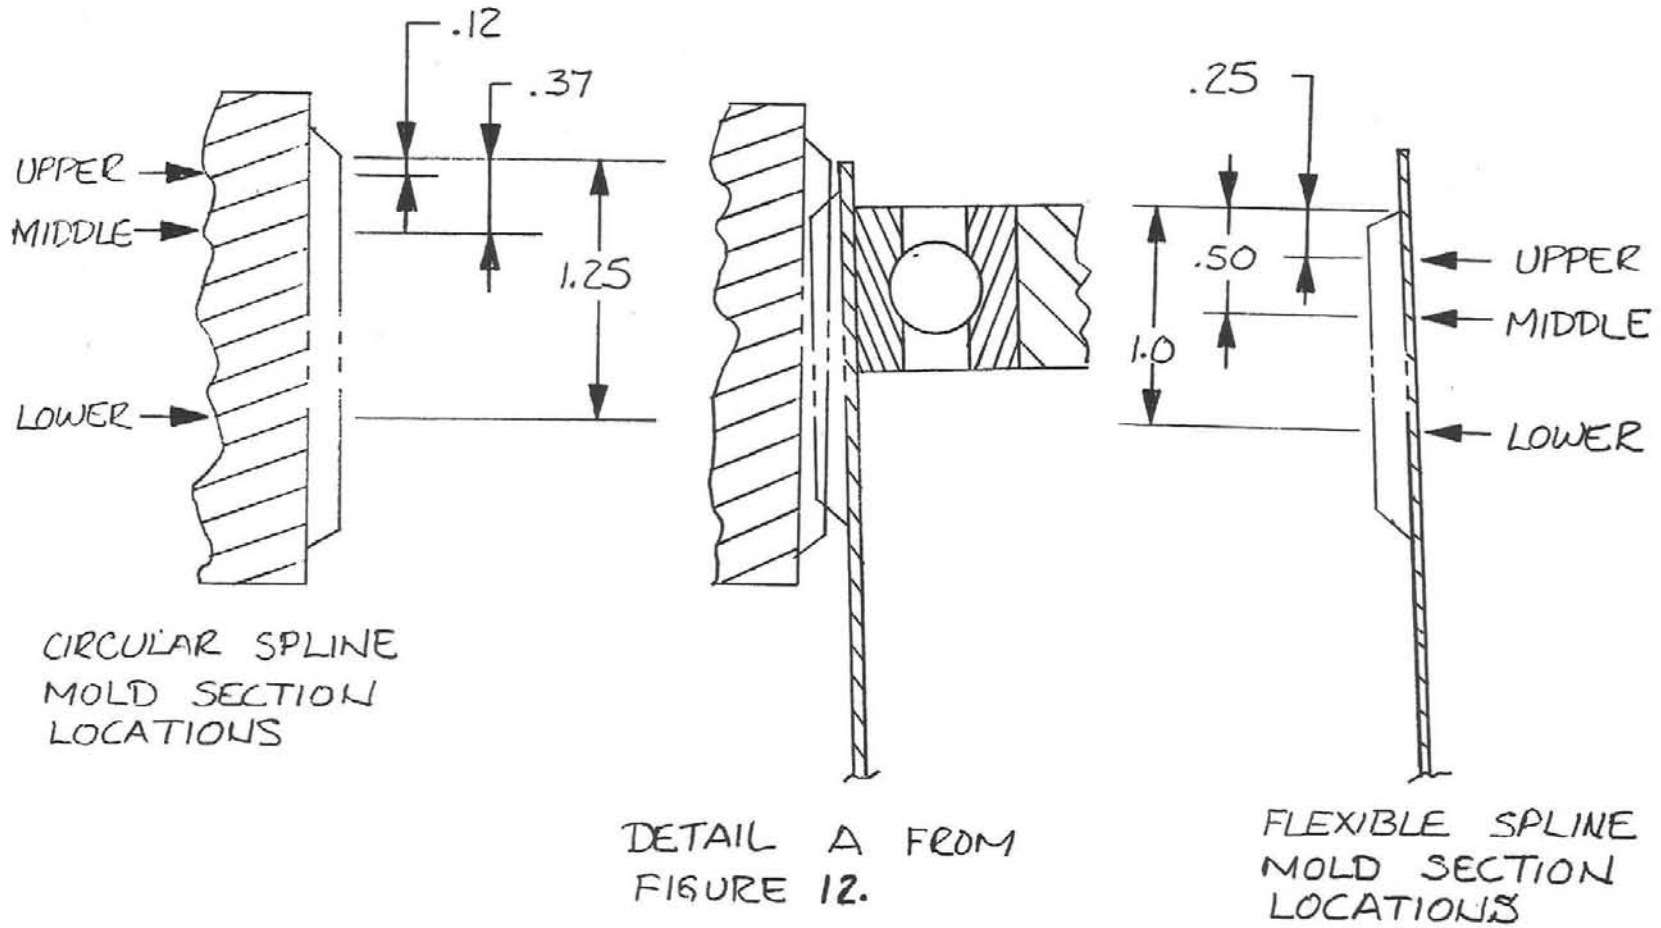
MOLD SECTION LOCATIONS
FIGURE 13

The flex spline teeth were in excellent condition with practically no evidence of wear. Silicone molds of the splines were obtained and sectioned slices were projected on a shadowgraph. Refer to photographic coverage in Figures 14 and 15 for flex spline details. The respective slices were obtained .25, .50 and 1.00 inches down from the top of the flex spline as shown in Figure 13. No readily discernable wear can be seen. The flex spline/wave generator interface looked good. The contact area was burnished, but no deep grooves or other damage were found.
