SAND87-8175  
Unlimited Release  
UC-62a

# 10 MWe Solar Thermal Central Receiver Pilot Plant Repaint of a Single Receiver Panel Test Report

10 MWe SOLAR THERMAL  
CENTRAL RECEIVER PILOT PLANT  
REPAINT OF A SINGLE RECEIVER PANEL  
TEST REPORT

ABSTRACT

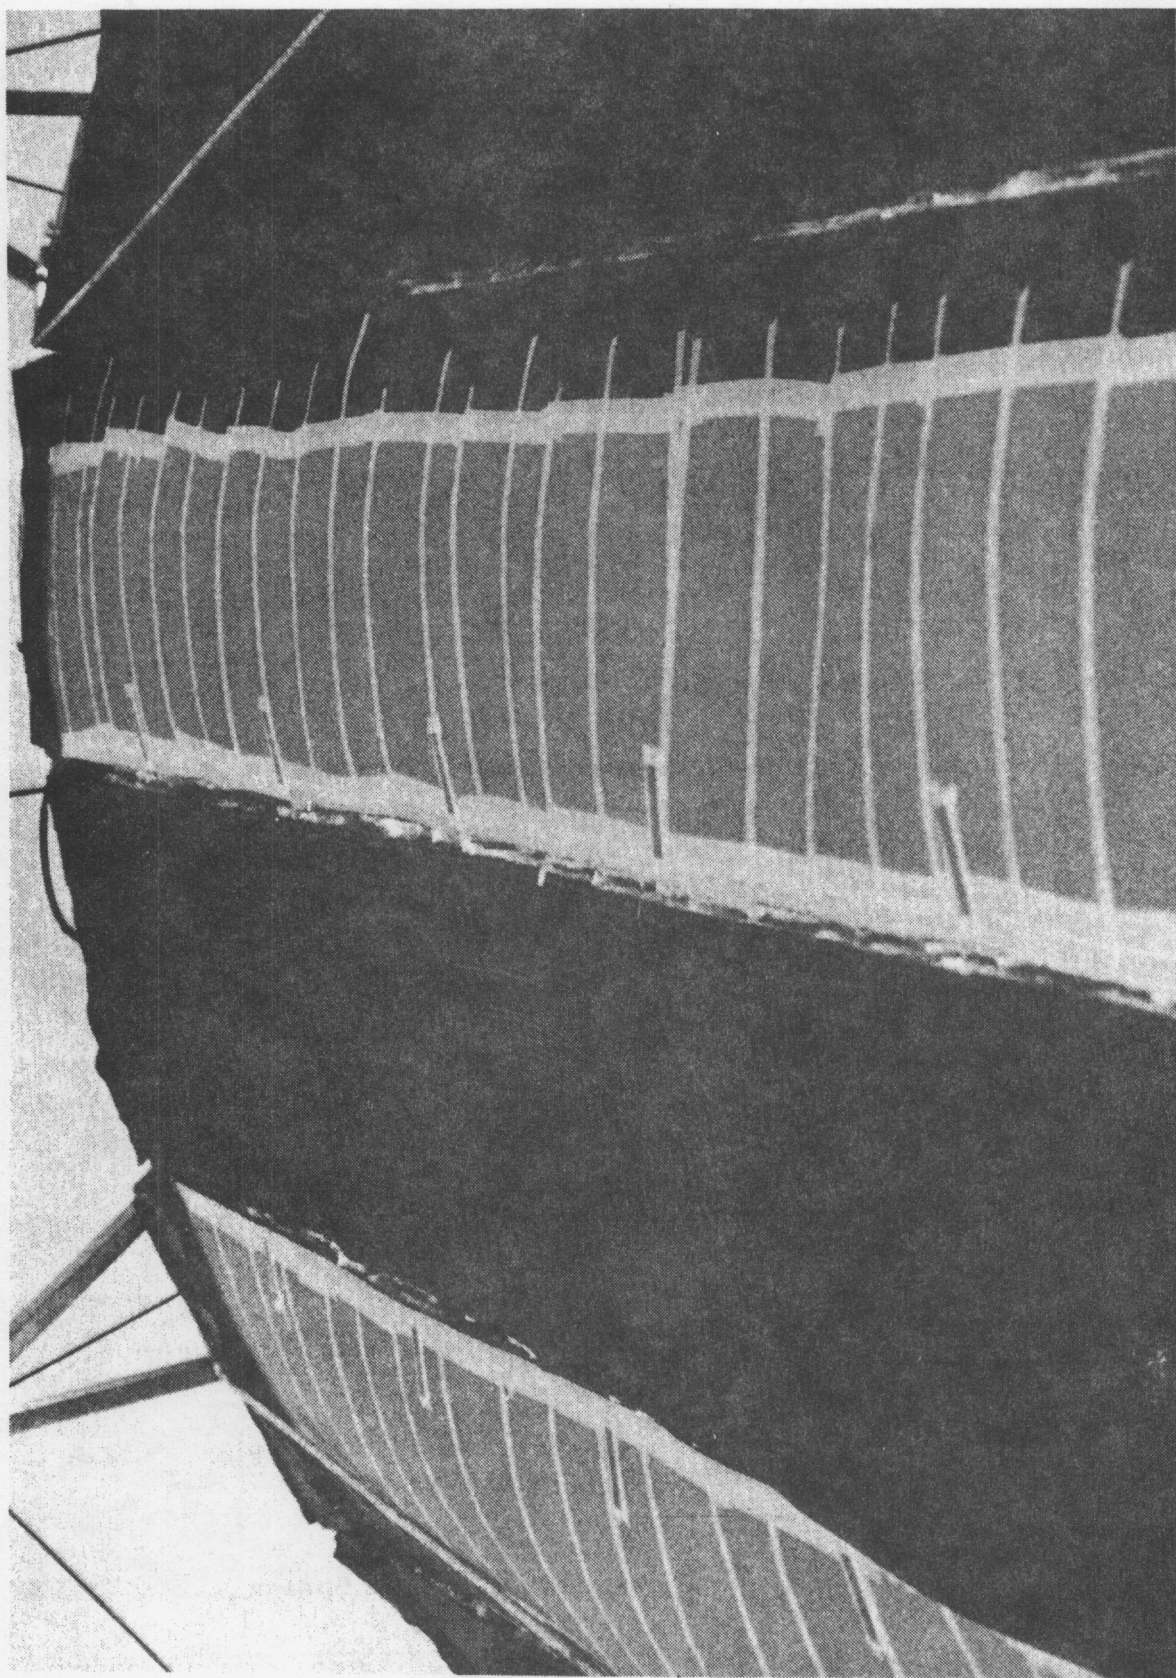
Figure 3-1. Panel 12 Prepared for Paint Application

the panel surface to remove loose dirt and masking the appropriate areas. These areas included the adjacent panel tubes, the top and bottom heat shields and the exposed tips of the heat flux sensors. Aluminum witness plates were attached to the masking which covered the adjacent panels in order to provide a record of paint thickness application. The position and spacing of these plates was consistent with the information contained in the Job Specification (Appendix A). The washing was accomplished from top down using water taken from the Solar One service water system and a nylon brush. A photograph of the prepared panel is shown in Figure 3-1. The first day tasks were completed in approximately 3 hours.

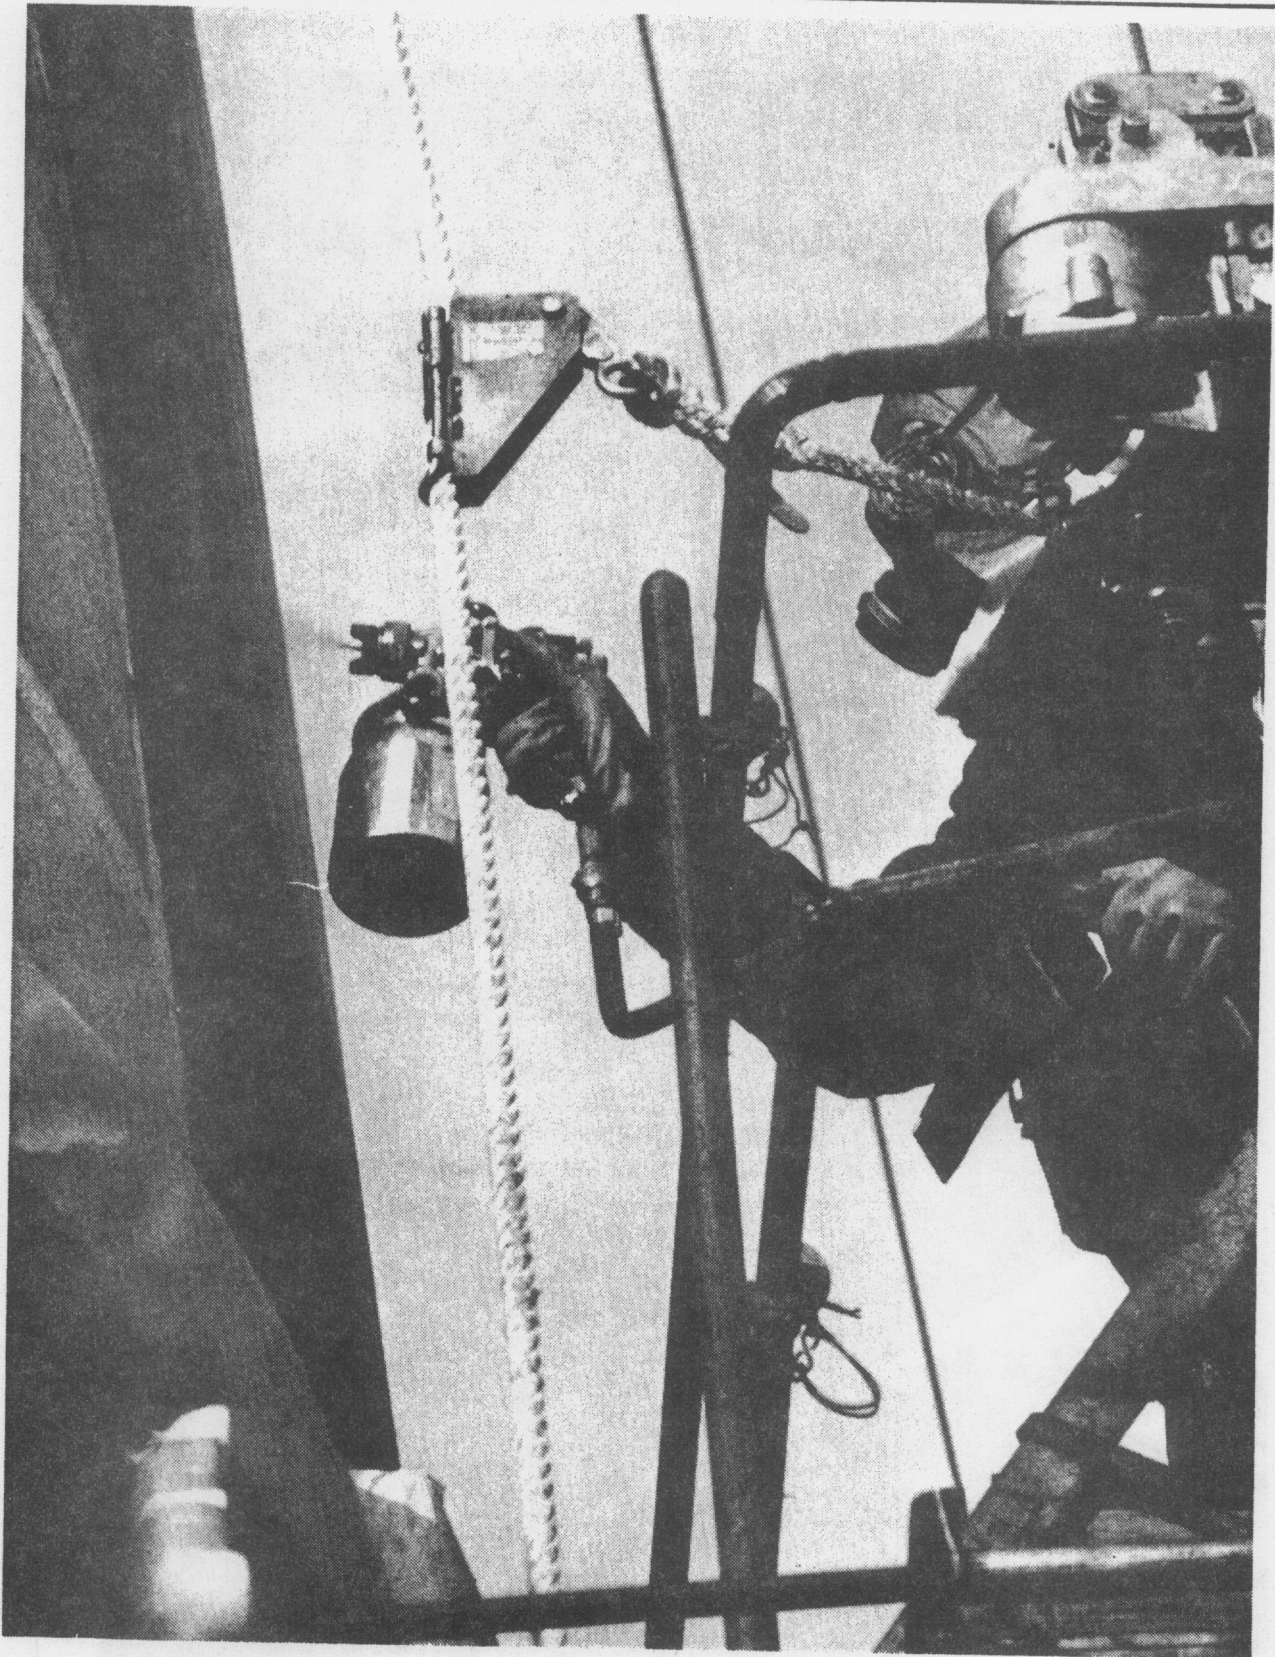
Figure 3-2. Panel 12 Paint Spraying Activity

The painting operation proceeded immediately by filling the spray gun with Pyromark 2500 and returning the sky climber to the top of the receiver. The painting procedure was consistent with the instructions prescribed in the Job Specification. The paint was applied with a side-to-side motion using 50% overlapping strokes. The spraying strokes were continued as appropriated into the masked area to cover the witness plates with representative coats of paint. The sky climber was gradually lowered until the entire panel had been painted. Figure 3-2 shows the paint spraying activity in progress. The combined solvent and paint spraying operation was completed in approximately 1 1/2 hours.

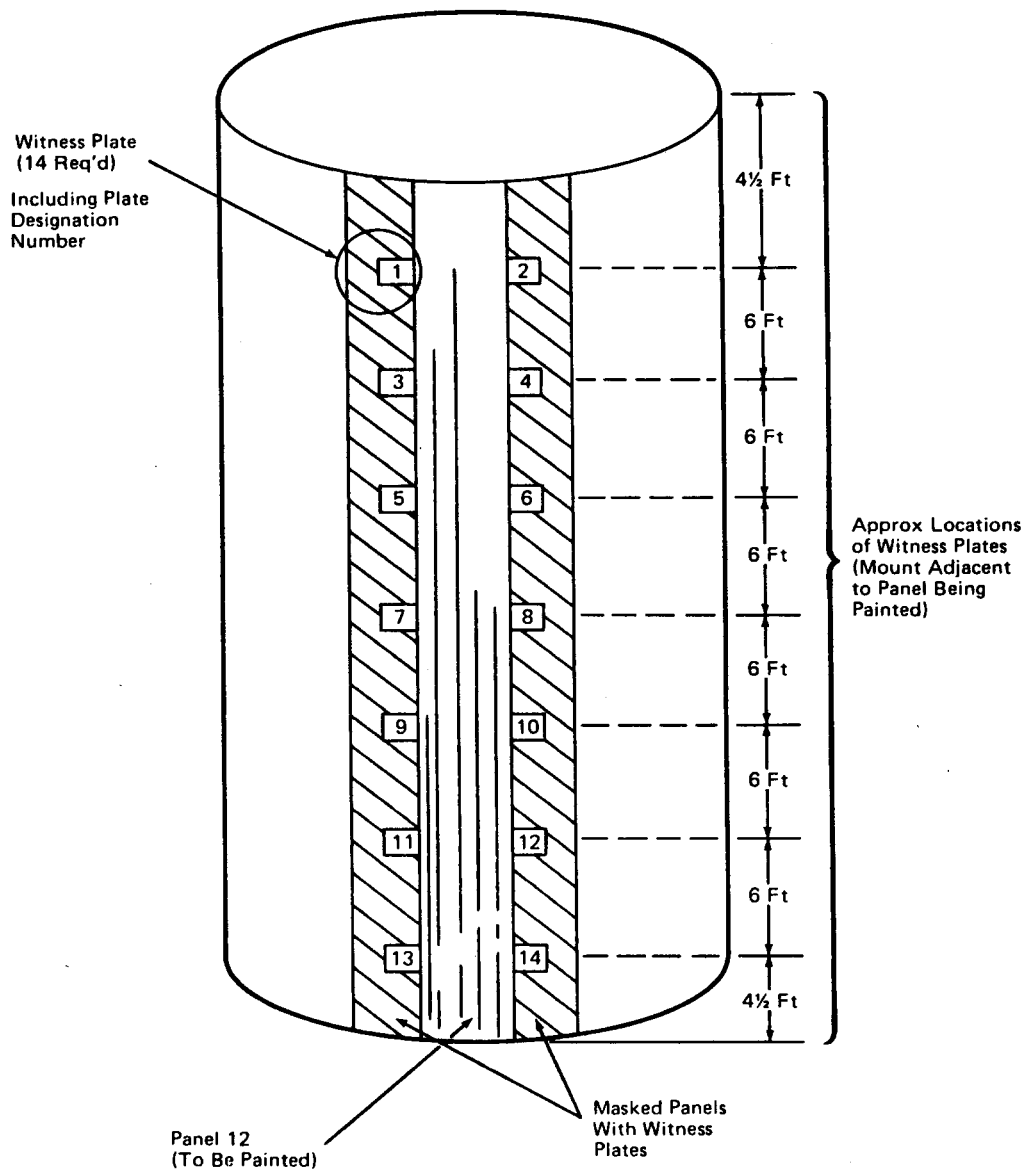
Figure 3-3. Witness Plate Locations and Numbering System

The freshly painted witness plates were returned to the McDonnell Douglas paint shop for analysis. Paint thickness measurements were made with a permascope on March 8. The results of these thickness measurements for the dry, uncured plates are shown in Table 3-1. The left and right designations refer to locations on the same witness plate and are included to give a better indication of the uniformity of the paint layer. The location for each witness plate relative to the freshly painted panel is indicated in Figure 3-3. Visual inspections of both the freshly painted panel and the witness plates showed the painted surfaces to be smooth, uniform, and crack free.

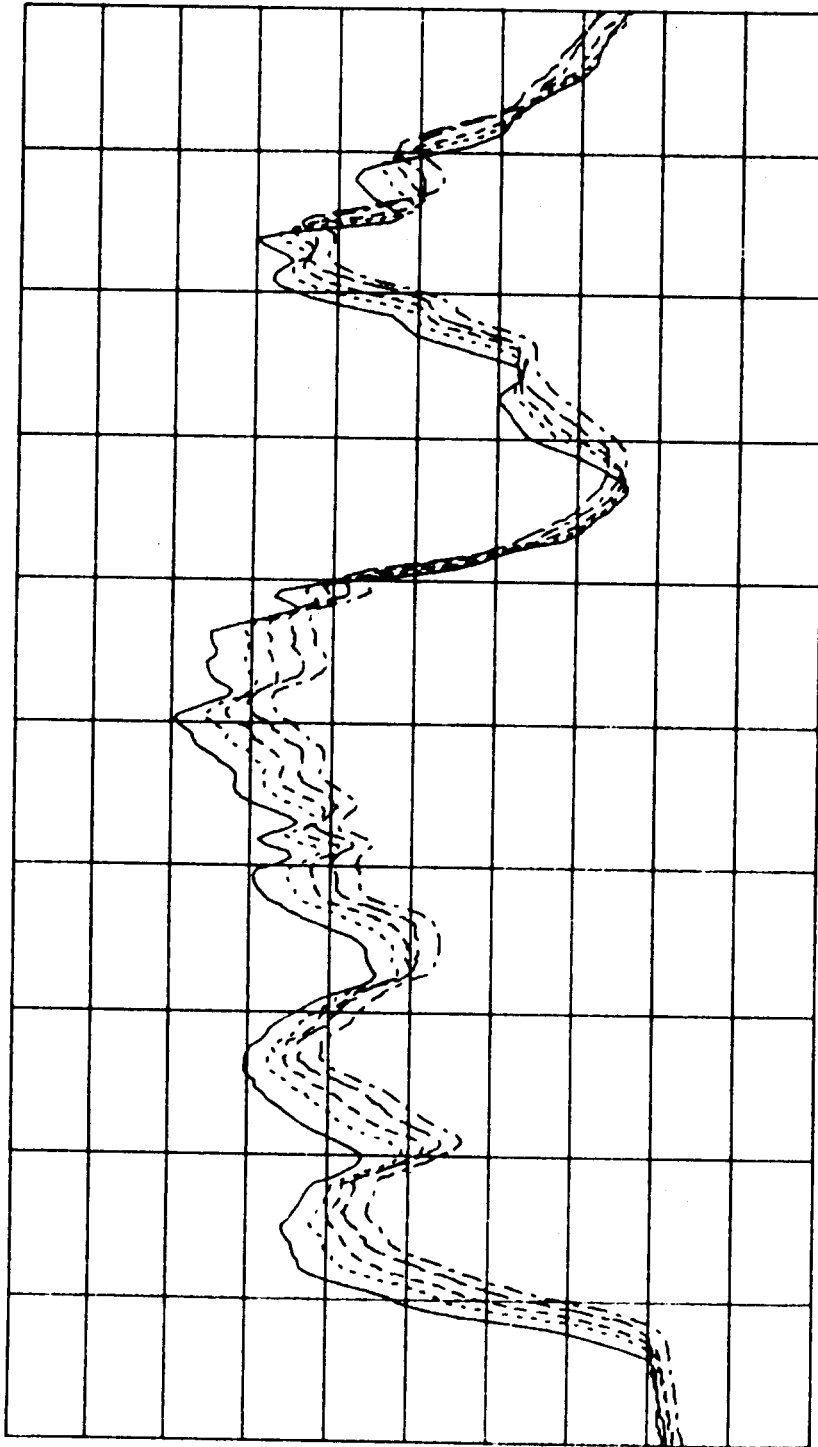
Figure 4-1. Representative Panel Temperatures During 250°F Cure Point

The next attempt to cure the panel occurred on March 11. The partly cloudy and windy conditions that prevailed on that day provided a highly transient environment which required continual operator action (adjustments to heat flux and panel flow) to maintain a reasonable temperature condition. A time history of representative panel temperatures is shown in Figure 4-1. The effects of the cloudy and windy conditions are apparent. This cure operation was halted at 1:20 PM due to cloud cover. Locations of thermocouples for these data and data subsequently presented are summarized in the following tabulation.

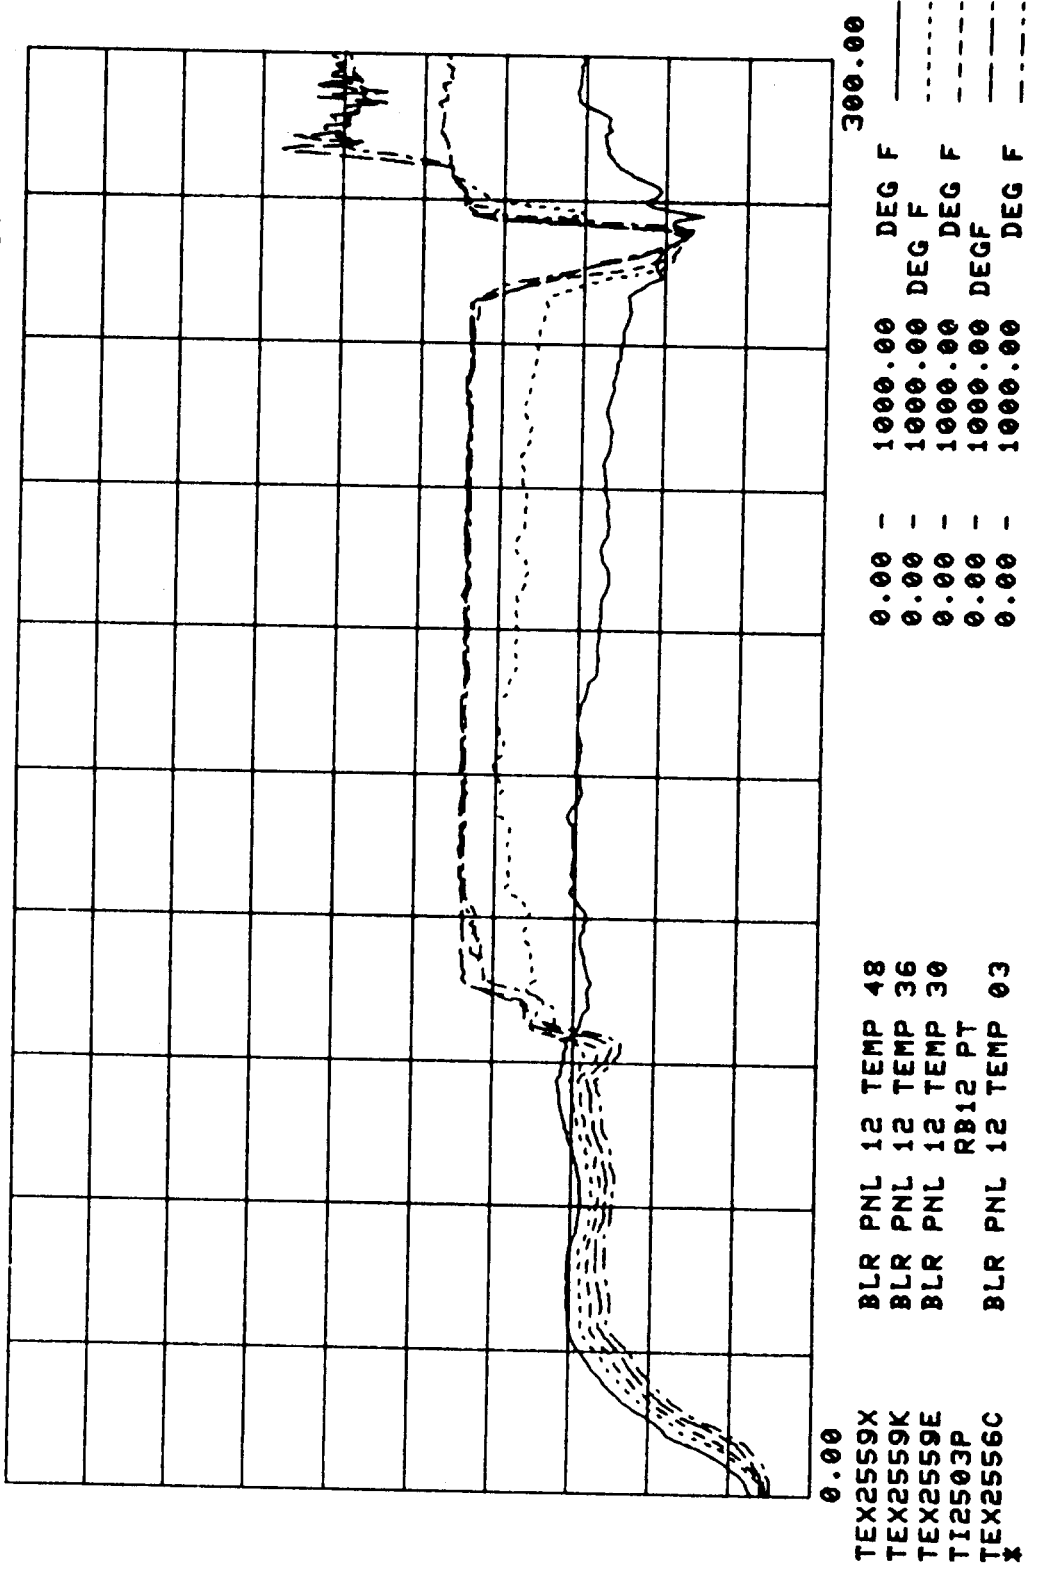
Figure 4-2. Representative Panel Temperatures During the 250°F and 450°F Cure Points

The third attempt to complete the paint cure and vitrification procedure occurred on March 12 which was a clear day with moderate winds. With these stable conditions, it was a relatively straight forward process of controlling heat flux and panel flow to complete the panel cure. Figure 4-2 shows representative temperatures as they existed during the completion of the 250<sup>0</sup>F and the execution of the 450<sup>0</sup>F hold. The spread in the temperatures that existed during the 450<sup>0</sup>F hold are typical of what is to be expected when the hold condition is based on readings provided by a single thermocouple.
