SAND87-8226 • UC-62a
Unlimited Release
Printed September 1987

10 MW_e Solar Thermal Central Receiver Pilot Plant Mirror Module Corrosion Torque Tube Damage and Vent Tube Assessment Survey July 1985 and July 1986

M. A. Danzo, R. L. Velazques, and C. L. Mavis

M. A. Danzo
R. L. Velazquez
Southern California Edison Company
Rosemead, California

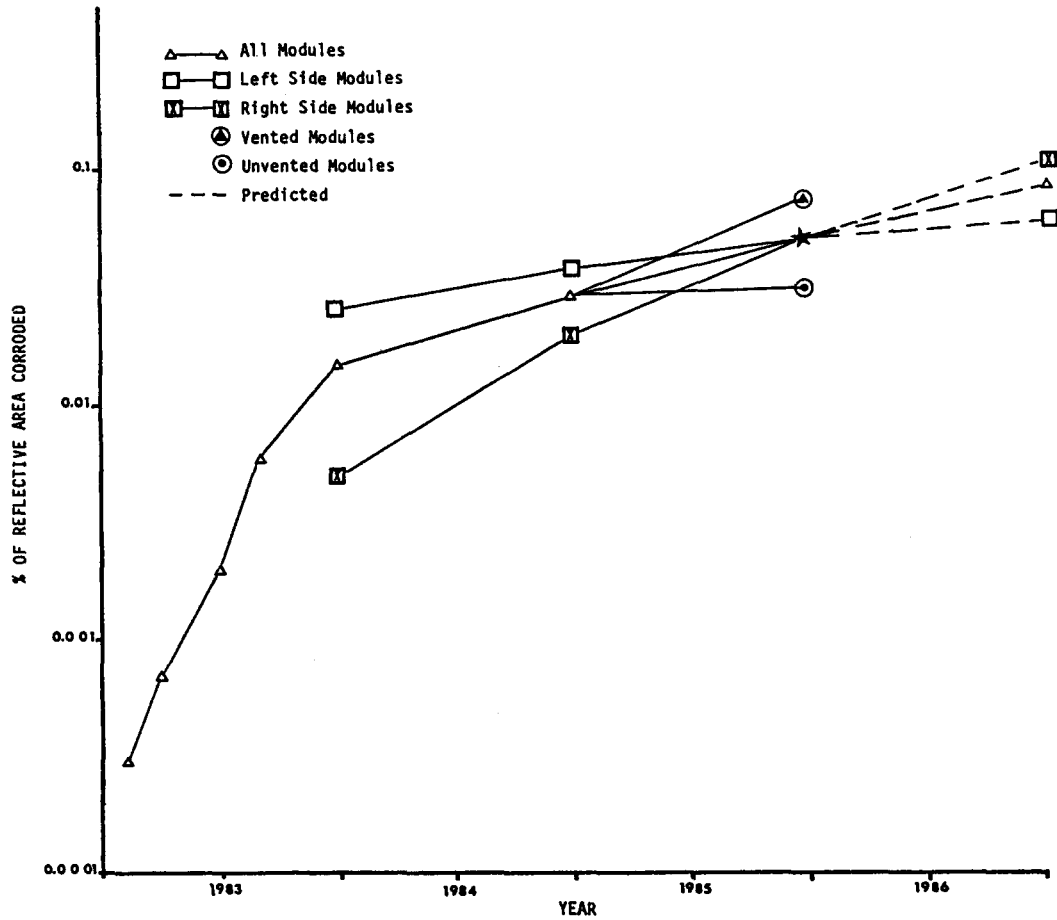
Figure 2. Actual and Predicted Mirror Module Corrosion

Figure 2 illustrates the actual and predicted logarithmic growth from the 1985 and previous surveys. Lines representing left-side, right-side, and total corrosion growth rates intersect at the value 0.052% of reflective area corroded. This shows again, that the right-side corrosion is now approximately the same as left-side corrosion. Left-side corrosion accounts for 49.6% of total corrosion whereas, right-side corrosion accounts for 50.4% of the total corrosion. Thus, 0.052% of both left-side and right-sides reflective areas are corroded. This serves to explain the intersection of left-side, right-side, and total corrosion growth rates. Ultimately, the collector field experienced a 78% increase in corrosion from July 1984 to July 1985.

Although corrosion is becoming more evenly distributed over the modules, July 1985 data suggests the corrosion remains concentrated along the mirror edges. Corrosion is heaviest along edges located furthest away from the original vents.

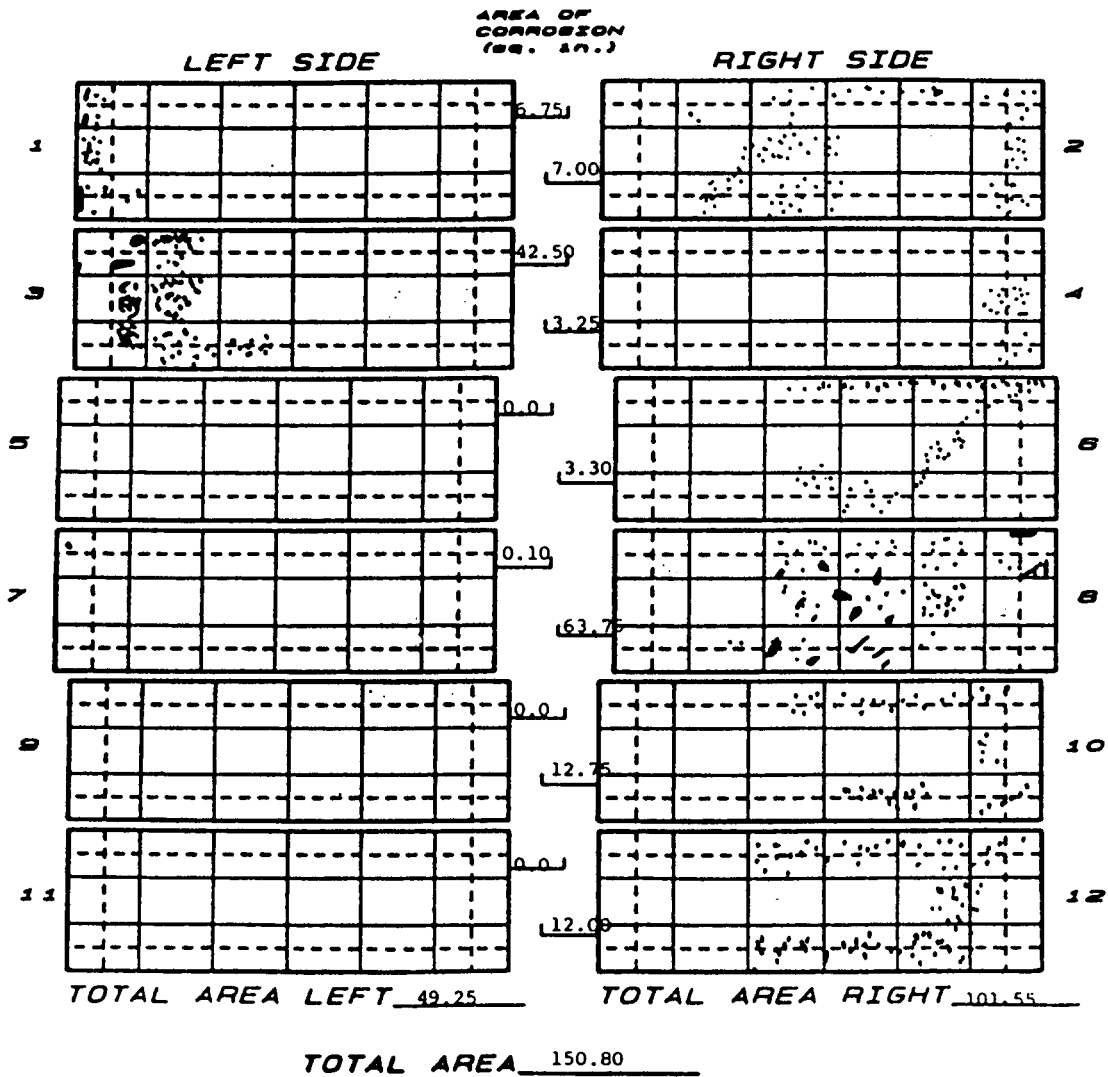
Figure 4. Sample Mirror Corrosion Map Sheet

In 1986 the corrosion survey of ninety-eight heliostats was performed in a different manner than in previous years. Each module was visually divided into eighteen sections (Figure 4) and each section was estimated separately. This estimation method proved to be more accurate.

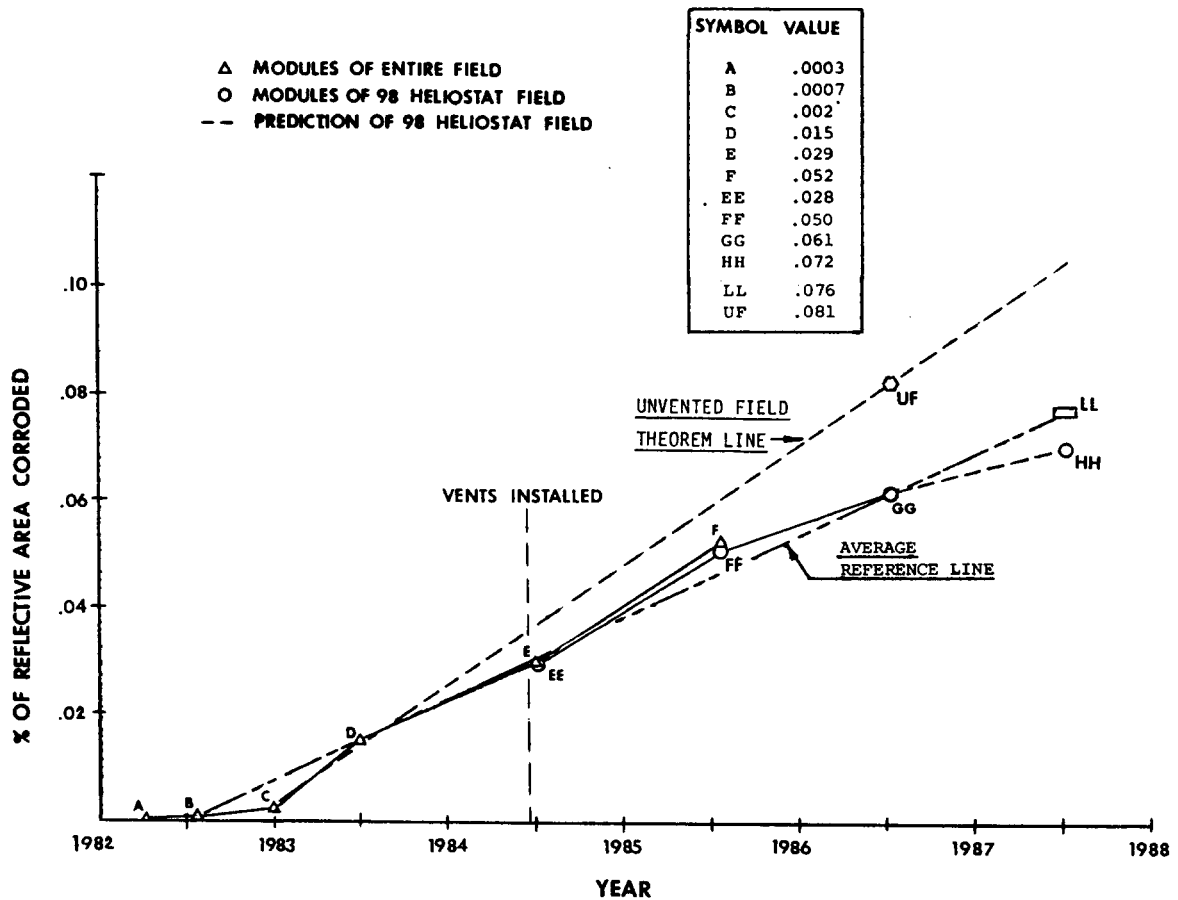
Figure 6. Total Corrosion Trend

In the total corrosion trend graph of Figure 6, line C-UF is the Unvented Field theorem-Line; it predicts the path of corrosion as if vents were never installed. This line is constructed using points B through E because they were not affected by ventilation. Based upon the Unvented Field Theorem-Line, the % reflective area corroded in 1986 would have been approximately .081 (point UF) rather than the actual .061 (point GG) estimated from the 98 heliostat field survey. The prediction for 1986 shown in Figure 2 is .090 rather than .081 which indicates that mirror venting was more effective than predicted.

In the same Figure 6, the Average Corrosion Reference Line was constructed from all the data points plotted. This average line shows that the corrosion growth is constant from summer 1982 to summer 1986. The % reflective area corroded has been .015 per year from point B to point GG. This small percentage area growth per year is due to vents being installed. Points F and FF are above the Average Corrosion Reference Line, and would have been higher, closer to the unvented field line, but summer 1985 was the first year affected by venting, causing it to be lower. Point GG is on the average reference line either for two reasons: first, the corrosion growth is continuing the average growth pattern or second, the growth pattern will continue this year's path toward HH, which seems to be apparent. A survey to be conducted in the summer 1987 should establish some answers on the permanent corrosion trend.

If results from the summer 1987 survey show that the % reflective area corroded is just above .072 (point LL), then the corrosion is following the average corrosion reference line. But, if results show that the % reflective area corroded is below (point HH), then it can be said that the corrosion growth rate is decreasing.

Mirror corrosion has increased to the equivalent of 1.13 heliostats and should continue to increase at a constant rate of .015% of reflective area corroded per year, based upon results obtained from the corrosion trend of Figure 6. It is predicted that over the next 25-years, the equivalent of 8 heliostats will have corroded causing a 52 MW_eh per year loss of energy in the year 2011. Therefore, the corrosion rate is not severe and will not have a serious impact on the plant's future performance.

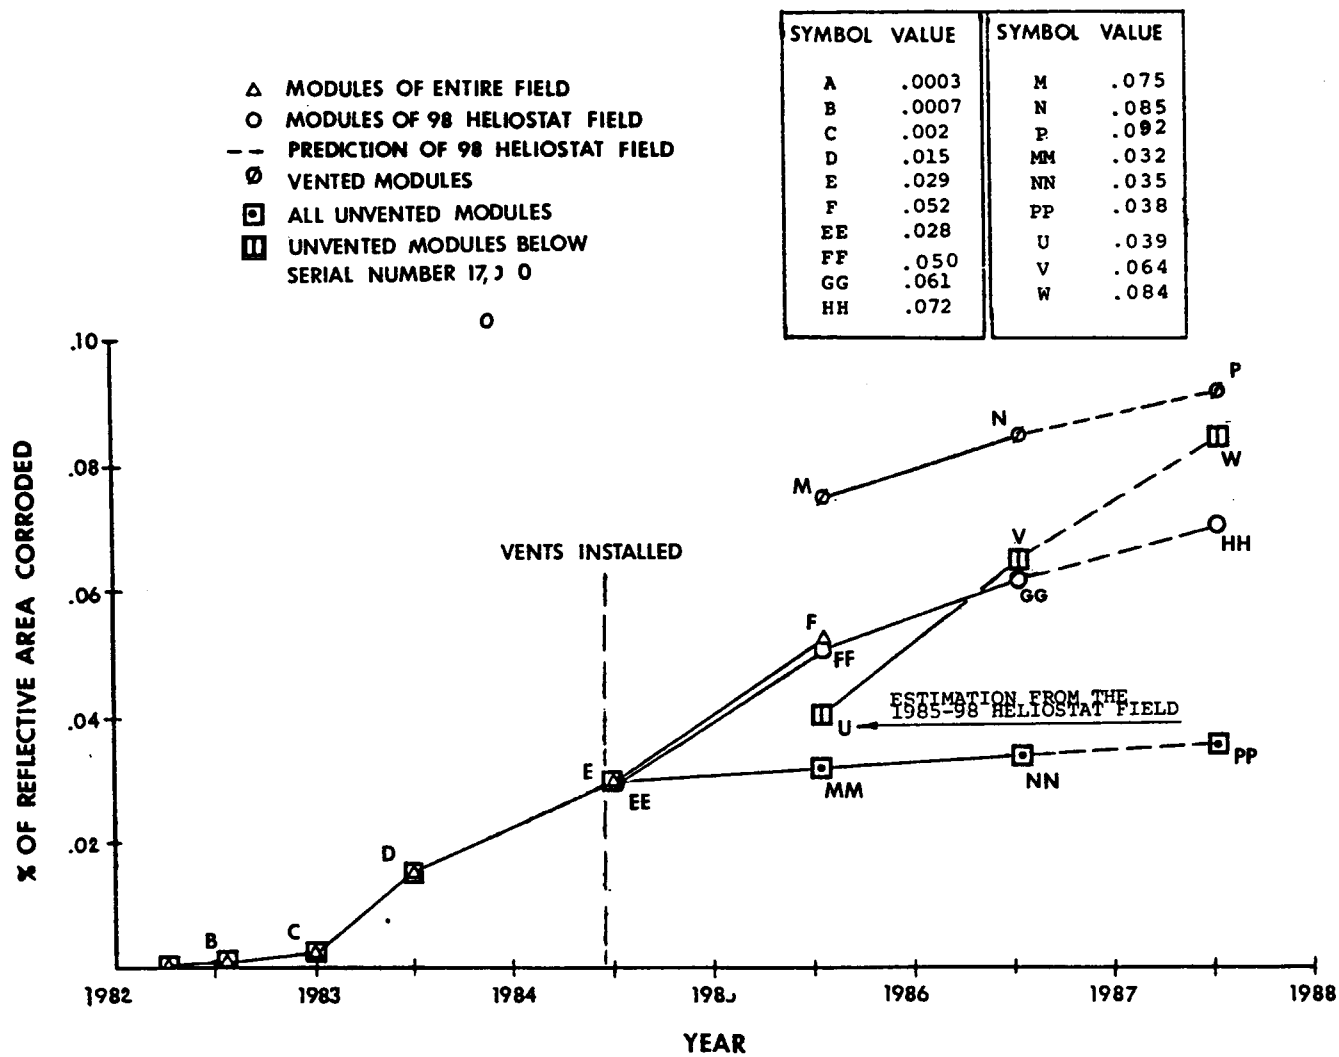
Figure 7. Vented vs Unvented Corrosion Comparisons

The reader should bear in mind that a greater number of modules below the 17,000 serial number have vents. This vented module category contained more corrosion than the unvented modules. This is the reason why the vented line lies higher than the unvented line in Figure 7. The important observation is that the vented slope is less than the unvented slope. The corrosion of unvented modules increases (.025%) at more than double the vented module (.010%) corrosion rate. This proves that venting has been effective in decreasing the corrosion growth of the field. If the % reflective area corrosion of .015% per year continues, then it would not be necessary to vent more modules. But in turn, if corrosion tremendously exceeds the .015% increase per year, then it would be advisable to install vents in unvented modules.

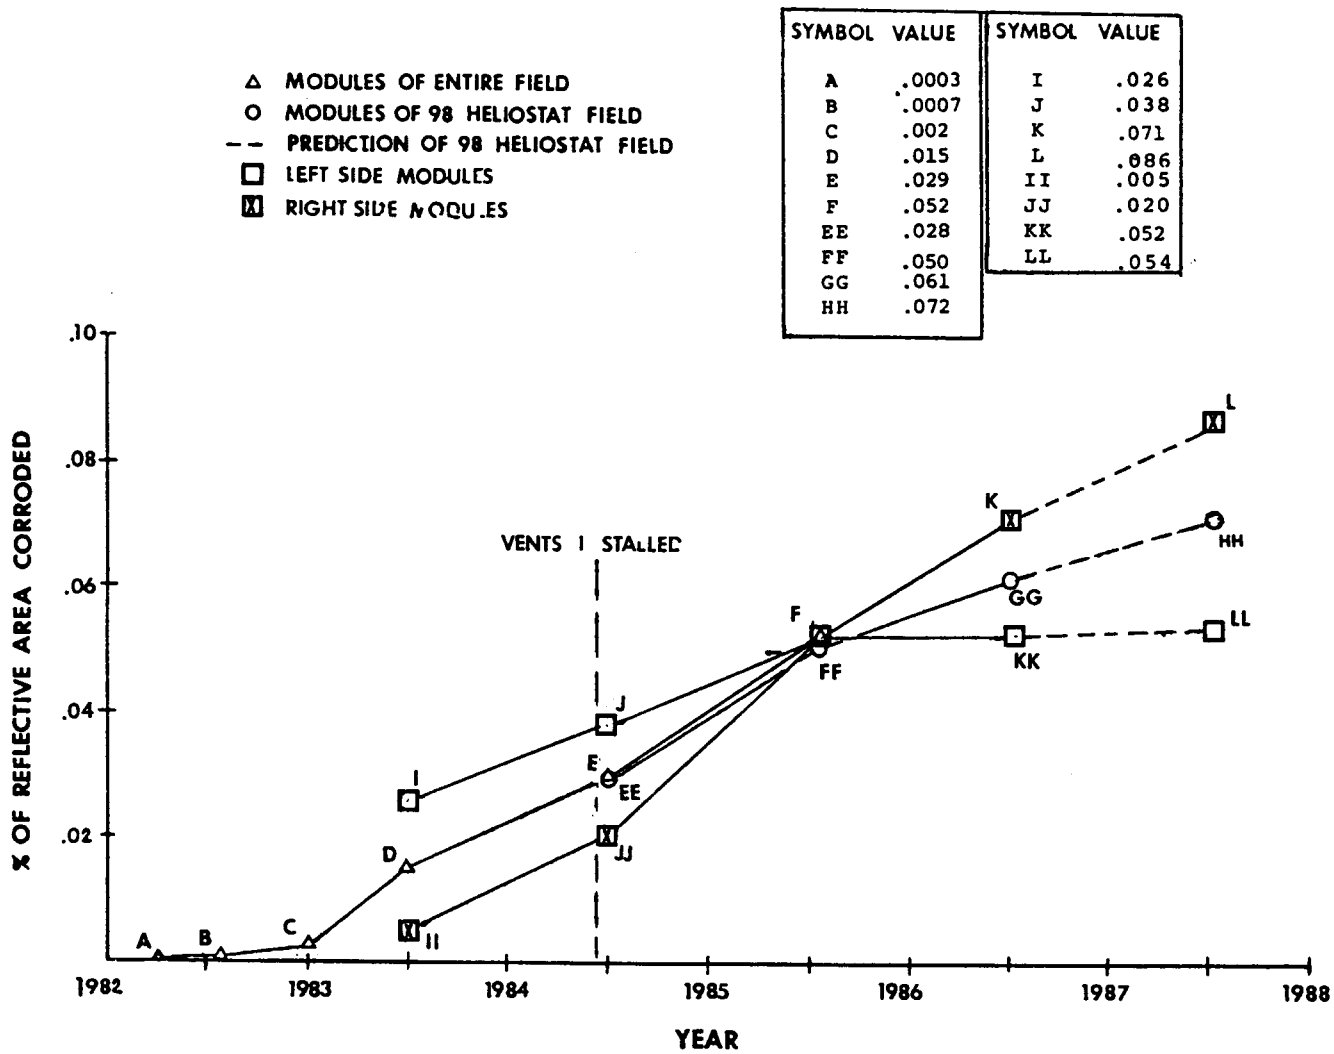
Figure 8. Left vs Right Corrosion Comparisons

It can be observed in Figure 8 that the difference in % reflective area corroded of left and right side modules was maintained for the summers of 1983 and 1984. This parallel growth was deviated after the 10,036 mirror modules were vented in April 1984. The vented left side modules comprised 75% of all modules with vents. The effects were apparent in summer of 1985 where the left and right side corrosions were almost identical. In the summer of 1985 it was predicted that the corrosion of right side modules would surpass the left side module corrosion; this indeed did happen in 1986 and is verified in Figure 8.

The left side modules had a 1% increase in corrosion growth from 1985, due to the vent installation. The left side modules have an annual .002% corrosion rate increase compared to a .020% rate for right side modules. This vast difference is mainly due to vents having been installed in left side modules.
