Reliability of the Solar One Plant During the Power Production Phase

August 1, 1984 — July 31, 1987

Sandia National Laboratories

SAND88-2664
Unlimited Release
Printed October 1988

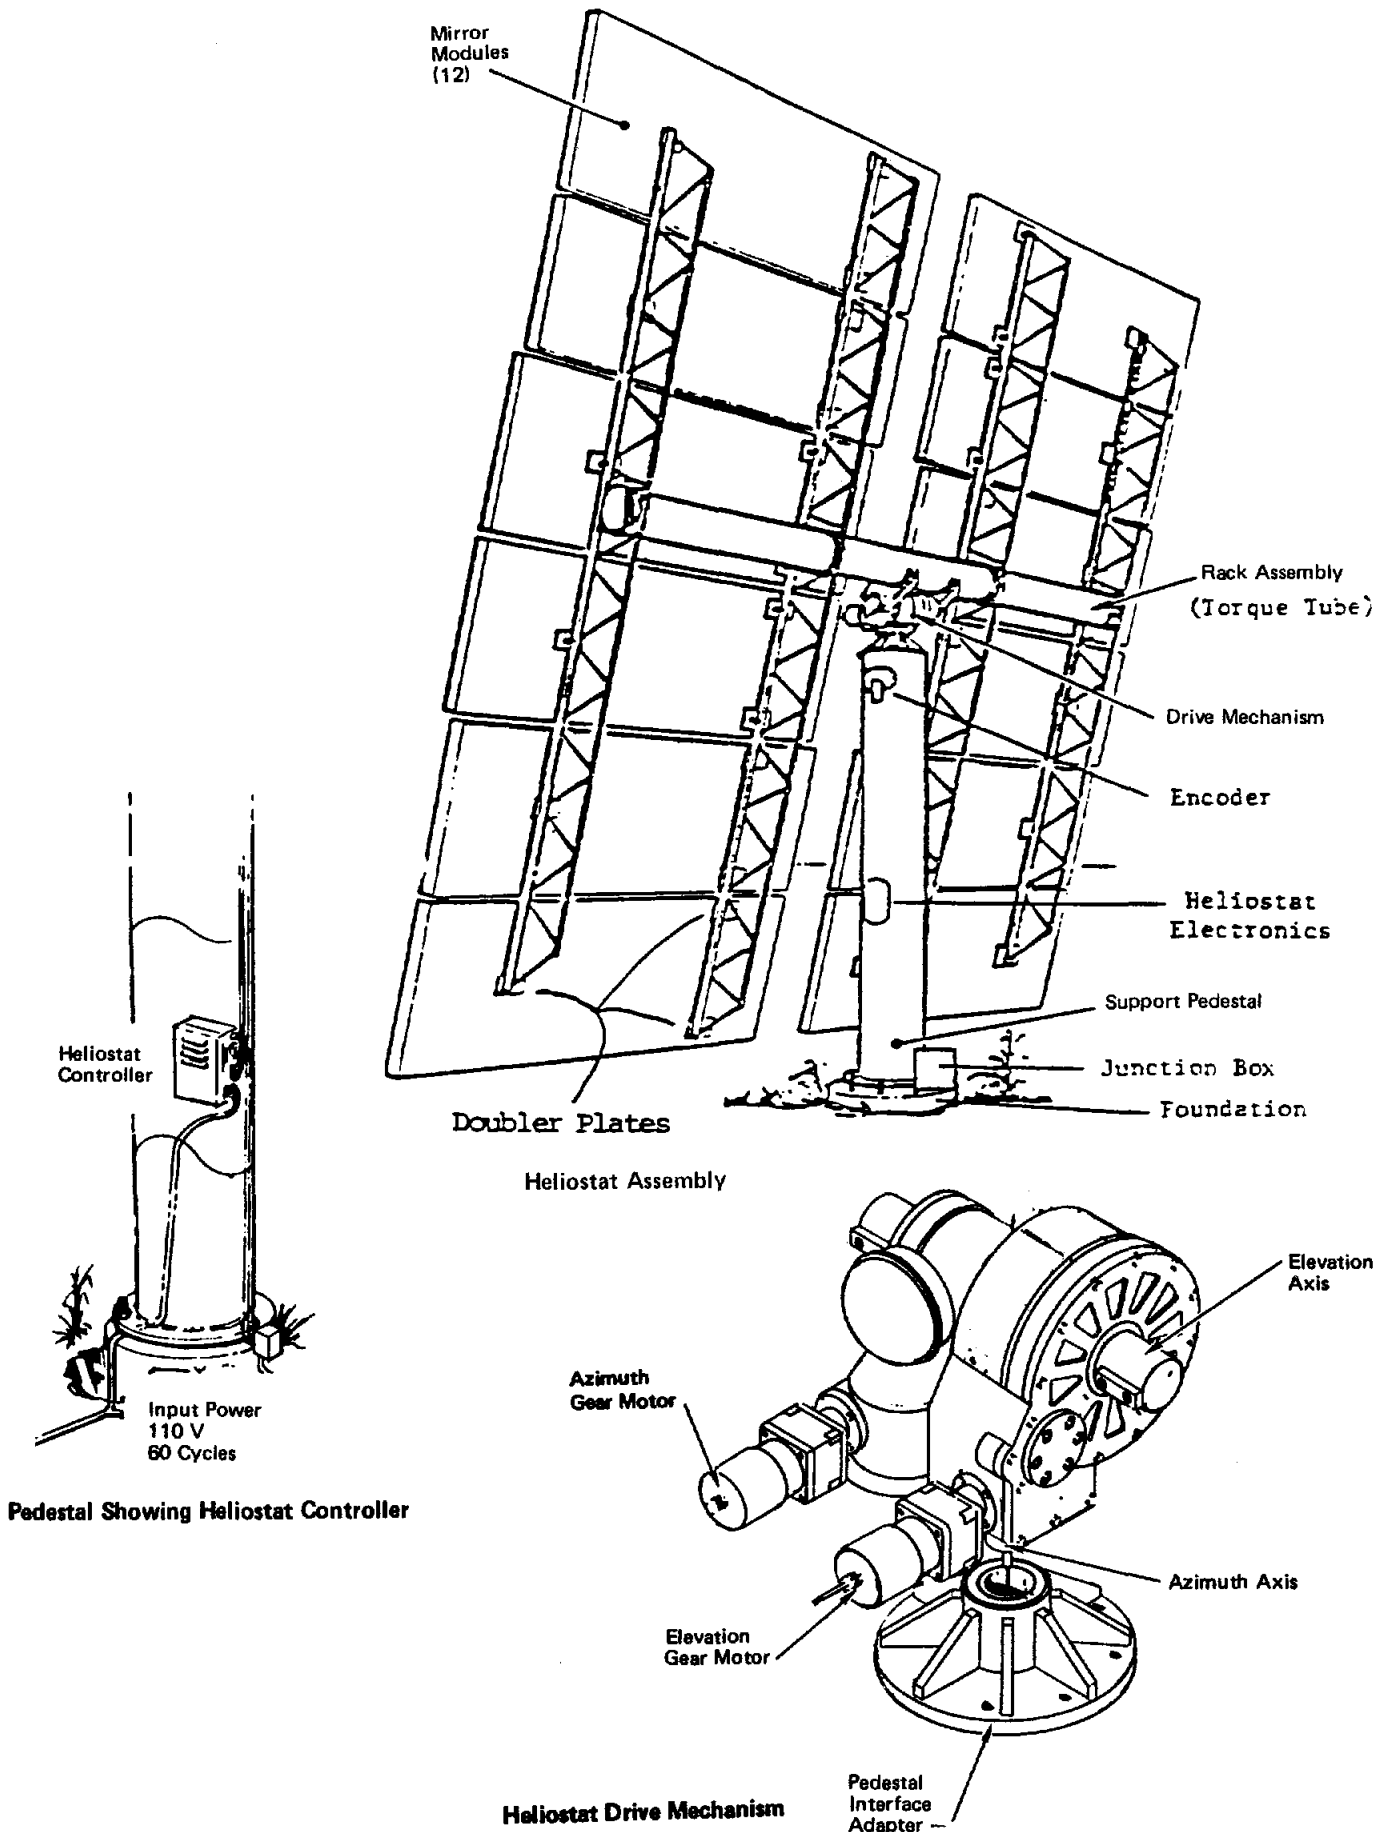
Figure 4-2 Heliostat Components

Each heliostat has twelve mirror modules consisting of a metal pan that forms five of the module's six surfaces (see Figure 4-2). The sixth surface is the glass mirror, which is supported by the aluminum honeycomb structure contained within the pan. Expansion of air contained within the pan places a high load on the epoxy adhesive that holds the mirrors together; therefore, the pan was originally equipped with a small vent. However,

The mirror modules have doubler pads which are epoxied on the back of the metal pans. These doubler plates are used to mount the mirror assemblies onto the heliostat structure. In the initial operating year, the plant experienced failure of many of the doubler pads. This caused the mirror assembly to fall to the ground and break. The doubler pads' failure was attributed to contamination of the epoxy, improper mixing of adhesive and accelerator, and improper priming of the metal pans prior to applying epoxy to the doubler pads. Selected mirror assembly doubler pads were retrofitted with pop rivets. During the failure period and following the retrofit, the wind stow limit was reduced from the original 45 to 40 mph. The retrofit significantly reduced the number fallen mirror assemblies.
