SAND94-8235 • UC-404
Unlimited Release
Printed January 1995

NaK Pool-Boiler Solar Receiver Durability Bench Test, Vol. 2: Metallurgical Analysis

S. H. Goods, R. W. Bradshaw

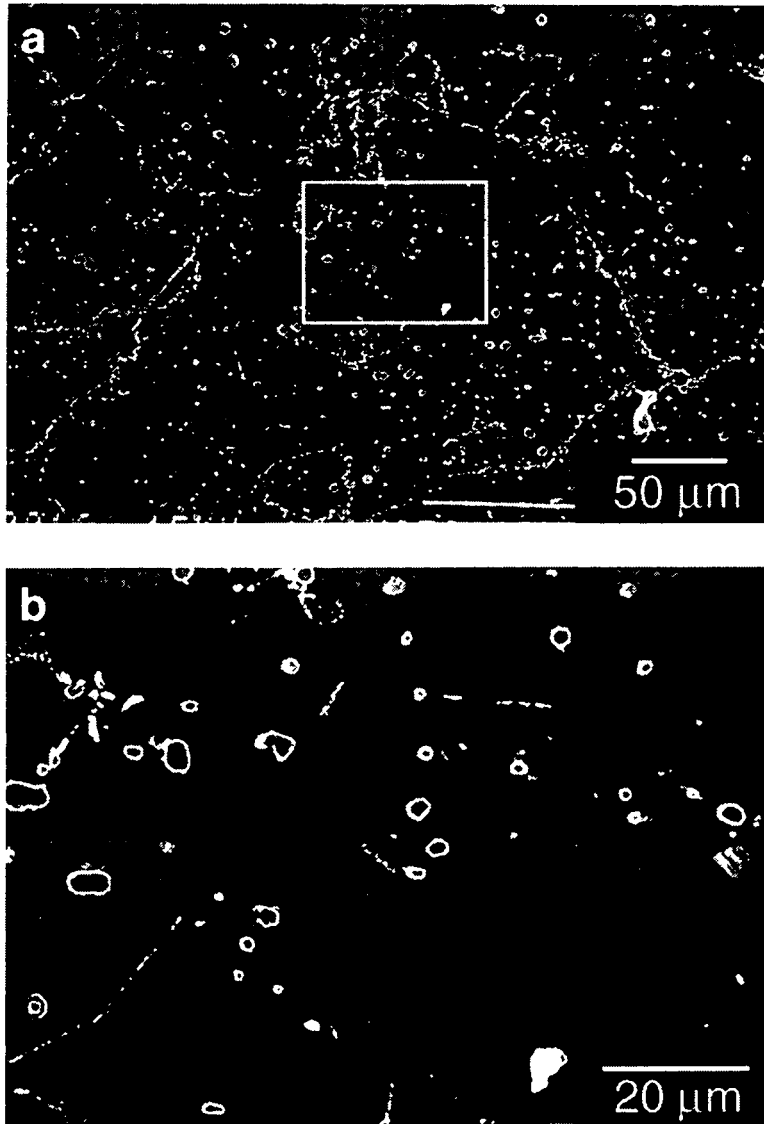
A second phase microstructure remains after solution heat treatment. This is shown in Figures 4a and b which are scanning electron micrographs (SEM) of a polished and etched cross-section of the as-received alloy. The micrographs reveal that the material contained a relatively uniform distribution of second-phase particles. This "primary" precipitate microstructure in the solution heat treated condition consists of face-centered cubic M_6C particles (as Ni_3W_3C). Chromium or other alloying elements may substitute for nickel in the carbide. These precipitates are stable and do not revert to solution. Extended high temperature exposure results in the formation of "secondary" chromium

Figure 4. a,b) Scanning electron micrographs of as-received microstructure of solution heat-treated Haynes 230 alloy used in construction of pool-boiler. Solution heat-treated alloy contains tungsten carbide precipitates.

tungsten carbides of the form $M_{23}C_6$. These precipitates have minimal impact on the performance of the alloy.

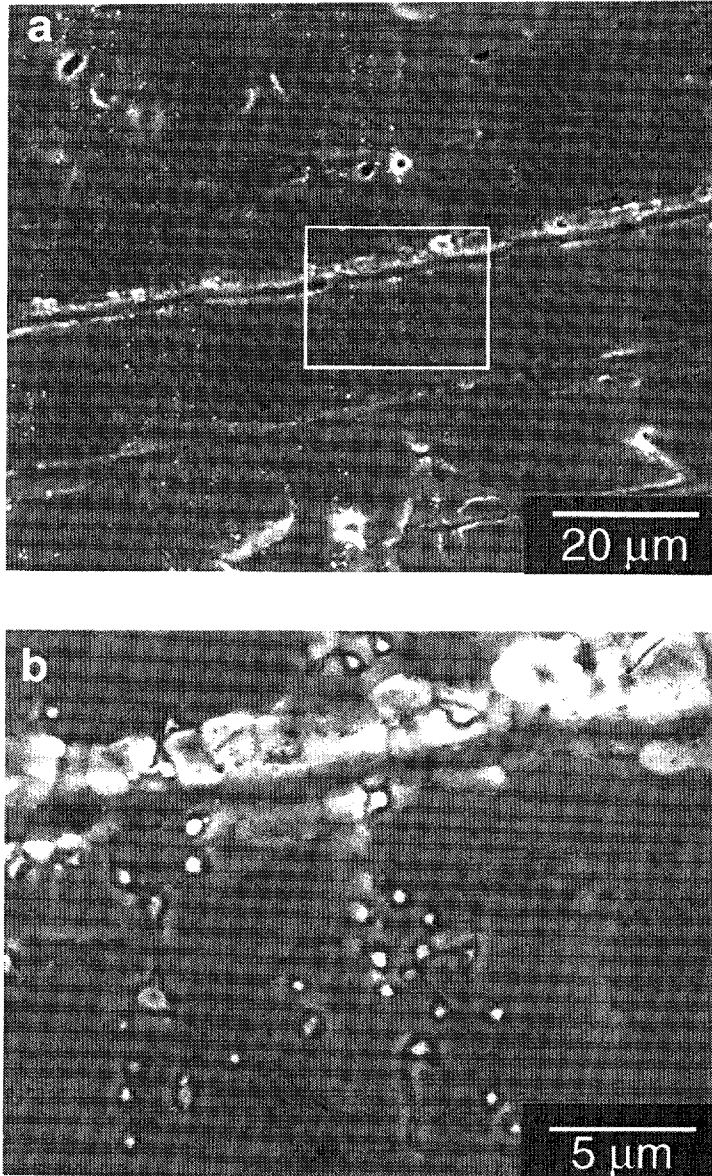
Figures 5a and b are scanning electron micrographs of the ID of the as-received tubing. Marks from the tube forming process are evident in Figure 5a. The particulates and grain boundaries that are shown in Figure 5b are revealed as the result of the chemical descaling procedure. The particulates on the tube surface have essentially the same composition as that indicated in Table II for the second phase particulates.

Figure 5. a) Internal surface of as-received Haynes 230 tubing. Parallel striations result from the tube forming process. b) Higher magnification image reveals presence of W-rich precipitates at the tube surface.

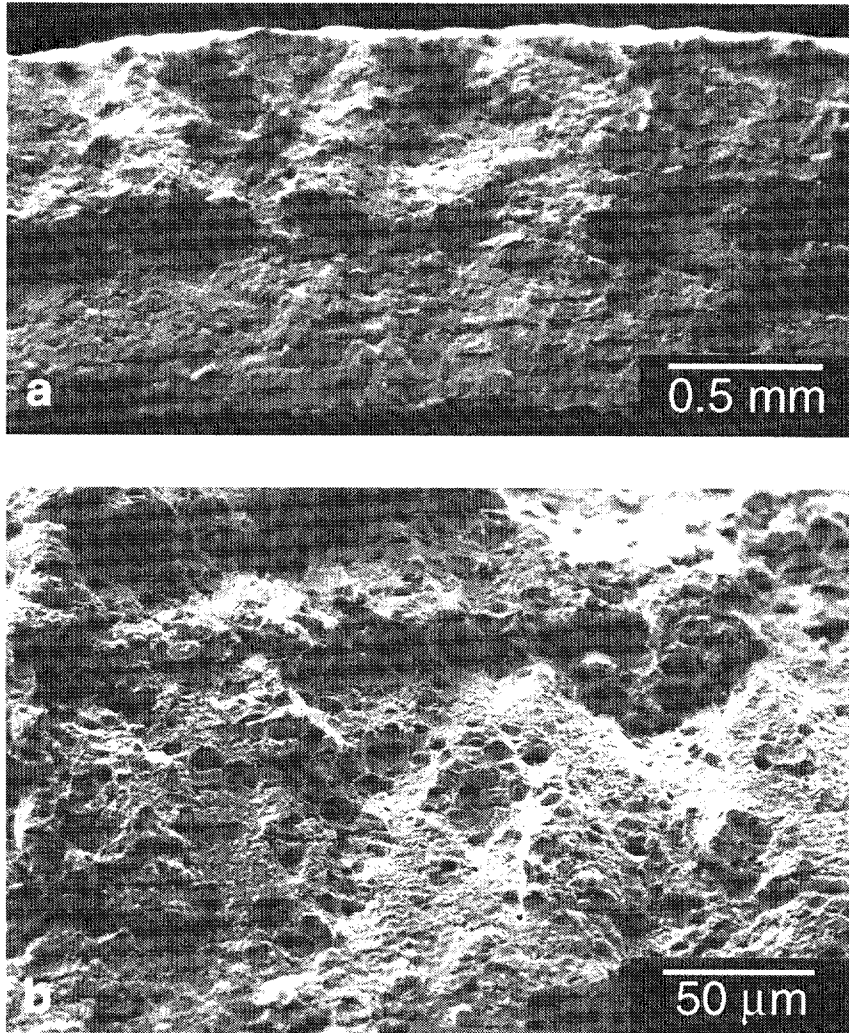
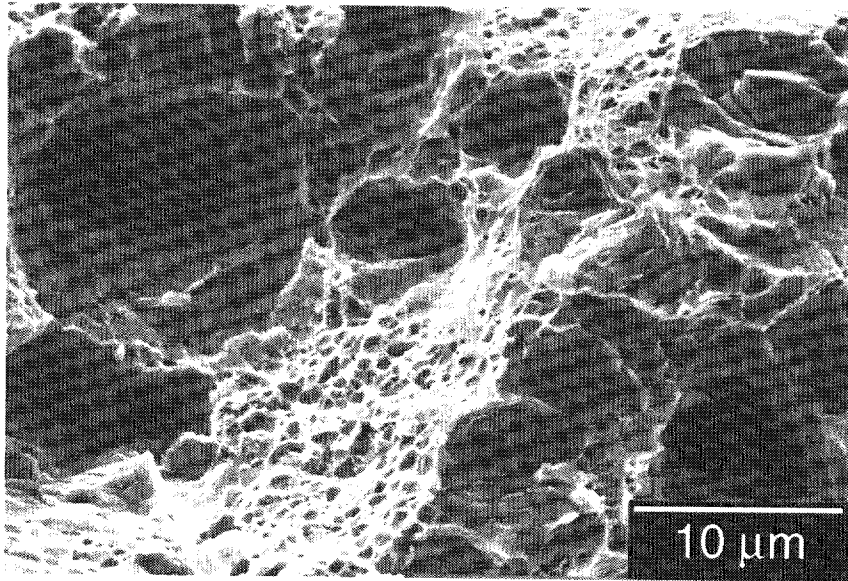
An example of the typical change in fracture mode can be seen in the next two figures. Figures 12a, b and c show the fracture surface of an as-received specimen tested to failure. At low magnification, Figure 12a shows that the fracture surface was quite flat with few distinguishing features. At higher magnification, Figure 12b reveals that the fracture could be described as having occurred via a process of transgranular ductile rupture. Fractured tungsten carbide particles decorate the fracture surface, indicating that these precipitates were well bonded to the matrix. Finally, Figure 12c reveals a generally bi-modal size distribution of dimples, where large, 5-10 μm dimples (nucleated around the fractured carbides) are surrounded by much smaller dimples not associated with

Figure 12. Fracture surface morphology of as-received Haynes 230. a) Fracture surface was quite flat with few distinguishing features. b) Higher magnification image reveals that fracture occurred via a process of transgranular ductile rupture. Fractured tungsten carbide particles decorate the fracture surface, indicating that these precipitates were well bonded to the matrix.

Figure 12. c) Large, 5-10 μm dimples (nucleated around the fractured carbides) are surrounded by much smaller dimples yielding a bi-modal distribution of dimples.

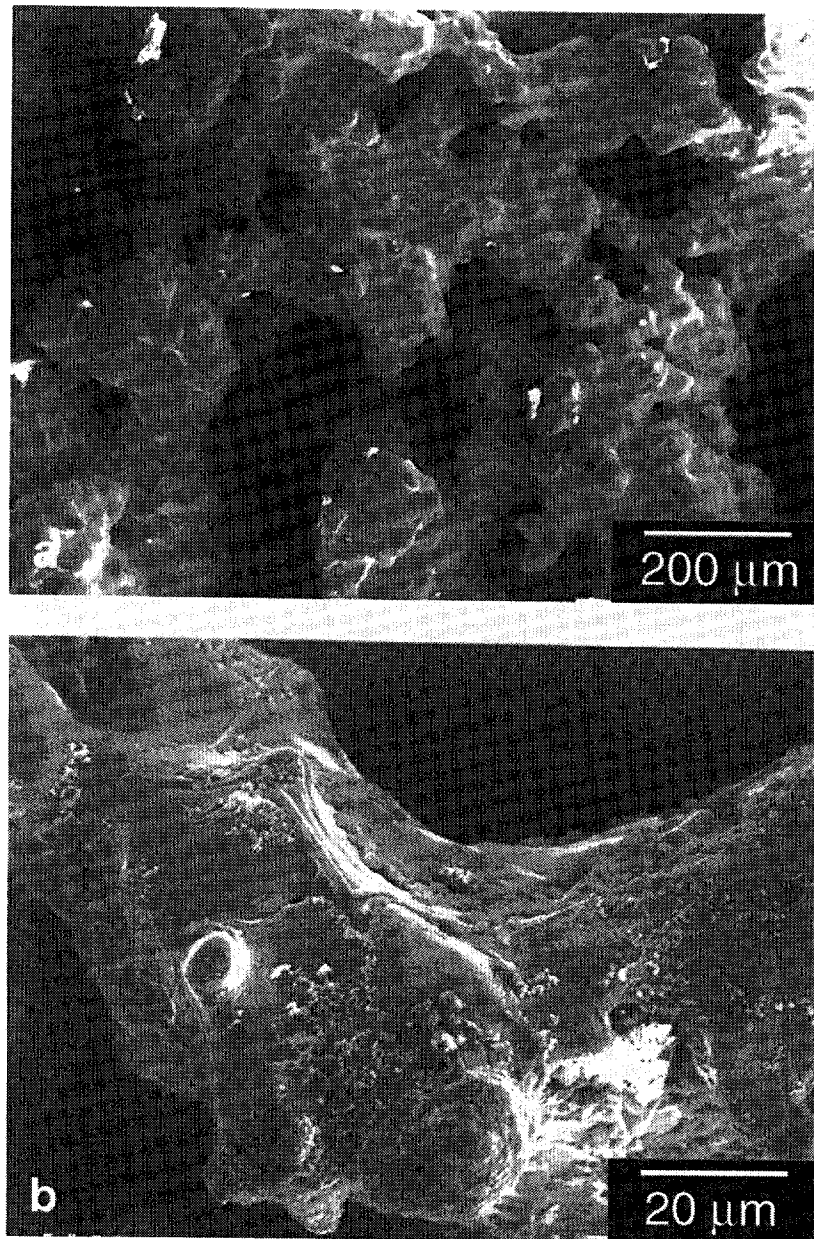
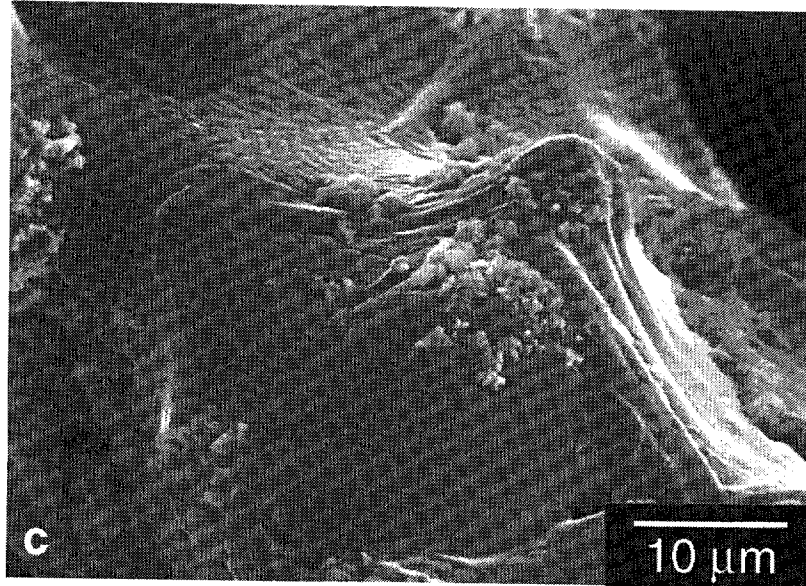
Archived sections of the brazed powder structure were used to assess the effects of long-term NaK exposure. Figures 14a, b and c are successively higher magnification SEM micrographs of the as-brazed stainless steel. Figure 14a reveals that the patch was composed of irregularly shaped particles with a free volume previously estimated to be $\approx 60\%$. [8] The irregular shape of the metal powder particles suggests that they were produced by a water atomization process. After brazing, the particle surfaces are covered with contamination composed of 0.5-2 μm silicon-rich particulates, see Figure 14b. These are likely to be silicon oxide particles. Such contamination is not typical of water atomized metal powders and we suspect that it arises from the post-atomization handling of the powders and/or the brazing process. At very high magnification, Figure 14c reveals the presence of a "terraced" structure on the surface of the metal powder. Such structures can arise from thermal etching.

The brazed patch was examined in detail. There was no evidence of spalling, cracking or any other structural degradation resulting from repeated thermal cycling. This was somewhat surprising in light of the relatively rigorous thermal cycling profile imposed on the patch over the operating history of the pool-boiler. Figures 15a and b are micrographs taken from the brazed patch in the pool-boiler. Figure 15a shows that the patch maintained the same general high surface area, open morphology of the as-brazed patch. The surface contamination shown in Figure 14b and c is no longer apparent. Silica will not be reduced by NaK as the alkali metal oxides are less thermodynamically stable than SiO_2 . [16] The absence of the silica contamination is therefore likely the result of some minimal dissolution of the underlying stainless steel allowing the contamination to break free or of thermal cycling which could promote the detachment of weakly bound particles. In addition, the zirconium getter can reduce silica which would facilitate its removal by either loss of adhesion or, possibly, dissolution. Figure 15b shows that the terraced structure on the original stainless steel powder surfaces was no longer visible, suggesting that the stainless steel suffered a very small amount of dissolution due to NaK exposure. This observation supports the argument that the loss of the silica contamination was the result of dissolution of the stainless steel.

Figure 14. Successively higher magnification micrographs of an as-brazed enhanced boiling surface stainless steel powder patch. a) Irregular stainless steel particles suggest a water atomization process. b) Silica contamination is present on the SS powder particle surfaces.

Figure 14 c) Terraced structure on the surface of the metal powder can arise as the result of thermal etching.

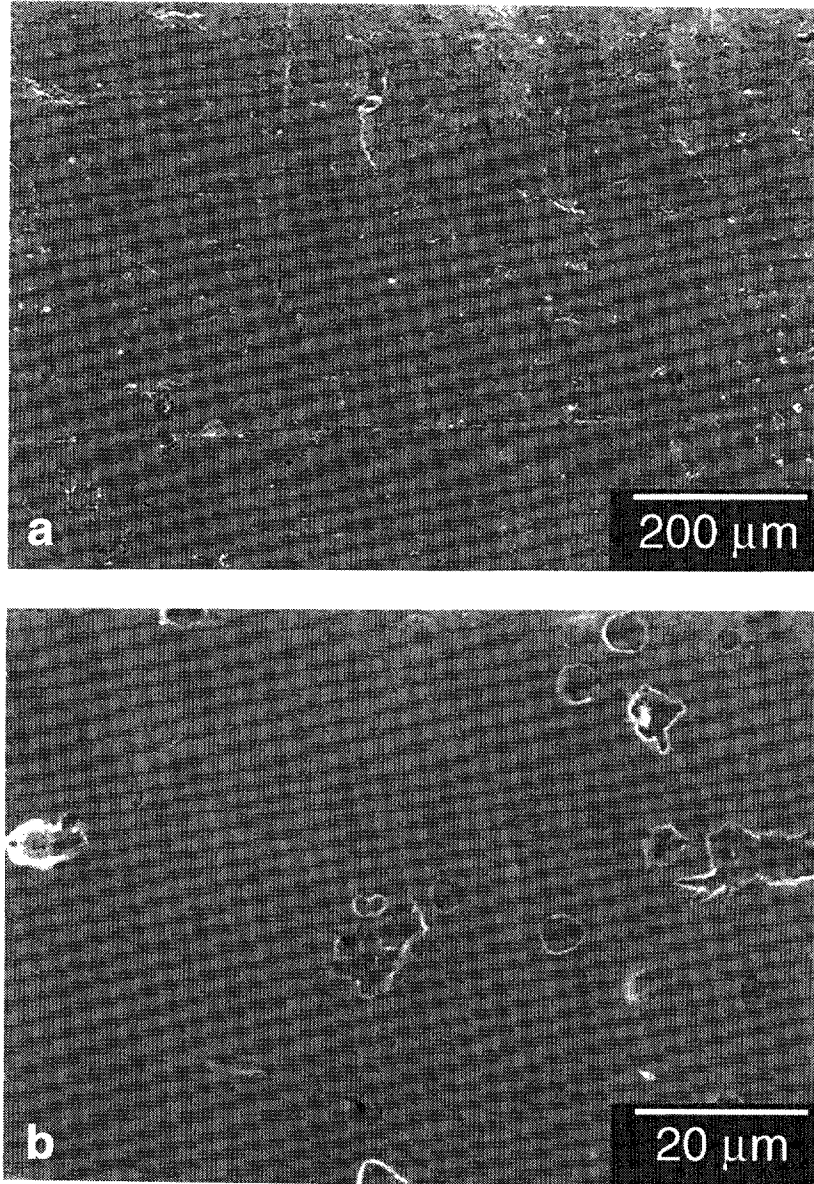
Scanning electron microscopy of the as-received thermowell tubing is shown in Figures 16a and b. Figure 16a shows, at low magnification, a horizontal surface striation and disturbed metal, both indicative of the tube drawing process. Dark regions resulting from surface contamination are also apparent. At higher magnification, Figure 16b reveals the presence of imbedded particles and pullouts, also indicative of a drawn surface. Aside from these, the surface of the tubing was essentially featureless, exhibiting neither any grain boundary structure nor any unusual surface morphology. In contrast, the IN 600 thermowells removed from the pool-boiler exhibited dramatic changes in structure. Figures 17a and b show the surface of a thermowell that was located below the liquid level of the NaK. At low magnification, the surface striations apparent in Figure 16a are no longer visible nor are the areas of darker contrast associated with surface contamination. However, the grain boundary structure can be clearly seen, obvious evidence of intergranular attack. At high magnification, Figure 17b the nature of the grain boundary dissolution is apparent. The alloy immediately adjacent to each grain boundary has a faceted appearance indicated that there was preferential dissolution along certain crystallographic orientations. Figure 17b also reveals that the grain surfaces themselves exhibit similar faceting, indicating that the alloy as a whole was subject to crystallographically preferred dissolution. The response of the IN 600 was the same in the condenser and as such no additional microscopy is presented. Metallographic cross-sections of the NaK-exposed tubing were prepared and it was determined that the grain boundary dissolution extended approximately 1-2 grain diameters into the tubing sidewall. The behavior of IN 600 observed here was similar to that reported for another nickel-based alloy, IN718, exposed to NaK at temperatures between 677°C and 777°C.[17] In that study the alloy exhibited evidence of grain boundary attack after 1090 hours of exposure.

Figure 16. a) Scanning electron micrographs of the as-formed IN600 thermowell tubing. b) Imbedded particulates and pullouts are evident on the surface of the as-formed tubing.

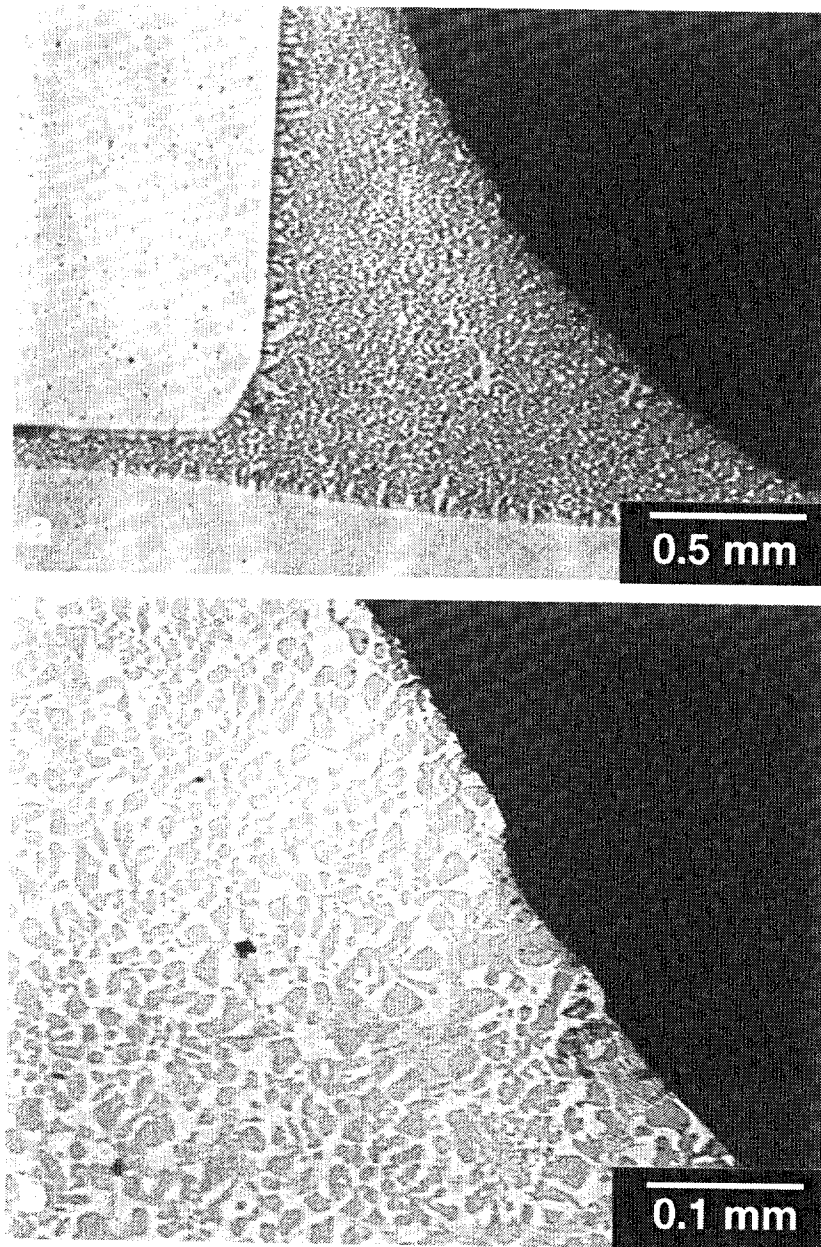
Figure 21a is an optical micrograph that shows the microstructure of a typical as-brazed joint between the Haynes 230 pool-boiler vessel to the Haynes 230 endcap. Within the interior of the braze some spherical porosity was occasionally noted (although not shown in this figure). This porosity is presumed to have formed during the brazing cycle due to entrapped gas. Figure 21b, also a higher magnification micrograph and reveals that the

Figure 21. a) Optical micrograph of a typical as-brazed joint between pool boiler vessel and endcap. b) The bulk of the braze consists of a two-phase structure. The lighter phase is nickel - boron. The darker regions are nickel - silicon. These two phases exist in nearly equal proportions.

bulk of the braze consisted of a two-phase structure. EDS analysis was used to determine the composition of these two regions. The results reveal that the lighter phase shown in Figure 21b was composed of ≈ 94 wt.% nickel and ≈ 5.5 wt.% boron while the darker regions were composed of ≈ 88 wt.% Ni and ≈ 11 wt.% silicon. Both phases contained between 0.5 and 1.0 wt.% chromium. These two phases existed in nearly equal proportions and therefore the elemental analyses are consistent with the overall composition of the braze alloy presented in Table I. Backscatter electron imaging revealed that the silicon-rich phase (either as-brazed or NaK-exposed) was, in fact, composed of a finer structure containing regions of greater and lesser silicon (see Figure 22). At high magnification the interface between the braze and the Haynes 230 showed evidence of other phases resulting from the interdiffusion of the BNi-3 and Haynes 230 constituents. The formation of such structures in brazed joints is common and is minimized by holding temperature and time to the minimum necessary to achieve a sound joint.[20]
