SAND81-0781
Unlimited Release

Fire Hazard Study of the Coolidge, Arizona, Solar-Powered Irrigation Facility

Gary A. Sanders

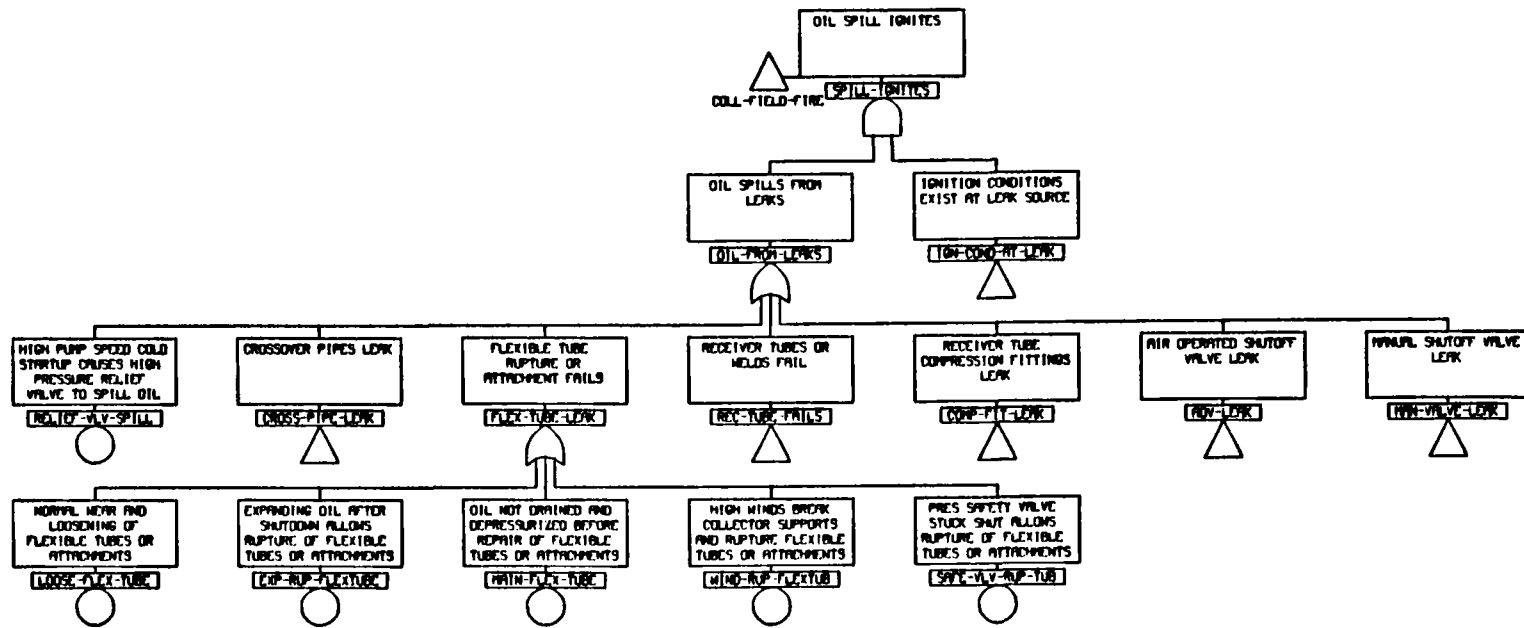
Diagram 1B. Fault Tree Logic for Collector Field Fire.

Diagrams 1A through 1F show the fault tree logic for an oil fire in the collector field. The diagrams show that a collector field fire can result from either an oil spill from a leak igniting or from high pressure and temperature conditions causing a component rupture which auto-ignites.

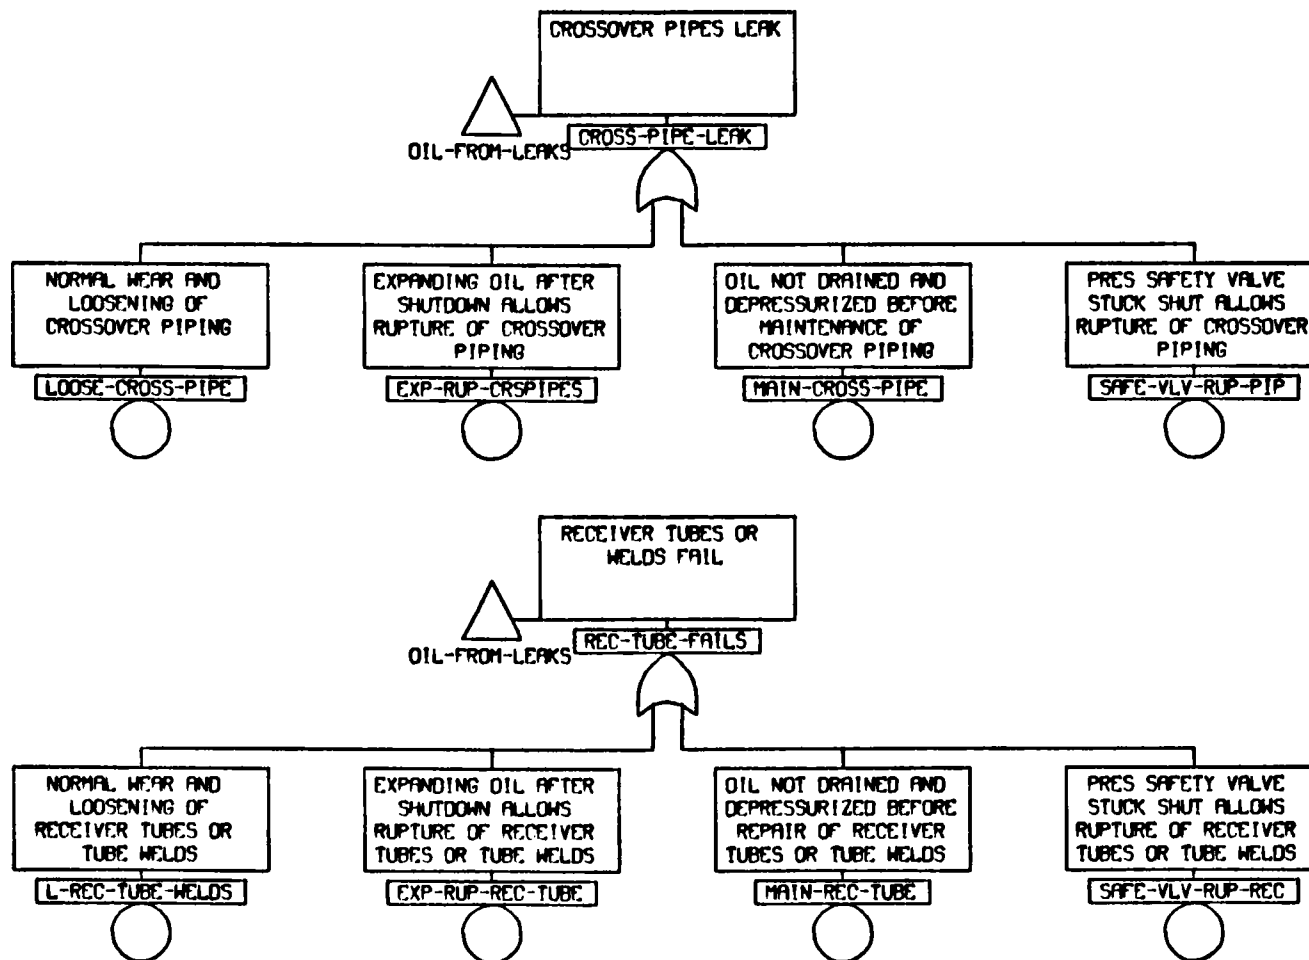
Diagram 1D. Fault Tree Logic for Collector Field Fire.

All of these components may leak as a result of any one of four scenarios. The first scenario involves simple wear and loosening of a component or its attachments allowing an oil leak which is assumed to persist for two days. The second scenario involves a technician not depressurizing and draining the oil prior to maintenance work. A third scenario resulting in collector field oil spills begins with a long term shutdown of the collector system without draining the oil. A startup will then allow the expanding oil to rupture one of the components listed above and result in an oil spill. The fourth scenario involves the high pressure safety valve which is located just downstream from the collector field pump. During a cold, high-pump-speed startup, the thick oil moves slowly and is under a great deal of pressure. If the pressure is above design specifications, the safety valve should open and spill Caloria HT-43 onto the ground. However, should the valve stick shut, any collector component may be forced to rupture with the flexible hoses between collector groups being most likely to do so. These flexible hoses have an additional scenario involving high speed winds breaking the collector panels from their supports resulting in major ruptures of the flexible tubes and their attachments.

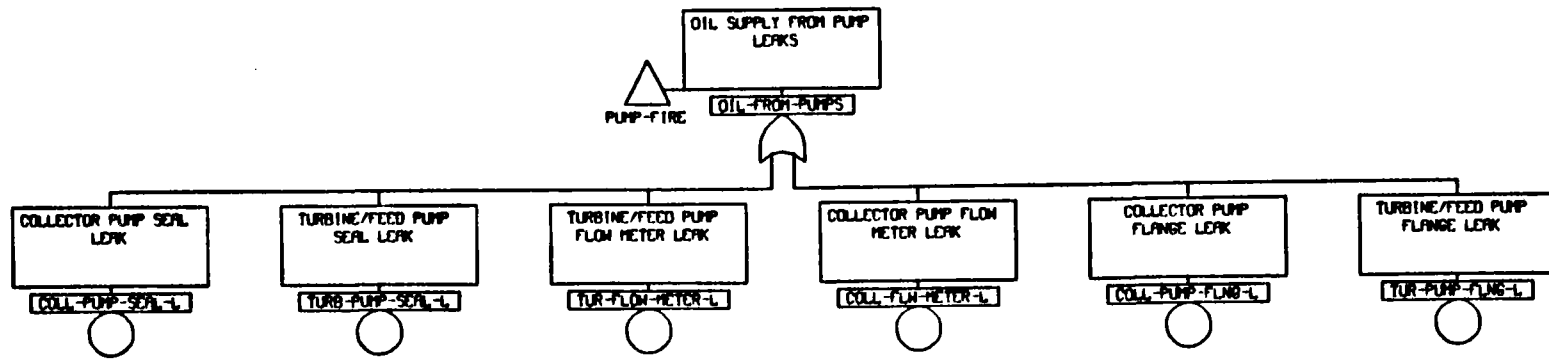
Diagram 2E. Fault Tree Logic for Pit Area Fire.

not only to normal wear and loosening, but also to rupture by expanding oil after a longterm shutdown without draining oil and to spills when the oil is not drained and depressurized before maintenance work begins.
