5105-146
Solar Thermal Power Systems Project
Parabolic Dish Systems Development

Bearing Development Program for a 25-kWe Solar-Powered Organic Rankine-Cycle Engine

September 15, 1985

JPL Publication 85-81

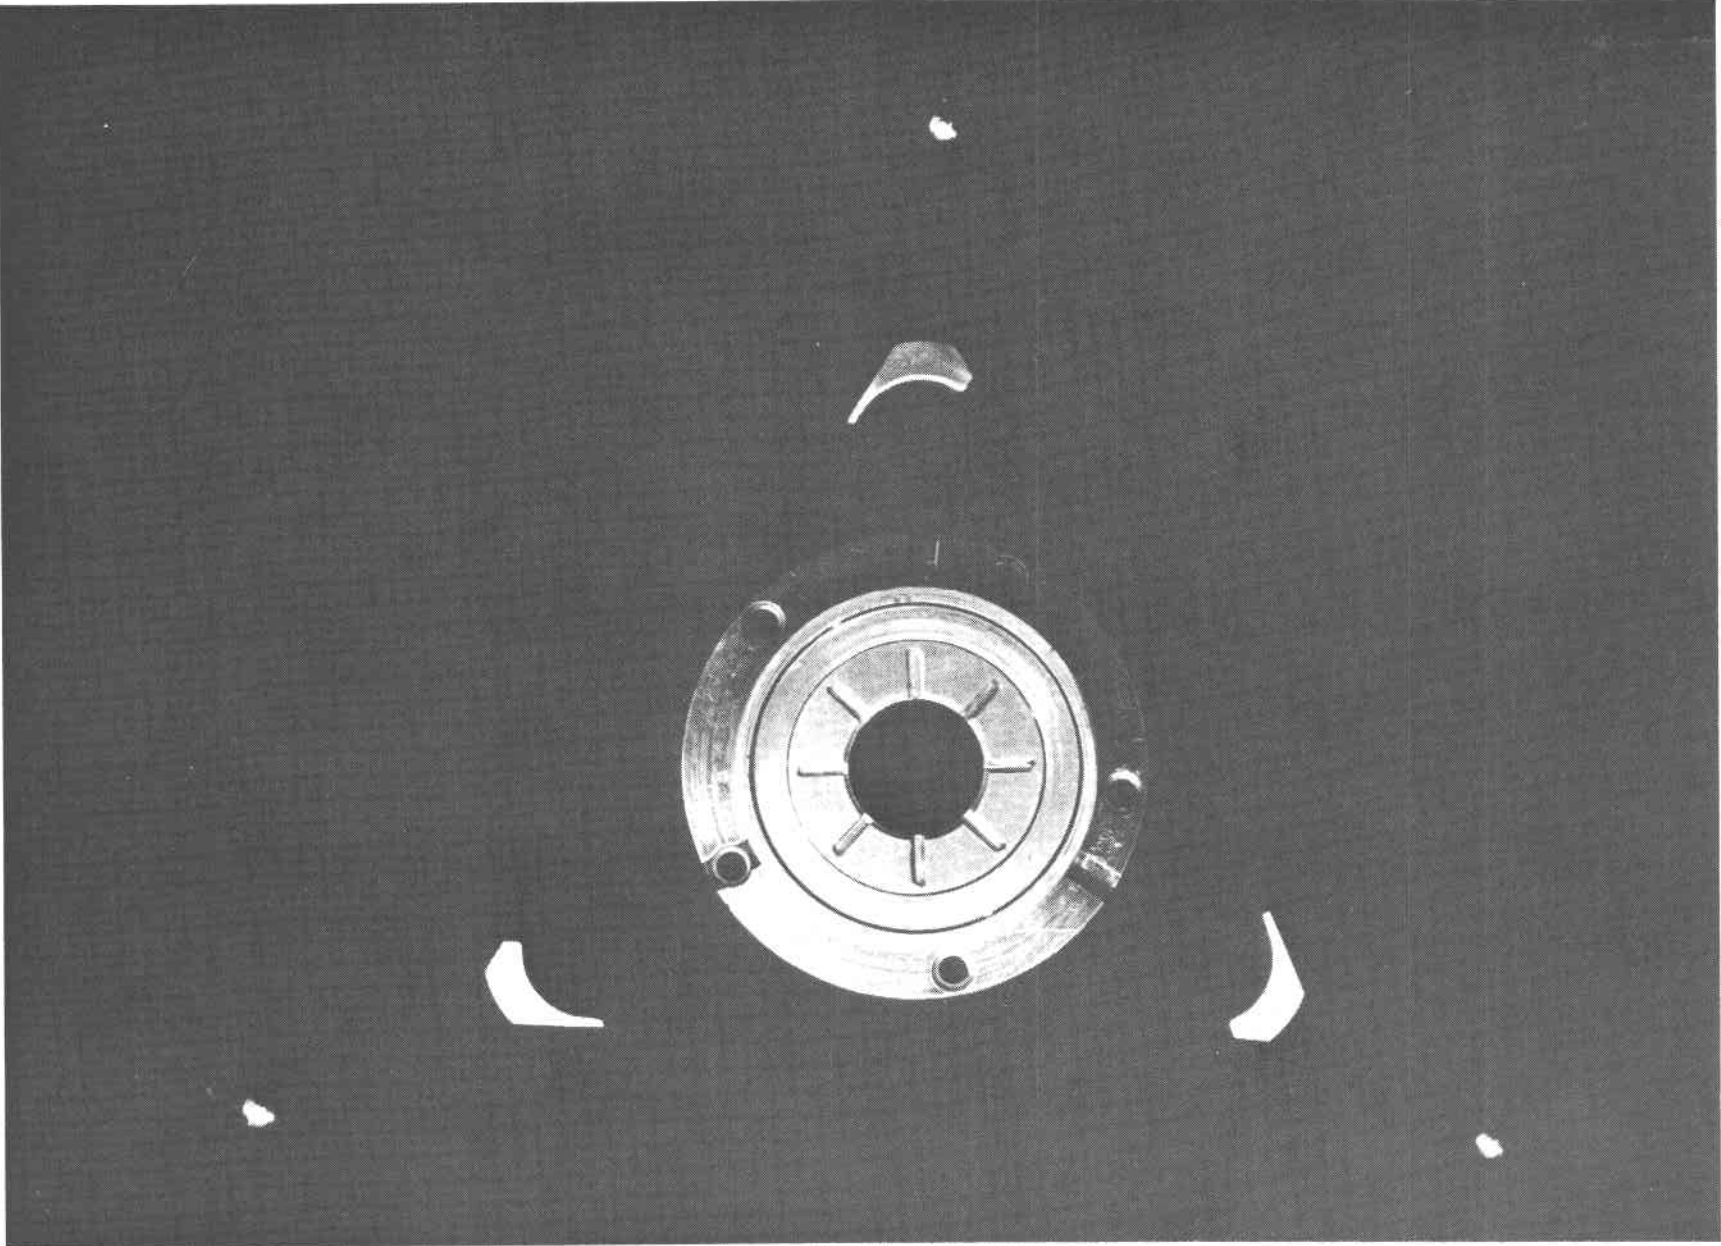
Figure 3-2. Reduced-Mass Tilting Pads with 10-deg Leading Edge Chamfer

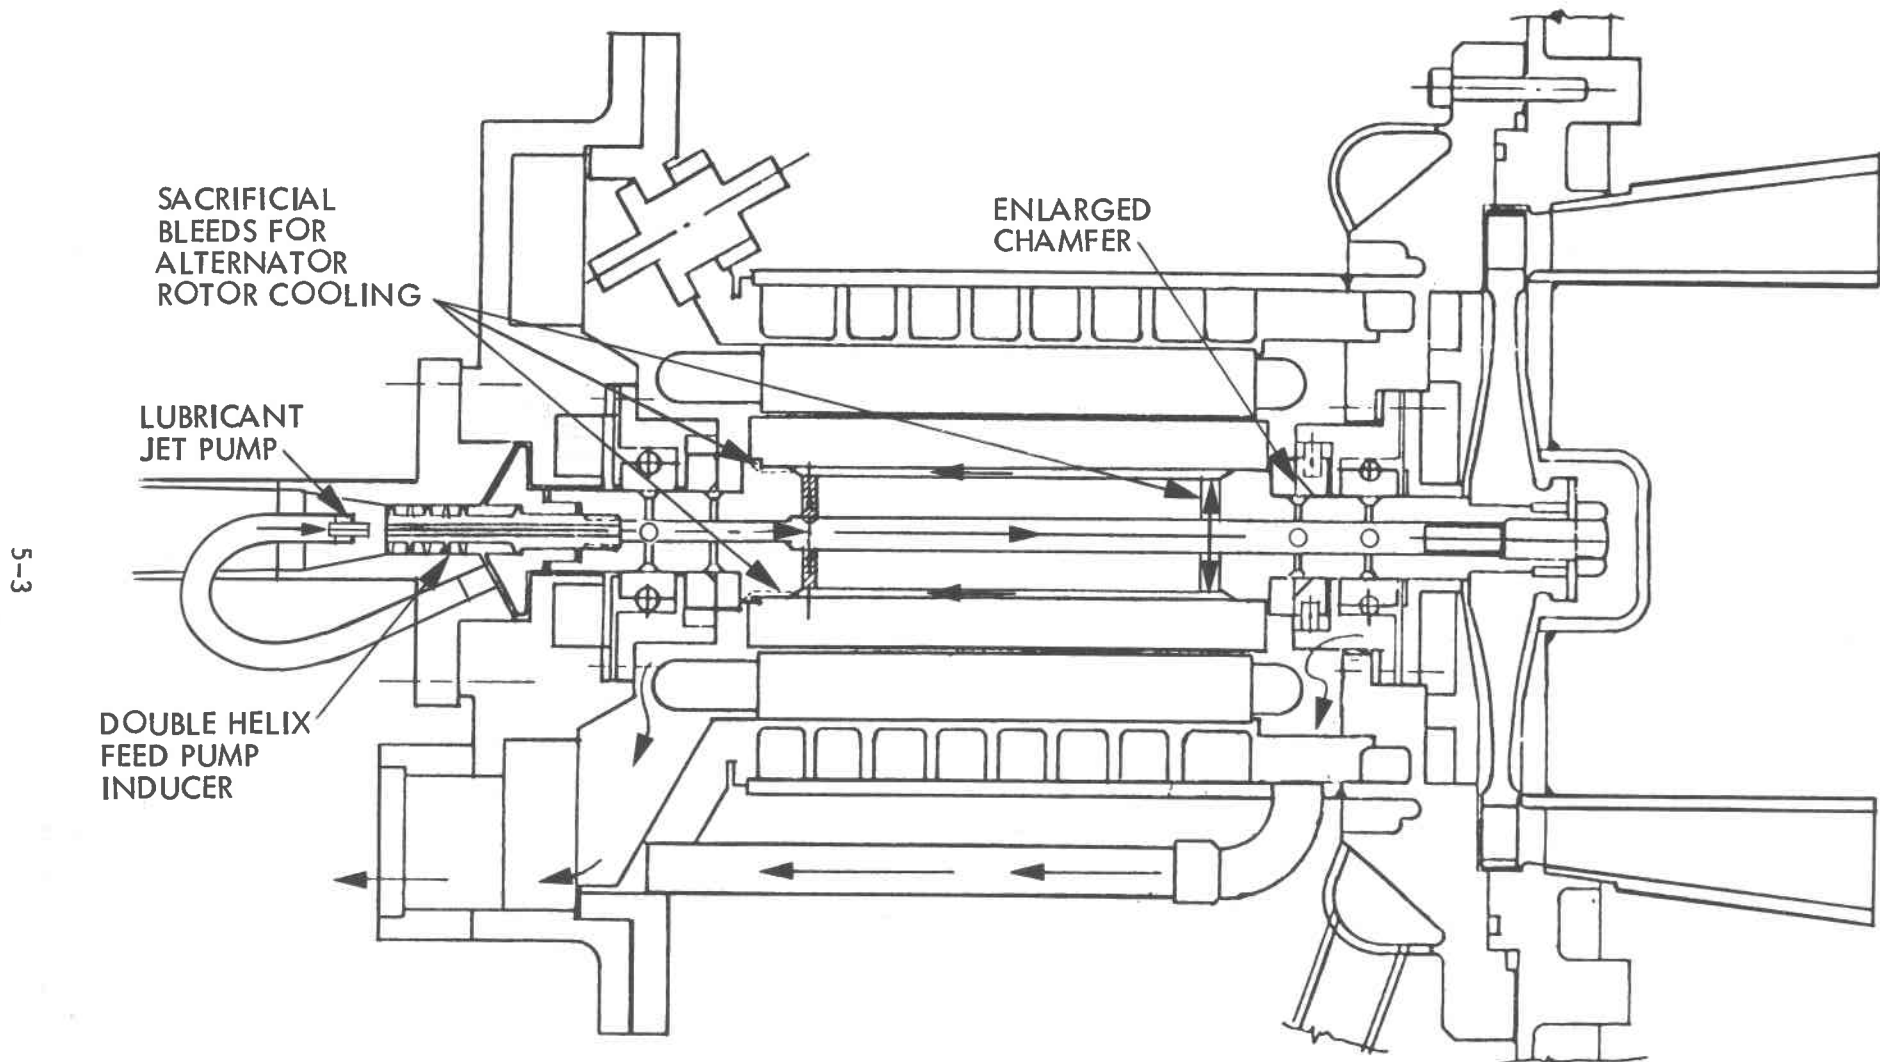
Figure 5-1. Shaft with Straight-Through Center Line Lubrication Channel (TAP Build 11)

TAP build 11 used for the PDS tests included modifications to the bearing lubrication system, the feed-pump inducer, and a general emphasis on quality control. Modifications to the lubrication system required the fabrication of a shaft with two radial lubrication holes at the pump end thrust bearing and four radial holes at all other bearings. The chamfer at the inside diameter of the turbine end thrust bearing was enlarged to function as a reservoir to provide additional immediately available lubrication to the bearing. The turbine end thrust bearing surface was improved to a 6-microinch finish. The shaft lubricant channel was made into a single straight-through shaft centerline hole (Figure 5-1) by boring through the shaft from the turbine end until the hole connected with the pump end center line channel. Both PMA rotor cooling holes were plugged except for a sacrificial bleed into the larger diameter annulus to cool the rotor (Figure 5-2). A small jet pump was installed at the shaft lubricant inlet that extracts fluid from the feed pump to increase the total lubricant flow to the bearings. The feed pump housing (Figure 5-3) shows the jet pump nozzle in the center and the off-center extraction port. The feed pump inducer was changed from a single to a double helix with a smooth entrance to increase load and flow symmetry (Figure 5-4).

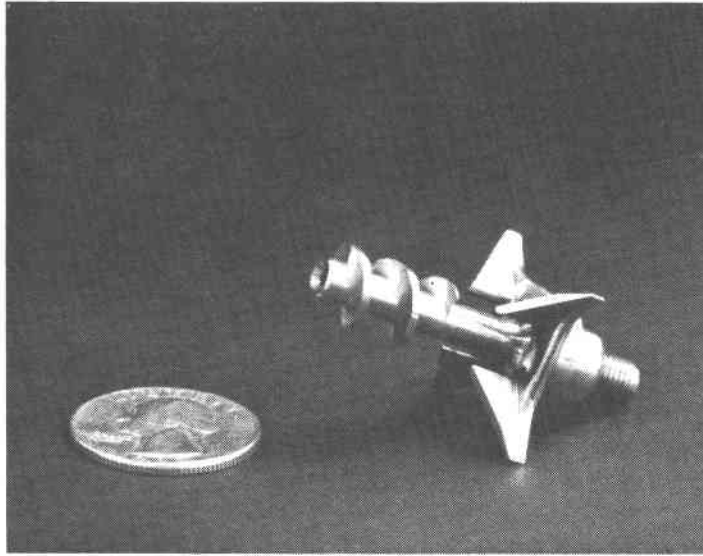
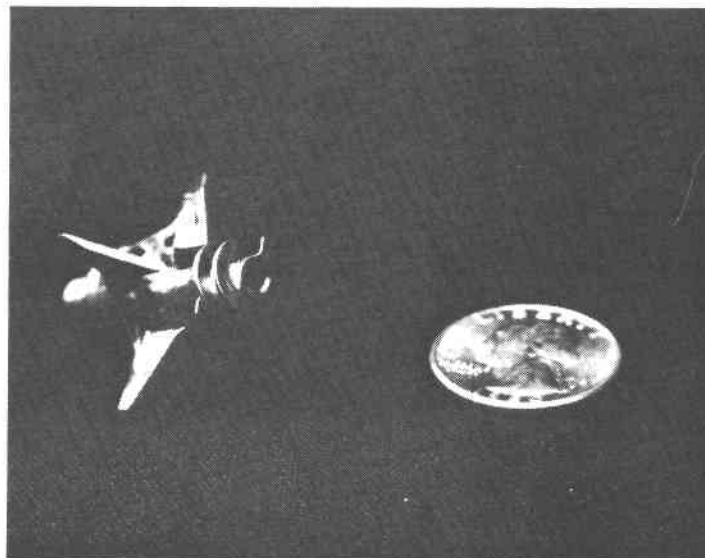
Figure 5-4. Single Helix (a) and Double Helix (b) Feed Pump Inducer

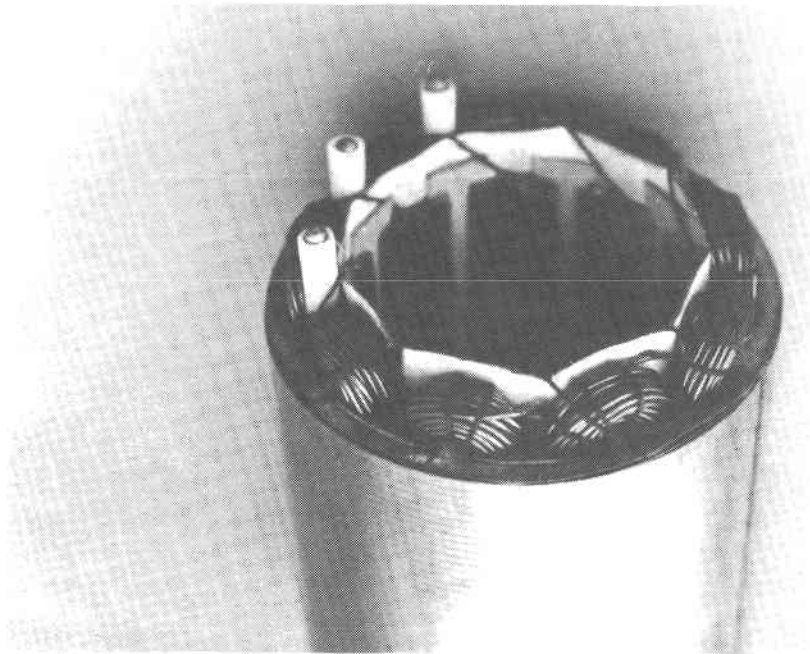
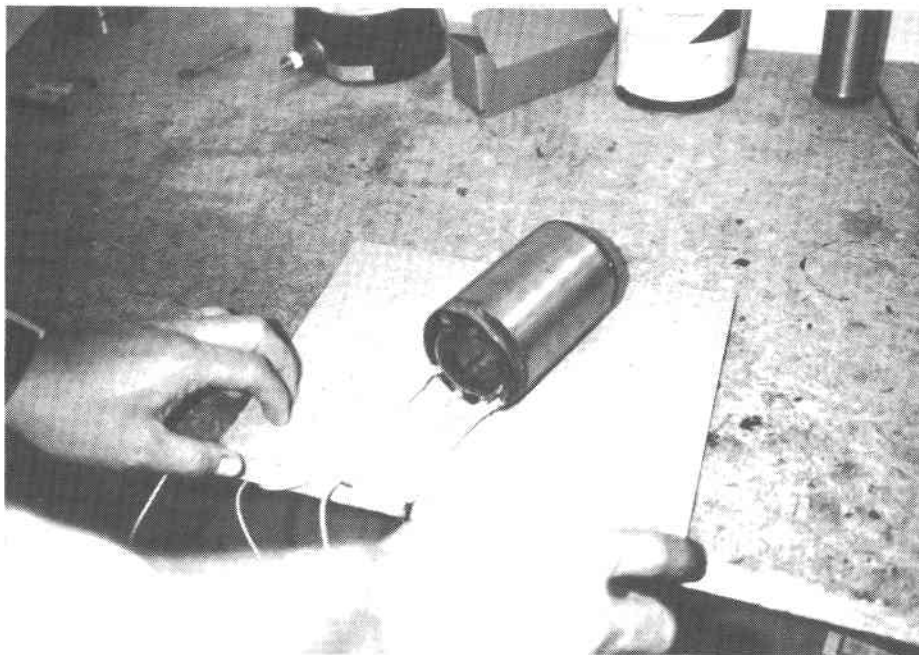
Figure 5-7. (a) Rewound Stator and (b) Rewound Stator after Potting and Encapsulation

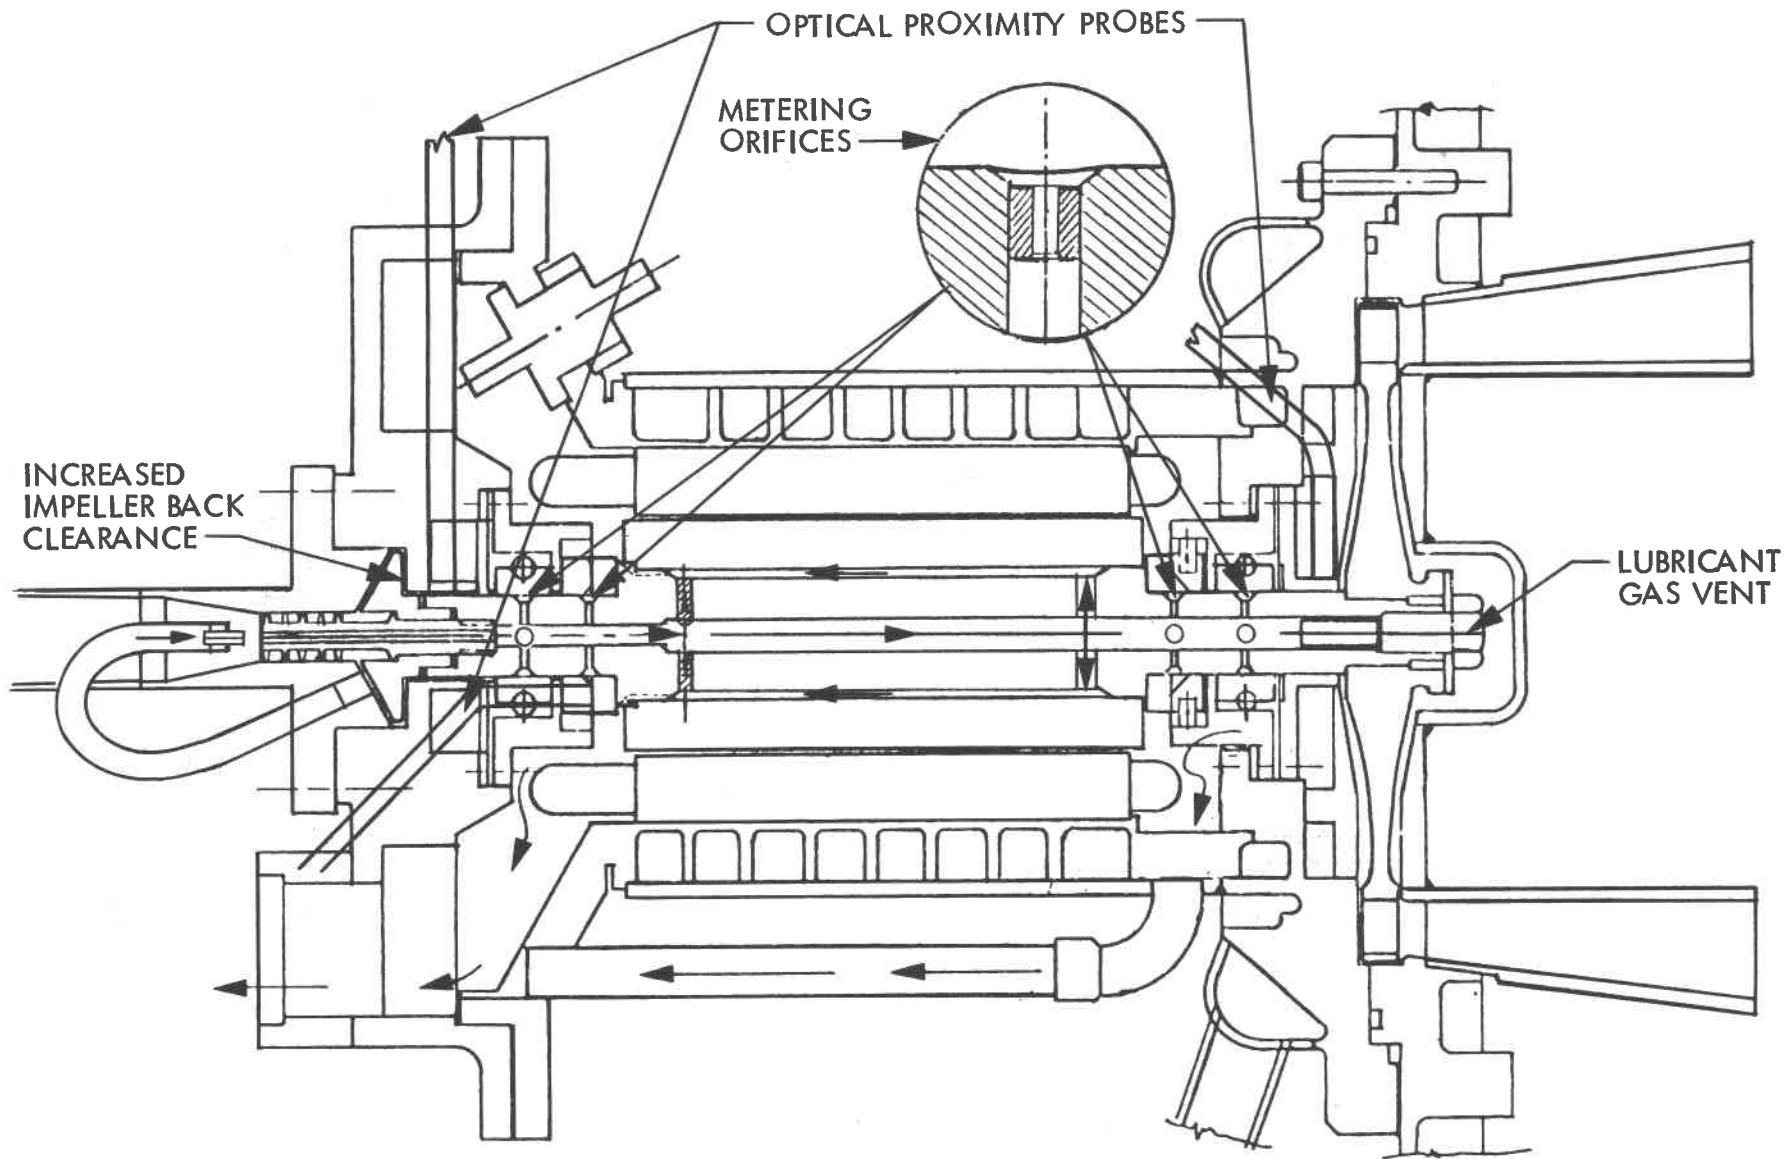
Figure 7-2. Metering Orifices Installed in each Radial Lubricant Hole (TAP Build 14)

The bearing lubrication and rotor coolant channels within the rotating shaft were the most obvious unconventional aspect of the TAP design and were extensively analyzed by B-N, FACC, and JPL personnel. Because of the extreme complexity of the fluid dynamics, only a few general conclusions were made. Cavitation was occurring at the entrance of each radial bearing lube hole and limiting the amount of fluid delivered to each bearing. The combination of cavitation and fluid momentum introducing vapor and dividing the hydrodynamic film under the pad may have significantly altered the stiffness and damping of the bearings and thus introduced rotordynamic instabilities. Modifications made to reduce this possibility were: (1) to install small orifices at the exit of each radial lube hole to minimize cavitation in the lube channels (Figure 7-2), (2) to enlarge the jet pump exit and shaft lubricant inlet to

increase total flow and pressure, and (3) to install a small vent on the shaft centerline at the turbine end to eliminate any possibility of trapped gases restricting flow to the bearings.

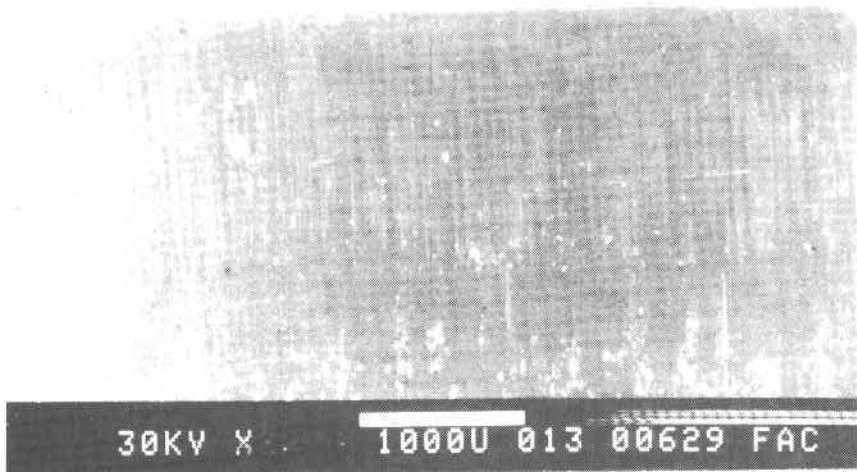
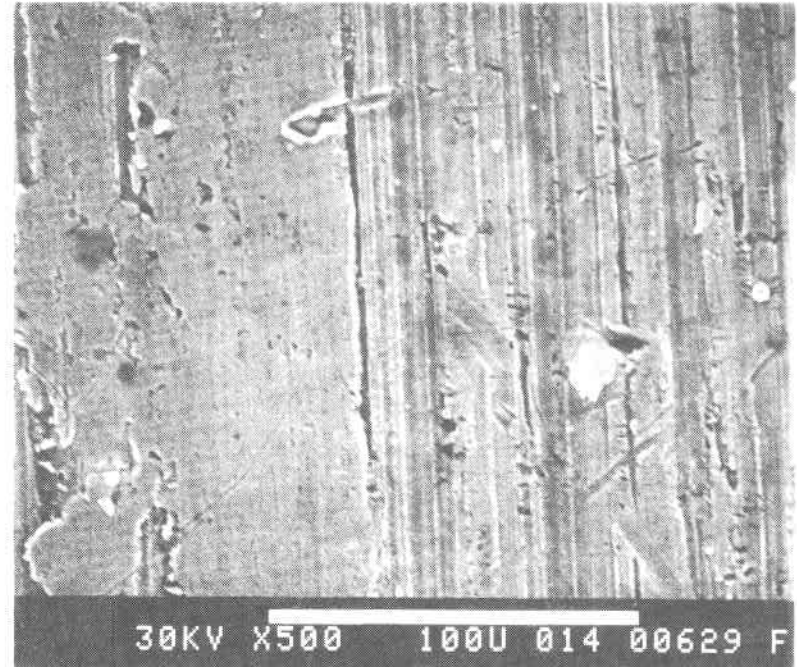
An extensive analysis of the build 21 damaged bearing surfaces was conducted by FACC using an electron beam microscope. The damaged surface on each pad had a frosted appearance, which was determined to be a number of separate but closely packed pits. Figures 7-12 and 7-13 show various magnifications of the pitted surfaces and compare them to unpitted zones. A chemical analysis inside the pits revealed high concentrations of zinc and chlorine, which were not present in the virgin babbitt or bearing material. This change is shown in Figure 7-14 where the virgin material analysis and an analysis inside a single pit are compared on one plot.

Figure 7-13. Leading Edge Surface of a Waukesha Pad without Electrical Discharge Pitting

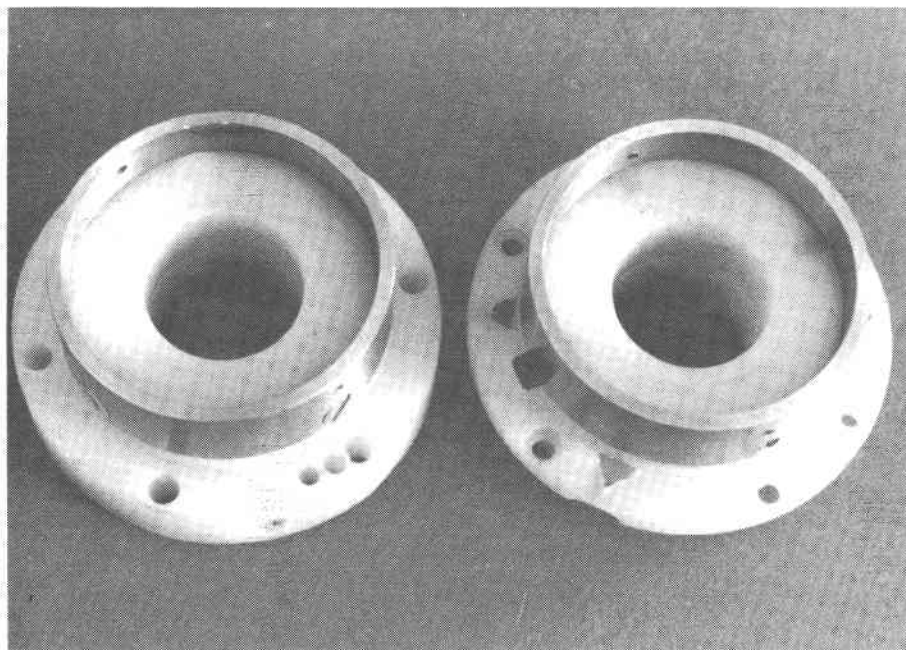
Figure 7-16. Electrically Insulated Bearing Carriers

The previously described process of electrical discharge across bearing surfaces was addressed in TAP build 26. A set of electrically insulated bearing carriers was fabricated. A copper grounding strap was added to further ensure that the shaft was grounded independently of the shaft drive system. Inspection of the TAP, following 1.1 h of horizontal operation delivering electrical power, revealed no bearing wear; however, an unrelated problem discovered was a small portion of the PMA coating material (stycast) separated from the stator and coated one-third of the rotor.

The five-pad Waukesha tilting-pad bearings, using B-N-fabricated pads and mounted in an electrically insulated nylon bearing carrier (Figure 7-16), were used in TAP builds 30 to 35 with essentially no changes. Figure 7-17 shows the pump and turbine end thrust bearings mounted on the insulated bearing carriers and provides a good view of the grooves that disperse the lubricant over the bearing face and the holes supplying fluid from the flooded bearing reservoir to the grooves. A total of approximately 21 h of operation were accumulated on these builds with no bearing distress or electrical arcing. The success of these tests at various altitude angles from horizontal to vertical and various powers and speeds indicated that the bearings were ready for hot testing in the engine.

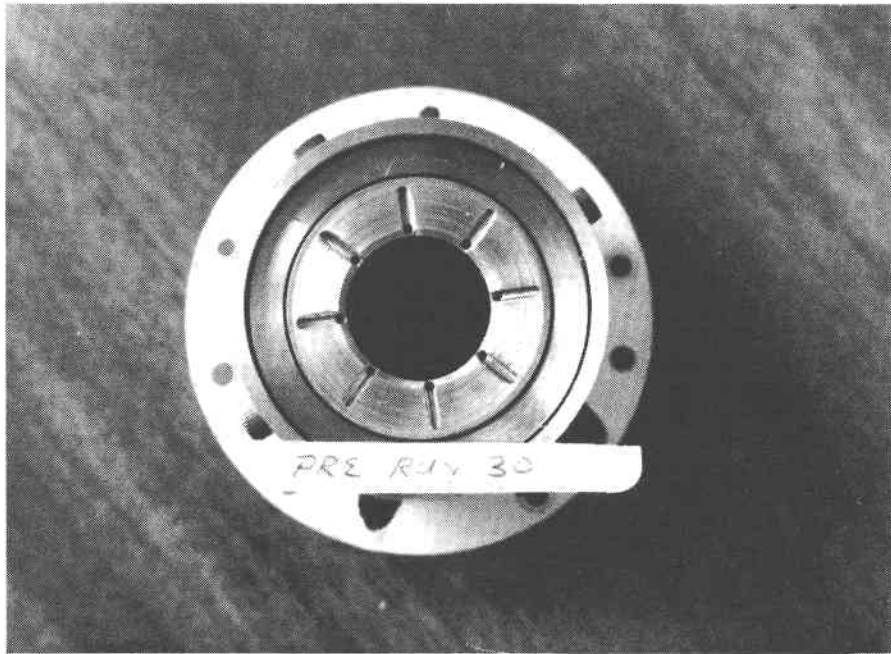
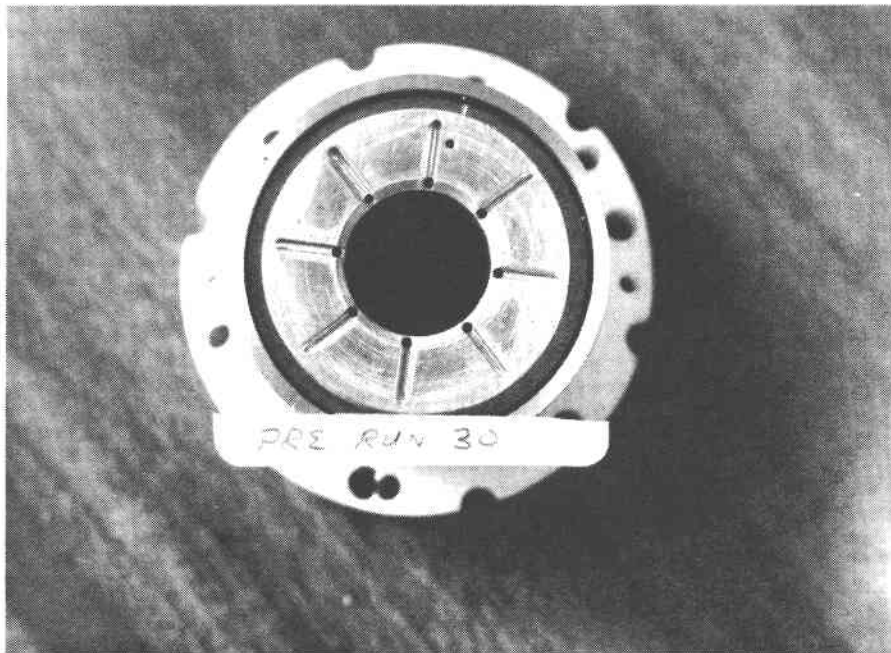
Figure 7-17. Electrically Insulated Bearing Carriers with (a) Pump End and (b) Turbine End Thrust Bearings Mounted

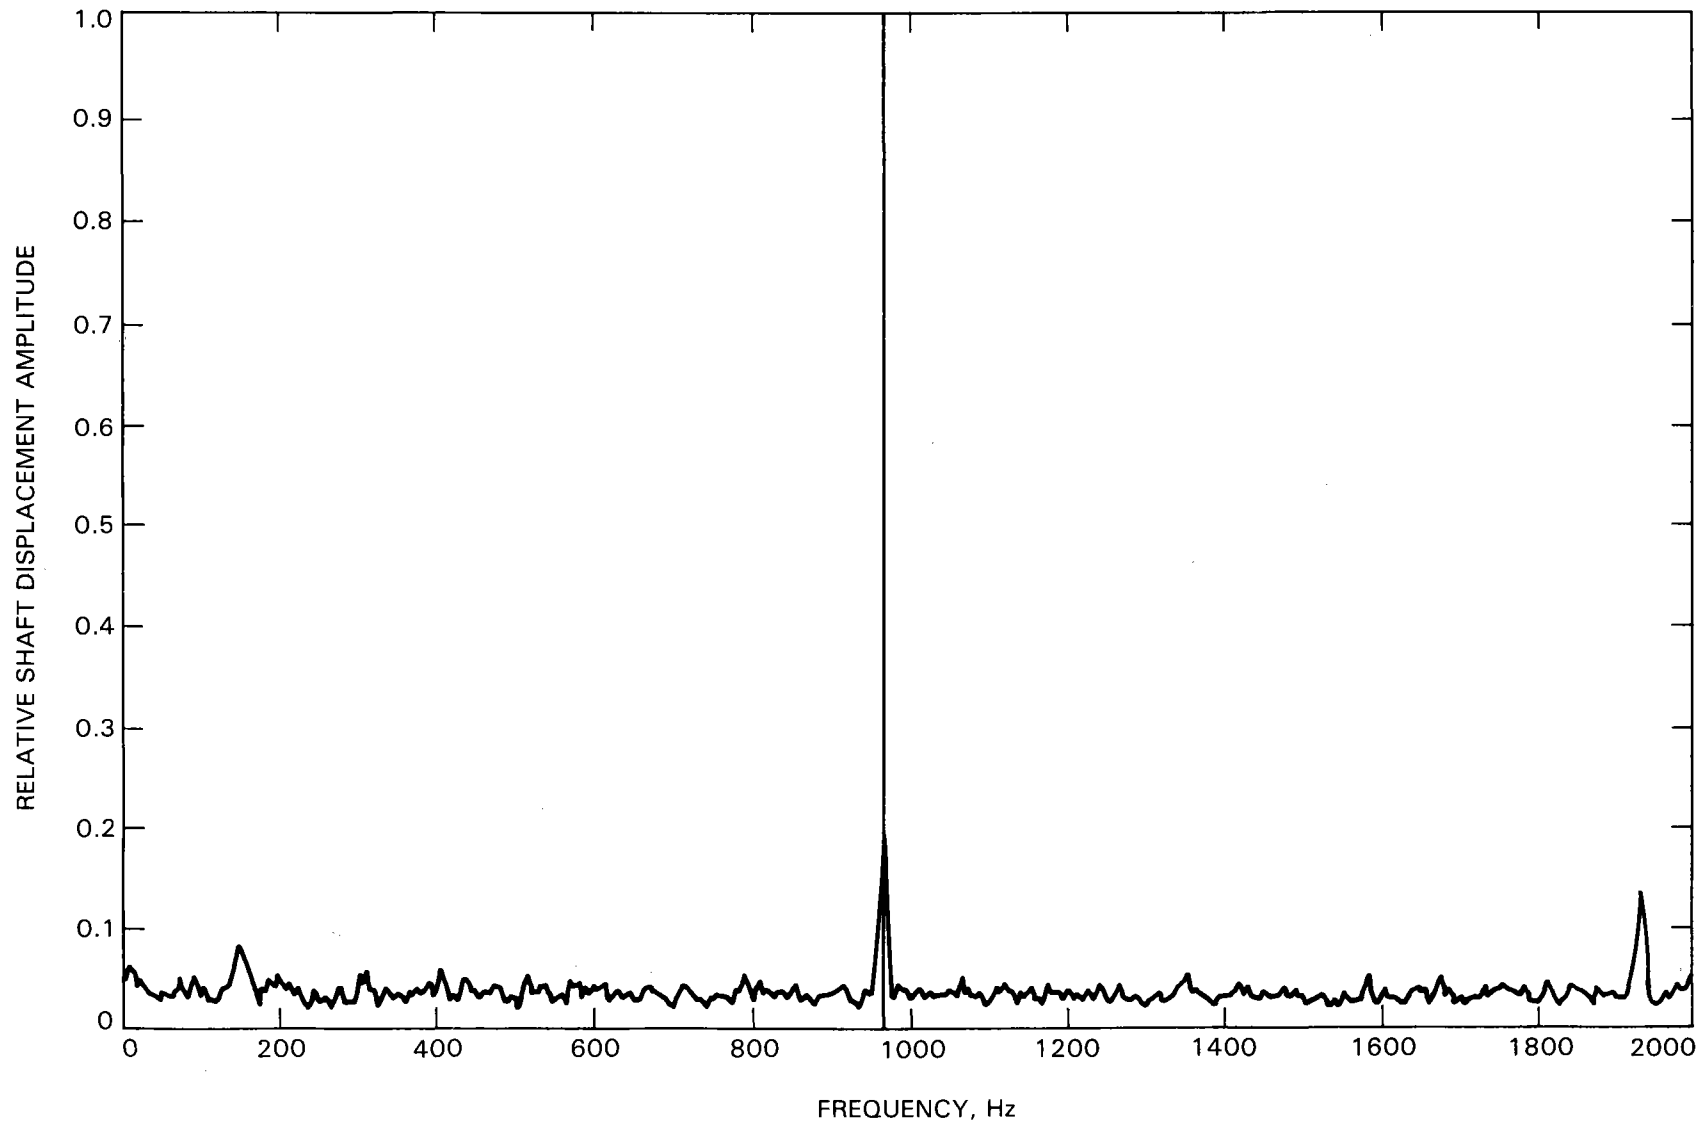
allowing the 100-h test results to be available for the November 1, 1983, DOE-scheduled ORC review. The only effect this had was that additional hours were run at 5 and 90 deg, and fewer hours were run at 45 deg. Figures 8-1 and 8-2 are shaft displacement amplitude versus frequency for TAP builds 38 and 39 (90- and 5-deg inclination) using comparable amplitude scales. Results of the test showed inclination angle does not seem to affect shaft dynamics and no bearing wear or component damage was observed.

Figure 8-1. Typical Shaft Displacement Spectrum of Waukesha Five-Pad Bearing at 90 deg on October 19, 1983 (Pump End "Y" Probe, TAP Build 38)

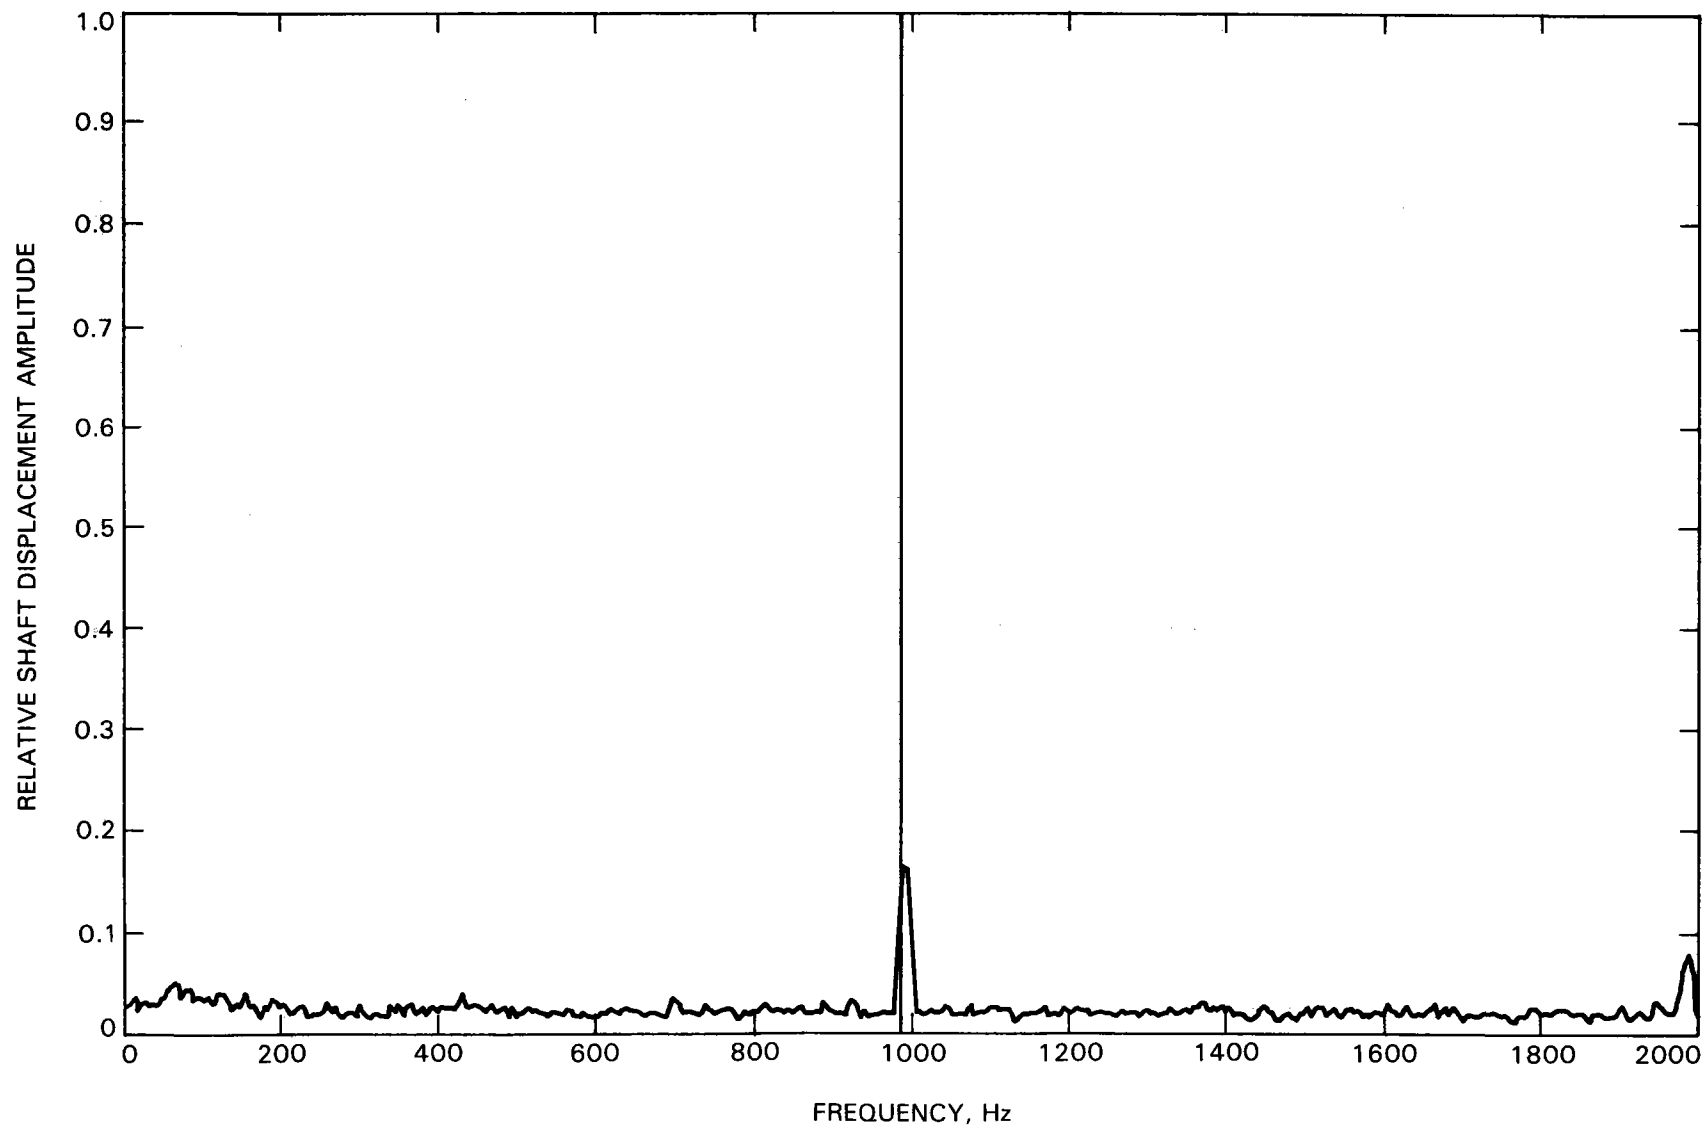
Figure 8-2. Typical Shaft Displacement Spectrum of Waukesha Five-Pad Bearing at 5 deg on October 29, 1983 (Pump End "X" Probe, TAP Build 39)
