## Heliostat Mirror Survey and Analysis

September 1979

Prepared for  
Sandia Laboratories, Livermore, CA  
under Related Services Agreement 300A01308  
and the U.S. Department of Energy  
under Contract EY-76-C-06-1830

This report is the result of comprehensive surveys and technical analyses performed for Sandia Laboratories in support of the U.S. Department of Energy Solar Thermal Large Power Systems authorized under Sandia Livermore integrated order 92-8165. The purpose of this work is to provide background information and procurement specifications for materials and processes which have potential applications in heliostat construction. This report covers the work performed under three tasks: the mirror industry survey, mirror degradation analysis, and advanced concepts for mirror protection.

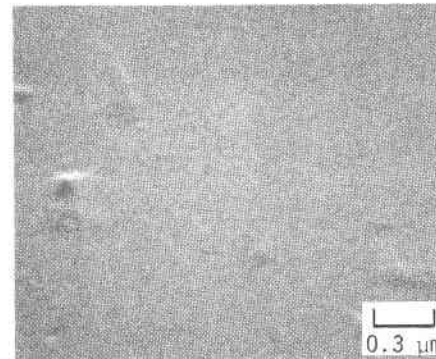
FIGURE 2.1. Normal Sequence of Initial Steps in Mirror Production. The as-received glass surface usually retains the Lucor/adipic acid powder. Most of the powder particles are removed by a ceric oxide scrub. The  $\text{SnCl}_2$  sensitization step has no visible effect on the glass surface.

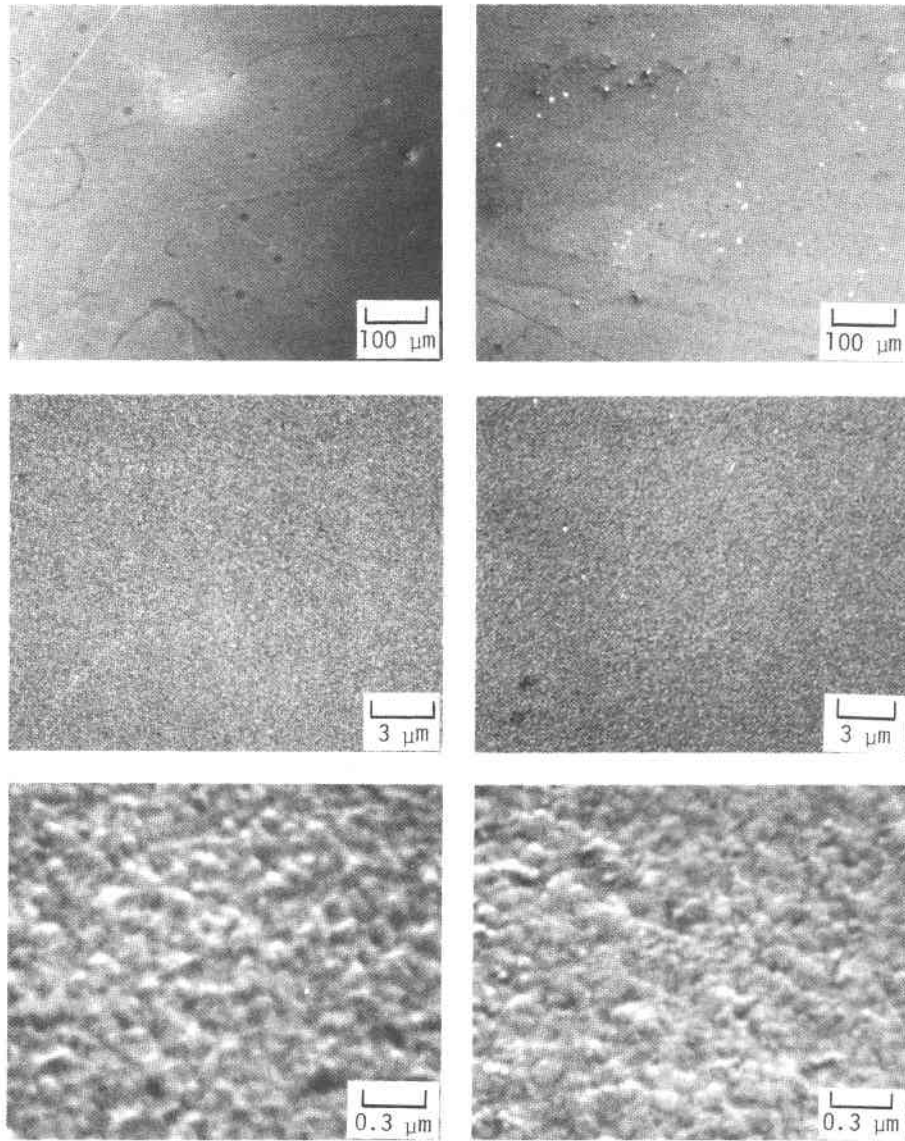
FIGURE 2.2. Production Mirrors by Buchmin Industries. Both the silver-only surface and the coppered silver surface show a uniform nonporous deposit. Only a few small free metallic particles are visible, also suggesting evenly applied metallic layers. The stains visible at low magnification apparently do not affect layer quality.

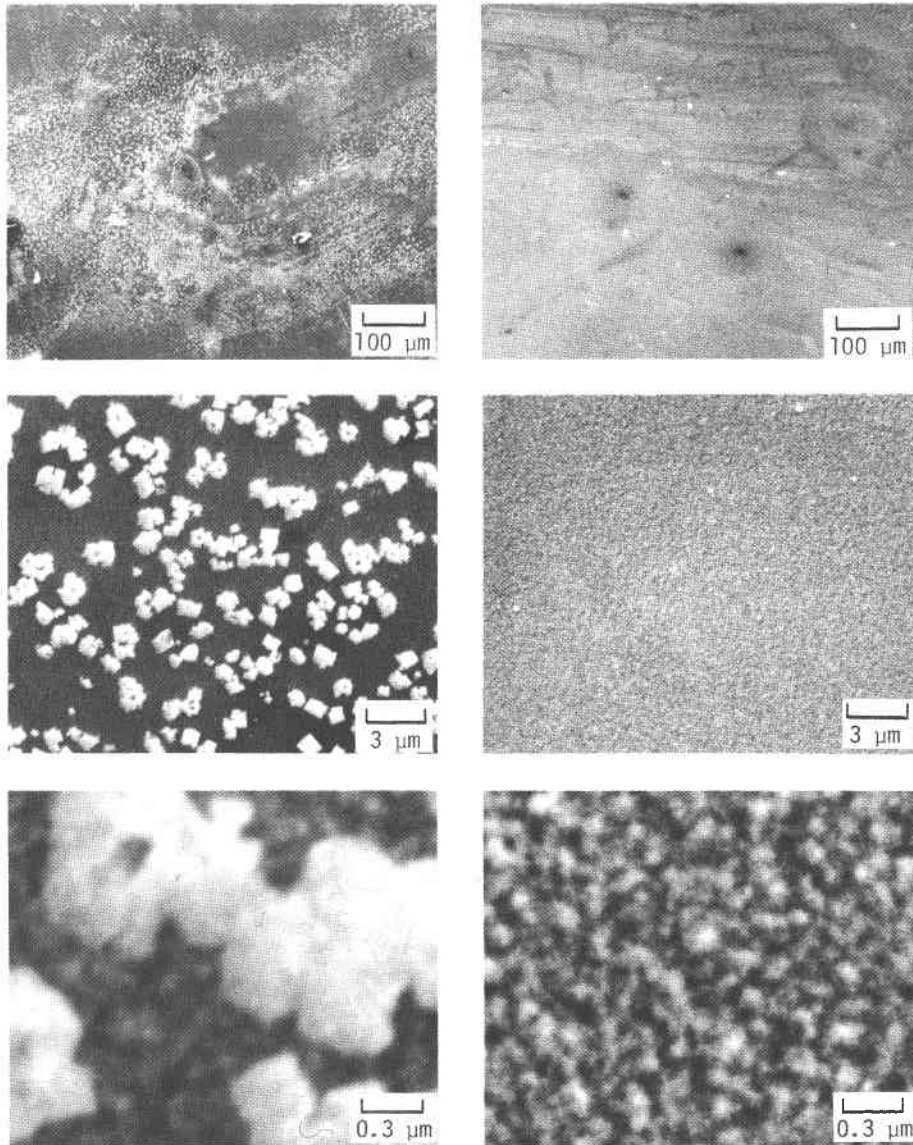
FIGURE 2.3. Examples of Obvious Surface Defects. Normally neither of these defect types should occur, since the metal surfaces are not touched by hand nor allowed prolonged exposure to air during production. The metal surface would be covered by the final paint backing before handling.

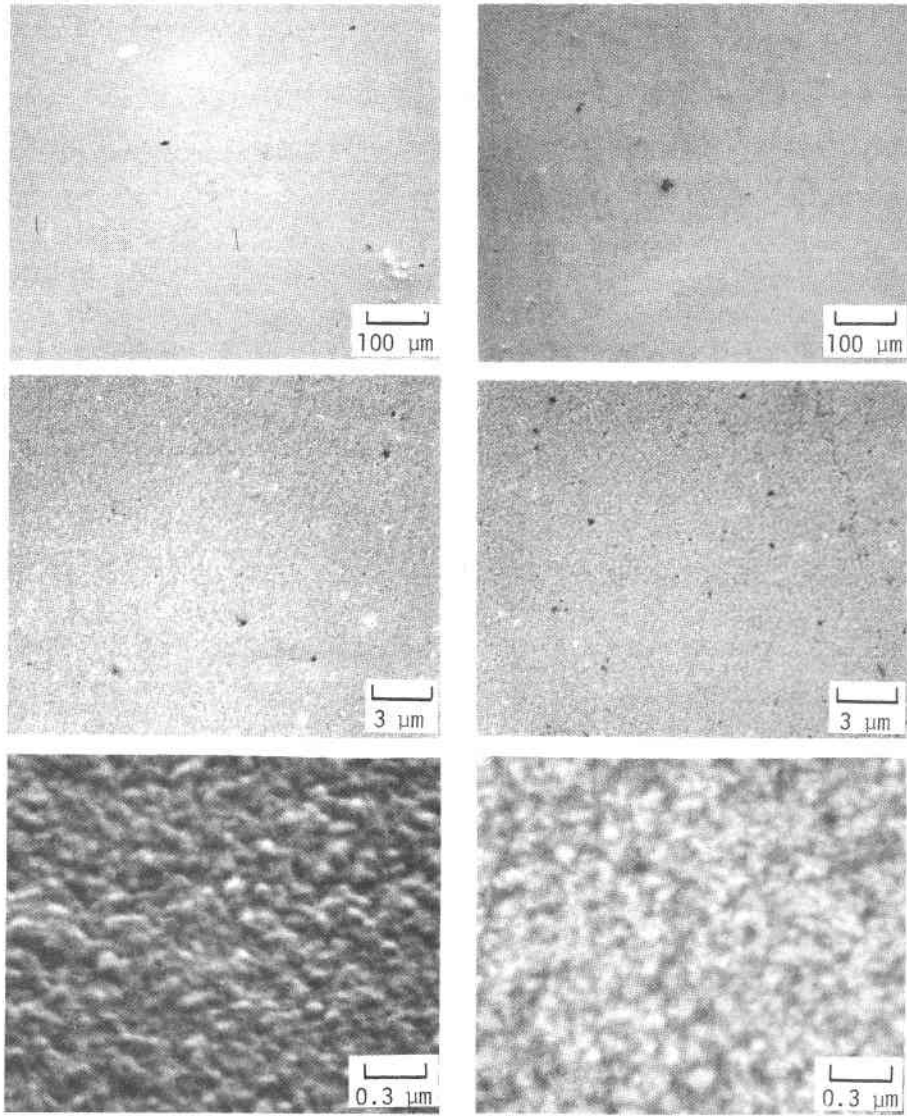
FIGURE 2.4. Production Mirrors by Gardner. The apparent metal particle size is about the same as for the mirrors of Figure 2.1 ( $\sim 0.1 \mu\text{m}$  average) but the general surface structure appears to be smoother. A few pores through the metal layers are observed.

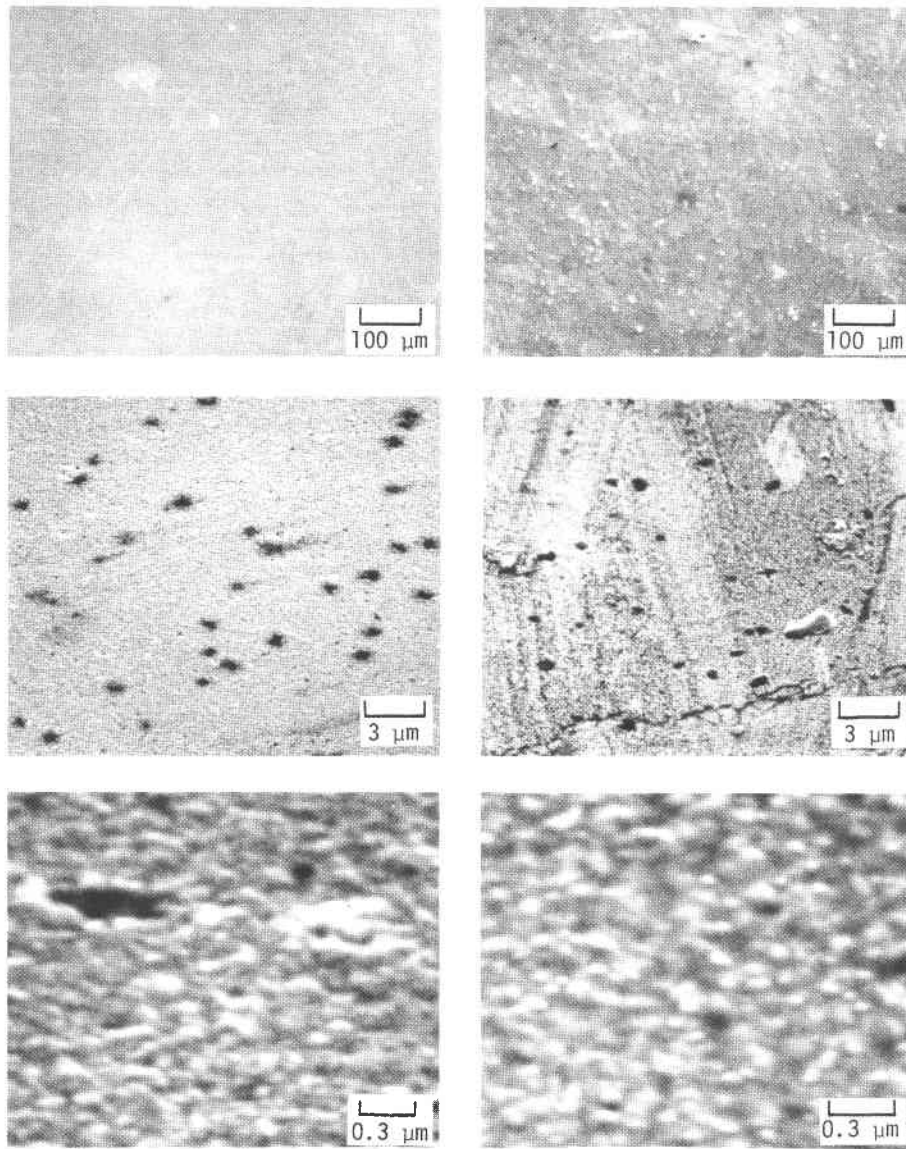
FIGURE 2.5. Production Mirrors by Carolina. These mirrors were allowed to stand in air (enclosed in a plastic bag) for 5 months before examination. Some handling abrasion is evident on the copper surface. The cause of the black spots (actually holes in the silver and copper layers) is not known; microprobe analysis does not show any reaction products such as  $\text{Cl}^-$  or  $\text{S}^{2-}$ . Inadequate glass cleaning might cause this kind of structure.

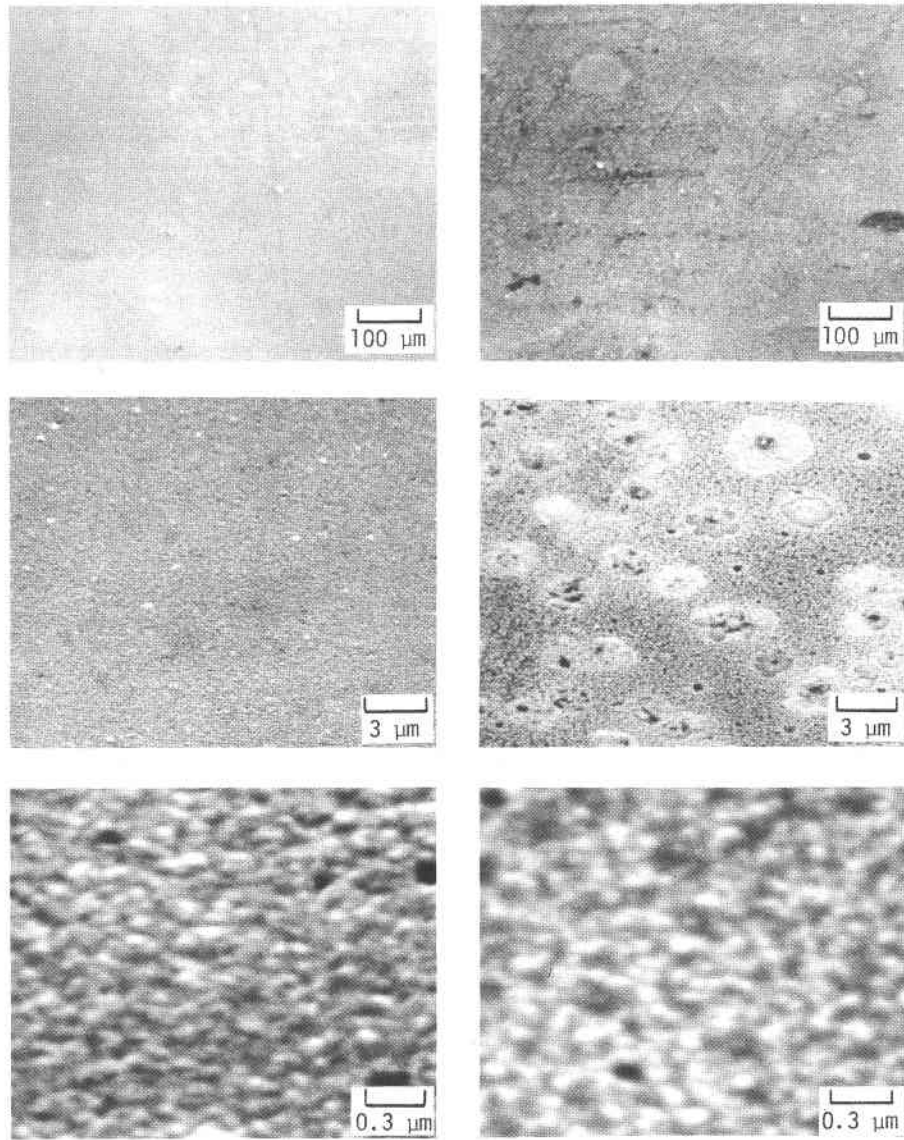
Even when the silver layer appears sound and uniform, a distribution of nucleation centers occasionally occurs on the mirrors (Figure 2.6). In some cases, these have been shown by microprobe to contain sulfur and appear to be the centers of reaction regions. These centers could be the forerunners of eventual deterioration or reaction spots. Even the application of a thin plastic film over the copper coated surface prior to shipment and storage did not prevent the occurrence of these nuclei reaction centers (Figure 2.7). It is concluded that the reaction began while the mirror was still exposed to the manufacturing environment where the metal films were deposited. However, when companion mirror coupons were allowed to proceed along the same production line to completion with the application of normal backing paint, these reaction points were not observed upon removal of the paint with glacial acetic acid. Apparently, the paint provided the necessary protection before exposure to the environmental contaminant. Approximately 4 months elapsed between production and analysis.

FIGURE 2.6. Production Mirrors by Falconer. The silver layer appears uniform, except for some holes in the metallic layer. The copper layer was unprotected during the 4 months between fabrication and these micrographs. The abundant nucleation centers, some of which have been shown by microprobe to contain sulfur, appear to be the centers of reaction regions. The form is reminiscent of the nucleation structure observed after long term exposure of some finished mirrors to exterior conditions.

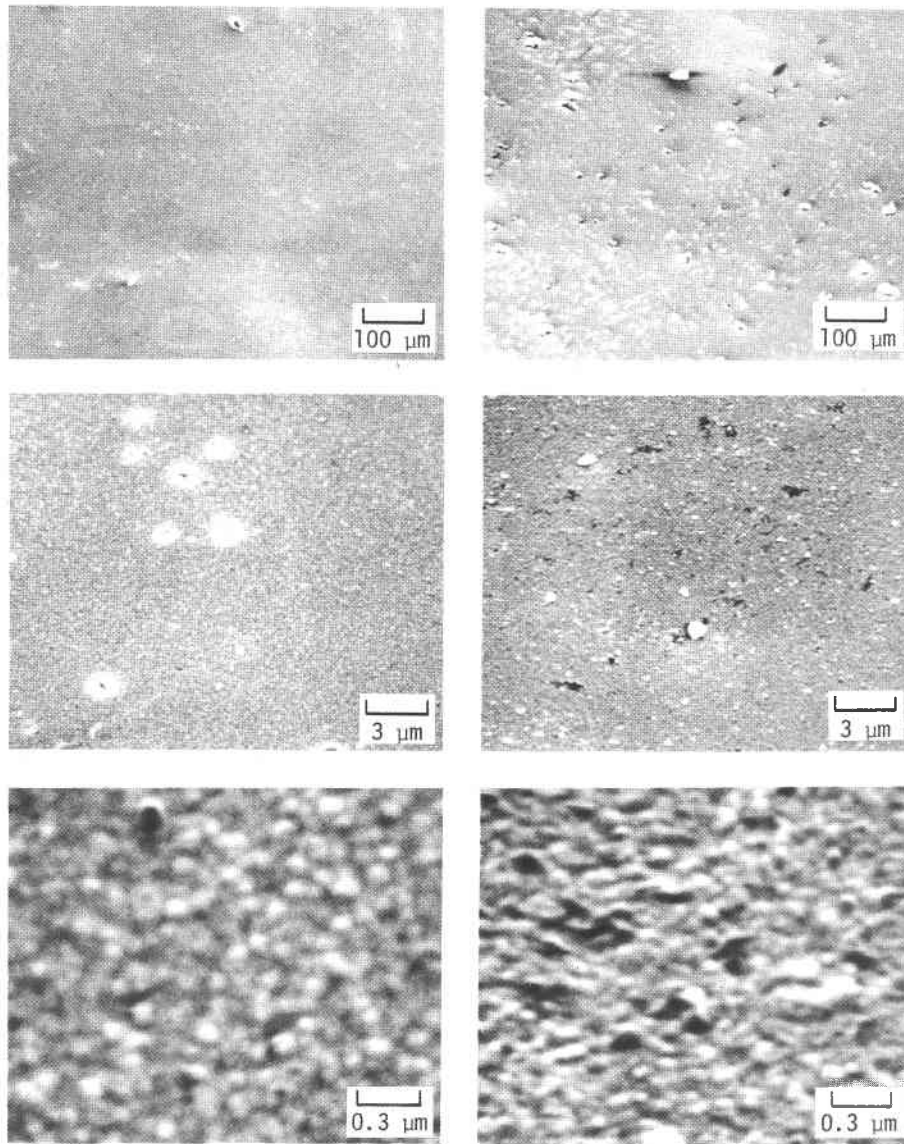
**FIGURE 2.7.** Silver-Copper Layers (After Removal of the Protective Coatings). A thin plastic strippable film (applied by the mirror manufacturer) covered the copper surface of mirror A. Nucleation sites are present, and only a small reaction zone is evident. Remnants of the paint applied to mirror B during the normal production process still cling to the surface. Some porosity is evident, but the mirror does not show reaction nuclei.

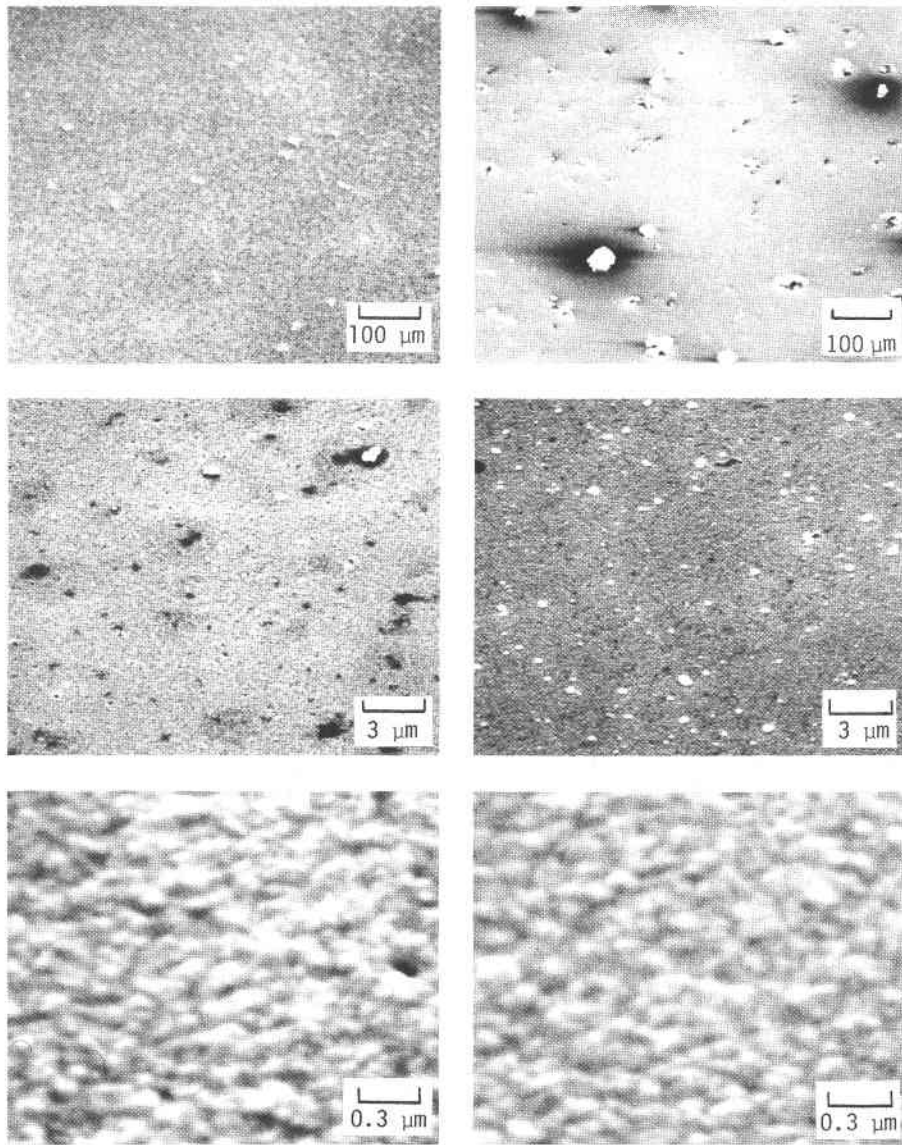
metallic layers were examined after the paint was stripped using glacial acetic acid (Figure 2.9). Both samples have large silver particles on the surface which indicates that they resulted from production procedures. It is important to note that the acetic acid removed the paint layer intact and caused no detected microstructural changes. This was substantiated by examining an uncoated mirror before and after an acetic acid treatment.

FIGURE 2.9. Copper/Silver Surfaces After Removal of Backing Paint. Both these mirrors were soaked in glacial acetic acid for 1 to 2 hours. The paint film floats off intact, but no other microstructural effects are evident. Mirror A is a non-abraded piece of the unbacked mirror in Figure 2.5B. Mirror B was a painted mirror from the same production run as Figure 2.8B, and also shows the Ag/Cu particles on the surface.

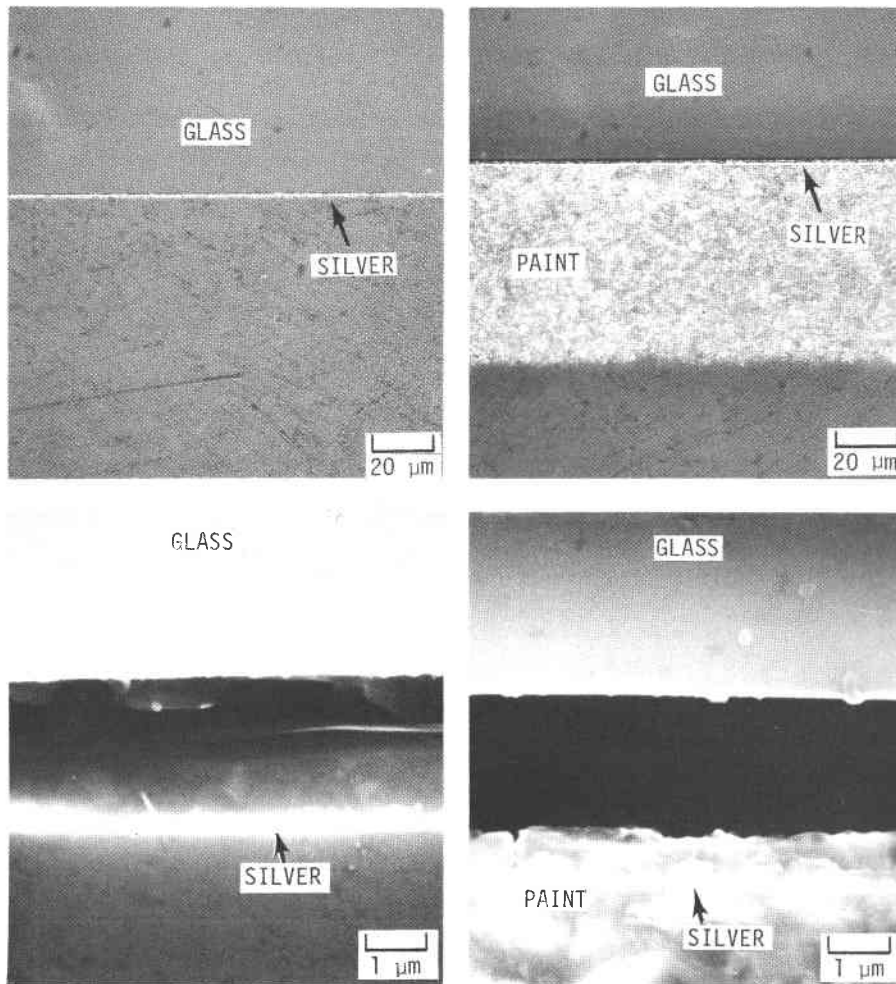
FIGURE 2.10. Bonding Between Silver and Glass on New Mirrors. Most of the glass-silver interfaces of new mirrors appear to be weakly bonded, allowing penetration of the epoxy resin between glass and silver during encapsulation for metallography. Bare copper/silver (A) and paint-protected metal layers behave the same way.

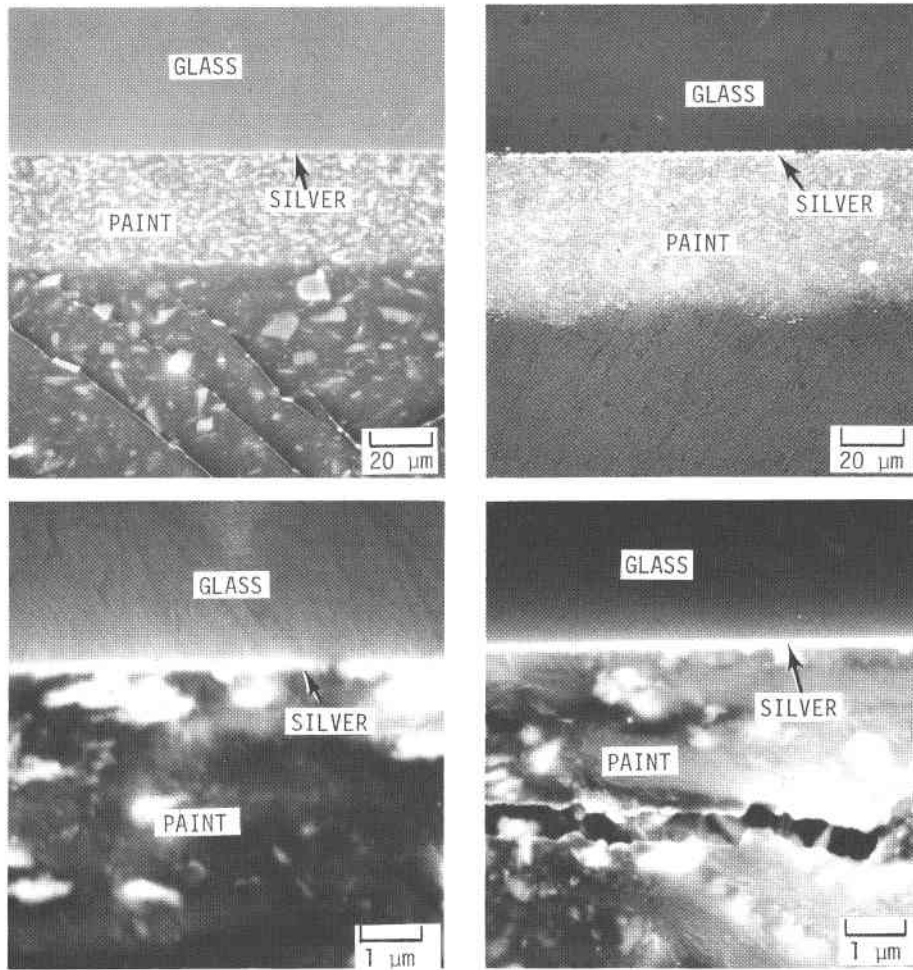
FIGURE 2.11. Silver-Glass Bond on Aged Mirrors. The silver-glass bond is known to strengthen after fabrication. On nondegraded areas of old mirrors the bond usually appears to be extremely tight even after long exterior exposure.

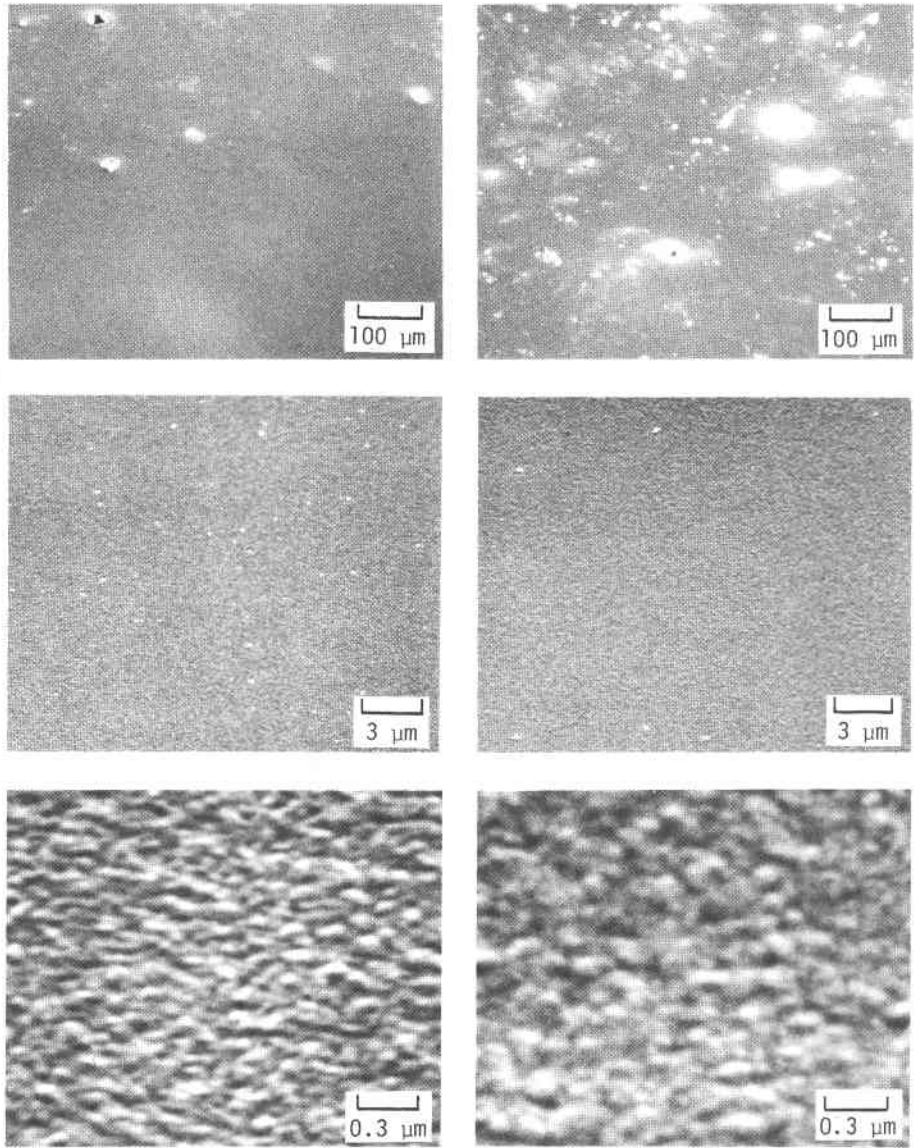
While laboratory-produced mirrors are not necessarily representative of commercially practical products, they are very useful in exploring the effects of variations in the coating process. For example, a high quality mirror (as judged by microstructure) can be achieved under carefully controlled and standardized laboratory conditions (Figure 2.12).

FIGURE 2.12. Laboratory Mirror Production by PPG. Under carefully controlled conditions excellent silver and copper layers can be produced as shown here. The surface debris on the copper layer is probably a result of repeated handling. Both these surfaces were unprotected during the 5 months between fabrication and this examination, but show no evidence of any surface deterioration.

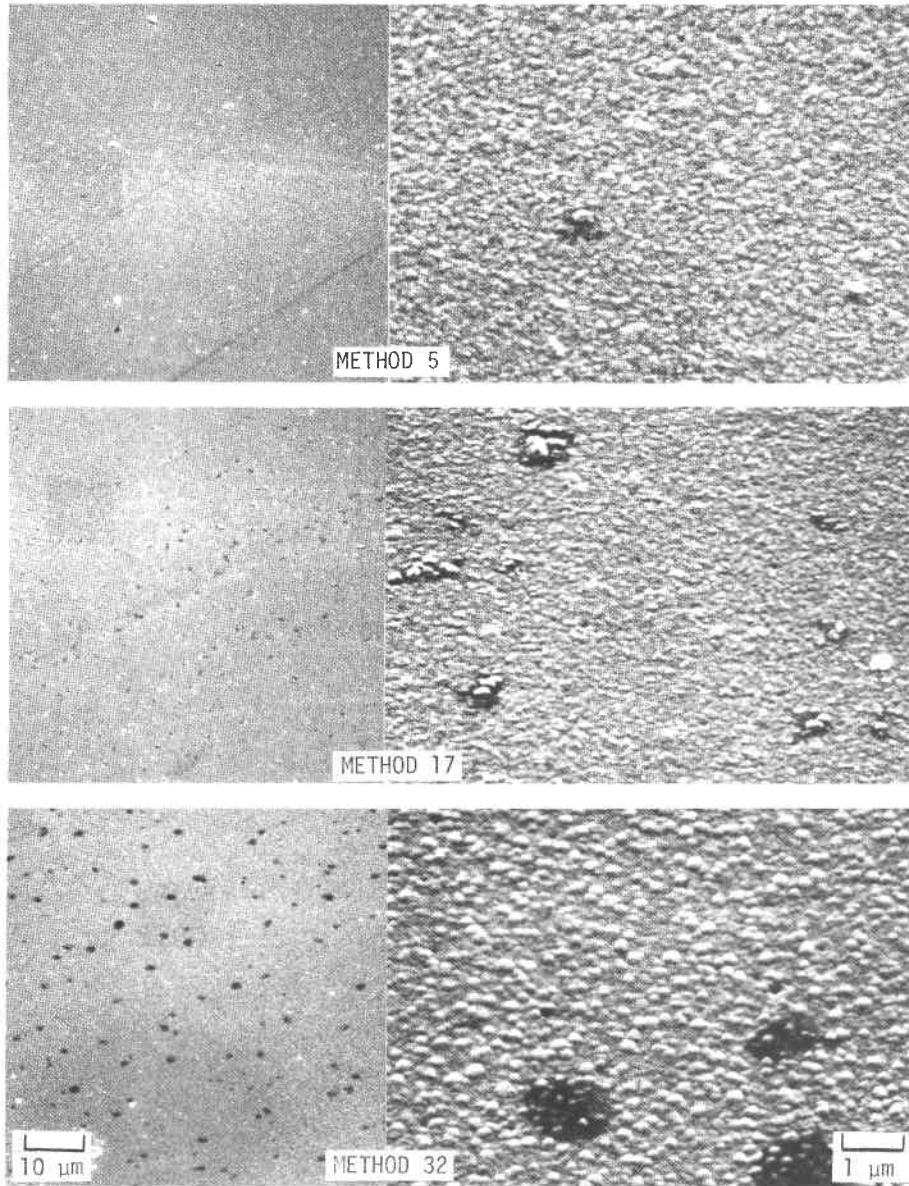
Some of the effects of changes in mirror fabrication method are evident from a series of specimens illustrated in Figures 2.13, 2.14, and 2.15. These specimens were selected from a series of 47 fabrication experiments performed by London Laboratories Limited in their Connecticut laboratory in which two different silver solution systems and two different methods of copper reduction deposition were used to deposit copper and silver layers of varying thicknesses (Table 2.4). The mirrors shown in Figure 2.13 all have the commercially accepted normal thicknesses of silver and copper, yet they differ markedly in the quality of their rear surfaces, ranging from "normal" to a surface with large silver particles and a sprinkling of stains or holes throughout. Differences appear to result from the mirroring chemistry and conditions used.

FIGURE 2.13. Effect of Changes in Mirror Fabrication Method. These three mirror samples have normal silver and copper thicknesses, but were produced by different silvering and copper reduction chemistry (see Table 2.4).

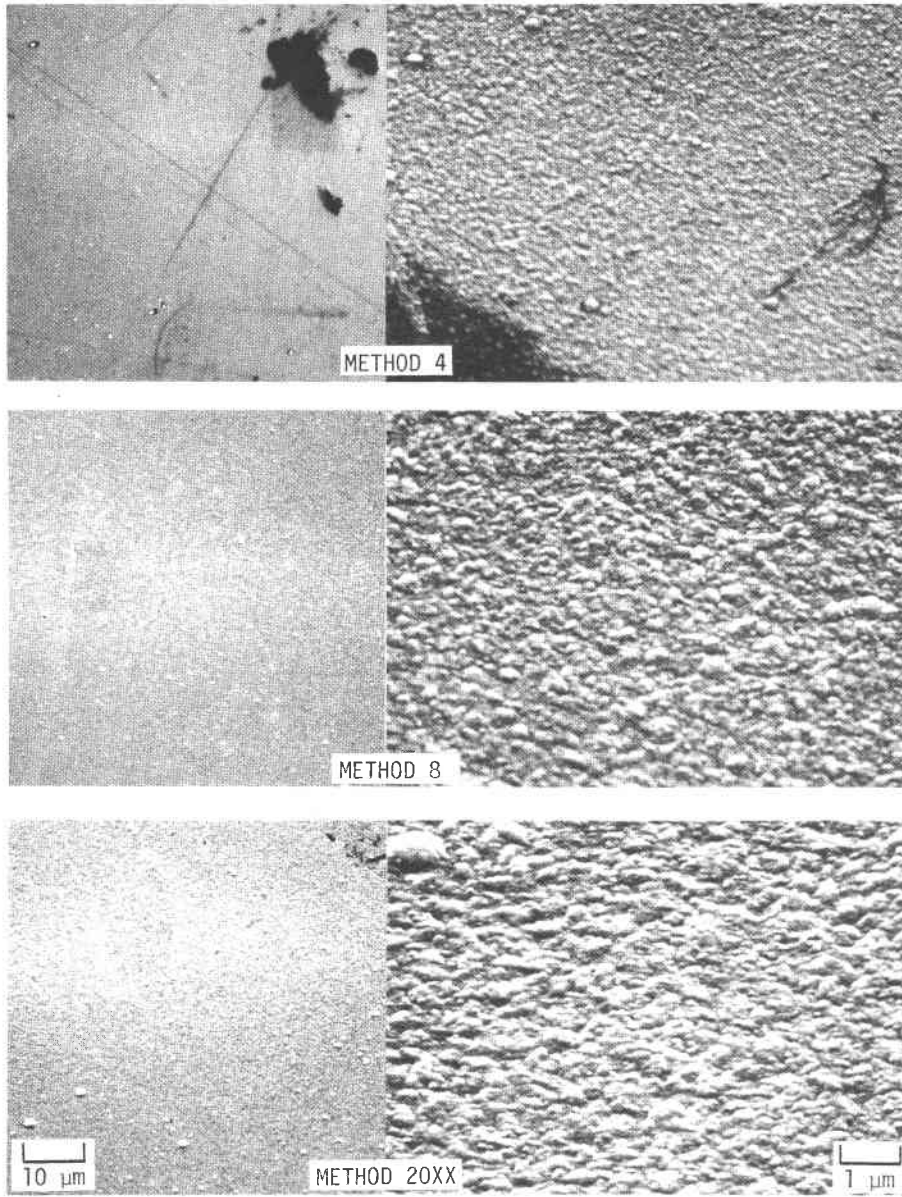
FIGURE 2.15. Effect of Changes in Mirror Fabrication Method. Microstructure of metal layers differs with method of application and layer thickness. Top: one-third normal silver; middle: 10 times normal copper; bottom: 20 times normal copper (see Table 2.4).

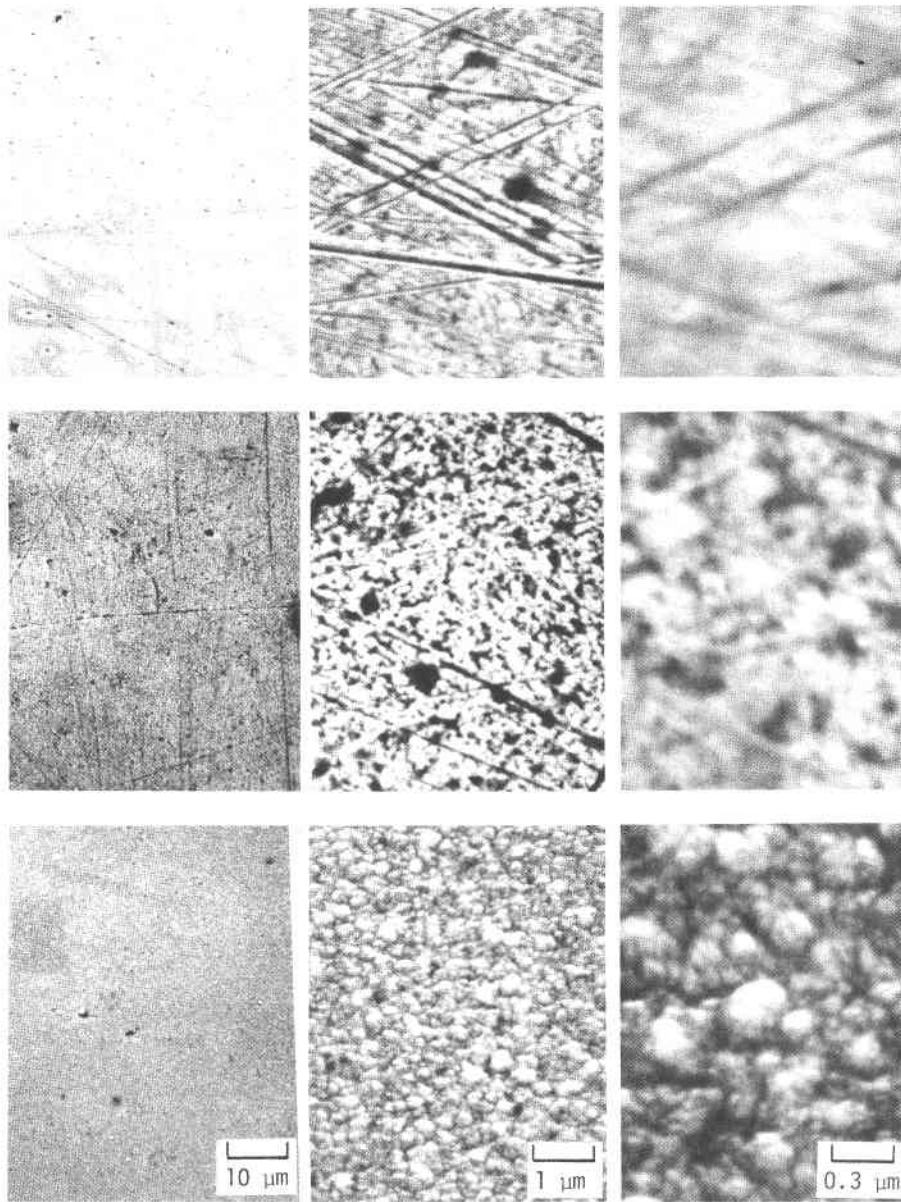
FIGURE 2.16. Effect of Precleaning Glass Surfaces on Mirror Microstructure. On the uncleaned glass the silver either peels off (top row of micrographs) or forms very porous poorly crystallized layer (middle row). When the same glass is vigorously scrubbed before silvering, the well-formed metal deposit is uniformly adherent with very little porosity (bottom row).

did not silver well at all. Silver either peels off readily, as shown in the top row of micrographs, or forms a very porous poorly crystallized layer as shown in the middle row of micrographs. Glass surface scratches are still prominently visible in both cases when the glass has not been properly cleaned (e.g., scrubbed with  $\text{CeO}_2$  slurry) prior to application of the silver. However, when the same glass was vigorously scrubbed before silvering a good quality mirror was produced. Some of the fabrication defects observed in previous fabrication examples may have been due entirely or in part to inadequate cleaning of the glass before the stannous chloride sensitization and the silvering steps were applied.

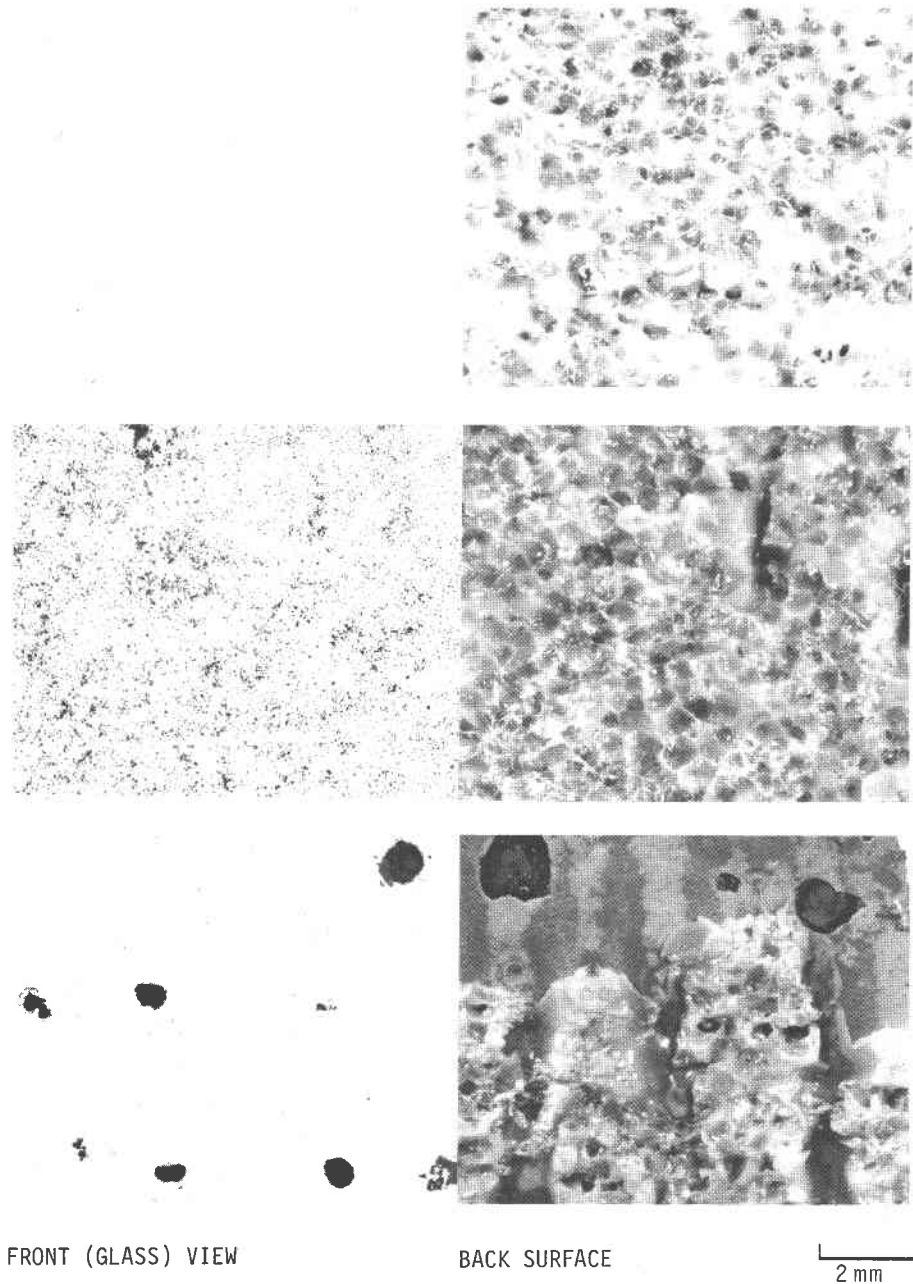
FIGURE 2.18. Typical Mirror Surface Features of Sandia Mirror. The mirror surface condition included nearly like-new areas, fine spot degraded regions, and aligned spots about 1 mm in diameter. The back appears uniformly covered with foam except for rake marks resulting from application of the adhesive for the foam backing.

growing phenomenon, and it is much more extensively distributed. The rear view shows the original paint and the foam backing partially removed. A detailed examination of the typical areas on this mirror (Figure 2.18) show that the large spots are aligned with the rake marks left by the application of adhesive for the foam backing. Apparently the physical disturbance of the raking process was a contributing, or perhaps major, factor in the failure evidenced by the large spots. However, the fine structure, which not only surrounds those large spots but is also widely distributed over the entire mirror, is potentially more significant and could be expected to grow in size with further exterior exposure. This random degradation does not limit itself to edges of the mirrors; in fact, more deterioration appears to occur in the interior of mirrors than on the edges, as the edges are relatively clear in this specimen.

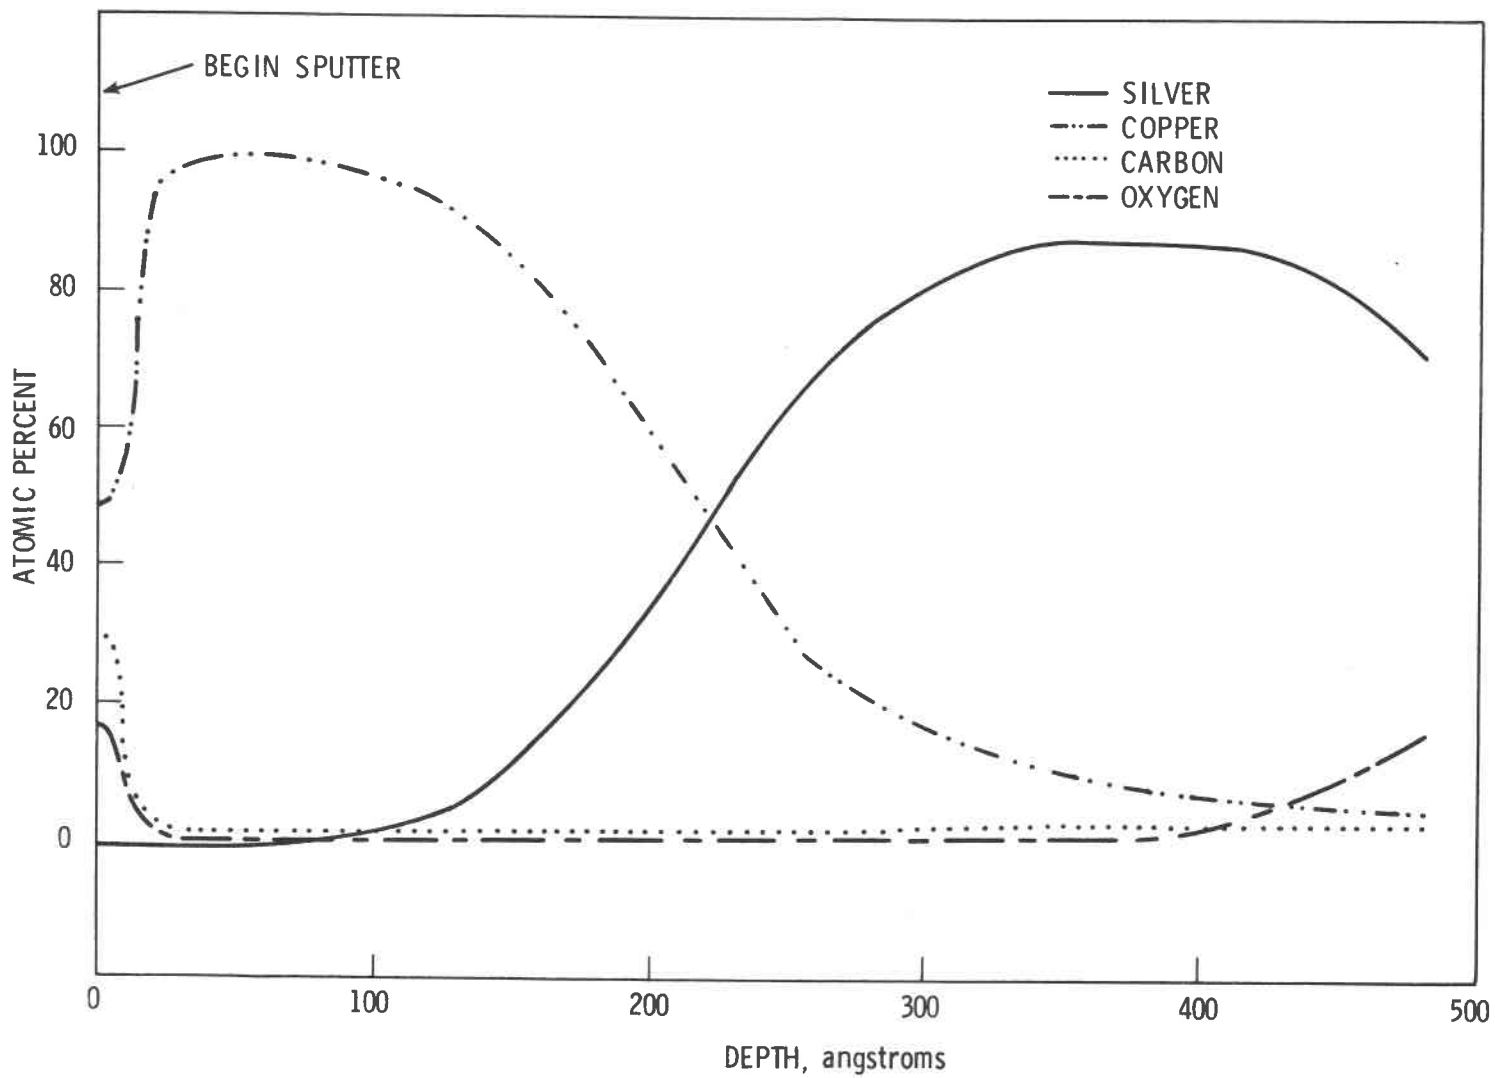
FIGURE 2.38. Auger Depth Profile of an Uncorroded Section of the Sandia Mirror. While regions of essentially pure copper and silver exist, extensive interdiffusion of copper and silver is indicated.

Silver and copper could exist in the form of a matrix of islands on the substrate, with dimensions smaller than the diameter of the probing electron beam (5 microns). If silver deposits as small islands on the glass, copper could be deposited between these islands as well as on top of them. The relatively large electron beam would then probe an average of several silver islands as well as the spacings between them. The result would be a depth profile indicating significant intermixing of the two metals. The island growth thesis is supported by the asymmetry of intermixing shown in Figure 2.38.

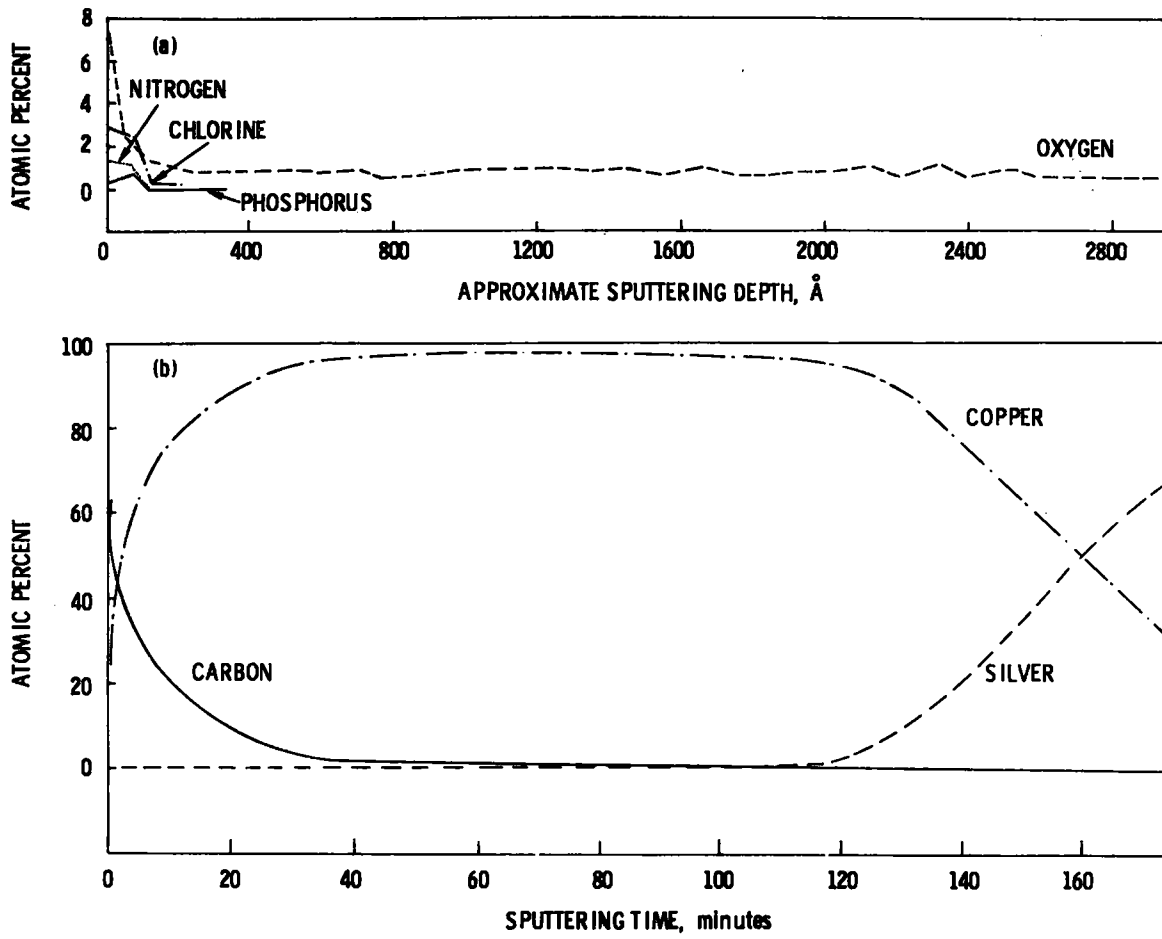
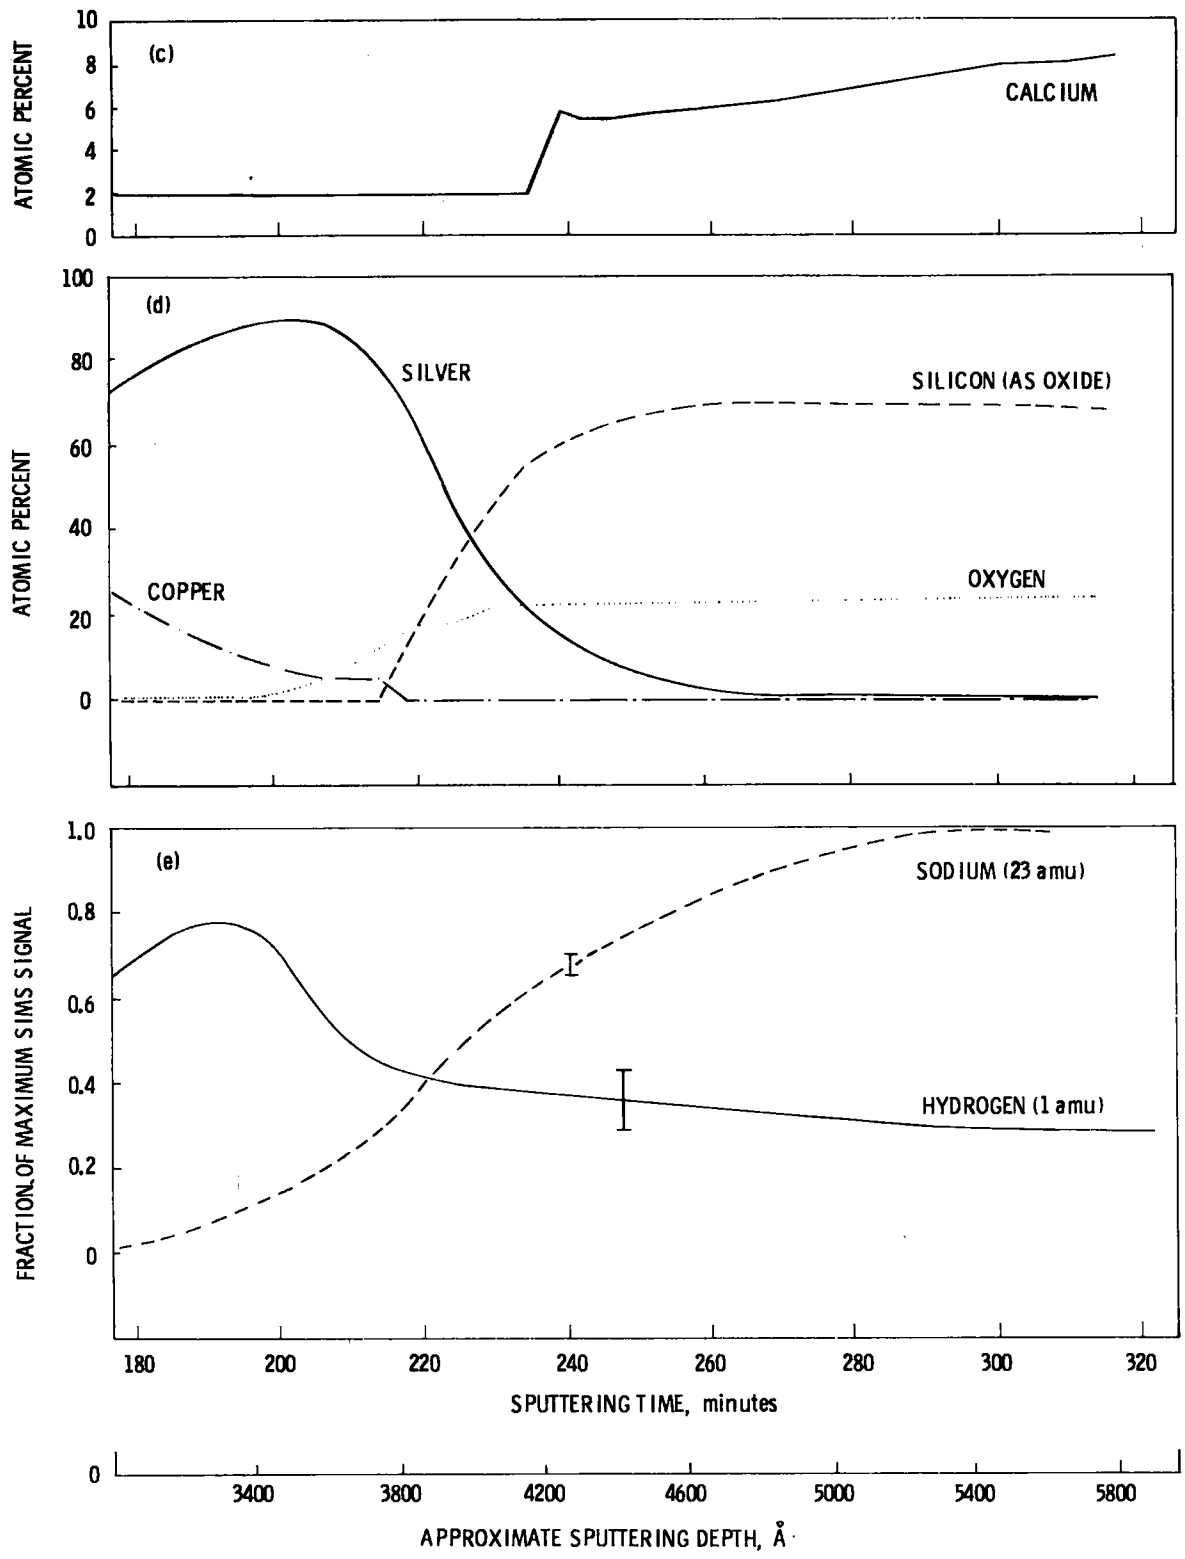
If the metal-glass interface is defined as the point in the profile where silicon is detectable and copper is no longer detectable, the data show that calcium has been leached from the vicinity of the metal-glass interface to a depth of several hundred angstroms. Sodium does not reach the bulk glass concentration for at least 1000 Å past the interface. Leaching of calcium and sodium from glass surfaces by water has often been reported, where it is postulated that hydrogen replaces calcium and sodium by ion exchange (Das, 1969; Clark, et al., 1976). It should be noted that some alkali and alkaline earth depletion on the float glass surface is expected prior to mirror manufacture, due to atmospheric exposure. Thus, the actual contribution of the mirror manufacturing process to the leached layer formation is not clear from these data.

FIGURE 2.44. Auger and SIMS Depth Profiles of the London Lab Mirror Coated on the Hard Scrubbed Glass. (c) through (e) show a continuation of (a) and (b).

Silver was found to penetrate the glass to depths in excess of 1000 Å, as shown in Figure 2.44d. This is somewhat surprising, given that the mirrors were reasonably new. Notice that no chlorine was detected within the glass or the silver, as had been found with the degraded Sandia mirror. This rules out the requirement of diffusion of silver and chloride ions as ion pairs, which is unlikely anyway due to the large size of the chloride ion.
