## Heliostat Mirror Survey and Analysis

September 1979

Prepared for  
Sandia Laboratories, Livermore, CA  
under Related Services Agreement 300A01308  
and the U.S. Department of Energy  
under Contract EY-76-C-06-1830

This report is the result of comprehensive surveys and technical analyses performed for Sandia Laboratories in support of the U.S. Department of Energy Solar Thermal Large Power Systems authorized under Sandia Livermore integrated order 92-8165. The purpose of this work is to provide background information and procurement specifications for materials and processes which have potential applications in heliostat construction. This report covers the work performed under three tasks: the mirror industry survey, mirror degradation analysis, and advanced concepts for mirror protection.

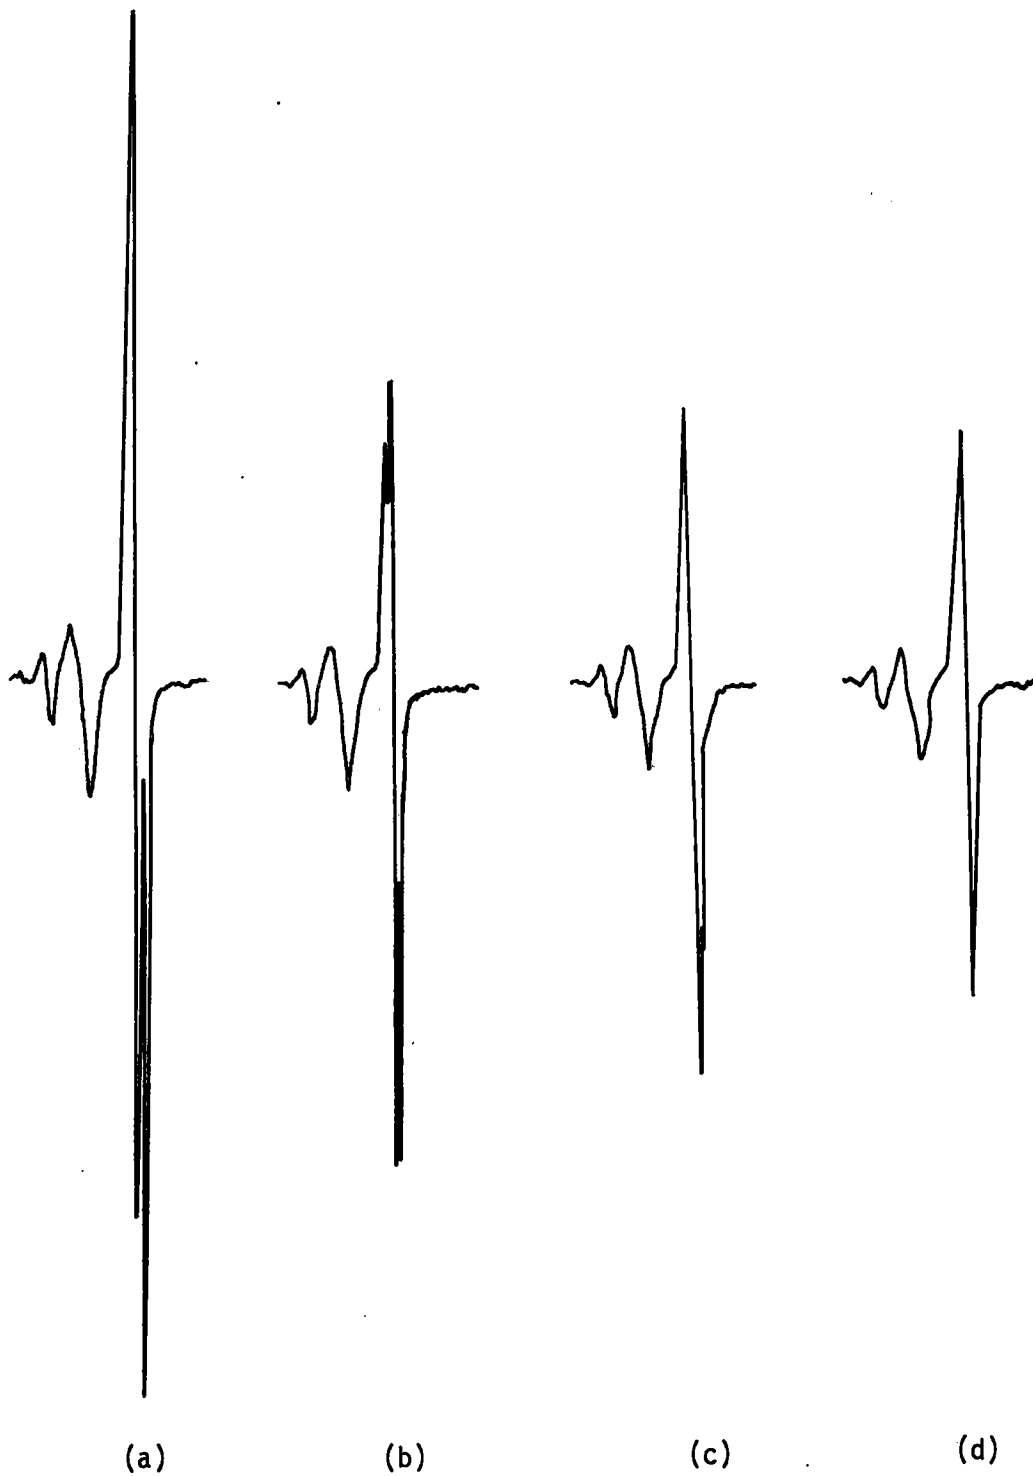
More striking were dramatic changes in the silver Auger peak shapes, from that corresponding to silver in the metal film to that of silver in the glass matrix. Figure 2.46a shows the 340 to 350 eV spectra of metallic silver. Figures 2.46b and 2.46c show a gradual transition to that of silver in a glass matrix, given in Figure 2.46d. The peak shape shown in the latter figure remained constant as long as silver could be detected in the glass. Since valence (4d) electrons are involved in this Auger transition, this peak should be sensitive to chemical changes.

**FIGURE 2.46.** Changes in the 350-355 eV Silver Auger Peak Shape From the Metal Layer (a) Through the Glass-Metal Interface to Glass (d). The shape changes are expected to be due to electrical charging of the sample, which can broaden the peaks.

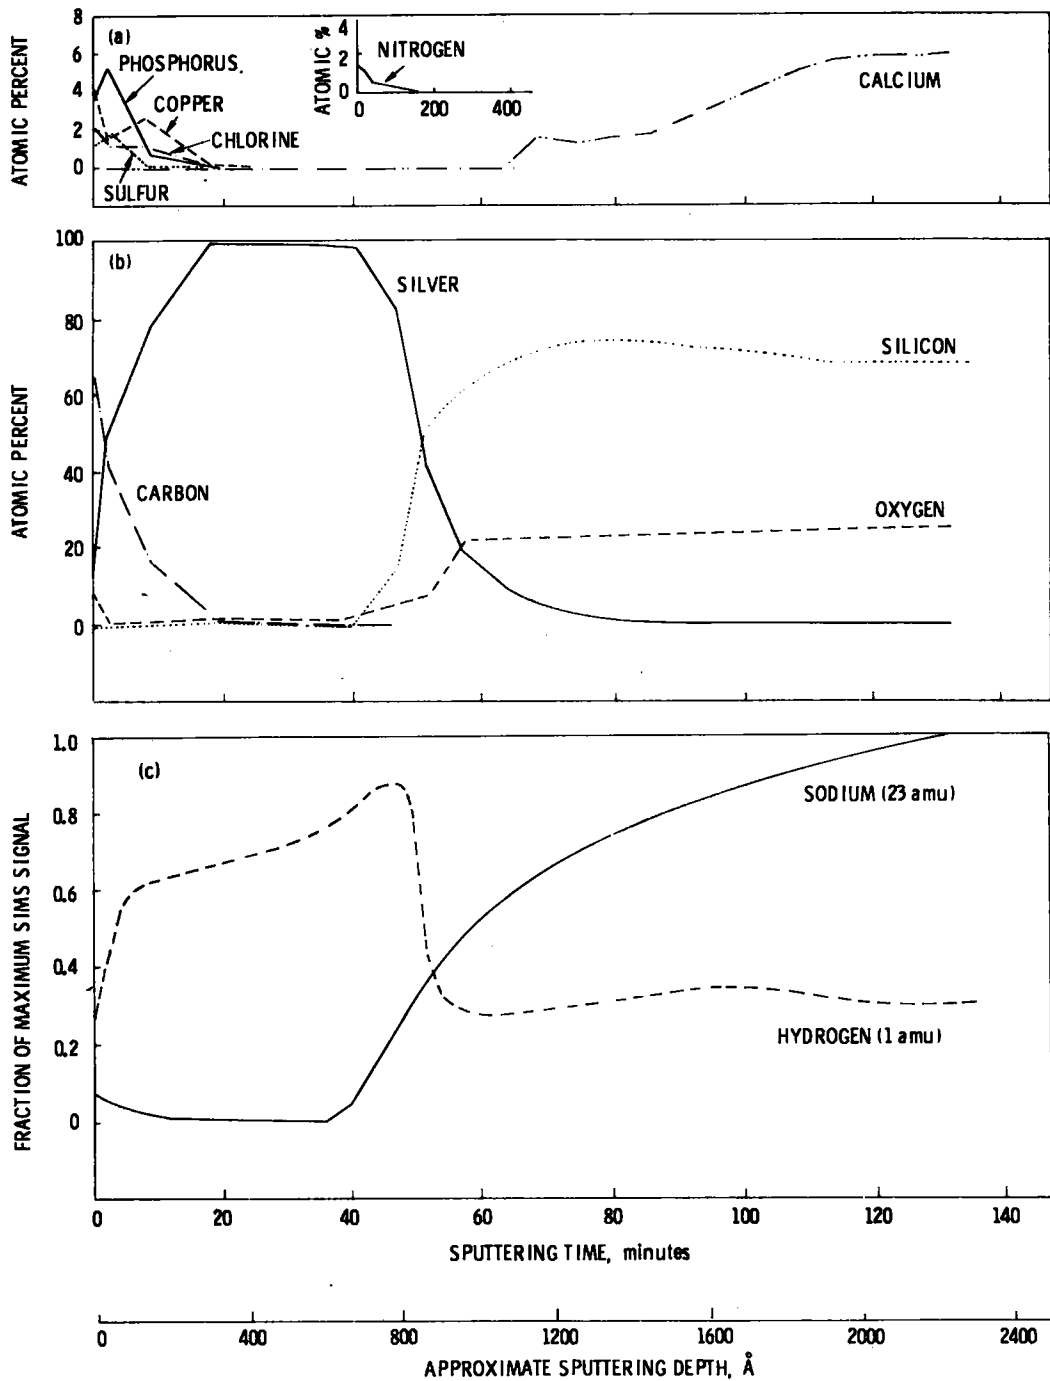
**FIGURE 2.48.** Auger and SIMS Depth Profiles of the London Lab Mirror Coated on Unscrubbed Glass. With the exception of the hydrogen profile, the elemental variations in the vicinity of the metal-glass interface are similar to that of the scrubbed glass.

As shown in Figure 2.48, very similar results were found in the case of the mirror with the unscrubbed substrate as was found in the previous case. The only obvious difference between the two samples was that the copper layer was very uneven on the mirror with the unscrubbed substrate. Analysis was performed in an area of low copper. Total amounts of silver on the two samples were nearly equal. Diffusion of silver into the glass proceeded to approximately the same depth past the metal-glass interface. The hydrogen SIMS signal shown in Figure 2.48c is increased close to the glass-metal interface. This should be contrasted to the corresponding cleaned mirror SIMS spectra (Figure 2.44e) which is smooth.

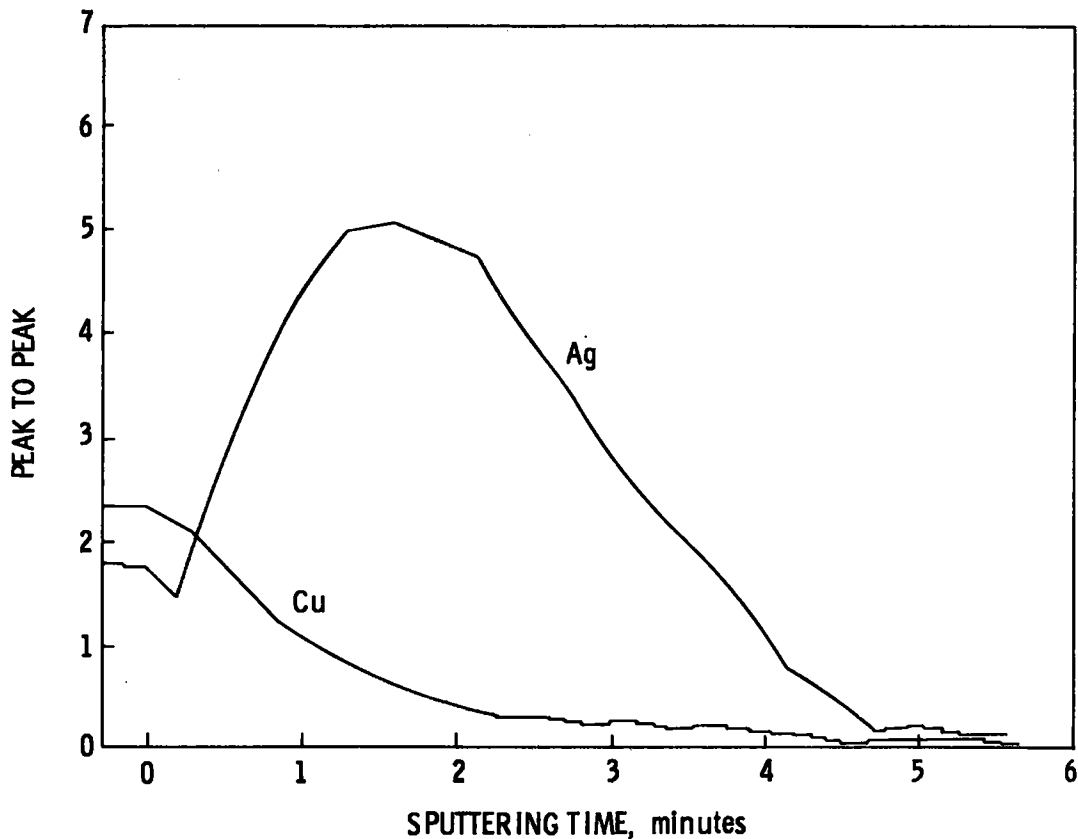
An AES depth profile showing the interrelation of copper and silver on the Carolina mirror surface is given in Figure 2.49. This analysis, which was performed with a 2000 Å diameter primary electron beam, showed copper and silver interdiffusion similar to that seen using a 5 micron beam. Thus, if

FIGURE 2.49. Auger Depth Profile of a 17-Year-Old Mirror Supplied by the Carolina Mirror Corporation

copper and silver microstructure is the cause of the apparent interdiffusion, crystallites smaller than 2000 Å must exist.

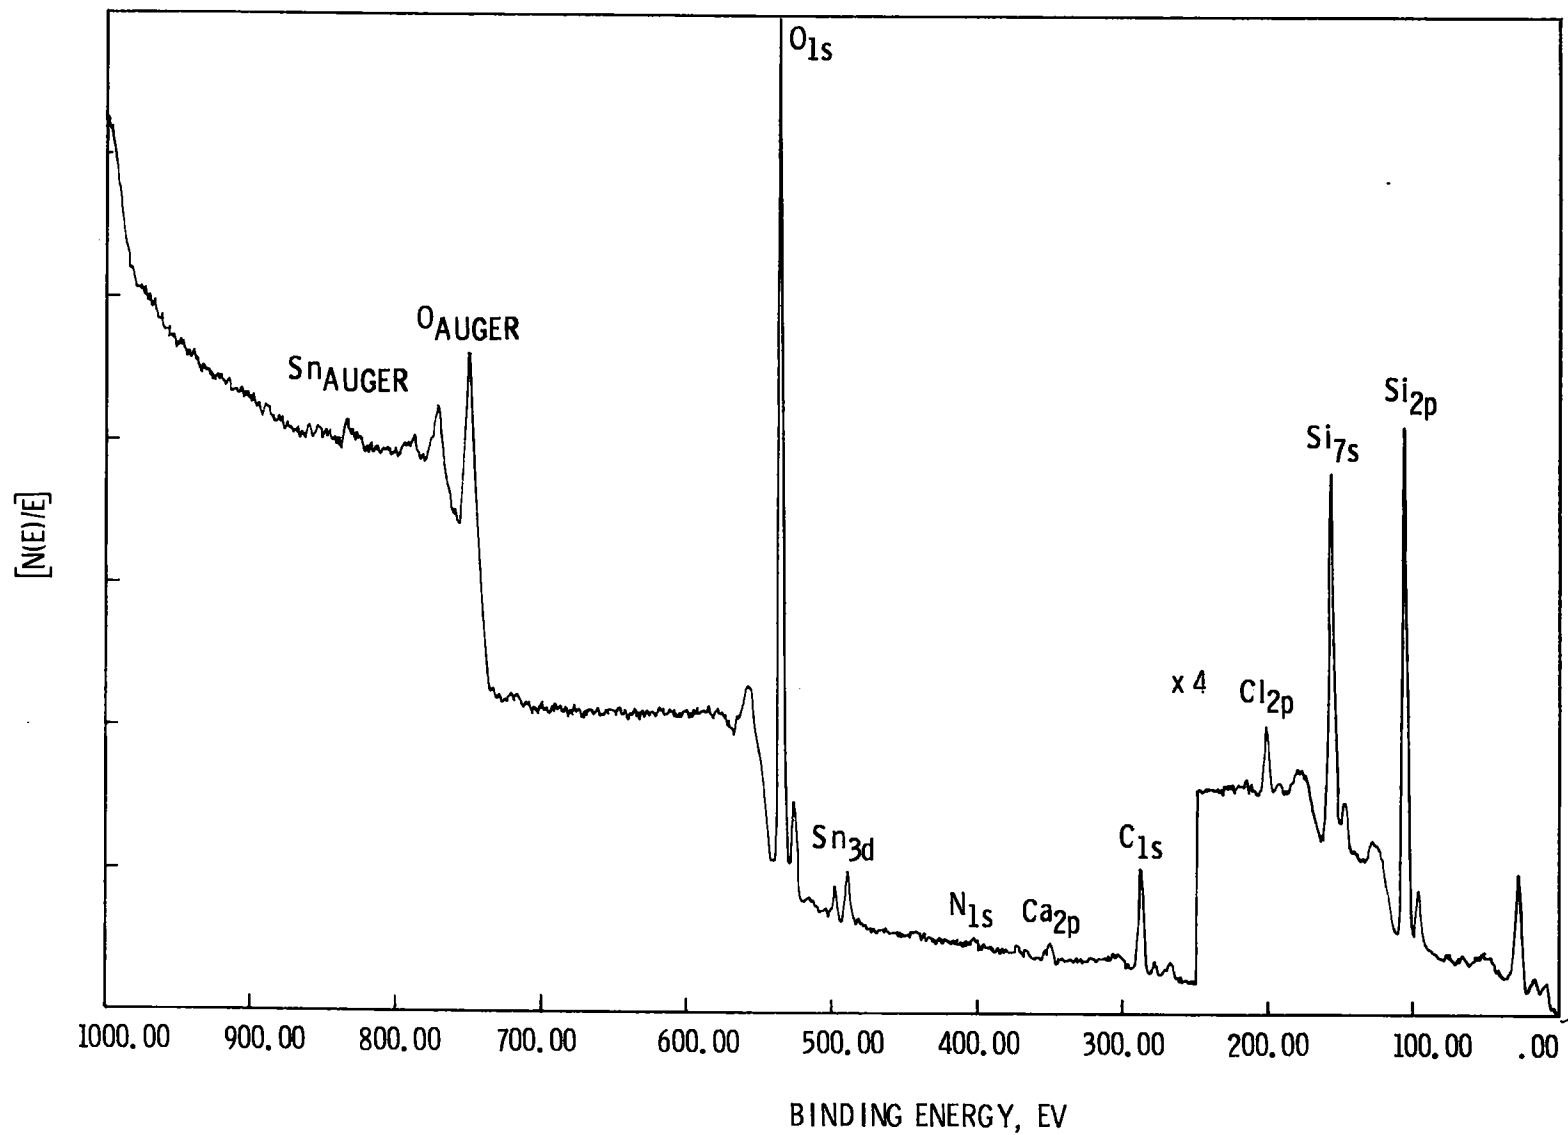
**FIGURE 2.51.** ESCA Survey of Soda Lime Glass After it had been Dipped into a Dilute SnCl<sub>2</sub> Solution. Tin was clearly detected in the form of an oxide or chloride.

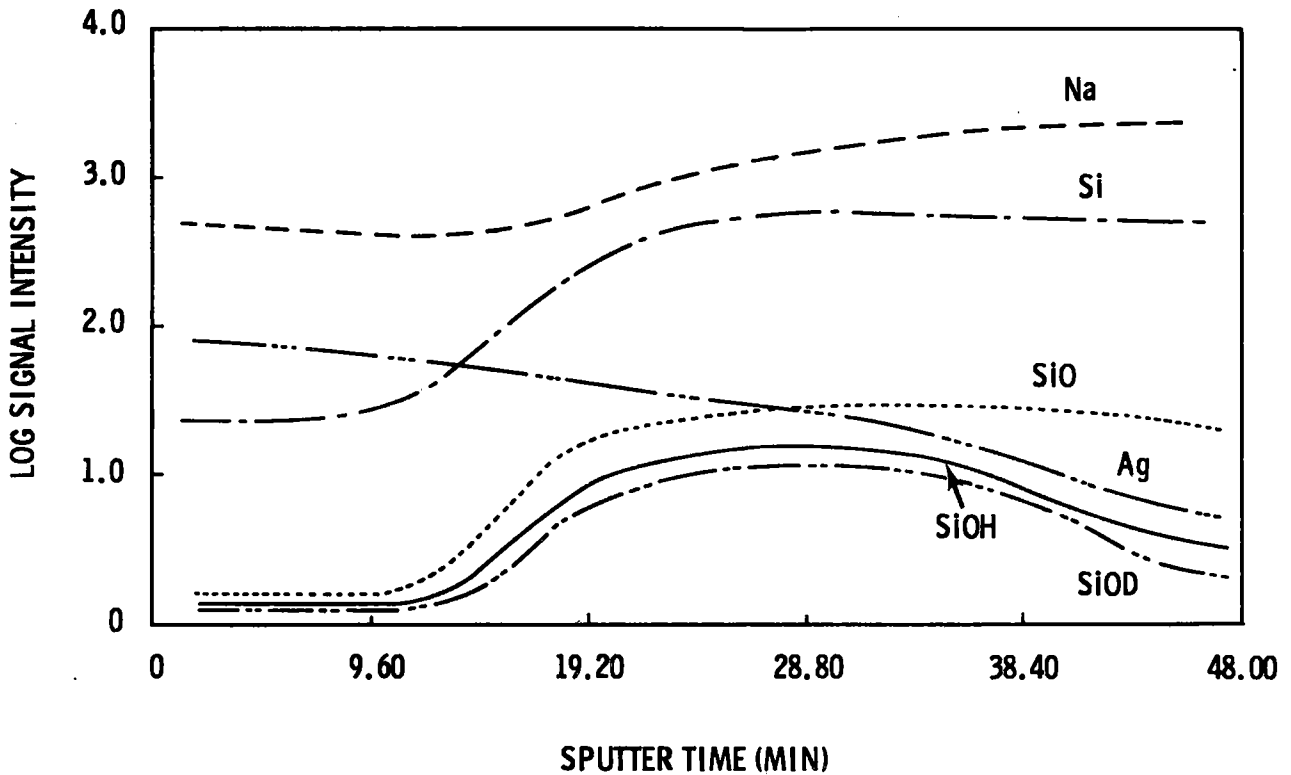
A solution of complexed silver in  $D_2O$  was used in the preparation of a silver mirror on soda-lime-silicate glass in order to ascertain the depth of the reaction layer that occurs during normal mirror processing. This mirror was subsequently sputter-profiled using SIMS, as shown in Figure 2.52. The position of the metal-glass interface in the figure is most clearly shown by the rapid increase in the silicon signal. The SiO signal rises with the Si signal and is then reasonably constant with depth into the glass. The SiOH and SiOD signals, however, rise sharply at the metal-glass interface, and then decay as a function of depth. The SiOH and SiOD signals show the depths to which  $H_2O$  and  $D_2O$  (and/or the corresponding anions or cations) have penetrated and reacted with the glass. The extent to which water reacts with the substrate glass during mirror preparation may strongly affect the durability of the mirror. More experiments are obviously needed to further explore this thesis.

**FIGURE 2.52.** SIMS Profile of a Silvered Mirror Which Was Chemically Deposited Using  $D_2O$  in the Silvering Solution. Evidence for deuterium penetration into the glass is present in the Si-OD signal.

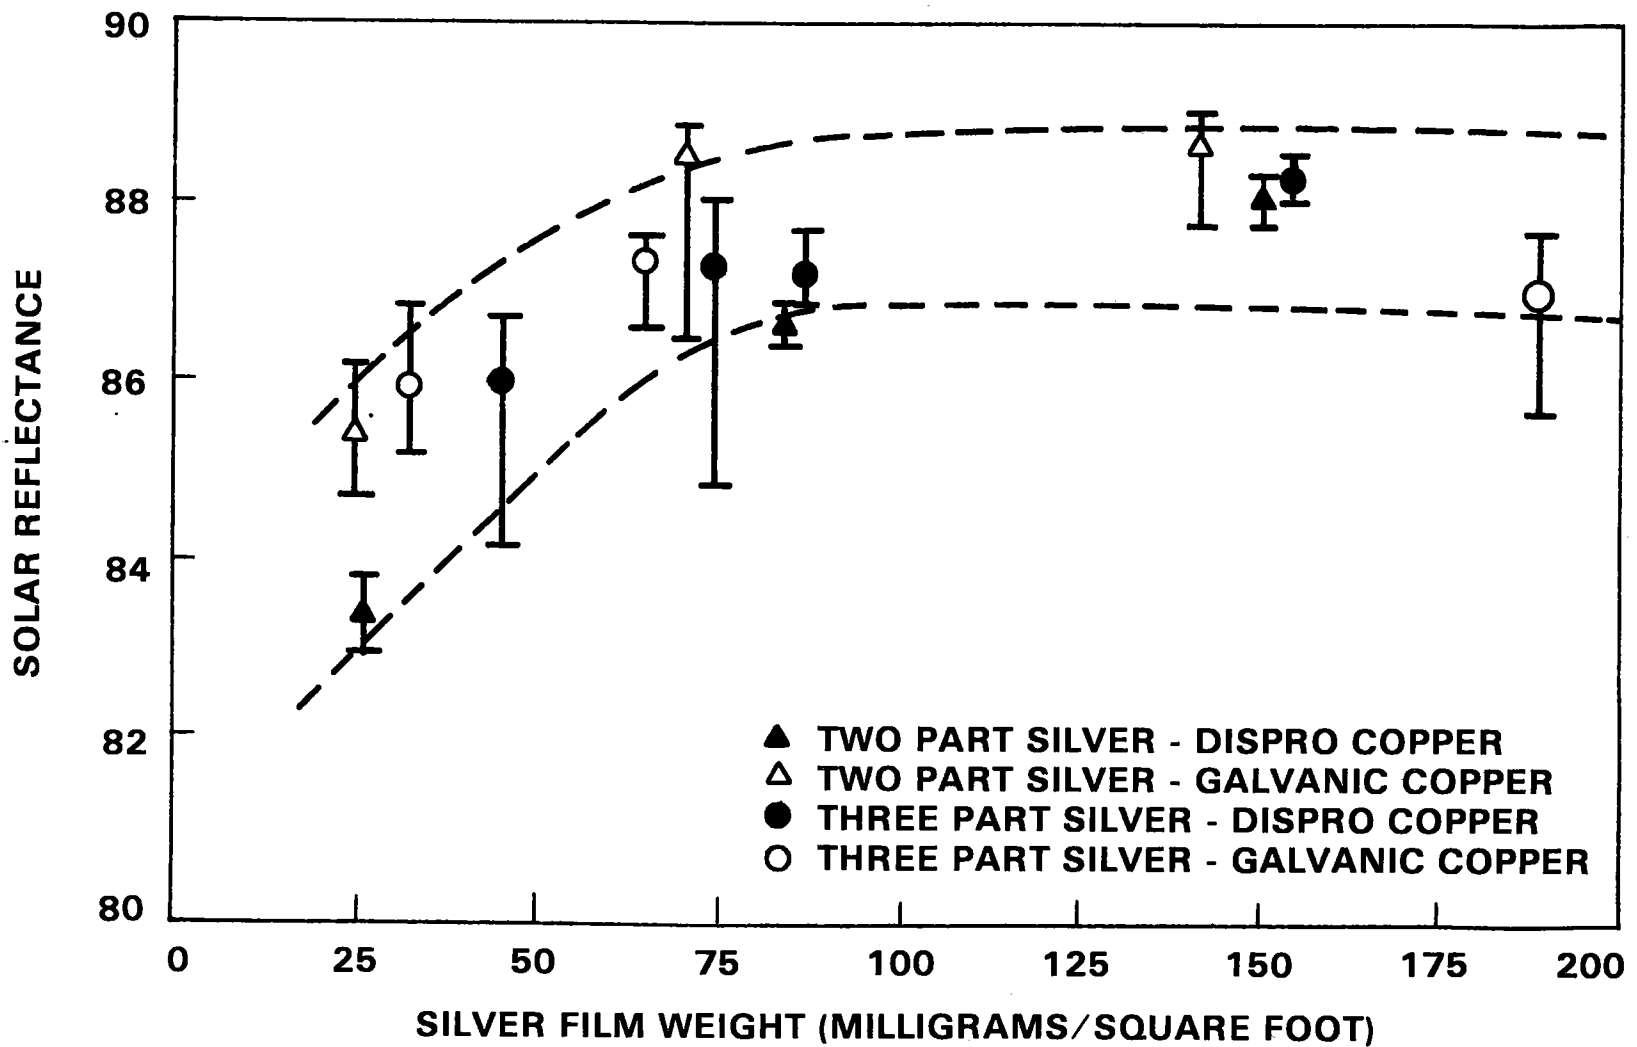
The spectral reflectance of the second surface mirrors was measured and weighted to Moon's AM 2 terrestrial solar irradiance distribution. The results are shown in Table 2.5 and summarized in Figure 2.53.

**FIGURE 2.53.** Variations in the Silver Thickness and Deposition Technique Influence the Solar Reflectance of the Mirror

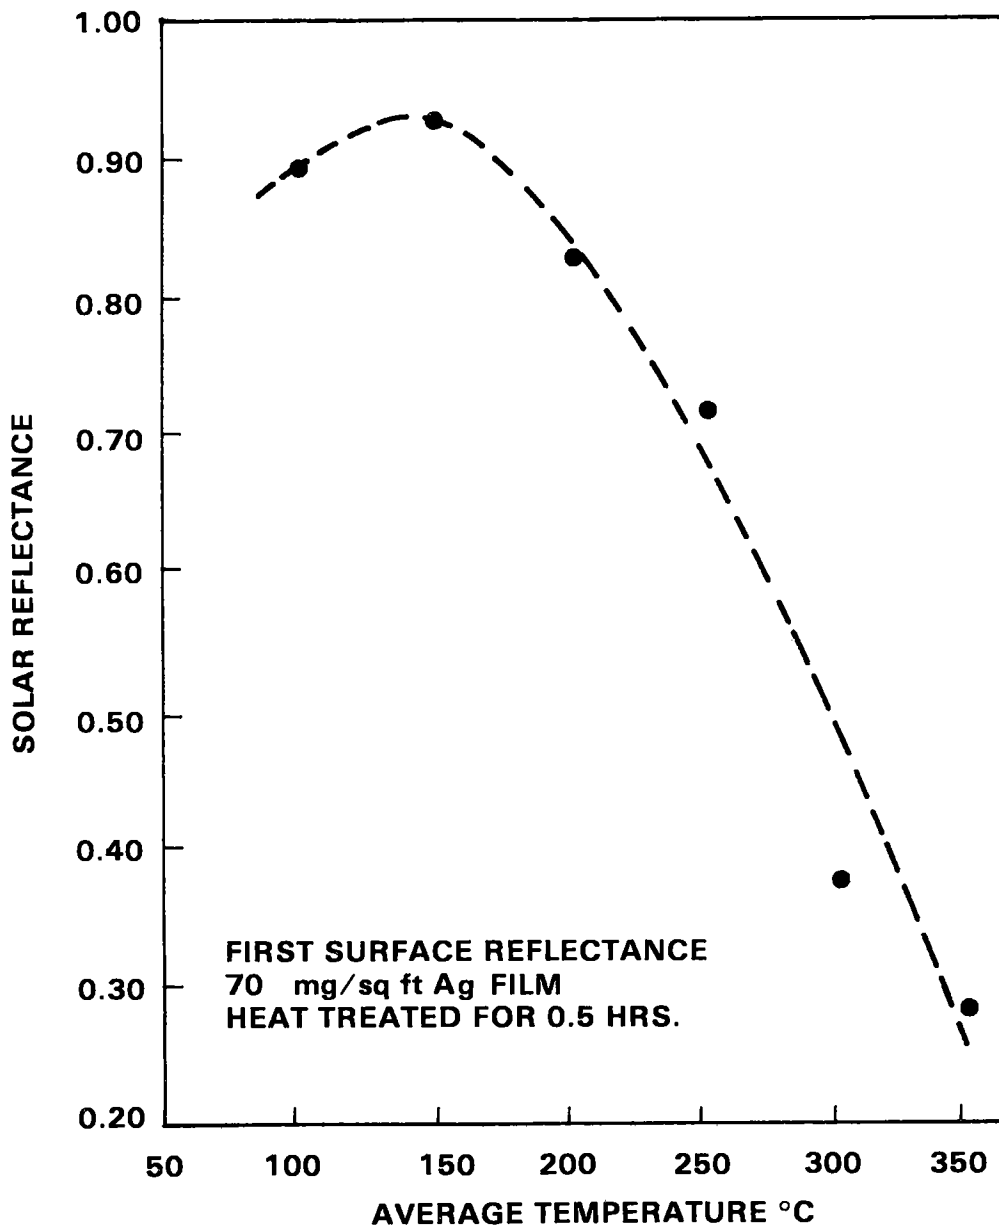
These same samples were measured for first surface solar reflectance. No copper overcoat had been applied. The results are shown in Figure 2.54. There is evidently some enhancement in reflectivity (~2-3%) due to the agglomeration. Further tests are underway to verify the results.

**FIGURE 2.54.** The Solar Reflectance as Influenced by the Amount of Silver Agglomeration

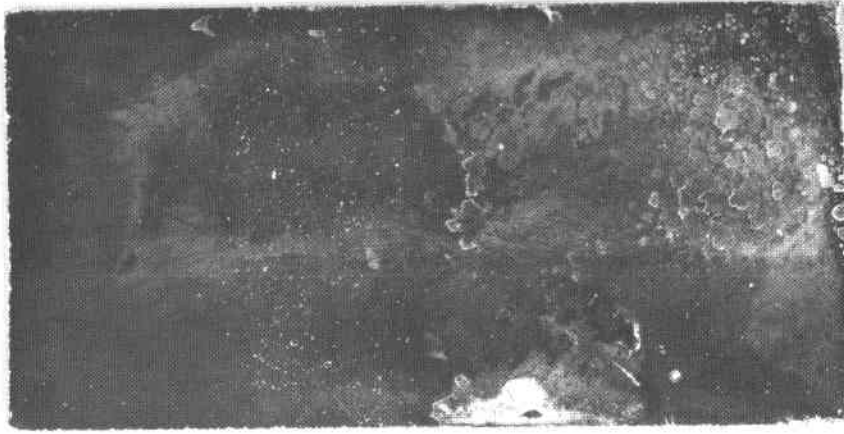
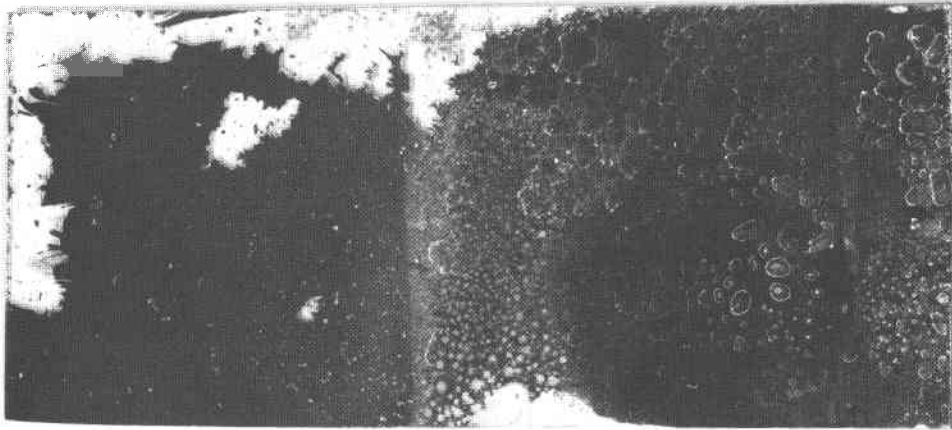
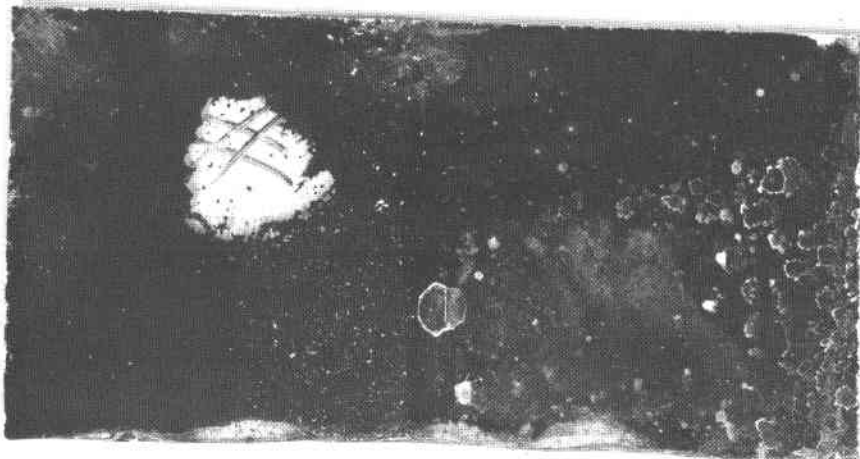
Time constraints did not permit a thorough evaluation for durability. However, the mirrors were screened for durability by using a leach bath of boiling deionized water as discussed earlier. Samples of a control mirror made by the traditional silvering process at PNL, a lanthanide mirror, and a mirror supplied to PNL by a commercial mirror manufacturer were inserted vertically in the bath so that they were half immersed. After a 3-hour test both the control and commercial mirrors had degraded appreciably, while the lanthanide mirror showed considerably less degradation (see Figure 3.1). This same test was performed for 8 hours with the same qualitative result. This test has been performed 7 times with the same results each time.  $\text{Nd}^{3+}$ ,  $\text{Ln}^{3+}$ ,  $\text{Er}^{3+}$  and  $\text{Sm}^{3+}$  have all been tested. On the basis of this abbreviated screening test, it appears that the lanthanide concept has some merit.

FIGURE 3.1. Mirrors After Leach Bath Test. The lanthanide mirror on the top fared considerably better than either the PNL control mirror or the commercial mirror.

The use of lanthanides in the industrial process has one distinct advantage. It can be implemented with no capital investment. Since the solution can be codeposited with the tin chloride sensitization solution, no modification of the wet process silver production line is required.
