TECHNICAL REPORT

No. 3/87

LESSONS FROM THE
SSPS - CRS
SODIUM FIRE INCIDENT

Motor Columbus
Consulting Engineers Inc.
CH-5401 Baden, Switzerland

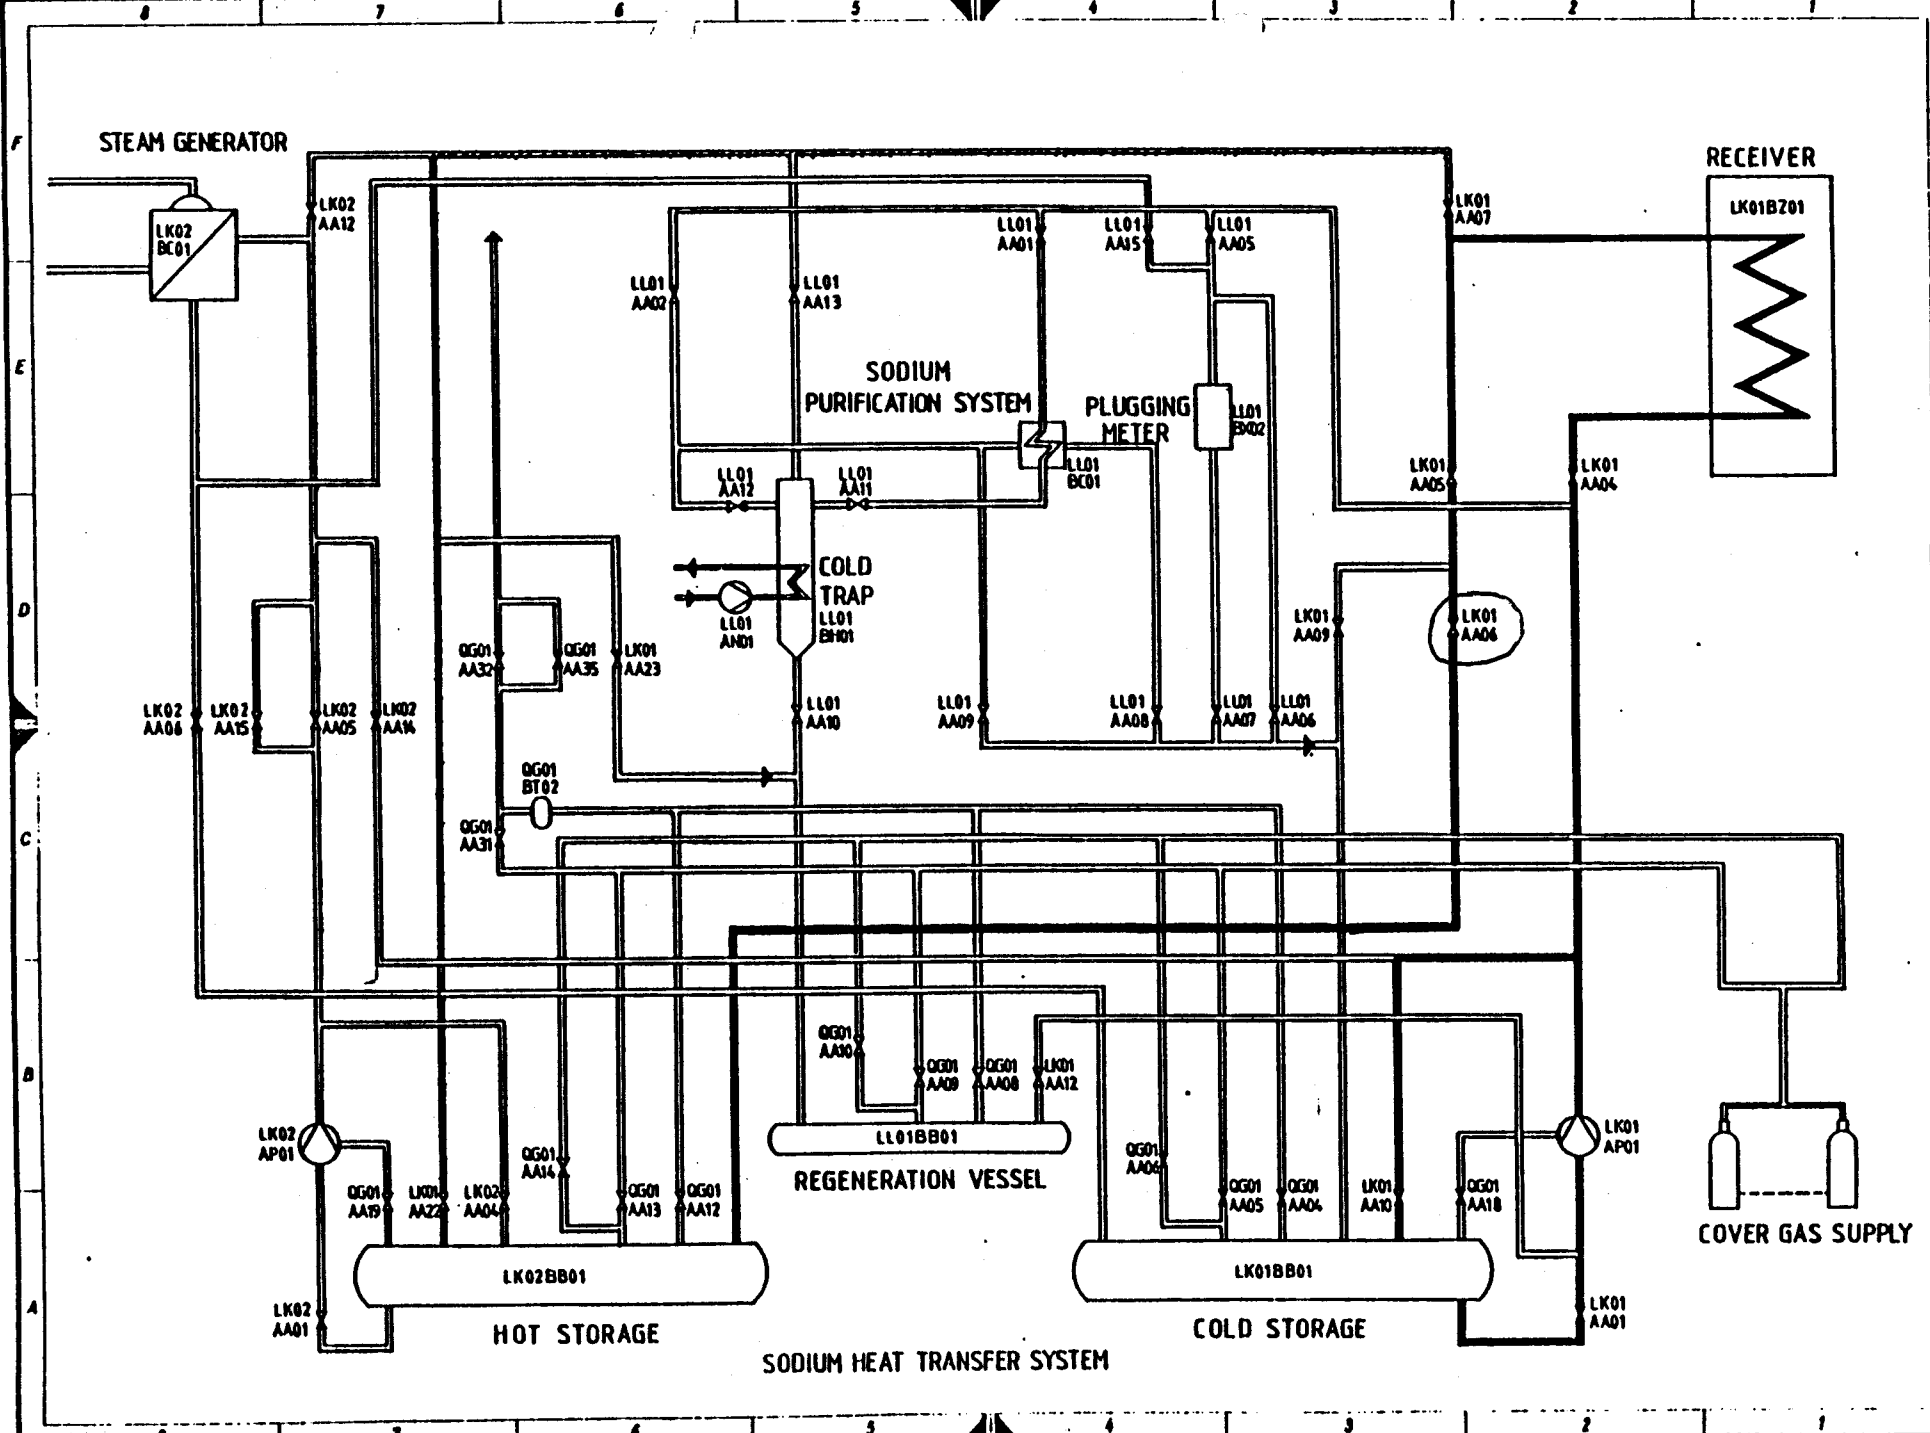
FIGURE 1

During the routine daily inspection of all the valves and components of the sodium circuit, solid or 'frozen' sodium (sodium hydroxide) was observed in the spindle (valve shaft) of valve LK01-AA06 between the valve body and motor (Figure 1) This valve is located between the receiver and hot sodium storage tank, and is located 18 m from the latter.

The reparation started at 10:00. The spindle, bellow, and connecting disk are attached to the valve body by means of the stainless steel casing and the connecting disk (Figure 1). The casting disk is clamped to the valve body (bottom clamp) with ten bolts. To ensure a hermetic seal, INTERATOM welded the connecting disk to the valve body (Figure 1), making any repair work in this area difficult.

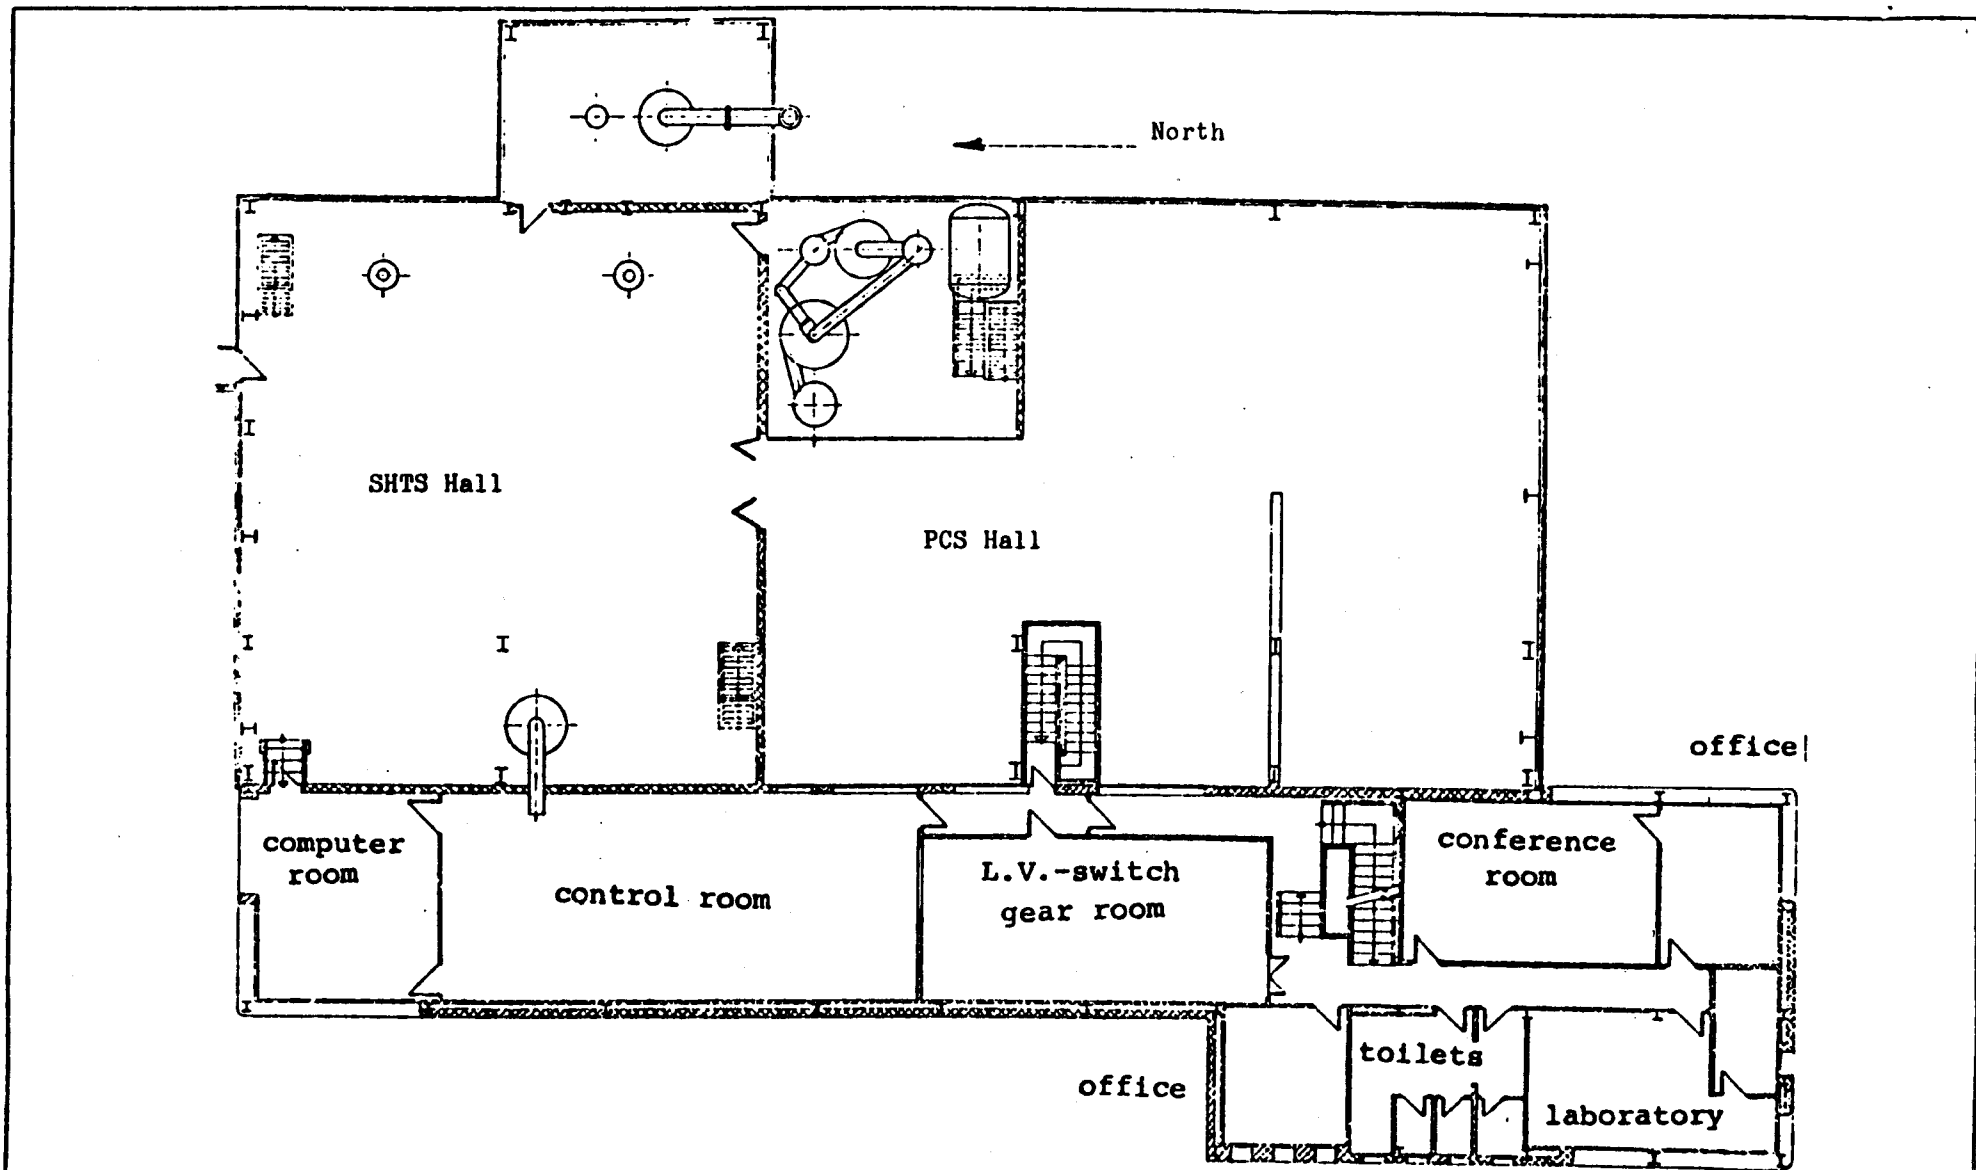
FIGURE 3

The valve being repaired was located at the North end of the SHTS Hall (Figure 3).

- The Director of the Plataforma was informed of the incident, and ordered the immediate evacuation of the plant, due to the unbearable atmosphere and possible danger of a water/sodium explosion. This action was taken due to the water storage existing in the PCS hall, adjacent to the SHTS Hall (Figures 3 and 4) within reach if the fire assumed greater proportions.

- At 13:00, the steam generator room (Figure 3) was inspected and apparently this had suffered no damage. It was decided to take the graphite from this area and use it to control points where the fire reignited.
- At the same time, the fire in the Computer Room which had started again was fought from the outside by firemen, and was wholly extinguished at 13:30. This is the room where the Director of the Plataforma burned his hands and arms when the false floor fell beneath him.
