SSPS Technical Report No. 5/83

Investigations and Findings
concerning the
Sodium Tank Leakages

edited
by
W. Bucher
DFVLR

IEA Operating Agent, DFVLR
Cologne, Germany, July 1983

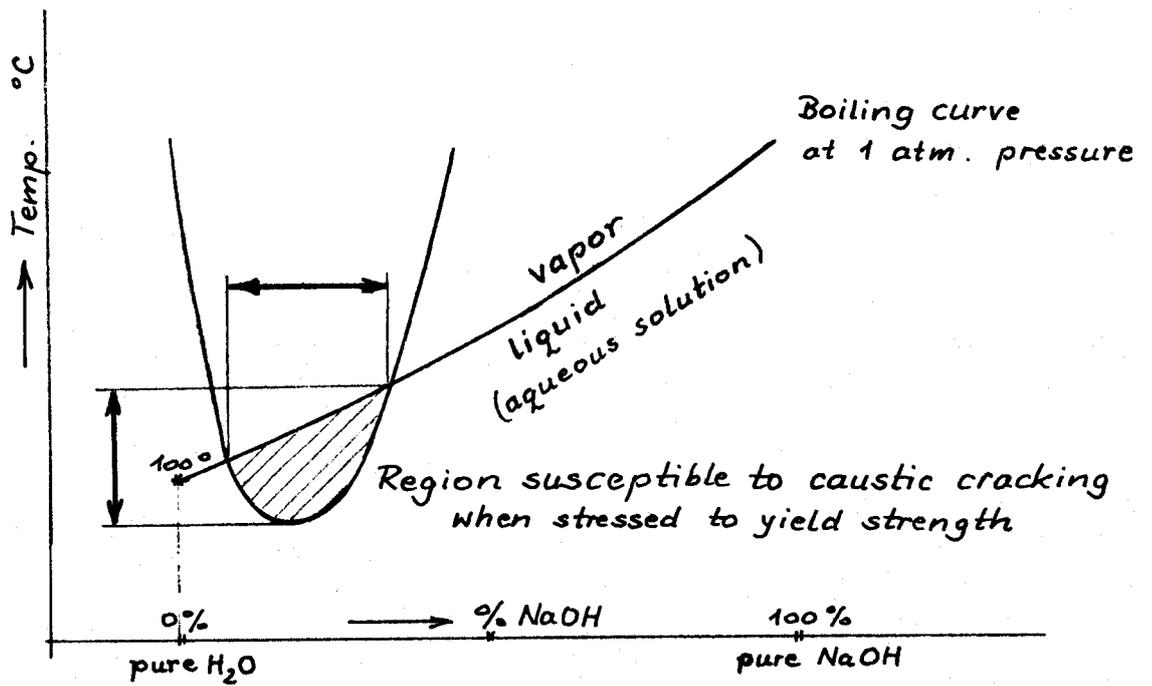
Figure 3 : CAUSTIC CRACKING OF FERRITIC STEEL

Caustic embrittlement of the weldment and heat-affected zone is much rarer for ferritic steels than for austenitic, but it will occur if highly stressed steel is subjected to NaOH of a fairly limited concentration range for fairly long times. The regenerator vessel definitely had weld-associated cracks caused by caustic embrittlement so such conditions are a potential problem for this hardware. As far as we know, the initial crack could not have had caustic present, so another embrittlement phenomenon in addition to caustic cracking is strongly suspected (unless filling, emptying, and inadequately cleaning of the cold sodium storage vessel occurred before the first failure). Once a leak has developed, contact with moist air will generate NaOH and so enable establishment of caustic cracking conditions on the outside of the vessel underneath the logging. The conditions for caustic cracking of these weldments are approximately those shown in the figure 3, but the concentration and temperature limits are not known. An additional parameter of critical importance is time to failure, which is usually many days for ferritic steels.

Lines with heavy arrows show an example of temperature range and concentration range for caustic cracking

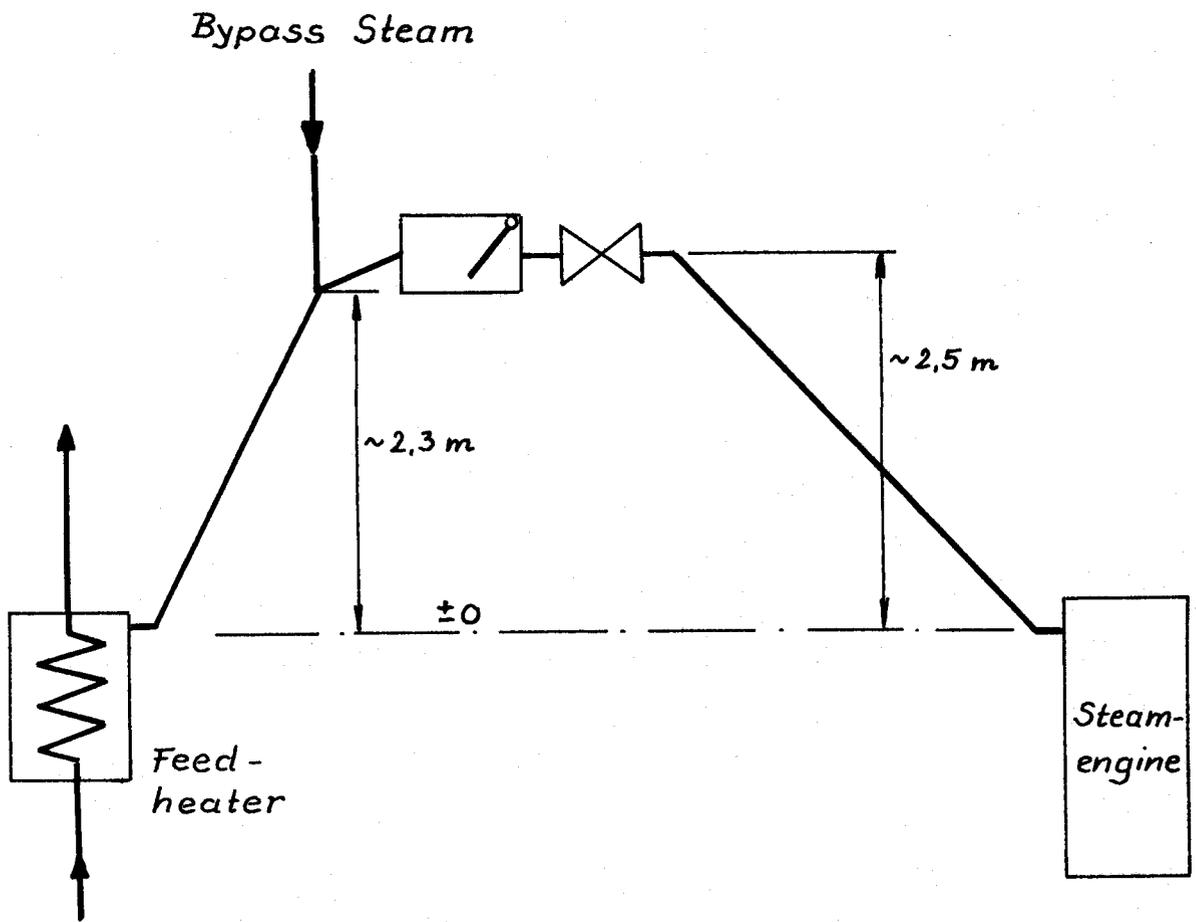
Figure 5 : BLEED LINE LEVELS , SPILLING PCS

The enclosed sketch, Figure 5, shows this arrangement. The information was phoned by Mr. Pescatore in Almeria. He could not find drains on the engine side, but the insulation makes checks extremely difficult.

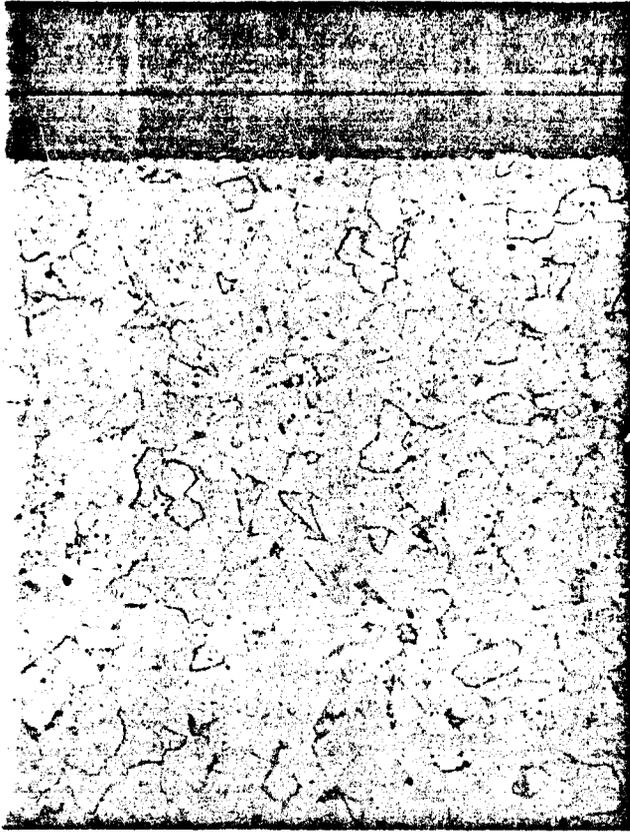
SCK Bild 25 143

— sodium side with particles
— diffusion layer (4 μm)
— eutectic- depleted zone (100 μm)

— matrix

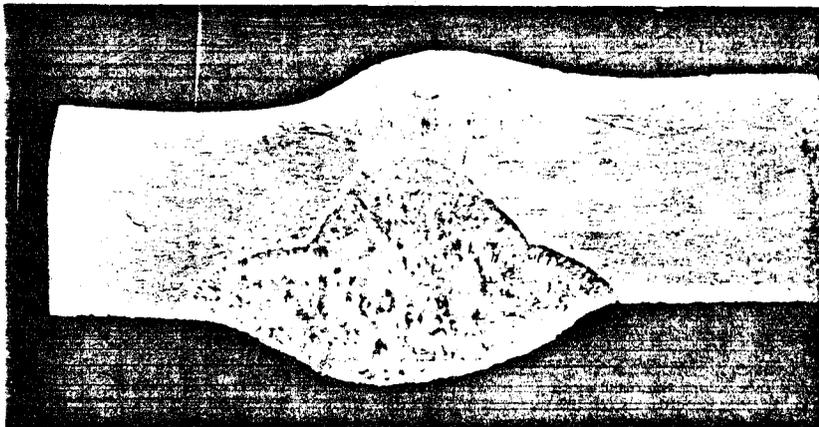
B.2

Schweißnaht im Bodenbereich (V= 3:1)

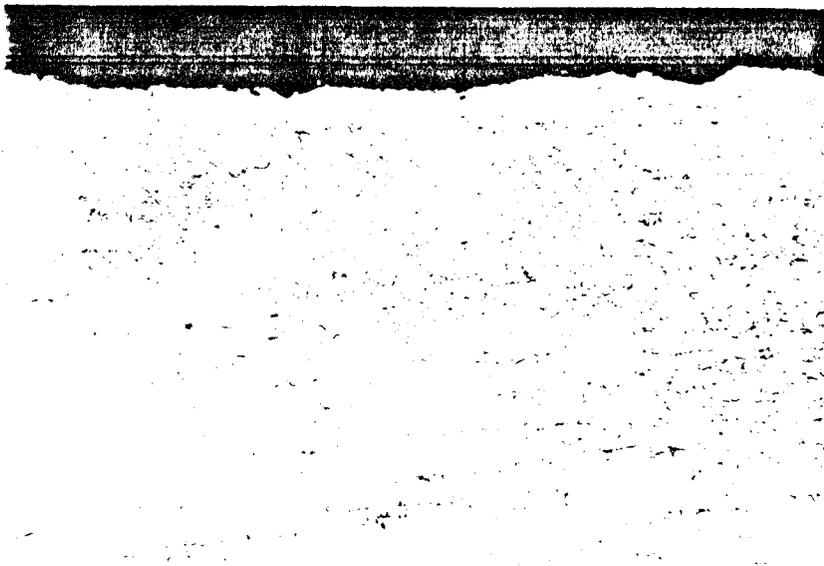
B.3

Innenseite des Bodens mit SG und WEZ (V= 100:1)

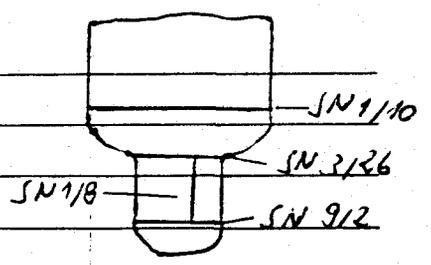
Prüfgegenstand	Werkstoff	Abmessungen
<u>Regenerationsstank Mannloch</u>	<u>15 Mo3</u>	<u>Wanddicke 12 mm</u>
<u>Bereich 100% Klöpperboden</u>		
<u>Ring, Klöpperboden bis einschließlich</u>		
<u>SN 1110</u>		
Prüfköpfe u. Frequenz: <u>MWB 45° N4; MWB 70° N4</u>		
Prüfgerät: <u>L17 2</u>		
Anforderungen: <u>in Anlehnung an AD-Merkblatt HP 513</u>		
Geprüfte Zone: <u>100% der gesamten Bereiches bis SN 1110 auf</u>		
<u>Längs- und Querschnitten</u>		
Einstellung des Gerätes: <u>Erg 0,1 mm</u>		
Prüfbereich: <u>0-100 mm SW</u>	Verstärkung: <u>nach AVG-Diagr.</u>	Auflösung: <u>✓</u>
Unterdrückung: <u>✓</u>	Imp.-Stärke: <u>✓</u>	
Ankopplung: <u>Kl. 5 Ker</u>	Prüfkopf <u>angeschliffen/nicht angeschliffen*</u>	
Oberflächenbeschaffenheit: <u>beschliffen</u>		
Ergebnis der Prüfung: <u>Keine registrierpflichtigen Anzeigen</u>

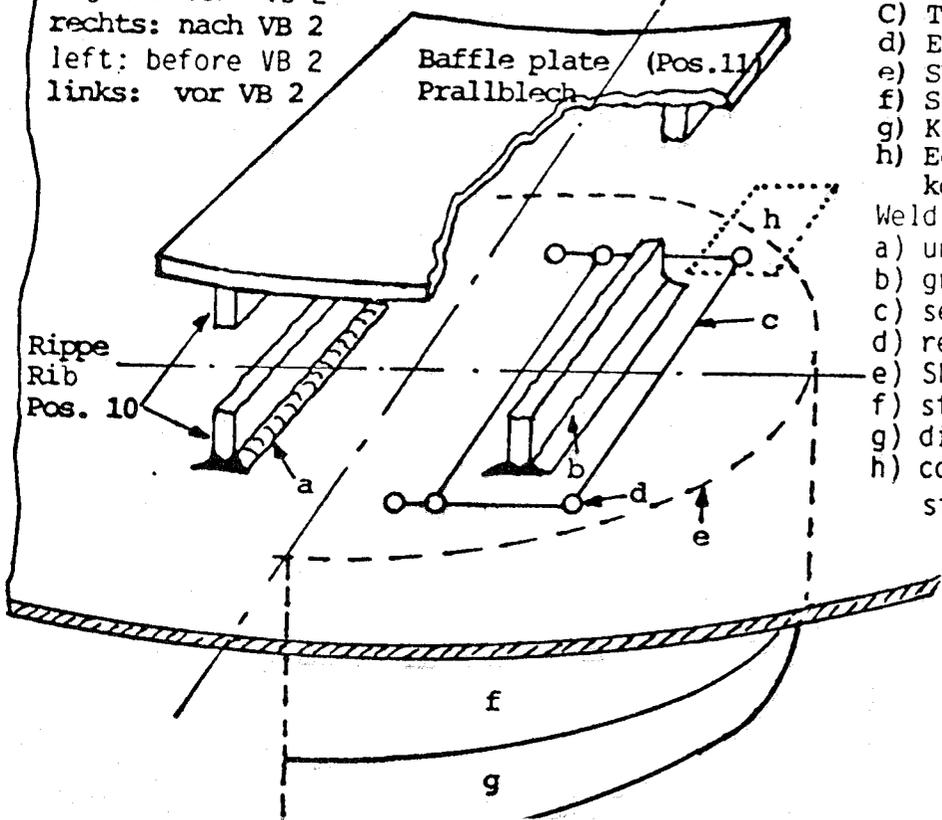
Welding seam SN 4

- a) unground side
- b) ground side
- c) severance cuts
- d) relief boreholes
- e) SNR 5
- f) stud
- g) dished head
- h) corners of high stress concentration

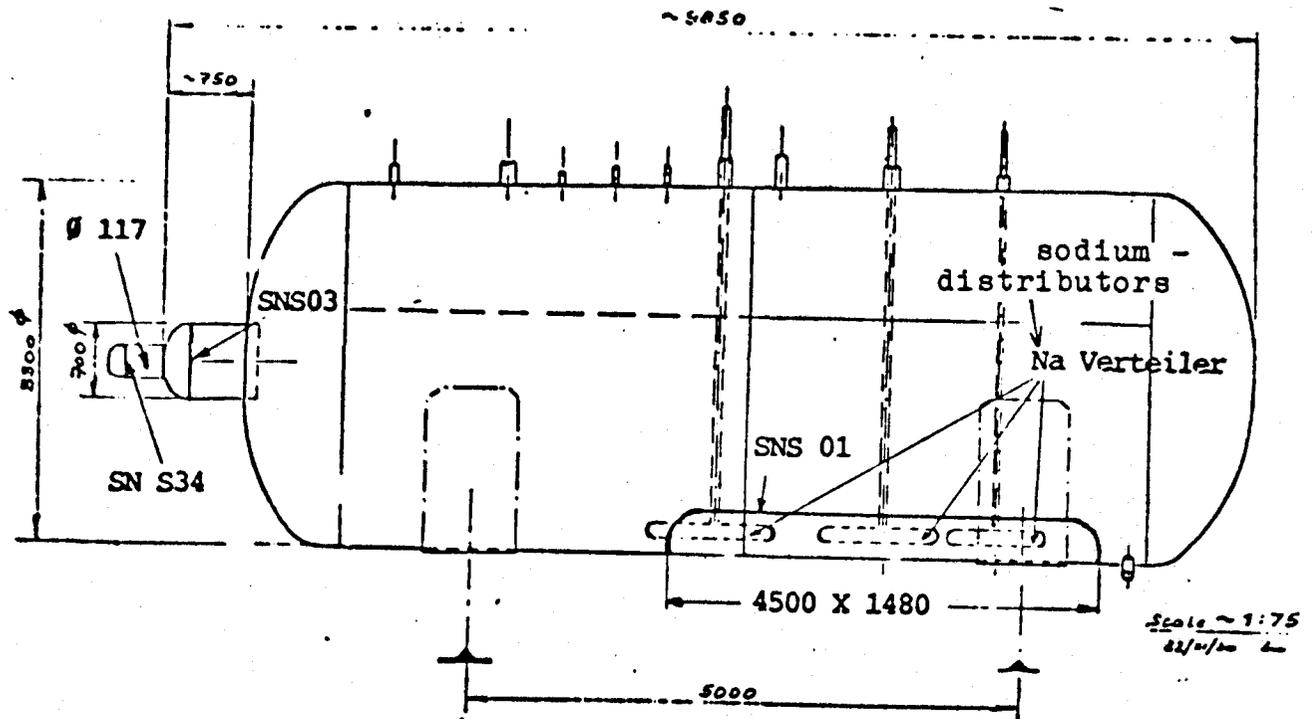
Vessel after the repair:

Requirement according to AD-Merkblatt HP 20	Out-of-roundness $\leq 2\%$ related to the vessel diameter $\hat{=} 66$ mm	Straightness $\leq 0.5\%$ of the cylindrical length $\hat{=} 36.3$ mm
Anforderungen nach AD-Merkblatt HP 20	Unrundheit $\leq 2\%$ bezogen auf den Behälterdurchmesser $\hat{=} 66$ mm	Geradheit $\leq 0,5\%$ der zylindrischen Länge $\hat{=} 36,3$ mm
Prior to repair Vor der Reparatur	8 mm	7 mm
After repair Nach der Reparatur	26 mm	10 mm

- Inner surface ground down to the plate surface in the area around SN S01 and SN S03
- Innenoberfläche blecheben beschliffen im Bereich der SN S01 und SN S03.
- Installation of sodium distributors with sodium - outlet to the top
- Einbau von Na-Verteilern mit Na-Austritt nach oben.
- Rigidity
- Formhaltigkeit

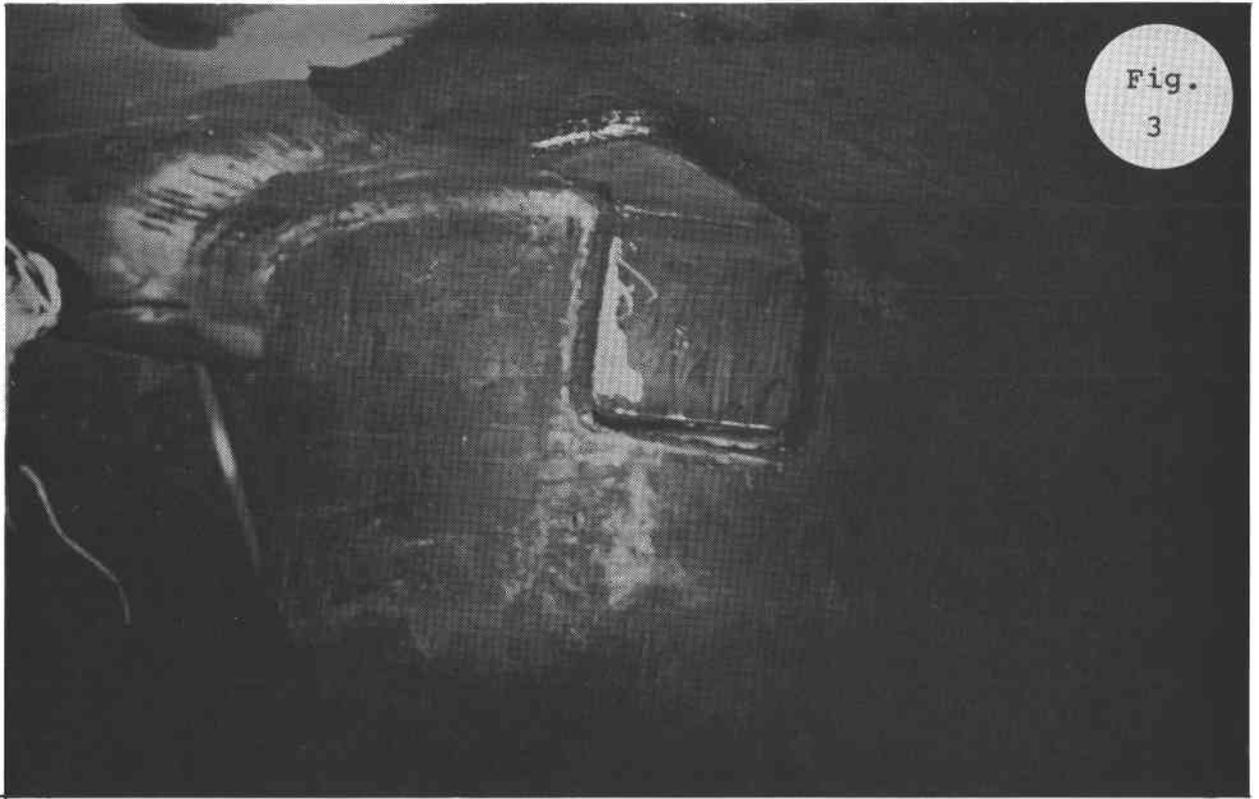
Fig.
3

In order to permit the performance of a continuous test programme, the defects were covered by makeshift cover plates, see Figs. 3 and 9.

The approximately 3 week operating period after completion of the temporary repair (cover plates Figs. 3 and 9) was used to determine the level of the wall temperature in the damage area during operation and to establish its temporal change. The highest measured temperature amounted to 297° C in the area shown in Fig. 5 beside the forked crack on the outside of the vessel. The maximum temperature change velocity was 4.5 K/min.

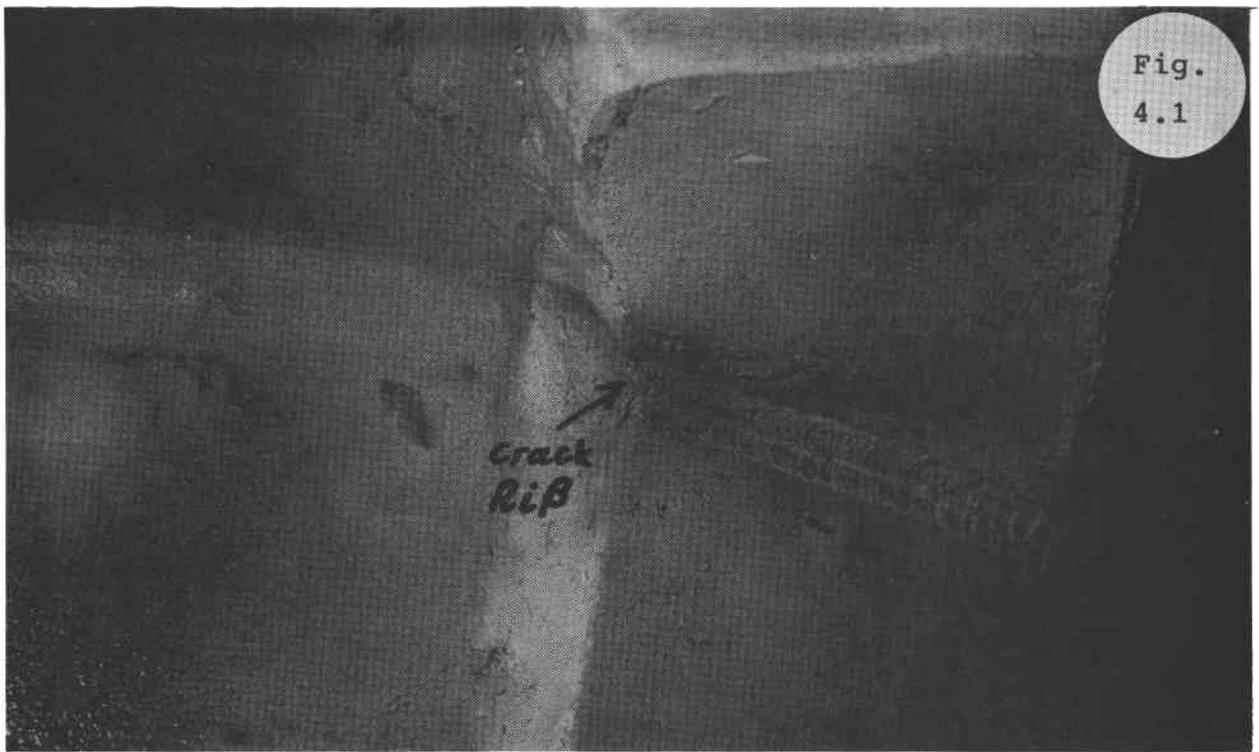
Fig.
4.1

Sodium leakage at both gussets of the cover plate-welding seam, see Figs. 4.1 and 4.2.

Crack
Riß

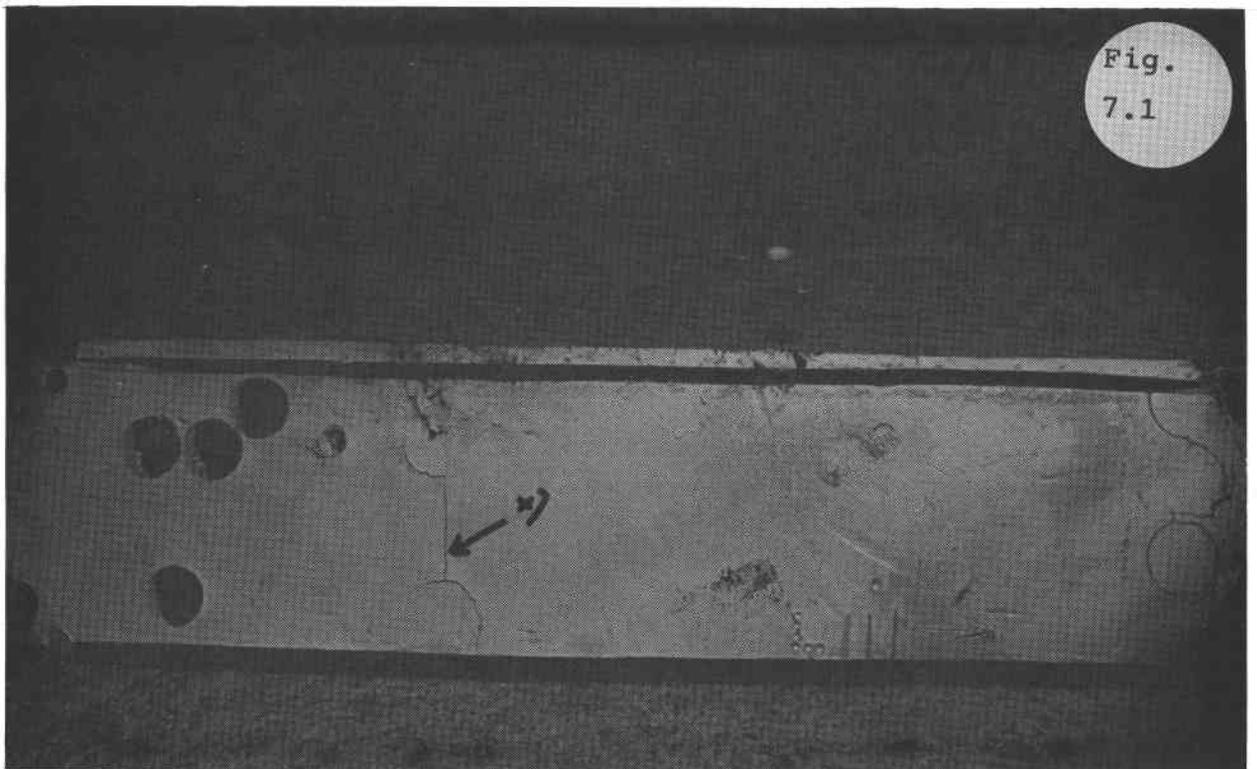
Sodium leakage in weld area SN 4, crack at right angles to the weld, see Fig. 7.1.

After removing the baffle plate weldings from the vessel wall, these were subjected to a magnetic particle inspection. The pictures were obtained using black magnetic particles on white contrast colour. The transverse cracks which were detected and are identified in detail in the pictures are located at notches. The crack displayed in Fig. 7.1 caused the first vessel leakage (VB 1). The visible

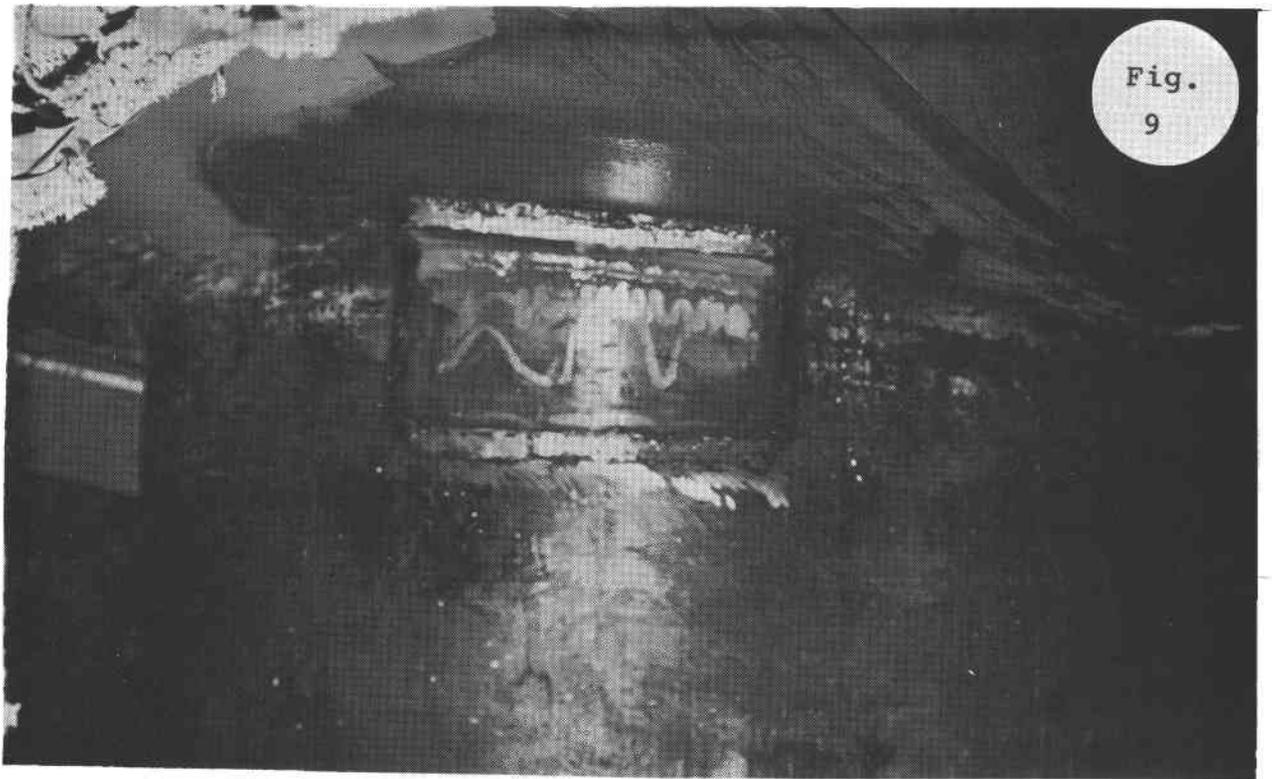
Fig.
9

Crack, Fig. 8 covered with plate during temporary repair.

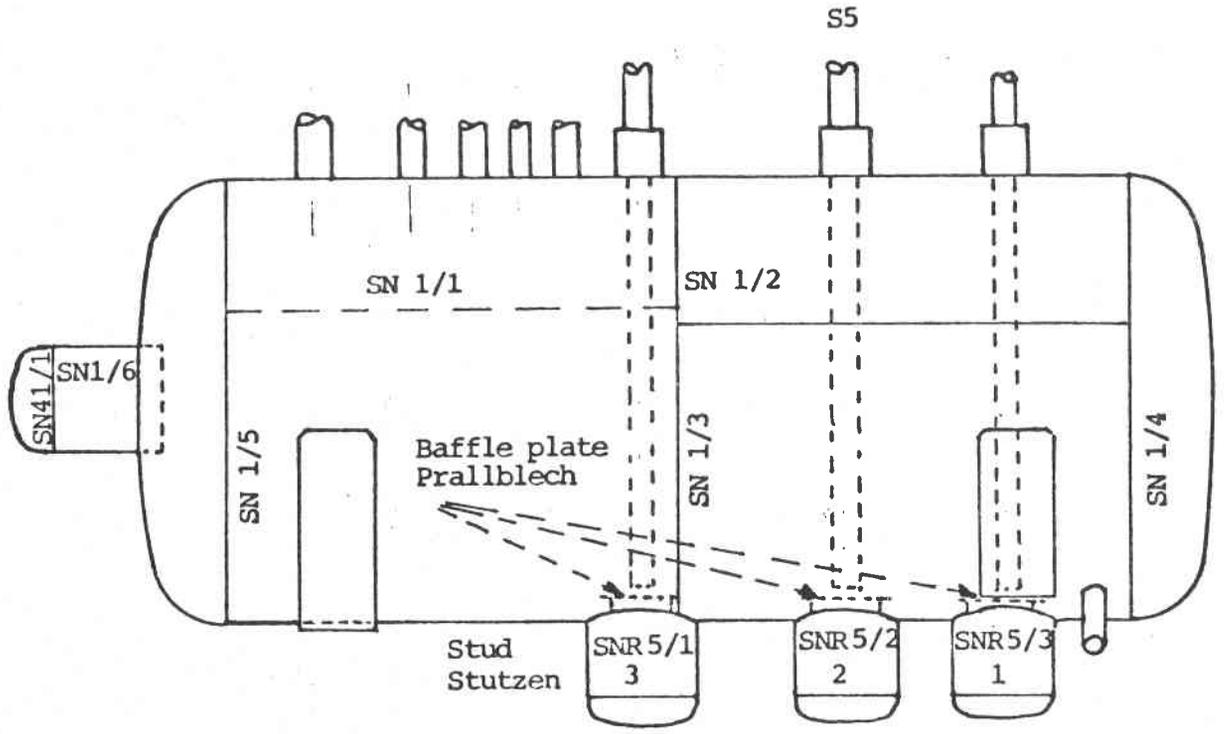
↓ Damage location
Schadstellen

Supplied vessel section with separated stud

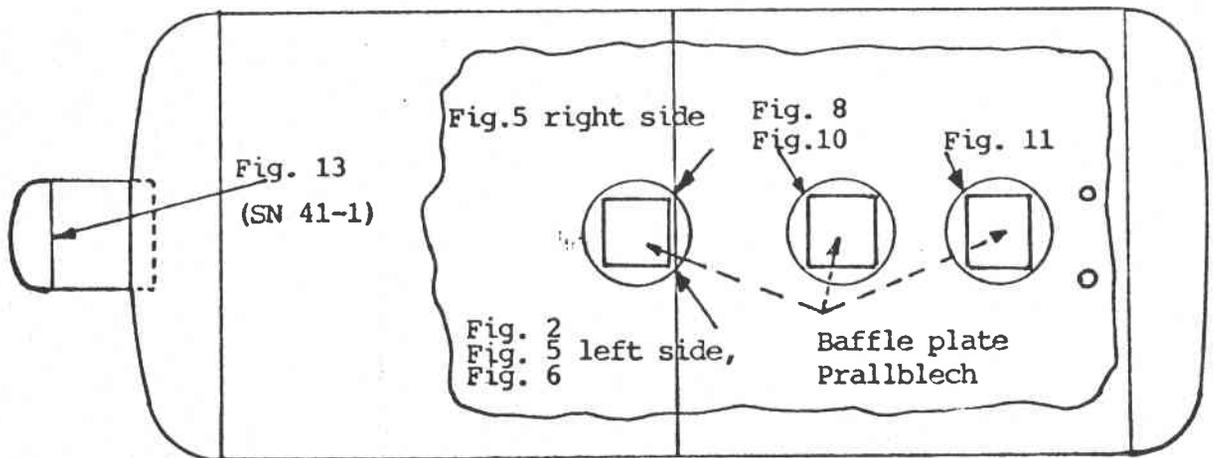
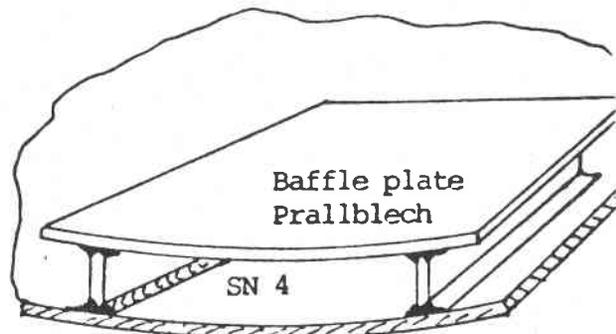
Fig. 7.3/12

SN = Welding Seam
SNR = Repair Welding Seam

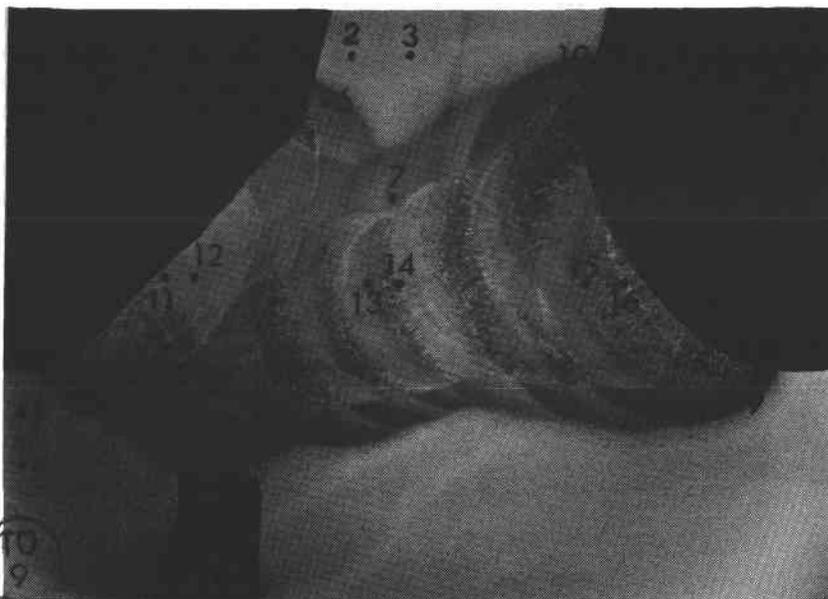
Sample No.: 1.1

1.	1.2	Web 1, Longitudinal microsection (location see Fig. 2)	The microsection is located in a part of the sample with 2 ultrasonic indications. However, no defect could be detected in the microsection itself (no illustration).

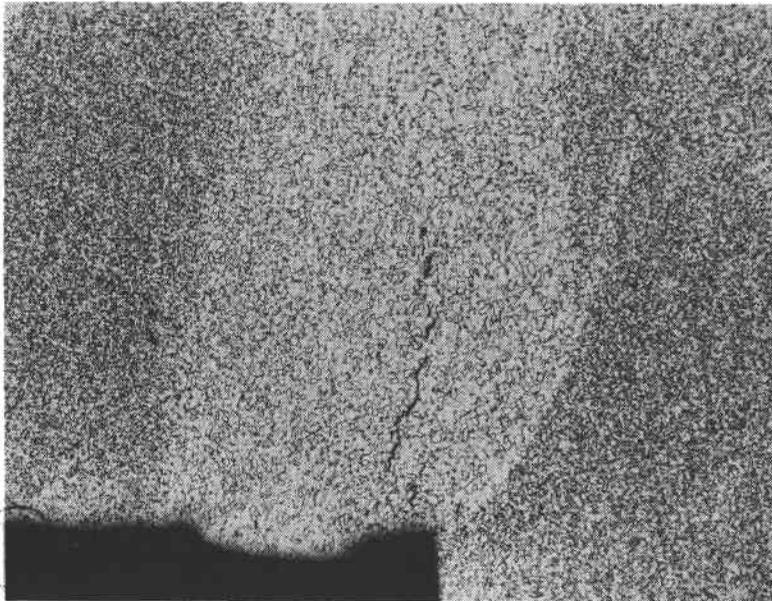
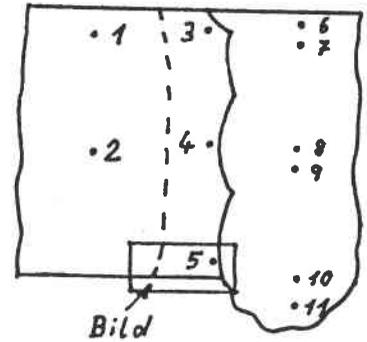
Sample No.: 4.1

Sample No.	Microsection No.	Point of removal	Results
4.	4.1	Manhole transverse microsection, location Figs.7+8	There was a crack with a mainly inter-crystalline course in a decarburized zone beside the root pass. The crack appearance was similar to that in Fig. 15. A survey photo and the determined hardness values are listed in <u>Annex 2, Page 6</u> .

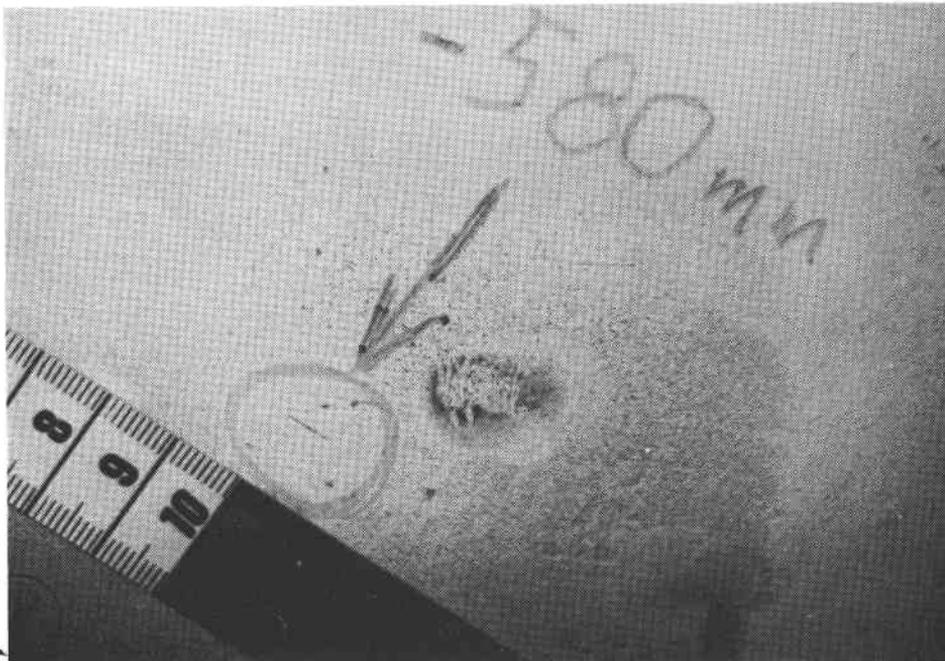
2 Manhole weld segments	Magnetic particle	Several crack indications both longitudinal and at right angles to the welding seam (<u>Figs. 7 and 8</u>).
2 sodium inlet lines	Magnetic particle and dye penetration test	The pipes were cut through longitudinally and tested inside and outside. No indications were found (no illustration).
Stud weld (see Fig. in Annex 0)	Magnetic particle	4 crack indications in the weld metal on the inside of the stud (<u>Fig. 9</u>) and one along the weld in the base material on the casing side (<u>Fig. 10</u>). Crack locations : + 75, + 460, + 735, - 125 measured from the zero point.

Fig. 10 Indications in the base material opposite the stud weld

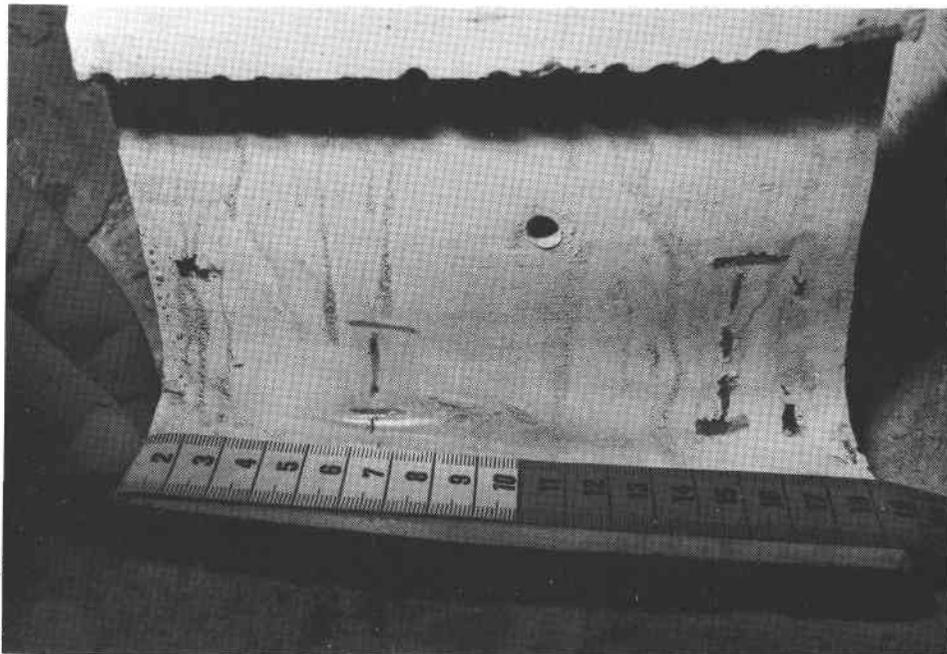
Fig. 12 Rear view of the sample from fig. 11

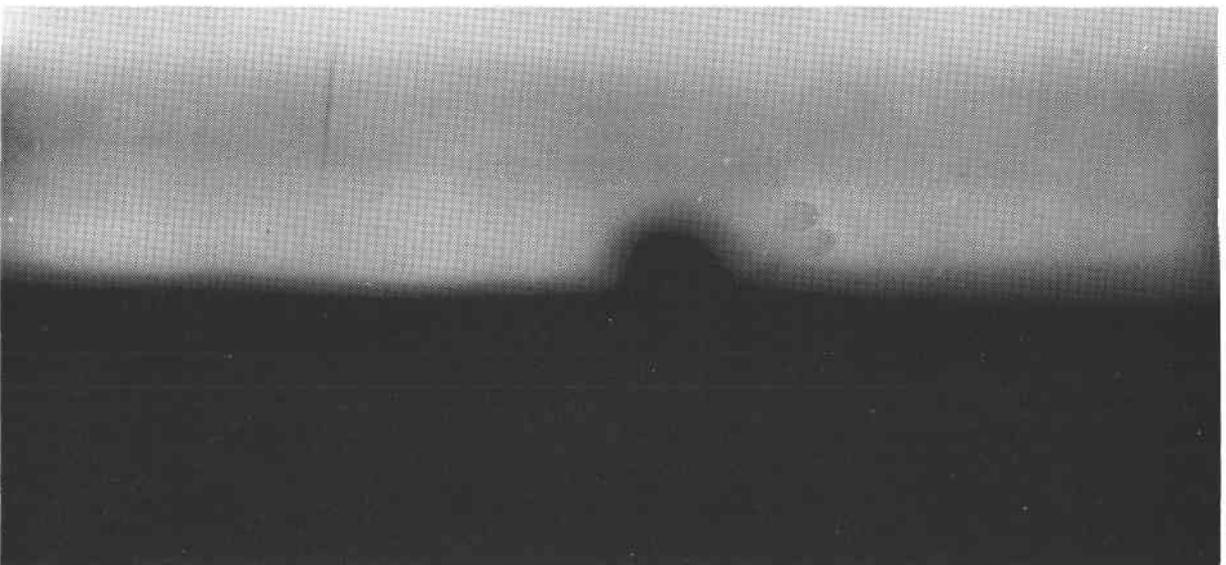
The radiographic inspection of Samples 1,2 and 3 shows that the crack indications are finely branched in the base material and that some of them run on several planes in the material (Figs. 12a and 12b).

Fig. 12b X-ray indications in the stud

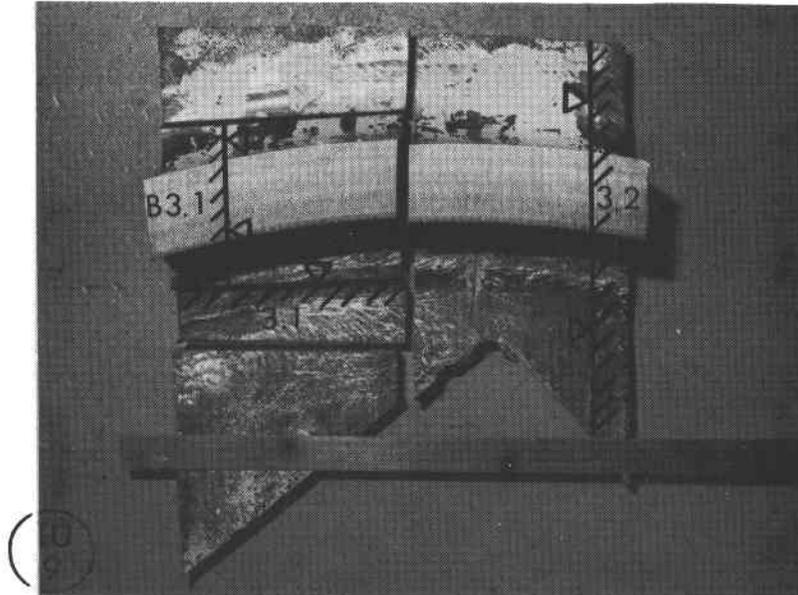
Fig. 13 Division of sample, sample 3

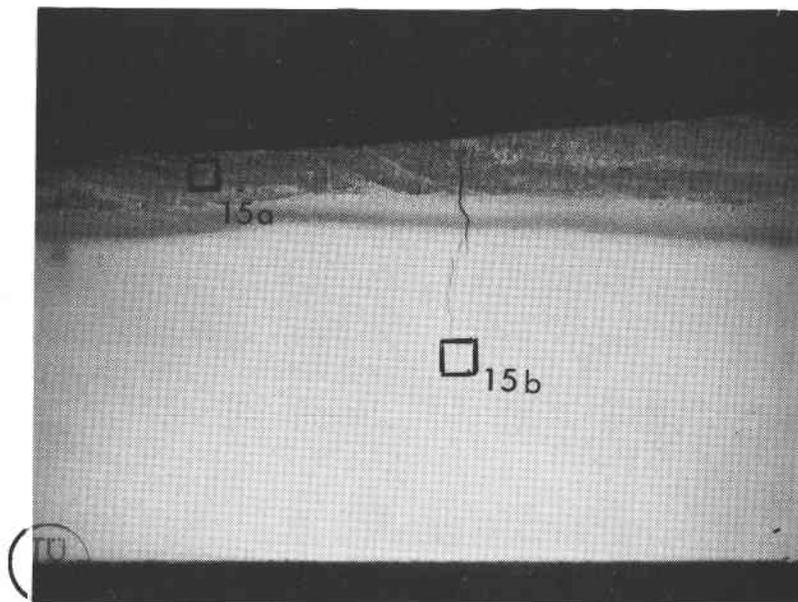
3.	3.1	Stud longitudinal microsection (location see Fig. 13)	The microsection was taken through the crack in the weld metal presented in Fig. 5, left. The 2 cracks shown in Fig. 14 appeared in the weld metal, one of these continued into the base material. In Figs. 15a and b one can see that the faults in the weld metal and in the base material are both inter- and transcrystalline.

Fig. 14 Survey microsection 3.1 3:1

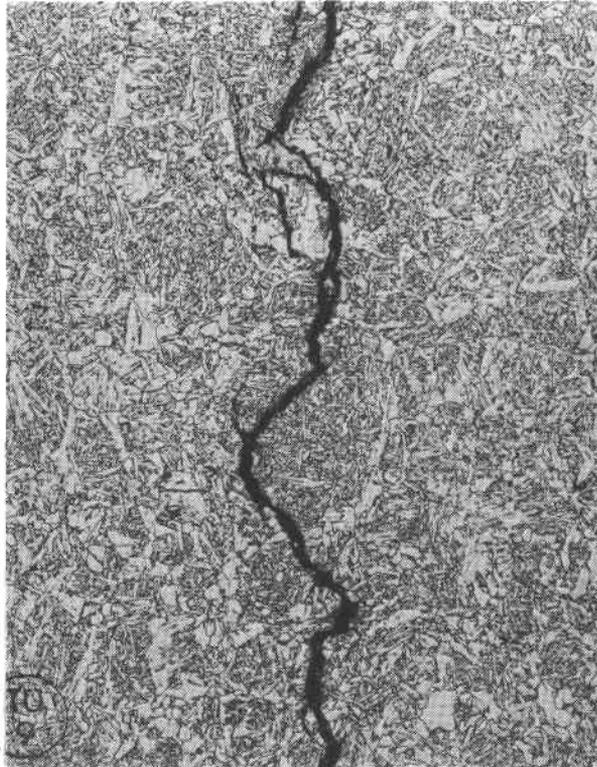
Fig. 15e

4.	4.2	Manhole longitudinal microsection, location Figs.7 + 8	A crack with a mainly transcrystalline course starts from a surface notch of the root welding. After approx. one third of the crack length, it passes through a pore in the weld metal. The crack is partially branched and approx. 6 mm long. Survey and detailed photos are presented in <u>Figs. 15 c to 15 f</u> .

Detail from Fig. 15c, centre of crack

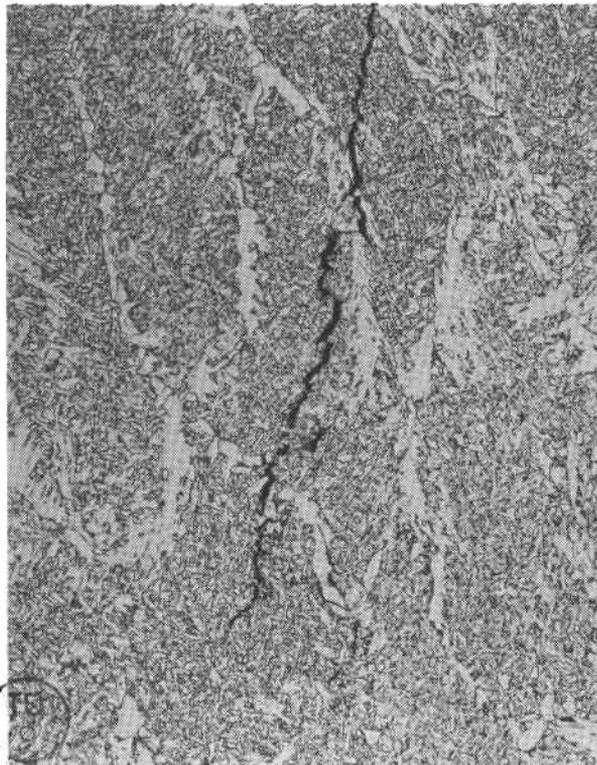
Fig. 15f

Detail from Fig. 15c, termination of crack

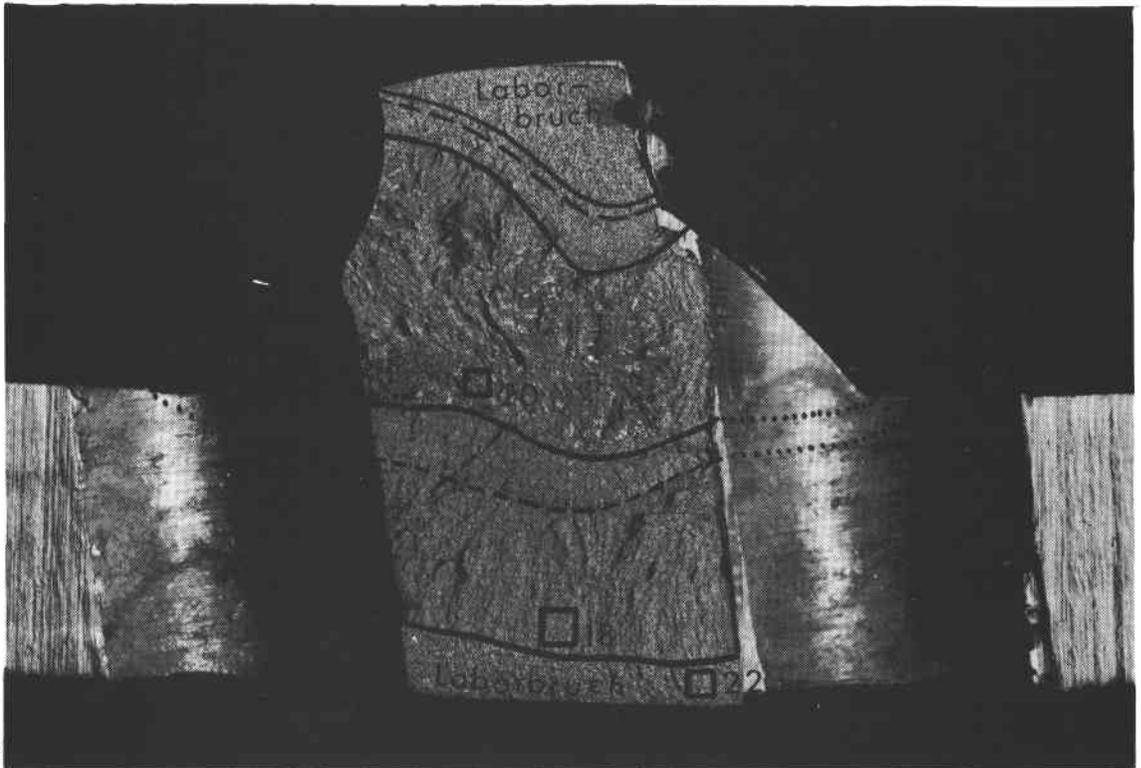
Fig. 16

2.	B 2.1	Web 2 bored crack in web plate	After separation of the material to the left and to the right of the boreholes, the sample was cooled in liquid nitrogen and the fracture surface was exposed. <u>Figs. 16 and 17</u> present the fracture surface, and, as a comparison, a transverse microsection from the same sample. <u>Figs. 18 - 23</u> show details from the base material, weld metal and laboratory fracture. One can see that the fracture in the base material is essentially intercrystalline (Fig.19), while that in the weld metal is basically transcrySTALLINE (Figs. 20 and 21). The laboratory fracture was a pure cleavage fracture.
3	B 3.1	Stud crack from microsection 3.1 (Fig.13)	After removal of the microsection 3.1, the remaining part of the crack was exposed. <u>Fig. 24</u> presents the fracture surface. In order to facilitate orientation, the fusion lines were drawn in using the microsection picture and the fracture structure. The outlines of the damaged areas are marked with dotted lines. It is evident that the crack started from a pore (<u>Fig. 24a</u>) on the inside of the stud, which reaches to the surface of the weld, and that it has passed through approx. 75 % of the wall thickness in this case. As in sample "B 2.1", the weld metal and the adjacent base material zones were damaged. <u>Figs. 25 and 26</u> were taken in the damaged part of the sample and show the interface between weld metal and base material. The fracture appearance therefore resembles that of sample B 2.1.

Fracture surface "B 2.1"

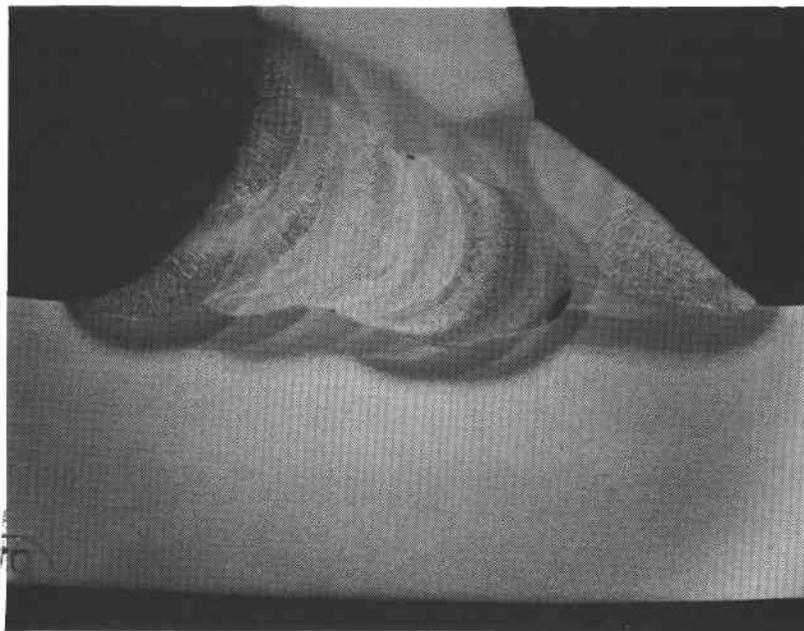
Fig. 17

Weld buildup

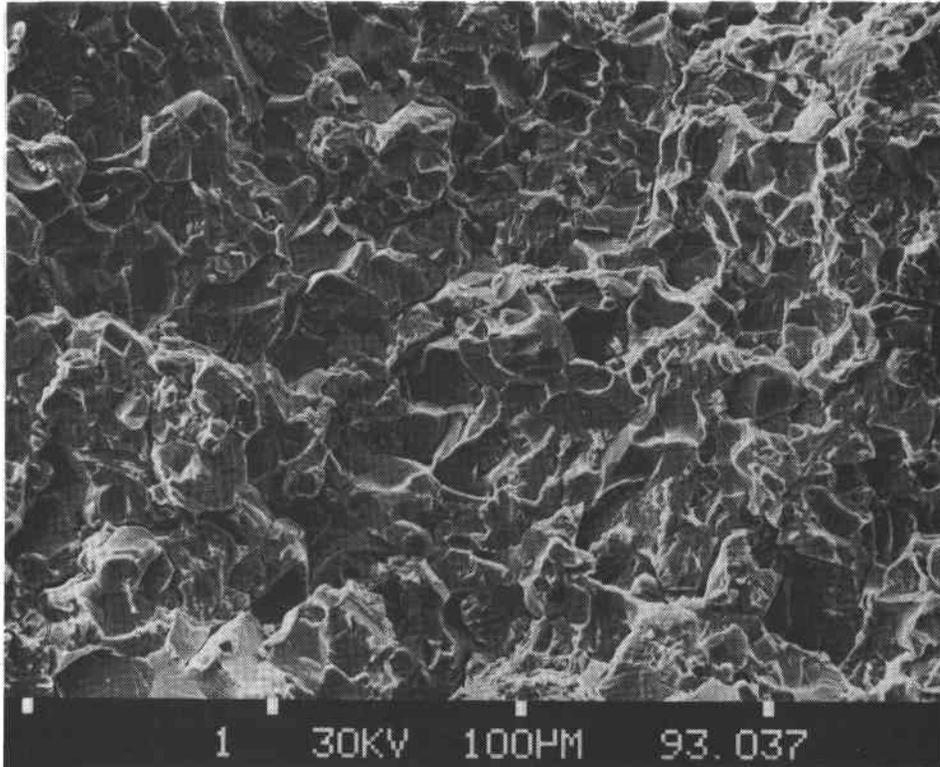
Fig. 18

The course of the crack is primarily intercrystalline in the base material (Figs. 18 and 19) while the weld metal mainly exhibits transcrystalline fracture with clear intercrystalline fractions (Figs. 20 and 21).

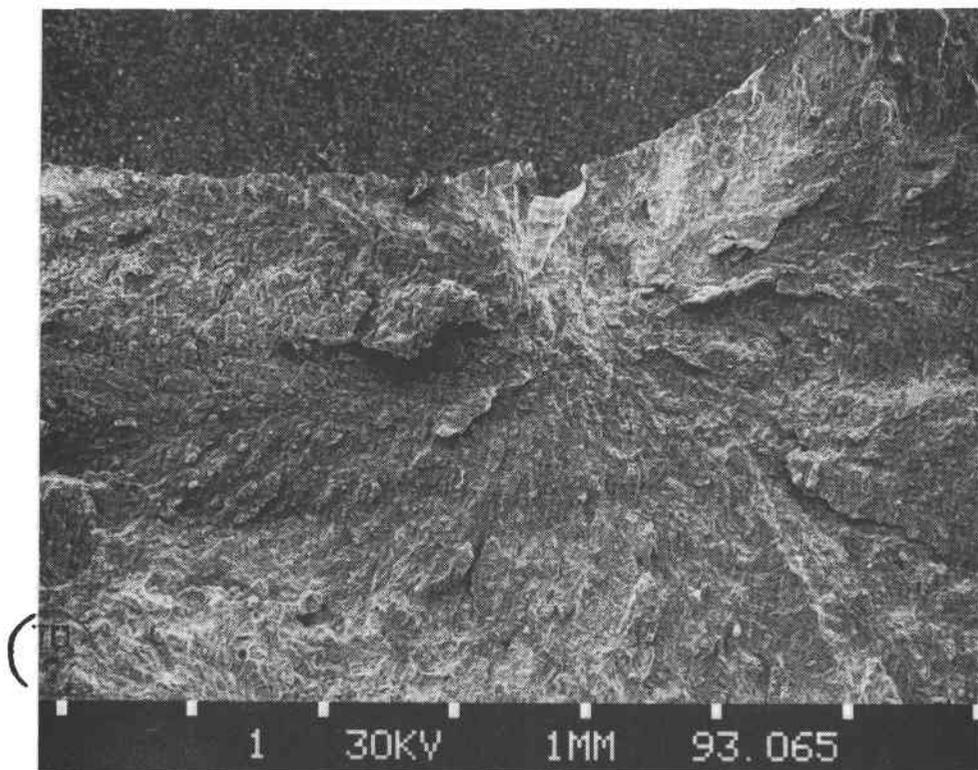
Fig. 24a Detail from Fig. 24

Welding flaw

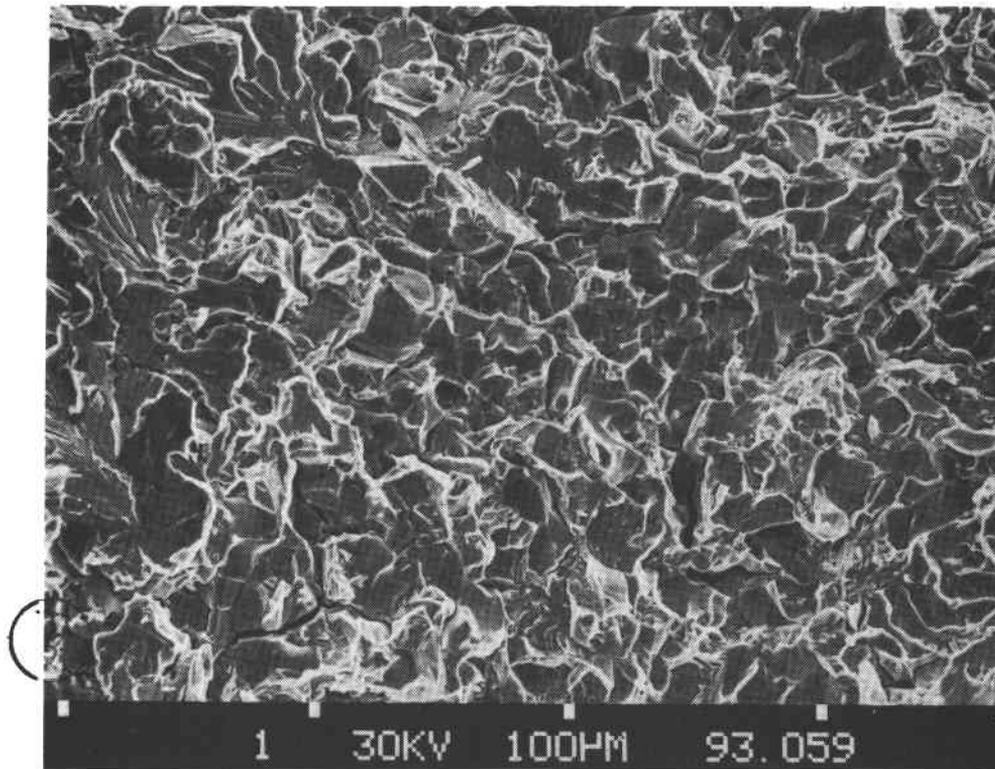
Fig. 25 Detail from Fig. 24 300:1
Interface between weld metal and base material

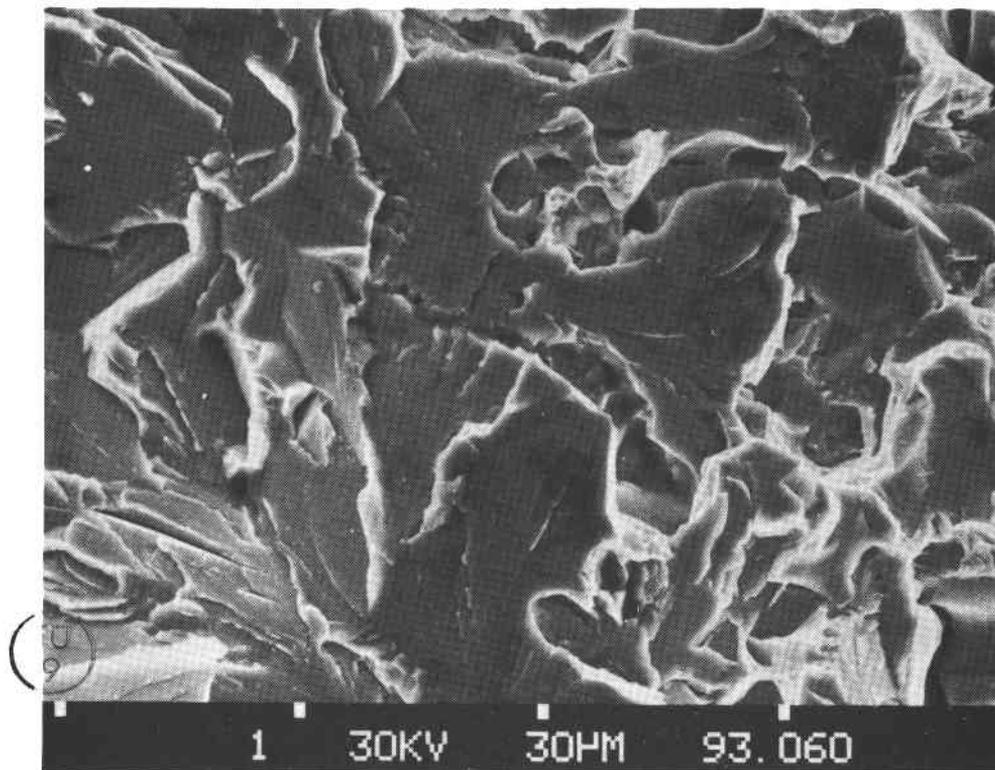
Fig. 26 Detail from Fig. 25 1000:1
