SSPS Technical Report No. 5/83

Investigations and Findings
concerning the
Sodium Tank Leakages

edited
by
W. Bucher
DFVLR

IEA Operating Agent, DFVLR
Cologne, Germany, July 1983

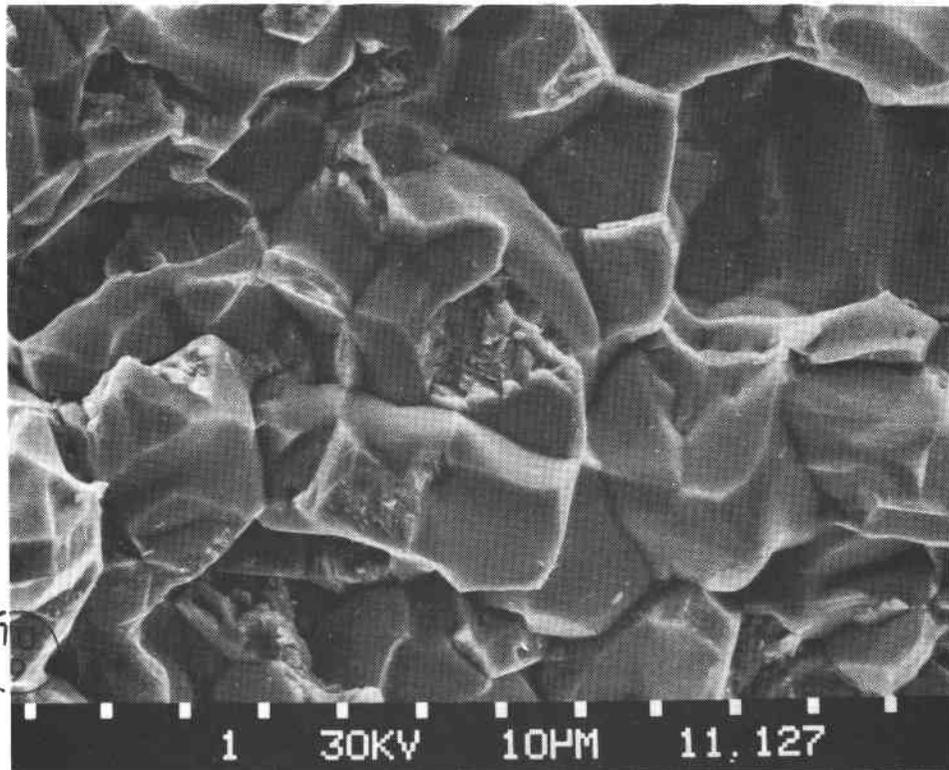
Fig. 27 Fracture surface base material 1000:1
Jones simulation sample in NaOH

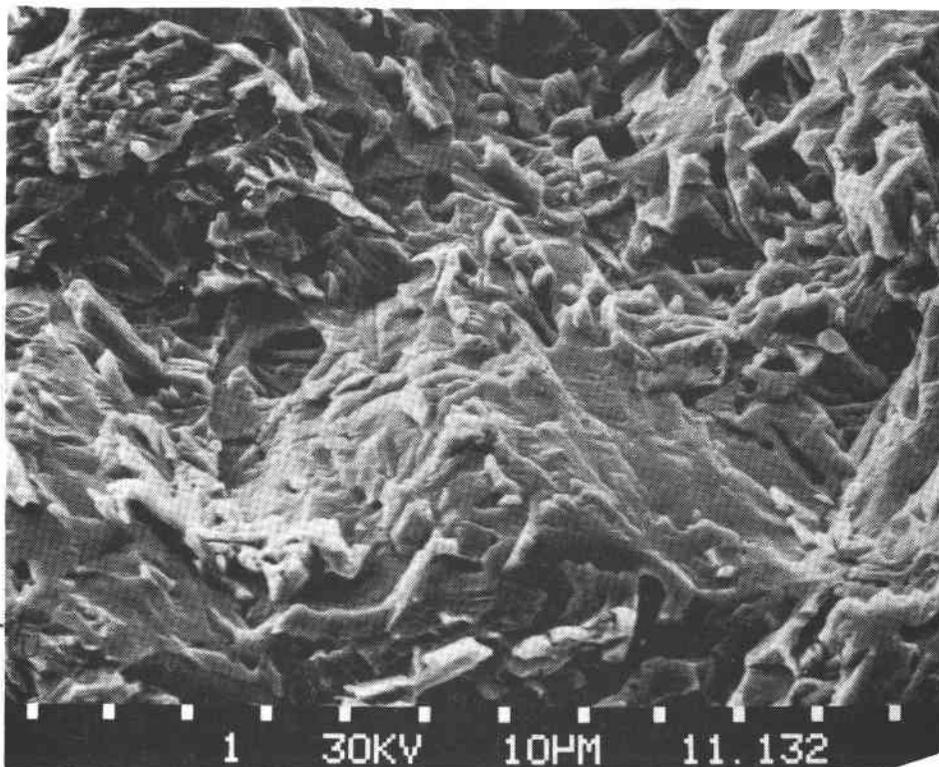
Fig. 28 Fracture surface weld metal 1000:1
Jones simulation sample in NaOH

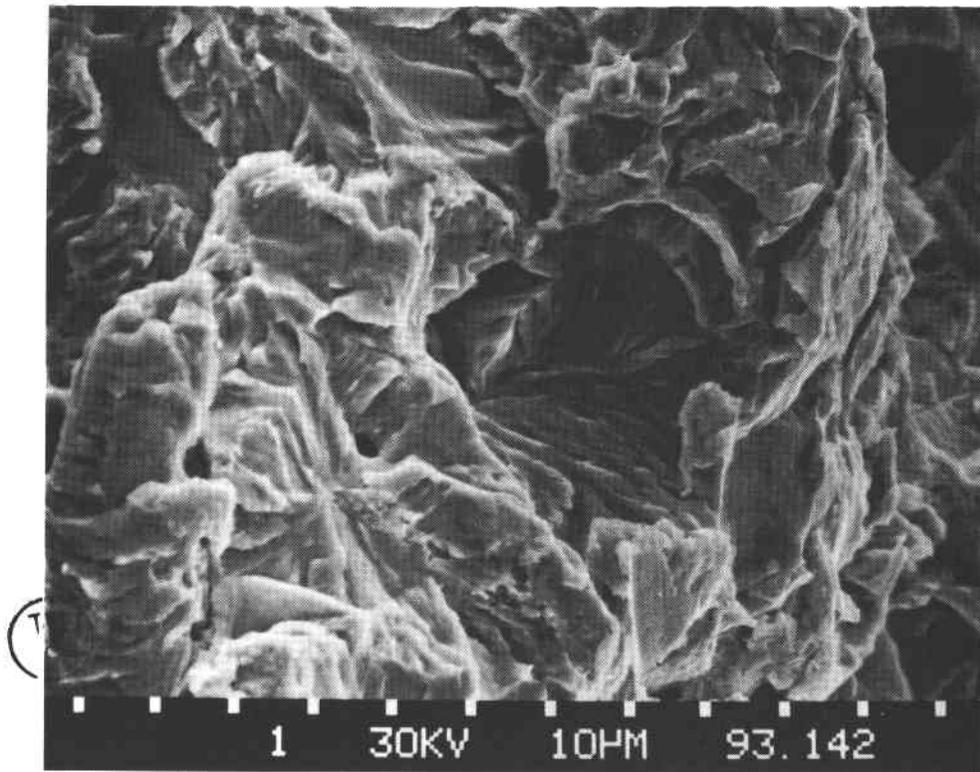
Figs. 31 and 32 present the transcrySTALLINE fracture surfaces which were obtained in the base material and the weld metal. One can see, that these clearly differ from those produced in caustic soda solution and also from those which were present in the damage case.

Fig. 31 Fracture surface base material 1000:1
Jones simulation sample in H₂S

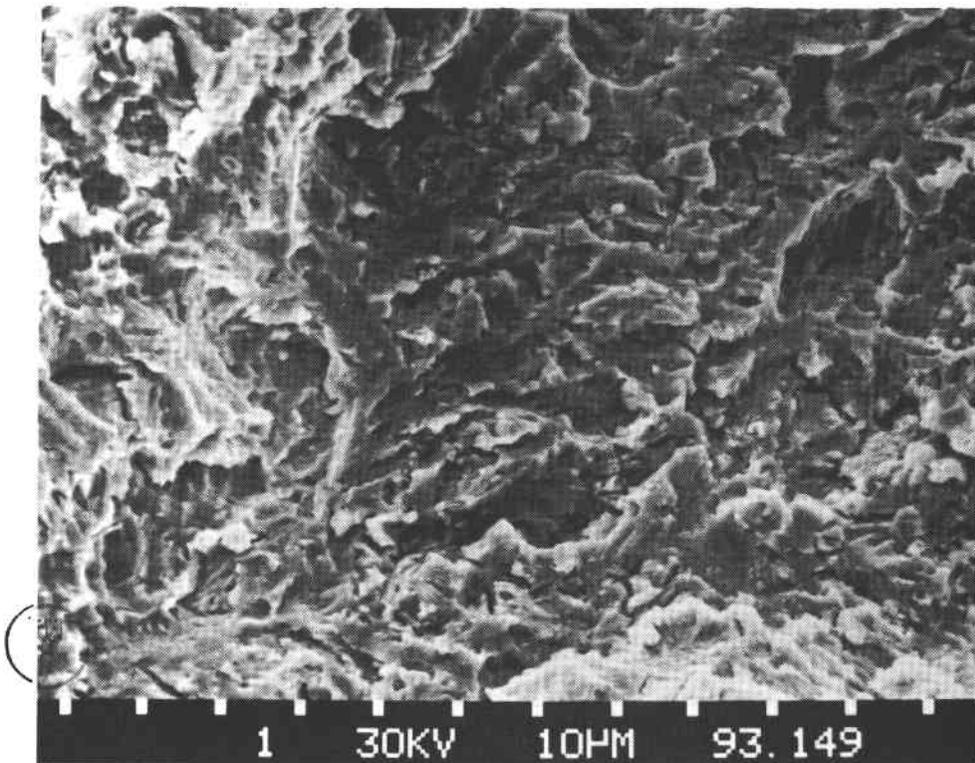
Fig. 32 Fracture surface weld metal 1000:1
Jones simulation sample in H₂S

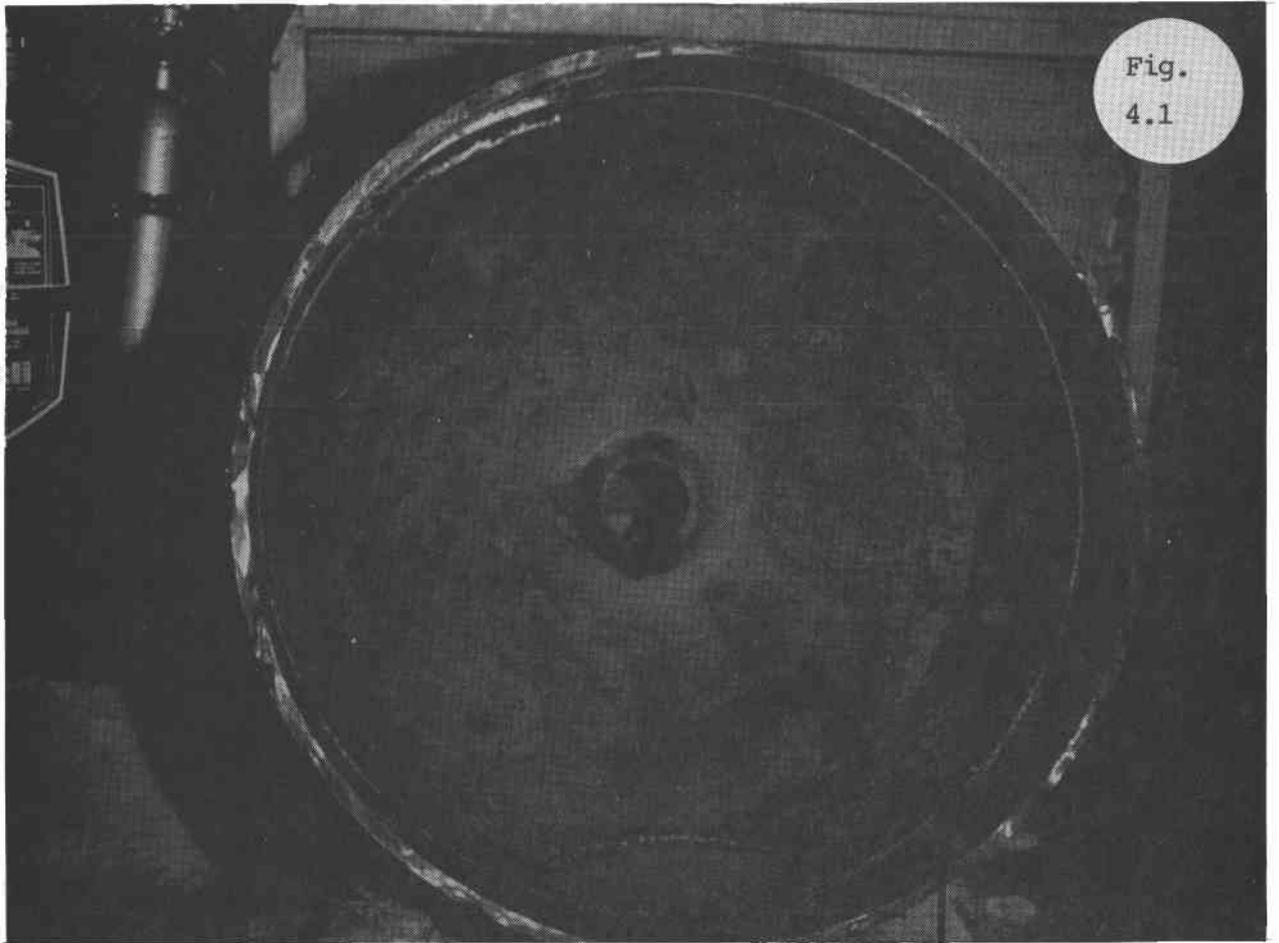
Sodium leakage at both gussets of the cover plate-welding seam, see Figs. 4.1 and 4.2.

The total root pass SN 9/2 is illustrated in Fig. 4.1 (without the sample Fig. 3.2). It exhibits poor formation over large sections, e.g. drops, severe root ripples and notches in longitudinal and transverse direction, Fig. 4.2. Three adjacent root beads indicate a multiple repair in the root area in Fig. 4.2.

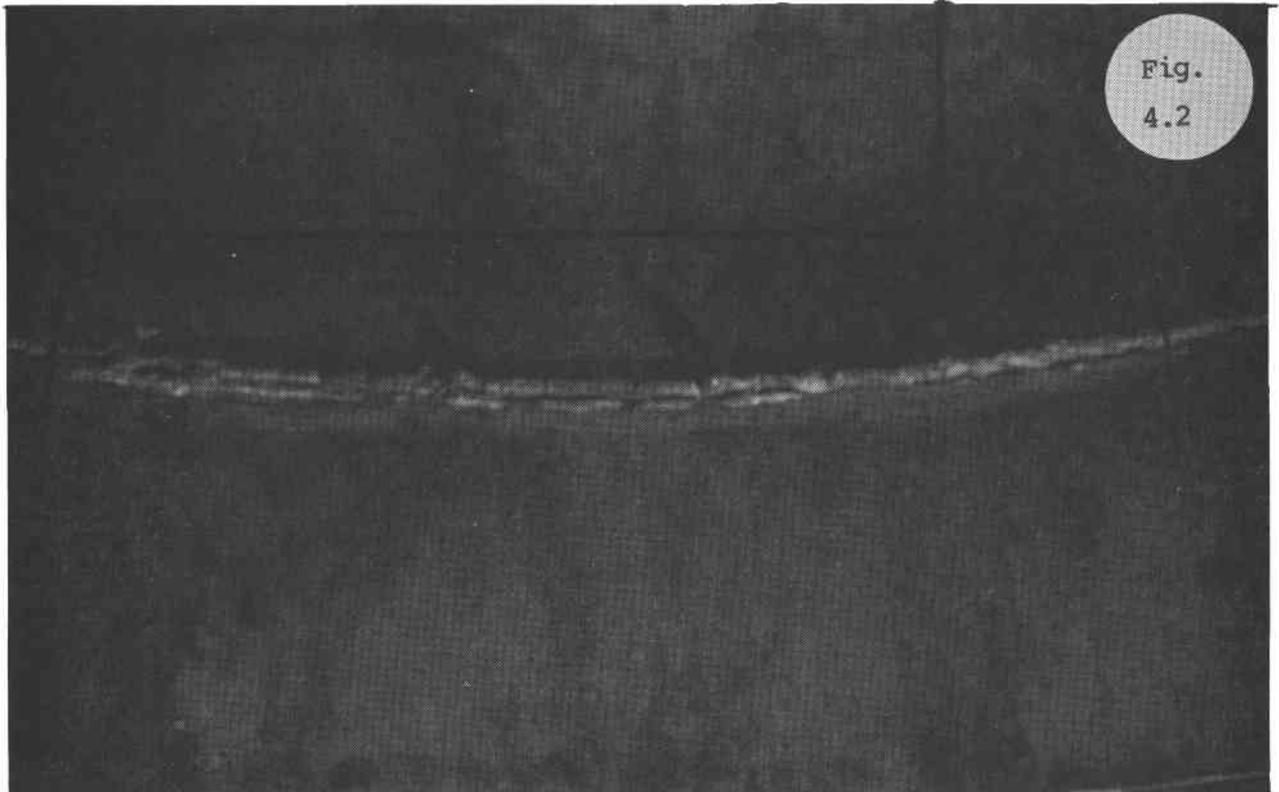
Fig. 4.2 gives an impression of the manufacturing quality. A horizontal multiple repair has been performed in the area X. The dripping liquid metal drops (see Point 4.2, Report prepared by Institute for Materials Testing, page 4, second dash) adhered to the surface in the damage area (sample).
