CHARACTERIZATION OF HELIOSTAT CORROSION

J. E. Shelby, J. Vitko, Jr. and R. L. Farrow
Applied Physics Division, 8342
Sandia National Laboratories
Livermore, CA 94550

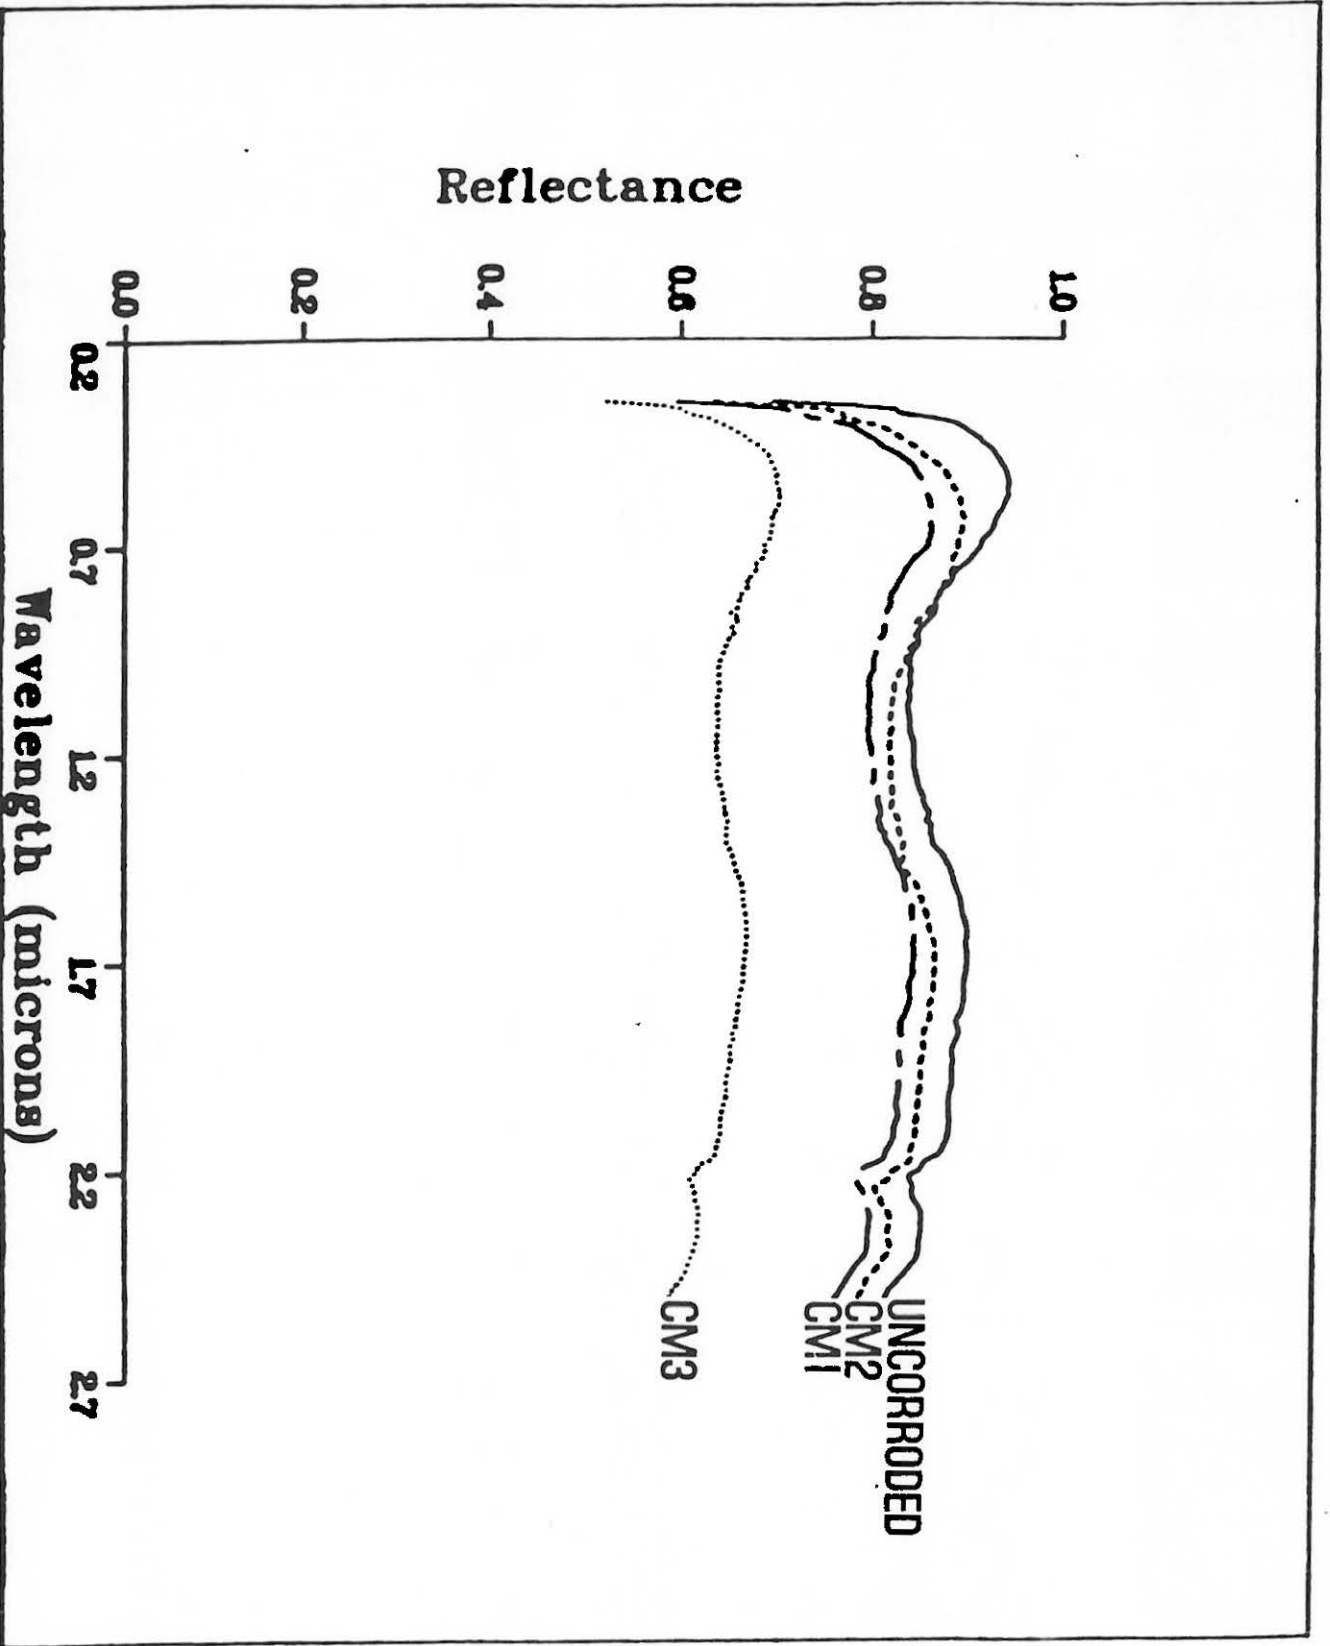
B. HEAT TREATED -- 275 °C

- Figure 6 A comparison of the morphology of an (A) corroded mirror and (B) a heat treated uncorroded mirror.
- Figure 7 Optical properties of uncorroded (solid lines), outdoor exposed (CM1 and CM2, dashed and chain-dashed lines, respectively) and accelerated aged (CM3, dotted lines) mirrors. (A) Specular reflectance of the mirrors. (B) Transmittance spectra of the glass superstrates. (C) Specular reflectance of the silver-glass interface. (D) Difference spectra, obtained by subtracting the reflectance of the corroded interface from that of the uncorroded interface.
