**INSTALLATION AND STARTUP OF THE
FIXED MIRROR SOLAR CONCENTRATOR
COLLECTOR FIELD SUBSYSTEM**

**FINAL REPORT
FOR THE PERIOD JANUARY 31, 1977
THROUGH MARCH 31, 1979**

by
G. H. EGGERS,

Prepared by
General Atomic Company, San Diego, California
for
Sandia Laboratories
under Contract Nos. 07-7195 and 05-4569
and by
Sandia Laboratories, Albuquerque, New Mexico
and **Livermore, California**
for the
United States Department of Energy
under Contract AT(29-1)-789

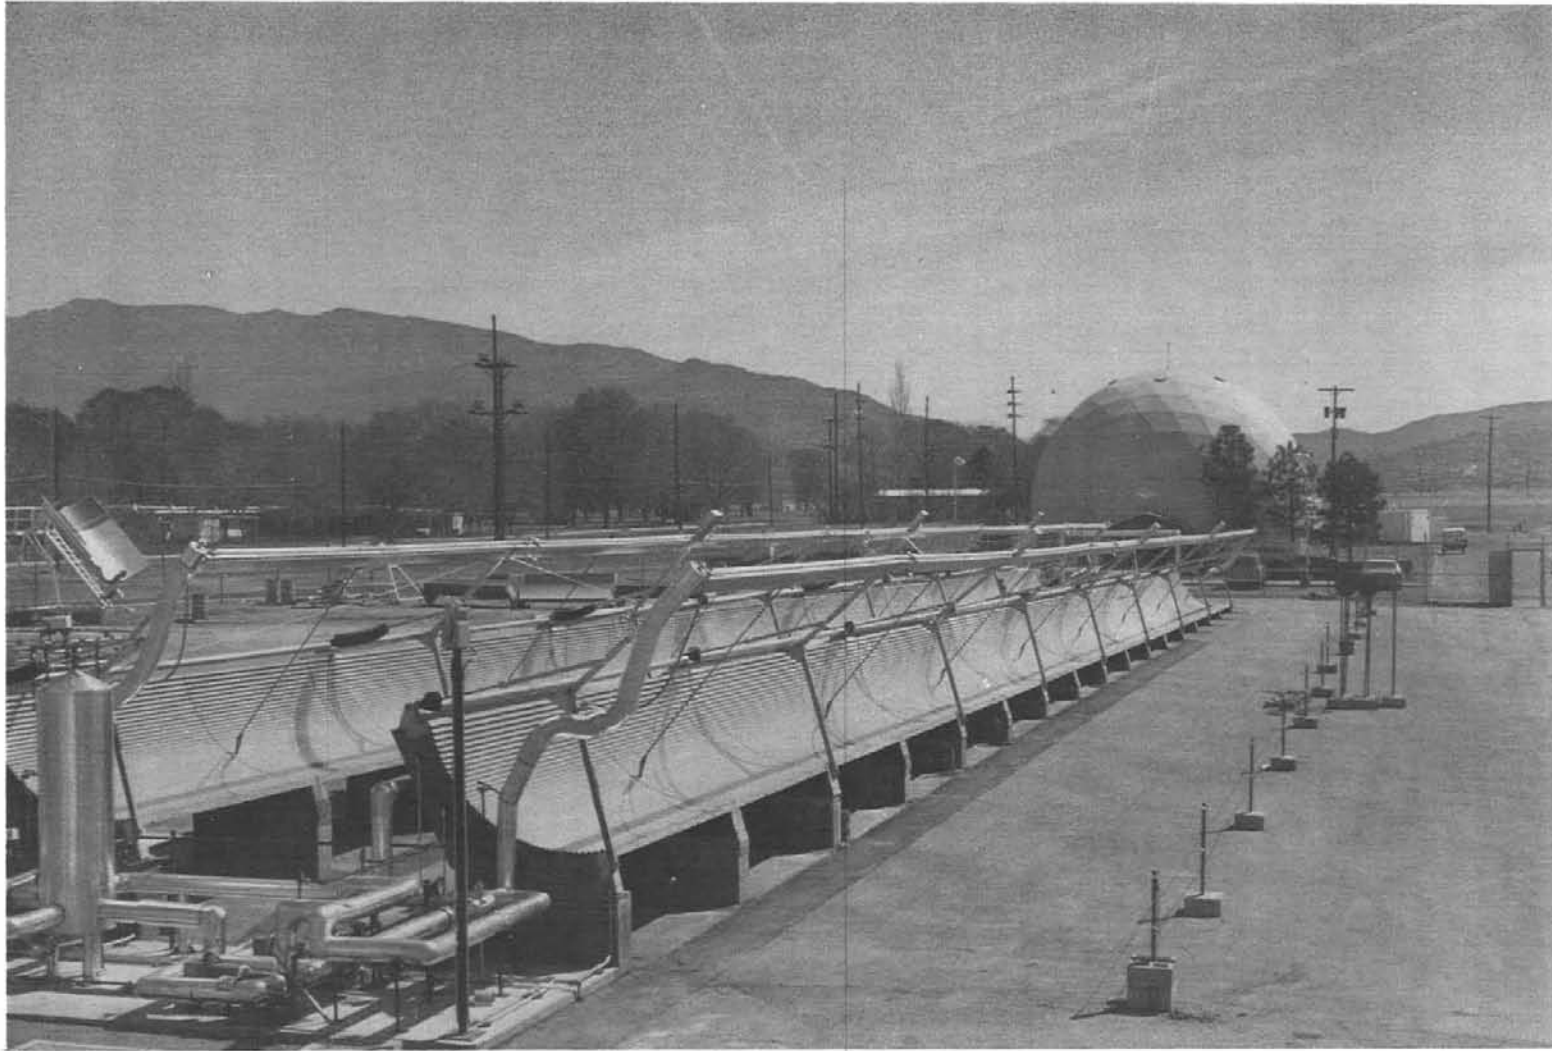
Fig. 1-1. The FMSC collector subsystem installed at Sandia Laboratories' solar total energy test facility

The FMSC subsystem installed at Sandia Laboratories in Albuquerque, N.M., is illustrated in Fig. 1-1. The subsystem consists of two 200-ft-long rows of FMSC collectors with associated piping, valves, buffer tank, instrumentation, and controls. The FMSC subsystem was designed to be essentially an independent unit and the amount of interfacing with other portions of the Sandia system was minimal. The fluid system and control system interfaces were the only two interfaces that had to be integrated into Sandia's system. The FMSC subsystem was provided with the means for receiving warm Therminol 66 heat transfer oil from the Sandia main storage tank, heating the oil, and returning it to the main storage tank. It also is capable of operating in a recirculation mode in which the FMSC subsystem is valved off from Sandia's main system.

width of 2.18 m (7.17 ft.), and contains forty-three 5.1 cm (2 in.) wide facets. The aperture is tilted 32 deg., corresponding to the latitude of Albuquerque, N.M. A module cross section is shown in Fig. 1-2. The modules are set on a foundation and lined up in an east-west row with the aperture facing south. For the subsystem two rows were used, each 61 m (200 ft.) long. The access spacing between the rows is 4.6 m (15 ft.) and the north row is elevated 15.2 cm (6 in.) higher than the south row to minimize the shadowing of the north row by the south row. Figure 1-1 shows the collector viewed from the east end.

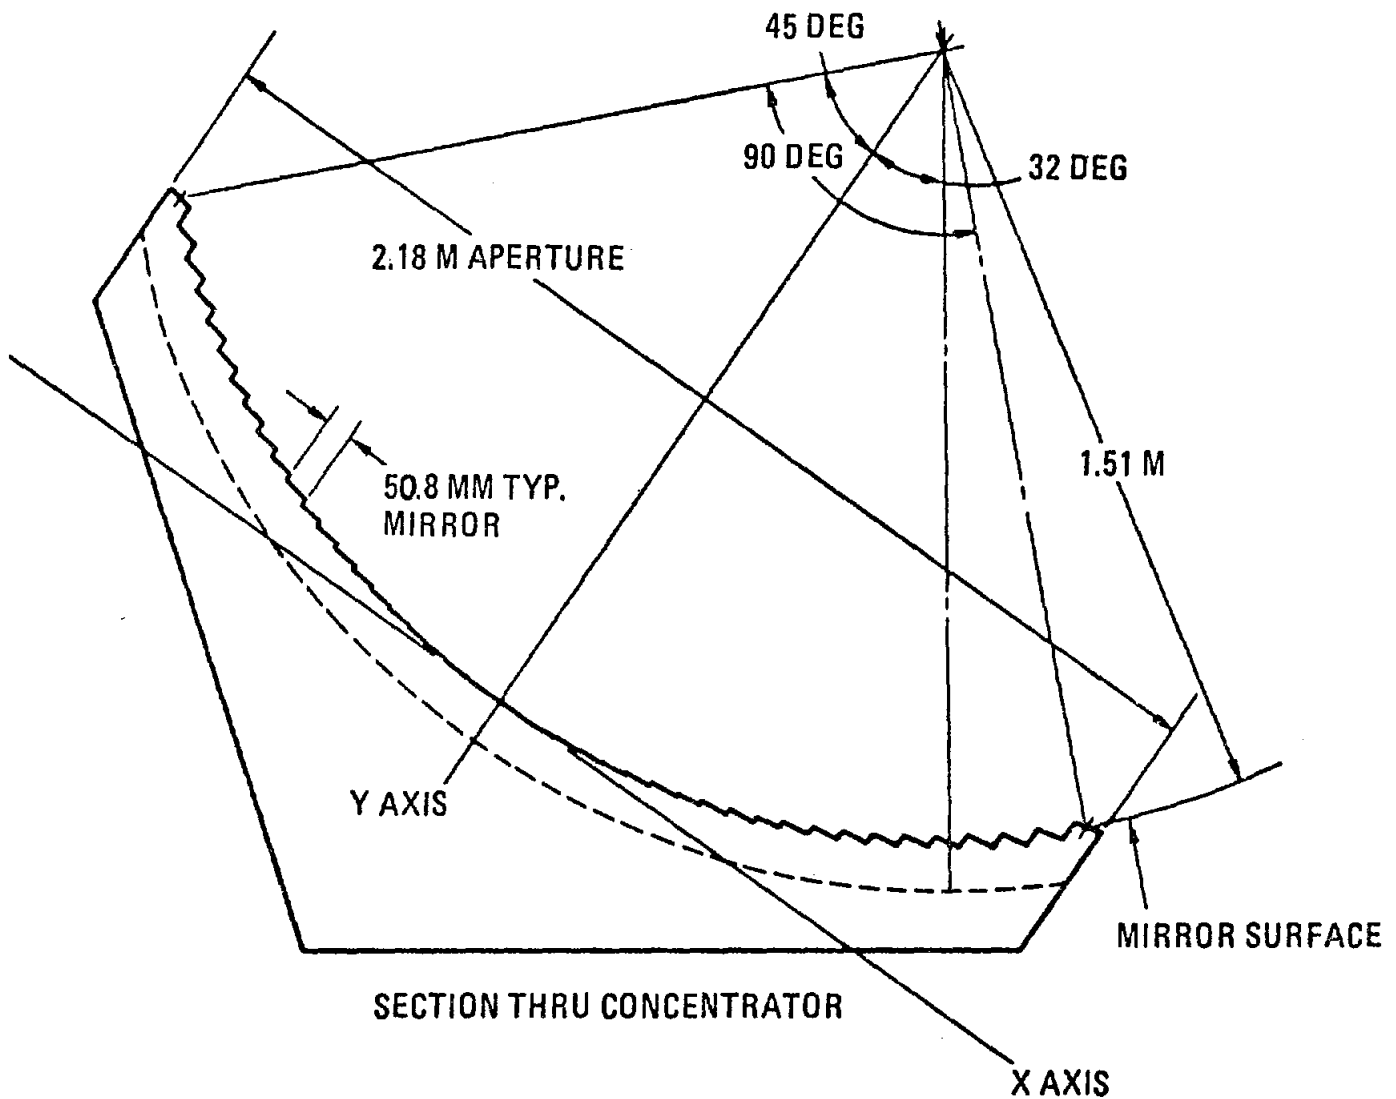
Fig. 1-2. Schematic diagram showing the cross section of the FMSC collector module

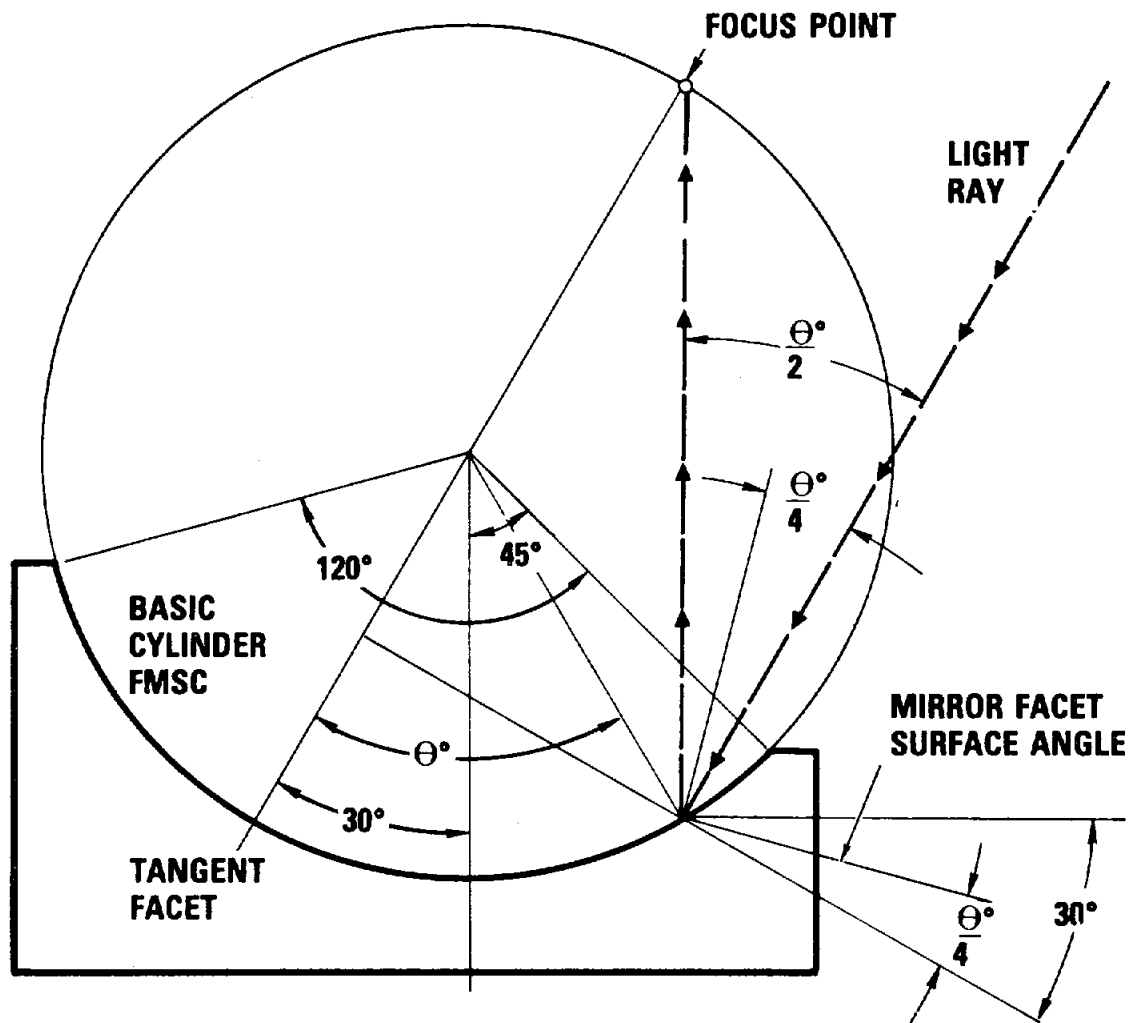
Fig. 1-3. FMSC geometric relationships

Figure 1-3 illustrates the geometric properties of the FMSC. It contains a reference or tangent facet that is just tangent to the reference circle. The surface slopes of other facets then differ from the slope of the tangent facet by one-quarter of the included angle between a facet and the tangent facet.

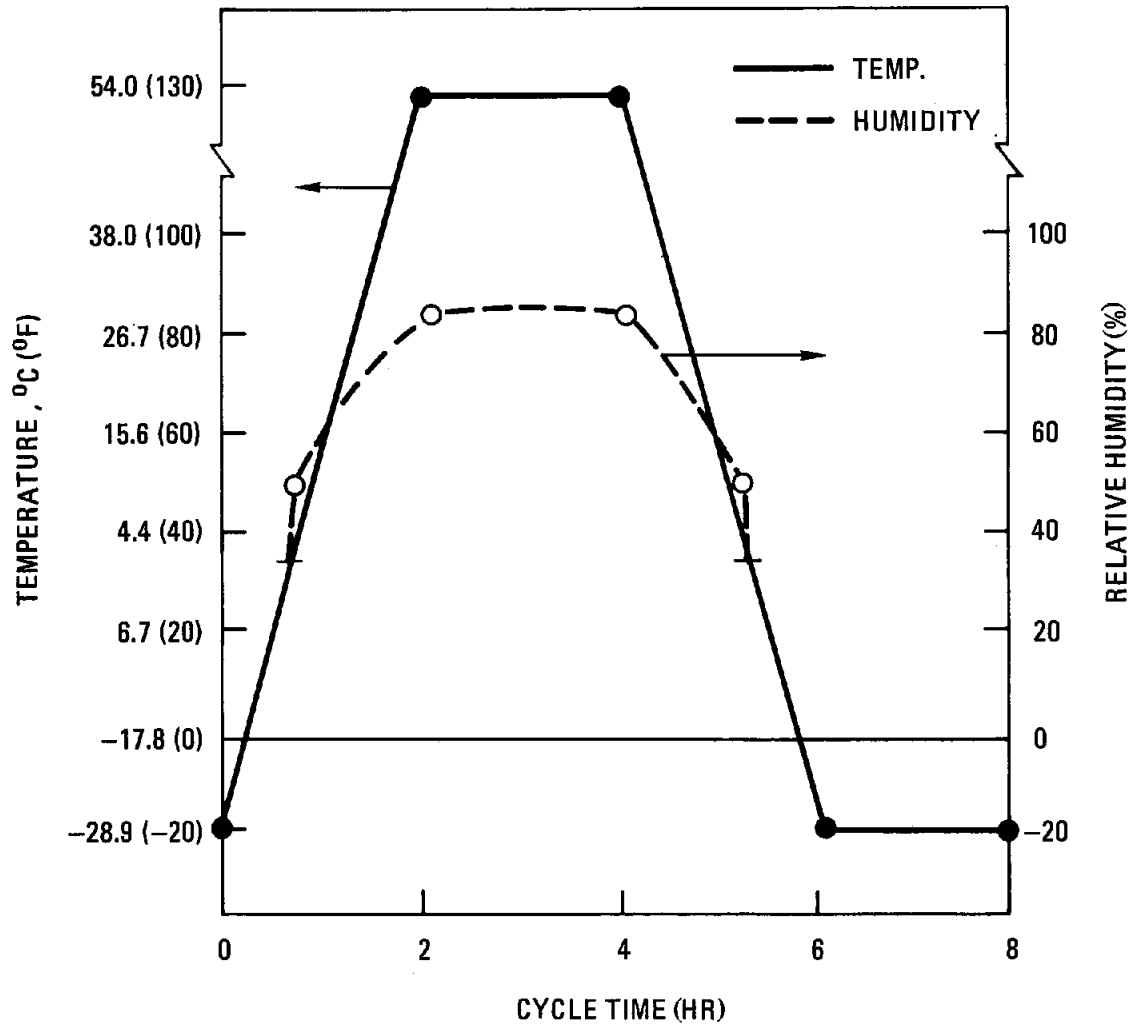
Fig. 2-2. Temperature and humidity as a function of time in the Sandia environmental test chamber for one cycle

The tests conducted in the environmental test chamber exposed mirrors bonded to concrete blocks to 8-hour temperature cycles from -24.5°C (-20°F) to 54.4°C (130°F) and relative humidity from about 20% to 80% as shown in Fig. 2-2. None of the enamel peeled in the test chamber, although some chipping of the composite coating (silver, copper enamel, and polyurethane) was observed after extended exposure.

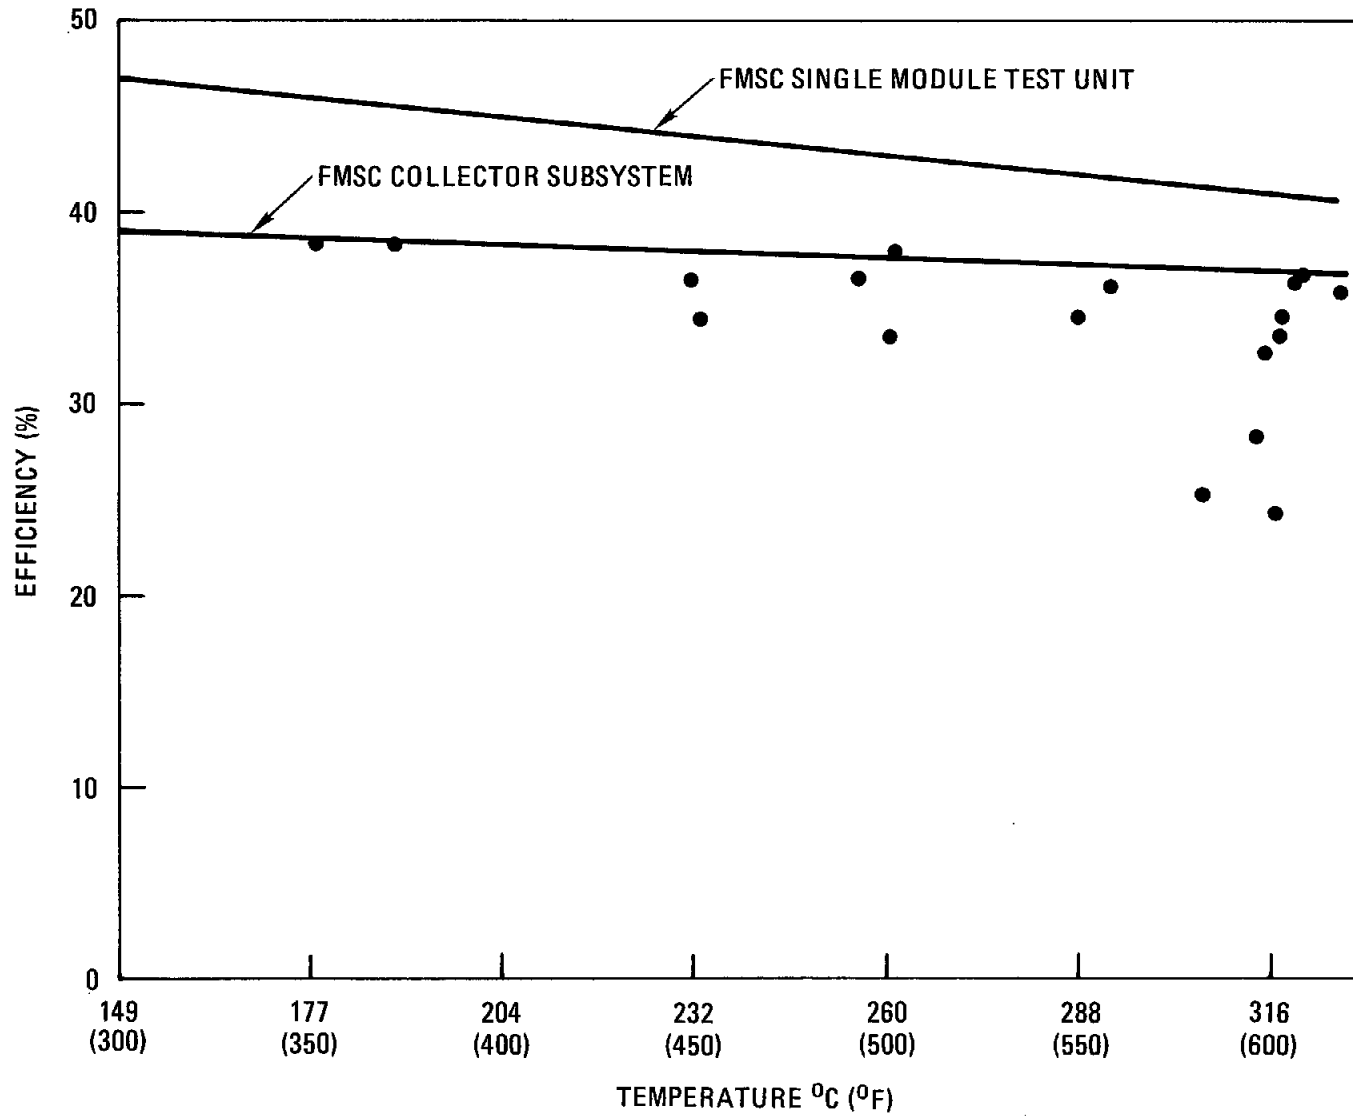
Fig. 3-1. Efficiency as a function of the outlet oil temperature comparing the performance of the test unit with the subsystem

Efficiency as a function of temperature is plotted in Fig. 3-1. The efficiency of the experimental module test unit is also shown for comparison. The effects of dirty mirrors and poor receiver alignment are indicated by the points below the line in Fig. 3-1.

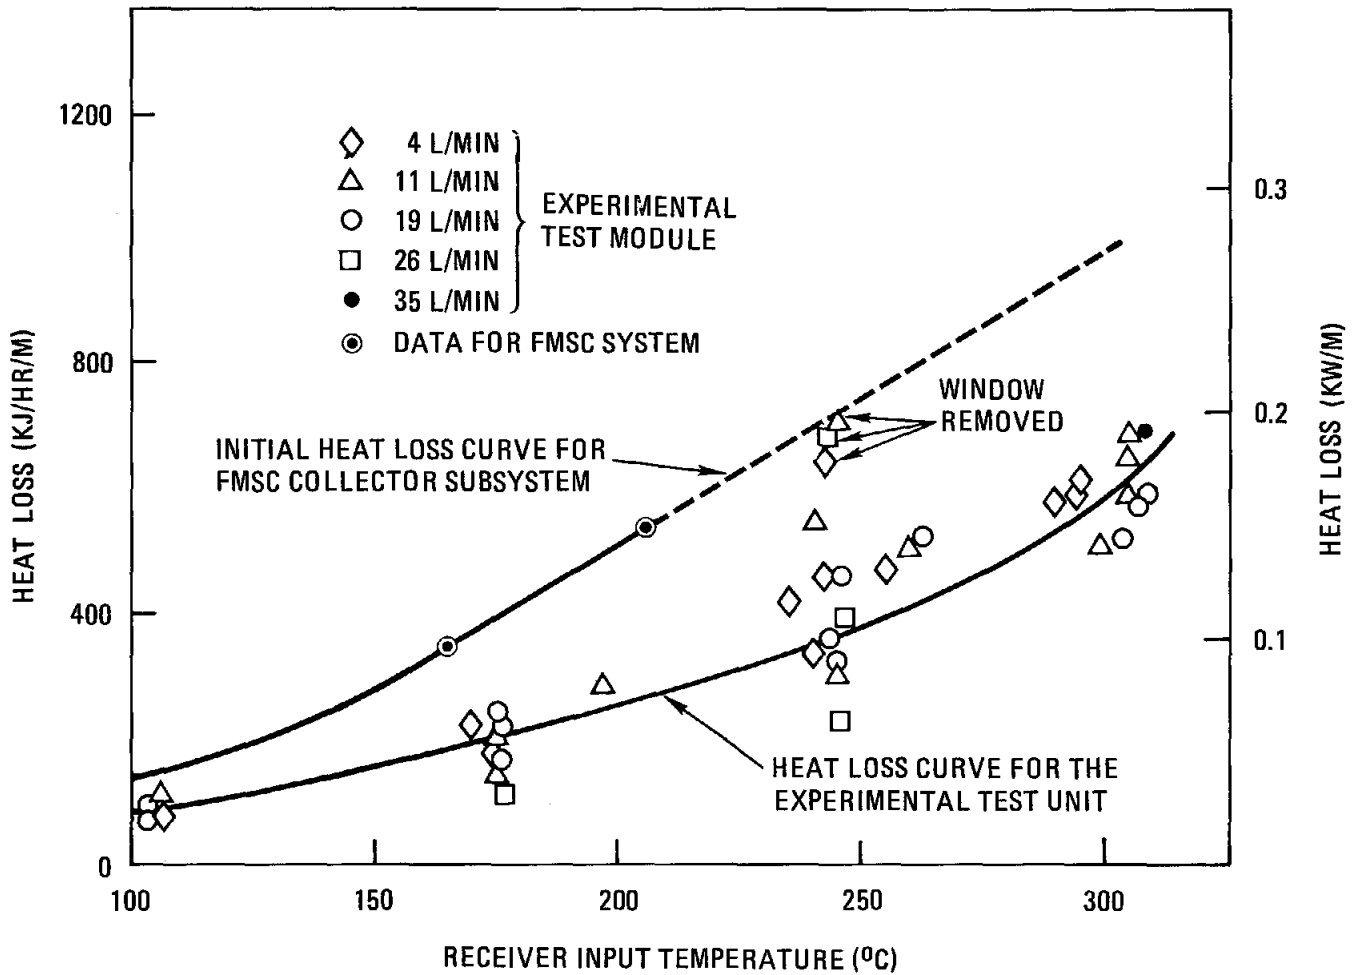
Fig. 3-3. Heat loss curve for the FMSC experimental test unit with the projected heat loss curve based on initial data

Two measurements were made of the heat loss between the inlet and outlet measurement points. One was made at an average fluid temperature of 166°C (332°F), and the other was made at an average fluid temperature of 204°C (399°F). The first measurement gave a total heat loss of 12.67 kW, which is equal to 48.7 W/m² of concentrator aperture. The second measurement gave a total heat loss of 18.54 kW, which is equal to a 71.3 W/m² aperture. This compares to 42.2 W/m² and 59 W/m² at the respective temperatures for the experimental test unit. The data are summarized in Table 3-2 and plotted in Fig. 3-3, which also shows the heat loss curve for the experimental test module.

Extrapolating the curve in Fig. 3-3 linearly to 311°C fluid outlet temperature indicates a heat loss of at least 275 W/m at operating conditions. This is equal to a total loss for the receiver and crossover pipe of 35.2 kW. For a very good solar day with insolation of 1020 W/m², this is a 13.2% loss.

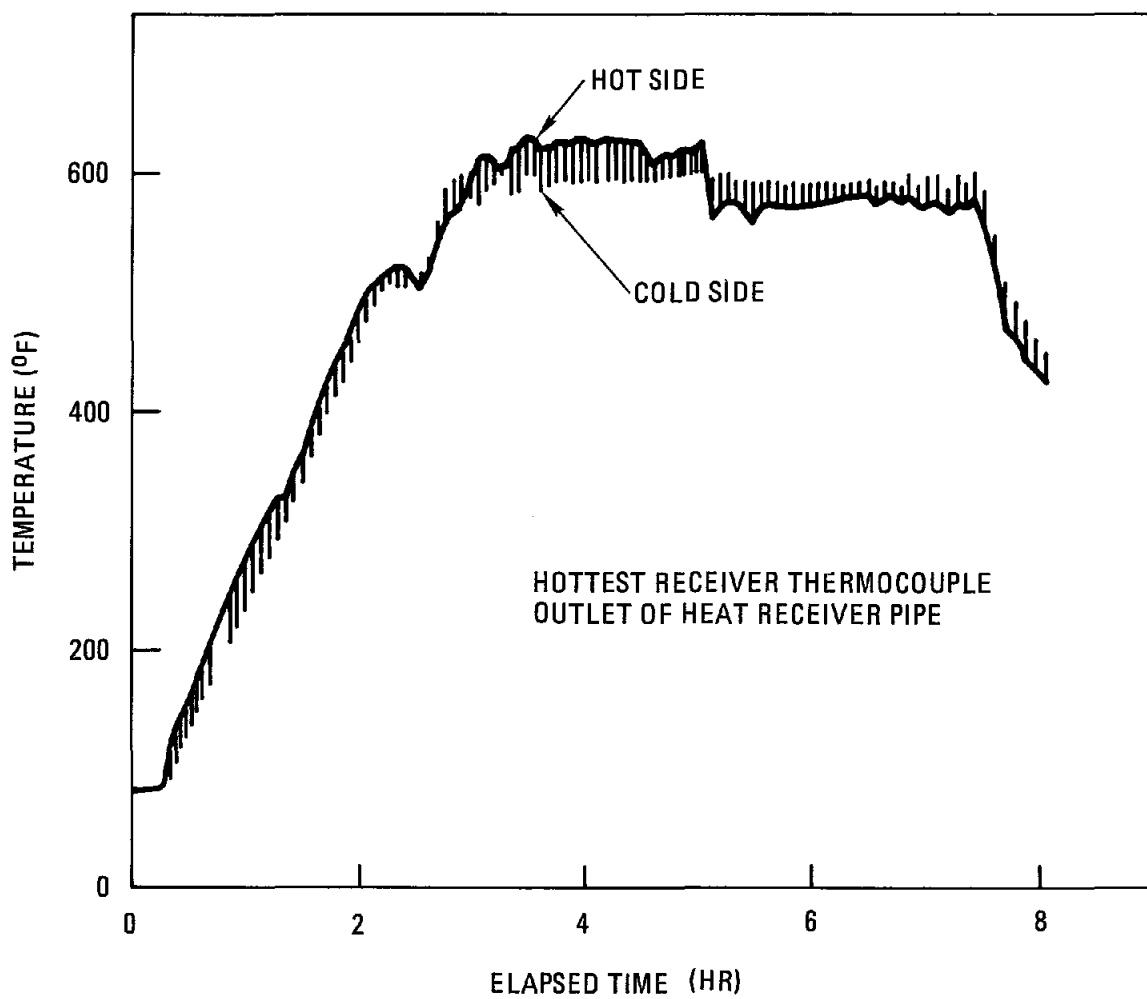
Fig. 3-4. Front and back temperature of the heat pipe as a function of elapsed time for the hottest (outlet end) pipe skin thermocouples. Note the reversal of ΔT polarity after noon

Each set of thermocouples consisted of one iron-constantan and one copper-constantan thermocouple on the exposed or hot face of the heat pipe, and the same type pair on the back side of the heat pipe. The copper-constantan thermocouple on the hot face was used for over-temperature control. The remaining thermocouples were used for data, and their signals could be printed out. A summary of this data is given in Table 3-3. It is noted that the No. 5 thermocouples used for data sometimes indicate a negative ΔT between the front face (exposed to sunlight) and the back face. This says that the exposed face was at a lower temperature than the back face, which is not possible. Therefore, there is some malfunction or incorrect connection. The two thermocouples could have been reversed so that the ΔT would show the back side temperature higher than the front side. The ΔT was about the same in magnitude but opposite in sign. A plot of the hot and cold side pipe temperature throughout the day is shown in Fig. 3-4. This shows the sign reversal of the ΔT between the front and back face occurring

about noon. This sign change occurred on only a few days, and was recorded properly at other times as shown in Fig. 3-5 and Table 3-3. Figures 3-4 and 3-5 are for one day's run of the No. 5 location near the outlet. The ΔT for the other four locations and for a number of other data runs are given in Table 3-3.

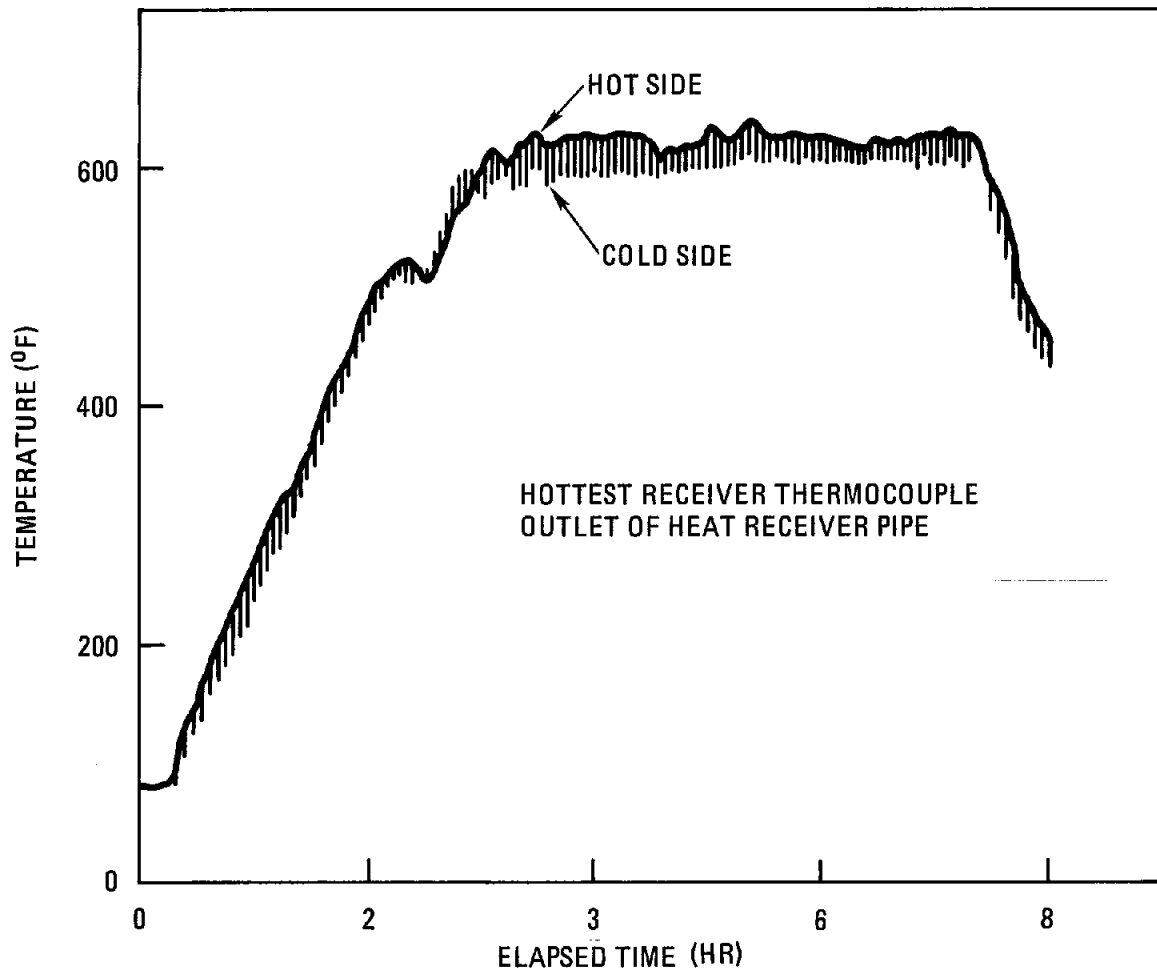
Fig. 3-5. Front and back temperature of the heat pipe as a function of elapsed time for the hottest (outlet end) pipe skin thermocouples

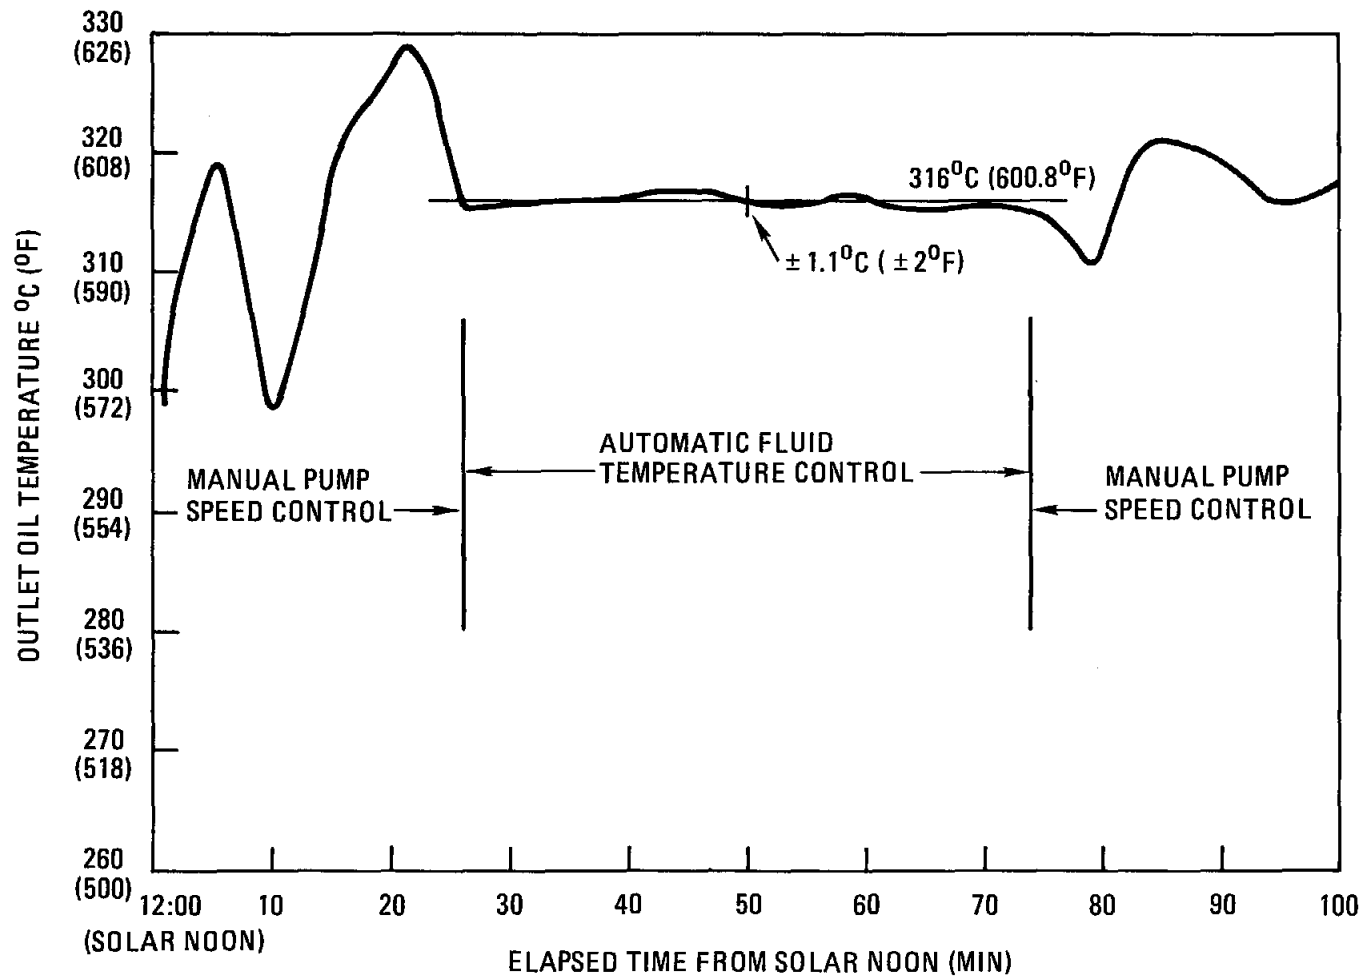
Fig. 3-8. Outlet fluid temperature versus time after adjustment and calibration of automatic fluid outlet temperature control

In January 1979, after the receiver was repaired and the system operated, the final adjustments were made. Figure 3-8, a plot of the fluid

outlet temperature as a function of elapsed time, shows that the fluid outlet temperature is being controlled to $316^{\circ}\text{C} \pm 1.1^{\circ}\text{C}$ ($600.8^{\circ}\text{F} \pm 2^{\circ}\text{F}$). Additional testing was attempted, but bad weather prevented successful test completion. The temperature control was set to regulate the outlet oil temperature to 316°C (600.8°F) so that the oil delivered to Sandia's hot storage tank would be $311^{\circ}\text{C} \pm 2^{\circ}\text{C}$ ($592^{\circ}\text{F} \pm 5^{\circ}\text{F}$). The control system, therefore, controls the oil temperature well within the required bracket.
